Allnorth Information		VICTORIA GOLD CORP.	
Project #:	2302851	Client Project #:	
Document #:	2302851-800-001	Client Document #:	
Document Rev. #:	0	Client Doc. Rev.#:	
Prepared By:	Spencer Bergin, P.Eng.	Client Contact:	Hugh Coyle
Reviewed By:	Don Williams, P.Eng.

Annual Physical Stability Assessment Report – Victoria Gold – Eagle Gold Project

Visual inspection of the following structures: Open Pit, Platinum Gulch Dump, Eagle Pup Dump, Lower Dublin South (Control) Pond, Primary Crusher, Secondary & Tertiary Crushers, Secondary Stockpile, Adsorption, Desorption and Recovery (ADR) Plant, Heap Leach Facility, Heap Leach Overburden Stockpile, Event Pond, Emergency Pond, Ditches A, B, and C, Heavy Duty Truck Shop, Warehouse Pad, Water Treatment Plant, Orica Laydown, Various Un-named Stockpiles.

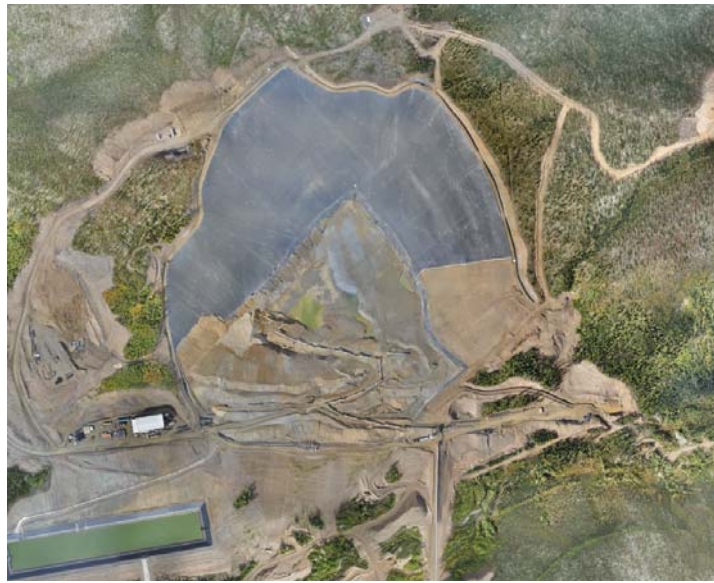
**Figure 15: Heap Leach Facility Overview 2020**

1. The Heap Leach Facility (HLF) is currently operational. In 2019 the Phase 1A expansion had been constructed as shown in Figure 14. By the time of the 2020 inspection the Phase 1B expansion was largely complete as shown in Figure 15. During the 2021 inspection land was being cleared and graded for the Phase 2 expansion as shown in Figure 16, and for the 2022 inspection liner was installed on part of the cleared area (Figure 17). The Phase 2 expansion was complete as of this years inspection (Figure 18).

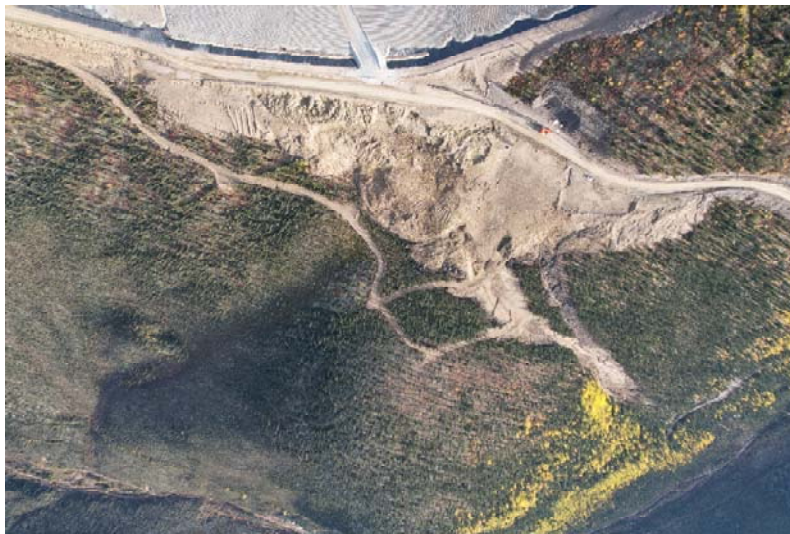
**Figure 24: HLF Overburden Stockpile collapse – plan view 2022**

shifted and partially collapsed some time in the late summer of 2021, roughly 4 – 5 weeks prior to the 2021 inspection (Figure 23). Since the 2021 inspection the collapsed area has been re-sloped (Figure 24, Figure 25). Some minor cracking was noted on the re-sloped surface (Figure 26). The area had also been seeded with grass by helicopter and the grass was starting to sprout at the time of this inspection.

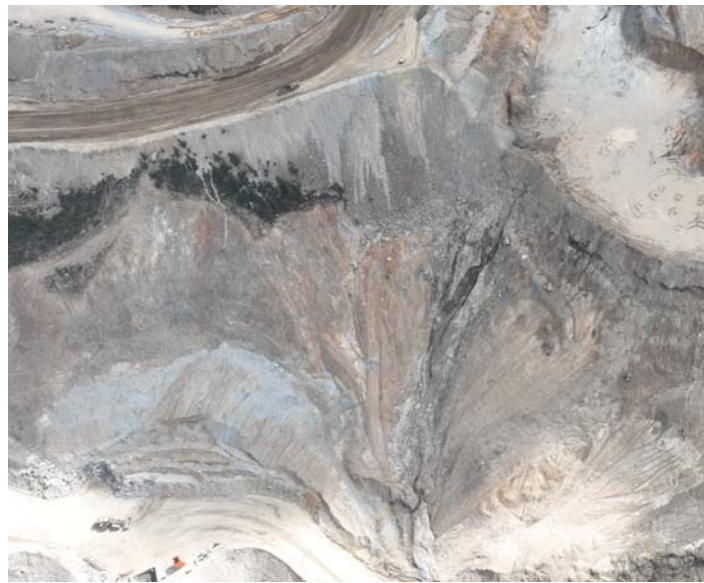
**Figure 30: Open Pit Erosion – Aerial View 2023**

2. There is a section between the open pit and the eagle pup dump where run-off had eroded a cut into the slope above the primary crusher access road prior to the 2022 inspection (Figure 29). The cut is still present but appears to have partially collapsed in on itself (Figure 30).

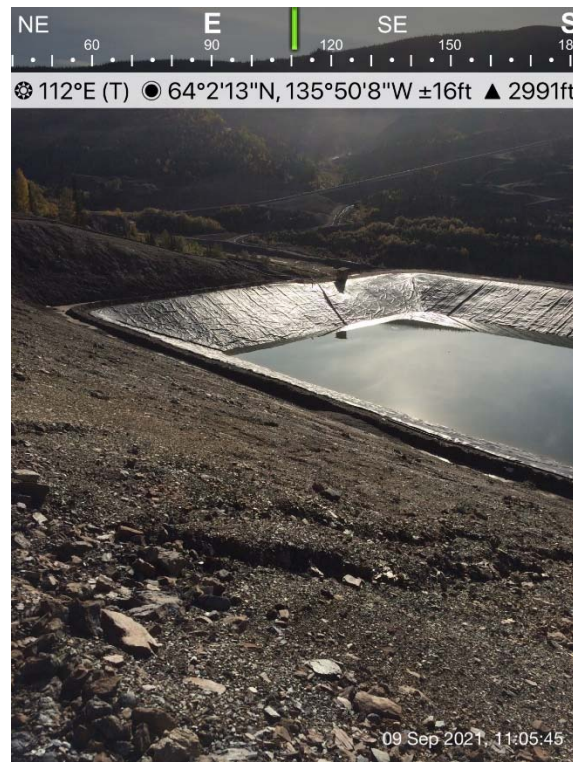
**Figure 53: Pooling water above Event Pond 2021**

1. Pooling water appeared to be forming above the North-East corner of the Event Pond at the time of this inspection (Figure 51). Pooling water had also been noted in this location on the 2022, 2021, and 2020 inspections (Figure 52, Figure 53, Figure 54).

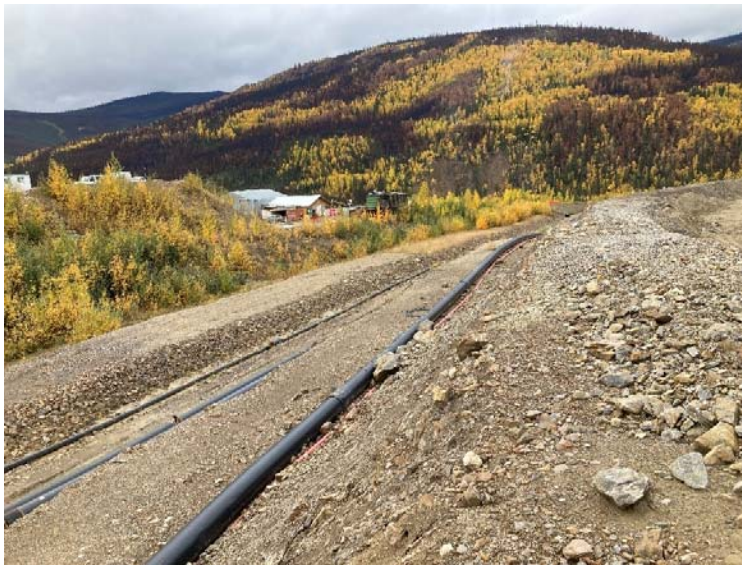
**Figure 64: Ditch C with WTP Pipeline**

1. Diversion Ditch C begins at the 1500mm outlet culvert for the Control Pond and terminates in Haggart Creek. This ditch acts as both an emergency spillway if the Control Pond is filled over capacity. At this point Ditch C is not in use as water from the LDSP is being pumped direct to the Water Treatment Plant (Figure 64).

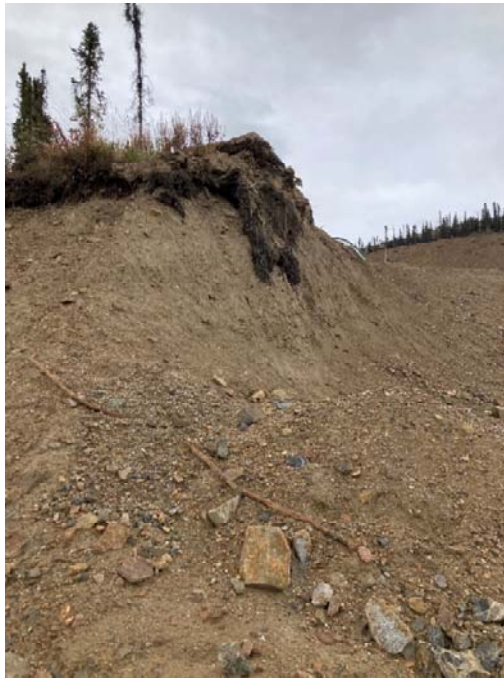
**Figure 66: Over Steepened Slope – Truck Shop**

2. There is a section of over-steepened cut slope near the North-West corner of the truck shop pad. Material can be seen collecting at the base of the over steepened slope (Figure 66).

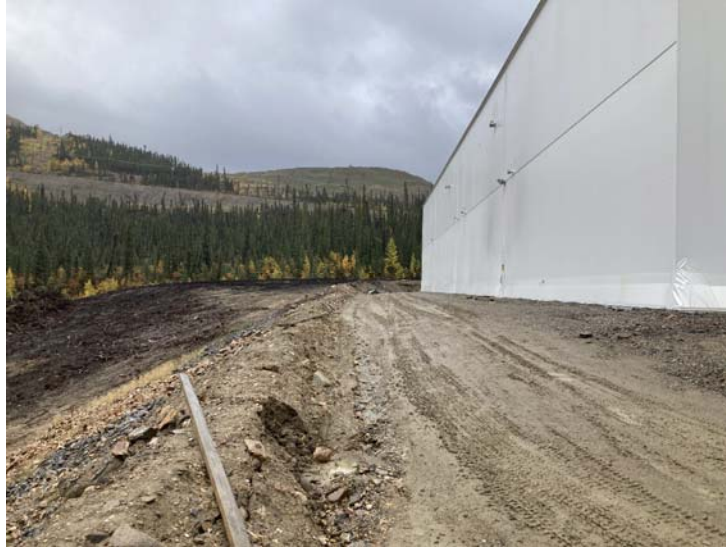
**Figure 69: Water Treatment Plant Slopes**

1. A water treatment plant was under construction during the 2022 inspection and has since been completed adjacent to Ditch C. Slopes surrounding the water treatment plant pad appear stable (Figure 69).

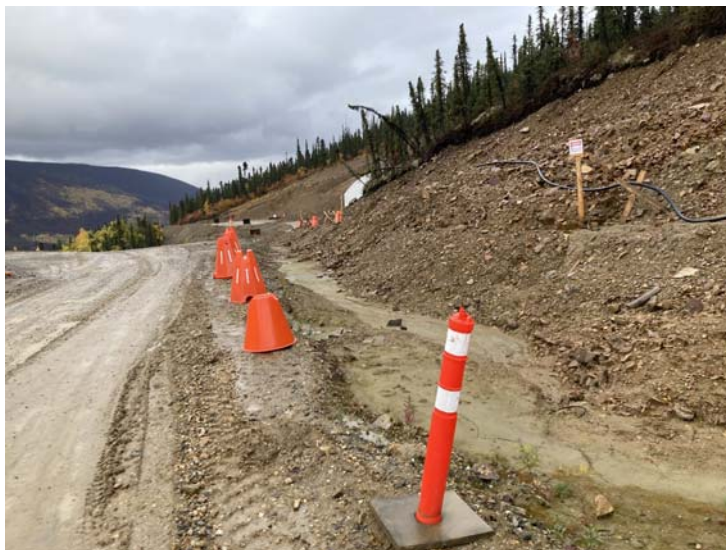
**Figure 70: Orica ditch sediment build-up**

1. An unlined, unarmored ditch from the portable structures of the laydown has pools of sediment (Figure 70) but the overall grade of the ditch continues to flow to the sump (Figure 71) uninterrupted.

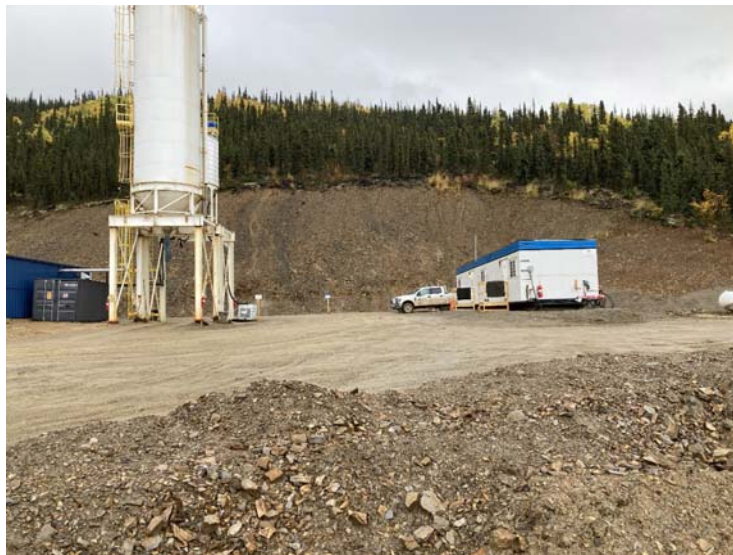
**Figure 73: Orica site trailer new location (2023)**

2. Between the 2021 and 2022 inspections sediment and material accumulated behind the Orica site trailer from the cut slope behind it (Figure 72). The trailer has since been moved South to a new location where it does not back against a cut slope (Figure 73). The area where the trailer formerly sat has been re-graded (Figure 74).
