Allnorth Information		VICTORIA GOLD CORP.	
Project #:	<b>19-PG-0305</b>	Client Project #:	
Document #:	<b>191029</b>	Client Document #:	
Document Rev. #:	<b>0</b>	Client Doc. Rev.#:	
Prepared By:	Jordan Smith, EIT	Client Contact:	Richard Tuohey
Reviewed By:	Don Williams, P.Eng.

Annual Physical Stability Assessment Report – Victoria Gold – Eagle Gold Project

Visual inspection of the following structures: Open Pit, Platinum Gulch Dump, Lower Dublin South (Control) Pond, Secondary Crusher, Primary Crusher, 90 Day Stockpile, Adsorption, Desorption and Recovery Plant, Heap Leach Facility, Event Pond, Ditch A, B, and C, Former Nuway Crusher Pad, Orica Laydown, Various Un-named Stockpiles.

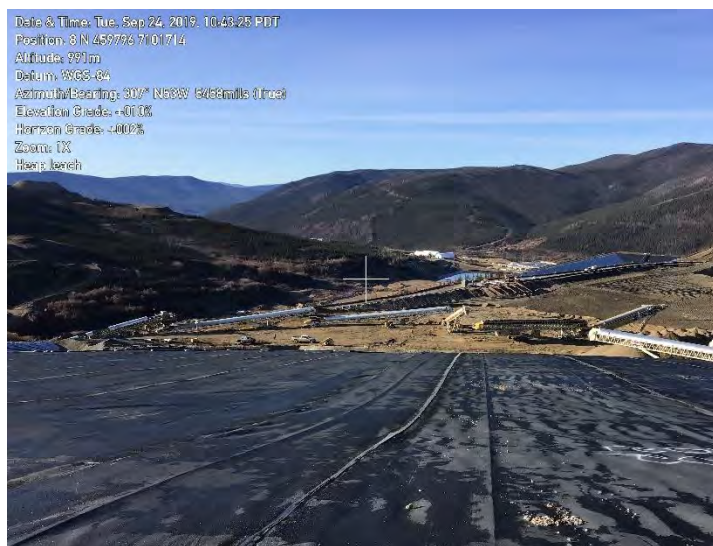
**Figure 12: Heap Leach Facility Overview**

The Heap Leach Facility (HLF) is currently operational including the deployment of irrigation network and the placing of over-liner drain fill on the phase 1A pad area (Figure 12).
