## **EAGLE GOLD PROJECT**

WATER LICENCE QZ14-041-01

QUARTZ MINING LICENSE QML-0011

2019 ANNUAL REPORT

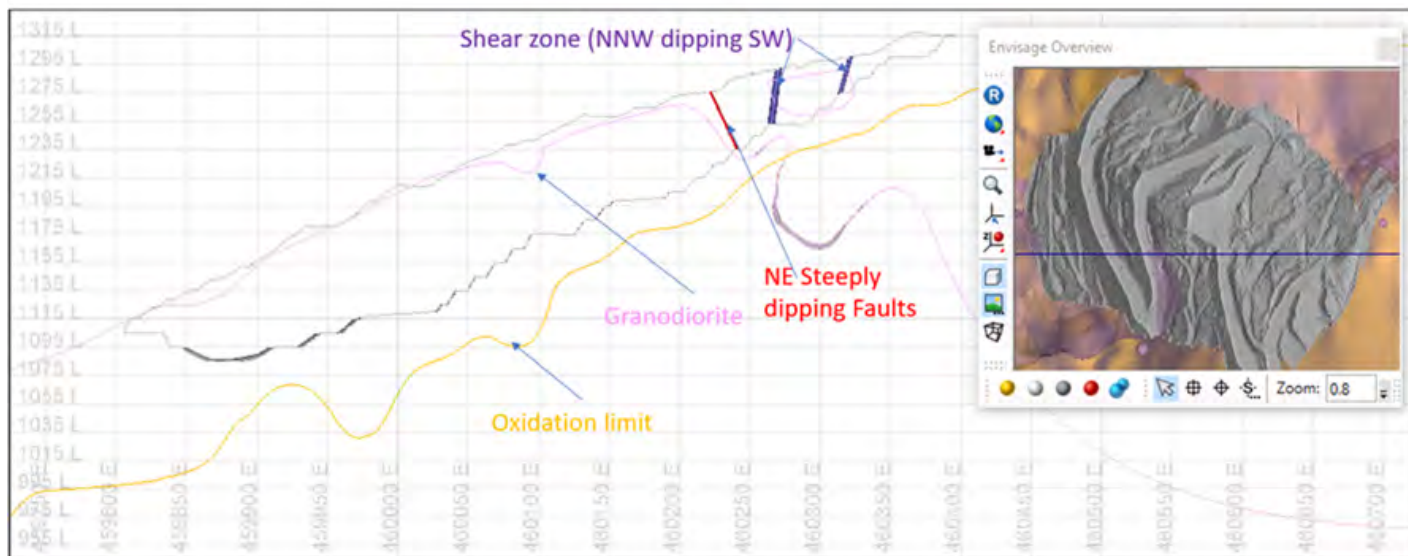
Figure 4.1-2: Eagle Pit Phase 1 - East-West Vertical Section Looking North

The majority of the pit wall developed was still within the upper highly weathered rock mass (Figure 4.1-2). While there have been localized wedge failures in the upper benches associated with a broad shear zone and steeply dipping faults (Figure 4.1-3 and Photos 4.1-1 and 4.1-2), overall, the wall stability is performing as per design. These localized failures were remediated and stabilized as they were encountered with the use of excavators and dozers.

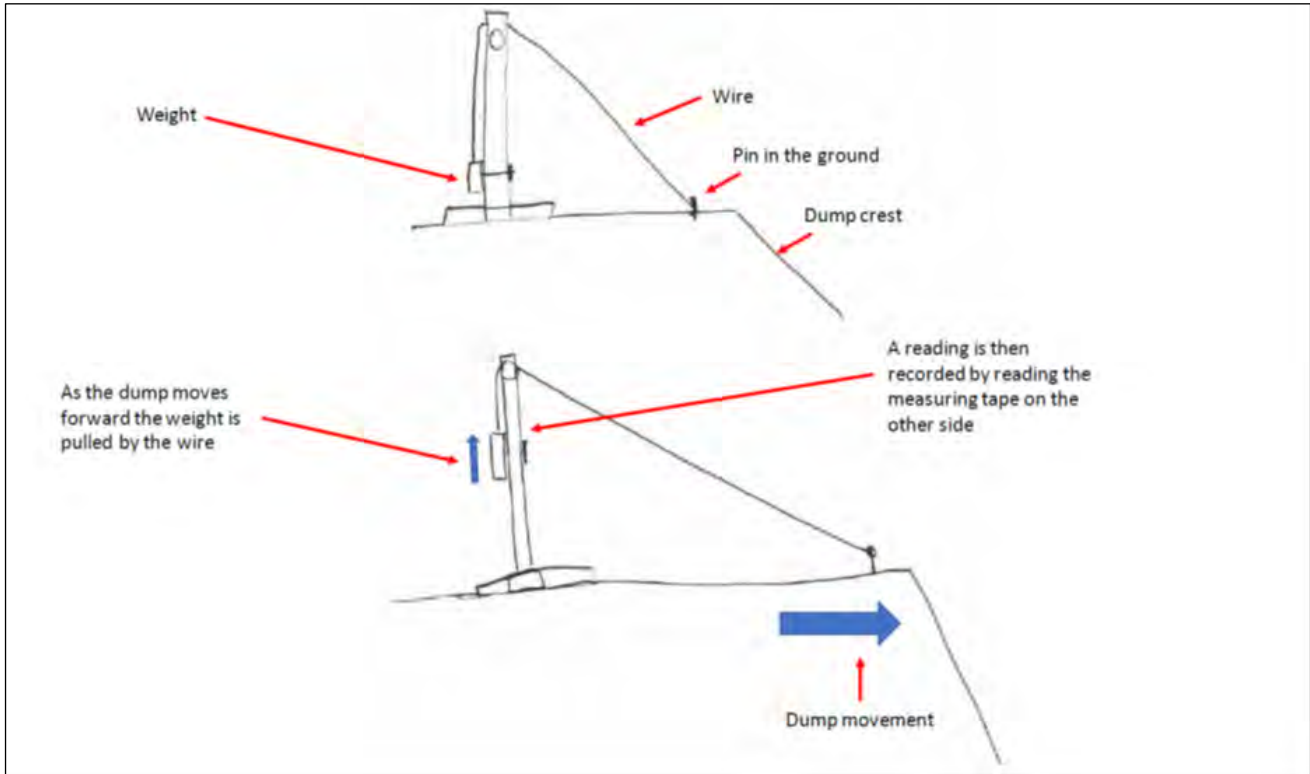
**Figure 4.2-1: Diagram of Extensometer Deployed on an Active WRSA Lift**

Active lifts of the WRSA were monitored for movement using extensometers on a regular basis and results were recorded. Calculations on these measurements were conducted on a regular basis to determine the rate the structure is moving. Figure 4.2-1 provides examples of how the extensometer data is being used.

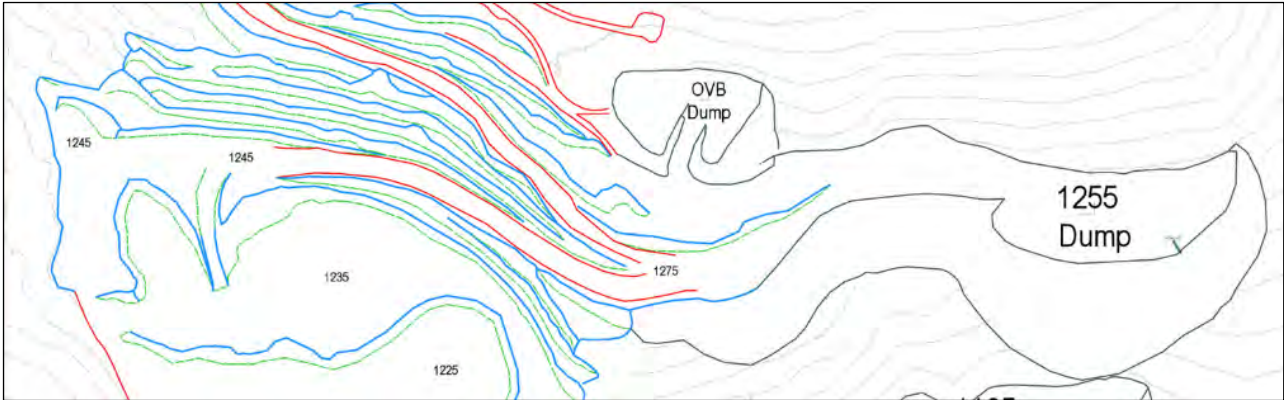
**Figure 4.2-2: Location of 1255 Pin Line 1 Extensometer on PGW RSA 1255 Lift**

Table 4.2-1 provides the movement rate thresholds for guiding the monitoring activities. Figure 4.2-2 and Figure 4.2-3 illustrate the locations of extensometer monitoring pin lines on the 1255 and 1155 dump lifts, respectively.

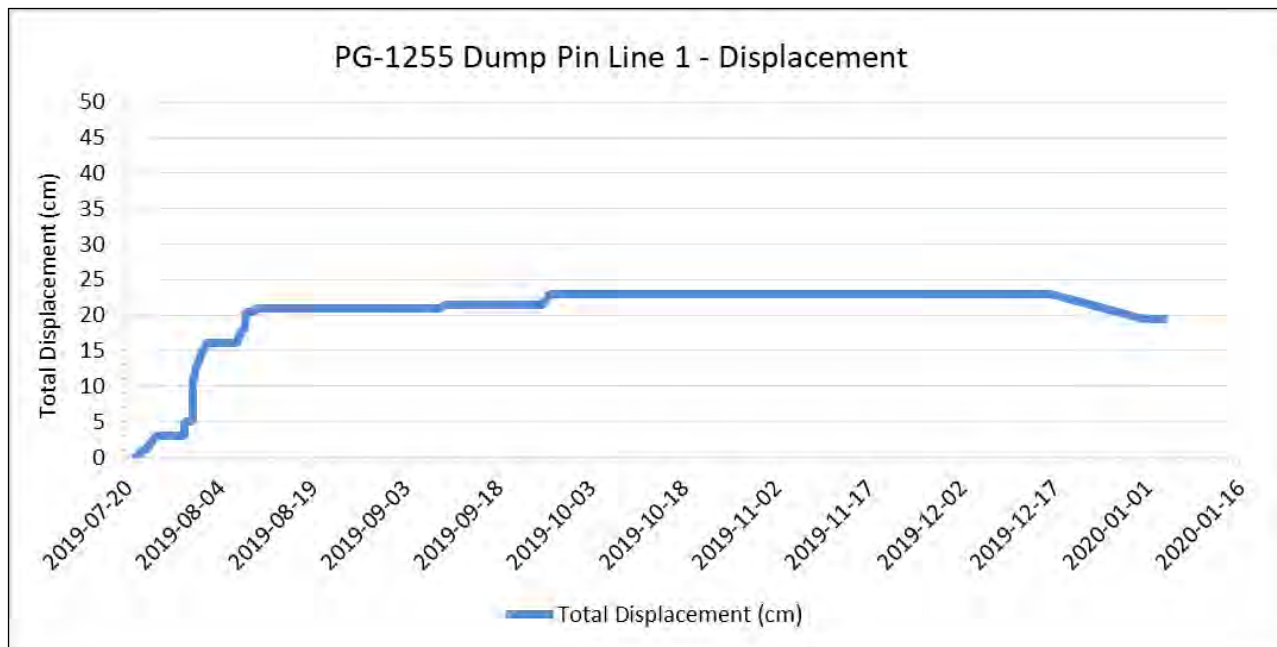
Figure 4.2-4: Total Displacement for the 1255 Pin Line 1 During 2019

Figure 4.2-4 through Figure 4.2-7 illustrate the results of extensometer monitoring for the 1255 and 1185 lifts of the PG W RSA. Movement rates are well below the thresholds listed in Table 4.2-1. The Platinum Gulch W RSA is performing as per design.

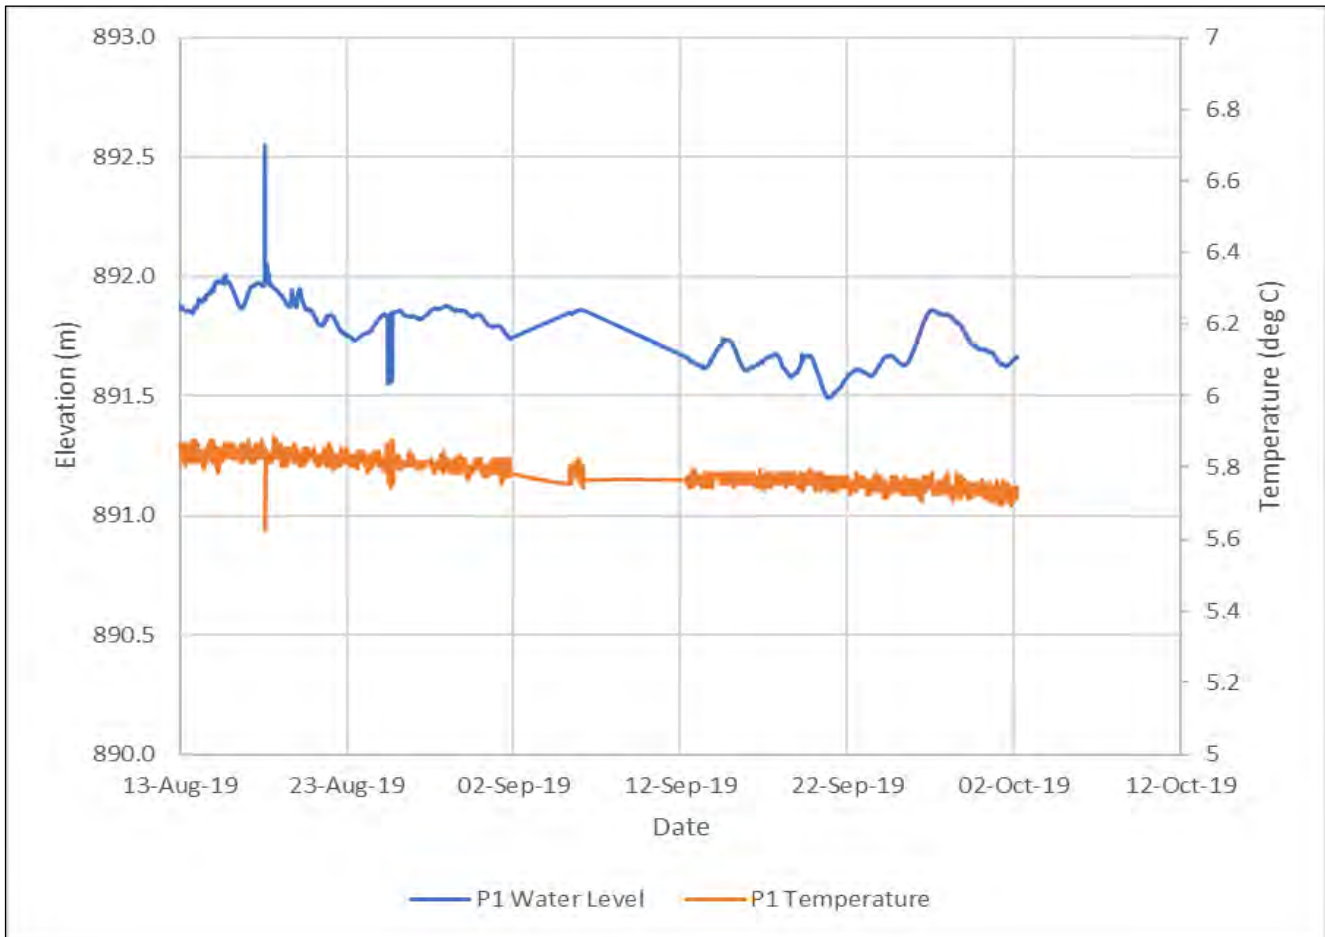
**Figure 4.3-2: Piezometer P1 Readings**

Three standpipe piezometers were installed through the HLF dam crest in 2018 (BGC 2018), and then were later installed with vibrating wire piezometers in early August 2019. Table 4.3-1 presents the most recent readings converted to water level elevation for each piezometer. Piezometer P1 was installed into the dam foundation bedrock and Piezometers P2 and P3 were installed in the dam fill just above the western and eastern underdrains, respectively. Piezometers P2 and P3 have been reportedly dry since installation. The water level in P1 reflects groundwater in the fractured and weathered bedrock foundation. The well log for P1 indicates a bedrock contact elevation of about 899.5 m asl. The water level readings since mid-August for P1 are presented in Figure 4.3-2 and reflect a general downward trend.
