Alexco Resource Corp.
3 – 151 Industrial Road
Whitehorse, YT Y1A 2V3

ISSUED FOR USE – REVISION I

FILE: W14103450-01

Subject: 2014 Annual Inspection – Surface Engineered Earth Structures
Bellekeno Mine, Keno City, YT

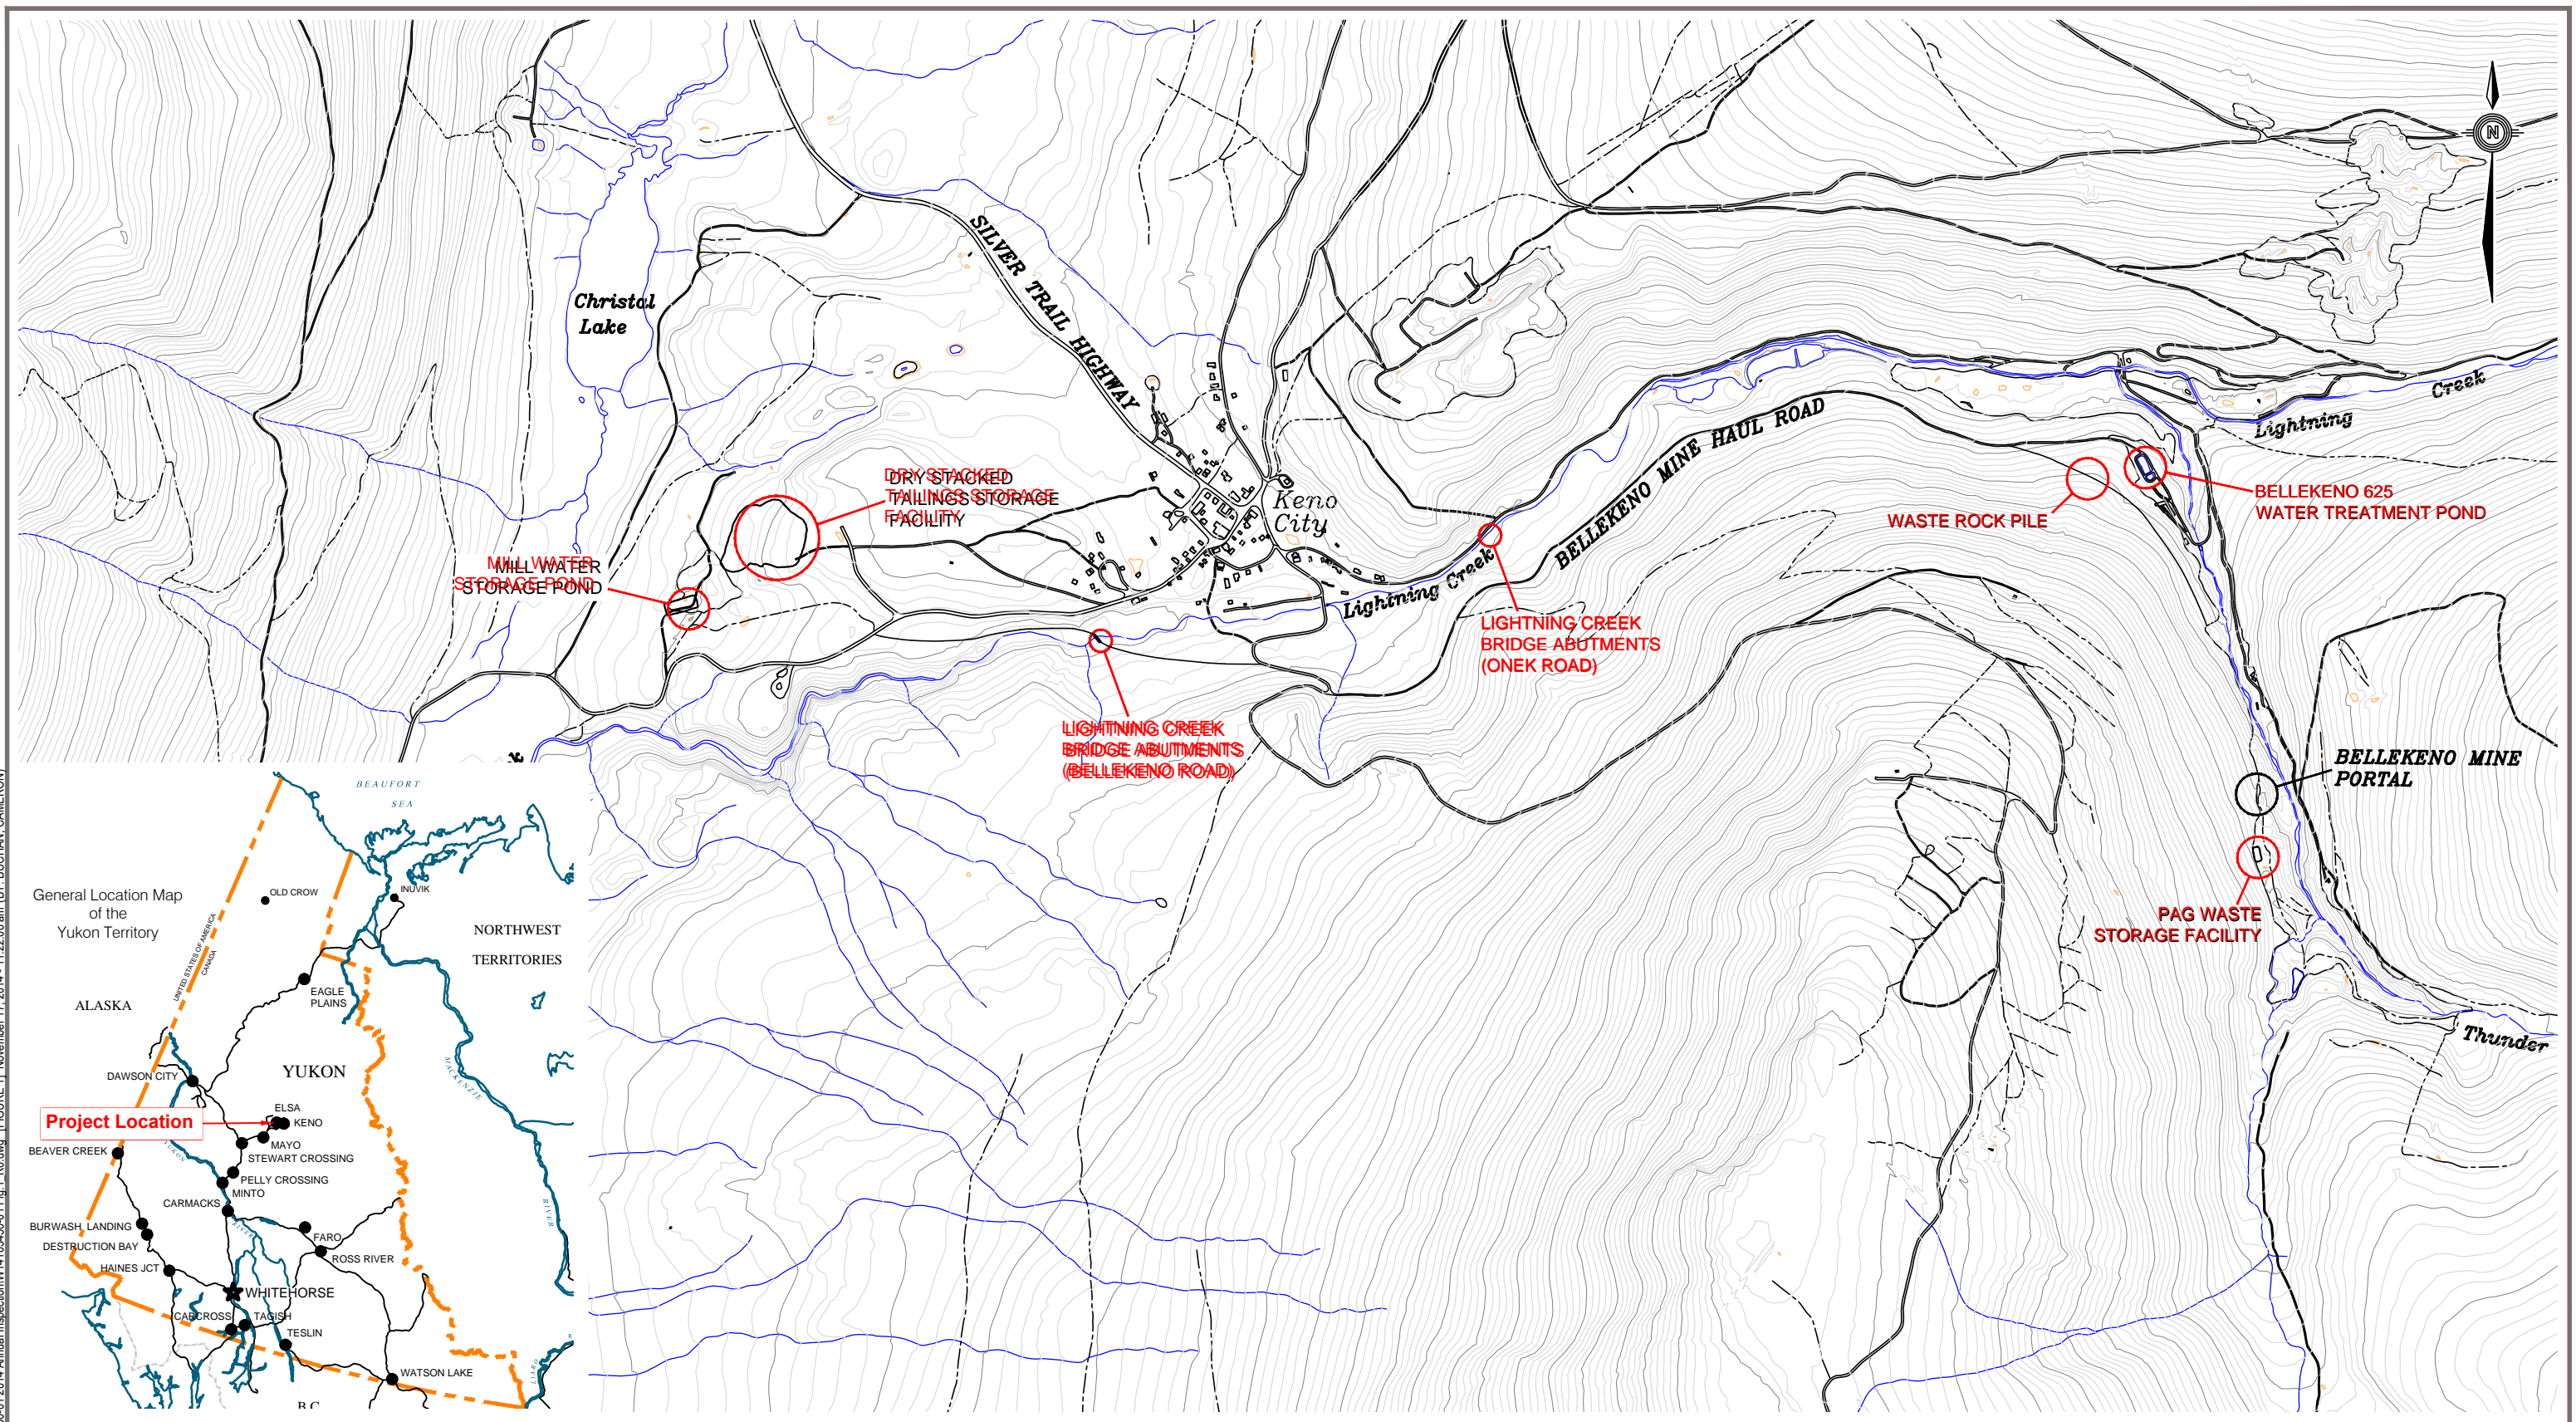
Figure 1

The location of each structure is shown on Figure 1.

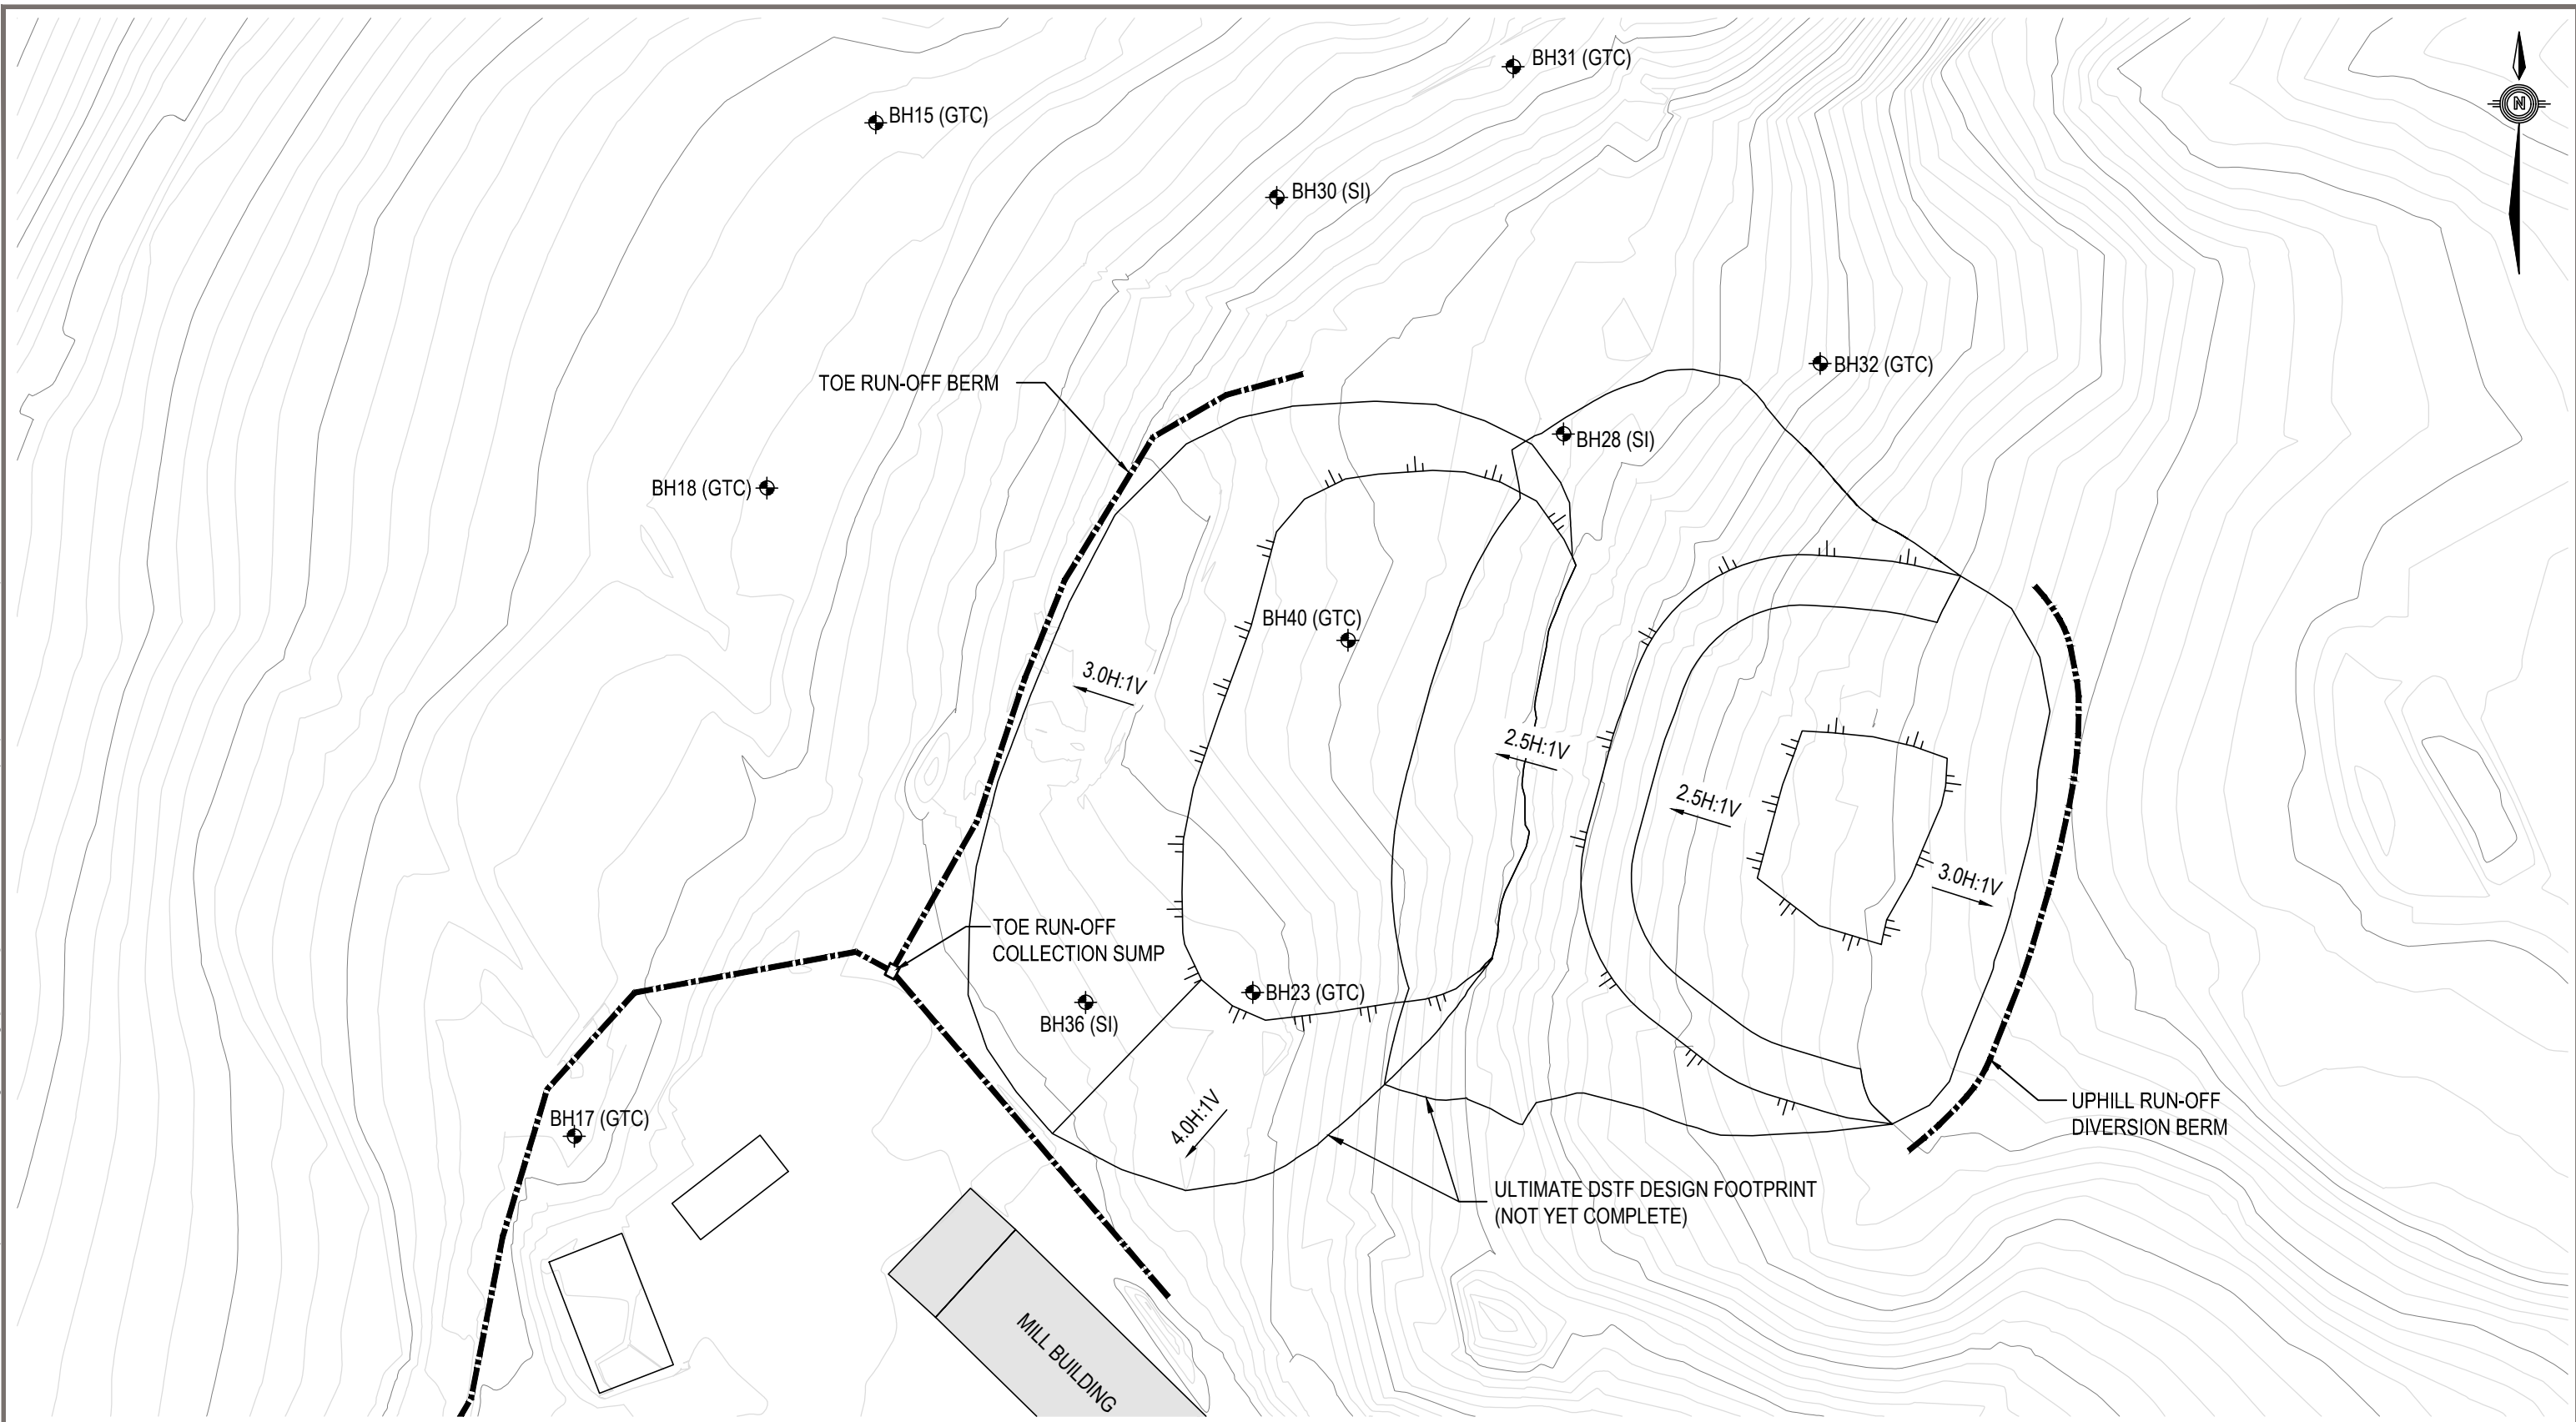
Figure 2

Performance of the DSTF is monitored with compaction testing during tailings placement and regular instrumentation readings. DSTF instrumentation consists of seven ground temperature cables installed to monitor permafrost conditions (six in natural soils adjacent to the DSTF and one through tailings placed within the DSTF footprint) and three slope indicators installed to monitor lateral movement of the frozen foundation soils. The locations of installed instrumentation are shown on Figure 2.

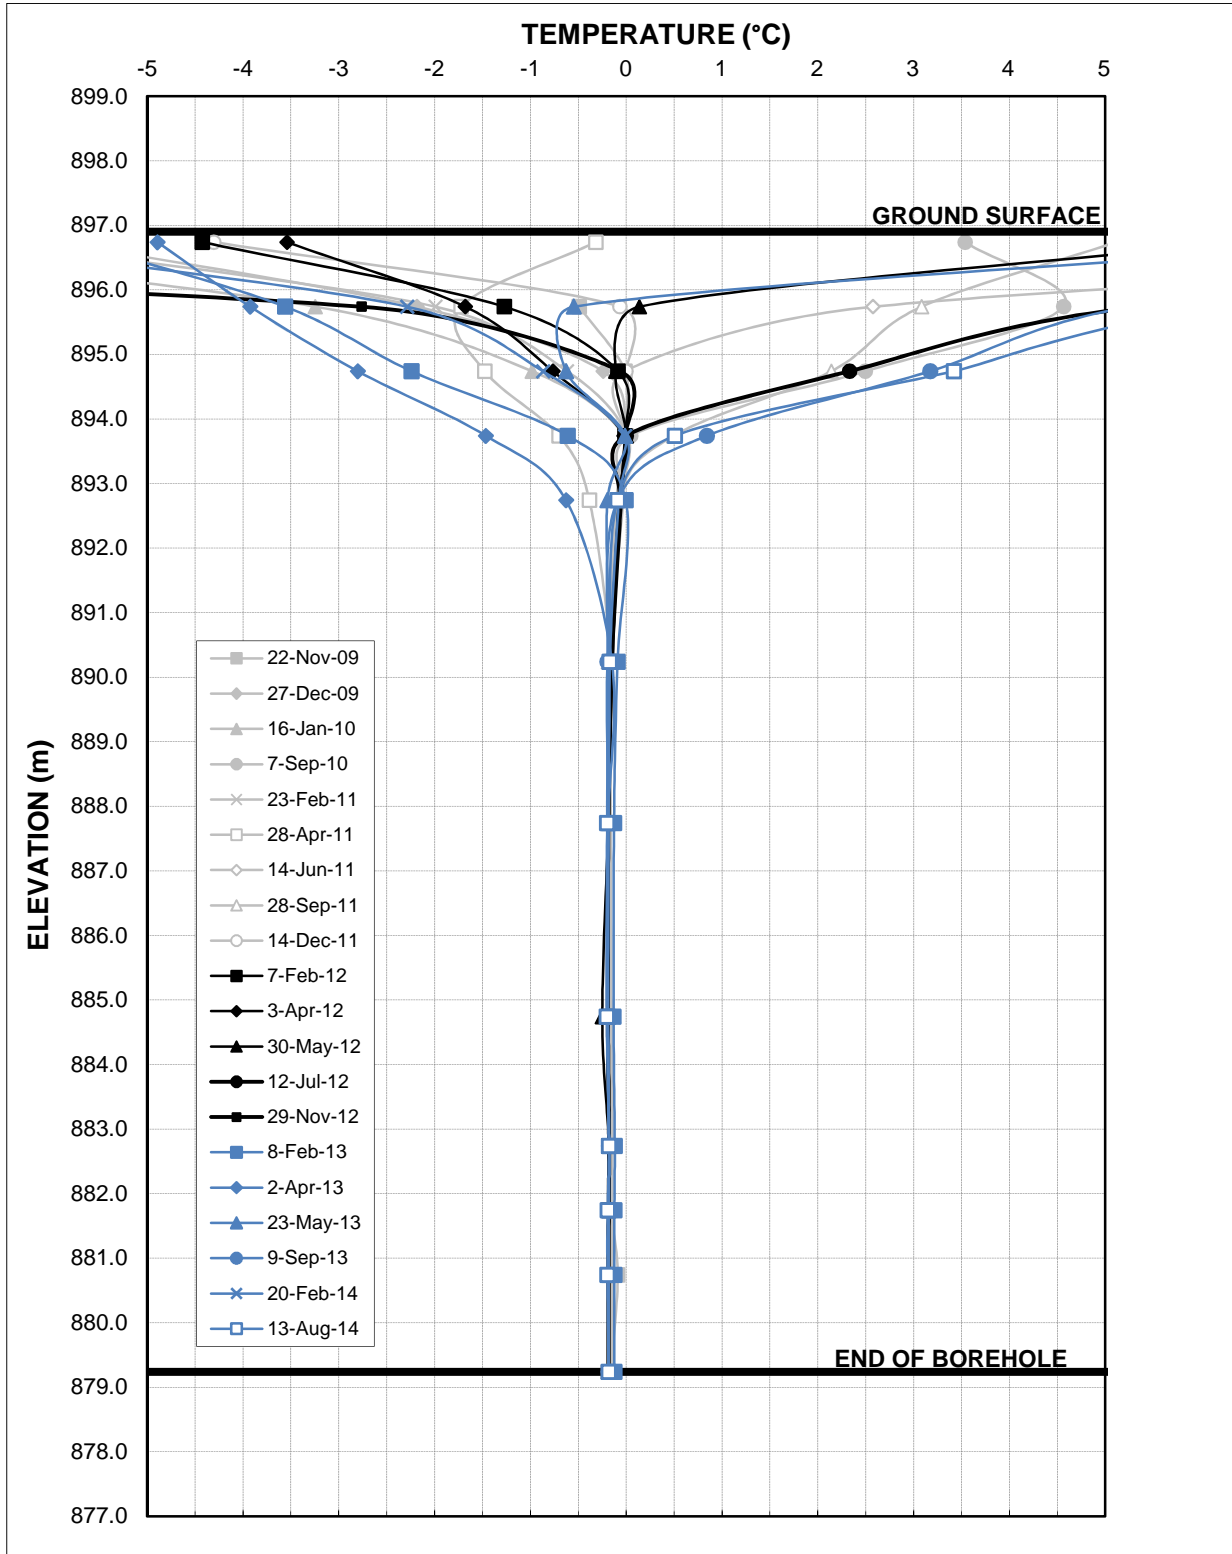
Ground Temperature Profile
Keno Hill District Mill Site Borehole BH15
Figure T1

Install Date August 30, 2009
 Last Updated August 13, 2014
 Cable No: 2207

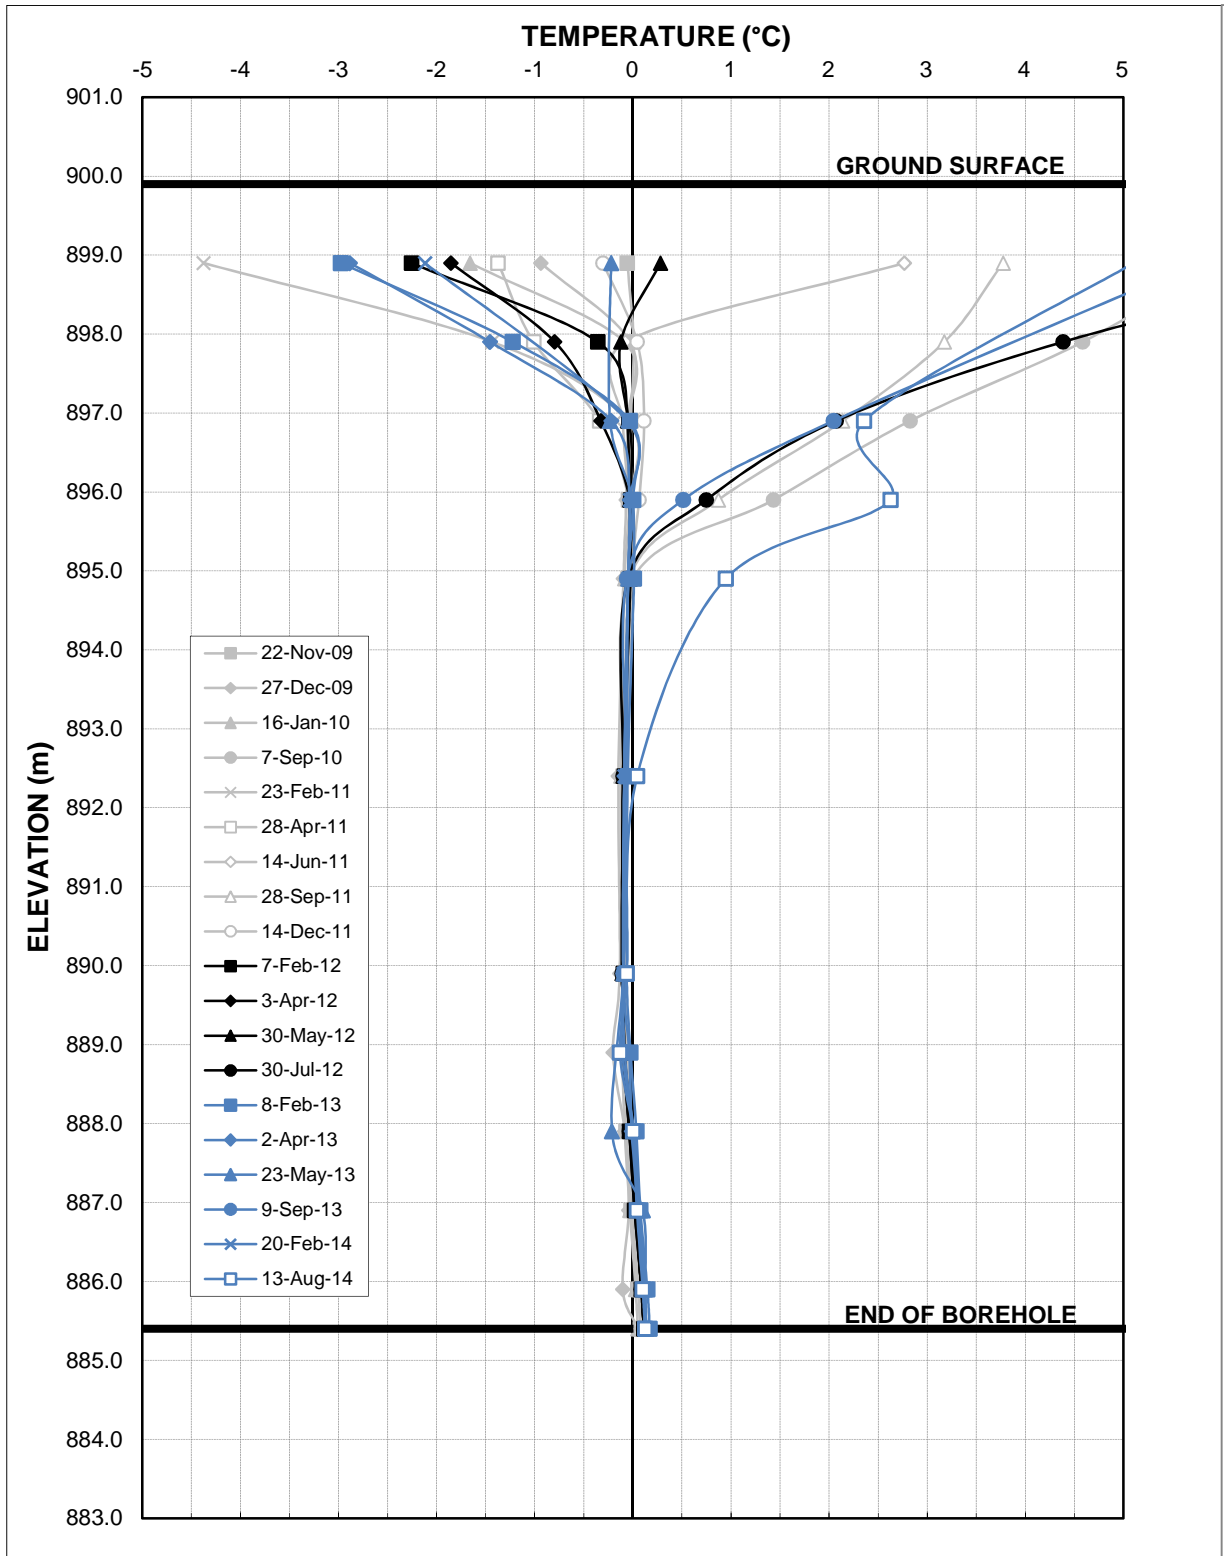
Ground Temperature Profile
Keno Hill District Mill Site Borehole BH17
Figure T2

Install Date August 30, 2009
 Last Updated August 13, 2014
 Cable No: 2208

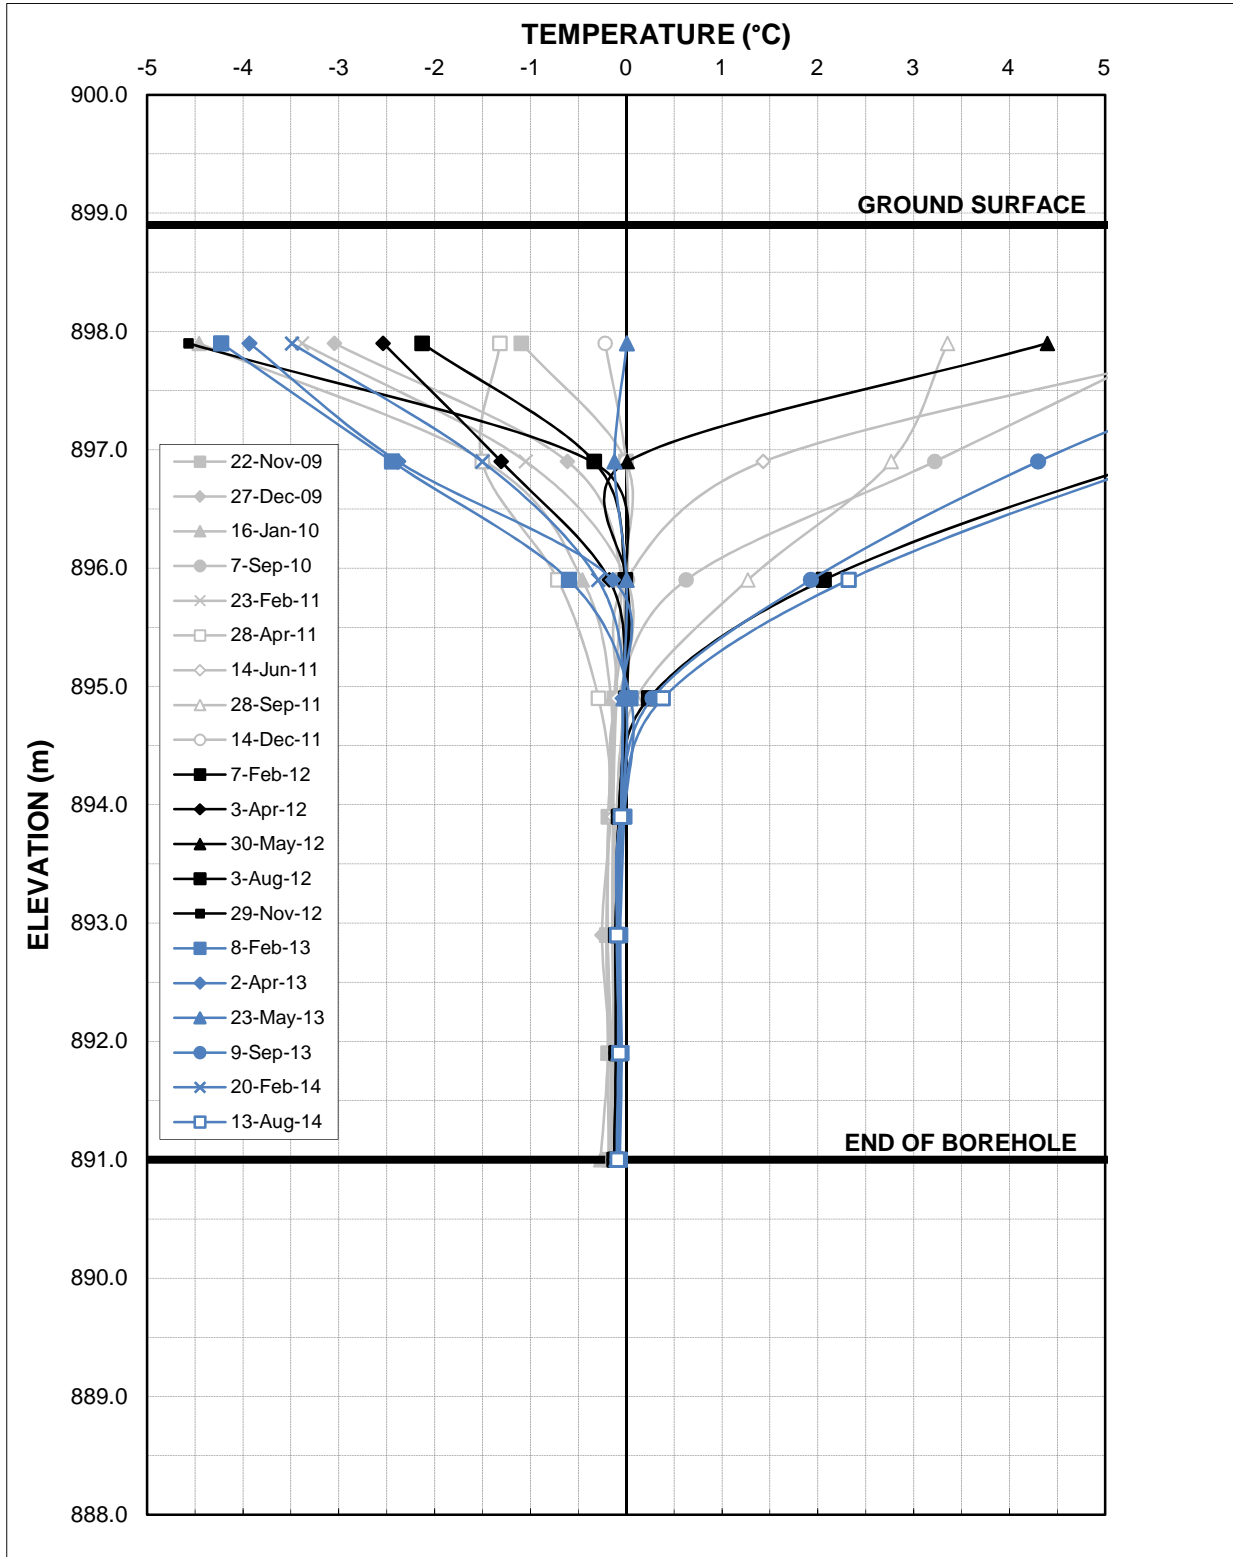
Ground Temperature Profile
Keno Hill District Mill Site Borehole BH18
Figure T3

Install Date September 2, 2009
 Last Updated August 13, 2014
 Cable No: 2209

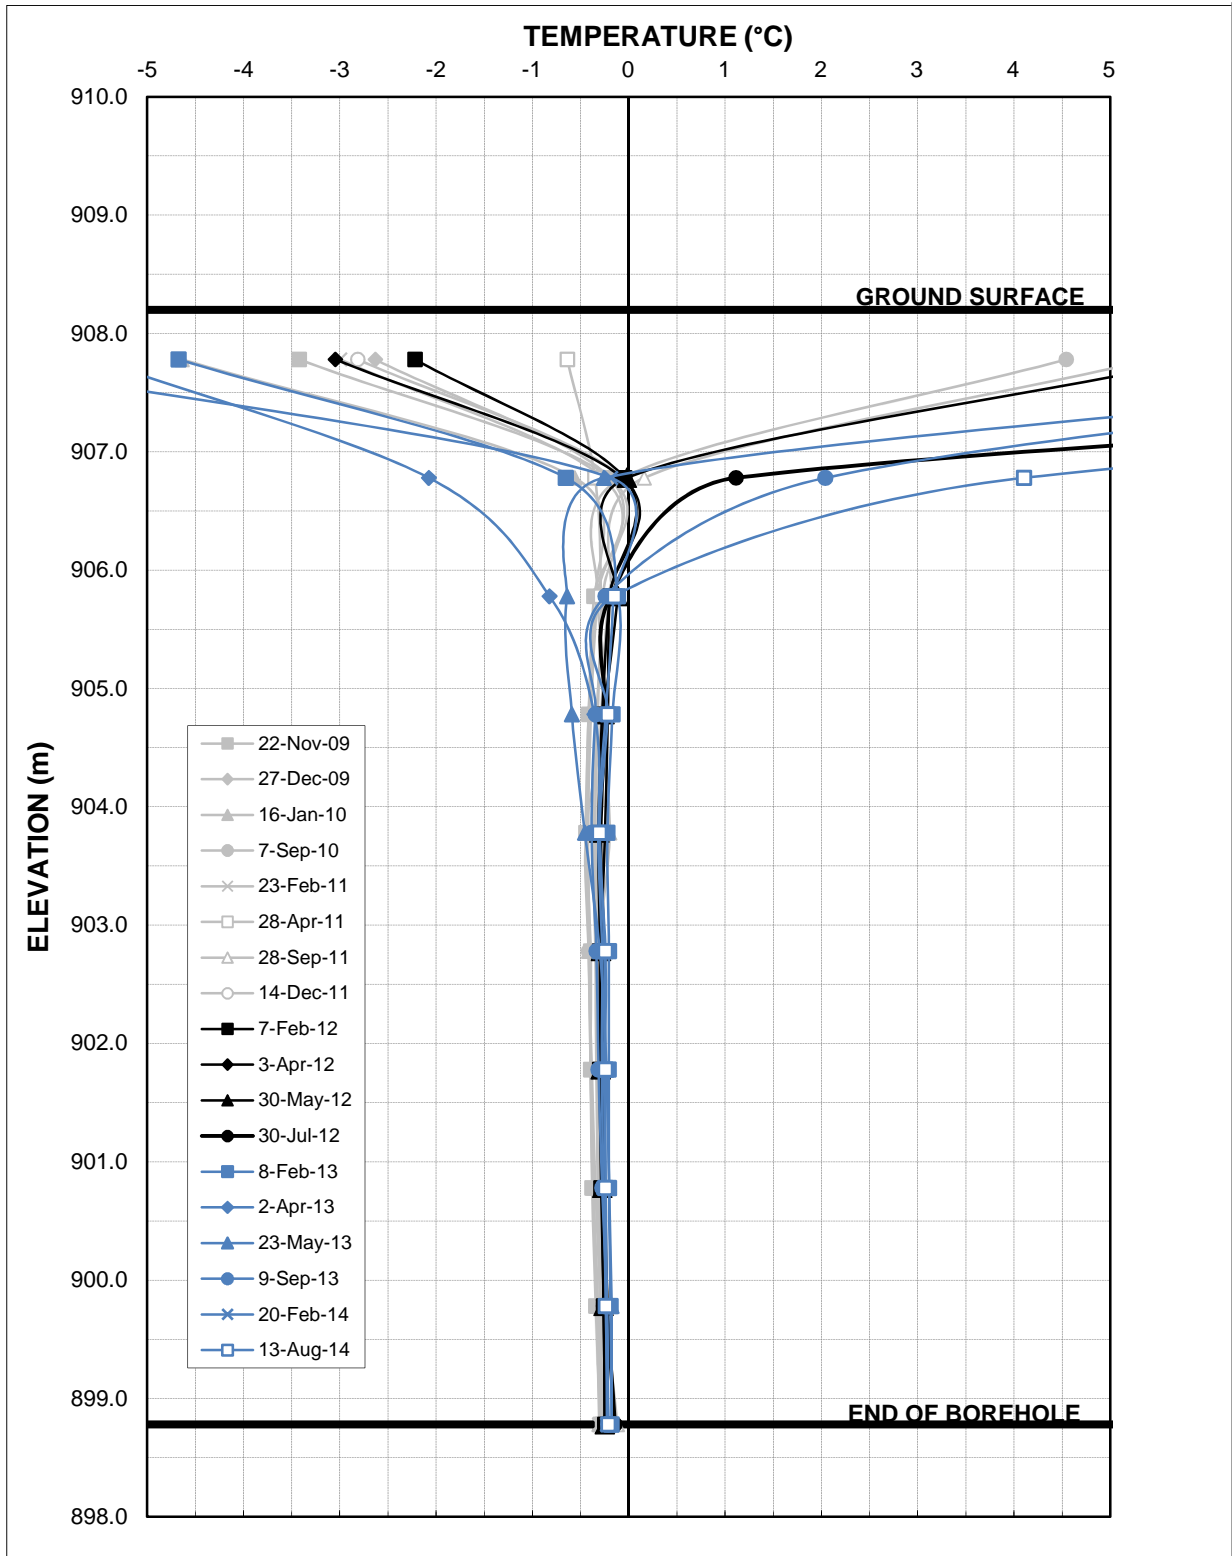
Ground Temperature Profile
Keno Hill District Mill Site Borehole BH23
Figure T4

Install Date September 29, 2009
 Last Updated August 13, 2014
 Cable No: 2210

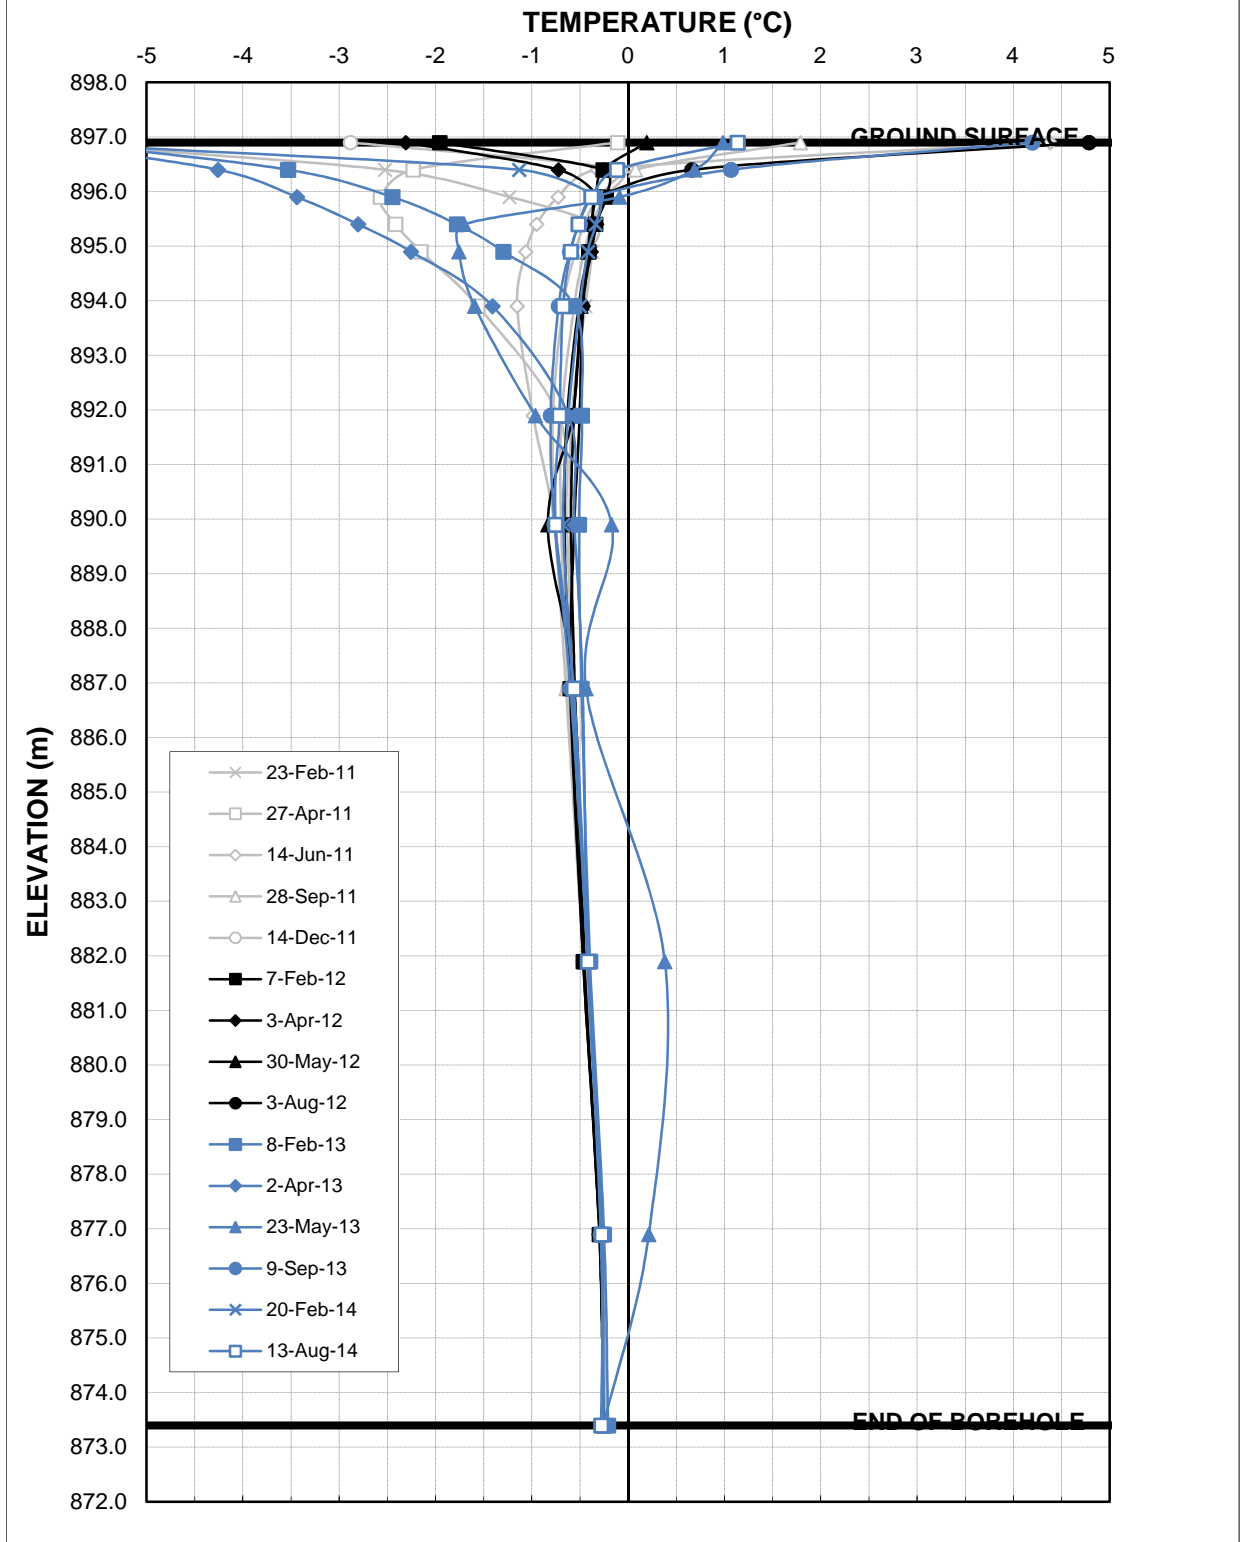
Ground Temperature Profile
Keno Hill District Mill Site Borehole BH31
Figure T5

Install Date February 22, 2011
 Last Updated August 13, 2014
 Cable No: 2263

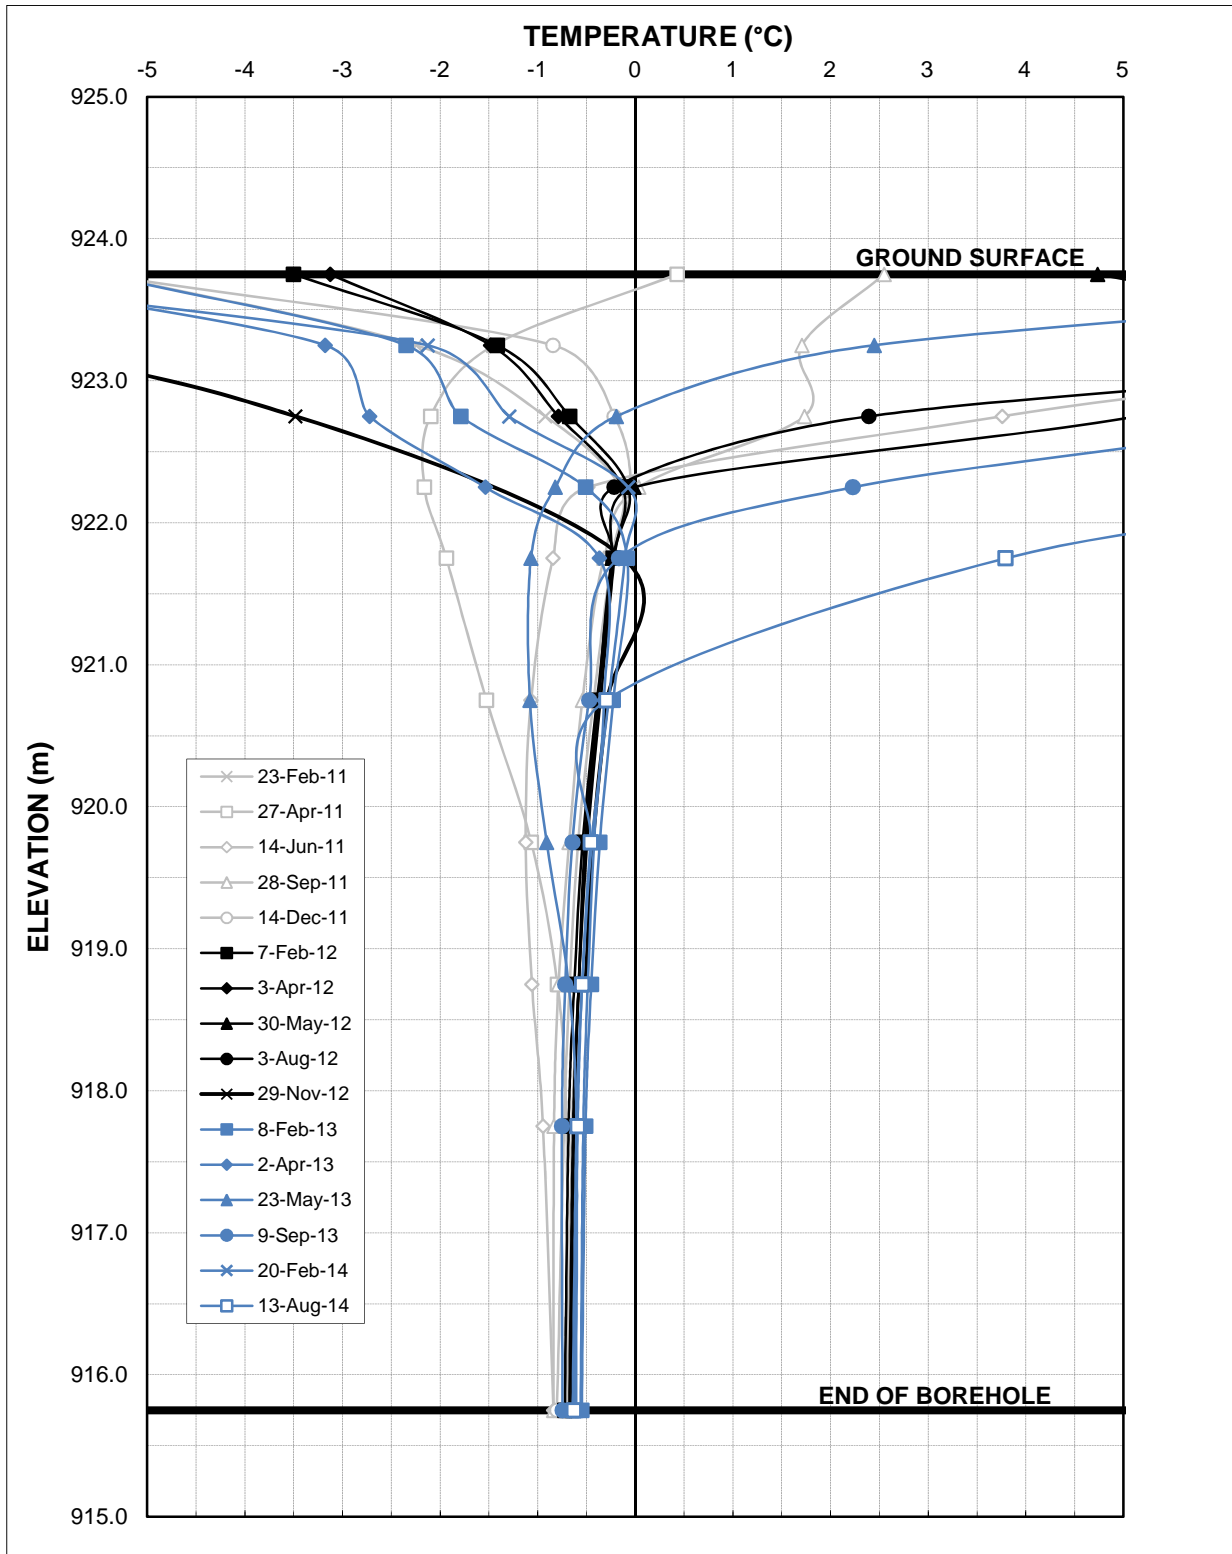
Ground Temperature Profile
Keno Hill District Mill Site Borehole BH32
 Figure T6

Install Date February 22, 2011
 Last Updated August 13, 2014
 Cable No: 2264
