November 7, 2017

Alexco Resource Corp.  
3 – 151 Industrial Road  
Whitehorse, YT Y1A 2V3

**Subject:** 2017 Annual Geotechnical Inspection – Surface Engineered Earth Structures  
Bellekeno Mine, Keno City, YT

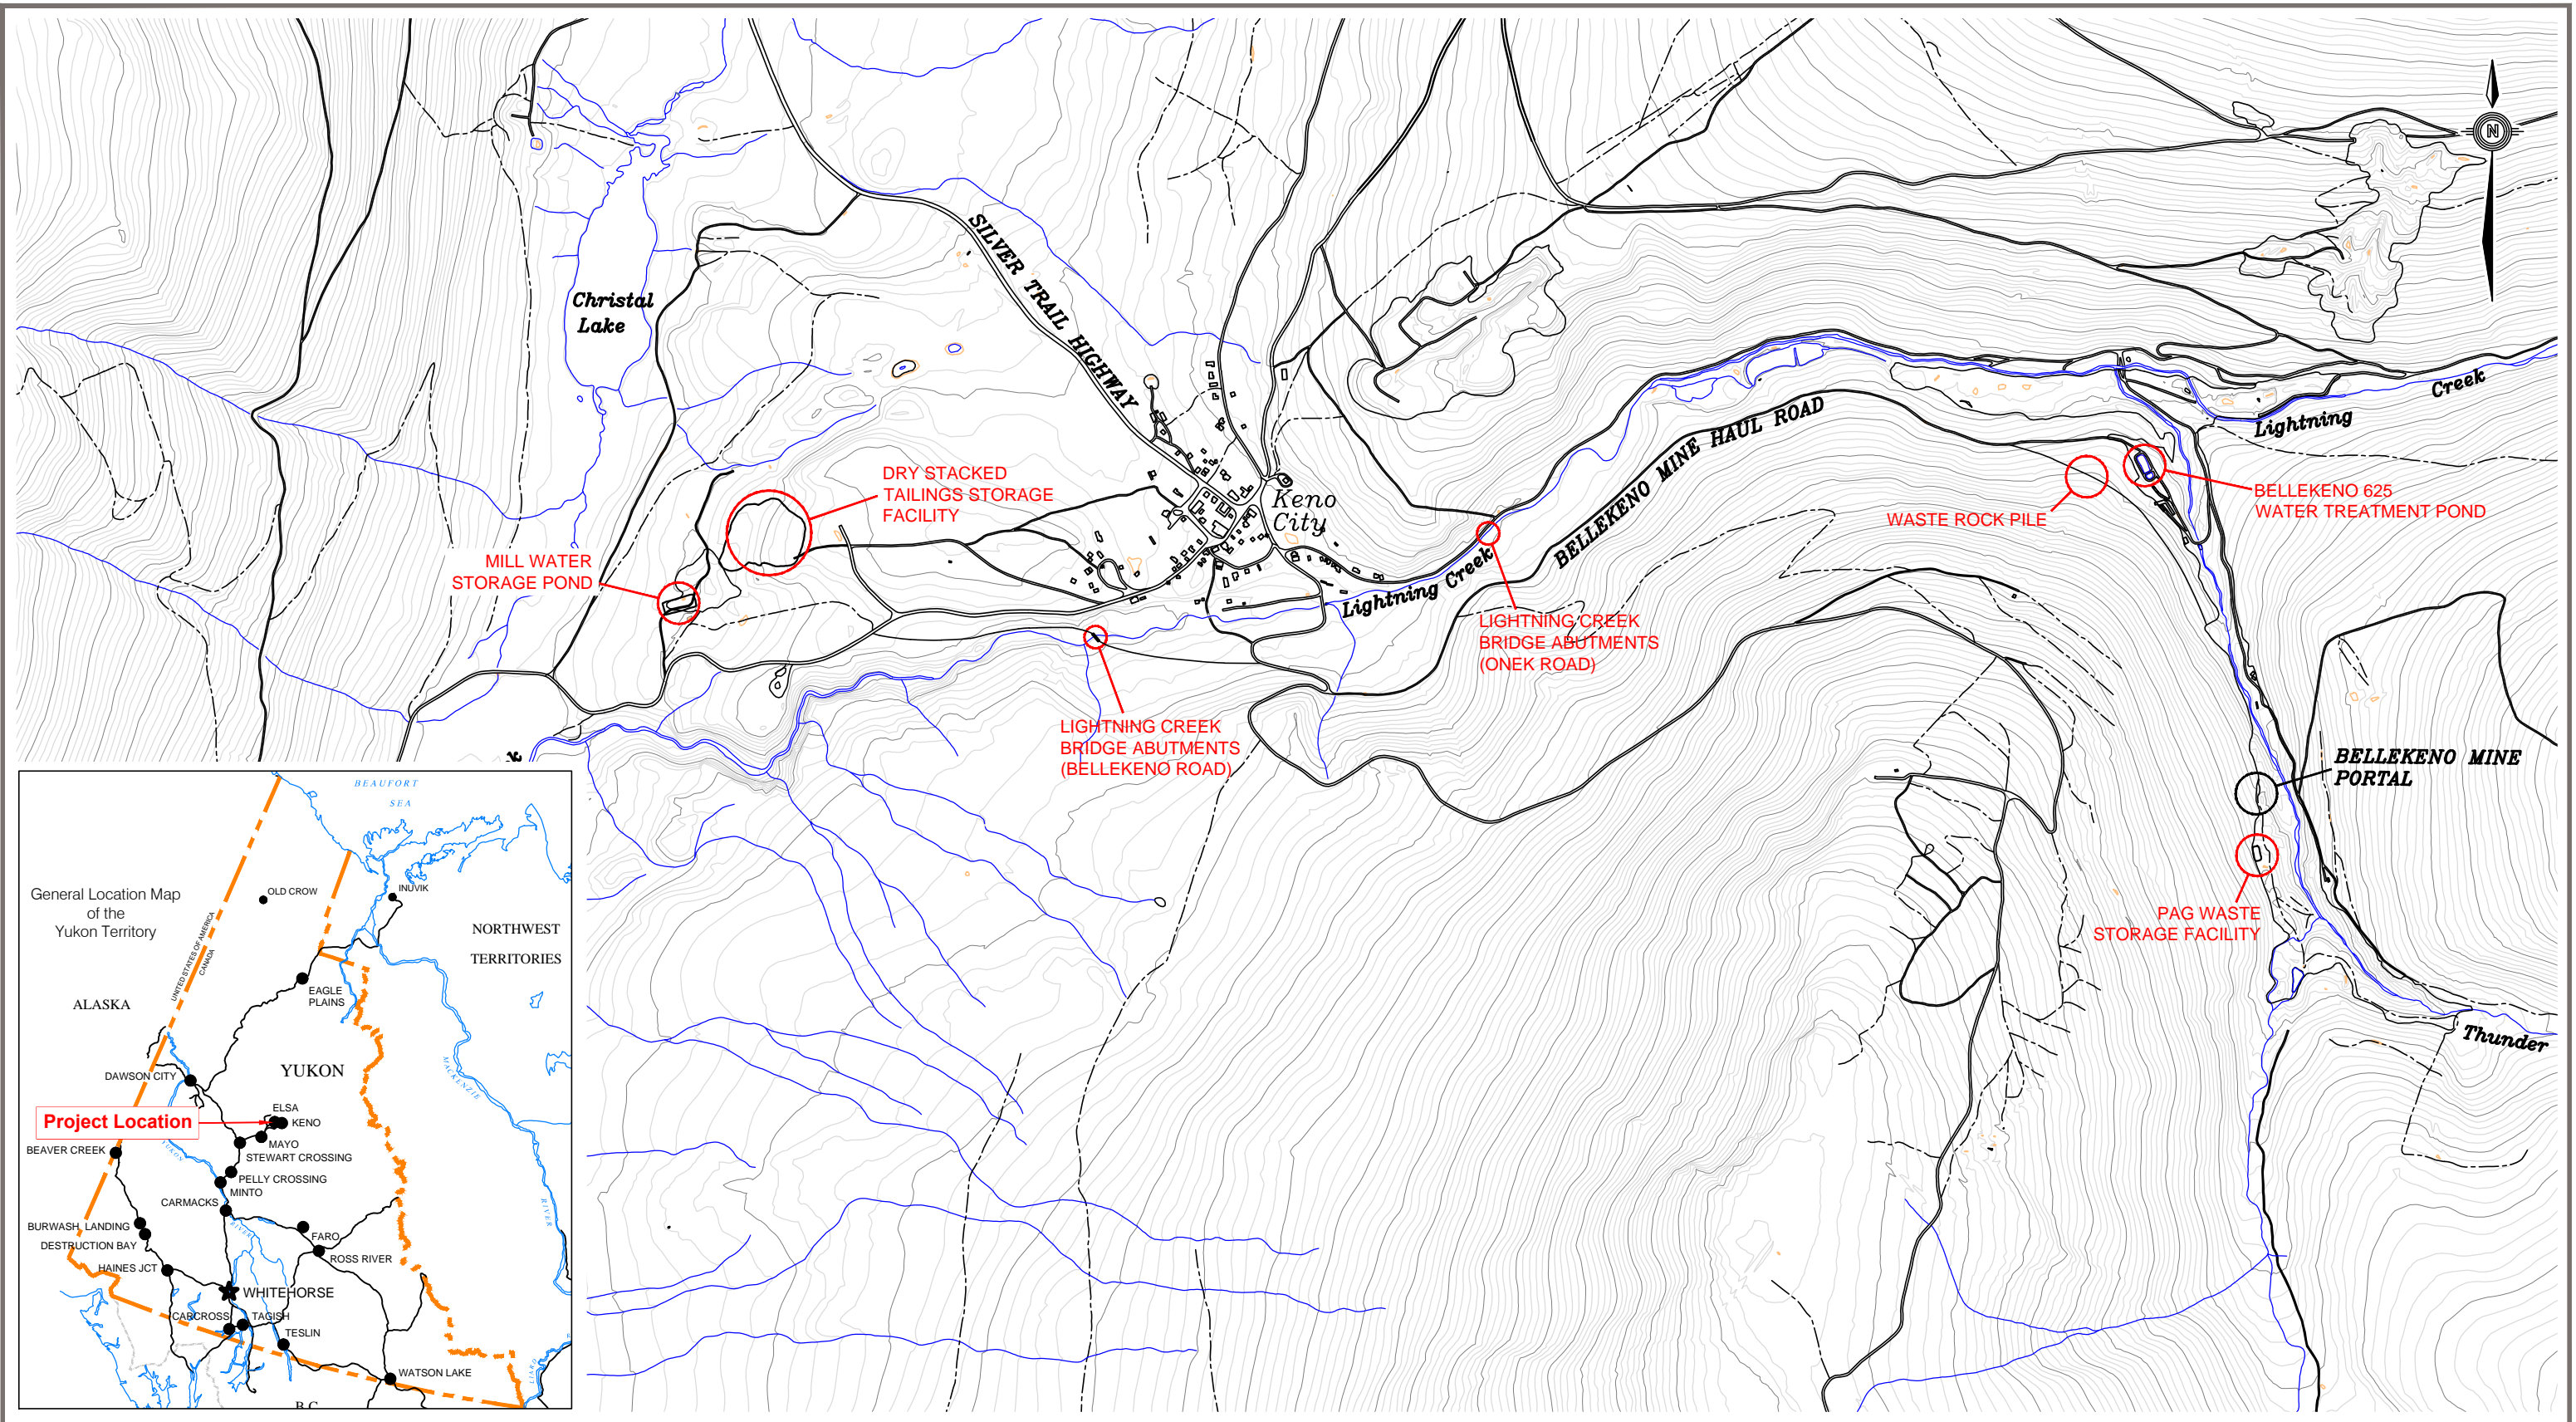
<b>2017 ANNUAL INSPECTION BELLEKENO MINE SITE - KENO CITY, YUKON</b>				
<b>SITE PLAN SHOWING BOREHOLE AND INSTRUMENTATION LOCATIONS</b>				
PROJECT NO. ENG.WARC03301-01	DWN CB	CKD TP	REV 0	<b>Figure 2</b>
OFFICE EBA-WHSE	DATE August 31, 2017

Performance of the DSTF is monitored with compaction testing during tailings placement and regular instrumentation readings. DSTF instrumentation consists of seven ground temperature cables installed to monitor permafrost conditions (six in natural soils adjacent to the DSTF and one through tailings placed within the DSTF footprint), and three slope indicators installed to monitor lateral movement of the foundation soils. The locations of installed DSTF instrumentation are shown on Figure 2.
