November 26, 2019

Alexco Resource Corp.
3 – 151 Industrial Road
Whitehorse, YT
Y1A 2V3

Subject: 2019 Annual Geotechnical Inspection – Mining Related Structures
Bellekeno Mine – Keno City, YT

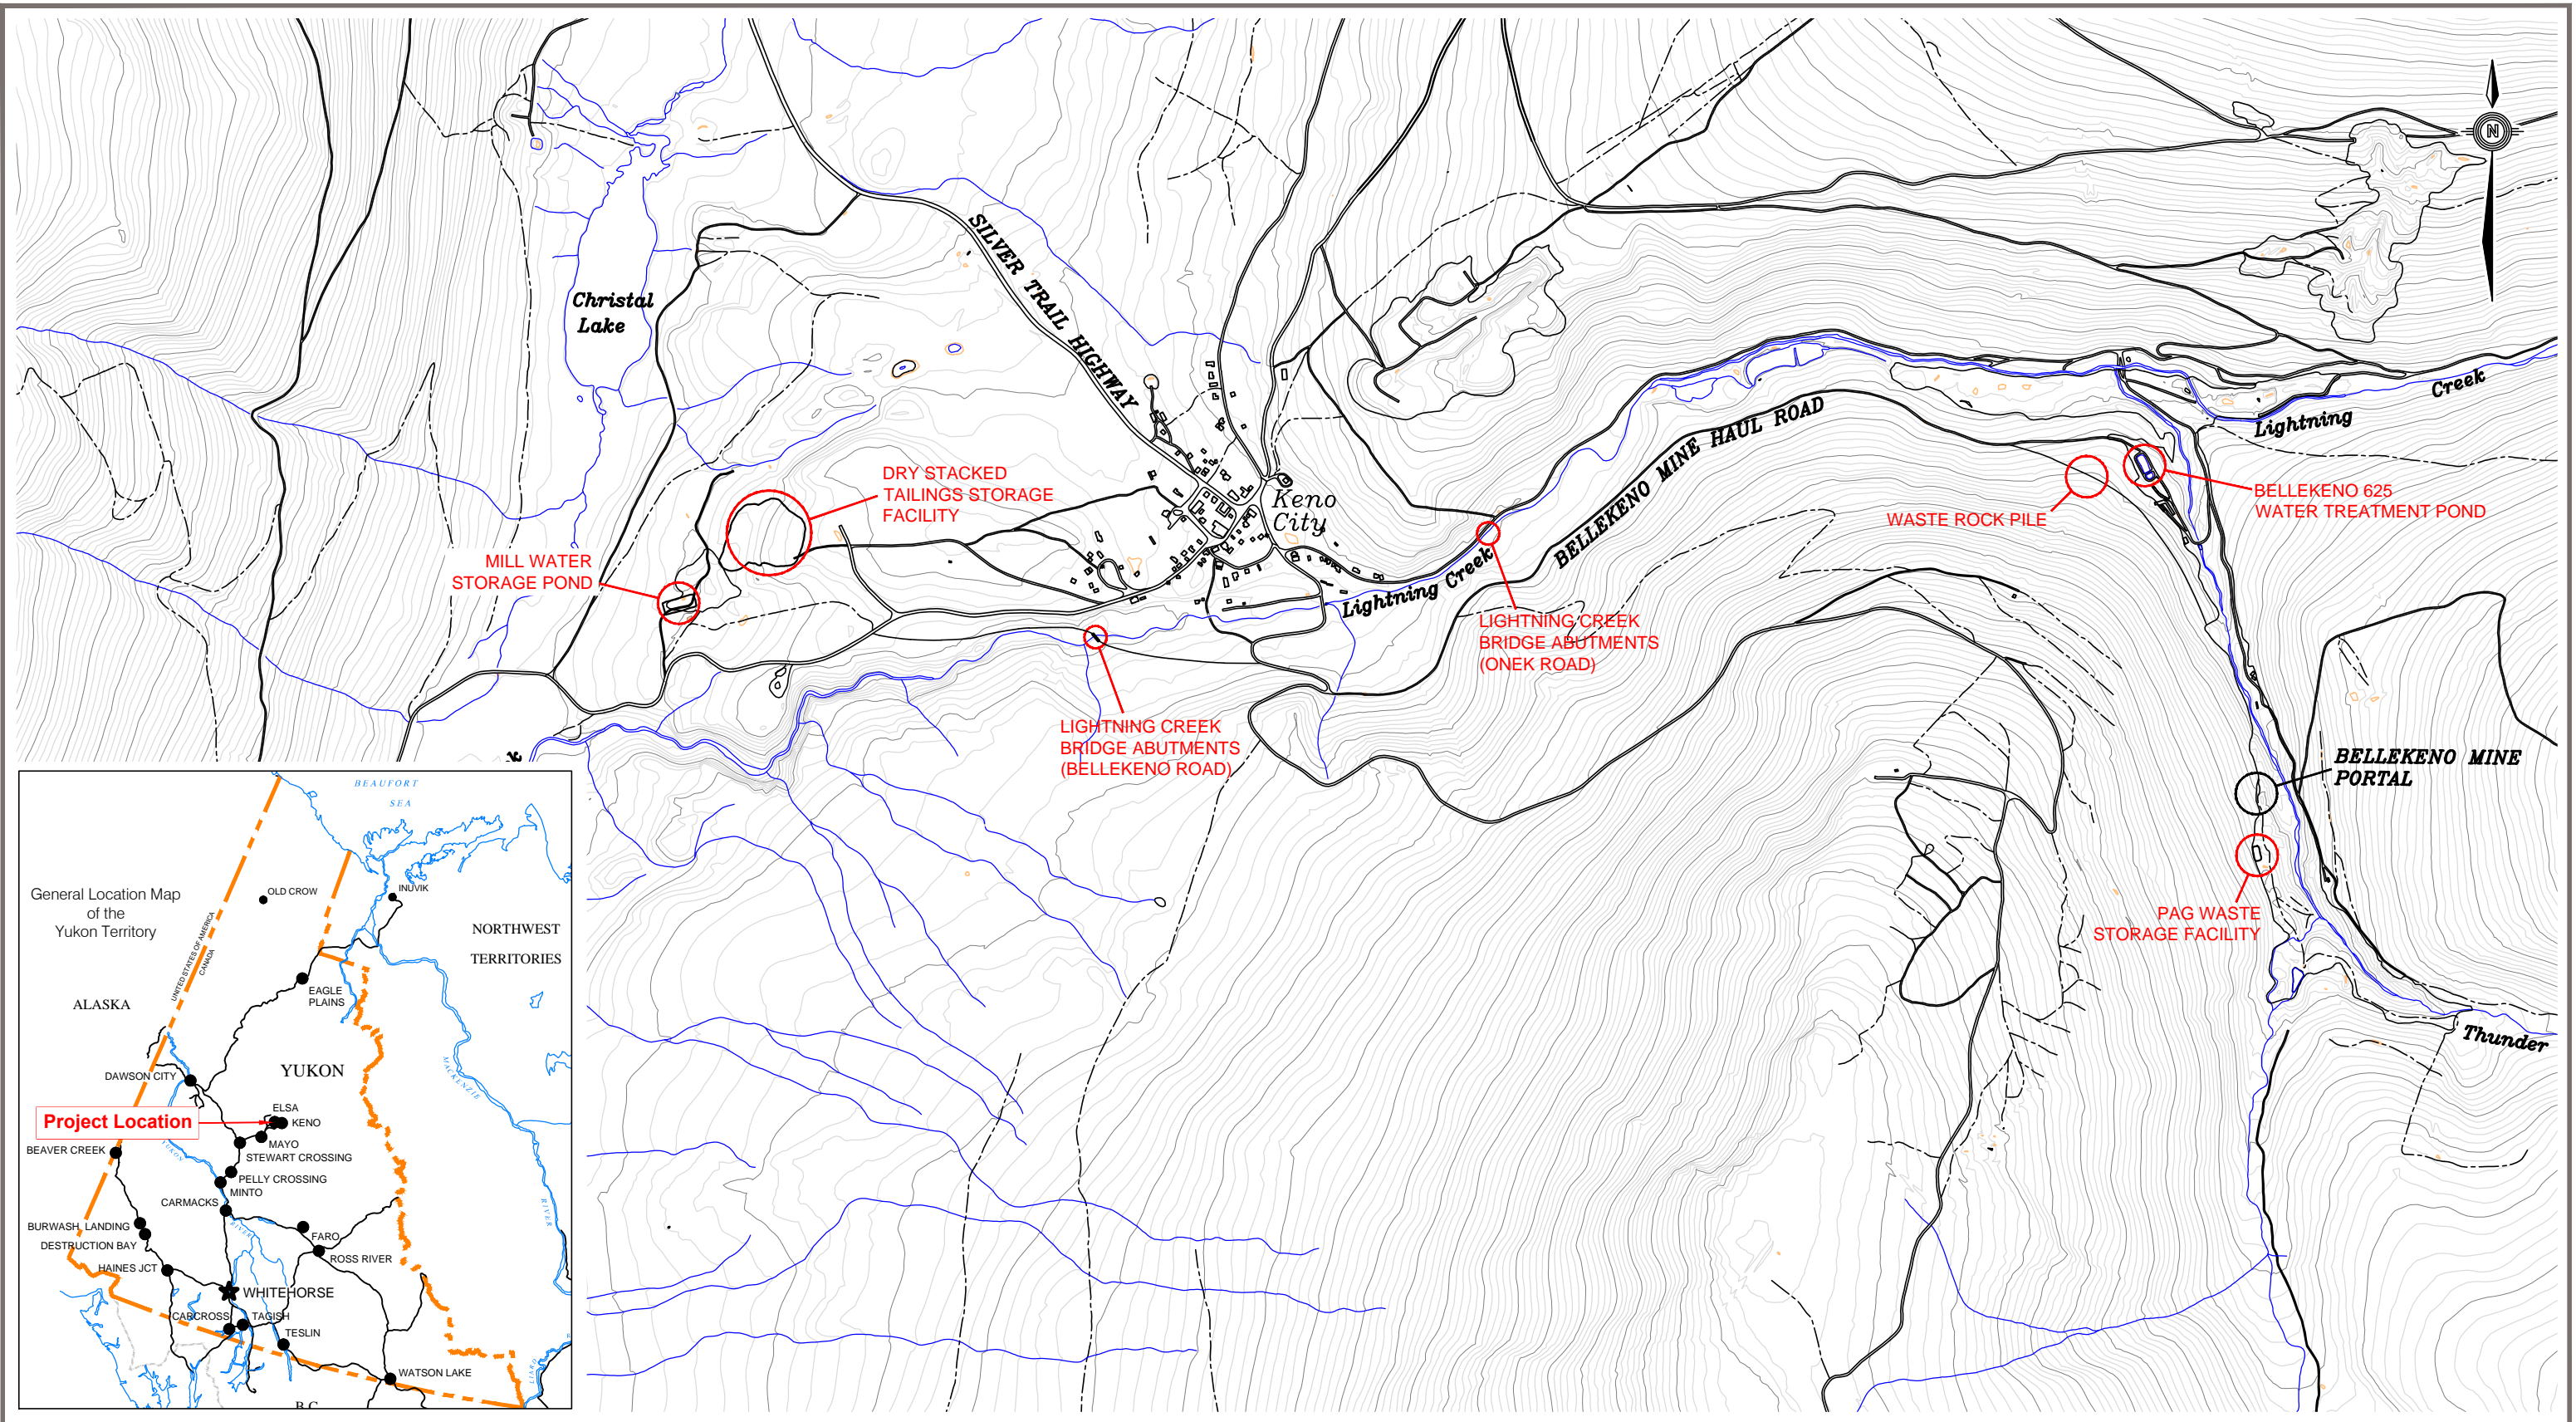
Figure 1

The Bellekeno waste rock pile forms a portion of the Bellekeno Haul Road and is located north of the Bellekeno portal, as shown on Figure 1. At the time of the inspection the side slopes of the waste rock pile appeared to be intact and stable. No remedial action is required.

The Bellekeno 625 water treatment ponds are located north of the Bellekeno 625 portal, as shown on Figure 1. The facility consists of two water treatment ponds that were both operating at the time of inspection. The primary treatment pond was operating at the discharge invert elevation with a freeboard of 0.5 m below the perimeter berm crest at the time of the inspection. The secondary pond was also operating at the discharge elevation, with a freeboard of 0.5 m in the south end. Treated water discharges through an HDPE pipe onto the hillside above Lightning creek. A small rip in the liner was identified at the south end crest of the secondary pond. The rip appeared to be caused by equipment operating around the pond but should be monitored and repaired if conditions worsen.

The Lightning Creek Bridge on the Bellekeno Haul Road is located southwest of Keno City, as shown on Figure 1. The bridge is a single span steel structure with wooden deck founded on earth filled timber cribbed abutments. The abutments were stable at the time of the inspection and are sufficiently protected by riprap armouring from erosion of Lightning Creek. Although the bases of the abutments are well protected, the approaches have undergone erosion and are starting to become undermined by washout (Photo 5). It is recommended that the eroded areas be backfilled with coarse rock and the berms built up to maintain stability. If coarse rock is used for the safety berm, surface drainage would not be impeded, but must be directed so that the berm is not eroded away.

The Lightning Creek Bridge on the Onek Road is located east of Keno City, as shown on Figure 1. The bridge is a single span steel structure founded on earth filled timber cribbing abutments. The abutments were stable at the time of the inspection and are sufficiently protected from erosion by riprap. No remedial action is required for the Lightning Creek Bridge on the Onek Road at this time.

The two mill water storage ponds are located at the Keno Hill District Mill Site, west of Keno City, as shown on Figure 1. At the time of the inspection the mill was not operating, but both ponds contained some water, with a freeboard of about 2 m below the perimeter berms in the older pond, and an estimated 6 m of freeboard in the newer pond.
