November 17, 2020

ISSUED FOR USE  
FILE: 704-ENG.WARC03869-01  
Via Email: lbroughton@alexcoresource.com

**Subject:** 2020 Annual Geotechnical Inspection – Mining Related Structures  
Bellekeno Mine – Keno City, YT

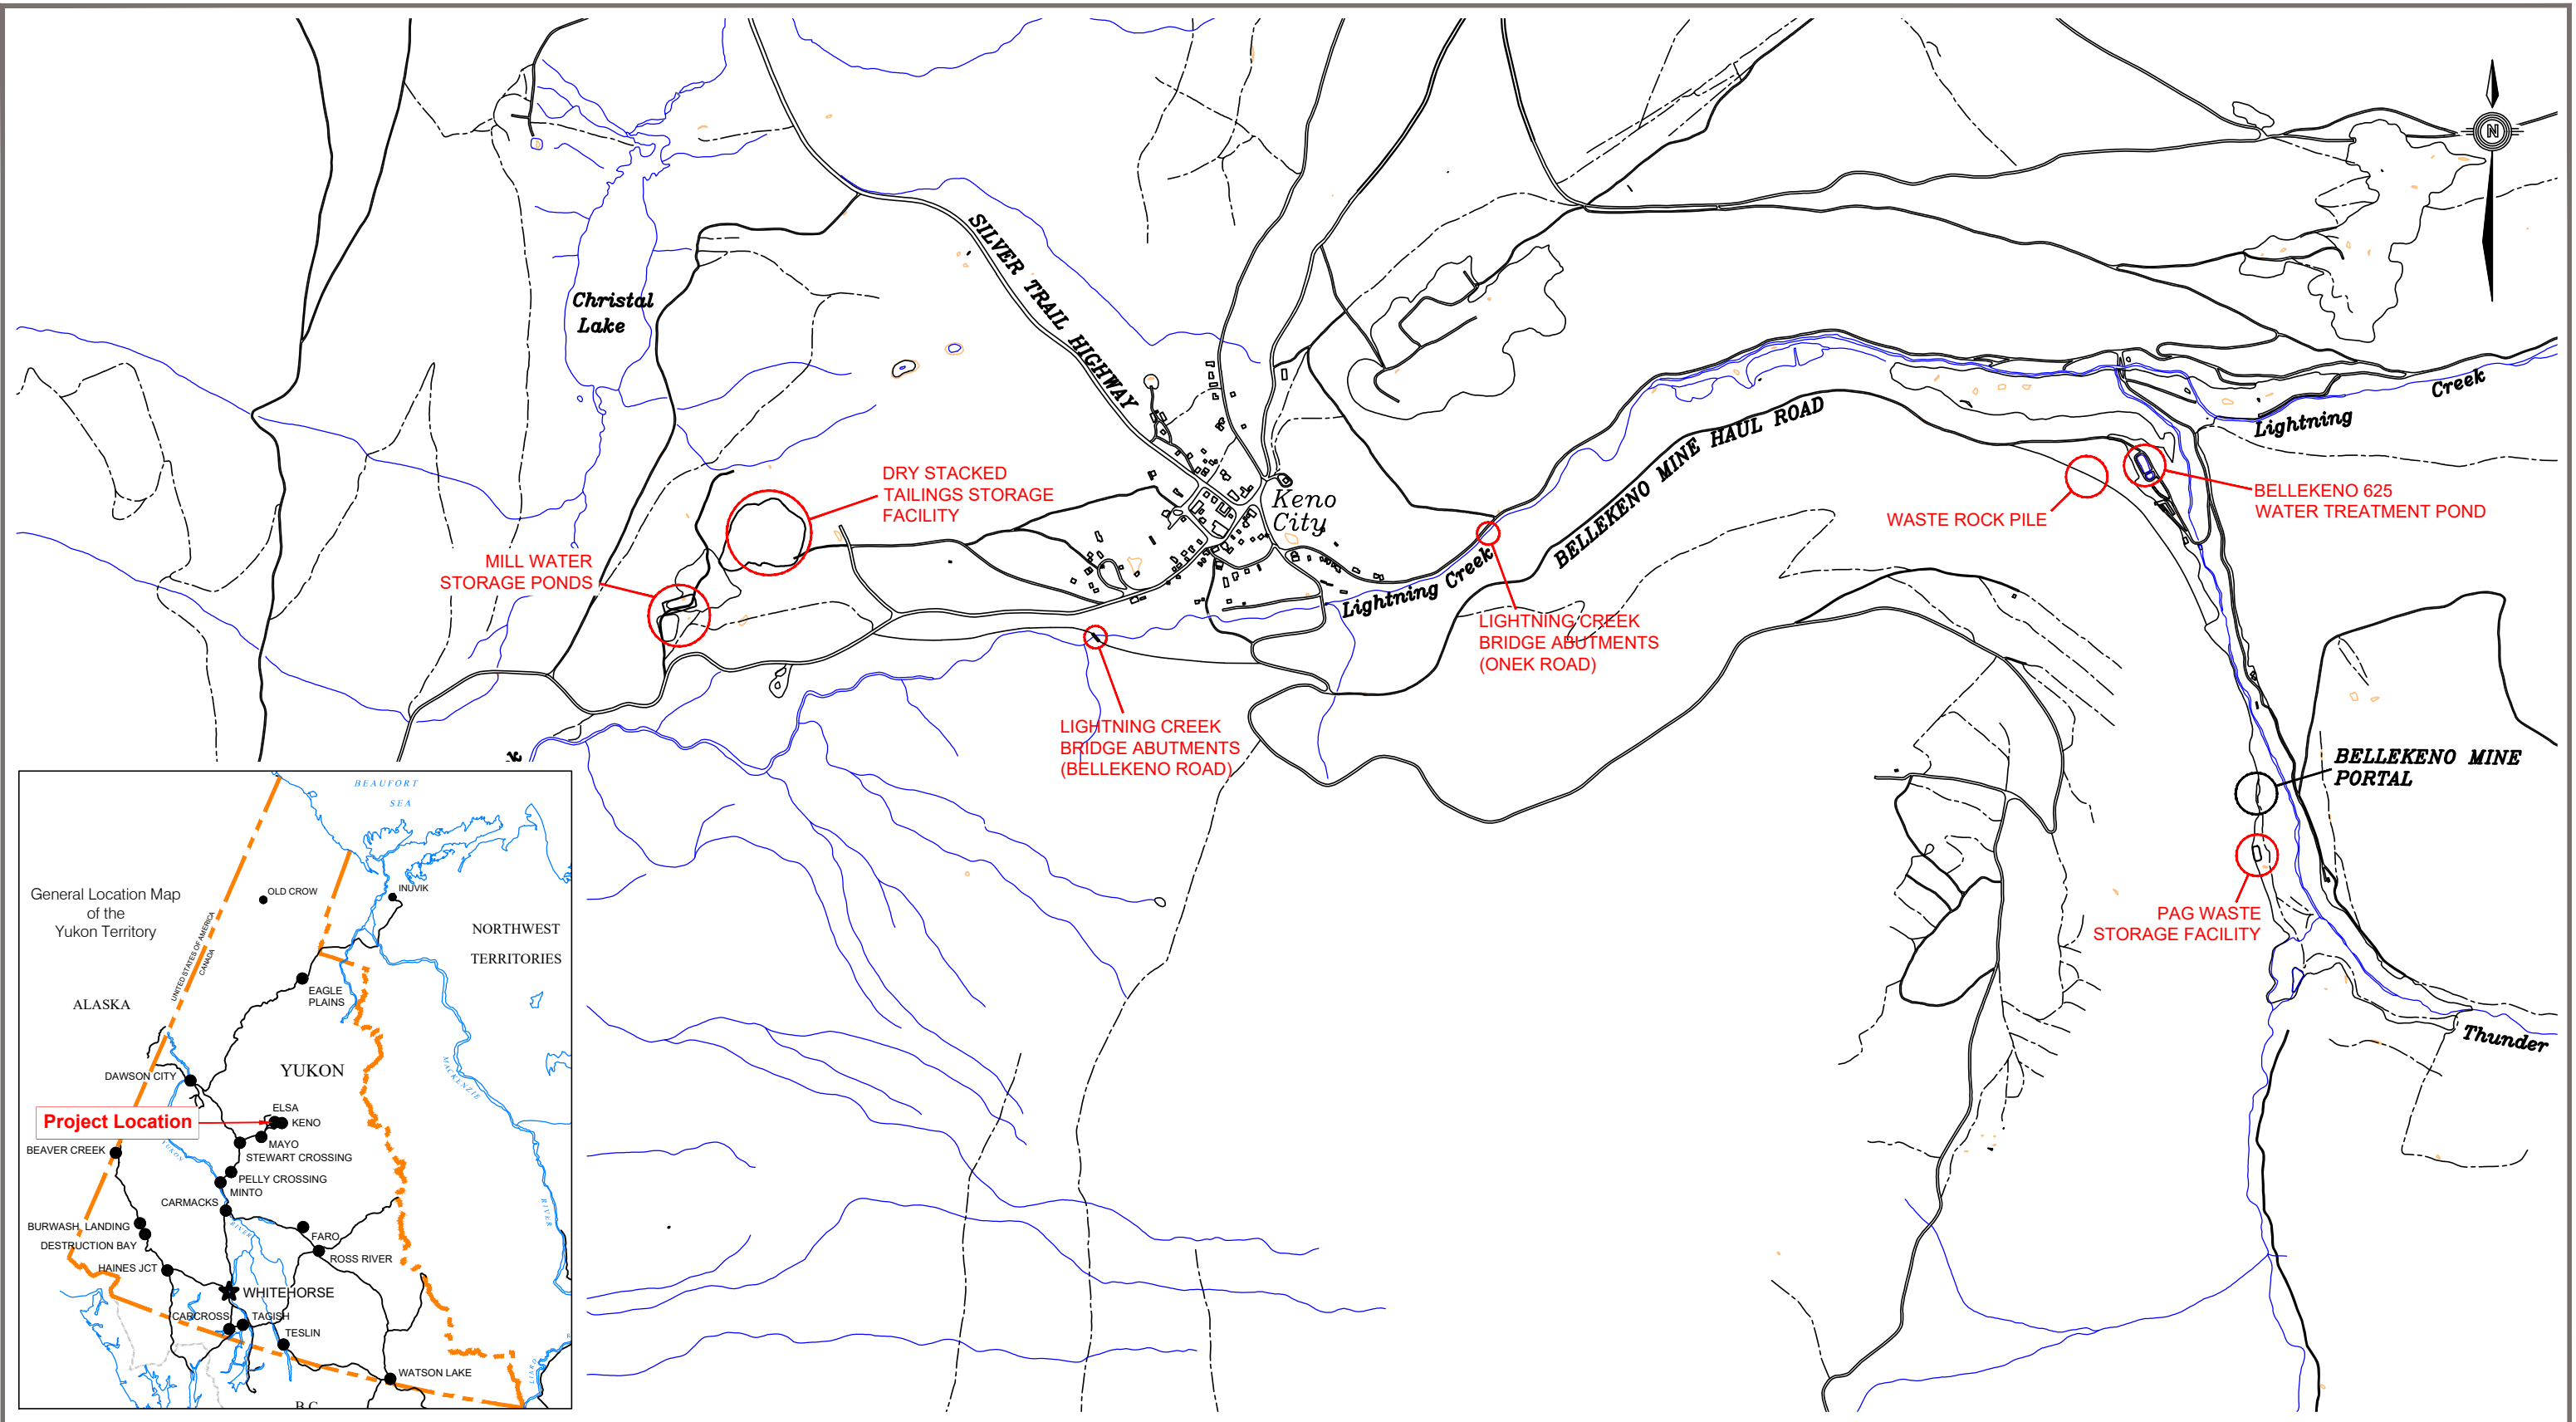
Q:\Whitehorse\Drawings\Keno\ENG.WARC03869-01 - 2020 Structures Inspection\ENG.WARC03869-01 Fig\_1\_RO.dwg [FIGURE 1] August 28, 2020 - 1:37:11 pm (BY: PASLOSKI, TAYLOR)

The location of these structures is shown on Figure 1.
