November 30, 2021

Alexco Keno Hill Mining Corp.  
Suite 1225 – 555 Burrard St.  
Vancouver. BC  
V7X 1M9

**Subject:** 2021 Annual Geotechnical Inspection – Mining Related Structures  
Bellekeno Mine – Keno City, YT

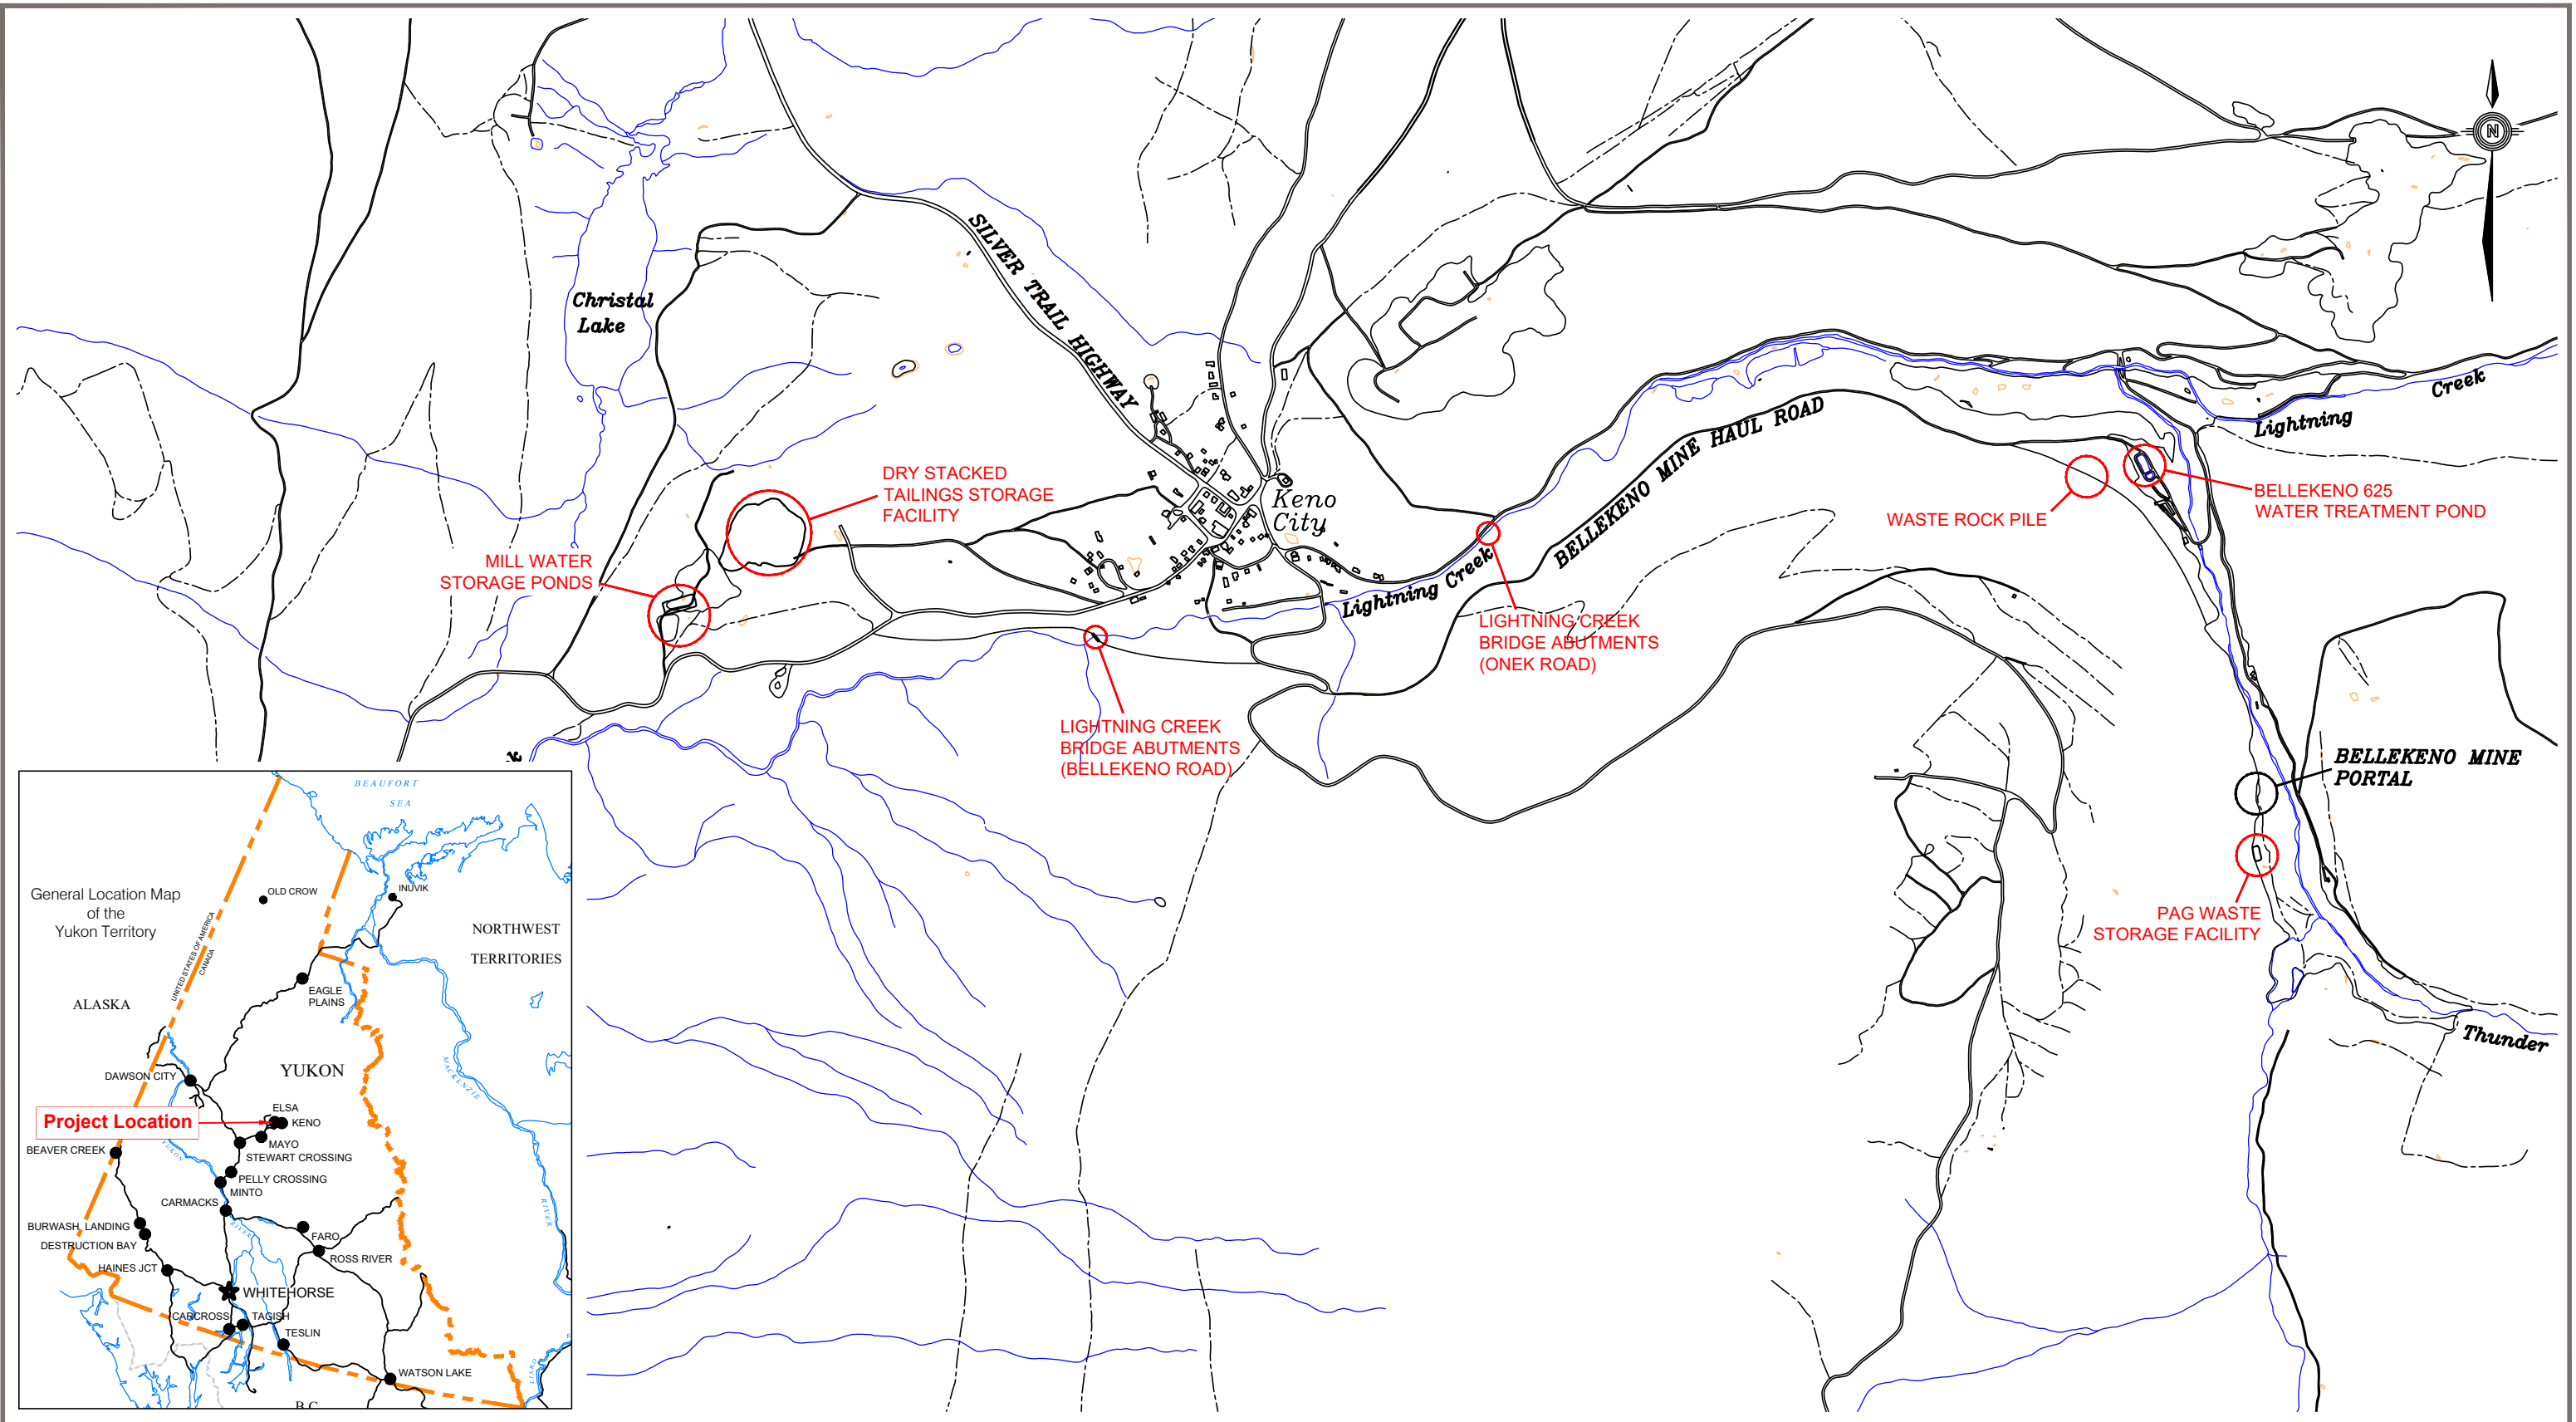
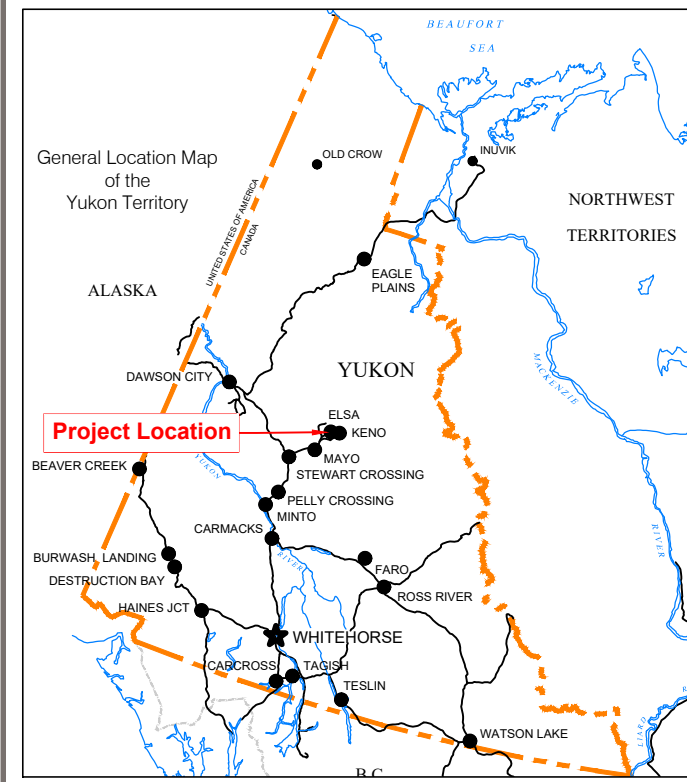
**Figure 1**

The location of these structures is shown on Figure 1.

The Bellekeno waste rock pile forms a portion of the Bellekeno Haul Road and is located north of the Bellekeno portal, as shown on Figure 1. At the time of the inspection the side slopes of the waste rock pile appeared to be intact and stable. No remedial action is required.

The Bellekeno 625 water treatment ponds are located north of the Bellekeno 625 portal, as shown on Figure 1. The facility consists of two water treatment ponds that were both operating at the time of inspection. The primary treatment pond was operating at the discharge invert elevation with a freeboard of 0.5 m below the perimeter berm crest at the time of the inspection. The secondary pond was also operating at the discharge elevation, with a freeboard of 0.5 m in the south end. Treated water discharges through an HDPE pipe onto the hillside above Lightning Creek.

The Lightning Creek Bridge on the Bellekeno Haul Road is located southwest of Keno City, as shown on Figure 1. The bridge is a single span steel structure with a wooden deck founded on earthfilled timber cribbed abutments. The abutments were stable at the time of the inspection and are sufficiently protected by riprap armouring from erosion of Lightning Creek.

The Lightning Creek Bridge on the Onek Road is located east of Keno City, as shown on Figure 1. The bridge is a single span steel structure founded on earth filled timber cribbing abutments. The abutments were stable at the time of the inspection and are sufficiently protected from erosion by riprap. No remedial action is required for the Lightning Creek Bridge on the Onek Road at this time.

The two mill water storage ponds are located at the Keno Hill District Mill Site, west of Keno City, as shown on Figure 1. At the time of the inspection the mill was operating, and both ponds contained some water with a freeboard of about 1.2 m below the perimeter berms in the older pond, and an estimated 2.4 m of freeboard in the newer pond. No remedial action is required for these ponds.

The dry stacked tailings facility (DSTF) is located at the Keno Hill District Mill Site west of Keno City, as shown on Figure 1. Mining production has resumed since the previous inspection and tailings have been placed for the first time since 2013. All the tailings previously placed have been regraded, covered with organic materials and glacial till, then seeded as part of the progressive reclamation activities.

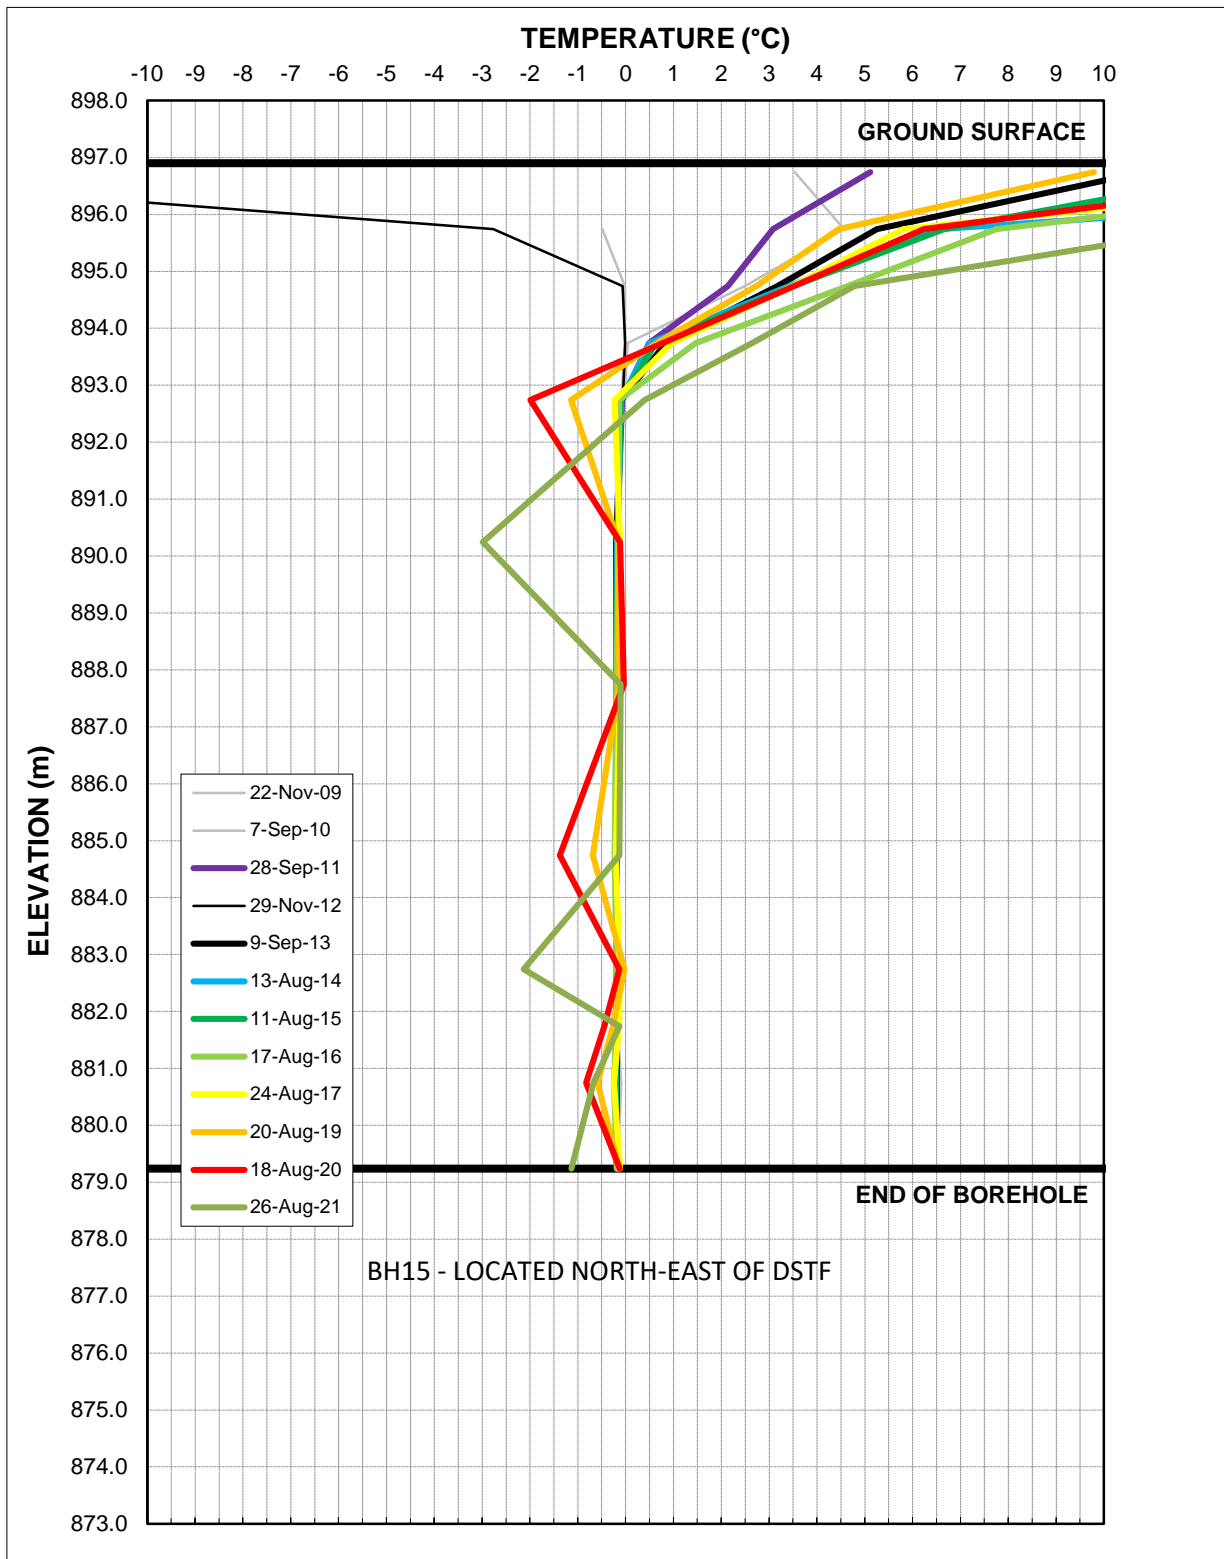
**Ground Temperature Profile**  
**Keno Hill District Mill Site Borehole BH15**  
**Figure T1**

Install Date      August 30, 2009  
 Last Updated     August 26, 2021  
 Cable No:         2207

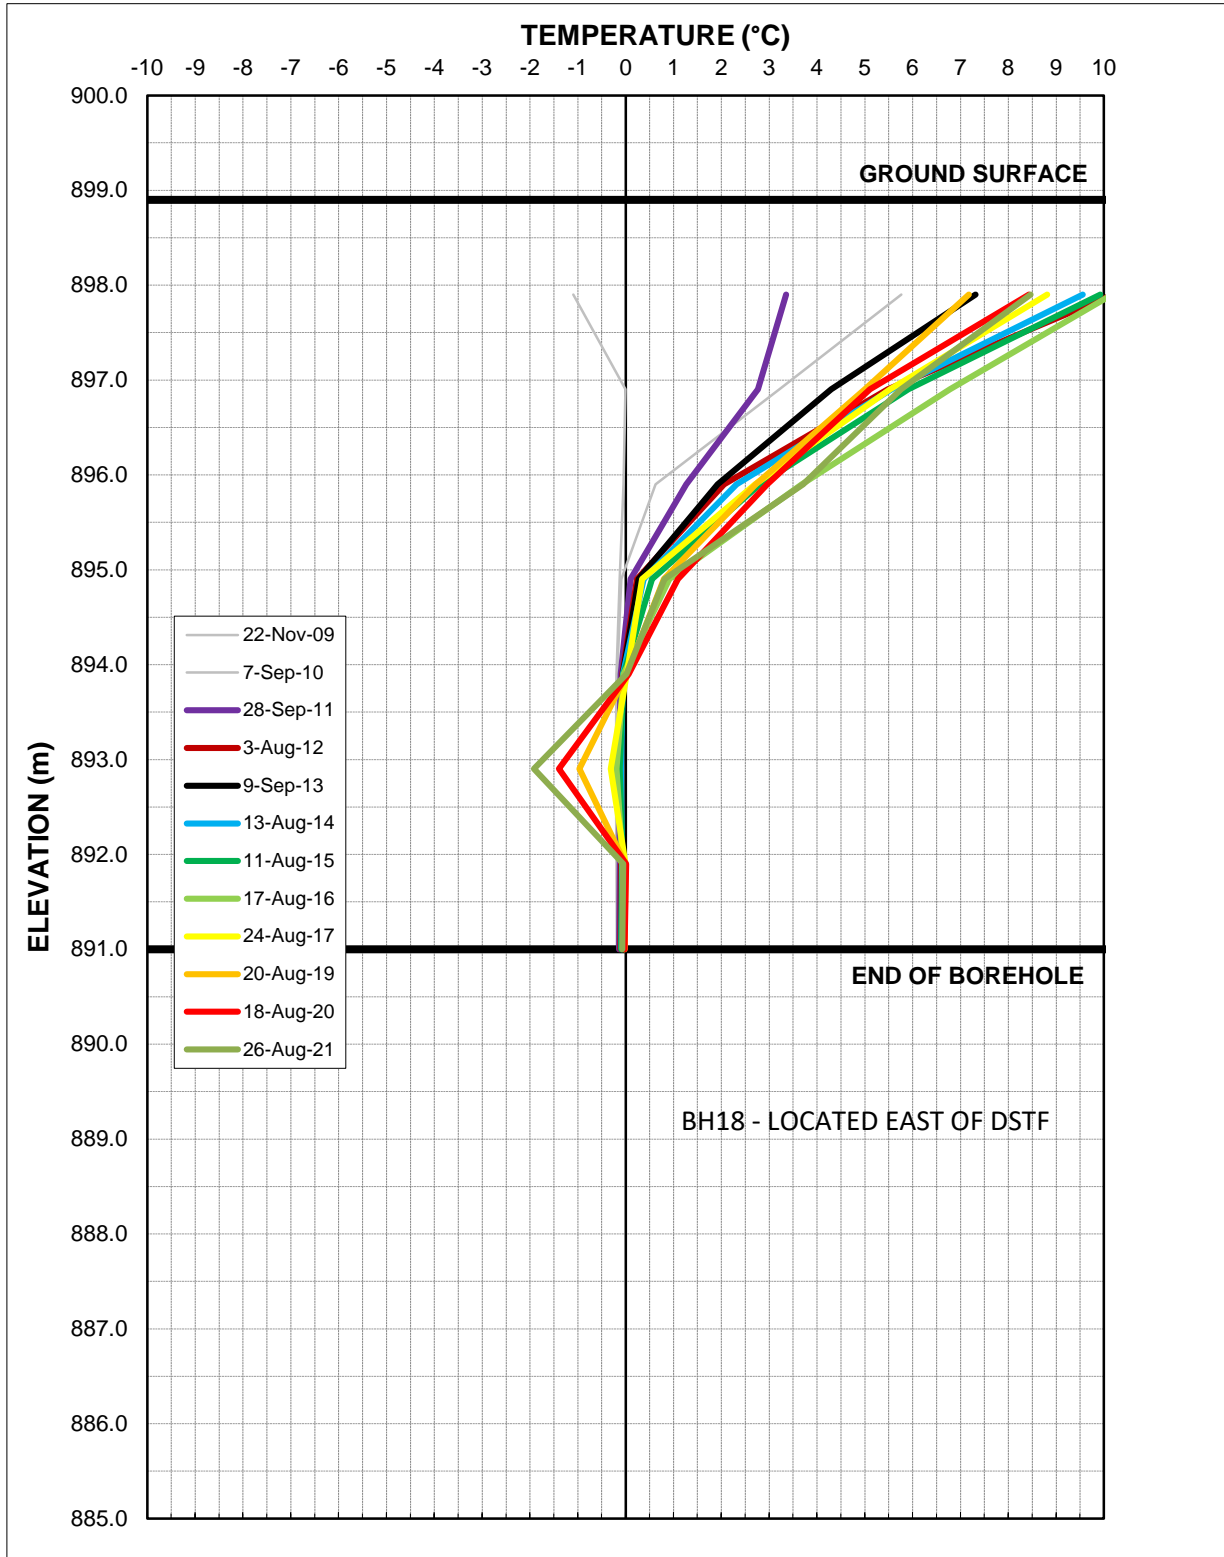
**Ground Temperature Profile**  
**Keno Hill District Mill Site Borehole BH18**  
**Figure T3**

Install Date      September 2, 2009  
 Last Updated     August 26, 2021  
 Cable No:        2209

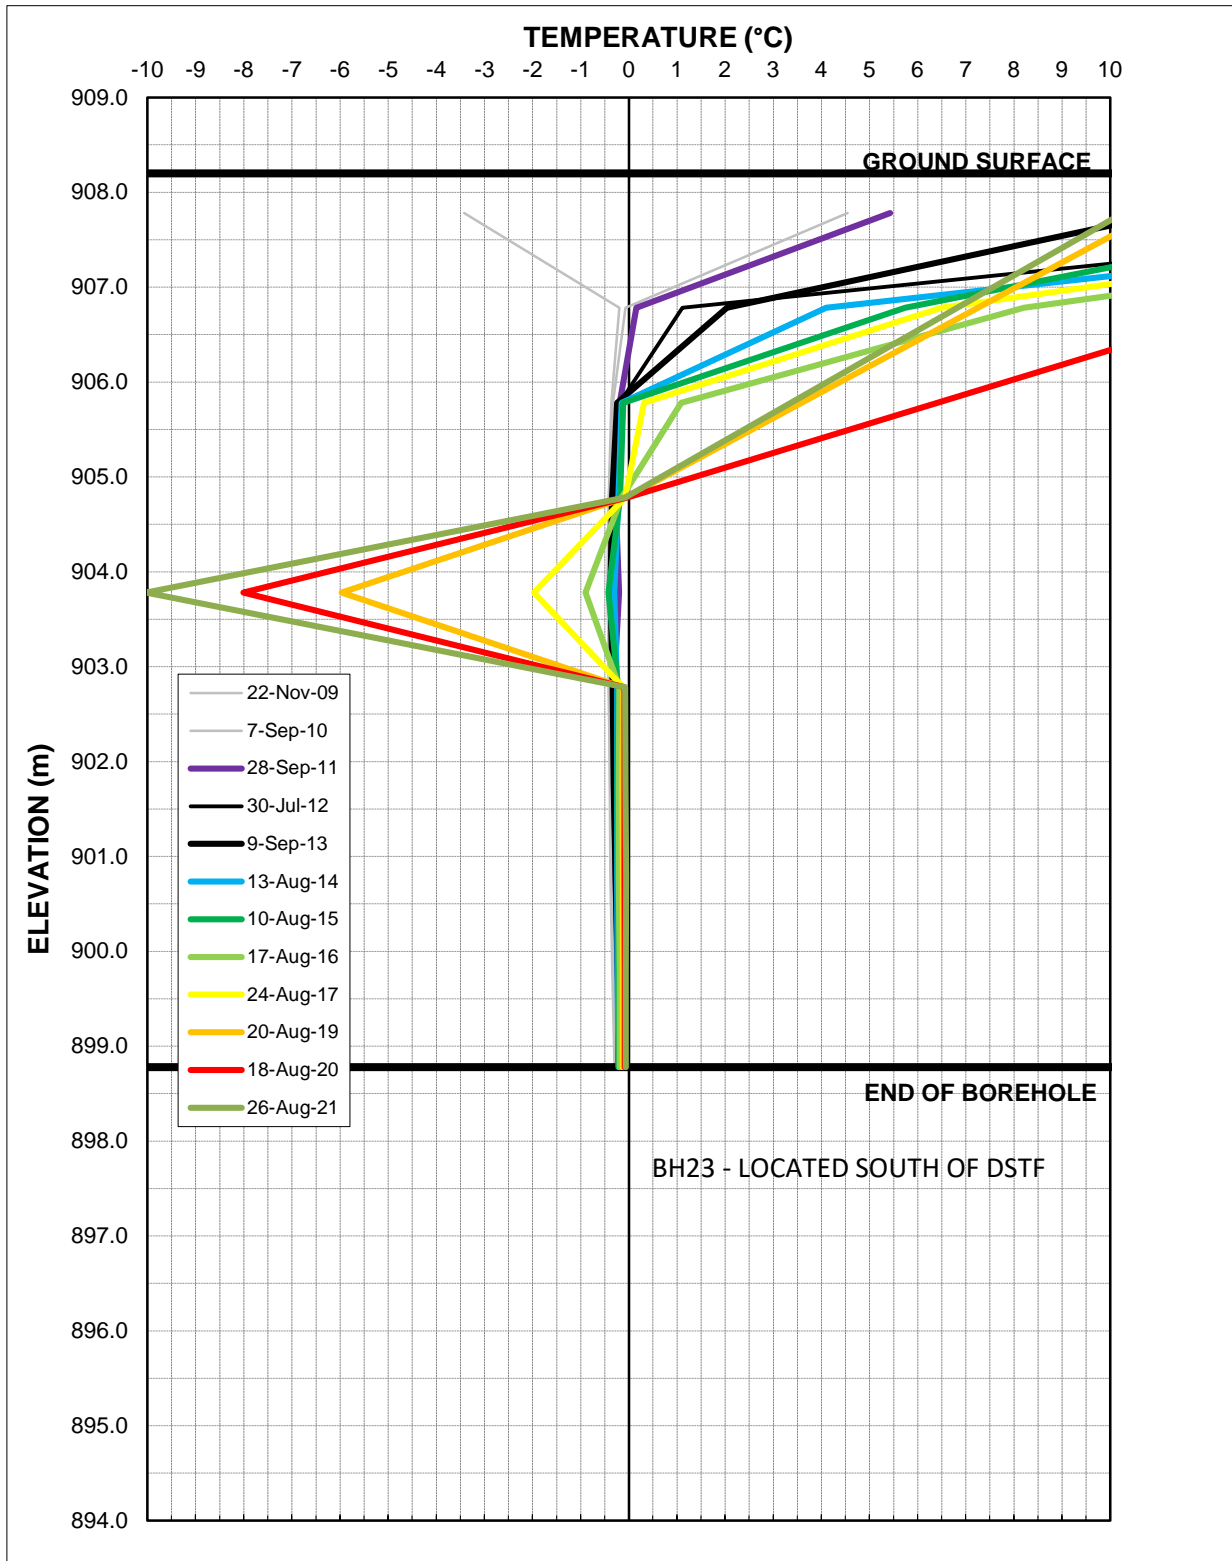
**Ground Temperature Profile**  
**Keno Hill District Mill Site Borehole BH23**  
**Figure T4**

Install Date      September 29, 2009  
 Last Updated    August 26, 2021  
 Cable No:        2210

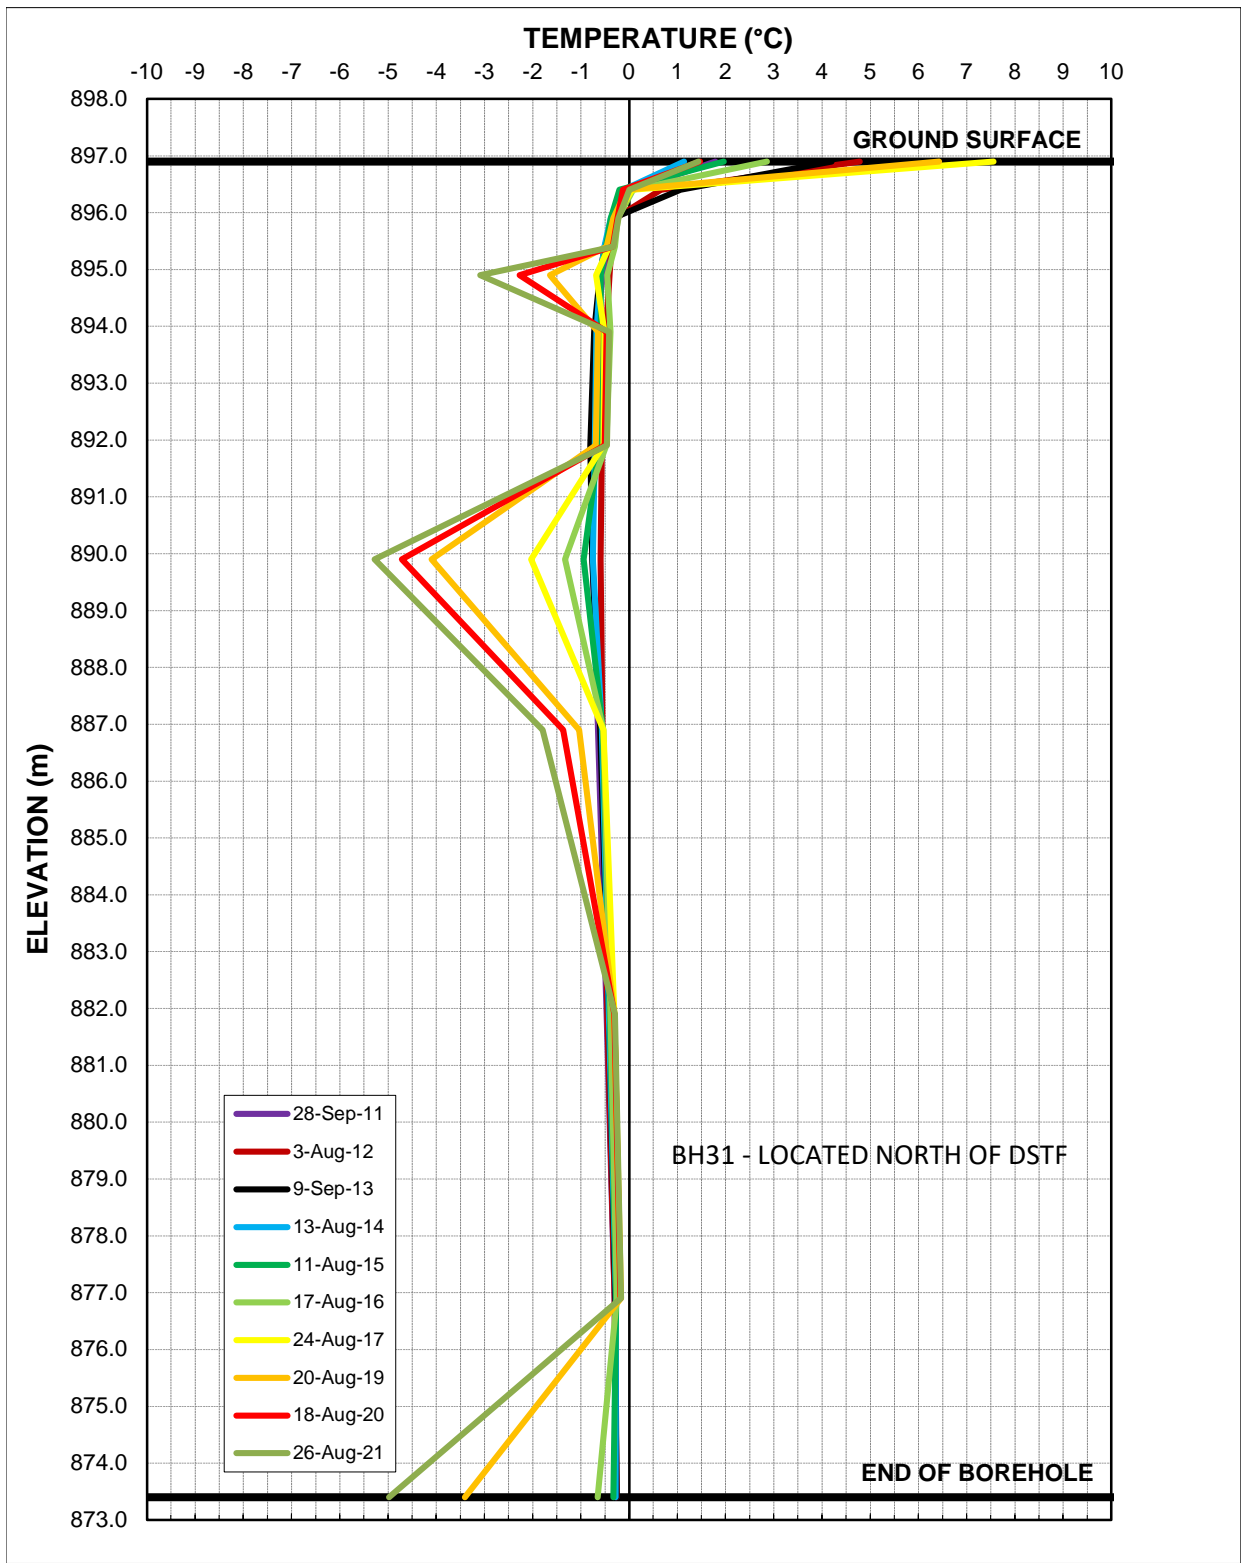
**Ground Temperature Profile**  
**Keno Hill District Mill Site Borehole BH31**  
**Figure T5**

Install Date      February 22, 2011  
 Last Updated     August 26, 2021  
 Cable No:        2263

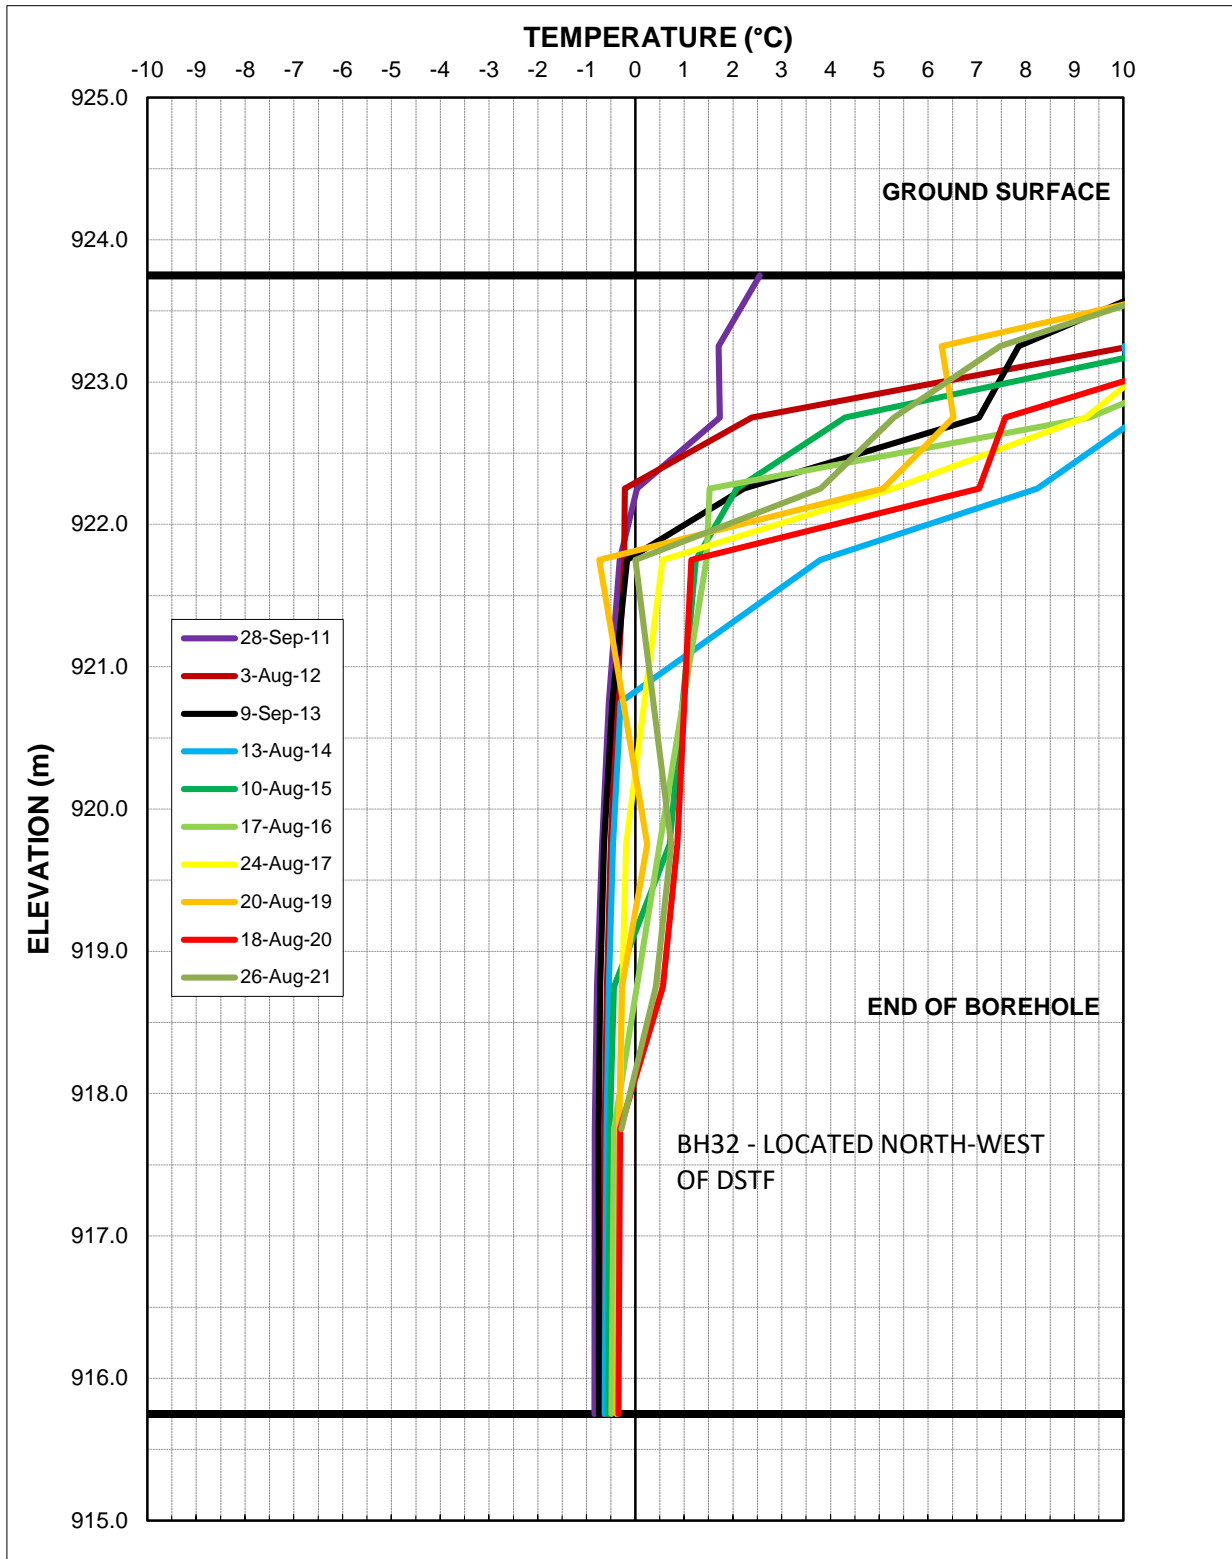
**Ground Temperature Profile**  
**Keno Hill District Mill Site Borehole BH32**  
**Figure T6**

Install Date      February 22, 2011  
 Last Updated     August 26, 2021  
 Cable No:        2264

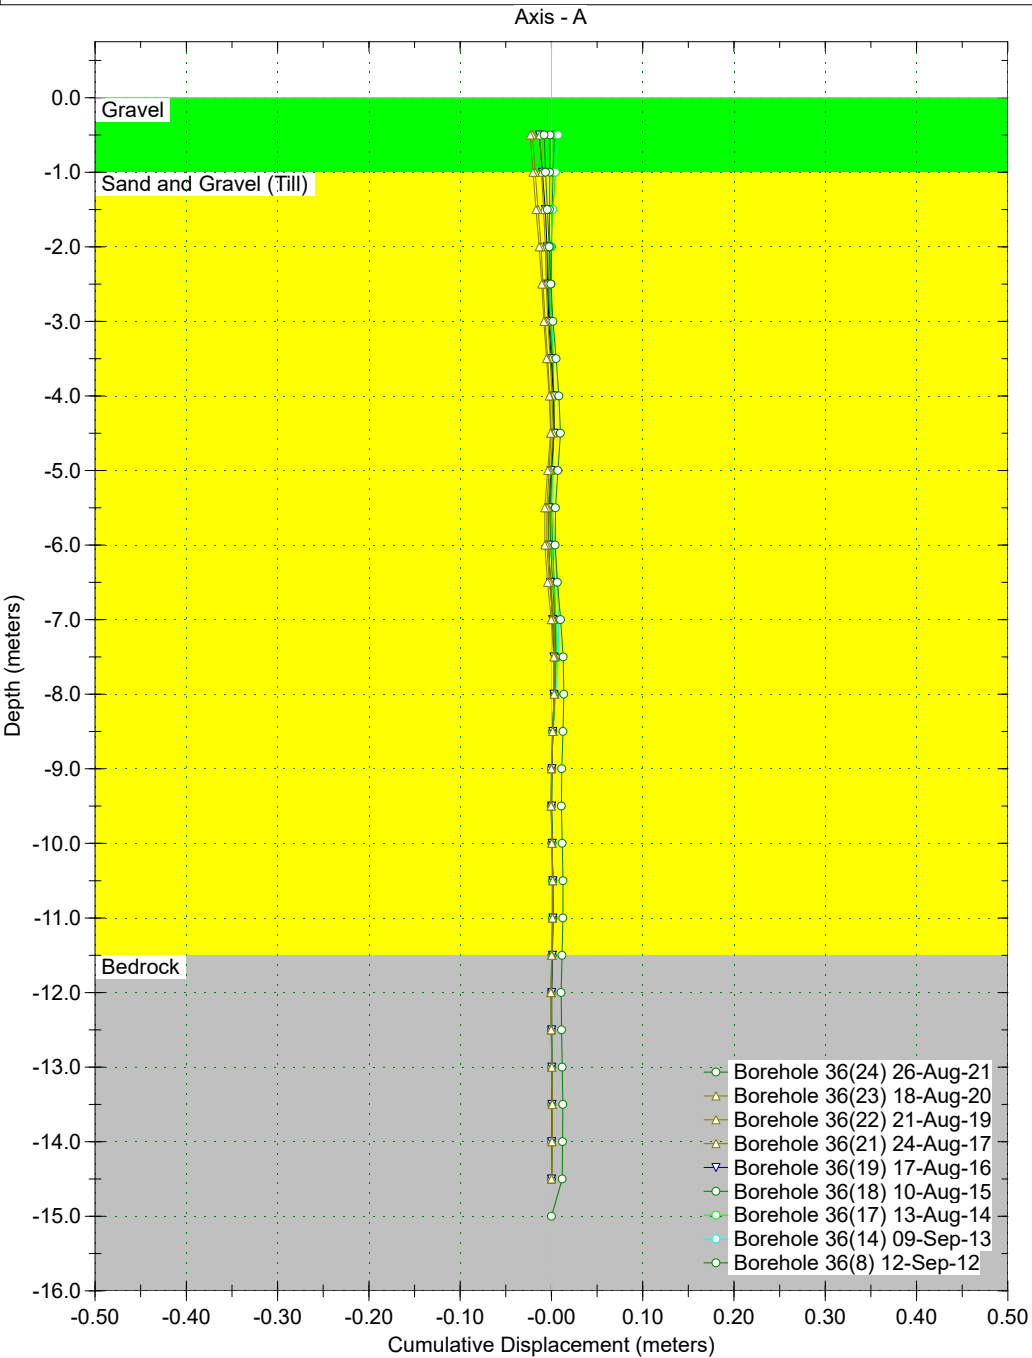
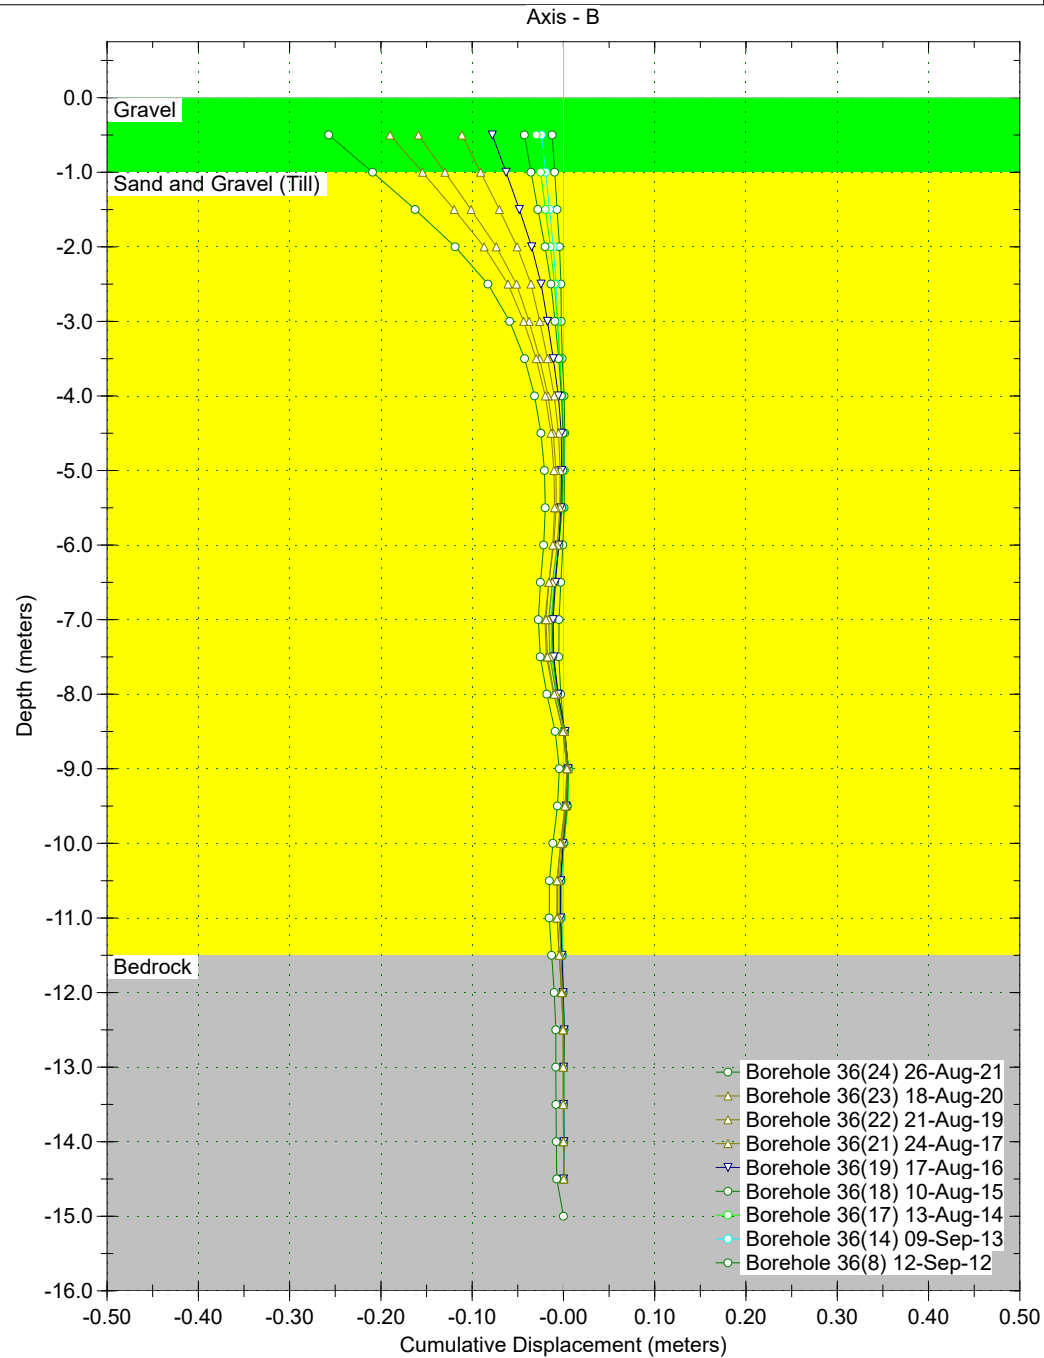
Borehole : Borehole 36  
 Project : Keno Hill District Mill  
 Location : DSTF  
 Northing : 7086872  
 Easting : 483931  
 Collar : 908.1

Spiral Correction : N/A  
 Collar Elevation : 0.00 meters  
 Reading Depth : 14.5 meters  
 A+ Groove Azimuth : 165  
 Base Reading : 2011 Dec 14 16:52  
 Applied Azimuth : 0.0 degrees
