TECHNICAL MEMO

TO: Katherine Penney
C: Vanessa Benwood
FROM: Justin Pigage, EIT
DATE: February 16, 2012
MEMO NO.: 008
EBA FILE: W14101696

SUBJECT: DSTF Instrumentation and Construction Monitoring
Keno Hill District Mill Site

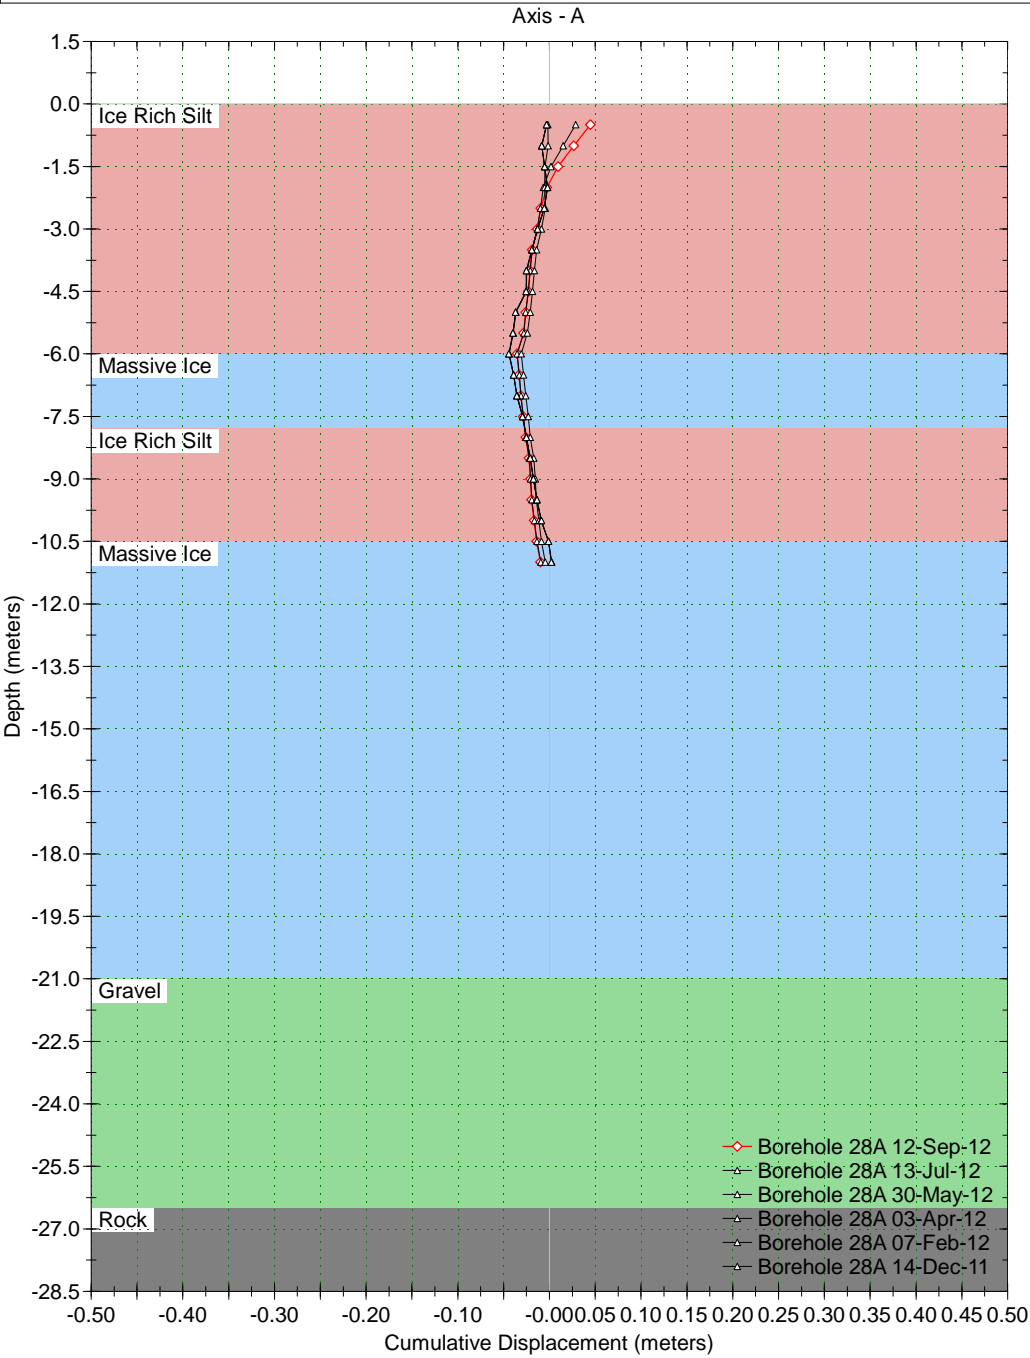
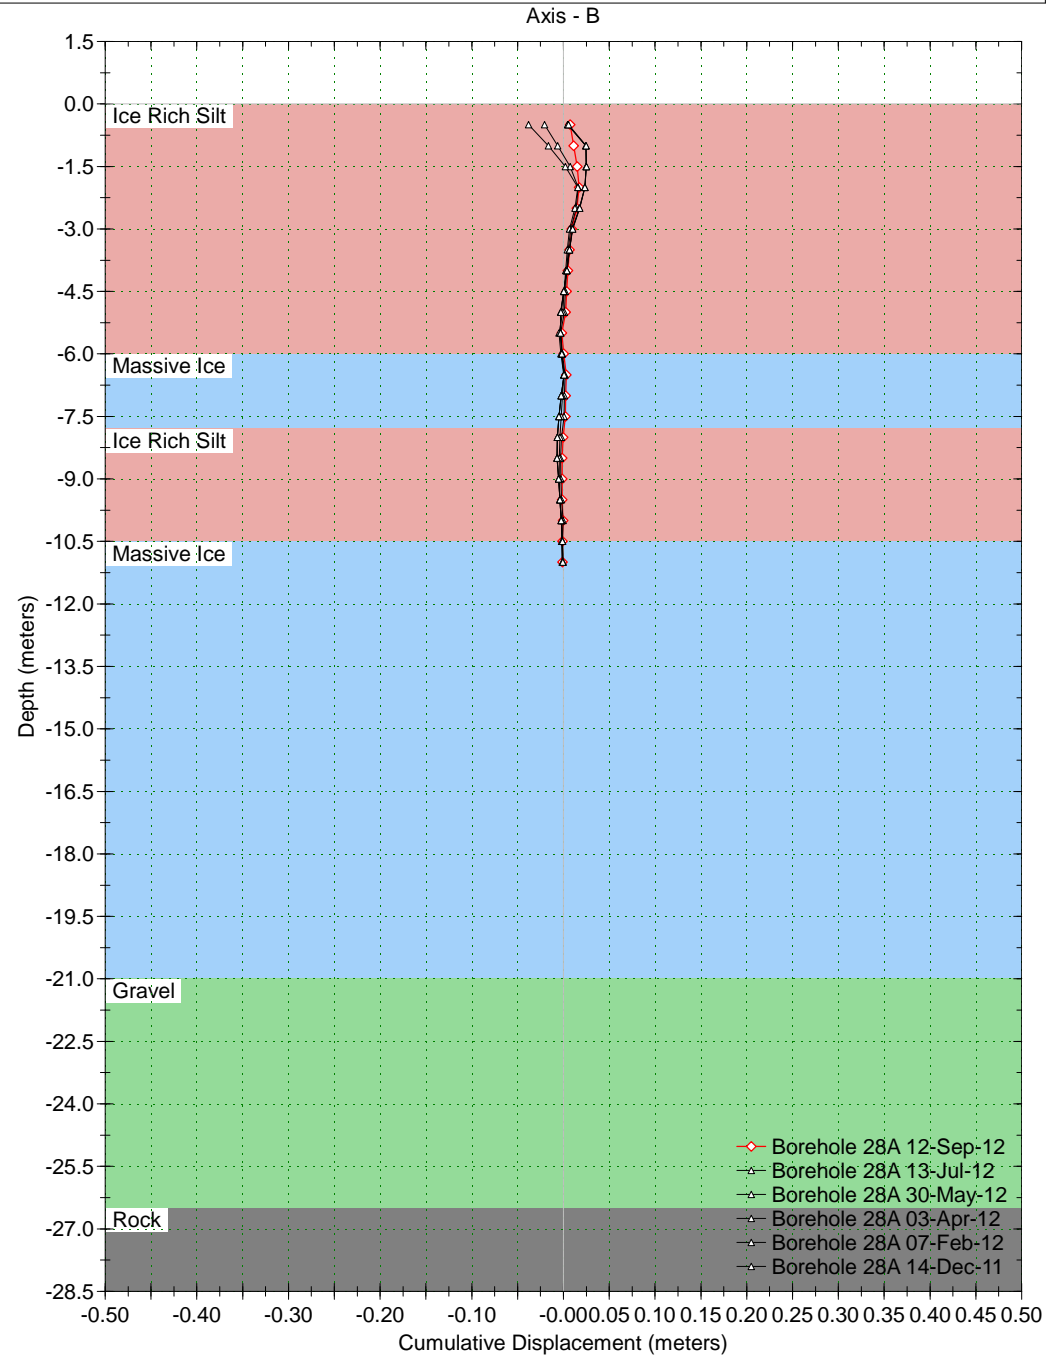
Borehole : Borehole 28A
Project : Keno Hill District Mill
Location :
Northing :
Easting :
Collar :

Only a partial set of SI readings were collected from BH28 during the site visit. BH28 seems to be damaged at a depth of about 11 m and the SI readings below 11 m are not considered reliable. Therefore, only SI readings above 11 m are included in the attached displacement plots.
