Keno Hill Environmental Audit – 2023 Hecla Mining Co.

Project No. 107840-01

October 19, 2023

Ausenco Sustainability Inc.
2237 2nd Avenue, Suite 230
Whitehorse, YT Y1A 0K7
T: 867.456.4865
ausenco.com

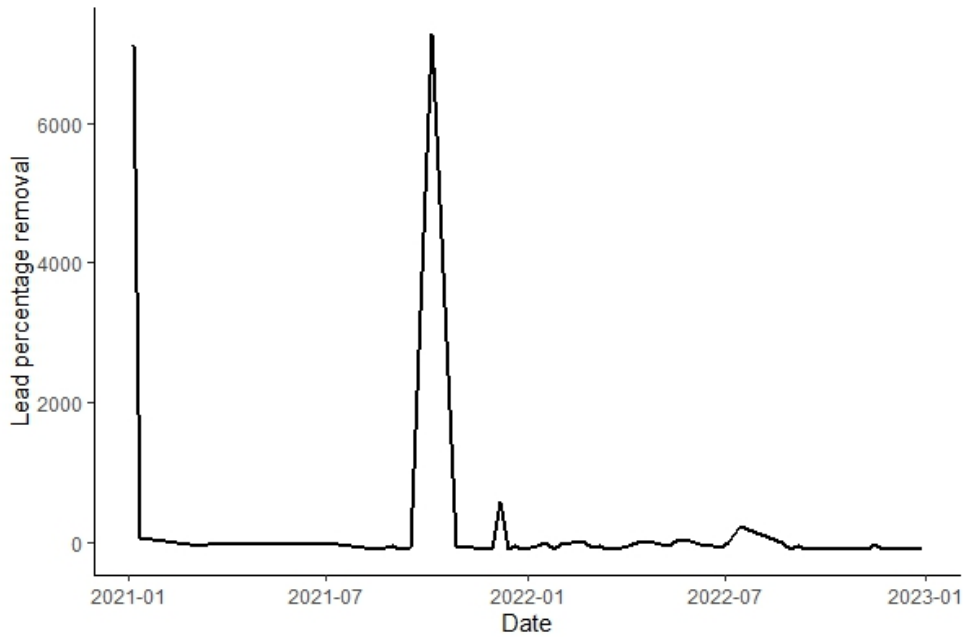
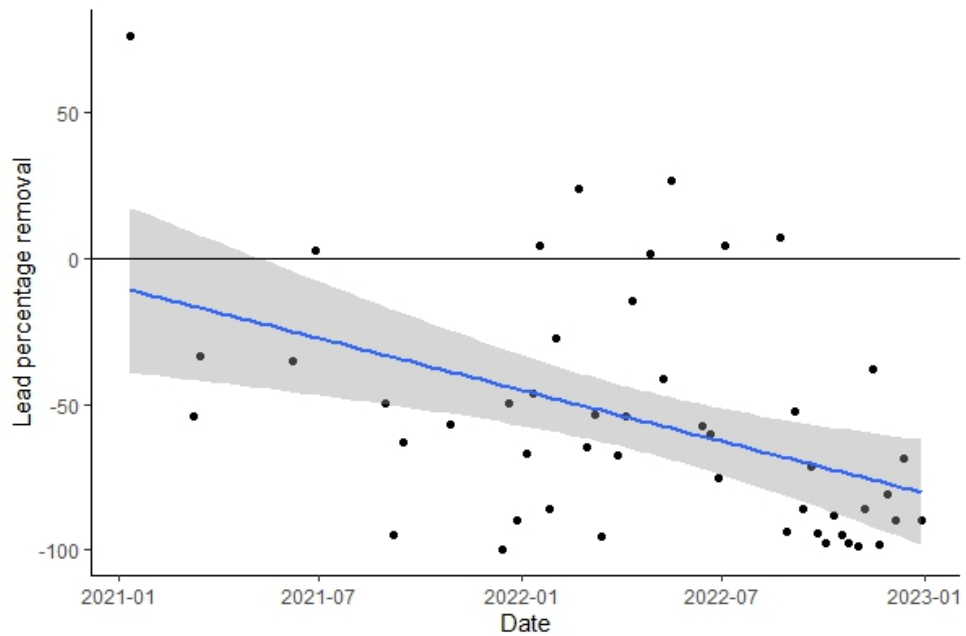
Lead (Pb)

Five outlier removed.

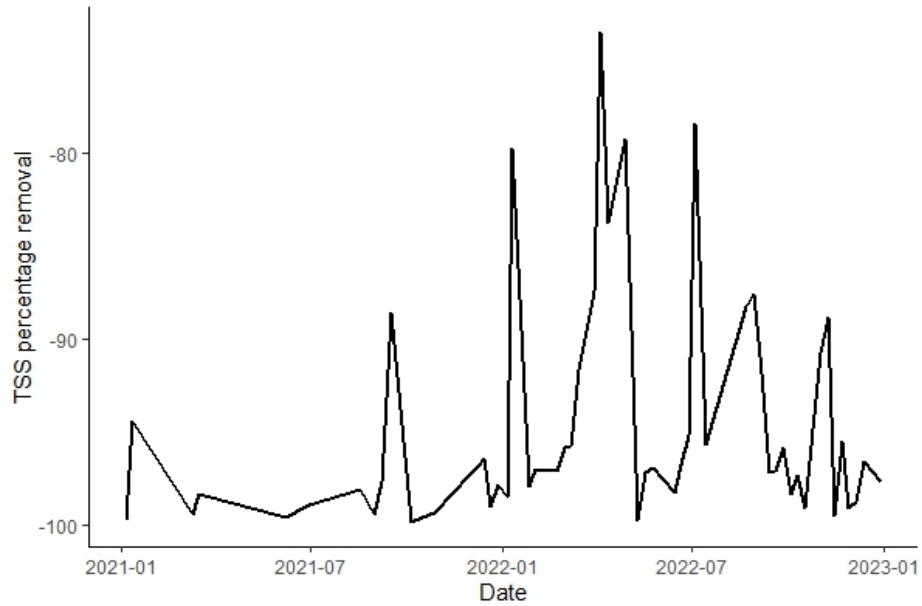
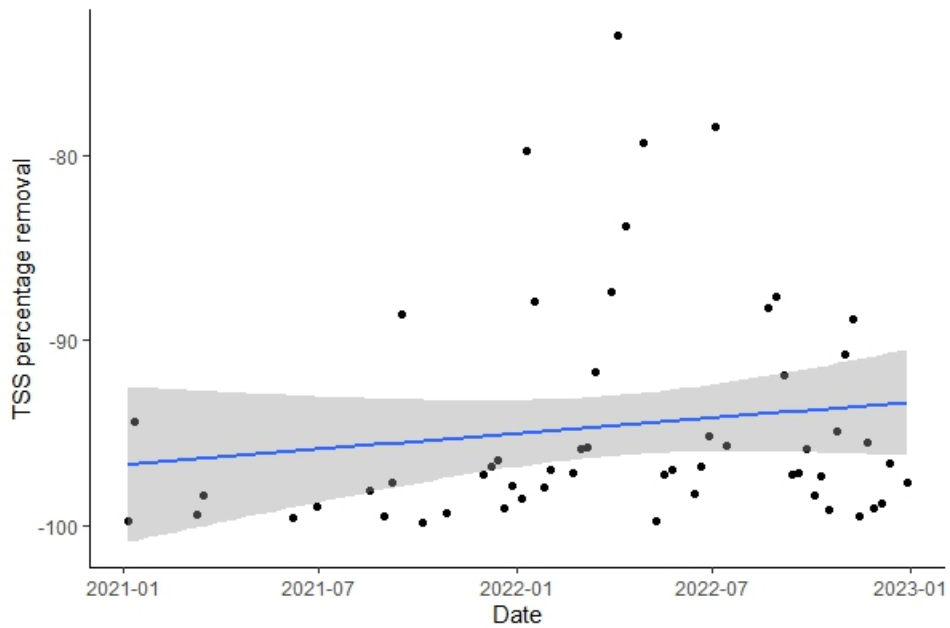
Total Suspended Solids (TSS)

data: HeCR\$Day and HeCR\$TSSBH
S = 96712, p-value = **0.0001098**
alternative hypothesis: true rho is not equal to 0
sample estimates:
rho
0.383407

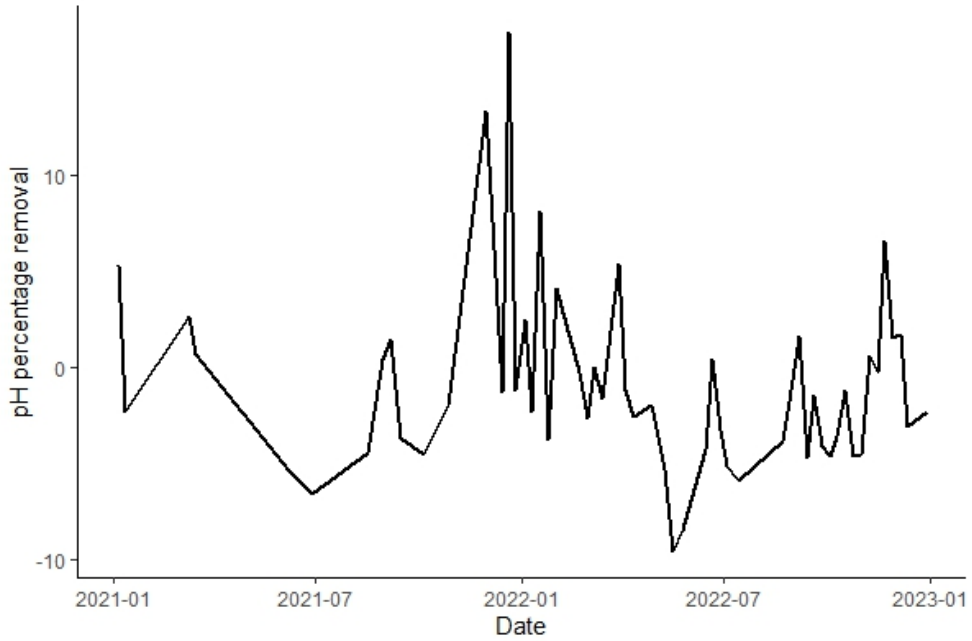
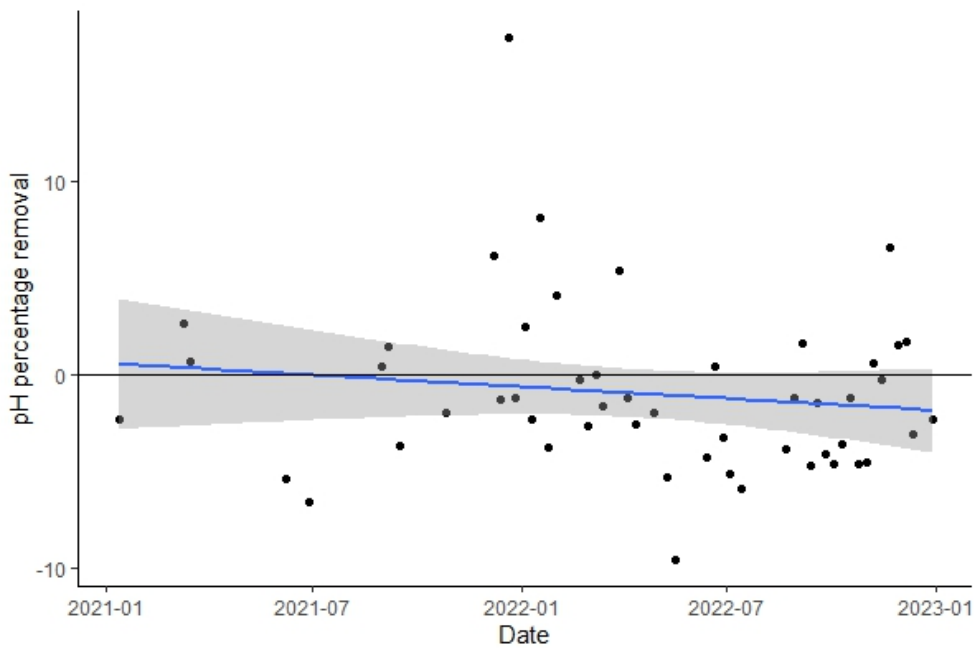
pH

```
data: HeCR$Day and HeCR$pHBH
S = 176851, p-value = 0.2108
alternative hypothesis: true rho is not equal to 0
sample estimates:
rho
-0.1275256
```

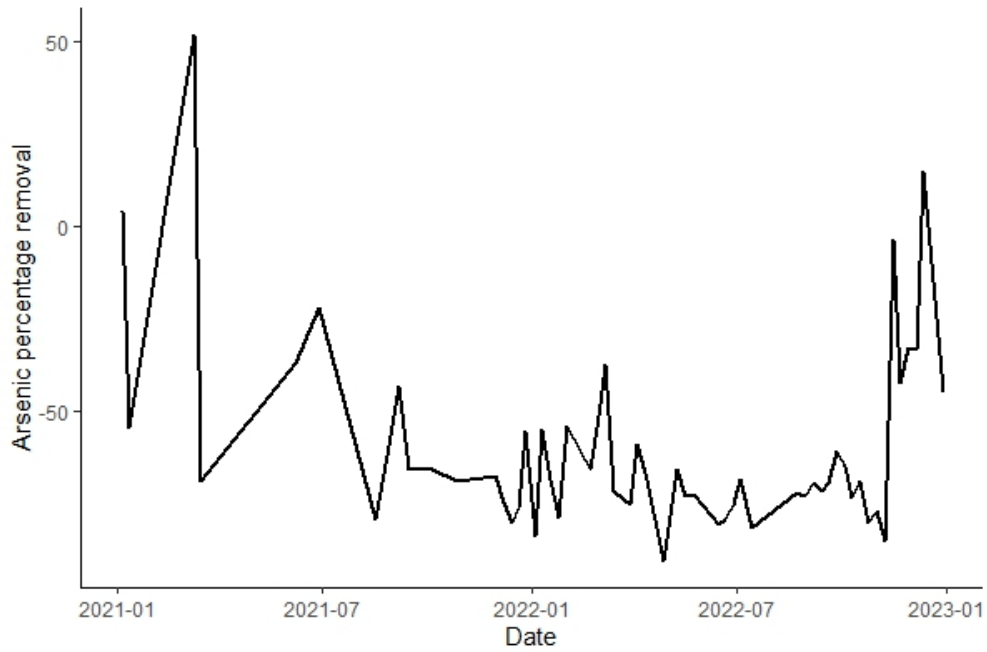
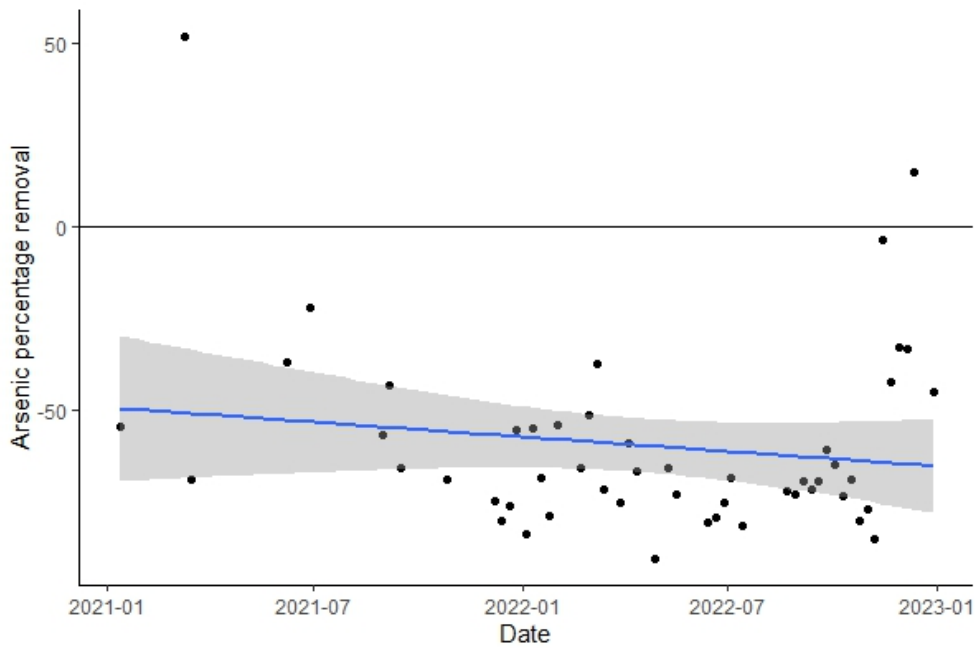
Arsenic (As)

```
data: HeCR$Day and HeCR$ASBH
S = 215556, p-value = 0.0001632
alternative hypothesis: true rho is not equal to 0
sample estimates:
rho
-0.3742899
```

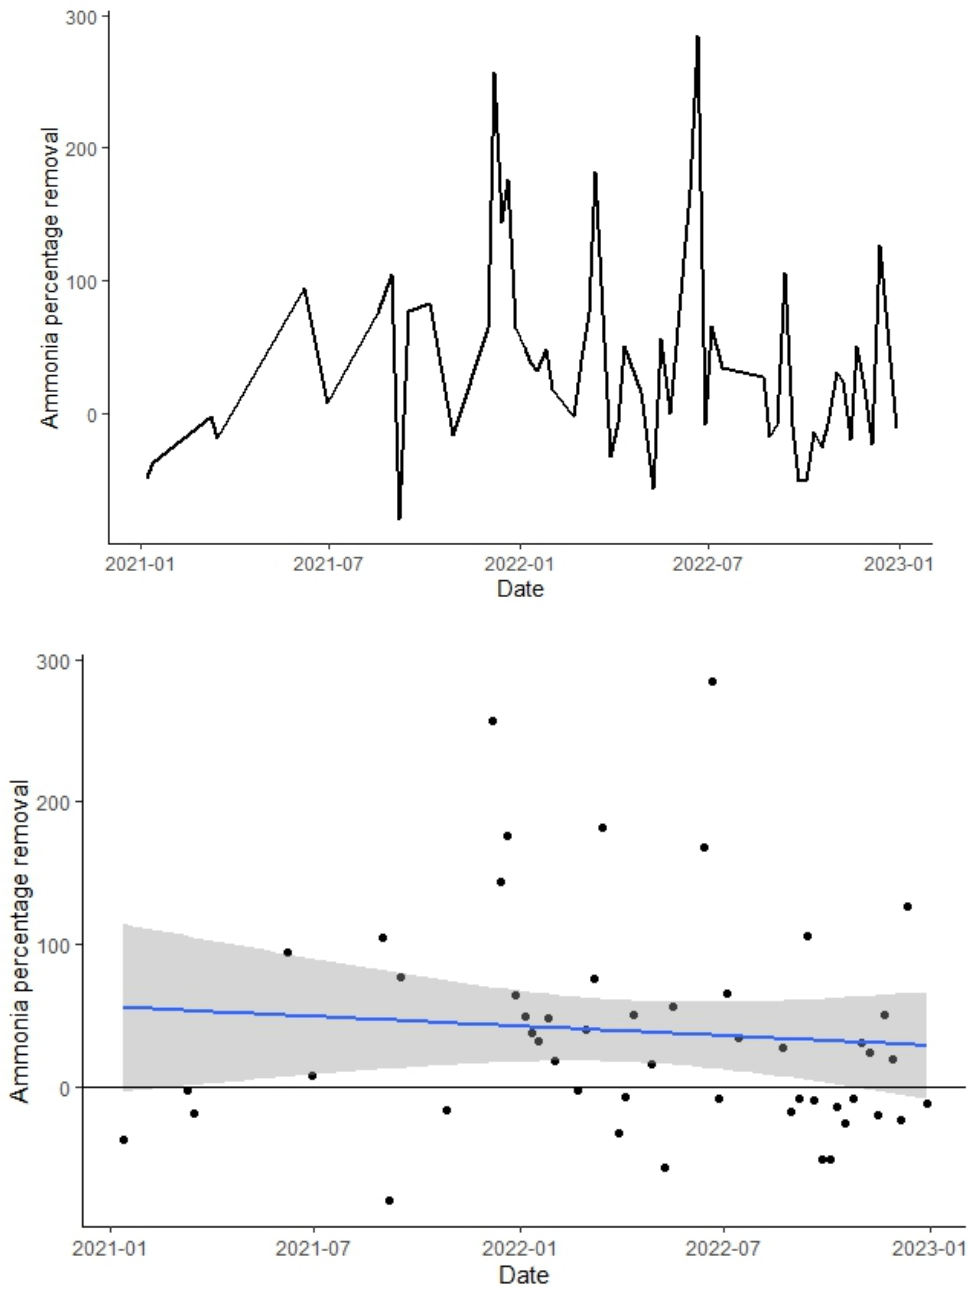
Ammonia (Am)

```
data: HeCR$Day and HeCR$AmBH
S = 147222, p-value = 0.755
alternative hypothesis: true rho is not equal to 0
sample estimates:
rho
0.03204555
```

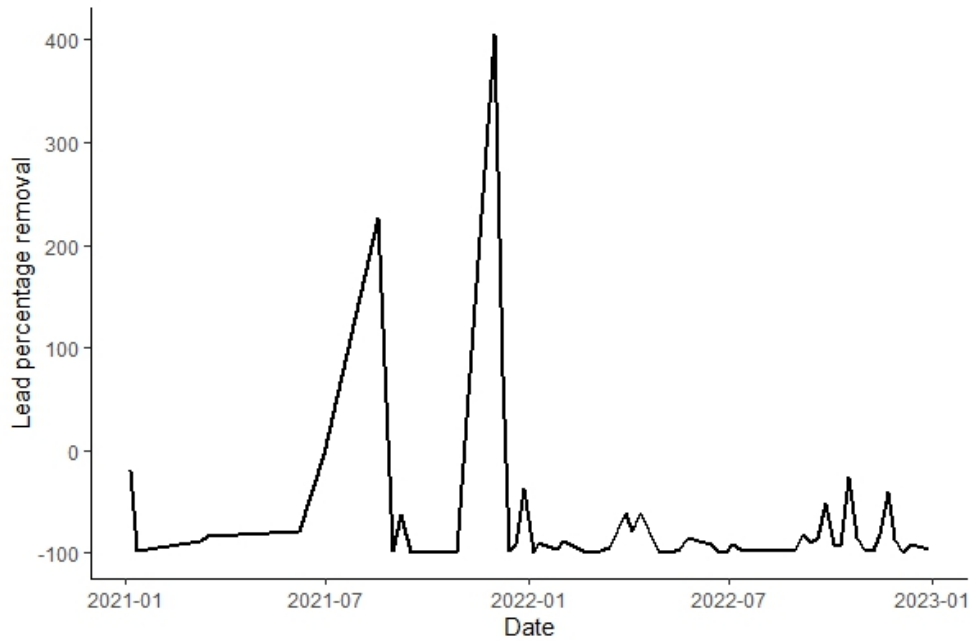
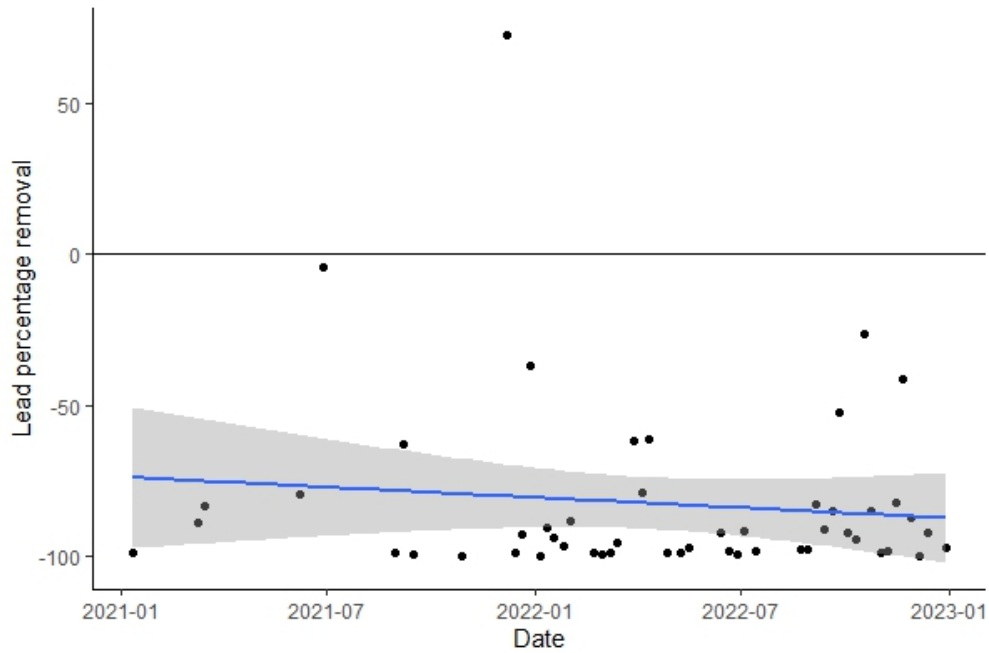
Lead (Pb)

Two outlier removed.
