**Ketza River Mine**  
**Environmental Liability Assessment**  
**FINAL Report**

*Prepared for:*  
**DIAND Contaminants / Waste Program, Whitehorse**

*Prepared by:*  
**Gartner Lee Limited**

*May, 2002*

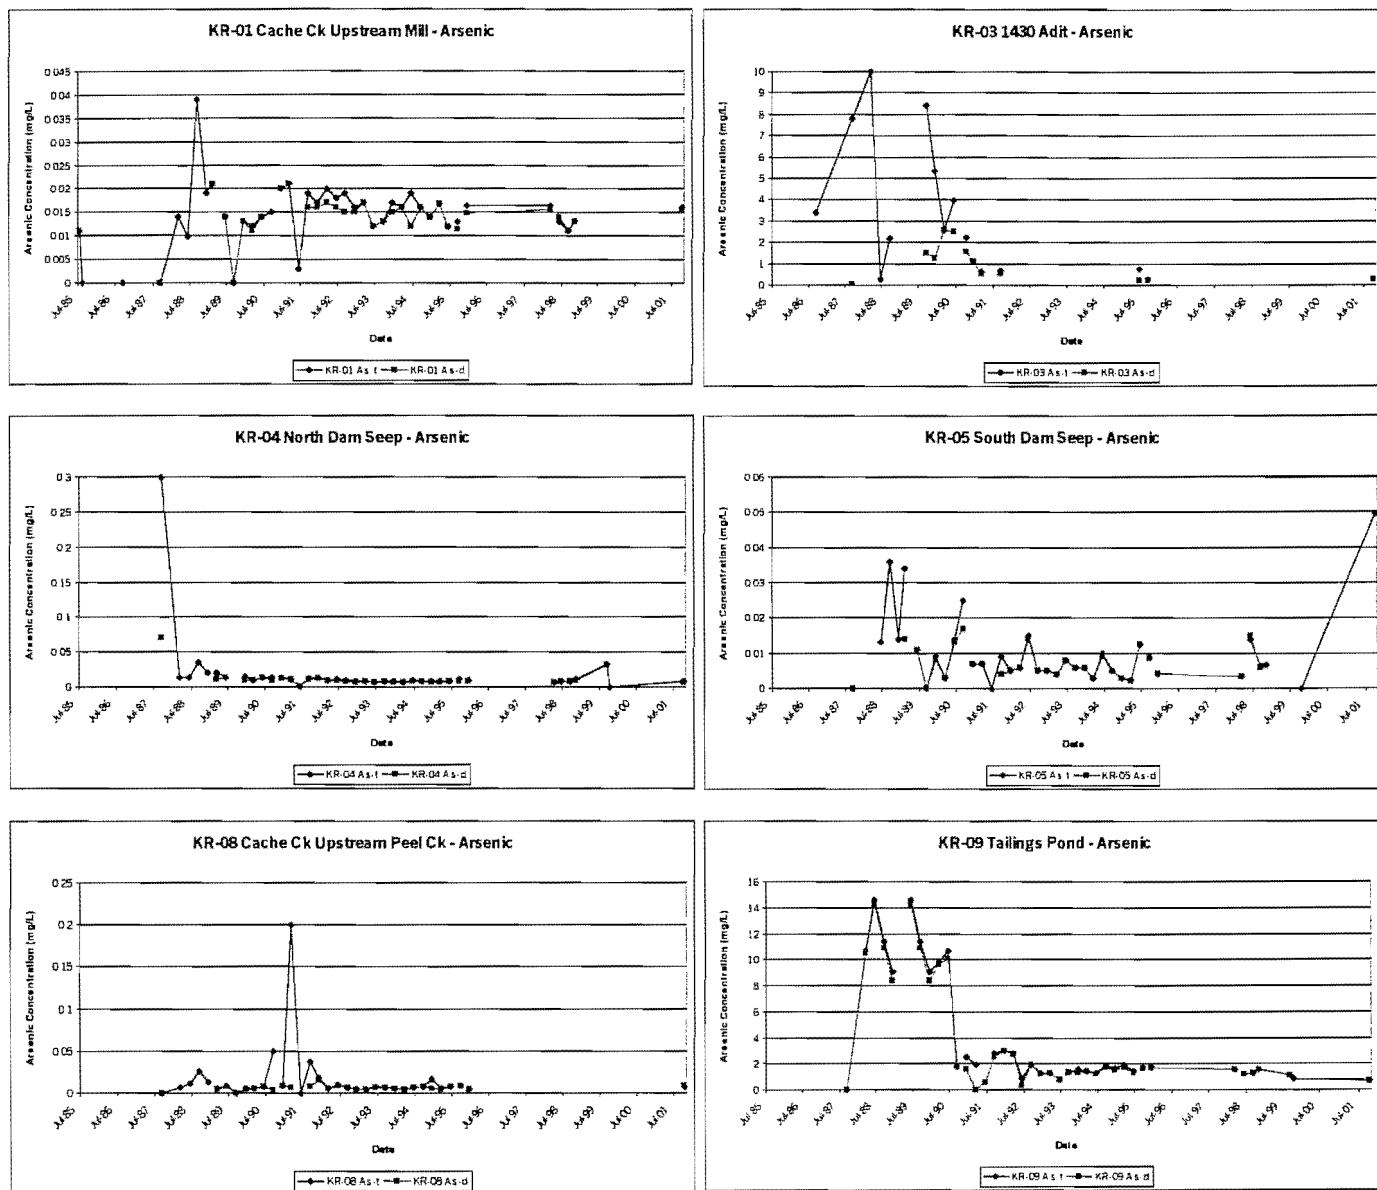
Figure 4.1: Historical Surface Water Arsenic Concentrations

A review of the available historical information listed in Table 4.4 provides the following observations that are illustrated on Figure 4.1:

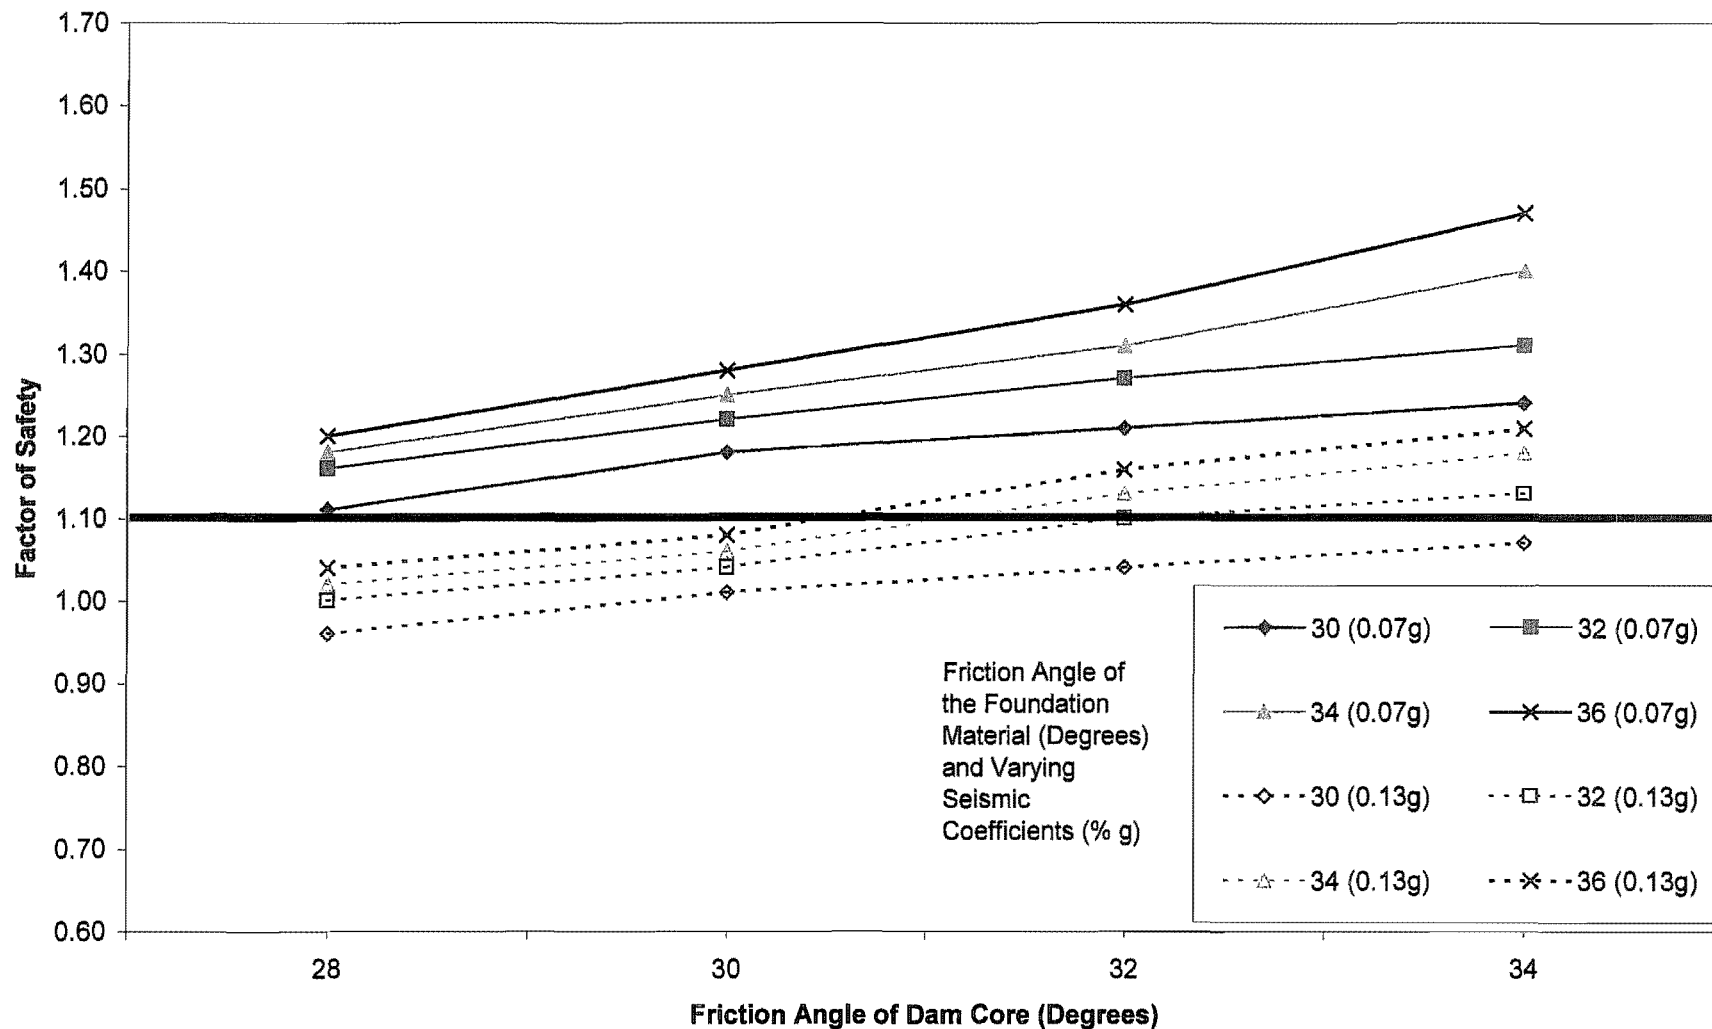
**Figure 4.6**  
**FOS Values For Static Analyses**  
**Case 2 Piezometric Conditions**

The results for the Case 2 static and pseudo-static analyses are summarized on Figures 4.6 and 4.7. Case 2 represents intermediate piezometric conditions in the dam section. For the static assessment, the dam meets the required factor of 1.5 when the either foundation material is  $34^\circ$  or higher and when the dam core frictional value is  $30^\circ$  or higher. In comparison to the results for Case 1, the Factor of Safety results for Case 2 conditions are lower and more varied. For the pseudo-static assessment, the majority of the results for a PGA value of 0.07g are equal or greater than the required 1.1. When the PGA value is increased to 0.13g, then the dam core needs a frictional value of at least  $32^\circ$  along with a foundation value greater than  $34^\circ$ .

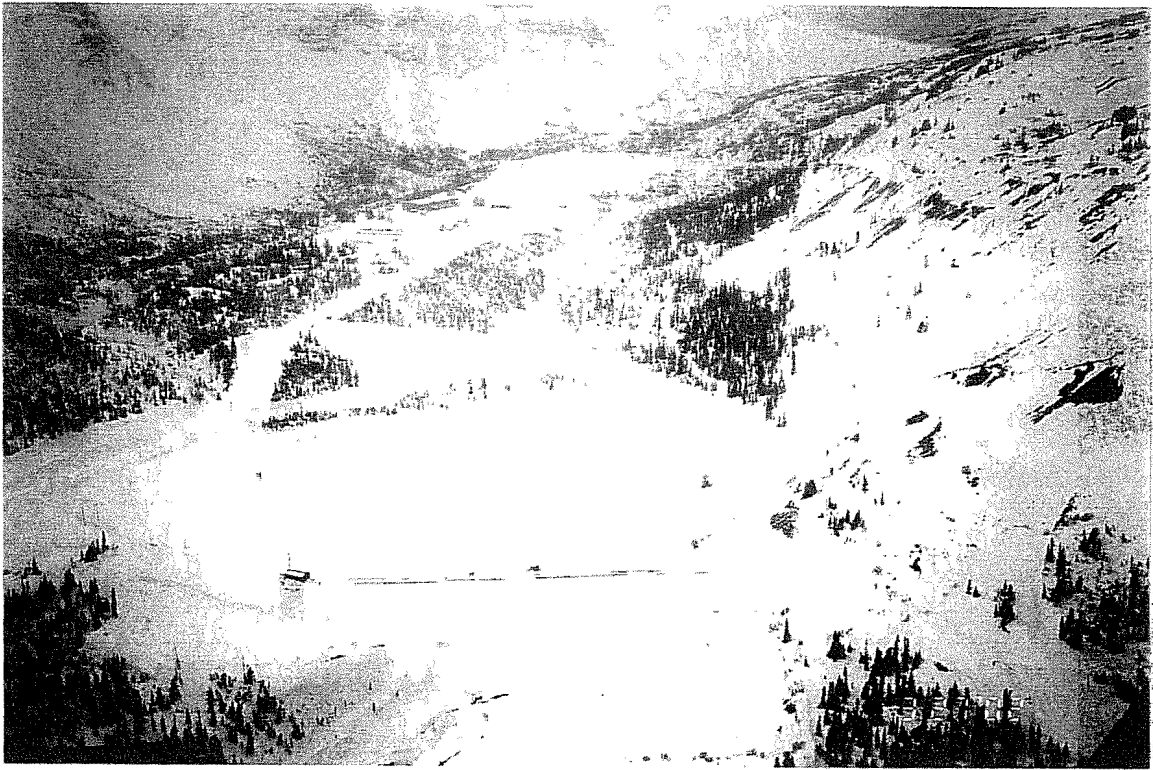
**Photograph 1. Overview of Ketza River mine and tailings ponds.**
