**Government of Yukon
Water Resources Branch
Ketza River Mine
2007 Geotechnical Inspections**

UMA Project No.: 6029 010 00 (4.12.4)

February 2008

**Re: Yukon Sites – 2007 Geotechnical Inspections
 Ketza River Mine**

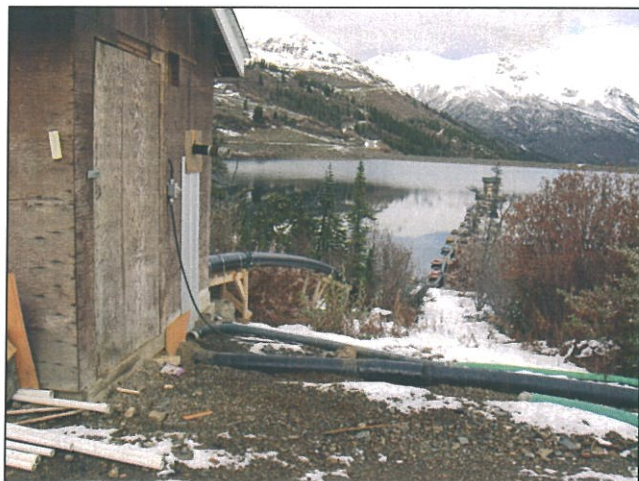
Figure 06 Pumphouse, Intake and Discharge Lines

At the time of our inspection, the water level in the tailings pond was estimated to be 2 to 2.5 m below the tailings dam crest level (Figure 04). A staff gauge in the tailings pond read 7 inches. At the current water level, small exposures of tailings beaches were noted along the upstream side of the tailings dams, in particular the South Dam (Figure 05). It was estimated that the water level was approximately 1 m below the invert of the spillway that separates the North and South Tailings Dams. This is approximately the same water elevation reported in the September 2005 inspection by SRK Consulting and probably 0.3 to 0.6 m lower than reported by EBA in their June 26 inspection of this year. It is our understanding that when necessary, tailings pond levels are lowered through pumping via the intake and pumphouse situated on the southwest side of the pond (Figure 06). Water from the pumphouse is discharged via a 150 mm line to the Cache Creek Diversion Channel (Figure 07). The pump was not in operation at the time of our October inspection.

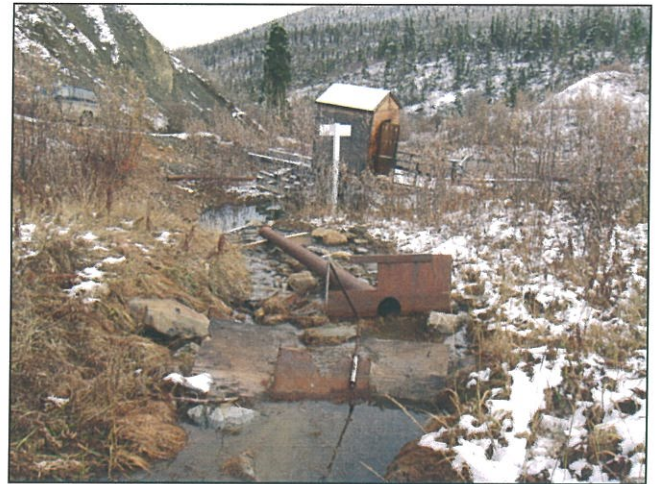
Figure 09 Pumphouse N1 and Weir

It is also our understanding that at one time, water from the tailings pond was circulated back to the mill via the abandoned pumphouse just north of the spillway. Seepage water was collected in ponds downstream of the North and South Dams and pumped back over the dams back into the tailings pond via Pumphouses N1, S1 and S2 (Figure 08). None of the pumps are currently operational.

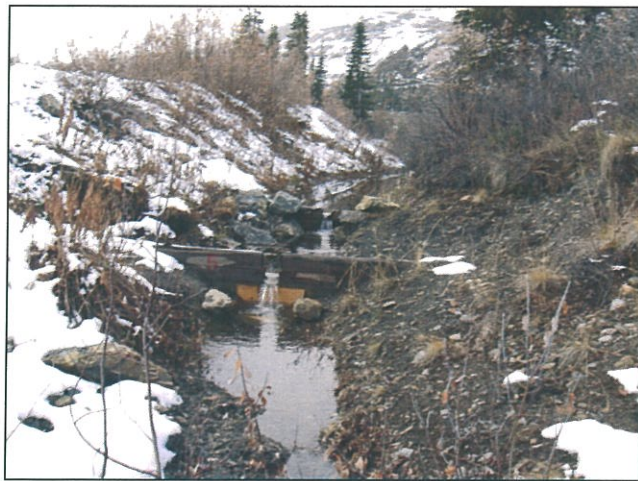
Figure 10 Weirs D/S of South Dam

When the tailings pond pumphouse is not operating, water levels in the tailings pond are somewhat self-regulated through seepage losses occurring at the toe of the North and South Dams. Weirs were installed during mine operation to measure seepage flow rates from both the North and South Dams. The V-notch weir installed in the drainage channel immediately upstream of Pumphouse N1 is no longer functional (Figure 09). Two timber weirs downstream of Pumphouse S2 are operational (Figure 10). A water treatment plant located beside the tailings pond pumphouse was not in operation during our inspection (Figure 11). While it is beyond the scope of UMA's assignment to evaluate the environmental impact from seepage effluent, it is our understanding that the seepage water from the tailings pond meets the effluent quality limits established for the site; it is not presently necessary to treat the effluent from the tailings pond.

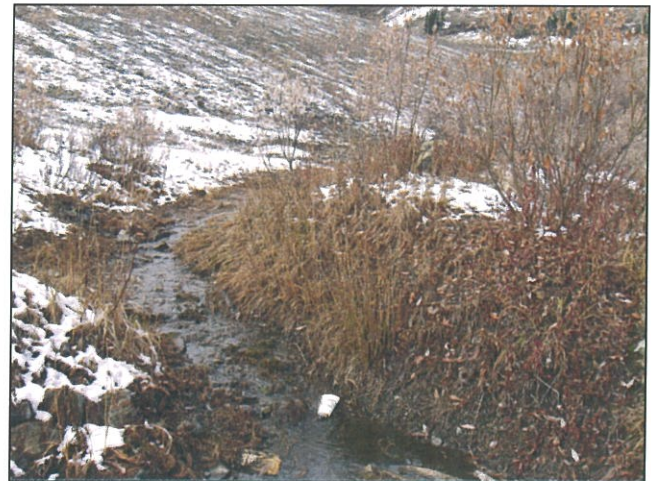
Figure 17 Drainage Channel at Toe of North Dam

Seepage was noted at the toe of the North Dam at several locations along a stretch of about 20 m (Figure 16). Water from these seeps collects into a common drainage channel that runs into the collection pond at Pumphouse N1 (Figure 17). Some fine grained soil has accumulated at the bottom of the drainage channel just upstream of the V notch weir. Although the source of these fines could not be determined they may be from surface erosion of the silty soil beyond the toe since the water seeping from the toe of the dam was clear. The ground is also very soft in the area of the seeps with quicking conditions evident. The soft zone extends up the face of the dam by approximately 1 m. Although seepage was not observed at the toe of the South Dam, water accumulating at the surface of the granular drainage blanket and flow downstream of the pumphouse clearly indicates that seepage losses similar to the North Dam are occurring.

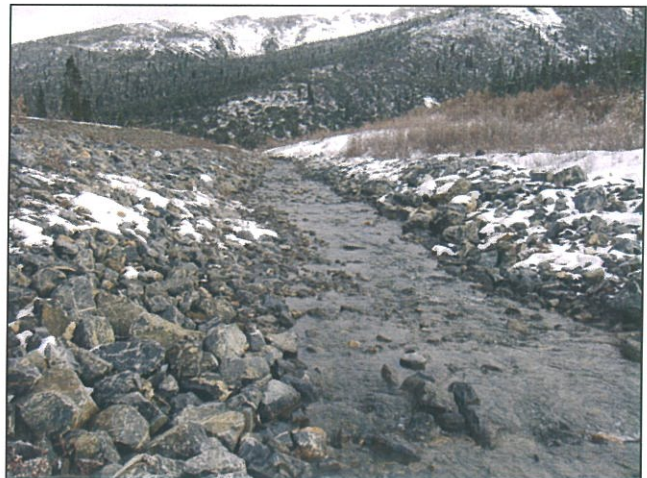
Figure 21 D/S Segment of Cache Cr. Div.

The upstream and middle segments of the Cache Creek Diversion are in good condition (Figure 20). The riprap armouring is stable and no down-cutting of the channel is evident. The far end of the downstream segment (east of the South Dam centreline) is considerably steeper with evidence of ongoing ravelling of riprap along the bank (Figure 21 and 22). Down-cutting of the bedrock through which the channel is founded at the confluence with the drainage channel from the South Dam seepage pond is also evident (Figure 23). The narrow channel width and steep banks of the downstream channel segment makes it more prone to blockages from bank instabilities or ravelling of riprap from the banks.

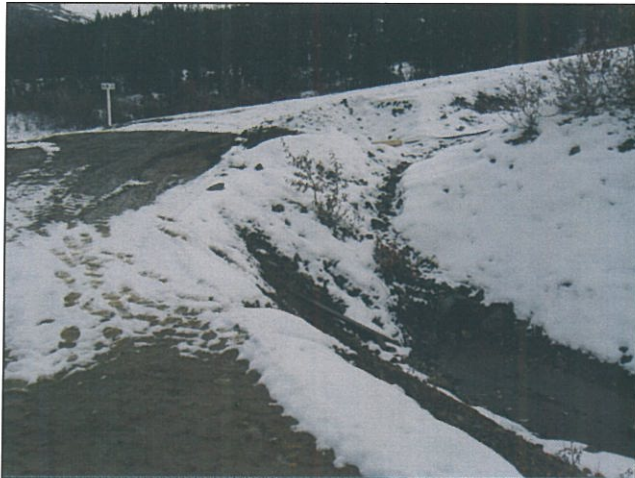
Figure 24 Culvert at End of Diversion Channel

The Lower Subsidiary Creek Diversion is in generally good condition along its length from the mine site access road to its confluence with the Cache Creek Diversion. The 600 mm diameter culvert at the downstream end of the channel is in good condition with no blockages (Figure 24). Based on observations at a weir just upstream of the culvert, the flow is estimated to be in the order of 1 l/sec (Figure 25). Tension cracks and minor slumping of the channel bank about 60 m downstream of the mine

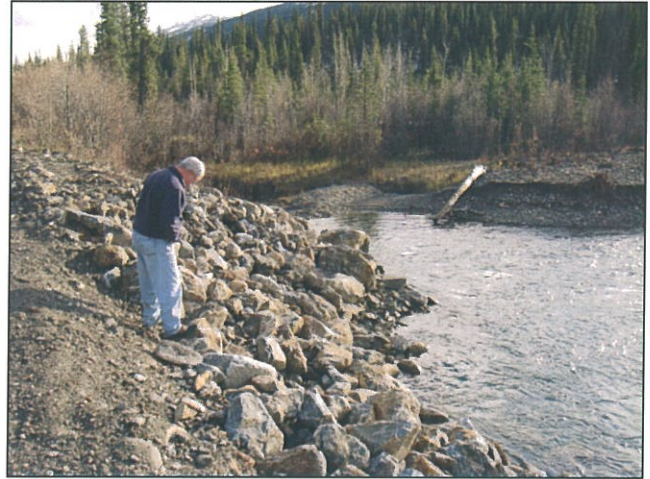
Figure 35 View U/S at Location C

Location C is a 15 m long section of riprap at a sharp outside bend of the river channel (Figure 34). The bank is about 2 m high with the riprap in good condition with no evidence of active bank erosion (Figure 35). Riprap size is up to 800 mm with an estimated D_{50} of 250 mm.

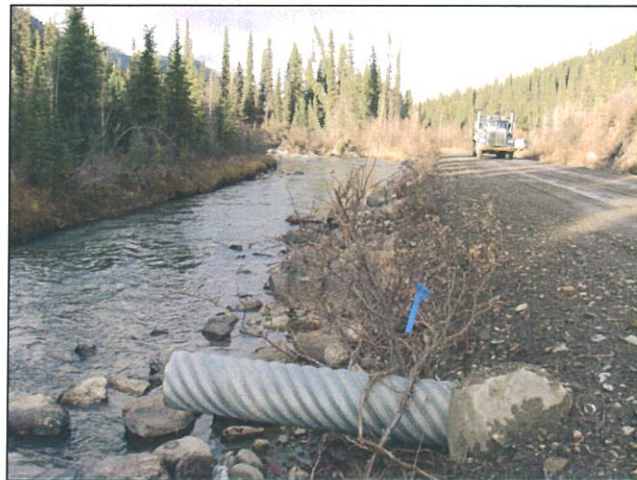
Figure 36 Culvert at Location D

Location D is along a 50 m long stretch at a gentle outside bend of the river channel. The riprap has been in place for many years and is in good condition with no evidence of active erosion. There is a 300 mm diameter culvert crossing the road at this location (Figure 36). The bank is about 1 m high. Riprap size is up to 900 mm with an estimated D_{50} of 250 mm.

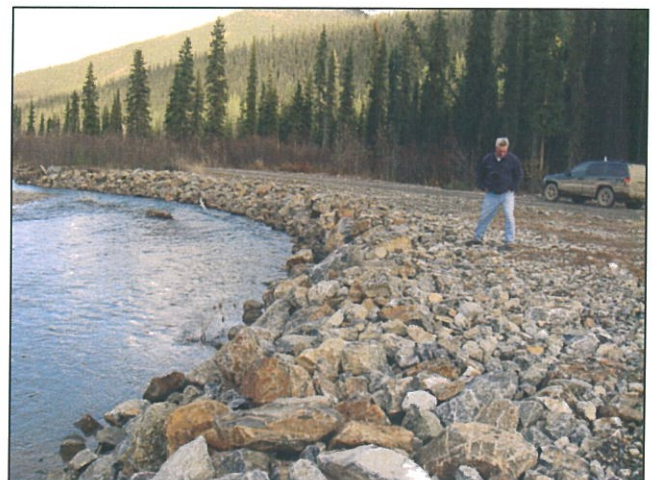
Figure 39 View D/S at Location F

Location F is about 50 m long along a moderate outside bend in the channel (Figure 38). The riprap is in good condition with no evidence of active erosion. The bank is about 2 m high (Figure 39). Riprap size is up to 1,000 mm with an estimated D_{50} of 450 mm. Many of the riprap pieces are flat.

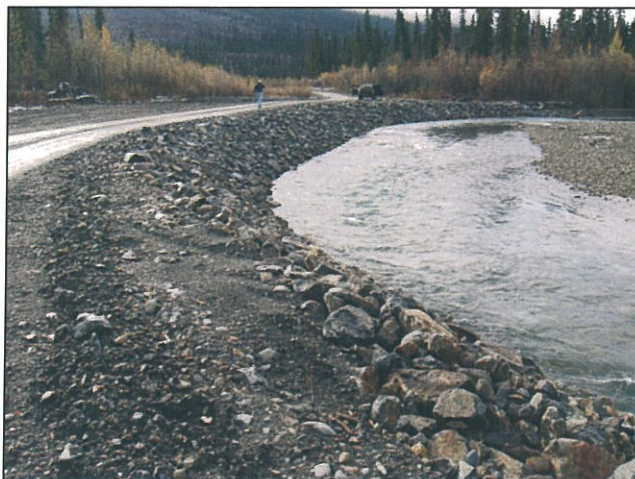
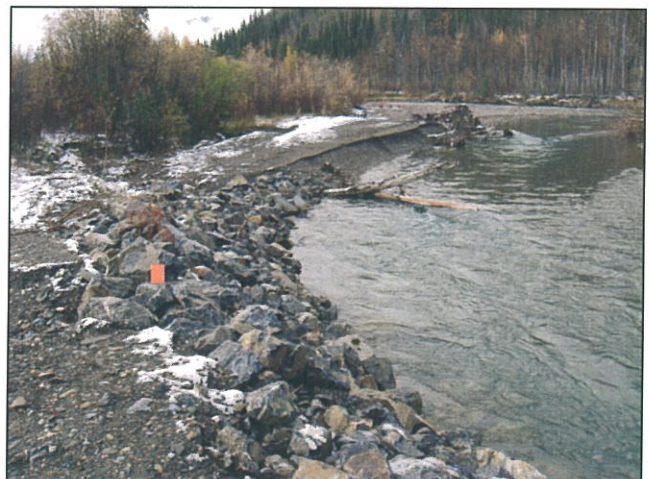
Location H is the farthest downstream point just before the road and creek channel diverge. It is located on the outside bend of a channel meander where armouring has been recently placed for a distance of about 100m (Figure 42 and 43). A 400 mm diameter culvert crosses the road from a recently excavated drainage ditch on the opposite side of the road (Figure 44 and 45). Although there was no water flowing in the ditch at the time of our inspection, the bottom 1/3rd of the culvert is blocked with sand from previous flows. The bank is about 2 m high. Riprap size is up to 900 mm with an estimated D_{50} of 300 mm. The upstream transition of the armouring with the shoreline is abrupt which may result in scouring towards the road during high flow events (Figure 46). The downstream transition appears adequate (Figure 47).
