Government of Yukon, Water Resources Branch

Ketza Mine North Tailings Dam Toe Berm Assessment

AECOM

December, 2009

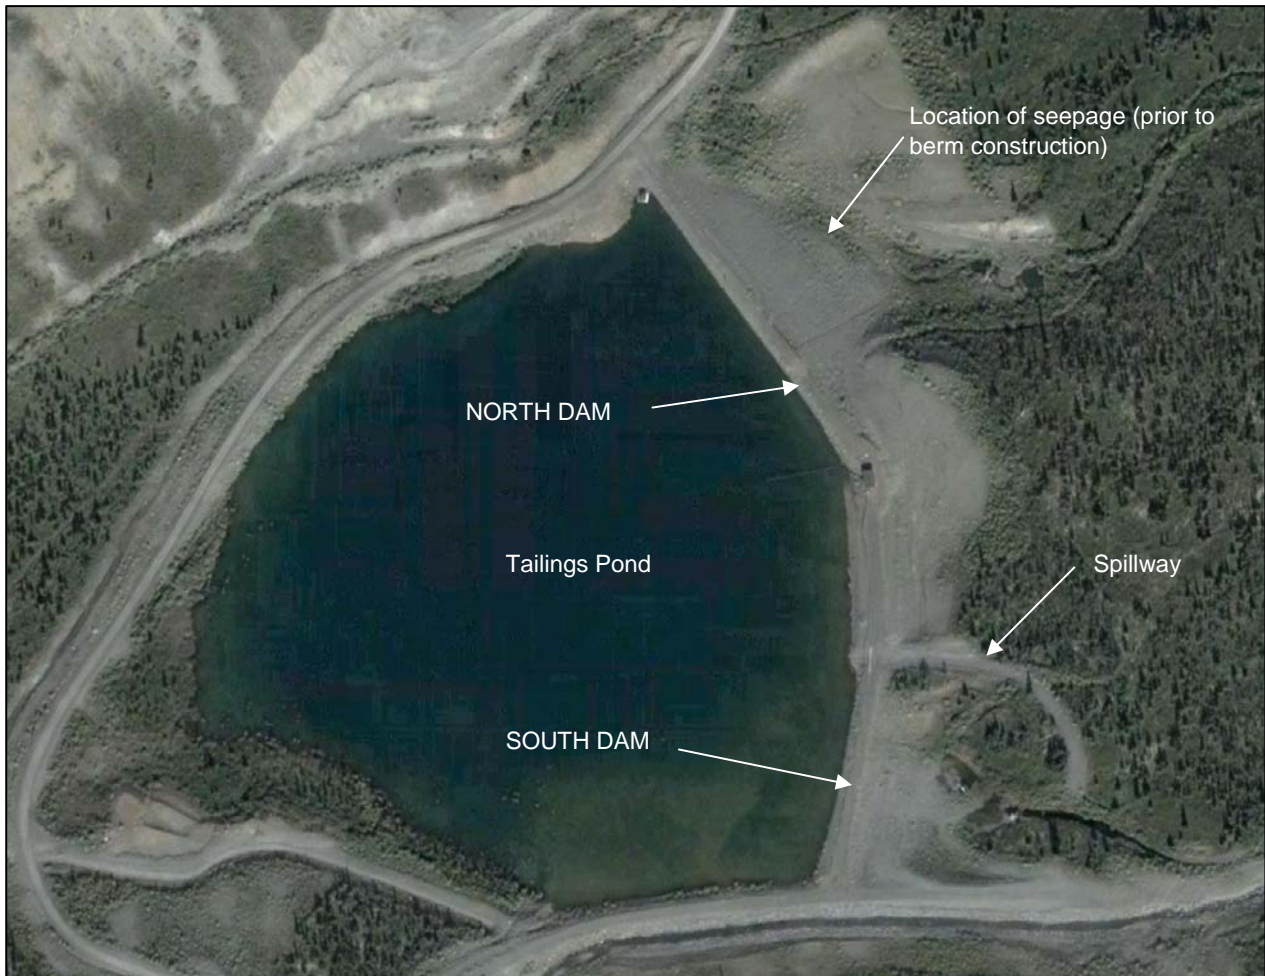
Fig 02 Tailings Impoundment and North Dam Prior to Toe Berm Construction

The tailings management area (TMA) consists of the tailings impoundment created by the north and south tailings dams, and diversion ditches to route Cache Creek around the tailings pond as illustrated on Figure 02. The north and south dams are separated by a spillway. Seepage was previously observed at the toe of the north dam at several locations along a stretch of about 20 m (Figure 03). Water from these seeps collected into a common drainage channel that runs into the collection pond at Pumphouse N1 (Figure 04). The ground was observed to be very soft in the area of the seeps with quicking conditions evident. The soft zone extended up the face of the dam by approximately 1 m.

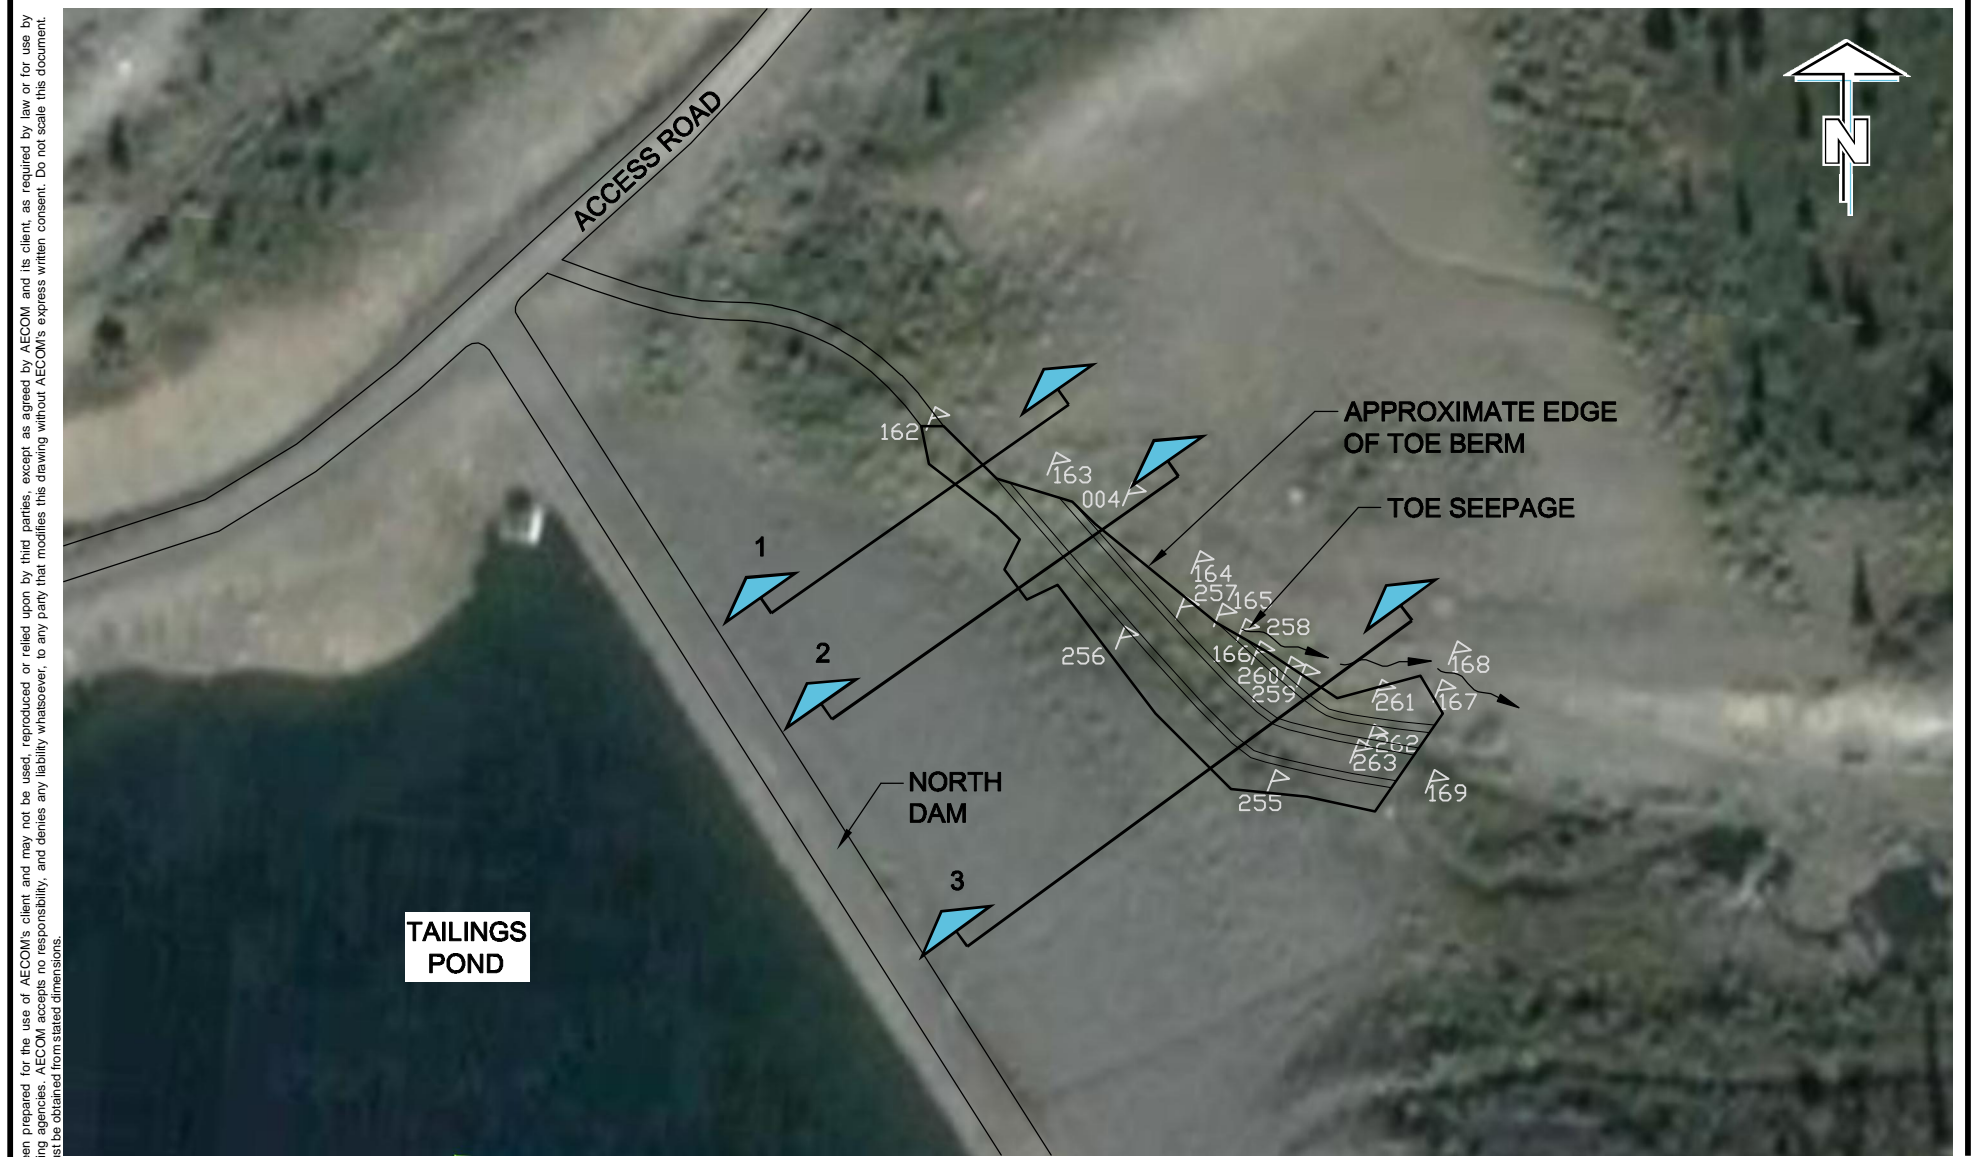
Drawing 01

In general, the berm appears to be in agreement with the design drawings although it was constructed with a series of 2 or 3 benches rather than a uniform slope (Figure 05). The berm material consists of rock fill placed on a non-woven geotextile. The saplings observed on the downstream face of the dam in 2007 have been removed. It is our understanding that the geotextile was originally placed to a higher elevation on the downstream face of the dam due to a misunderstanding as to the design elevation for the top of berm. A small amount of rock fill was also placed to a higher elevation as seen on Figure 06. Based on survey shots taken at approximately the section lines provided (Sections 2 and 3) and one intermediate shot, the top of the berm ranges in elevation from 1294.7 to 1295.2 compared to the design elevation of 1294.5 m. The north end of the berm at the access road to the seepage pond is at about elevation 1297.6 m. The top bench is in the order of 4 to 5 m wide. The benches below vary in width and height but the average slope was determined to be from 3H:1V to 3.2H:1V (compared with the design slope of 2.5H:1V). The berm surface is somewhat uneven, likely as a consequence of winter construction.
