**Ketza River Mine Site – Phase 1  
Environmental Site Investigation**

**Ross River Dena Council and  
DIAND Contaminants/Waste Program**

**Gartner Lee Limited  
Mehling Environmental Management Inc.  
BGC Engineering Inc.  
Sheila C. Greer**

*March, 2001*

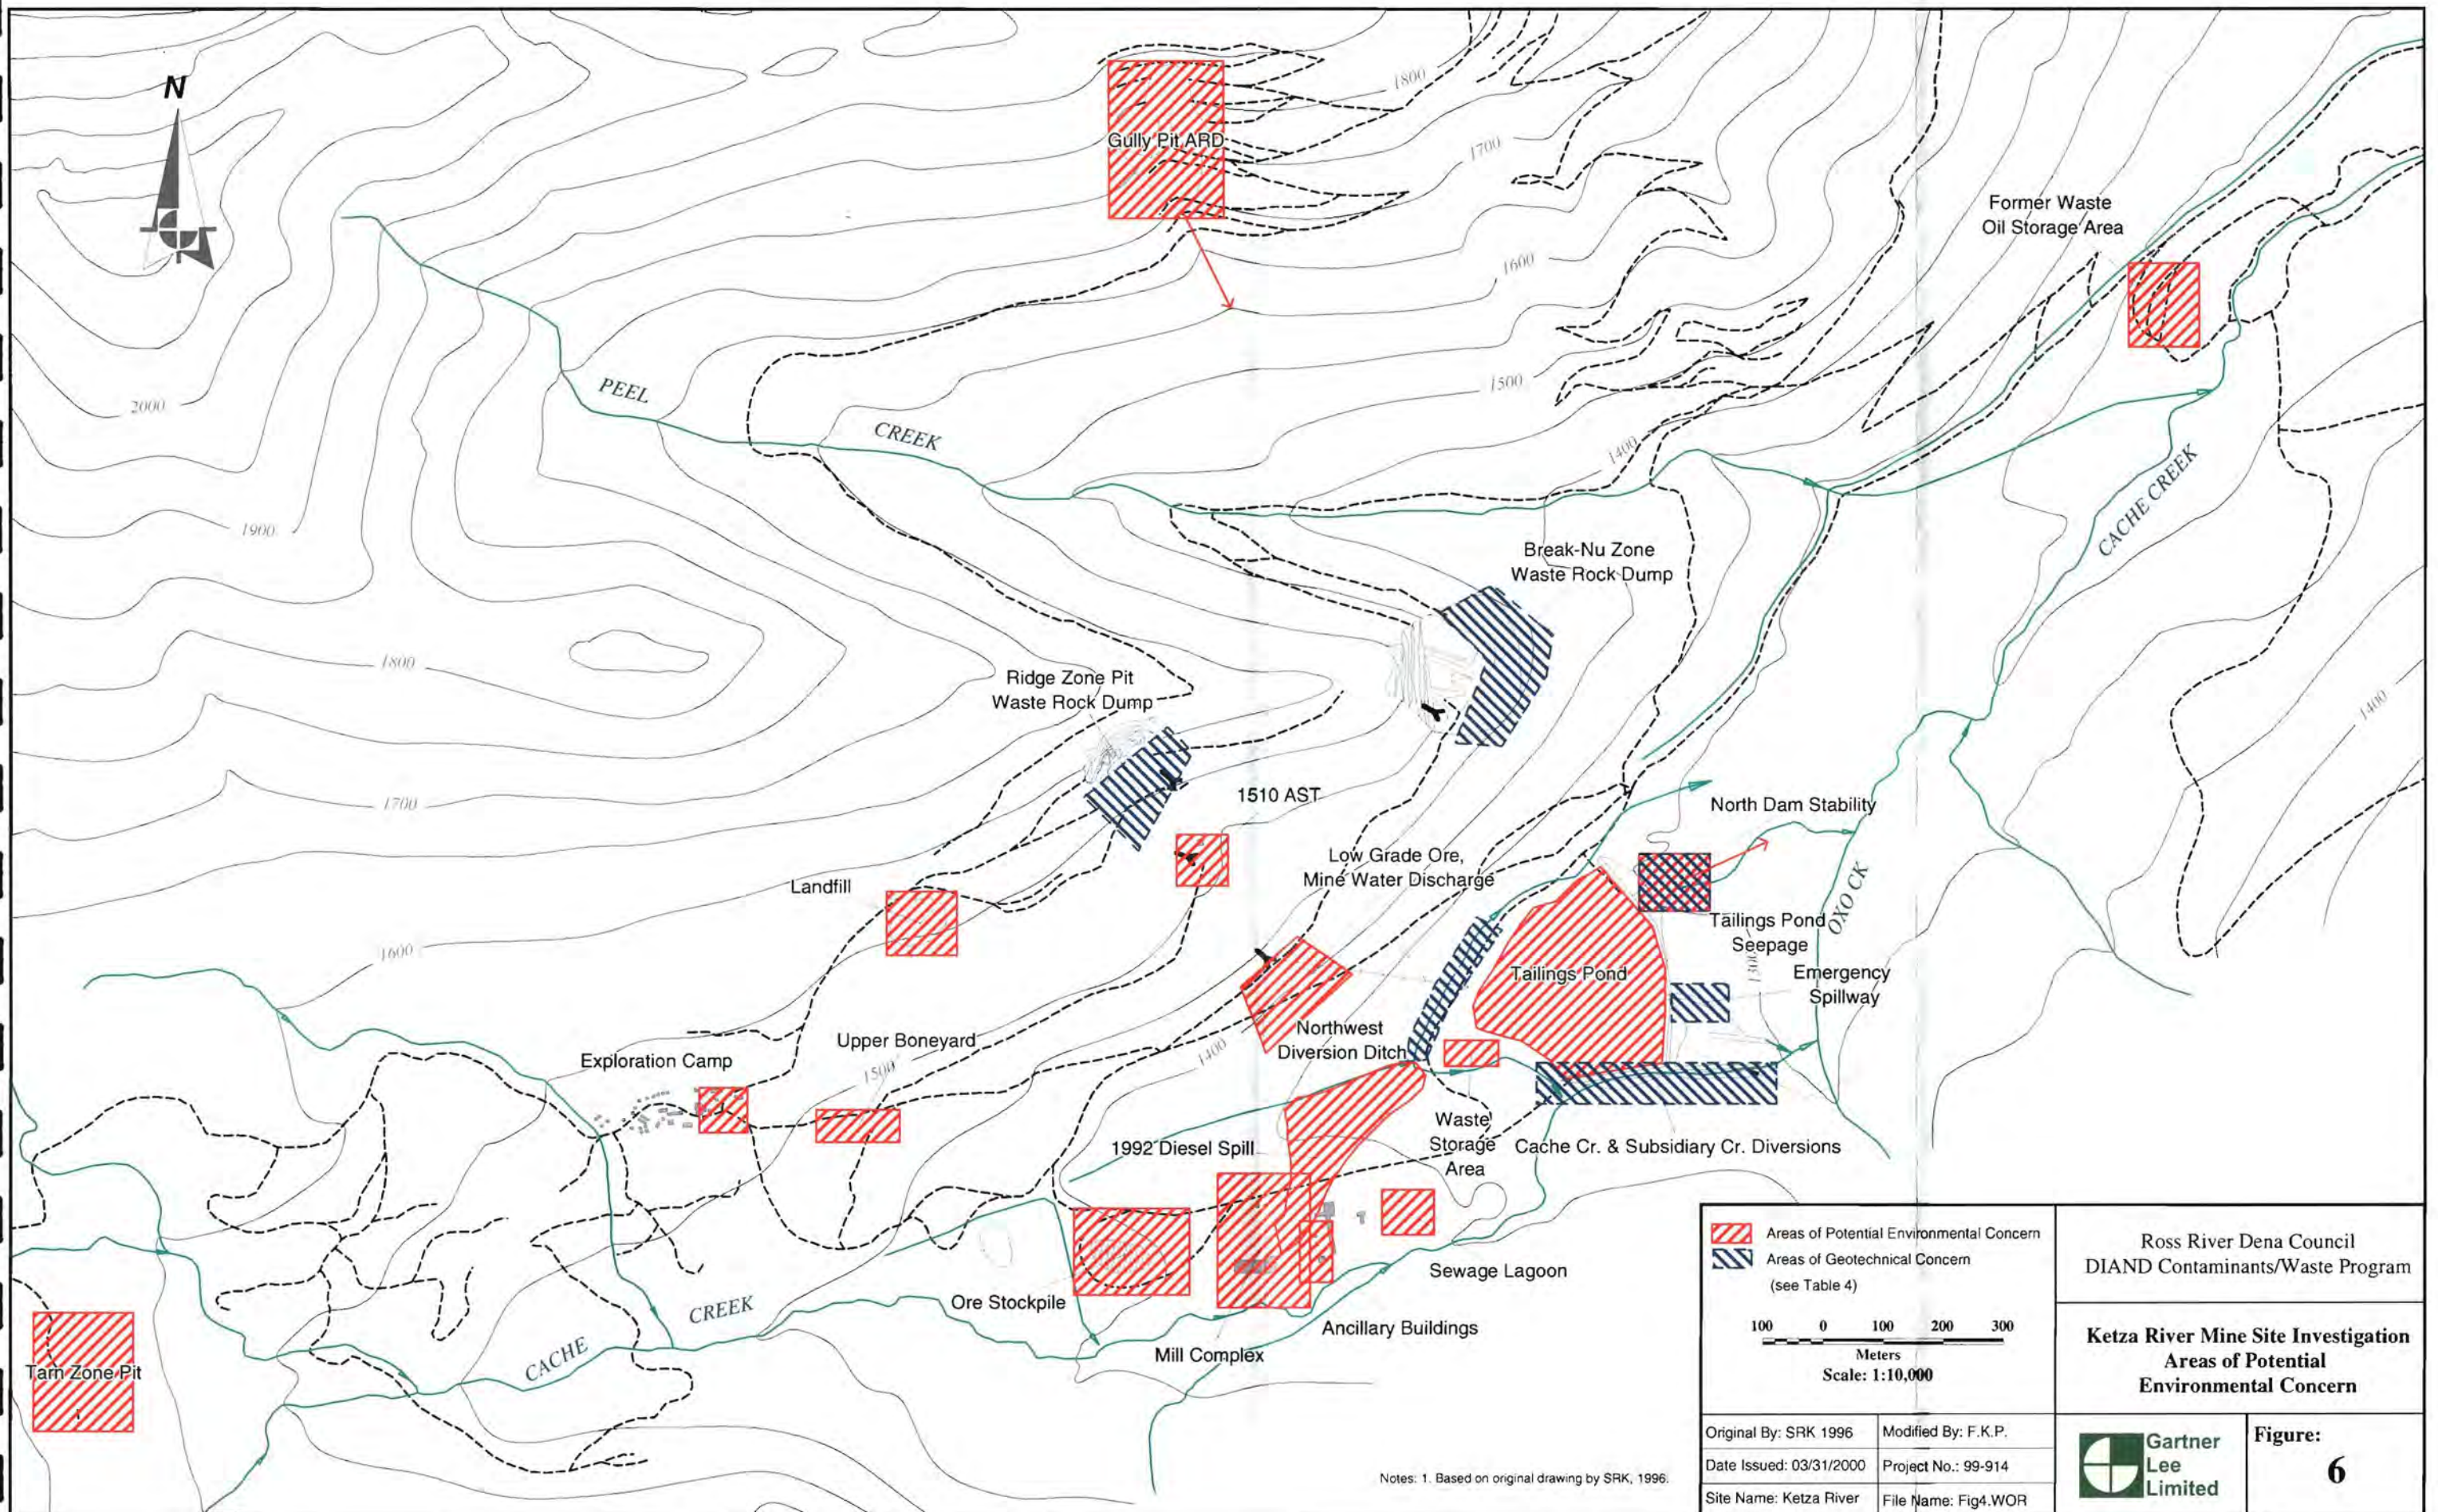
**Figure:  
6**

On the basis of the records review, interviews and site investigation, several areas of potential environmental concern (“APEC’s”) have been identified. The APEC’s are summarized in Table 7.2 below and are shown on Figure 6.

Location	APEC	Environmental Concern	Description
Tailings Pond	Diversion Ditches	Geotechnical	Slumping of Cache Creek diversion, erosion of drop structure. Spring overtopping (& leakage) of Subsidiary Creek diversion, & blockage of culverts. Erosion & slumping of northwest interceptor ditch.
	Waste Storage Area	Hydrocarbons, health & safety	Waste oil and solvent drums, crate of cyanide, drums of sulphuric and hydrochloric acid, caustic soda.
	Tailings	Metals, ammonia, cyanide	Metal (arsenic) in tailings, arsenic and ammonia (cyanide potentially) in pond water.
	Tailings dam	Geotechnical, metals, cyanide	Inadequate spillway, seepage from north dam, north dam stability. Potential arsenic and cyanide contamination of seepage water.
Mine Access Road	Access Road	Geotechnical	Erosion of road surface and undercutting by Ketza River.
	Former Waste Oil Storage Area	Hydrocarbons	Potential soil and groundwater contamination from waste oil storage and vehicle refueling from AST.

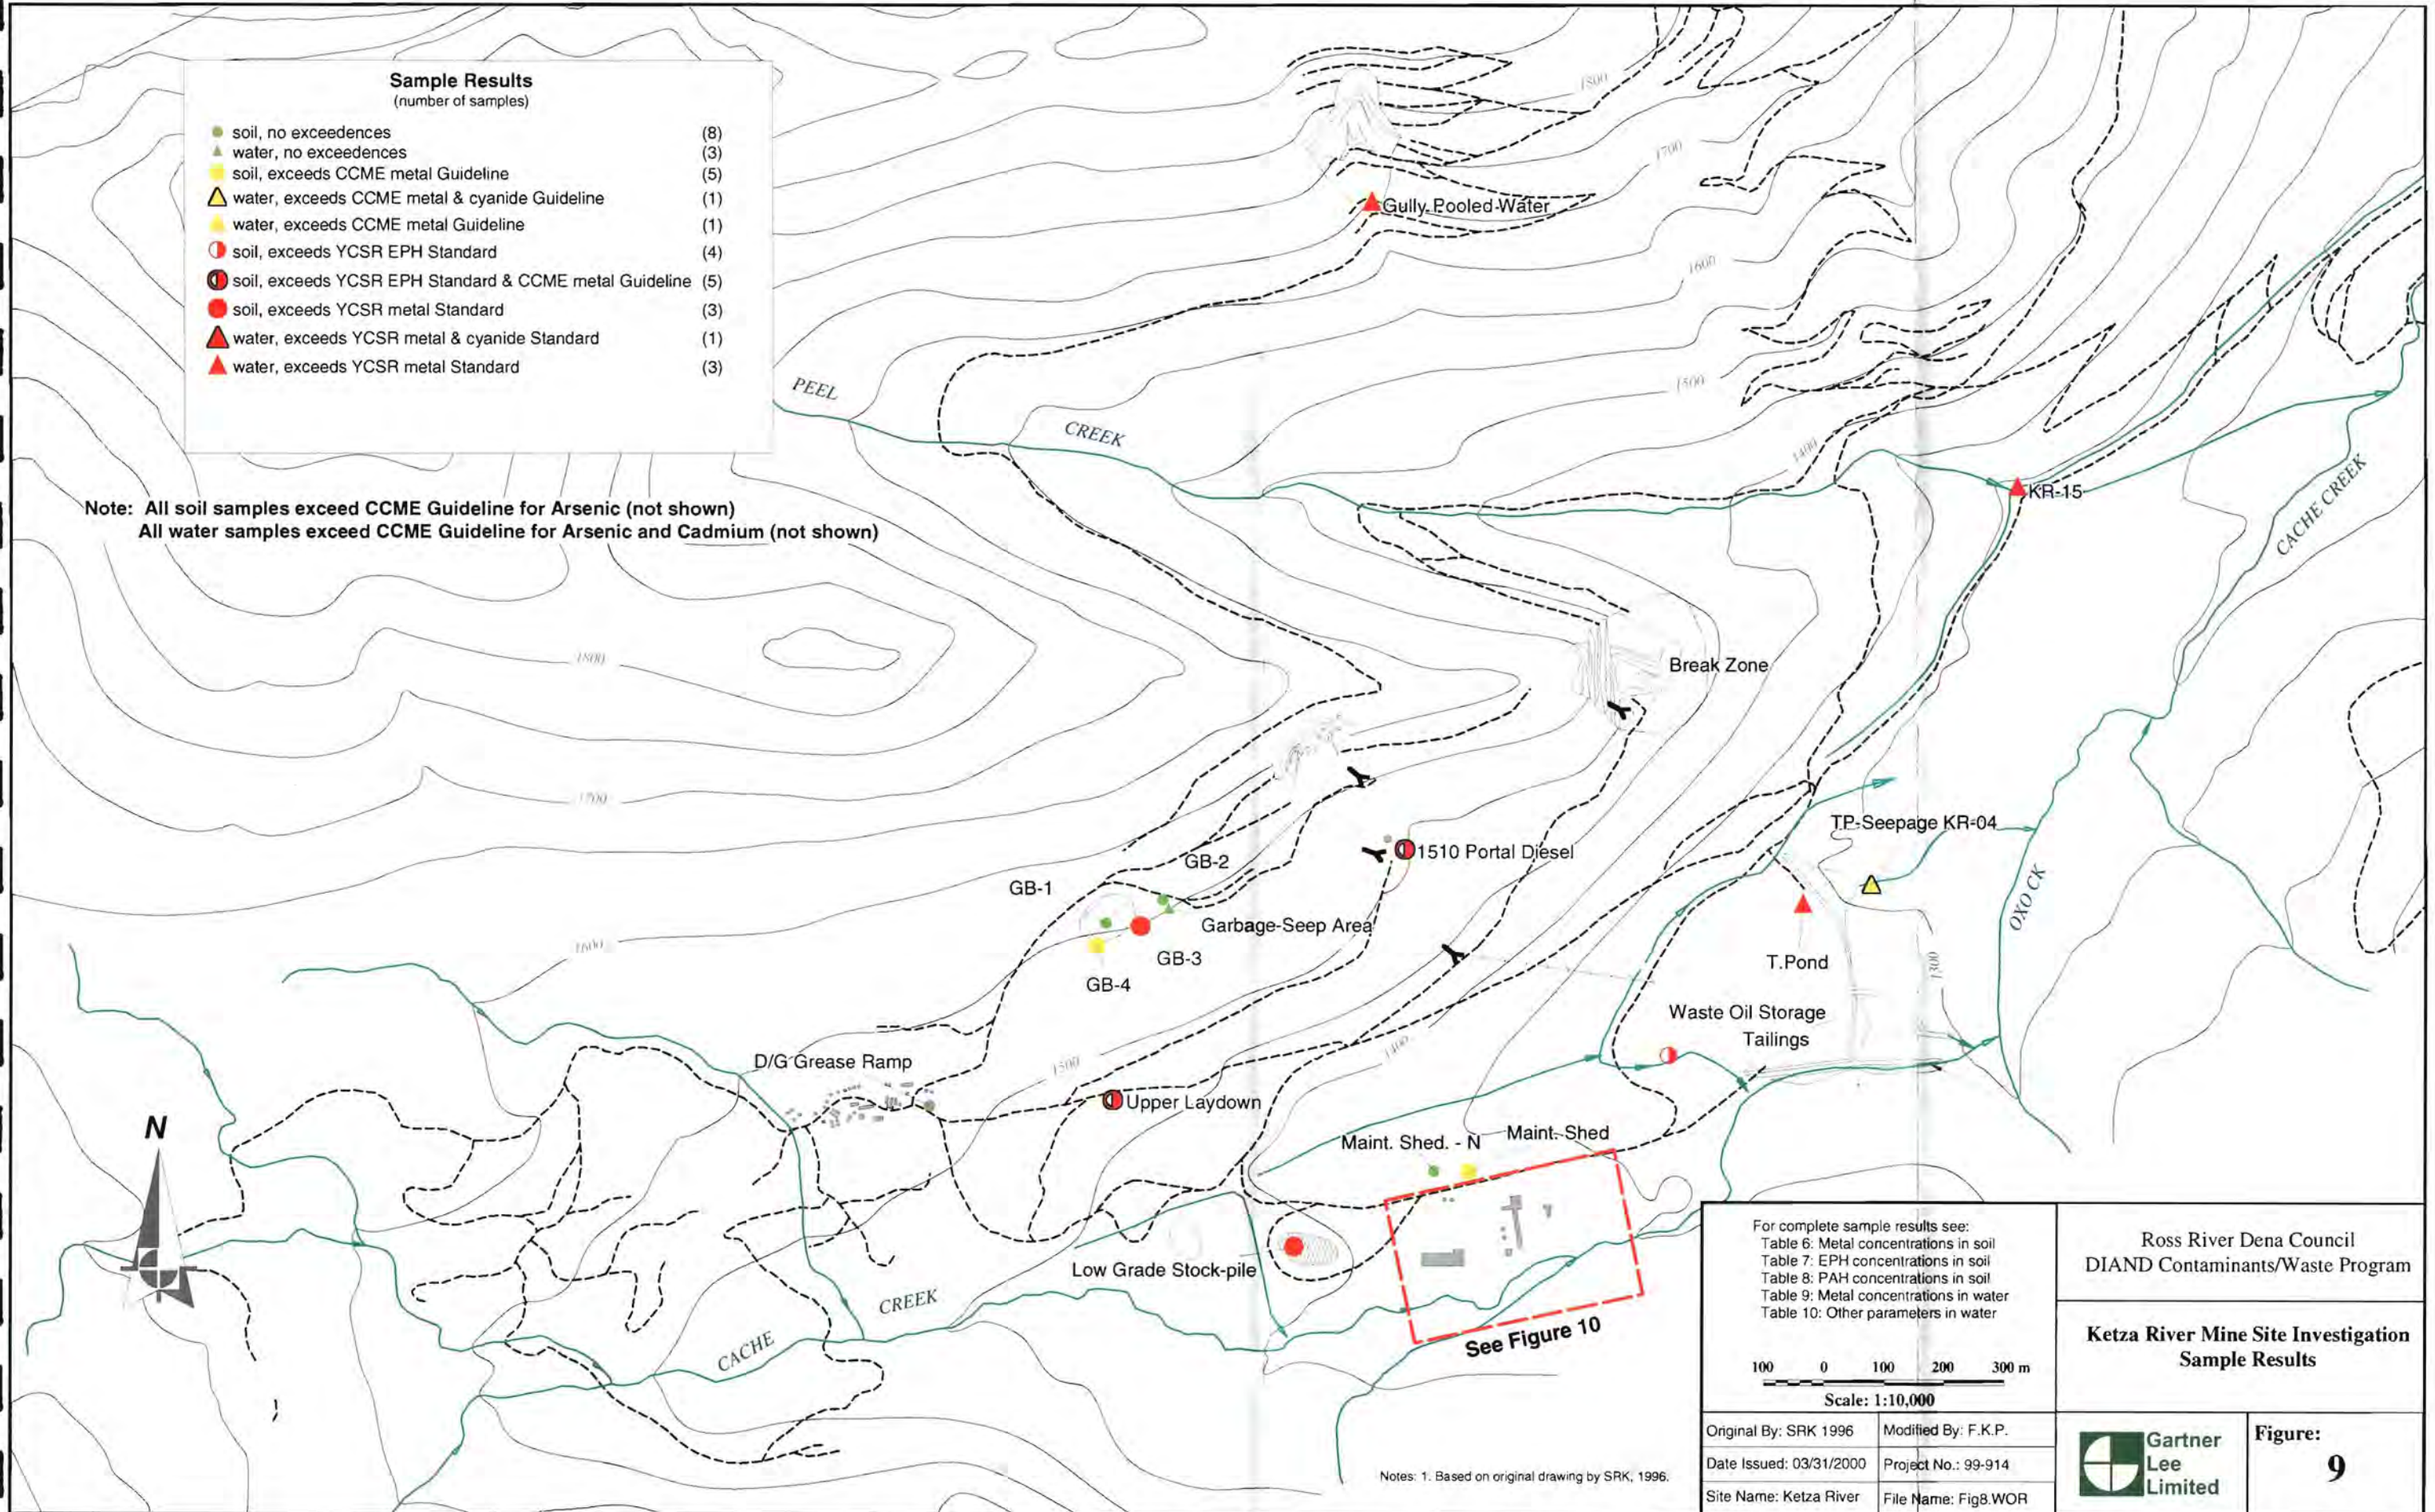
**9**

The applicable regulatory guidelines and/or standards for each analytical parameter are included with the analytical data in each table. The laboratory reports and results of the QA/QC program are included in Appendix D. Figures 8 and 9 illustrate the location of elevated metal and hydrocarbon concentrations in surface soil samples collected from the mine site.

- soil, no exceedences (8)
- ▲ water, no exceedences (3)
- soil, exceeds CCME metal Guideline (5)
- ▲ water, exceeds CCME metal & cyanide Guideline (1)
- water, exceeds CCME metal Guideline (1)
- soil, exceeds YCSR EPH Standard (4)
- ⊙ soil, exceeds YCSR EPH Standard & CCME metal Guideline (5)
- soil, exceeds YCSR metal Standard (3)
- ▲ water, exceeds YCSR metal & cyanide Standard (1)
- ▲ water, exceeds YCSR metal Standard (3)

Note: All soil samples exceed CCME Guideline for Arsenic (not shown)  
All water samples exceed CCME Guideline for Arsenic and Cadmium (not shown)

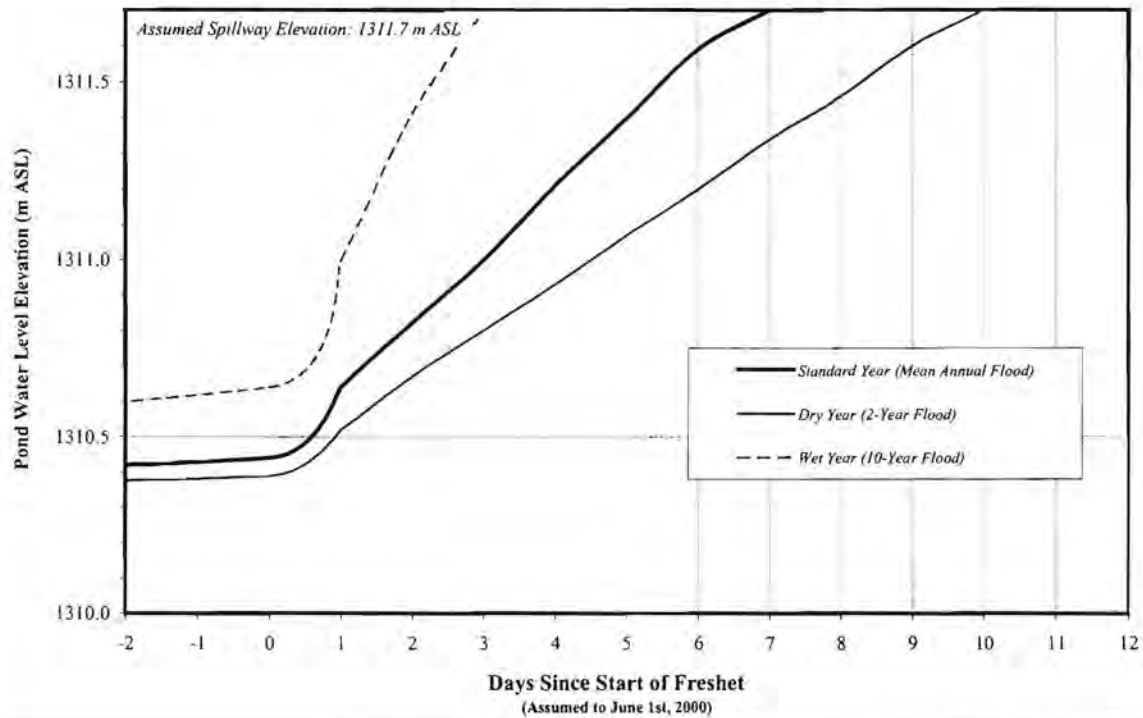
**Figure 12: Ketza River Tailings Pond Water Balance**  
Model 2 - Spring Overflow of Lower Subsidiary Creek Diversion, Scenario 1

- If the Lower Subsidiary Creek ditch is not blocked, water levels could reach the critical (overflow) elevation in September 2001 or July 2002, depending on ditch leakage and dam seepage rates.

The overflow condition could occur from 3 to 11 days after the onset of freshet in the spring of 2000 if the Subsidiary Creek Ditch is blocked with ice causing flow into the tailings pond. The onset of freshet varies but typically occurs in late May and early June. Extreme events, such as rapid melting of the snow pack due to warm weather could result in an overflow water level in less than two days. If the ditch is not blocked, water levels are predicted to reach the overflow elevation in September 2001 or July 2002, depending on ditch leakage and dam seepage rates.

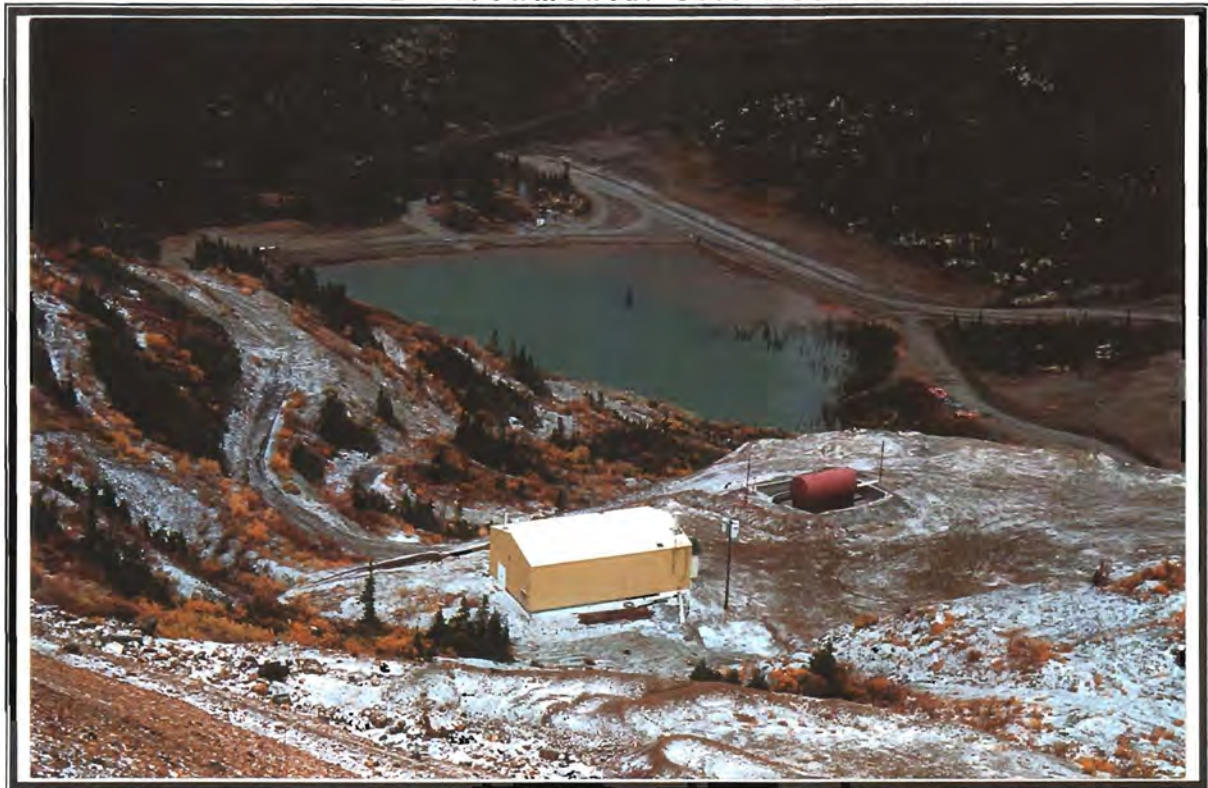
4. Other areas of hydrocarbon staining were observed around the site including:
  - 1510 AST (soil sample contained LEPH and HEPH concentrations > YCSR IL)

Photo 4: Mine dry and Aboveground Storage Tank (AST) at 1510 portal. Tailings pond and Cache Creek diversion in background.

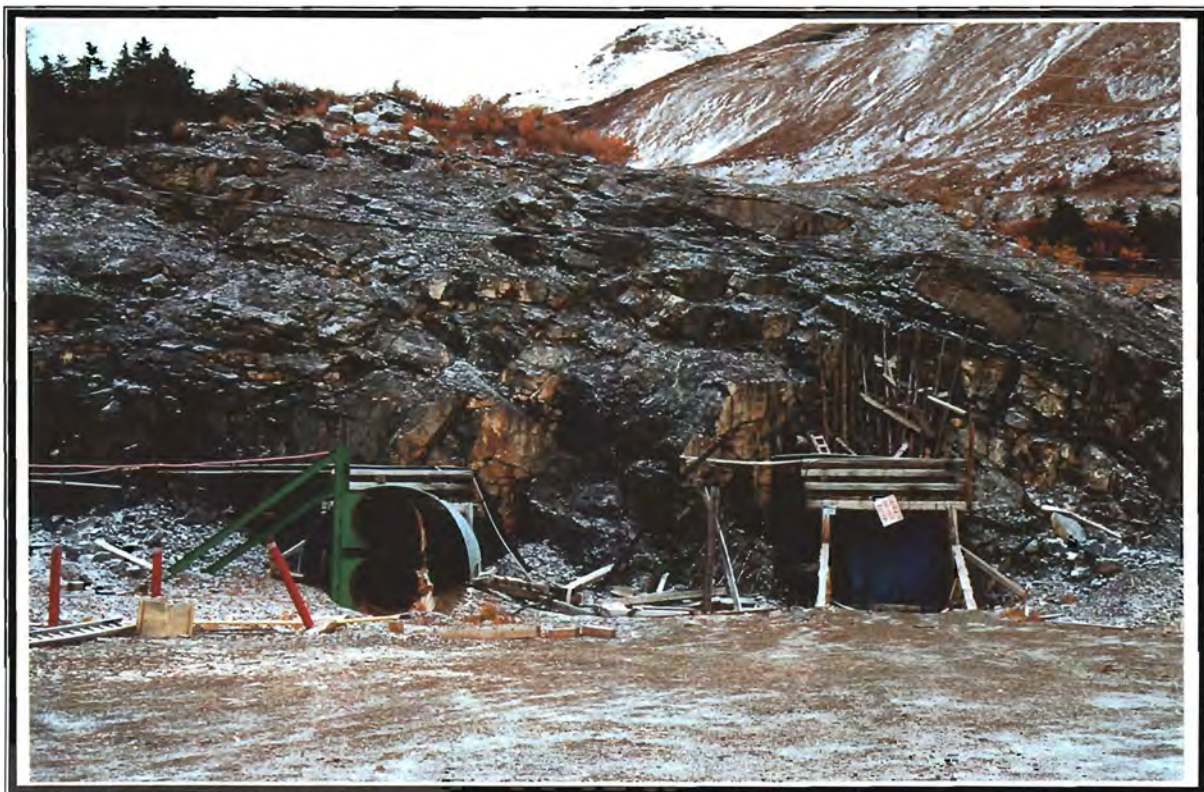
4. The 1430 and 1510 adits are poorly sealed. The seals do not adequately prevent public exposure to safety hazards in the underground mine.
5. The status of the 1550 backfill raise to the surface is unknown. If the raise is open and accessible, then it represents a public safety hazard.

Photo 7: 1510 portal, mine ventilation portal to left.

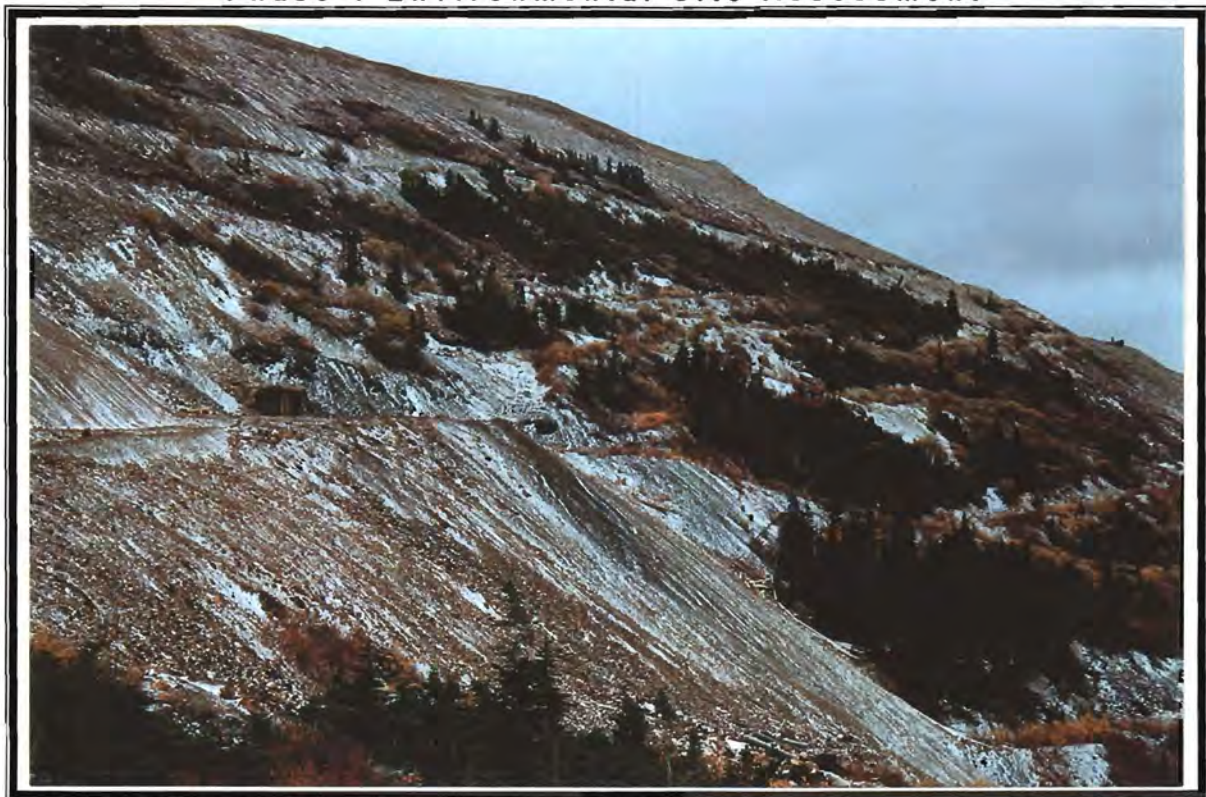
Photo 8: 1550 adit.

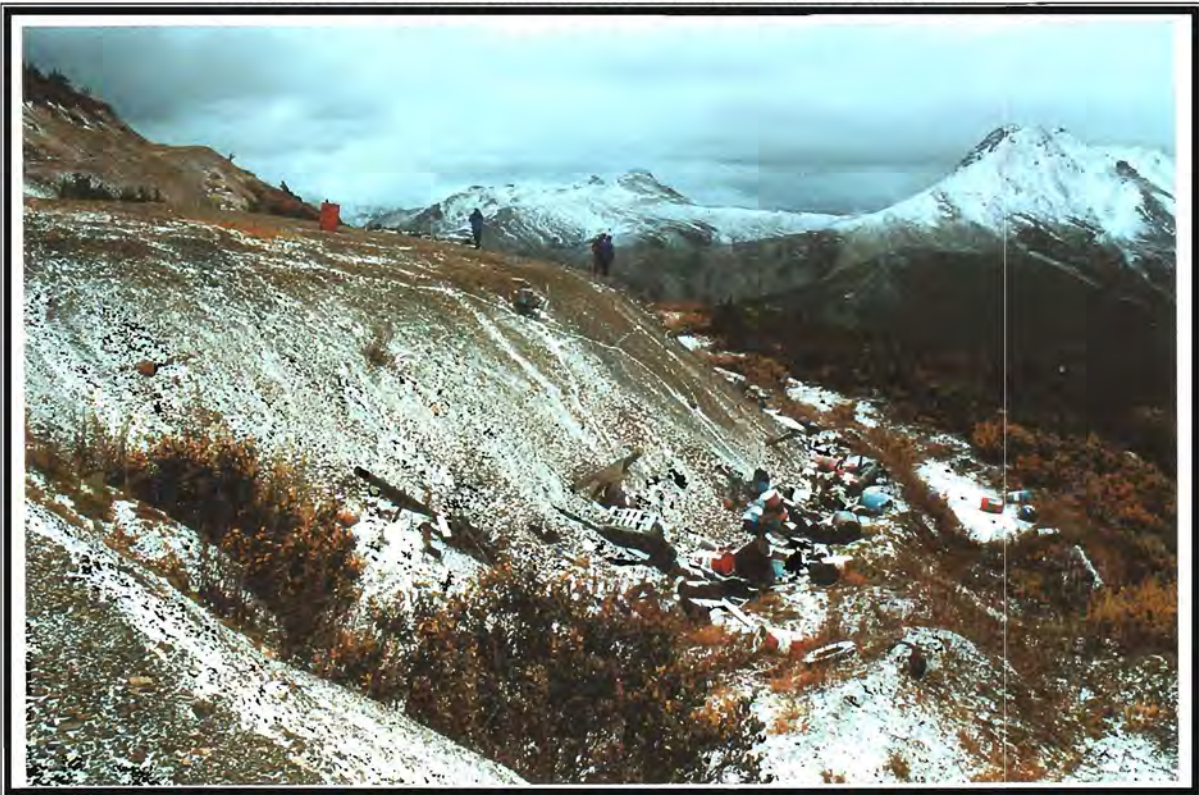
Photo 14: View of landfill crest and toe looking eastward.

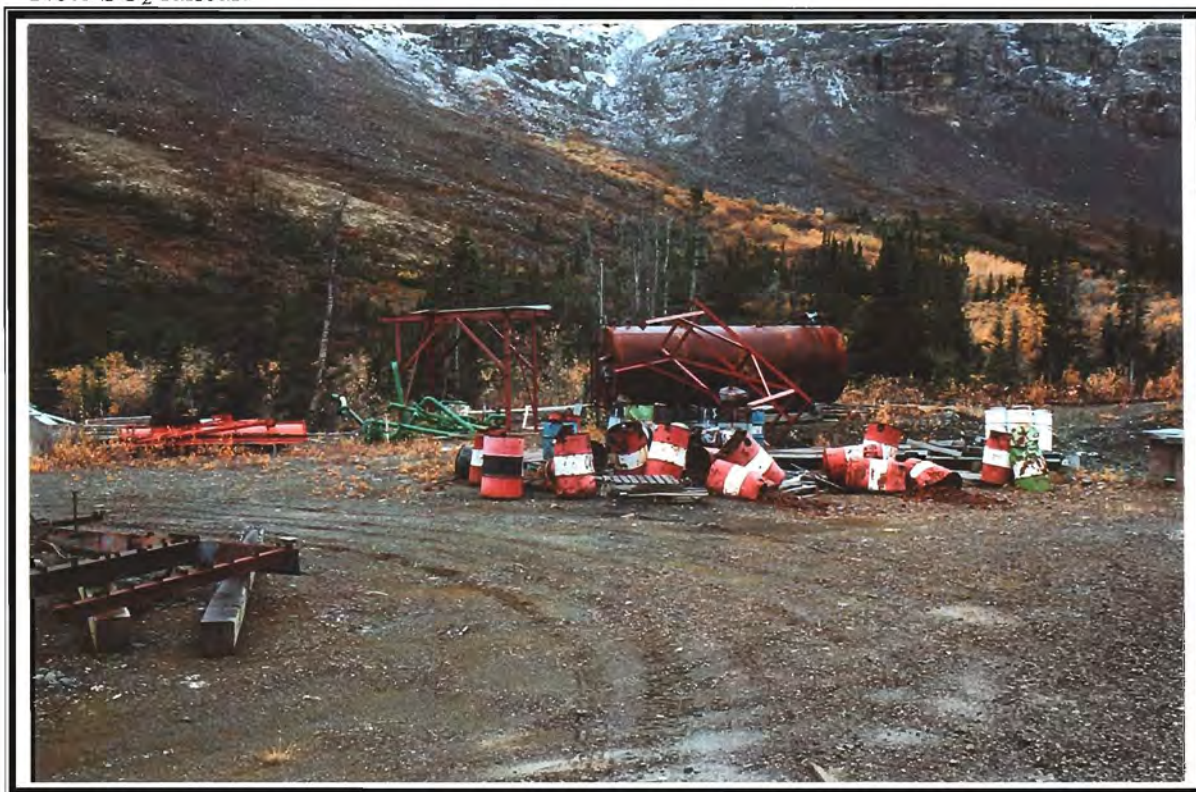
Photo 20: Portion of mill boneyard. Note drums of used mill balls in foreground. Tank in background is temporary storage.

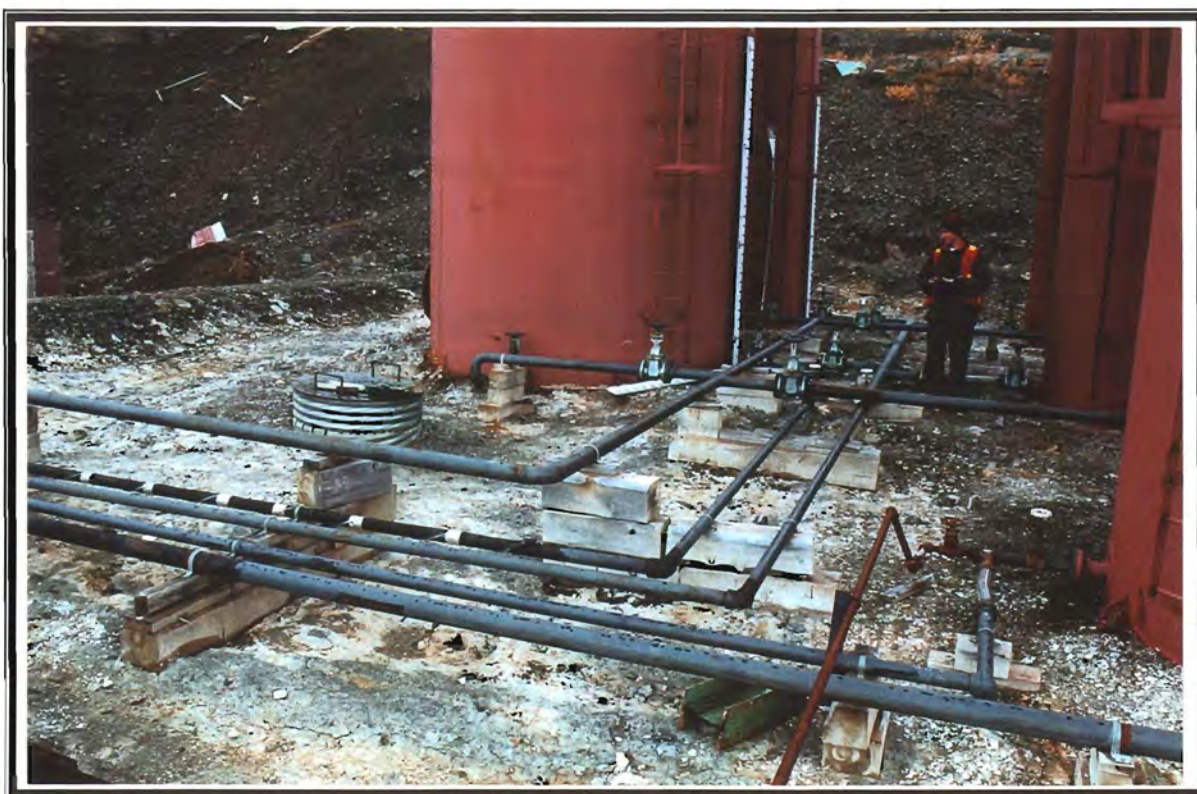
Photo 22: Interior of tank farm. Note limey/concrete liner.

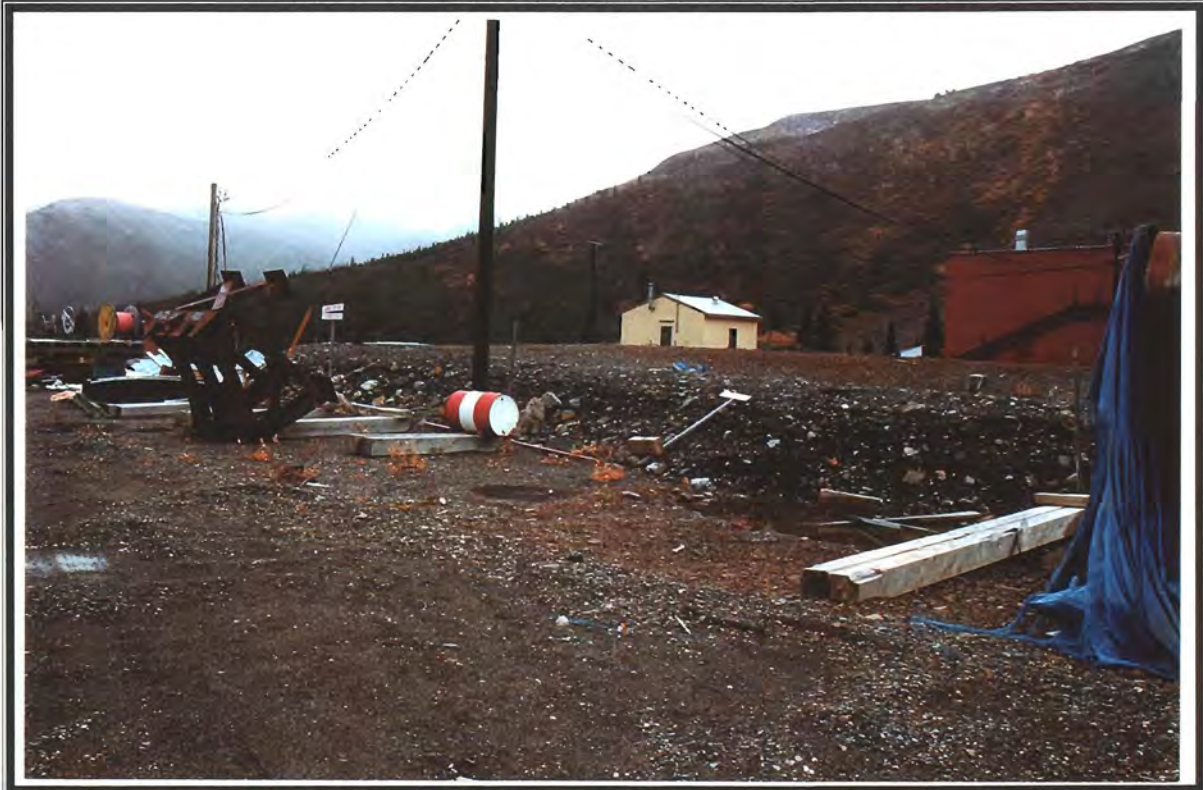
The oil, lubricants, grease and antifreeze storage area is located north of the polishing pond (Photos 23 & 24). This area contained a grinding mill, pumps, and metallic debris from the grinding mills. Oil, lubricants, grease, antifreeze and other liquid products were stored in 45-gallon drums, stacked horizontally. Many drum labels were either missing, or weathered beyond legibility. There were 2 full 45-gallon drums with unknown contents in this area, as well as 3 full 55 kg drums of grease. Soils in the lubricant storage area appeared hydrocarbon stained. Across from the lubricant storage area, 24 sealed 45-gallon drums were stored on pallets with unknown contents. The labels on these drums were weathered beyond legibility, but most were marked as being either Imperial Oil, Esso or PetroCanada products, and, therefore, are likely to be lubricants and oils.

Photo 23: Oil, grease, lubricant and antifreeze storage area. Polishing pond in background. Mill dry behind pond.

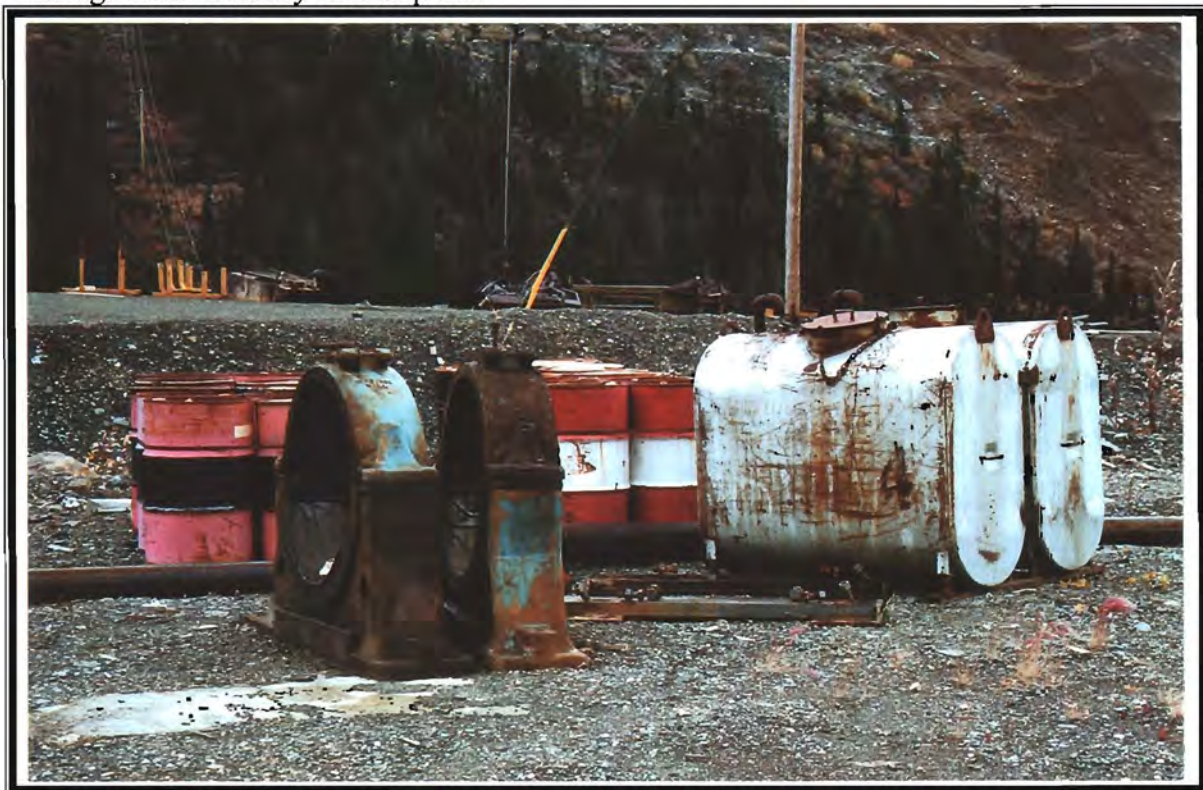
Photo 24: Full oil/lubricant drums in mill yard. Daytanks are empty.

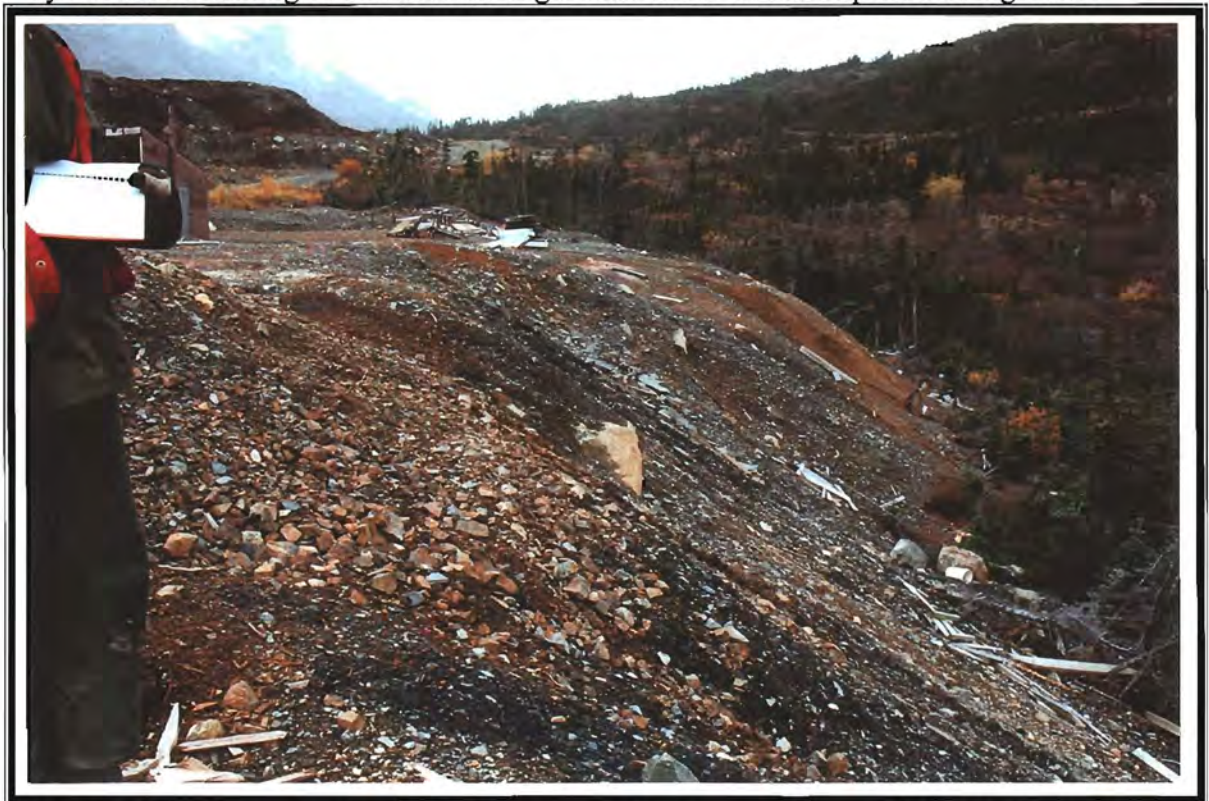
A Quonset hut used by the road maintenance contractor was formerly located across the mine access road from the main mill yard. The hut had a small shed built on the back that served as the carpentry shop and was referred to as the "sawmill". The Quonset hut had been removed prior to the September 1999 site investigation, but the sawmill shed and the concrete foundation for the hut were present (Photo 25). Much of the Quonset hut appeared to have had an earthen floor, and heavy hydrocarbon staining of the soils was observed. A large (est. 2000 gallon) fuel tank is located at the back of the Quonset hut area. The tank is labeled "gasoline", but was empty. North of the Quonset hut area is a bank leading down to Subsidiary Creek. This bank appears to have waste materials and earth pushed over the edge (see Photo 26). No environmental issues were identified associated with the sawmill shed.

Photo 26: Bank north of contractor's Quonset, looking upstream of Subsidiary Creek.

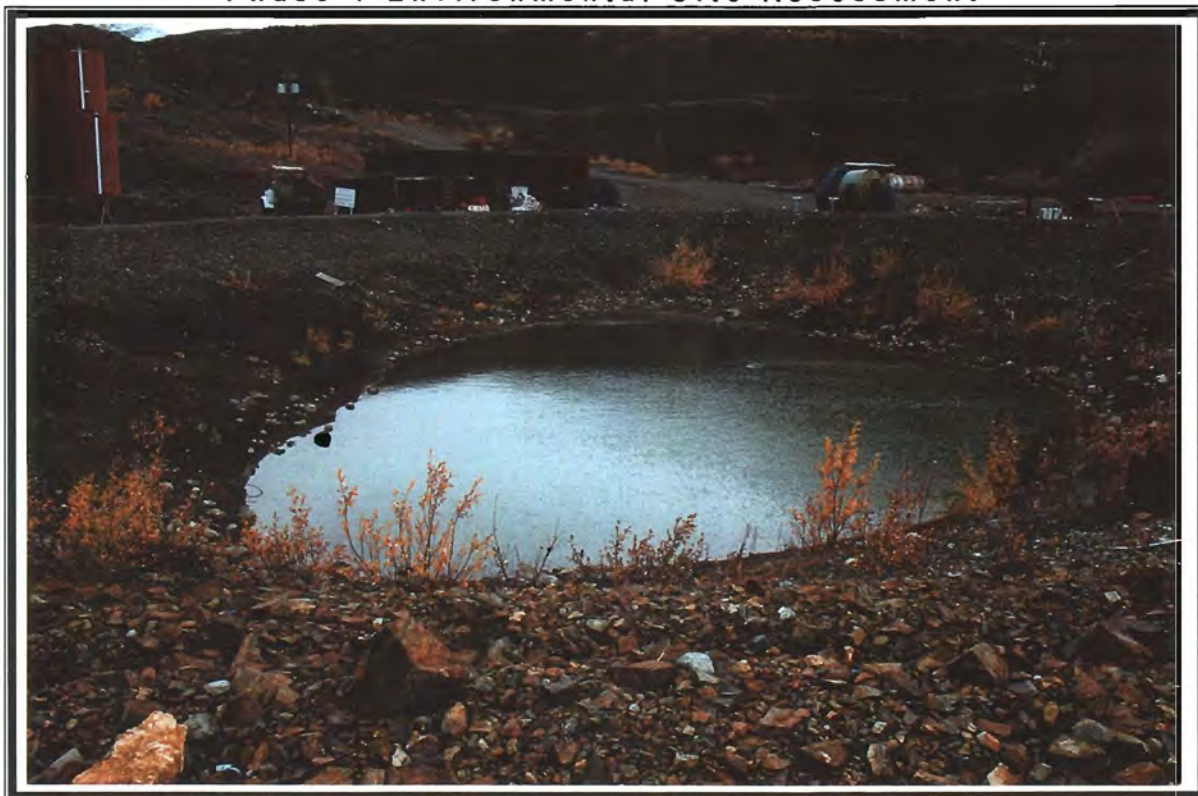
The polishing pond is circular, 30 metres in diameter with 1 to 2 meter high berms. The base of the pond is approximately 3 to 4 meters below the berm crests. Some water was present in the pond (Photo 27). The pond has fine-grained sediments around the perimeter and an undetermined geosynthetic material was observed. A process water well is located at the northeast corner of the pond. This well was reported as being artesian and containing elevated arsenic levels (Henry pers comm, 2000).

Photo 27: Polishing pond. Oil, lubricants and grease storage to right of photo behind pond. Mill reagent storage shed in background.

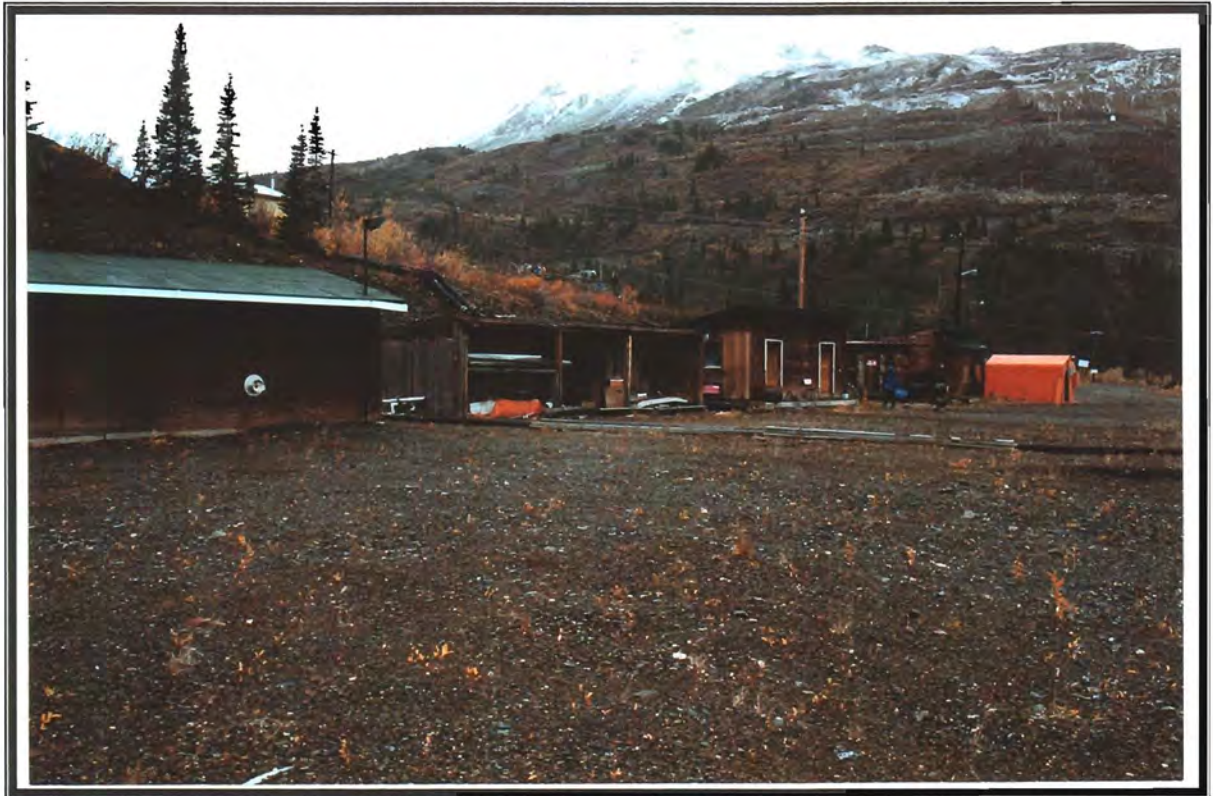
West of the accommodation complex is a row of ancillary buildings and sheds (Photo 29). With the exception of the accommodation and kitchen complex, all other camp ancillary buildings are of wood frame and plywood construction. These buildings/facilities include (from north to south):

Photo 29: Ancillary building next to accommodation complex. From left to right (south to north): camp water treatment building; storage shed/carpenter shop, paint(?) shop, electrical shed, backup generator shed, portable generator (orange).

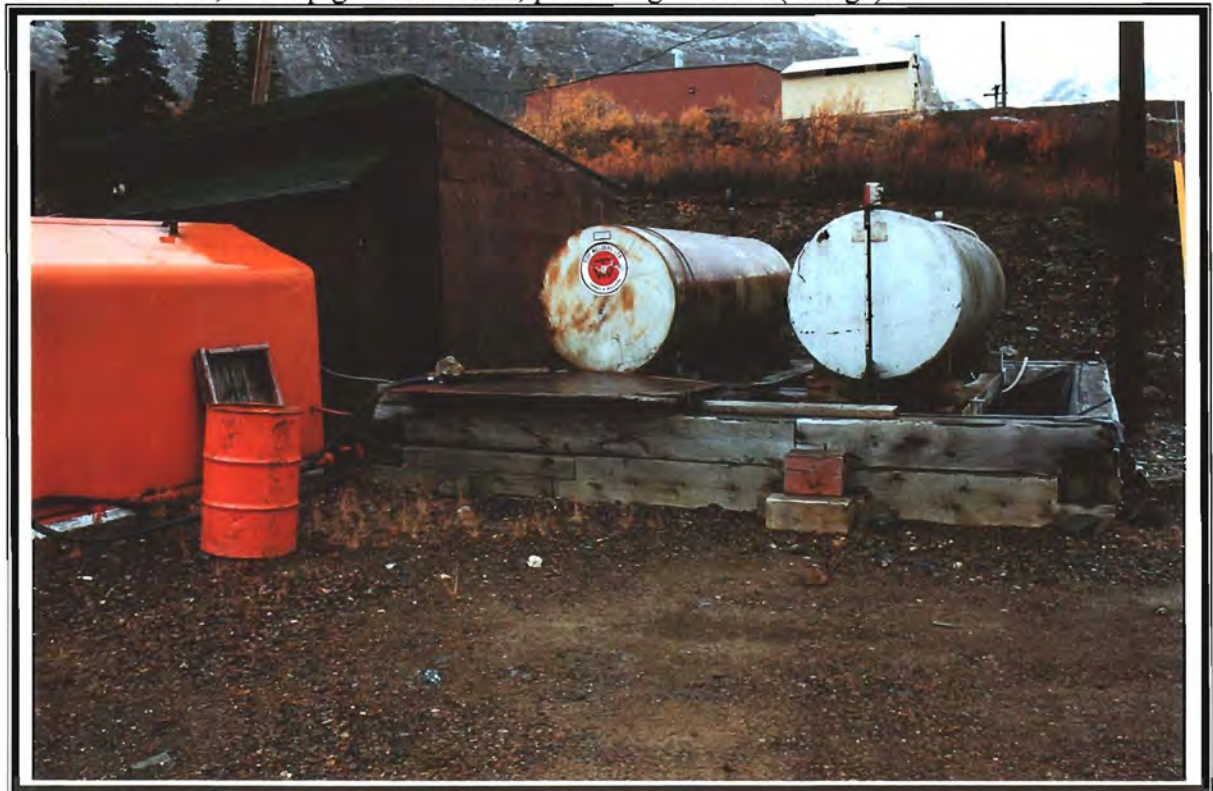
- three large horizontal propane tanks and associated small valve house;
- two above ground fuel storage tanks (1000 gallon estimated capacity) in a small lined wooden containment berm (Photo 30). These tanks are connected to the main tank farm at the mill complex by 1 inch above ground pipes. Some ponded fuel and water was observed inside the containment berm;
- a small portable steel generator building (orange) and generator used to supply camp power during exploration projects in the 1990's;
- a larger wooden generator shack with one large Caterpillar camp backup generator;
- a small building with miscellaneous electrical supplies and switching equipment;
- a larger shed with paint and other supplies;
- a open front carpenters shop; and
- a large building with two large water storage tanks and water treatment and filtration equipment (Petwa Canada Treatment Systems).

Two samples collected from an area of observed soil staining in front of the ancillary buildings contained HEPH concentrations greater than the YCSR Industrial Standard (IL). The sample collected from behind the camp generator ASTs (sample "Camp Diesel Intake") contained 1.5% LEPH, exceeding the YCSR Industrial Standard for LEPH. This high concentration of light extractable petroleum hydrocarbon is likely related to the spill in 1992 of 40,000 L of diesel fuel.

Photo 30: ASTs for camp generators.
