**Ketza River Mine Site – Phase 1  
Environmental Site Investigation**

**Ross River Dena Council and  
DIAND Contaminants/Waste Program**

**Gartner Lee Limited  
Mehling Environmental Management Inc.  
BGC Engineering Inc.  
Sheila C. Greer**

*March, 2001*

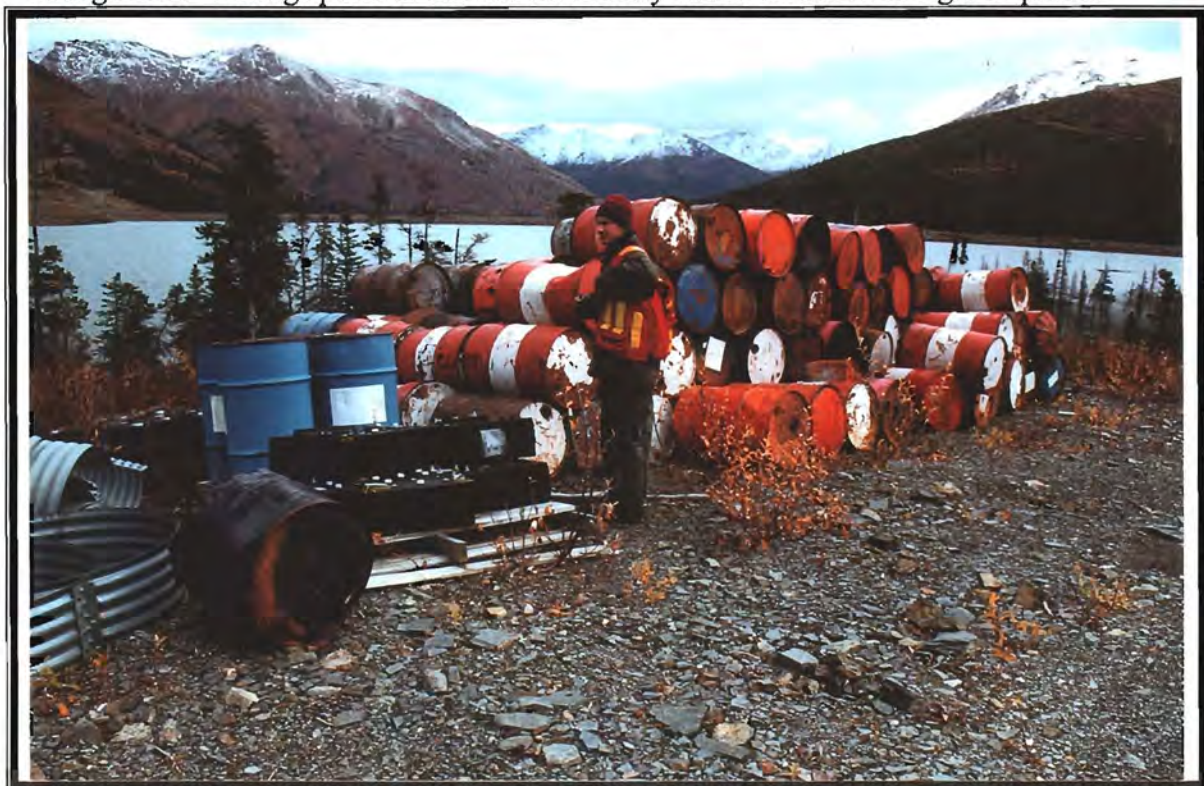
Waste material such as used oil, empty drums, coconut fiber, sulphuric acid drums, batteries, scrap culverts and hydrochloric acid are stored alongside the Subsidiary Creek interceptor ditch (inside the tailings dam catchment). The following wastes are stored in this area (Photos 35 to 38):

Photo 35: Industrial batteries and empty 45-gallon drums. Note pallet of black hydrochloric acid drums on left-edge of photo.

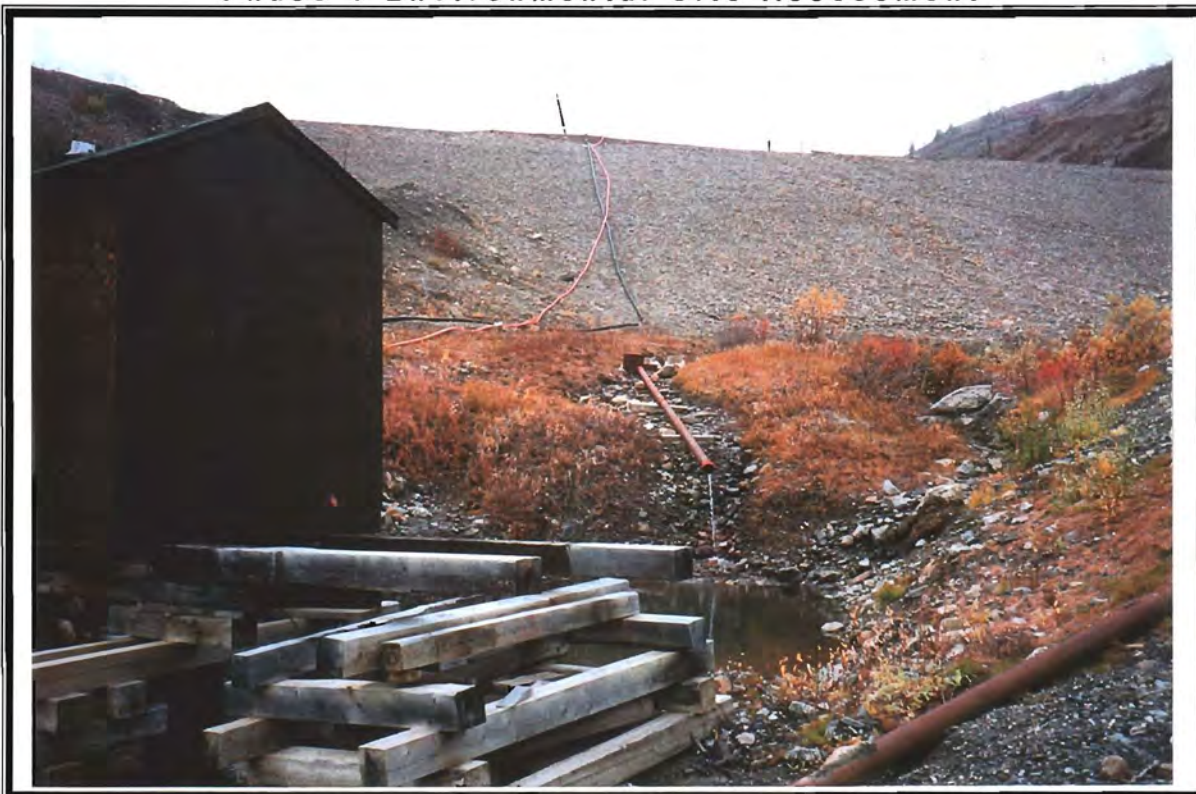
5. Arsenic in the tailings pond water continues to remain in the 1 to 2 mg/L range and is not decreasing.
6. Arsenic in tailings dam seepage water has remained at lower levels than most other samples. SRK (1996) has postulated that adsorption of arsenic by the dam and foundation soils is minimizing mobilization into the receiving water. The adsorption mechanism may be effective for the reduction of arsenic concentrations in the tailings pond seepage but in the opinion of this project team, this mechanism can not be relied upon to prevent future problems from arsenic and metal leaching from other areas of the site.

Photo 38: Tailings pond seepage sample (KR-04) taken from pipe-discharge from toe of North Dam.

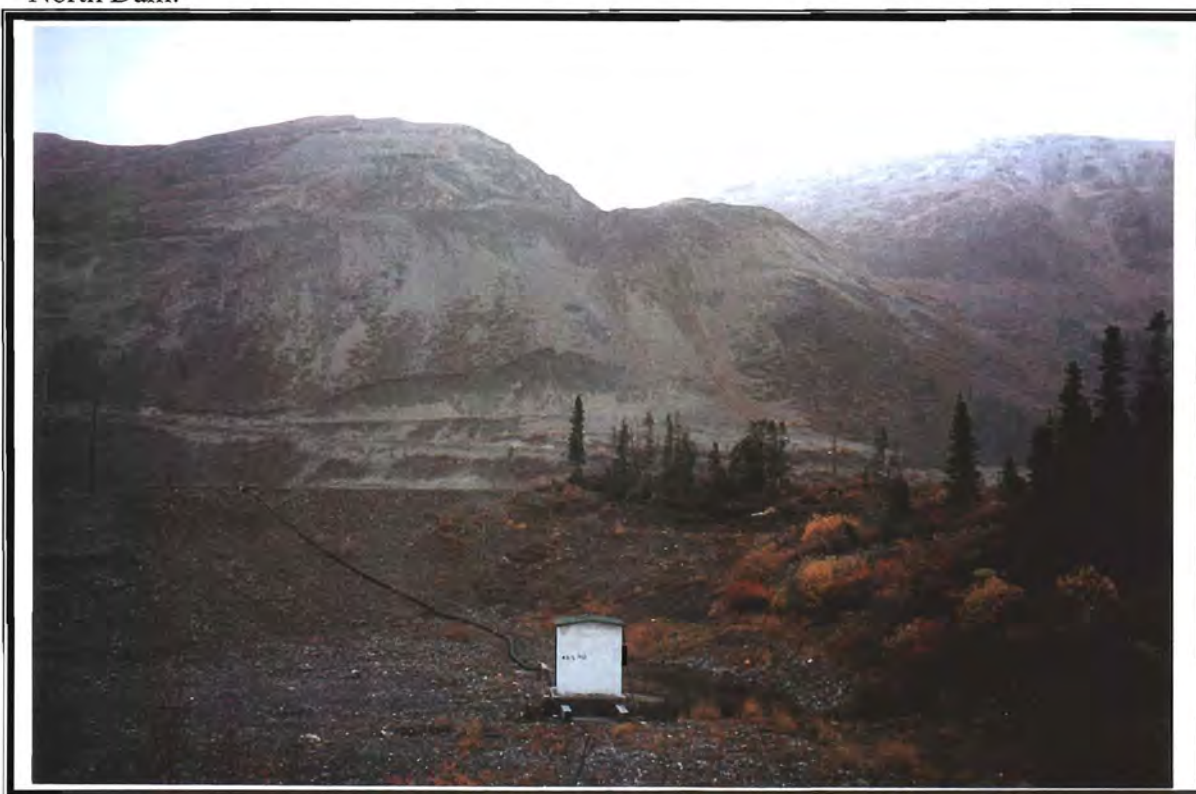
The north dam was observed to be about 18 to 20 m high and has been built with downstream slopes of 2.5 H:1V (Photo 39). The dam slopes appear to be stable and there are no signs of cracking or deformation. The crest of the dam is approximately 5 to 6 m wide and shows no signs of distress.

Photo 39: Sample location KR-5 (S1) – seepage from South Dam. Break Zone Pit and waste rock dump in background.
