2012 Geotechnical Annual Review, Minto Mine, YT

MINTO EXPLORATIONS LTD.

SRK Consulting (Canada) Inc.

November 2012

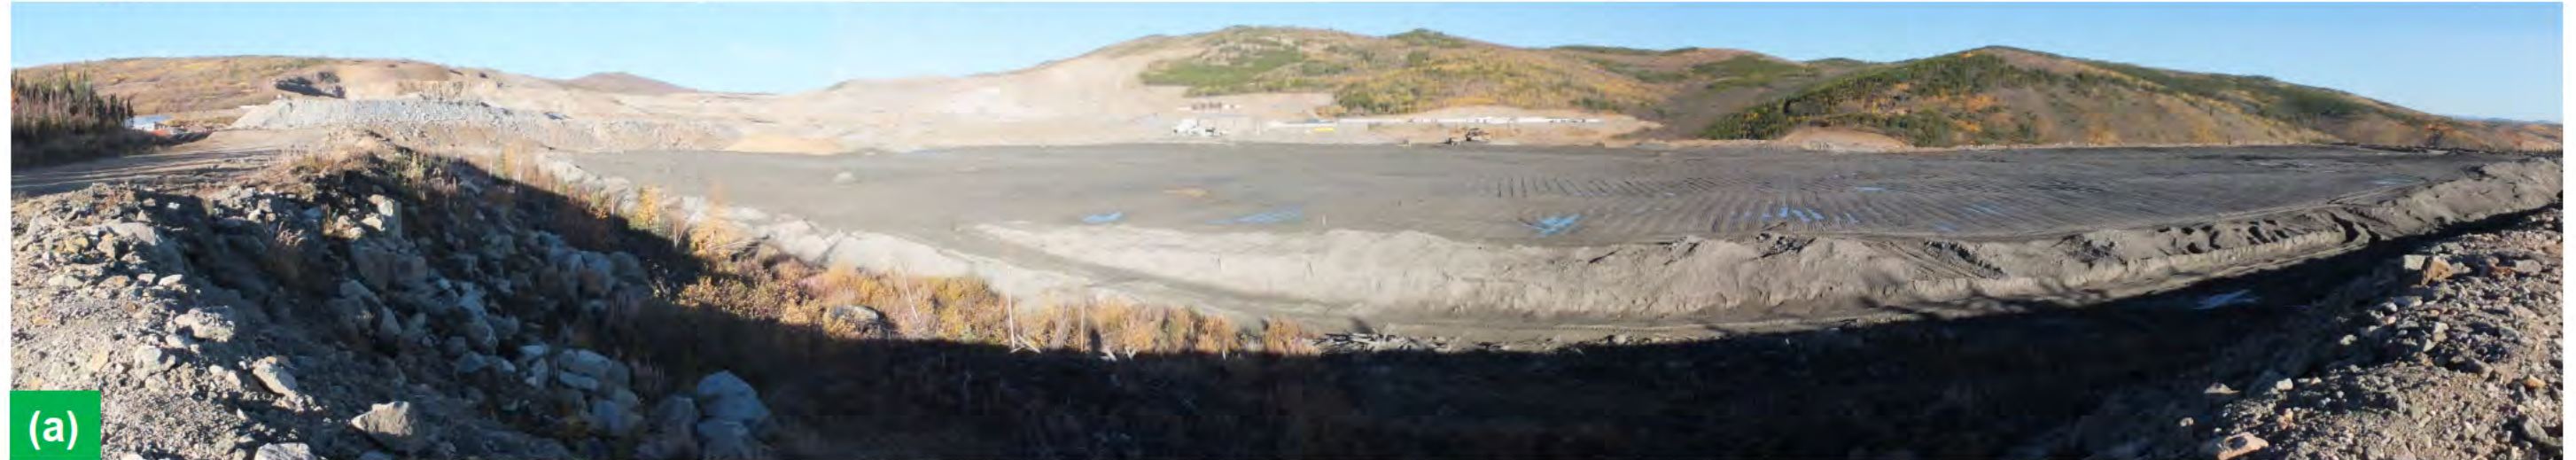
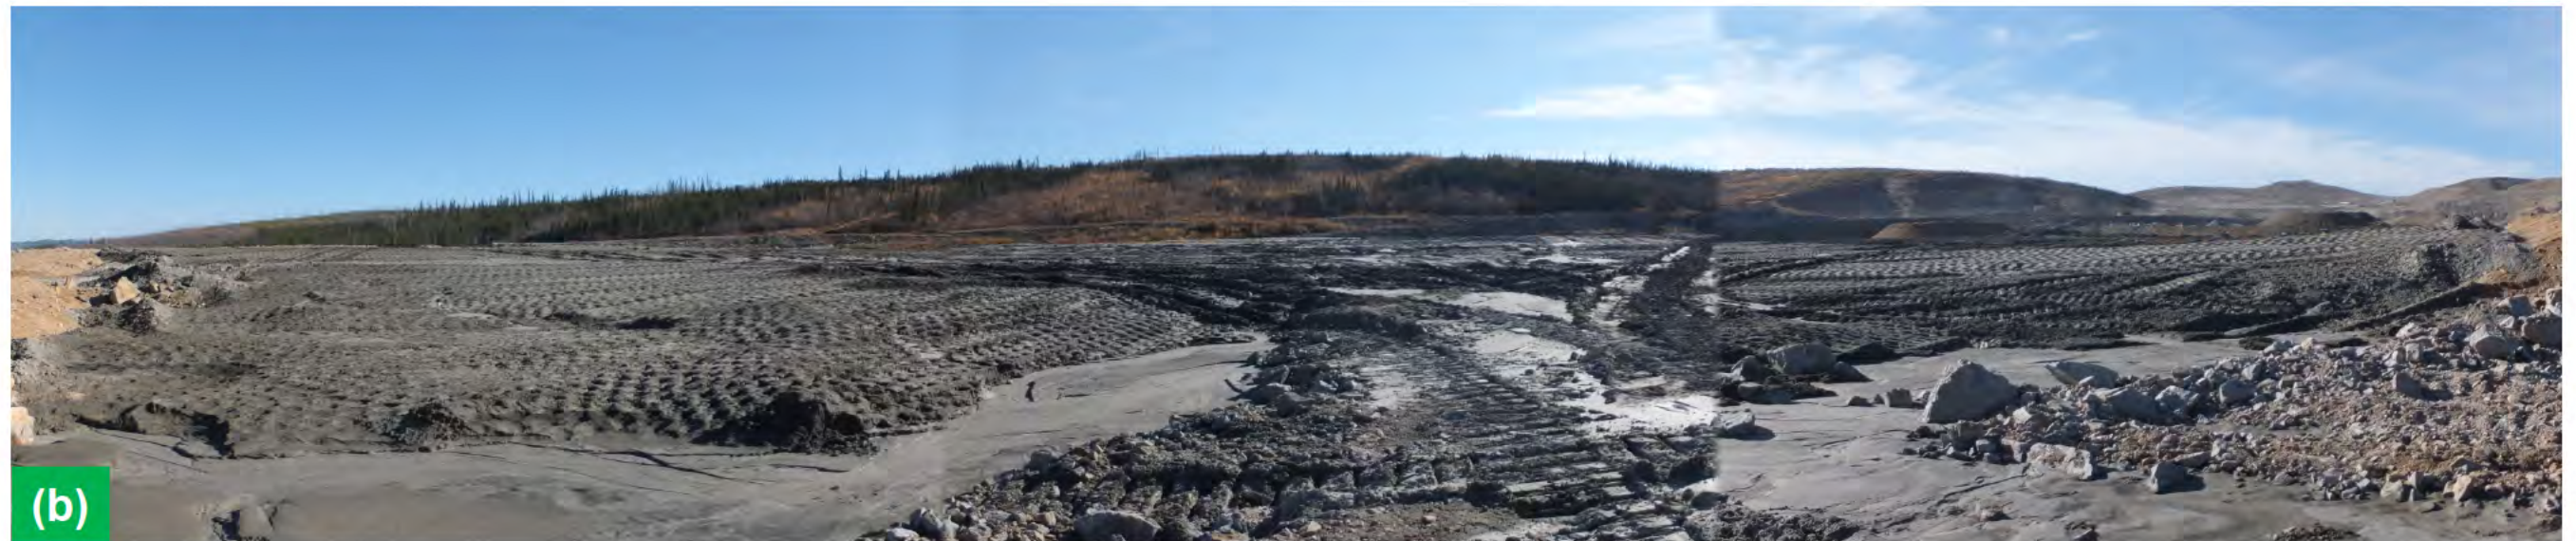
- The tailings surface was generally dry at the time of the inspection. No large-scale ponded water was observed throughout the tailings facility.
- Some ponded water was observed between compaction equipment tracks as can be seen near the center of the photo. The water can be attributed to recent precipitation events.

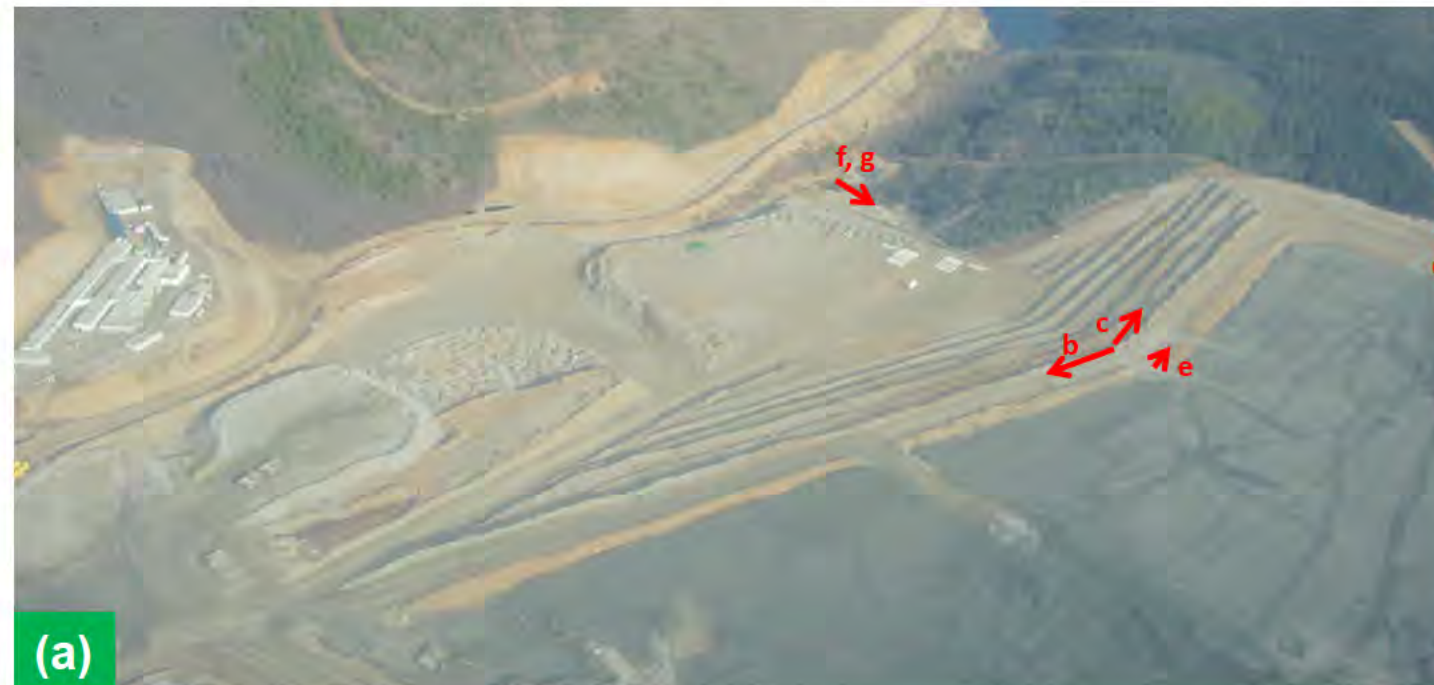
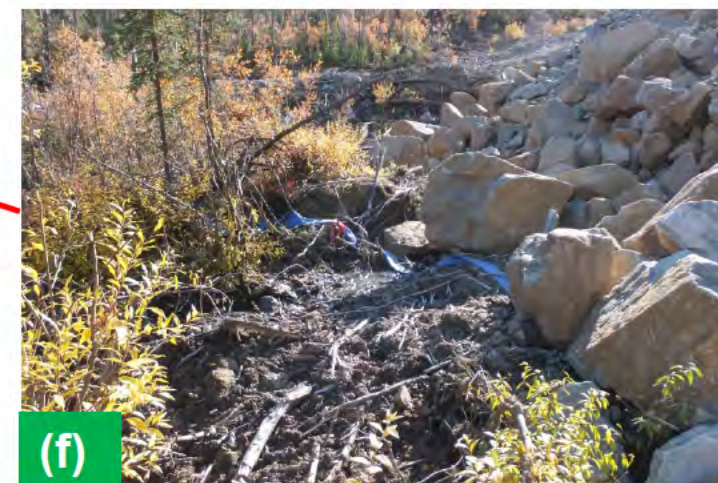
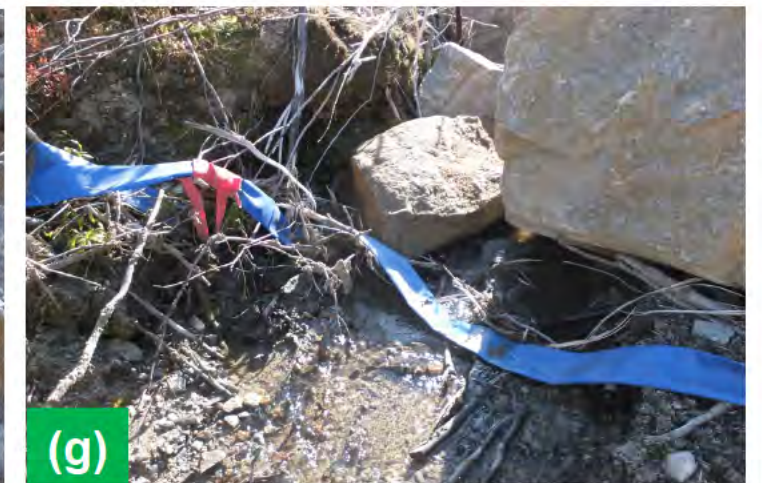
2012 Geotechnical Annual Review		
		Dry Stack Tailings Facility		
Job No: 1CM002.006.400 Filename: Minto 2012 Site Inspection.ppt	Minto Mine	Date: November 2012	Approved: PHM	Figure: 3

- Photos show the condition of the waste rock shell and slopes.
- The slopes appear to be consistent with original placement: no signs of slumping, bulging or tension cracks were observed.
- One small sinkhole was observed – see Photo (e).

- (c) North-east end of the waste rock shell looking east.
- (d) East end of the waste rock shell looking north
- (e) A small sinkhole was observed (handheld GPS coordinates: 6,944,850N, 385,757E, NAD83) with a diameter of approximately 1.5 m and a depth of 0.5 m. The hole is located on the inside edge of the shell access road and appears to be approximately above (or close to) one of the finger drain locations. The original shell toe in the area has been covered as part of mill valley fill construction and was not inspected. It is suspected that the sink hole is the result of excessive runoff from the facility collecting and infiltrating at this location and resulting in fines movement (note the wetter appearance of the sediments in the photo on the far side of the sinkhole).

- The sinkhole should be filled in to prevent equipment damage.
- The area should be regraded to direct surface runoff away from this location.

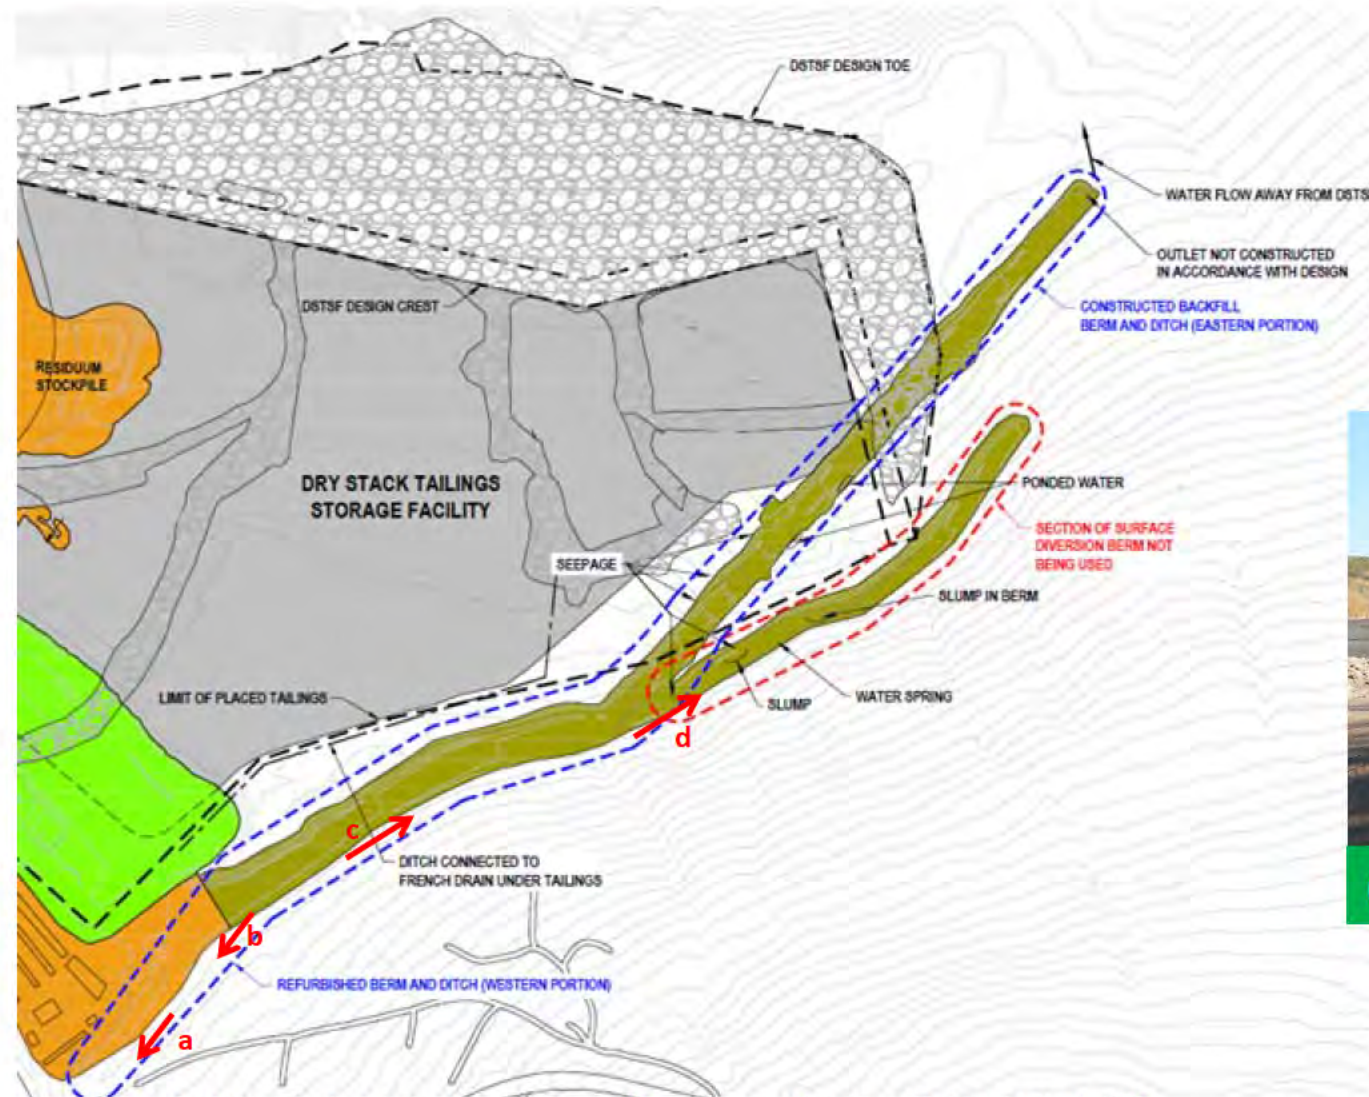
- The ditch near this location and further downstream is not well formed, with sediments building up in the channel, and the liner sagging down the channel sides.

- Liner sections are over-lapped, but not welded. Gaps are present between some sections allowing water to pass through.
- Water was also observed to flow over the sides of the liner in places.

- The surface diversion berm should be rehabilitated to capture and convey water along the entire length of the ditch.
- The ditch discharge should be constructed to an engineered design.

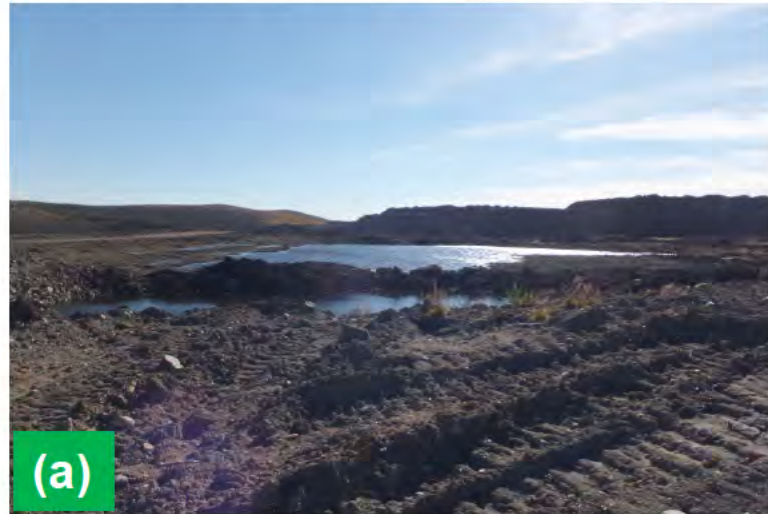
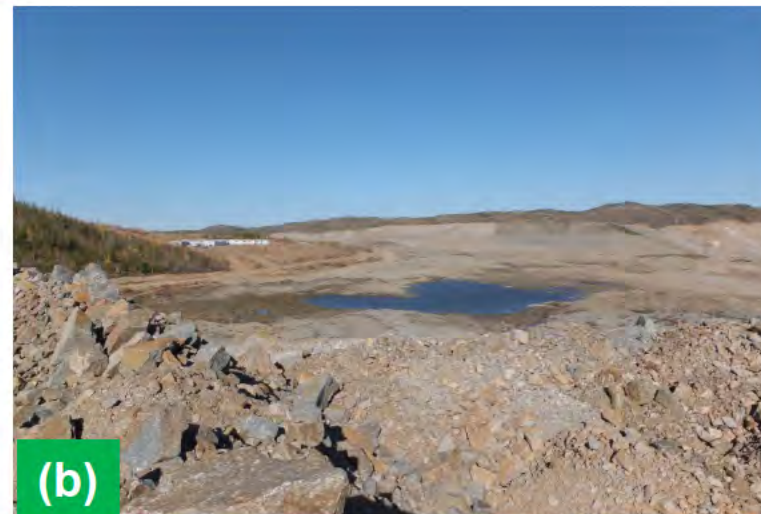
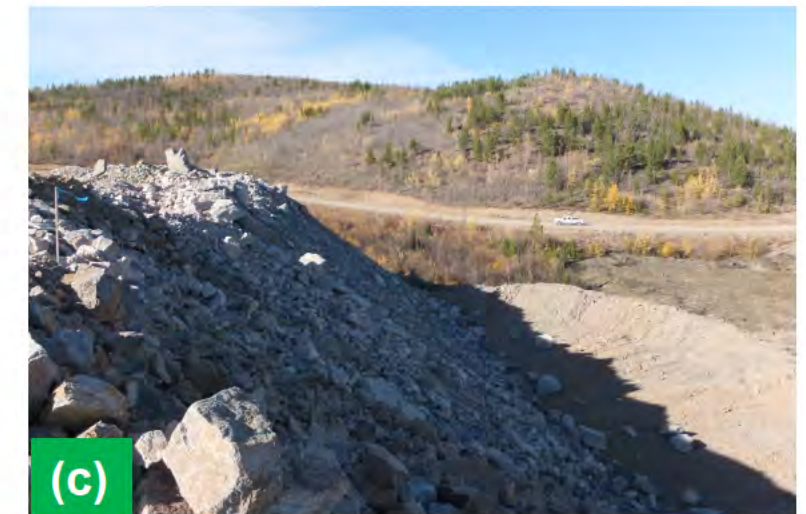
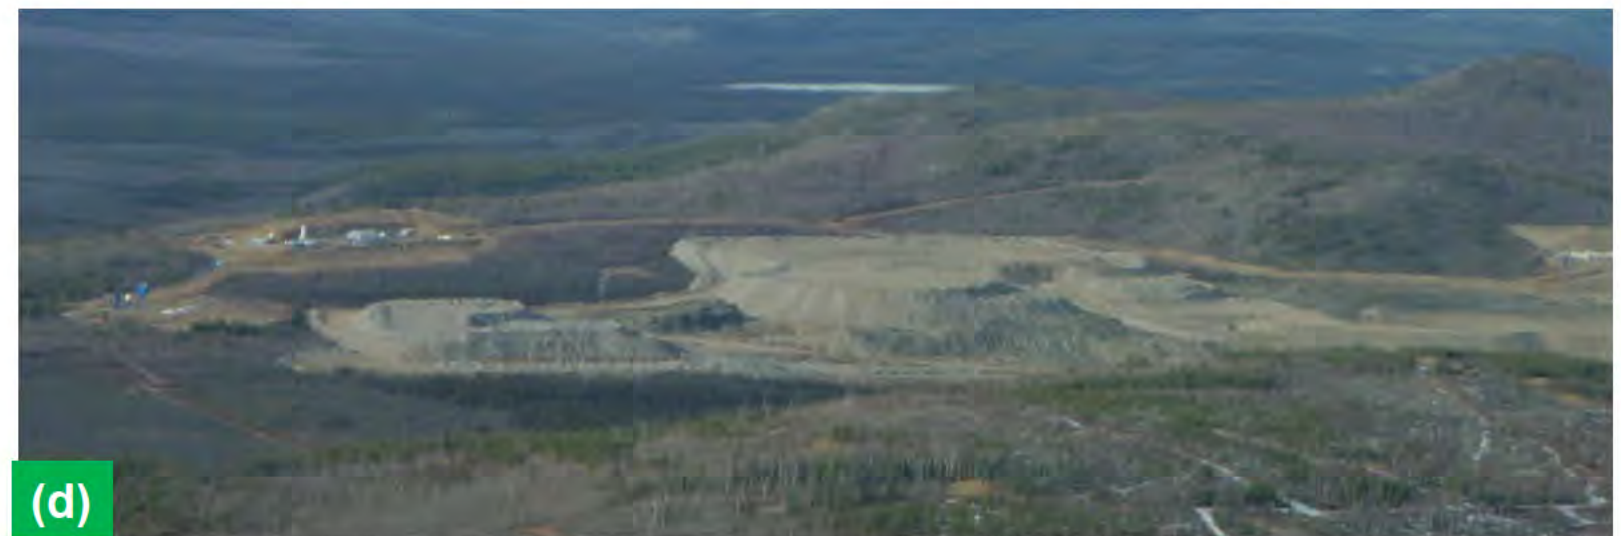
- Photo (d) was taken in October 2, 2012 on a flight to Minto.
- No signs of instability (slumping, bulging, tension cracks, differential settlement) were observed. Erosion was observed at the outlet of the culvert located north east of the dump (see Figure 8).

- Prior to placement of the next bench, areas with ponded water should be regraded to promote runoff and drain the large ponded areas.

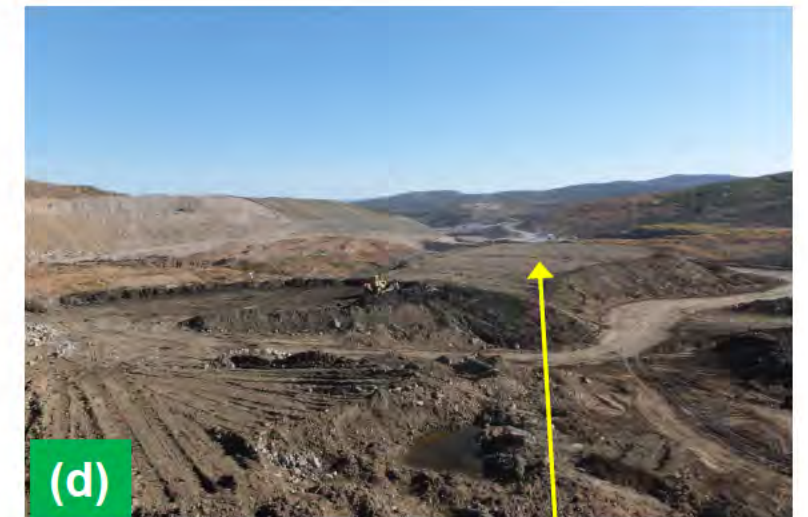
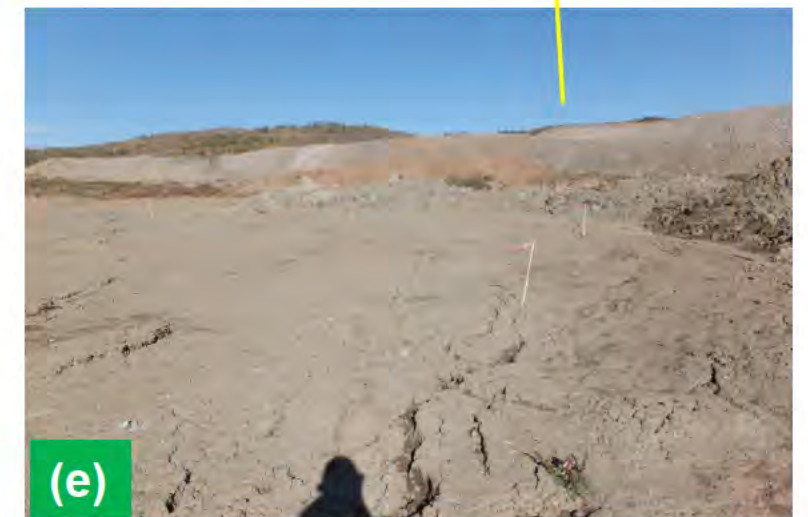
• Conditions of the dump are similar to conditions reported in the 2011 site inspection completed by EBA. Slumping, settlement and tension cracks are expected in the dump as it is constructed with frozen overburden with thawing expected.

- a) Ponded water adjacent to the Dyno Access Road southeast of the ROD. Two small erosional channels were observed (circled in yellow).
- b) Localized slumping of the perimeter slope. The 2011 inspection notes that some of the sloughing areas have increased in size.
- c) Discontinuous tension cracks and differential settlement observed along the perimeter crest (above the slope shown in Photo (b)).
- d) Overview of the ROD dump area.
- e) Tension cracks and zones of differential settlement present throughout the lift whose location is shown in Photo (d) and the figure below. The ground is undulating by approximately 0.3 m.

- Installation of a rip-rap channel down the slope to minimize slope erosion. Areas near the exiting erosion channels should be regraded to direct runoff to the rip-rap channel.
- Monitoring of the ponded water to ensure that the offset from the dump toe is maintained as stipulated in the design report.
- The toe of the dump should be surveyed annually to confirm it is within the permitted boundary.

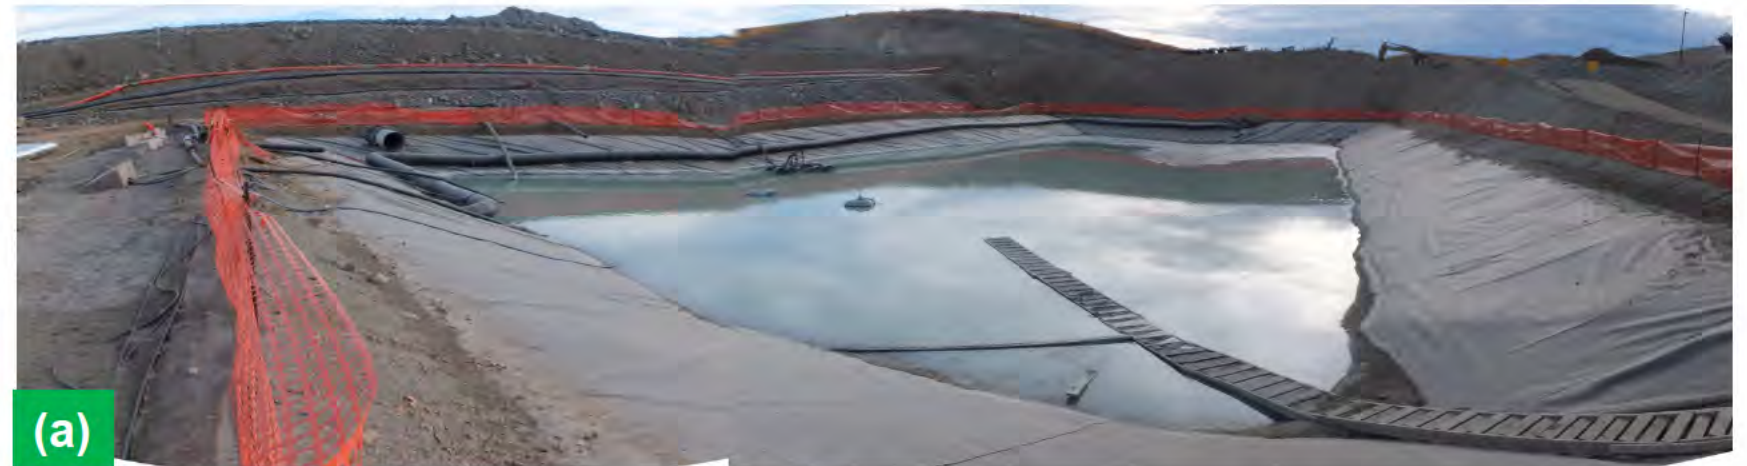
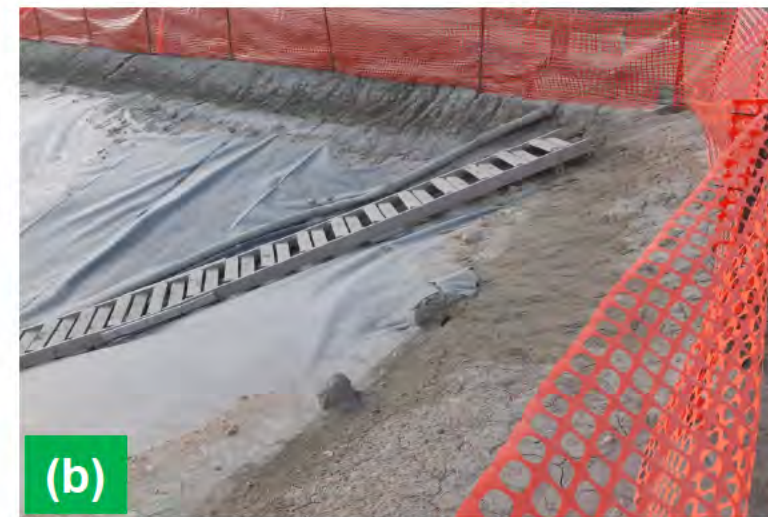
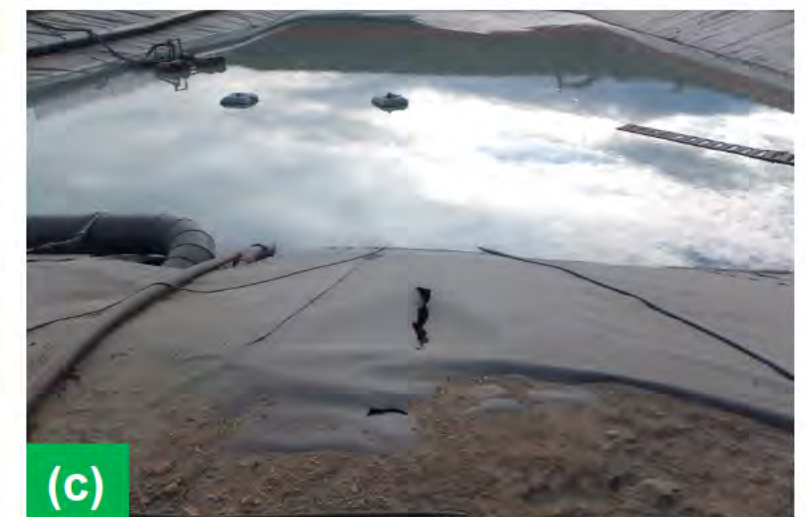
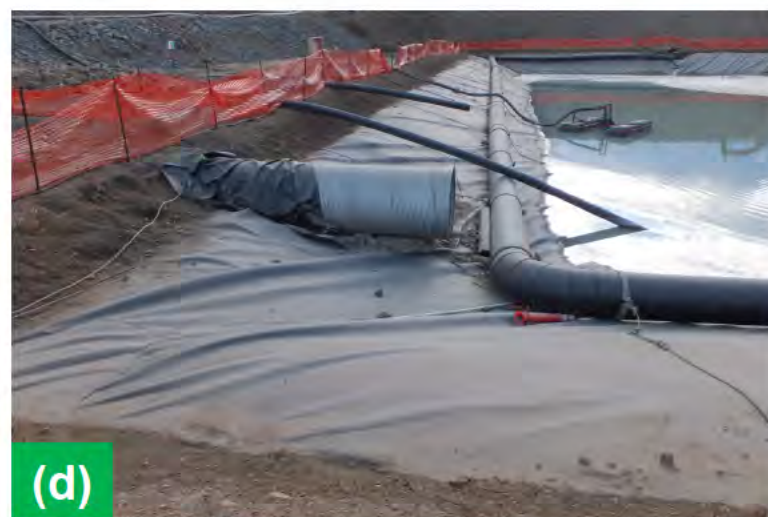
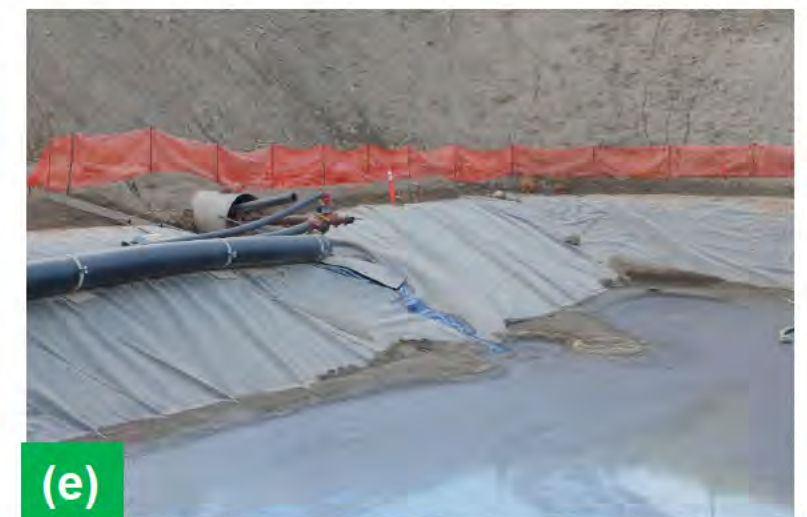
- The 2011 observation of a “minor bulge under the liner system in the vicinity of the southwest corner” was not observed during this visit. The liner in the area did not appear to be stressed or contain defects.

- e) View of the inlet culvert on the east side of the pond with a small flow of water entering the pond.

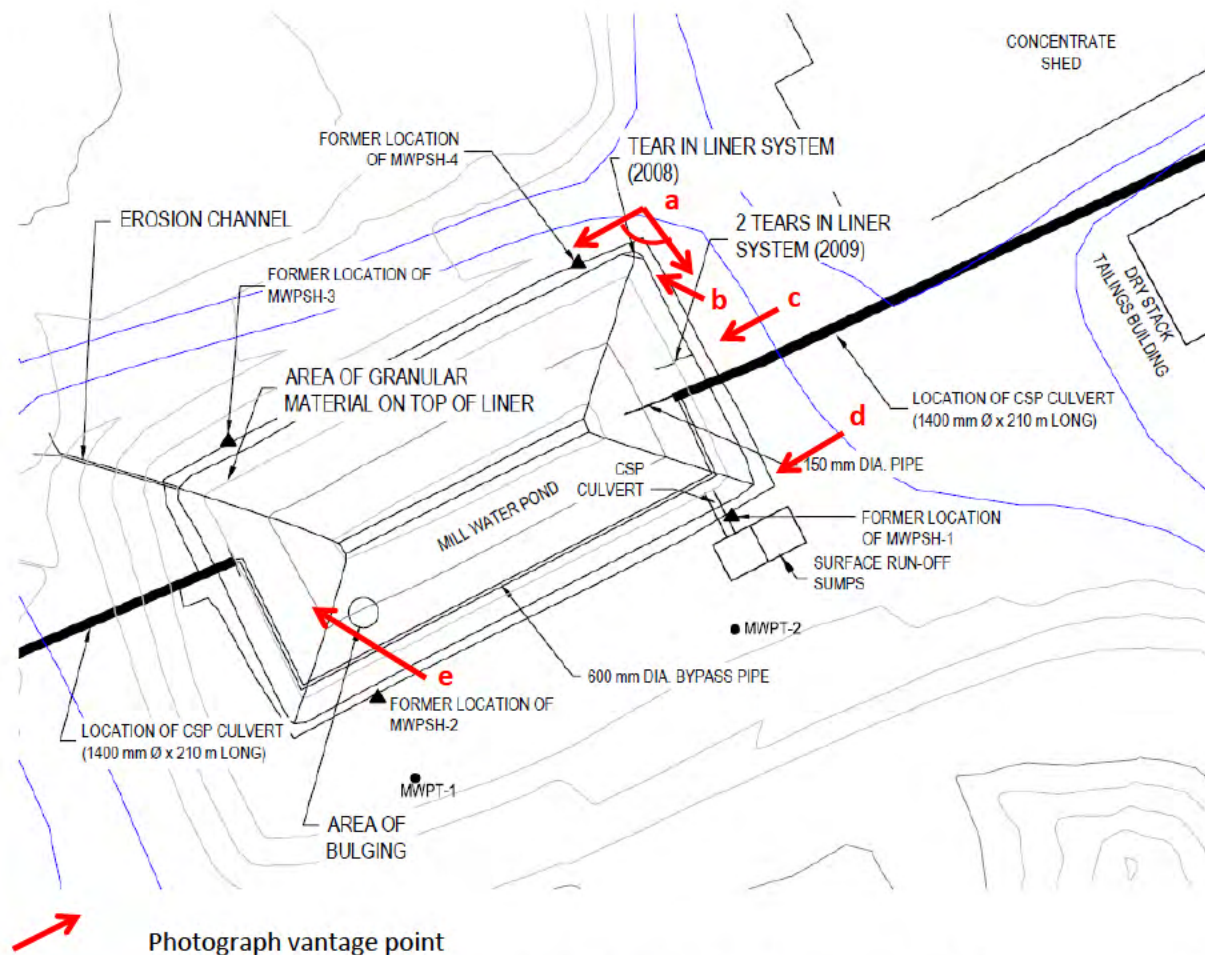
(e)

- a) Panoramic view of the mill pond. Tears in the liner system are the same as that reported in the previous inspection. No new tears or liner defects were observed.

- b) View of the tear in the liner at the north corner of the pond. The tear is approximately 1m in length and first noted in the 2008 inspection.
- c) Two tears in the liner midway along the northeast edge of the pond. These tears were first observed in the 2009 inspection. The largest tear is approximately 1.5m in length and is parallel to the slope. The smaller tear is approximately 0.5m in length and is orientated across the slope. A void is present beneath the slope that in previous EBA inspections has been noted to be increasing in size due to water penetration from surface.

- d) View of the south east side of the pond and by-pass pipe.
 - The bypass pipe and metal clamps are resting on pieces of plywood, while the 2011 review notes that they were resting directly on the liner. Placement on plywood is an improvement, but particular attention should be made at each support for liner damage in future inspections.

- The liner tears should be patched the next time a liner crew is onsite. For the liner tear noted in Photo (c), Figure 14, sand should be placed to fill the void beneath the tear.
- The liner condition beneath the bypass pipe supports should continue to be monitored.
- The sediments accumulated in the surface runoff ponds and culverts should be cleaned out.

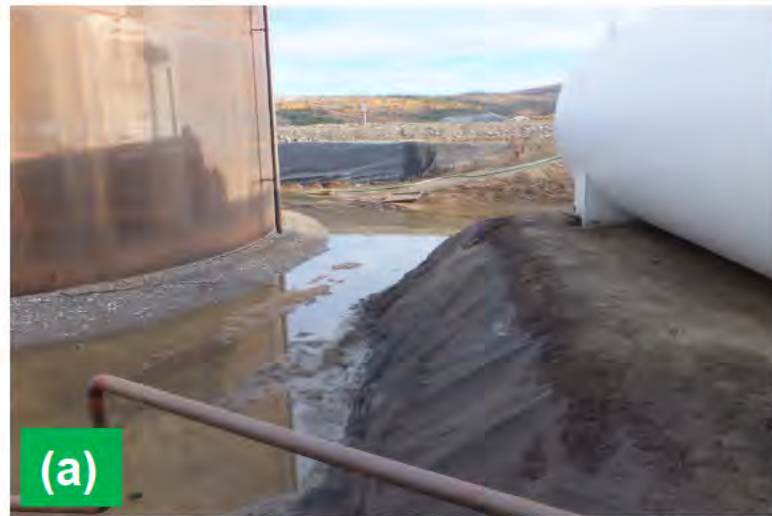
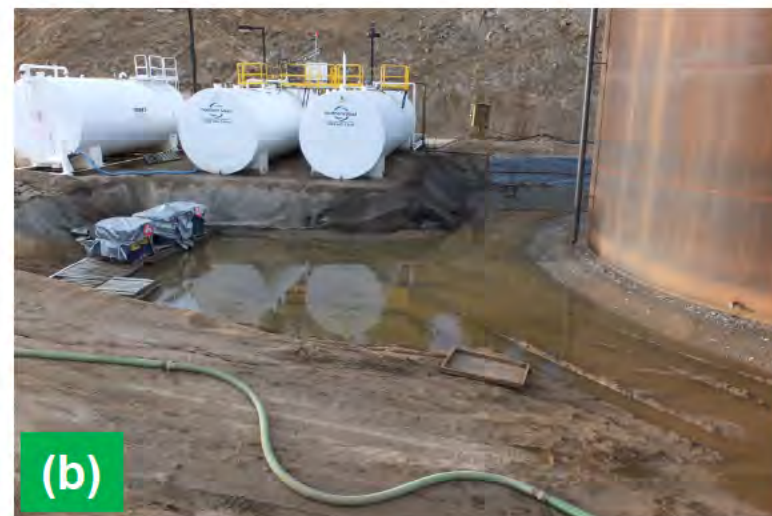
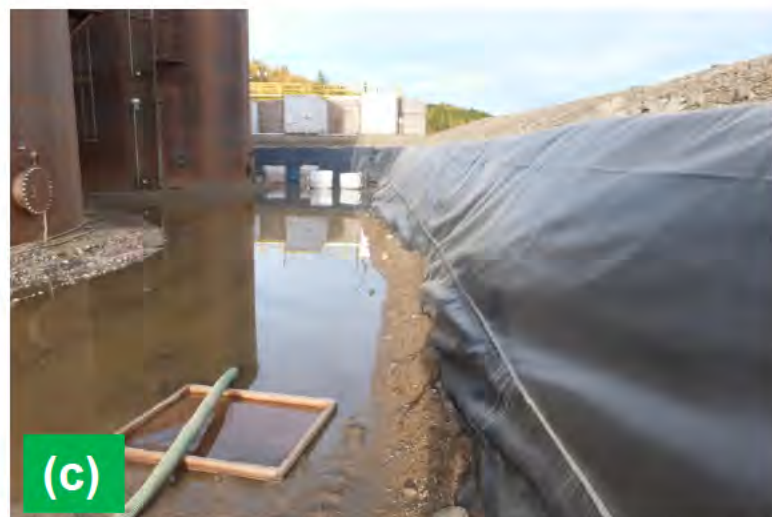
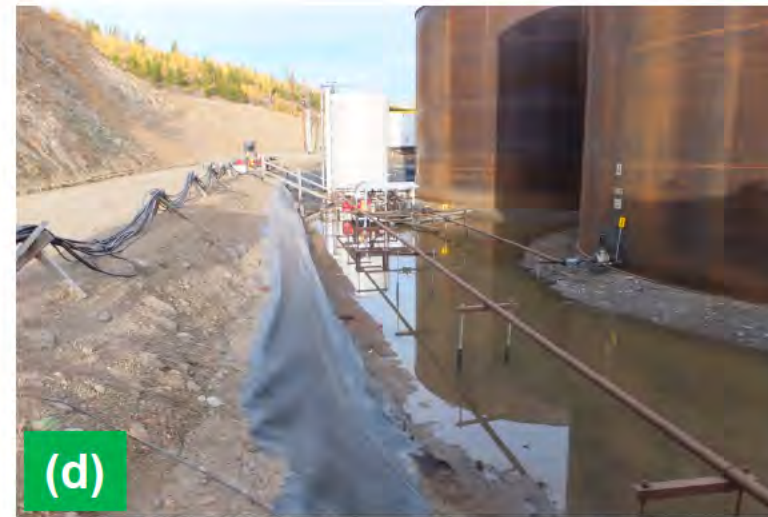
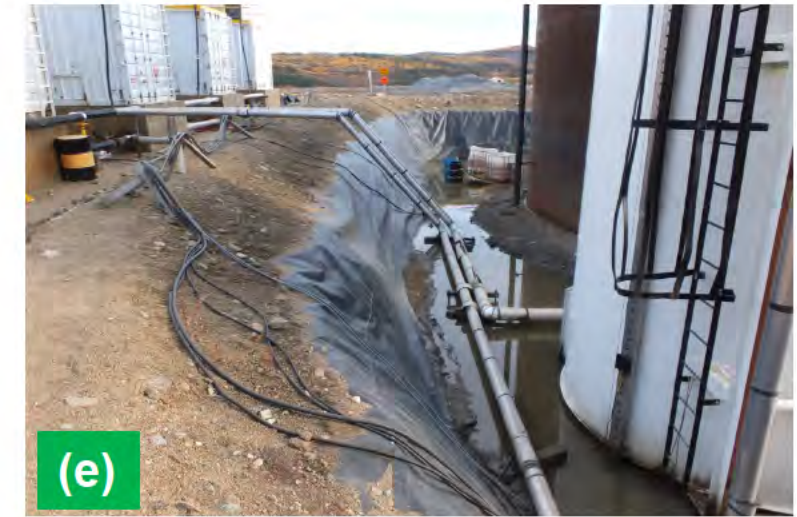
- Photos (a) to (e) show the condition of the liner on each side of the facility.
- Conditions of the facility appear to be the same as reported in the 2011 review.
- No tears or defects in the liner were observed.
- Ponded water is present throughout the facility.
- No ponded water was observed at the filling station area northwest of the containment area. The area appears to drain into containment area as per design.
- Ruts are present at the base of the ramp and at the western portion of the facility as seen in Photo (b). It is unclear if the ruts are new or the same as in the 2011 inspection.

- No actions required.
- As noted in the previous EBA inspections, the bedding layer over the geomembrane was not meant for heavy equipment. Vehicle access should be limited to the occasional visit with low ground pressure equipment.

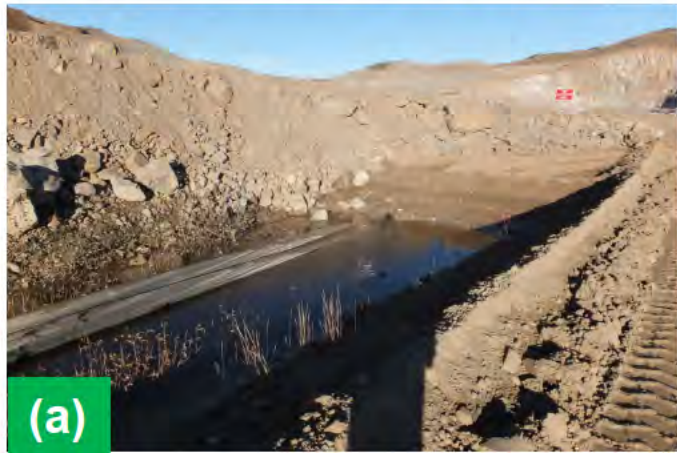
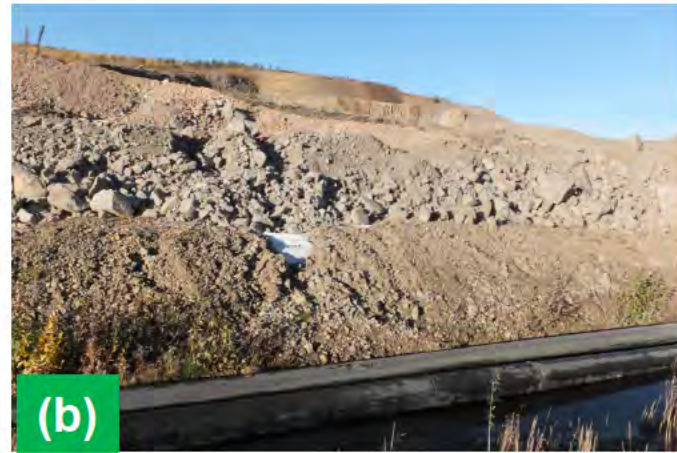
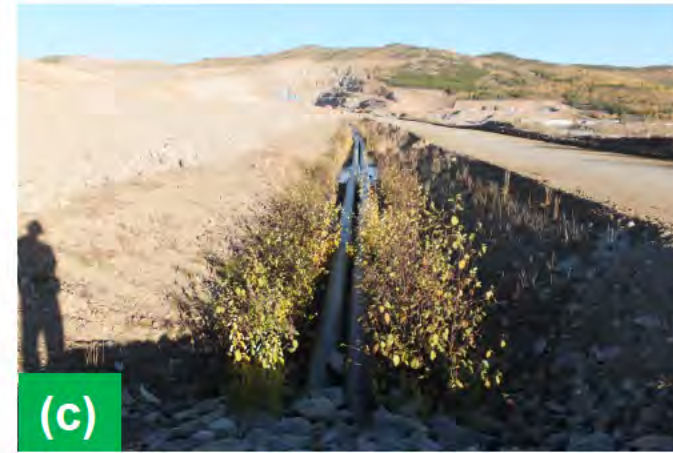
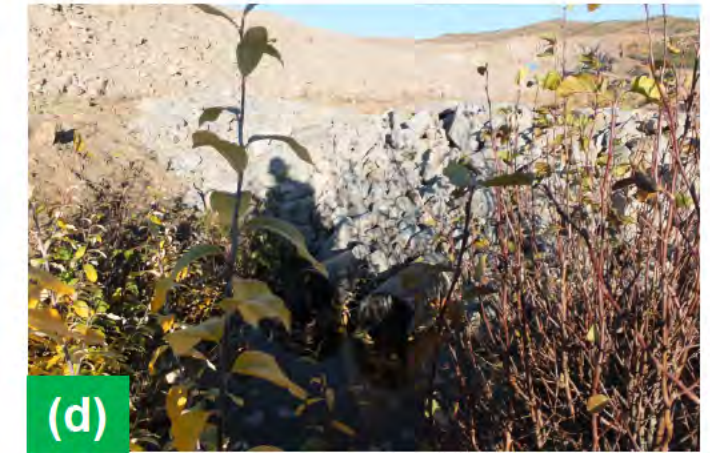
- STA 0+540 to 0+957 of the ditch were inspected during the site visit. The lower portion of the channel has been blocked off at a road crossing at STA 0+540 with flow diverted through two 16" HDPE pipes.
- The 2011 Annual Review completed by EBA notes that the upper portion of the channel is a lined ditch constructed to the specifications outlined in the "South Diversion Ditch Collection Pond IFC drawings, Figures SD1 through SD3, dated July 2007.
- The channel is generally in good condition with no blockages or instability along the side-slopes.
- The area of settlement noted in the 2011 annual review between STA 0+600 and 0+650 was not observed.

- To increase the capacity of flow into the diversion piping, it is recommended that the vegetation be removed. If the downstream portion of the channel is re-established (between STA. 0+540 and 0+650), vegetation along the channel should also be removed to increase flow capacity.
- The exposed liner should be covered as per the channel design.

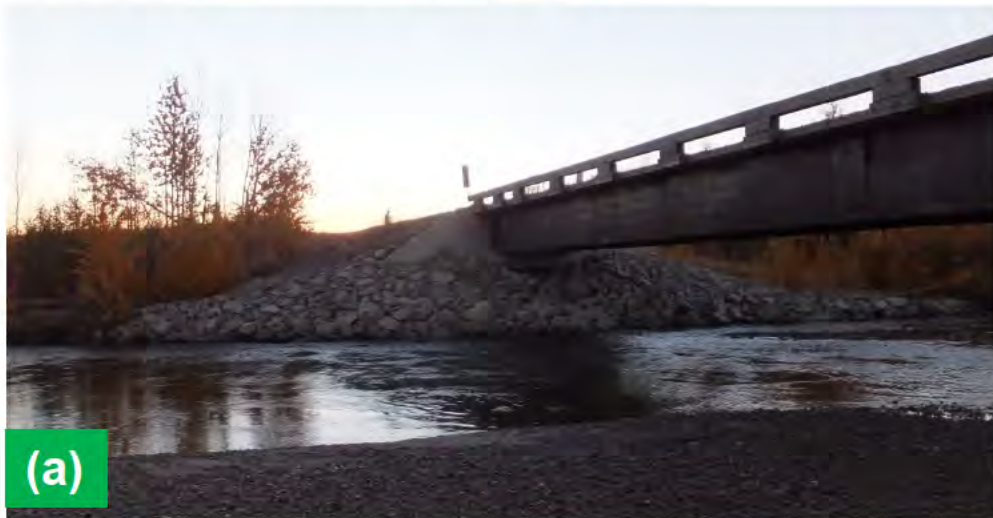
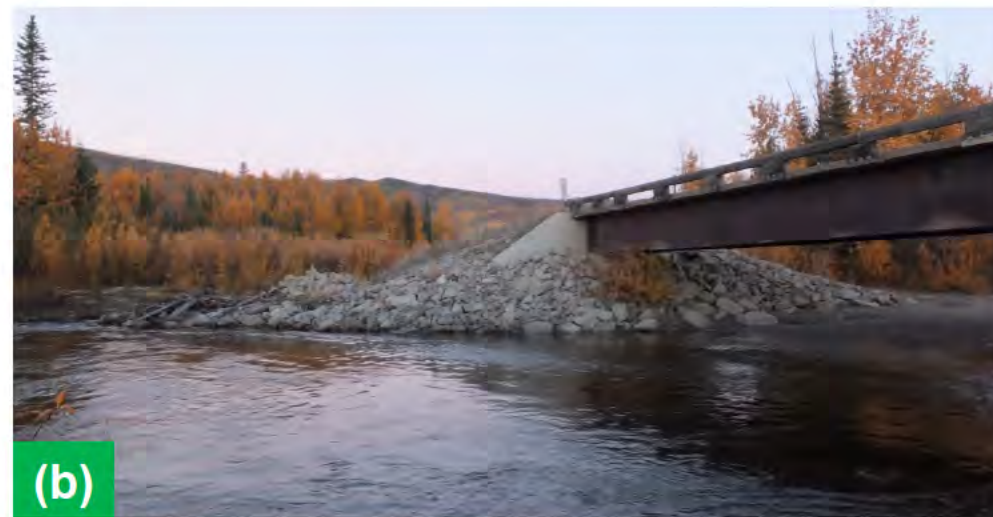
- Photos (a) and (b) show east and west abutments, respectively. The bridge abutments and road approaches are in good condition, no signs of instability were observed.

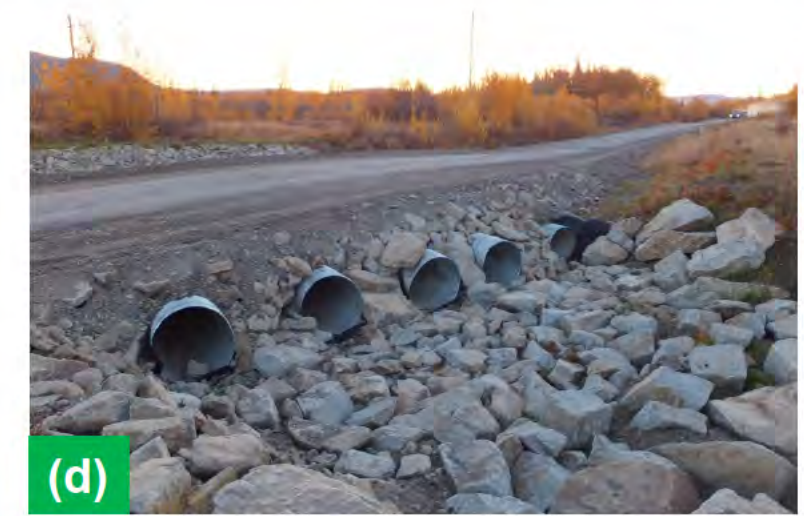
- Photo (d) shows 5 culverts, each with a diameter of 1.1 m, are located further west in the approximate location shown on the plan. The culverts are not noted in the 2011 inspection and likely installed within the past year. The culverts are in satisfactory condition. The middle culvert has been slightly damaged (dented) by a large rock.

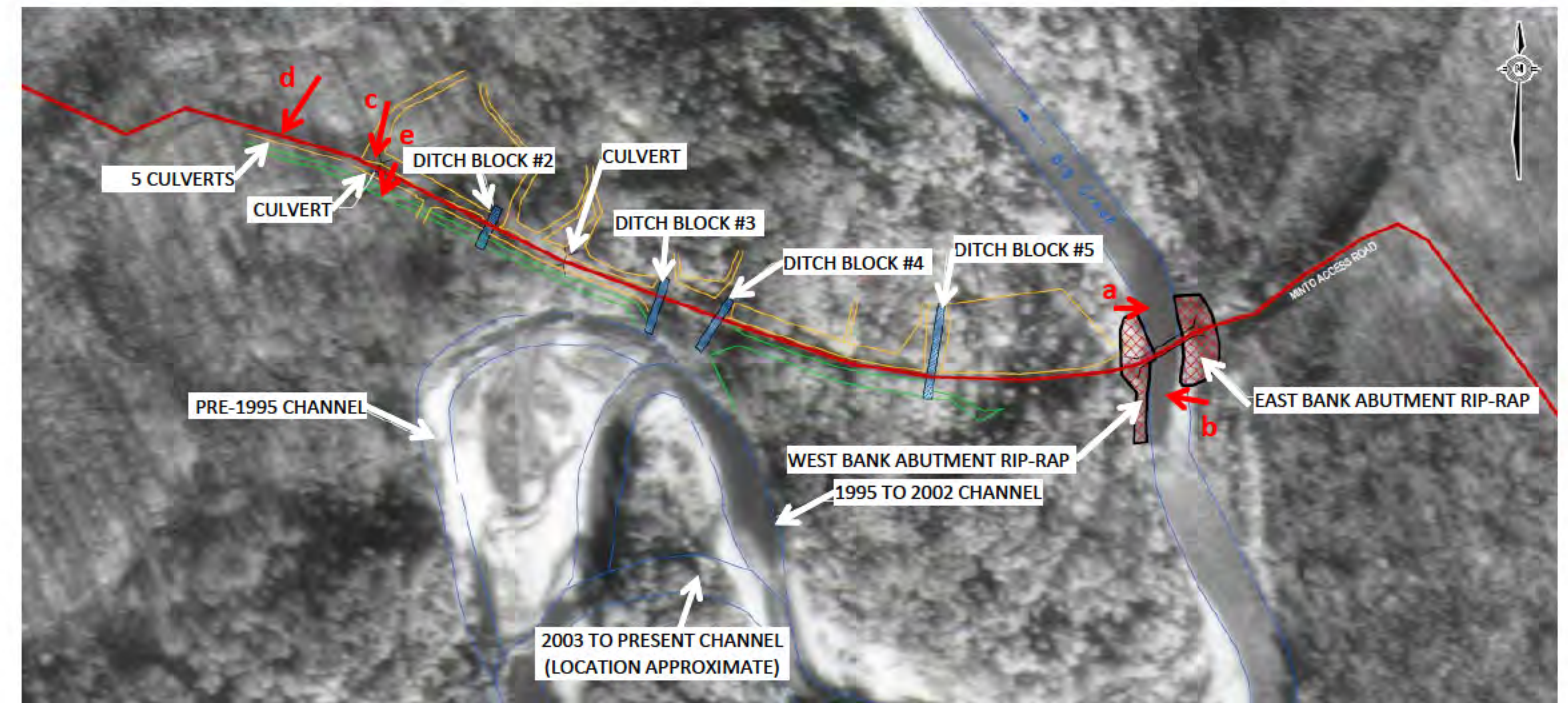
- Photo (e) shows a slough in the channel on the south side of the road located approximately 10 m downstream of the first culvert. The slough does not appear to cause a significant blockage to the channel, but should continue to be monitored.

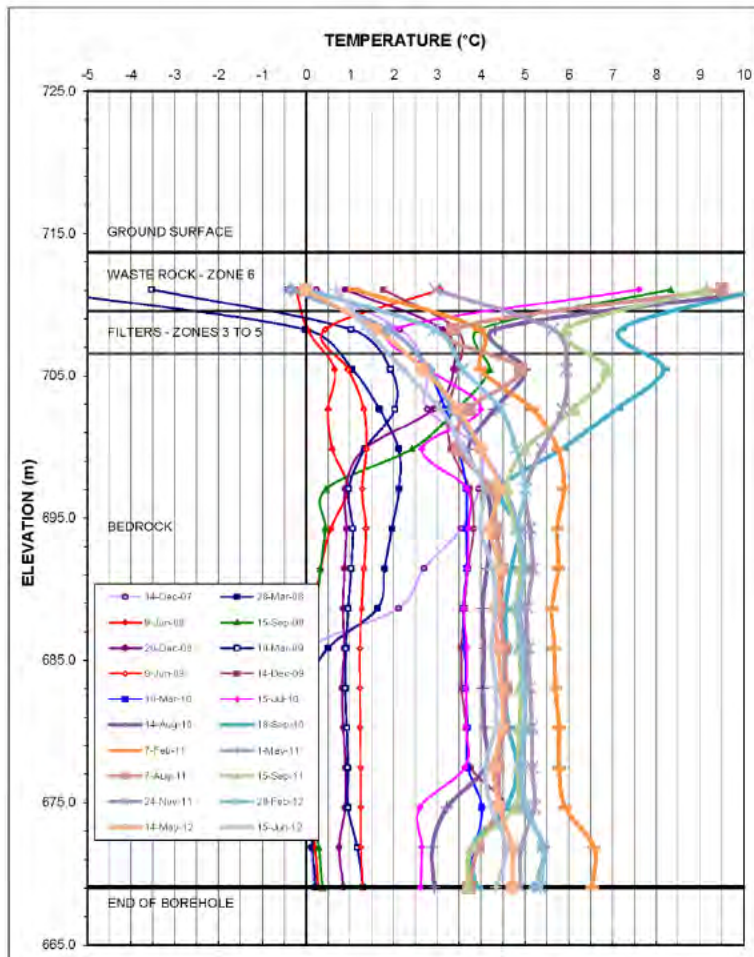
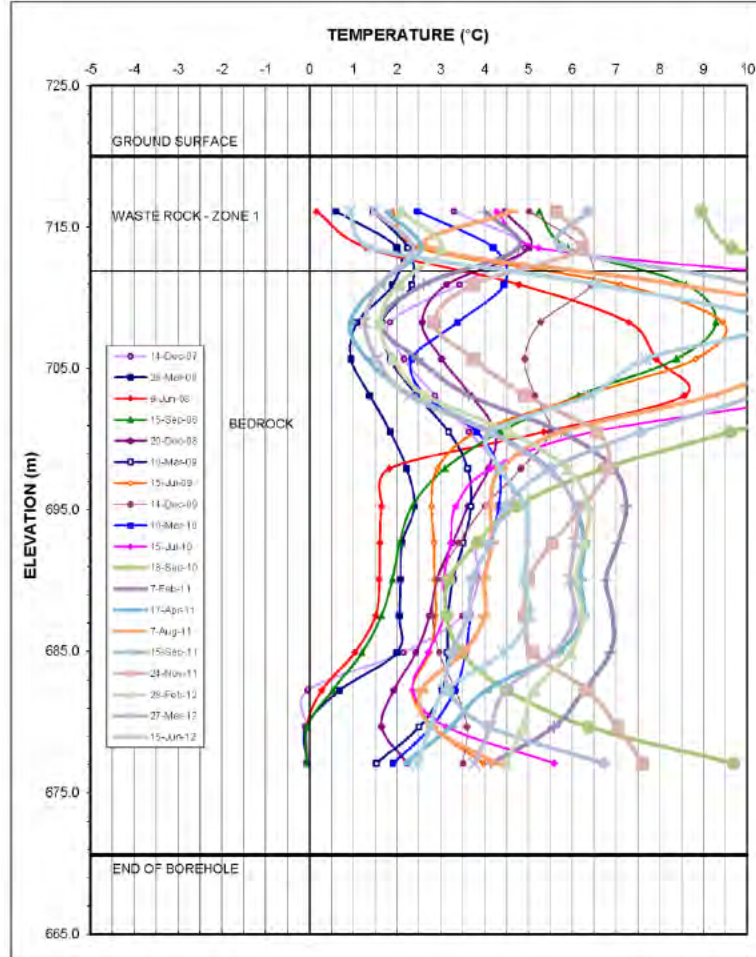
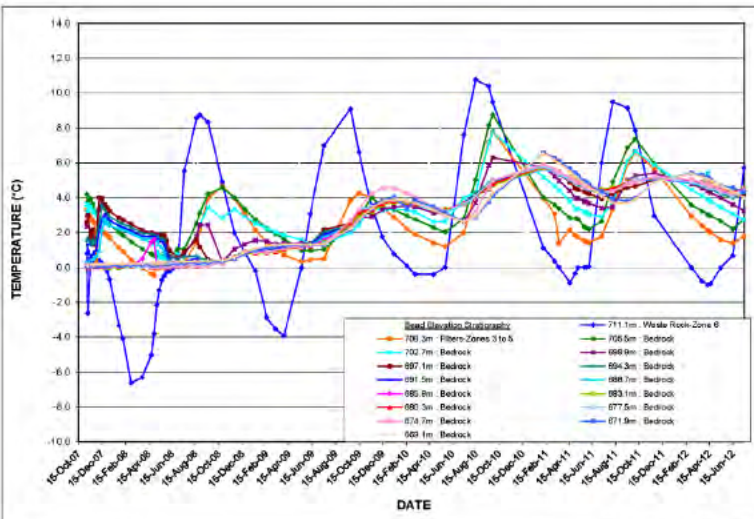
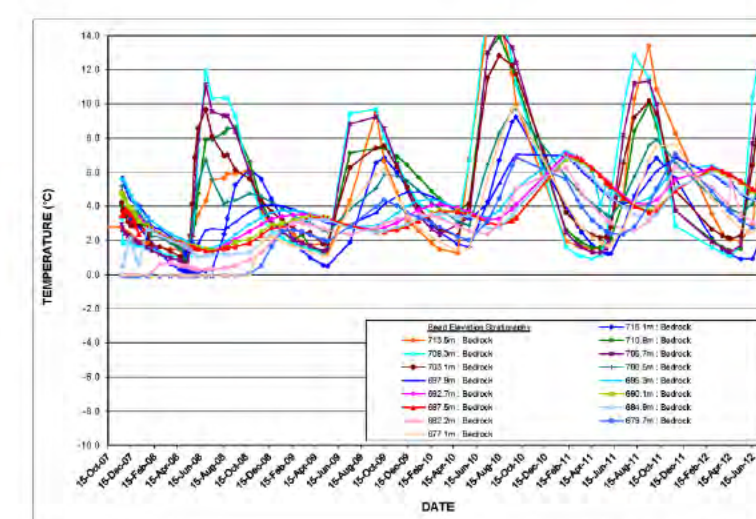
VANCOUVER	 MINTO EXPLORATIONS LTD. A Subsidiary of Capstone Mining Corp.	2012 Geotechnical Annual Review		
		Water Storage Pond Ground Temperatures		
Job No: 1CM002.006.400	Minto Mine	Date: November 2012	Approved: PHM	Figure: 8
Filename: Minto 2012 Site Inspection.ppt

Ground temperature profiles and temperature-time plots from the temperature cables are presented in Figures 8 and 10 of Appendix B. No permafrost is present in the monitored areas with temperatures generally increasing with depth. Temperatures beneath the upstream slope of the dam and away from the abutments and the surface (WDT-3 and 4) are stabilizing between 3 and 4
