2012 Geotechnical Annual Review, Minto Mine, YT

MINTO EXPLORATIONS LTD.

SRK Consulting (Canada) Inc.

November 2012

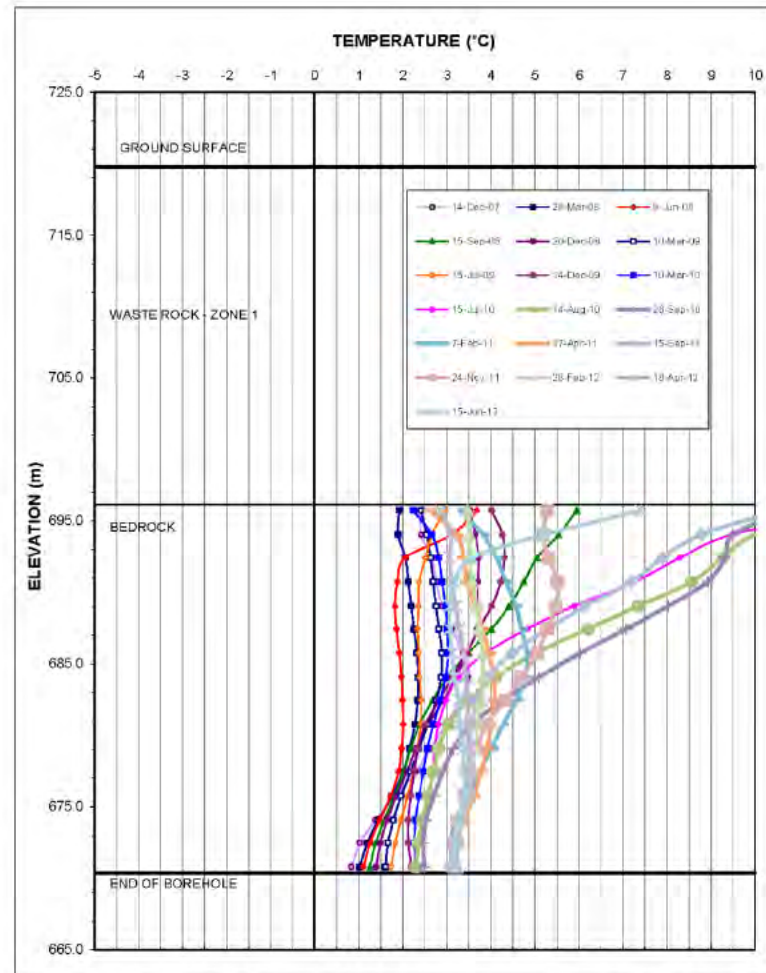
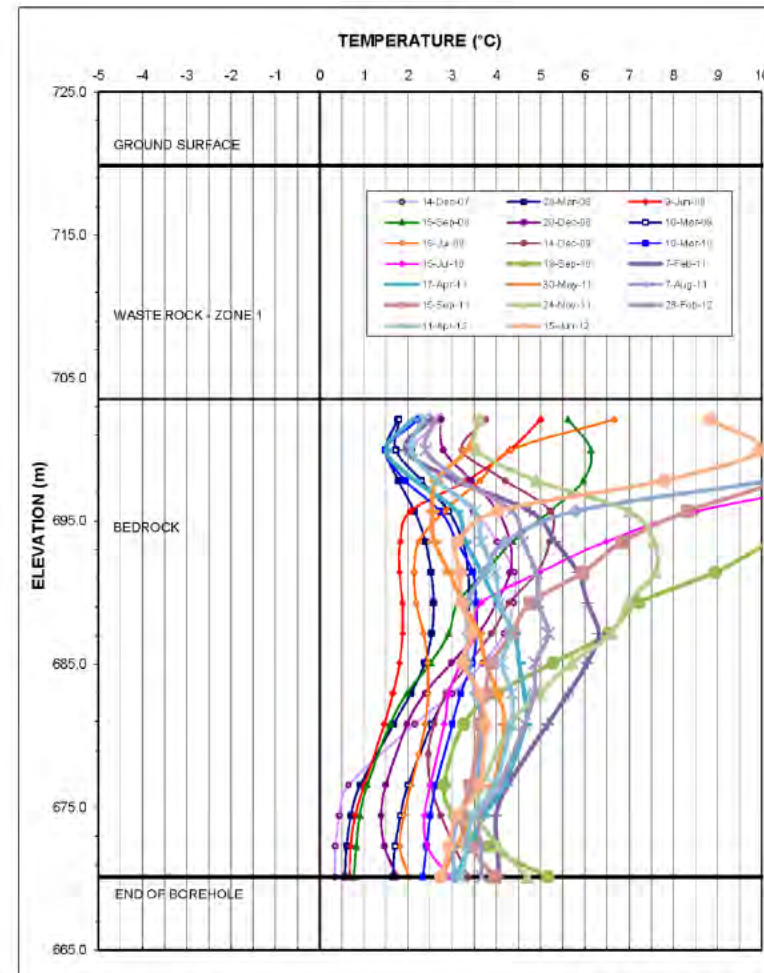
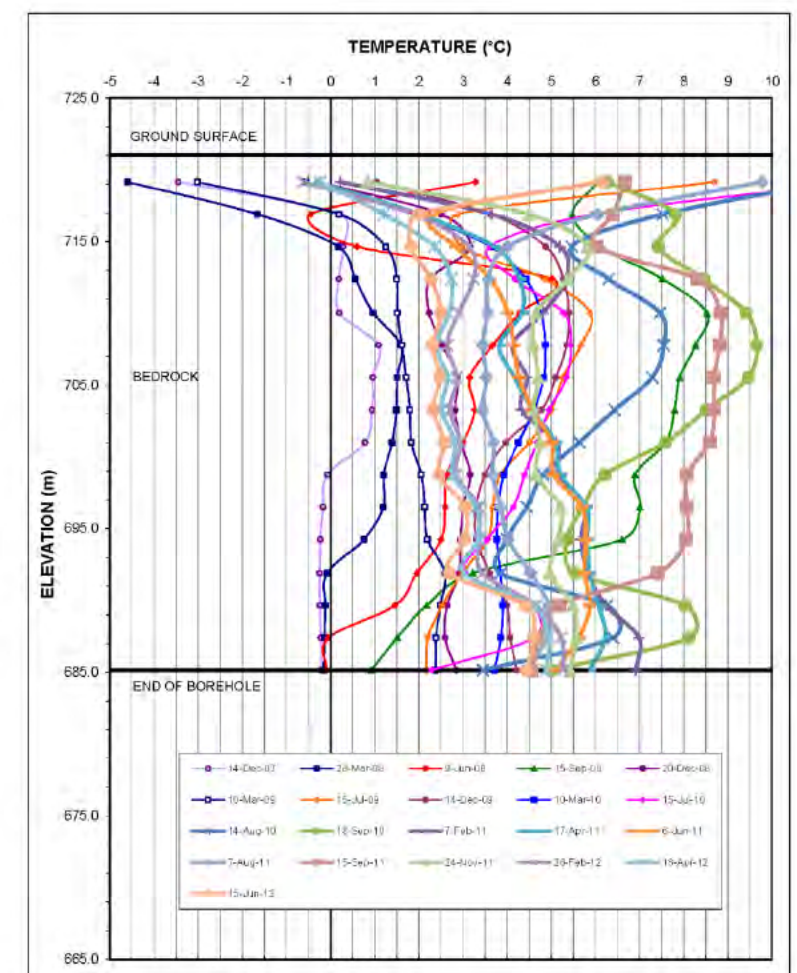
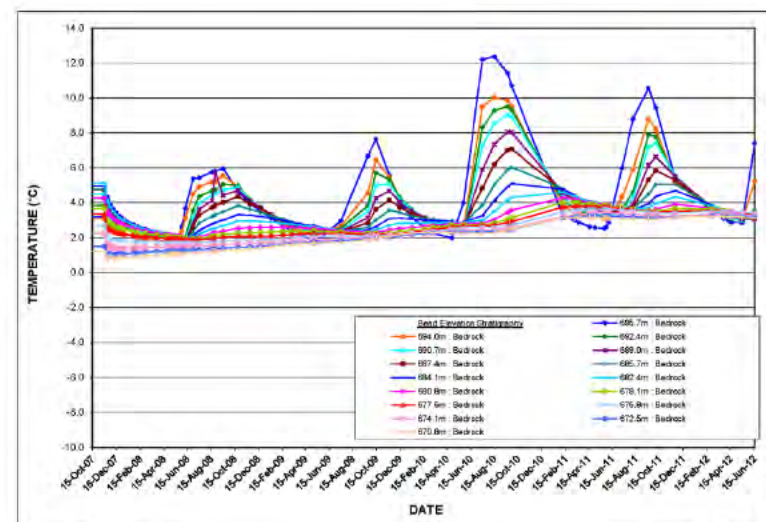
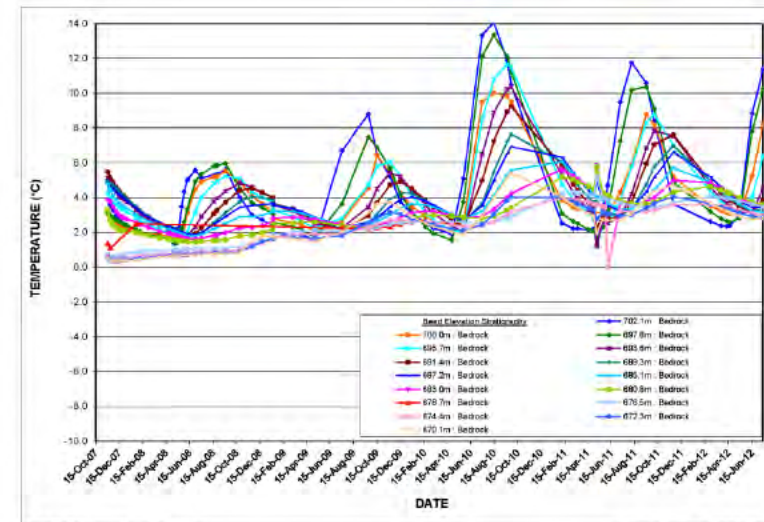
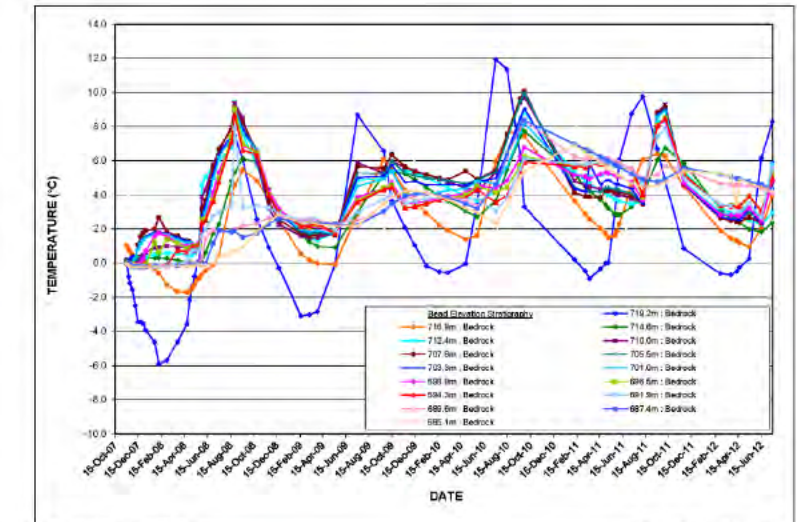
Date: November 2012	Approved: PHM	Figure: 9
------------------------	------------------	--------------

Ground temperature profiles and temperature-time plots from the temperature cables are presented in Figures 8 and 10 of Appendix B. No permafrost is present in the monitored areas with temperatures generally increasing with depth. Temperatures beneath the upstream slope of the dam and away from the abutments and the surface (WDT-3 and 4) are stabilizing between 3 and 4
