2013 Geotechnical Annual Review, Minto Mine, YT

Minto Explorations Ltd.

SRK Consulting (Canada) Inc.
1CM002.012.005
October 2013

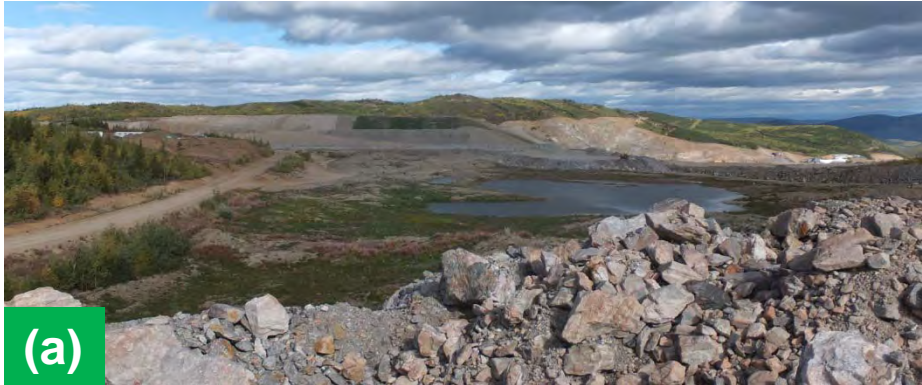
(a)

- The construction method of the dump is described in the 2011 annual review as follows: “Minto is utilizing a series of benches and setbacks during dump construction. Benches of finer grained non ice-rich waste have been constructed back of the overall crest of the facility. These benches are being and will continue to be capped with coarse waste rock until the ultimate dump dimensions are achieved. Therefore, the exterior slope will be constructed with coarse waste rock only.”

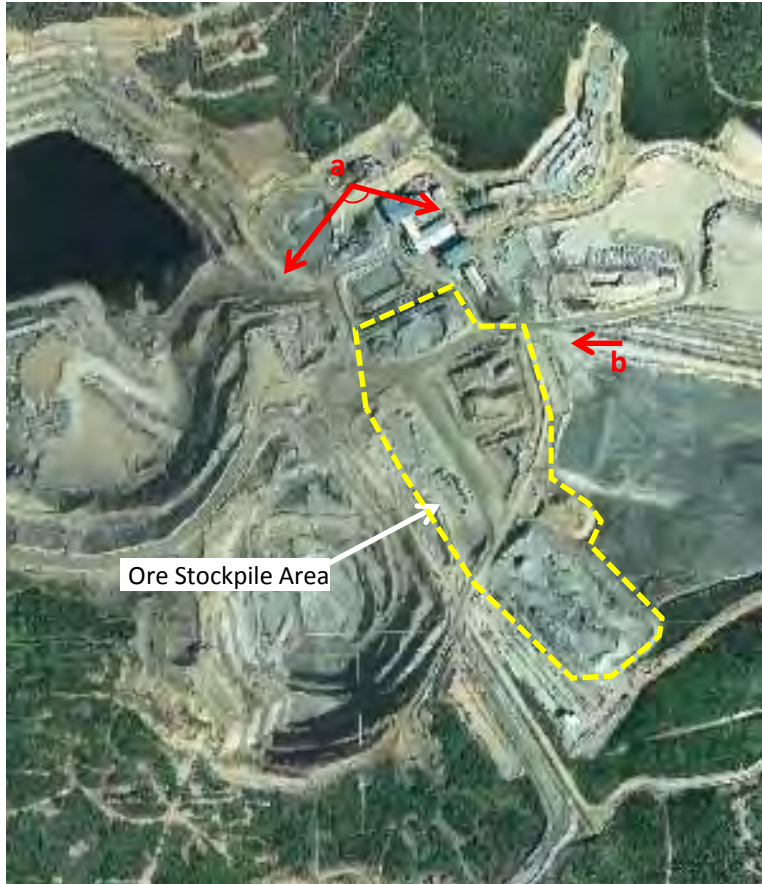
- The ore stockpile area was investigated briefly in passing. All slopes appeared in good condition: no slumping, bulges, cracks, or other signs of instability were observed.

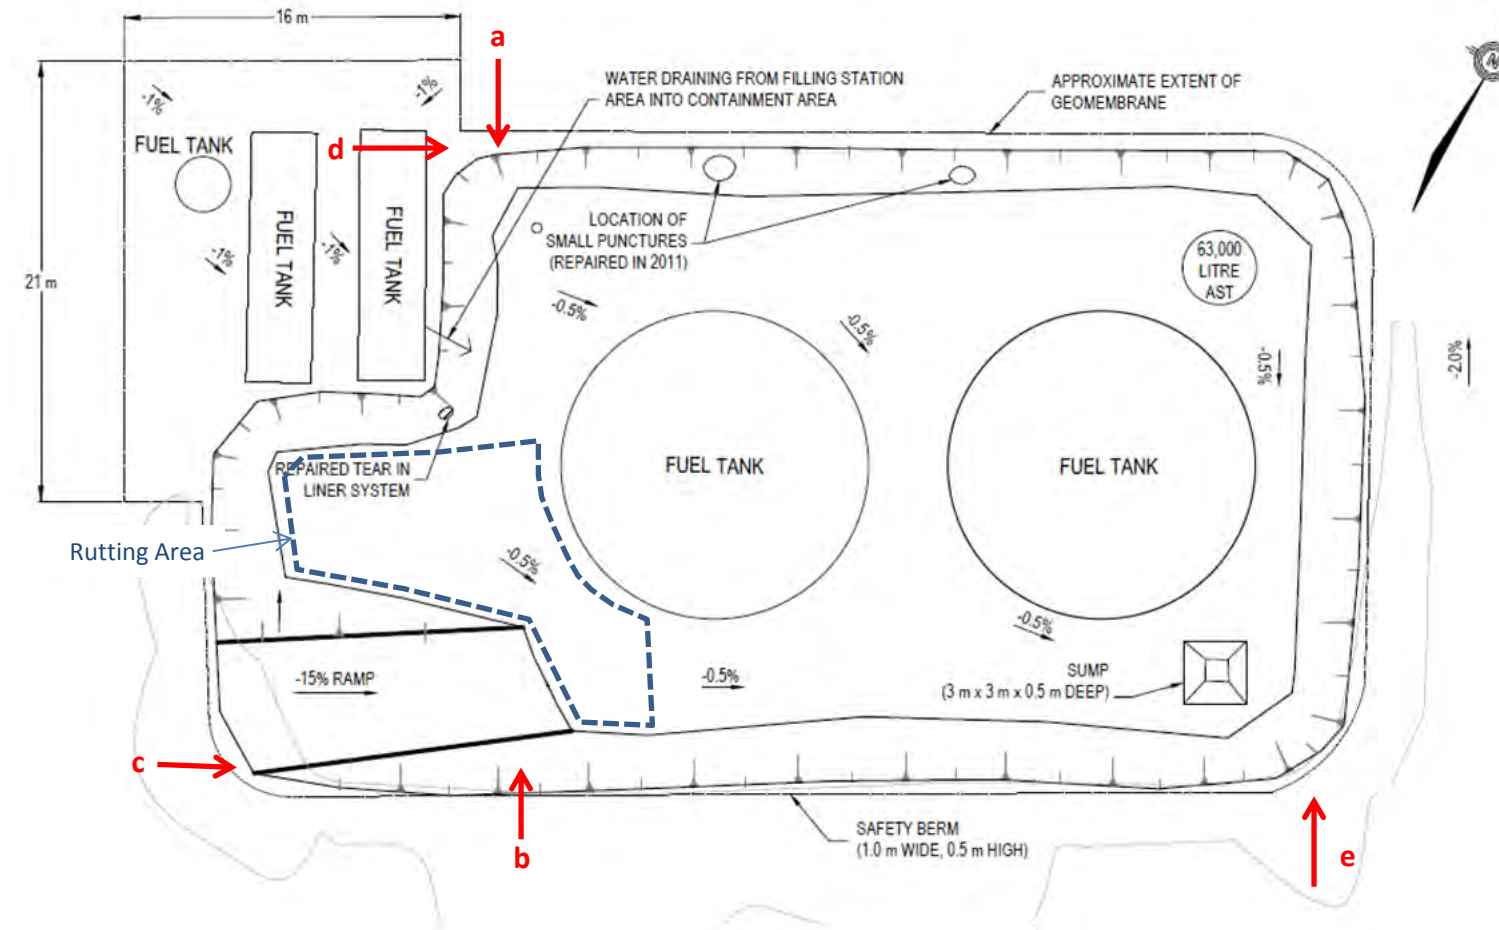
- Photos (a) to (e) show the condition of the liner on each side of the facility.
- Conditions of the facility appear to be the same as reported in the 2012 review.
- No tears or defects in the liner were observed.
- Since the Spring inspection, the water level has lowered, with water only present in the sump in the SE corner of the facility. The facility appears to drain into containment area as per design.
- Additional ruts are present in the southern half of the facility. Rutting is significant (approximately 2-3 inches deep) between the two tanks where equipment was turning. No liner is exposed as a result of the trafficking.

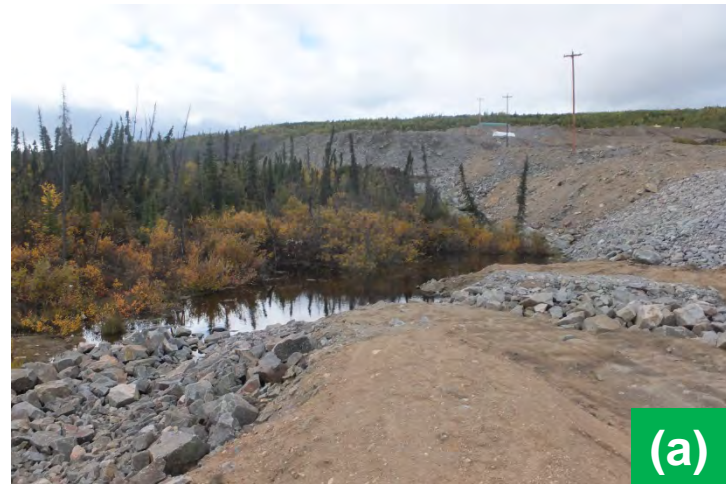
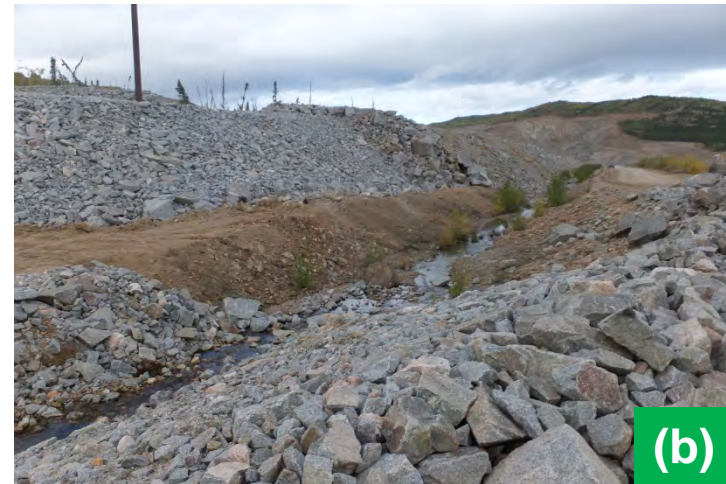
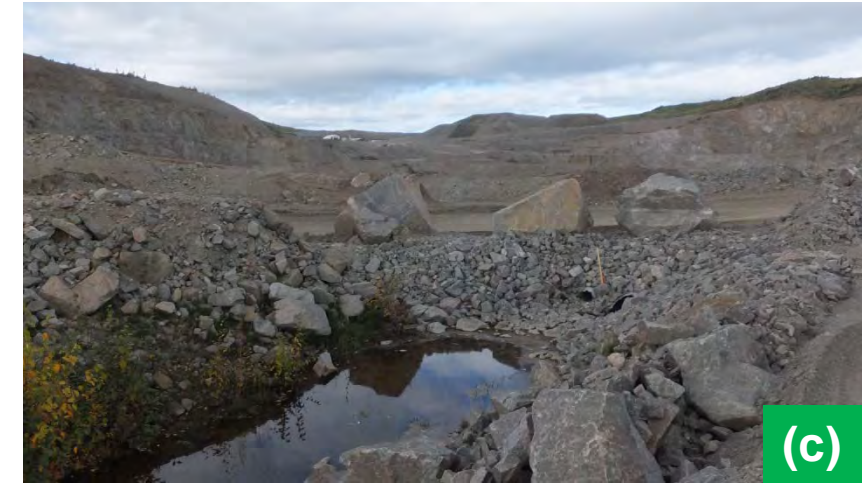
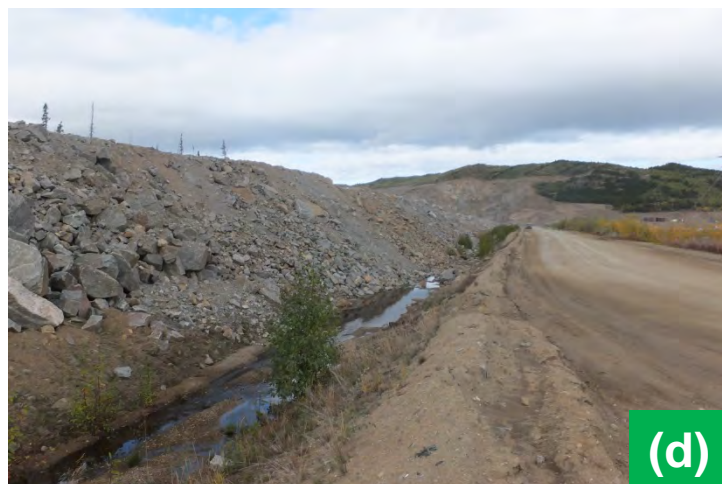
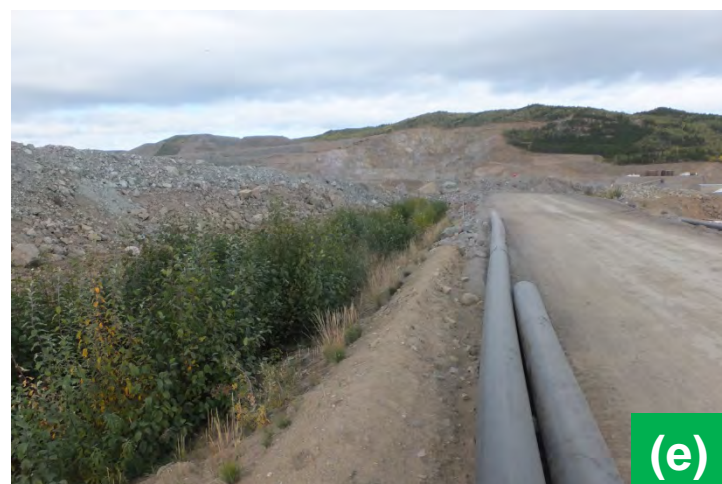
- The South Diversion Ditch was inspected between the areas shown in Photos (a) to (e) adjacent to the Airport Laydown area. The pipeline intake structure at the photo (c) location diverts water to the confluence area located near the Main Pit. The pipeline alignment was not inspected during the site visit.

- The lined ditch upstream of the intake structure was constructed to the design outlined in the “South Diversion Ditch Collection Pond IFC drawings, Figures SD1 through SD3, dated July 2007.

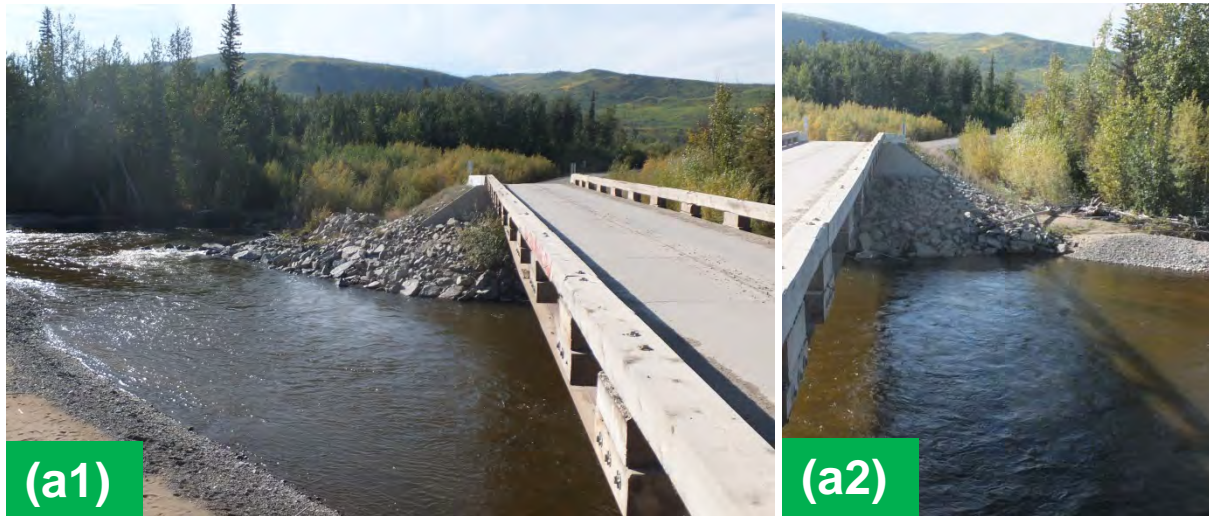
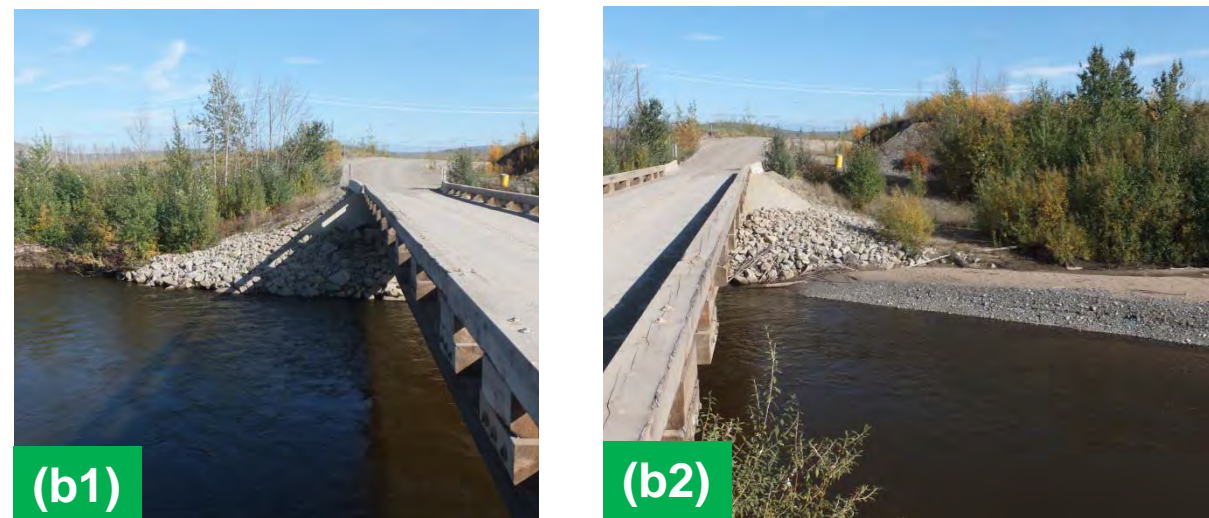
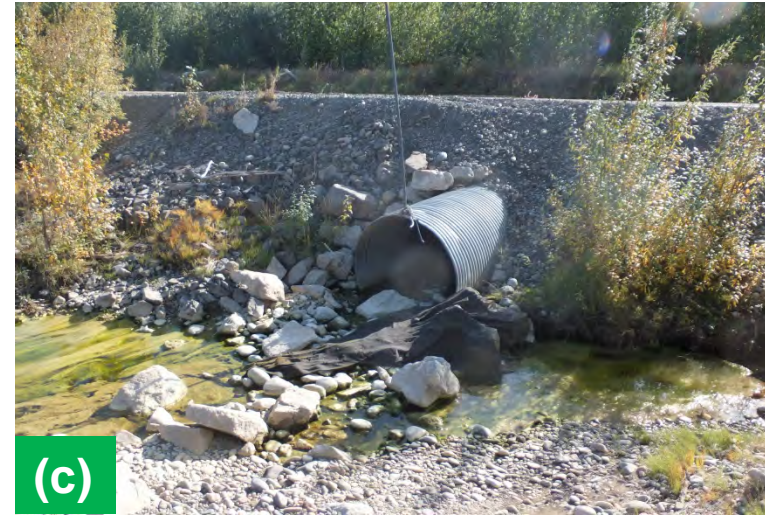
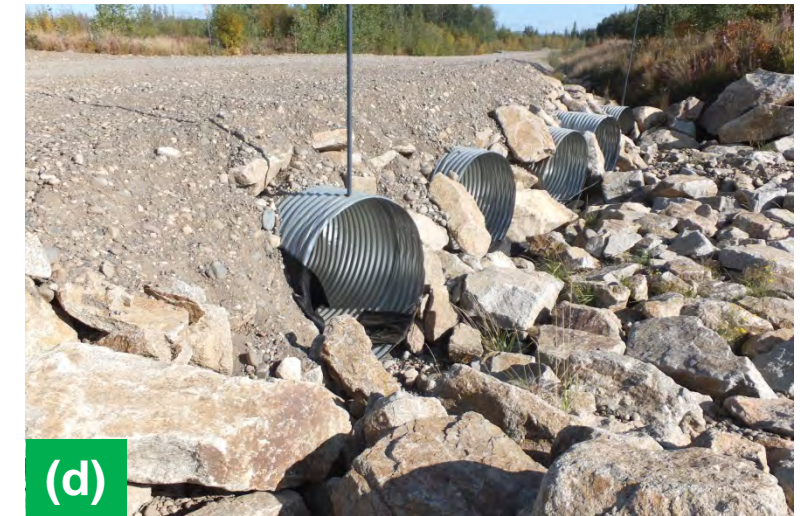
13 Big Creek Bridge

- Photos (a) and (b) show east and west abutments, respectively. The bridge abutments and road approaches are in good condition, no signs of instability were observed.

- Consistent with the 2012 inspection, Ditch Block #1 (closure berm) has not been constructed, Ditch Blocks #2 through #5 are in good condition.
- Ditch Block #5 was overtopped during the on the south side of the rock. No damage or erosion was observed as a result of the overtopping.

- The first culvert west of the bridge is in satisfactory condition. The north end of the culvert has been dented by a large rock. It appears that a compacted bedding layer has not been placed outside the culvert.

- Photo (d) shows 5 culverts, each with diameter of 1.1 m. The culverts are in satisfactory condition, with no blockages at either end.
- The downed power pole that was observed during the spring inspection has been repaired.

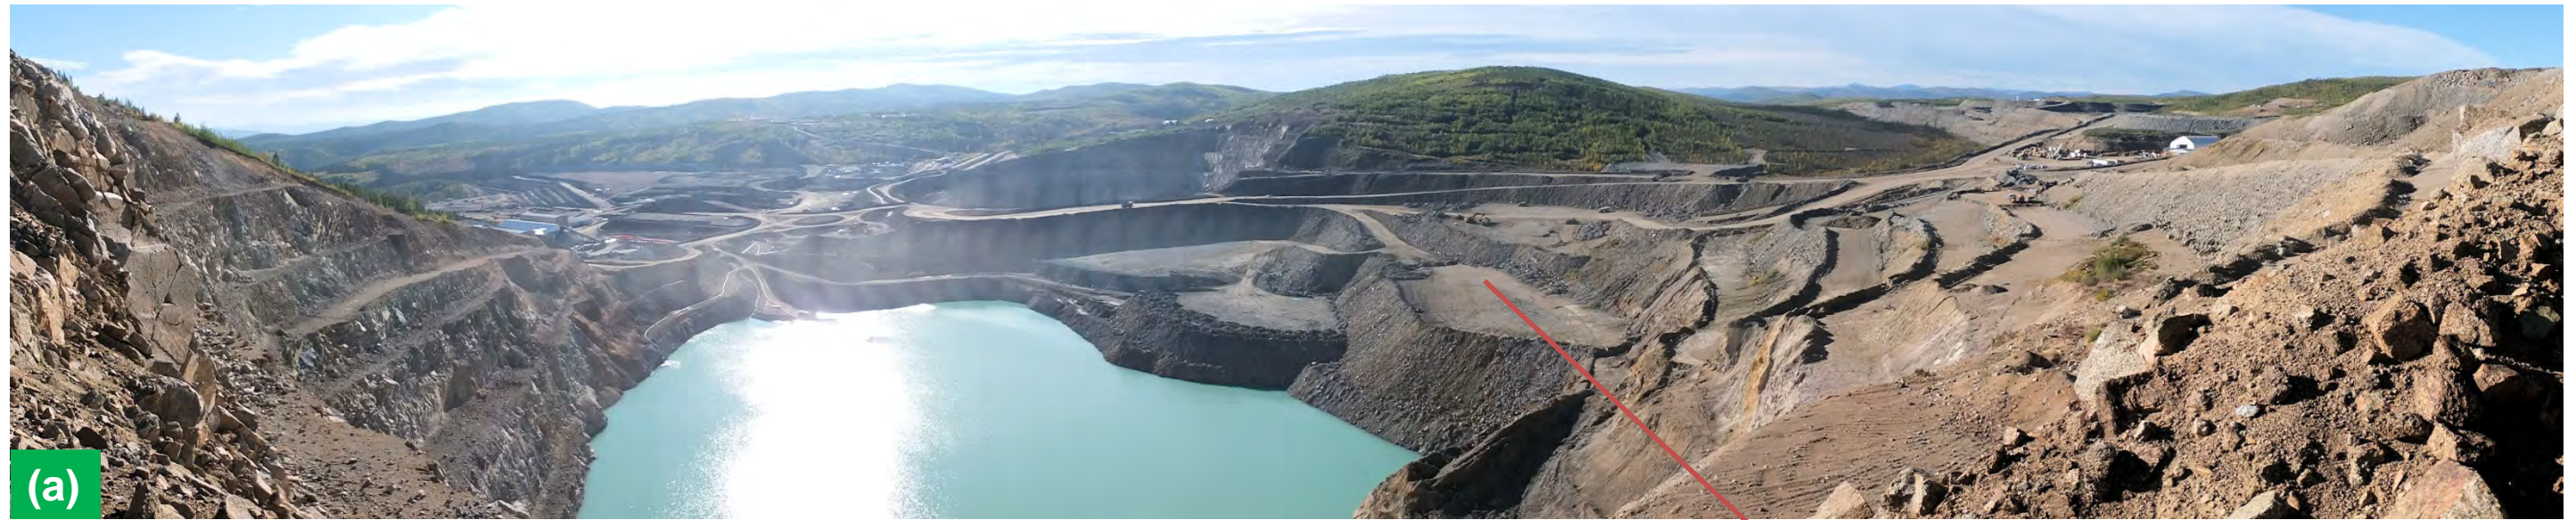
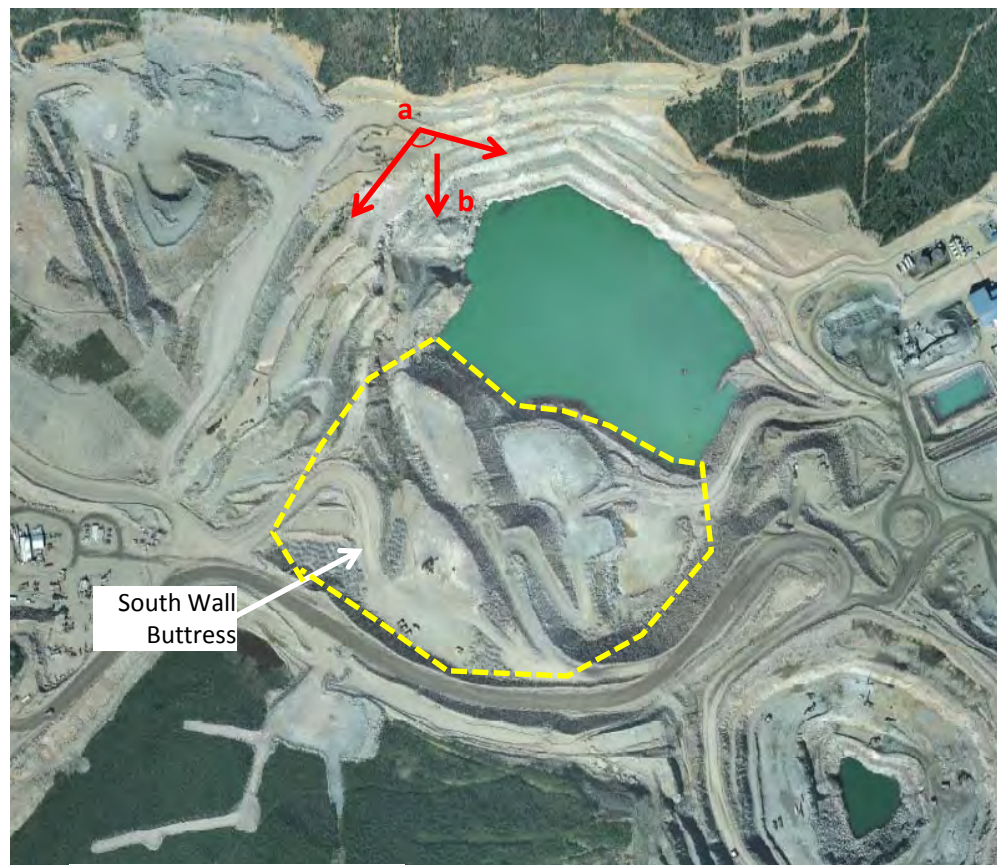
14 South Wall Buttress

- a) View of the Main Pit and South Wall Buttress taken from the north west corner of the pit.
- b) Close-up of a tension cracking present on the west end of a lower interim bench of the buttress. This area has been blocked off and is inaccessible to equipment.
 - At this time, the cause of the movement/instability is unclear.
 - Survey hubs along the perimeter rim indicate that movements of the south wall continue to slow and are generally less than 0.2 mm/day.
 - As this bench is placed over the slide debris from the south wall failure, the cracking may be due to settlement placed materials and/or slide material.

Extent of tension crack

- The tension crack area should be continue to be visually monitored. A photographic record should be maintained to inspect for changes in condition.
- Following completion of the buttress, additional survey hubs should be placed along the crest to monitor movement.
