# 2013 Freshet Geotechnical Site Inspection, Minto Mine, YT

SRK Consulting (Canada) Inc.  
1CM002.012.005  
July 2013

Project No: 1CM002.012.005

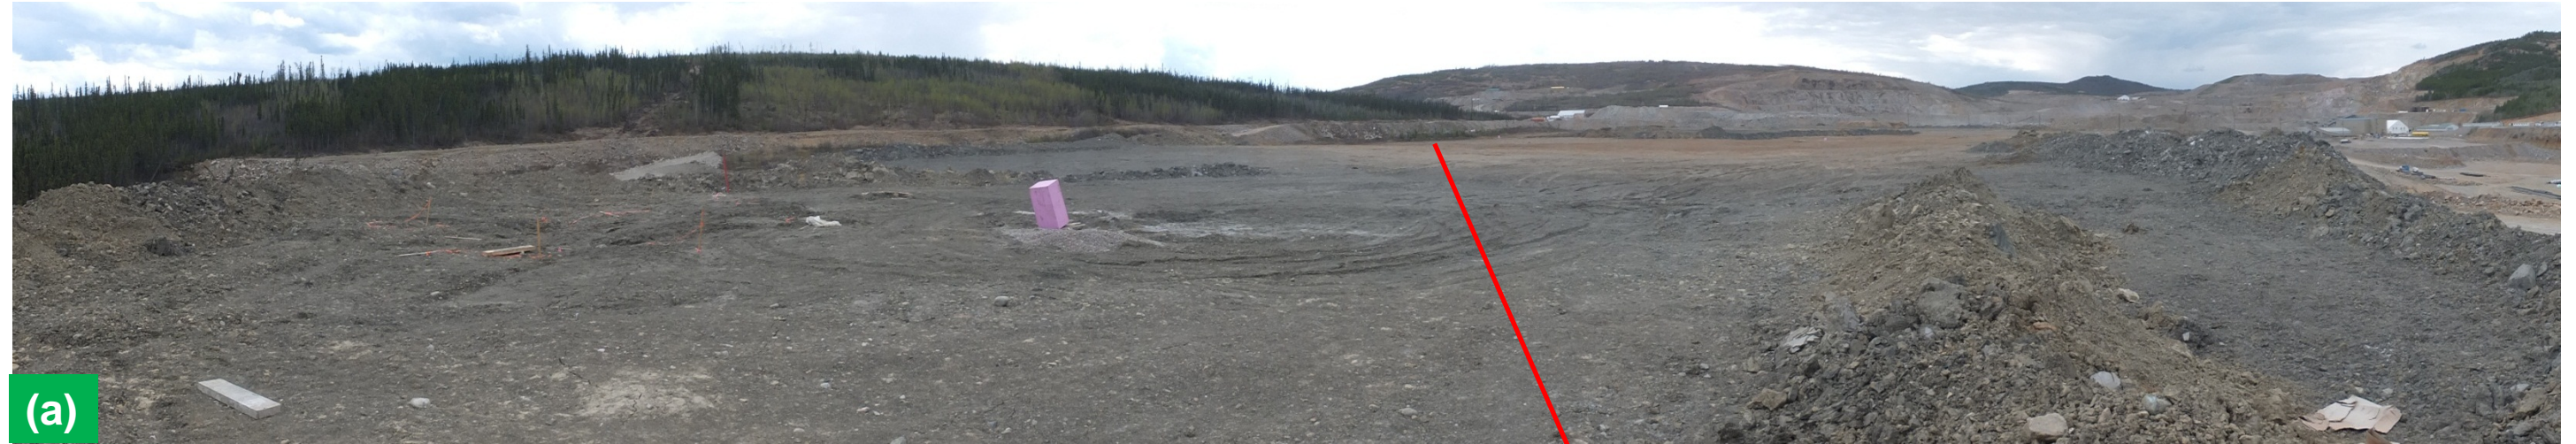
(a) Dry Stack Tailings Storage Facility surface from north east corner.

- Since the last inspection, approximately 2 m overburden has been placed over the entire tailings surface. It is understood that this is a temporary cover that was designed to have a 2% grade.
- In general, there are a significant amount of thaw bulbs, surface cracking and differential settlement of the material, which can be expected as the overburden was placed during winter. It is recommended that the surface be regraded in the fall once the frozen material has thawed.
- The pink box near the center of the photo is a protective cover for a recently installed inclinometer.

- The recently placed overburden material was placed during winter and will likely experience differential settlement due to thawing of frozen materials over the summer. In the fall, the grading and surface water management of the surface of the facility should be reviewed and areas graded as required to promote runoff.
- The remaining areas of exposed tailings should be covered and the uphill area south of the DSTSF should be regraded as required to control surface drainage, avoid ponding, and limit infiltration of water into the tailings as per Clause 36 and 37 of the water license QZ96-006, Amendment 8.

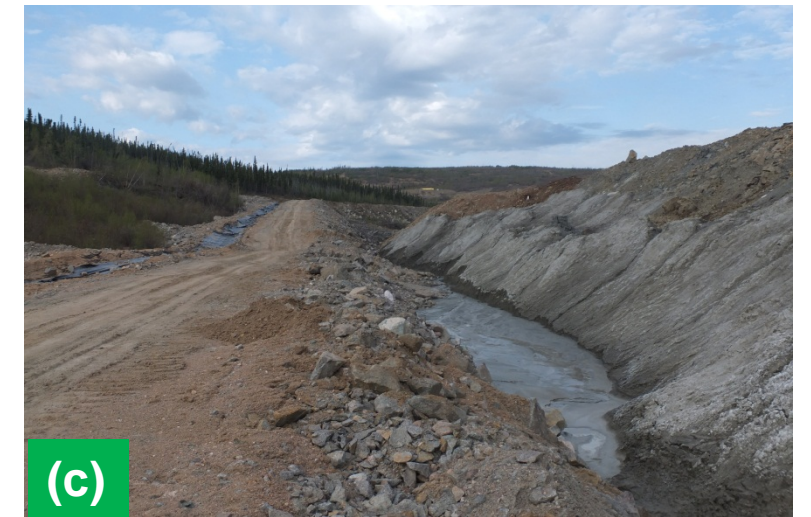
(c) Tailings remains exposed at surface on the south slope of the facility adjacent to the Tailings Diversion Ditch. Water was also observed to be impounded against the DSTSF on the south side of the facility at various locations as shown in photos (c) and (d). The water can be attributed to melting snow, recent precipitation and from water not captured by, or flowing under, the tailings diversion ditch. Seep locations and areas where the water was observed to flow beneath the tailings are noted on Figures 4 and 5.

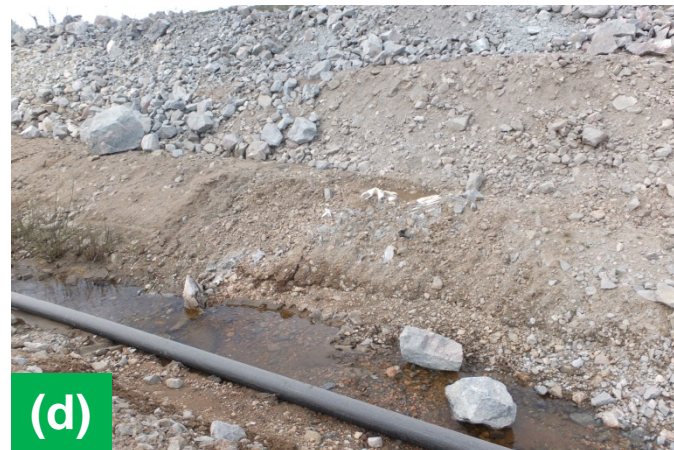
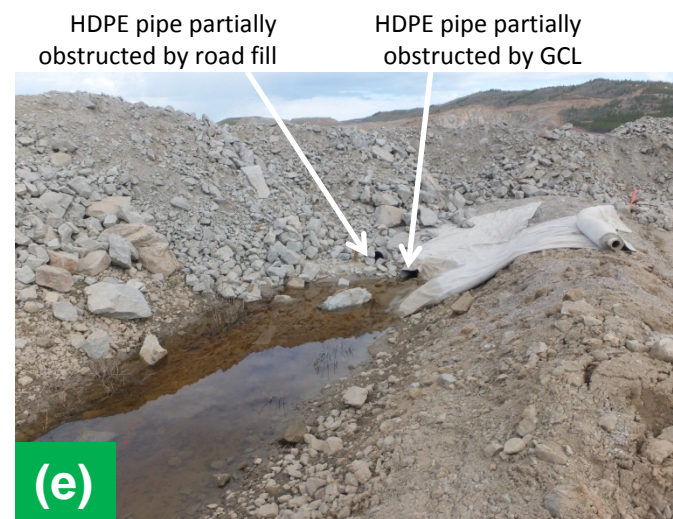
- The South Diversion Ditch was inspected between the areas shown in Photos (a) to (e) adjacent to the Airport Laydown area. The pipeline intake structure at the photo (e) location diverts water to the confluence area located near the Main Pit. The pipeline alignment was not inspected during the site visit.

- No signs of instability were noted along the side-slopes.
- The vegetation noted in the last inspection is still present, but less prevalent in the photos due to the time year.

- a) View of the inlet structure at the upstream end of the ditch. The Airport Access Road ditch can also be seen in the background.
- b) View from the inlet structure looking downstream. The impact of the road construction can be seen in the photo, the channel width has been significantly reduced in areas (from the design base width of 1.8m down to near 0.0 m.
- c) View looking upstream at the opposite of the channel restriction caused by road construction.
- d) Exposed liner the top of the SE near STA 0+600.
- e) View of the inlet structure to two 16” HDPE diversion pipes. Road construction has partially obstructed one of the HDPE pipes. GCL has been placed (exposed at surface) around the vicinity of the intake and is also partially obstructing the second HDPE pipeline.

- Ditch obstructions should be removed to increase flow to the design capacity. The noted obstructions include: road fill, vegetation, and GCL covering the HDPE pipe.
- The exposed liner should be covered as per the original channel design (EBA, 2007).
- The pipeline intake structure and an overflow spillway to the Area 2 open pit should be constructed as per the IFC design drawings provided in the SRK memorandum entitled “South Diversion Ditch Realignment and Overflow Spillway” dated February 1, 2013”.

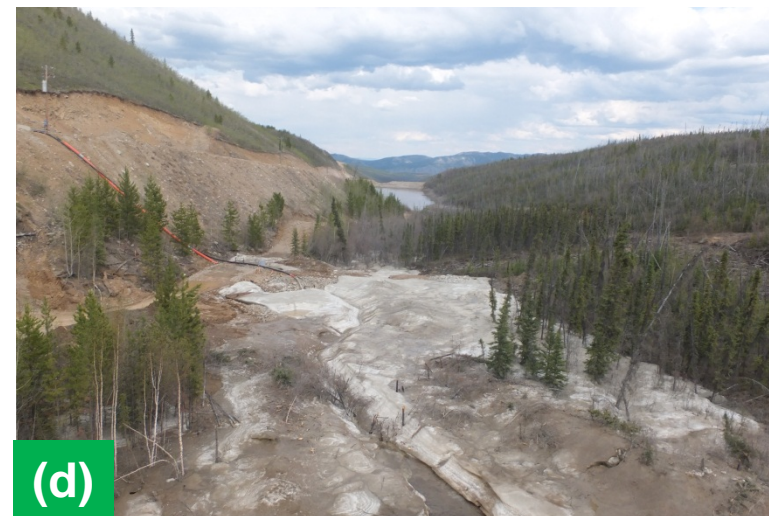
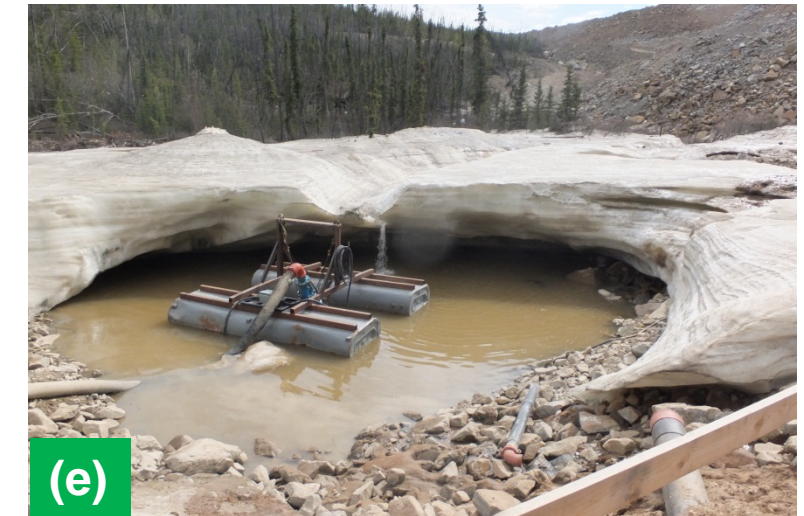
2013 Freshet Geotech Inspection		
		<b>Water Storage Pond Dam</b>		
Job No: 1CM002.012.05 Filename: Minto 2013 FreshetSite Inspection.pptx	Minto Mine	Date: June 2013	Approved: PHM	Figure: <b>18</b>

- Conditions of the dam are unchanged since the 2012 Geotechnical Annual Review issued by SRK in Nov. 2012. The WSP water level is significantly lower than the last inspection and is was estimated to be approximately 711m.

- View of the downstream slope and spillway. Three 200 mm diameter siphon pipelines are present in the spillway that run from the WSP to the pump house. No signs of instability, settlement or erosion were observed on the downstream slopes or abutment areas.

- View of the stilling basin upstream of the seepage pump house.
    - The seepage water was clear with no turbidity. No accumulation of sediments were observed.

- Continue regular monitoring of the dam, noting specifically the clarity of the seepage and flow exiting the stilling basin, and the seepage rate through the weir.
- A review of the seepage pump data and the flow rates measured at W-3 in the seepage pump house indicates that the pump data is influenced by discharge from other sources (the pit, water treatment plant, etc.). Options to obtain accurate seepage measurements should be reviewed. One solution would be to move the discharge point of water a minimum of 20 m down stream of the sump. The issue should be resolved prior to 2014 spring melt
- The OMS manual should be reviewed and updated.

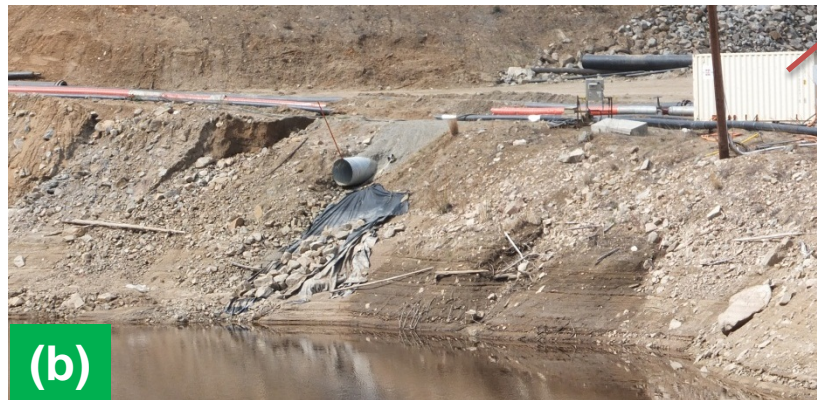
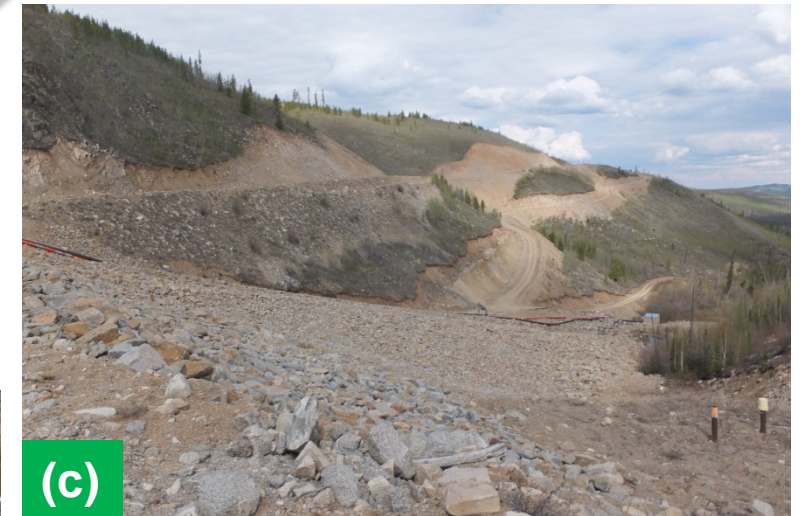
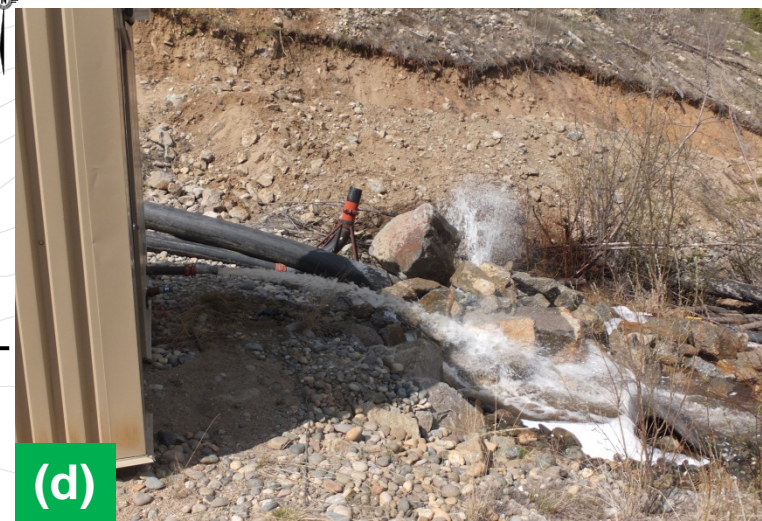
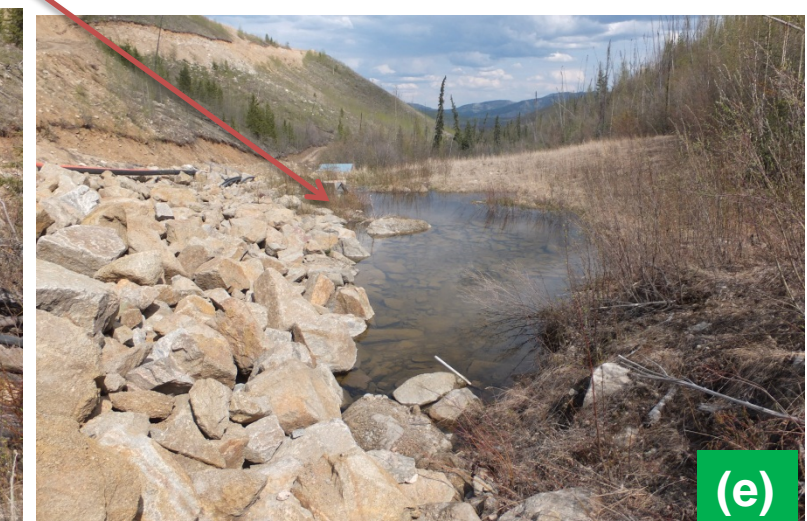
2013 Freshet Geotech Inspection		
		<b>Water Storage Pond Dam</b>		
Job No: 1CM002.012.05 Filename: Minto 2013 FreshetSite Inspection.pptx	Minto Mine	Date: June 2013	Approved: PHM	Figure: 19

- View of the ponded seepage water at the downstream toe of the dam.
    - Condition of the seepage water appears unchanged compared to the 2012 inspection.

- Water flow could not be heard in the rockfill adjacent to the seep.
    - The water was clear with no turbidity. Rocks in the pond contain a thin coating of fine rusty-brown sediments. The sediments are thought to be due flushing of weathered rip-rap from local run-off on the downstream toe during a high precipitation on May 12, 2013. See report for further discussion.

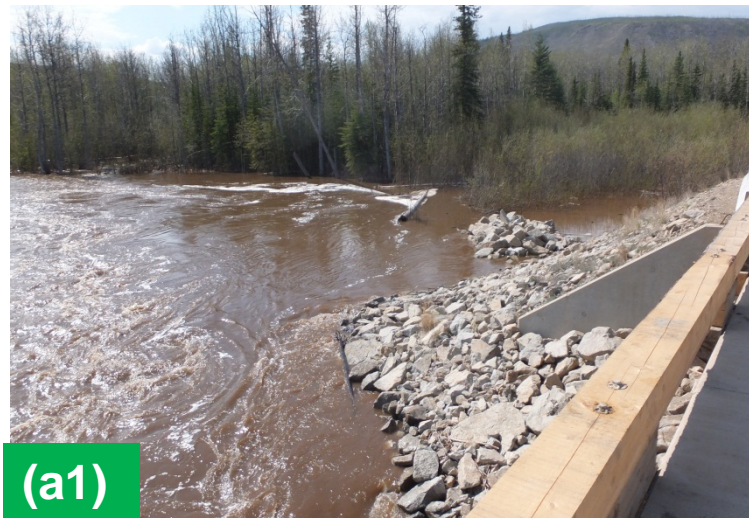
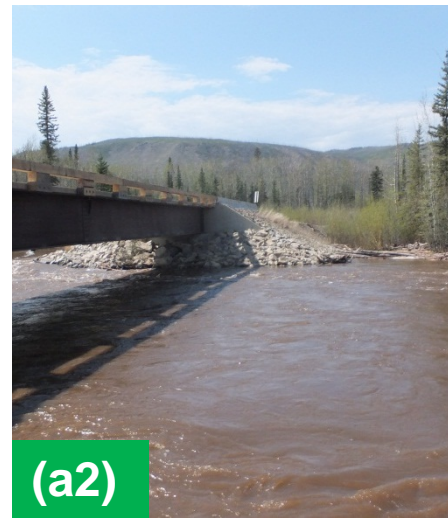
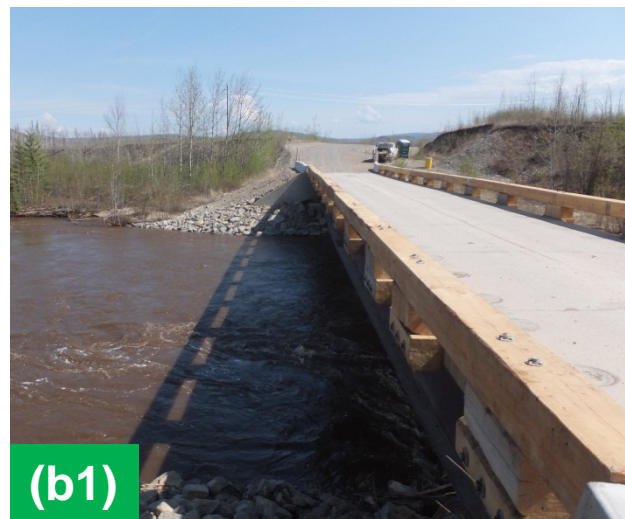
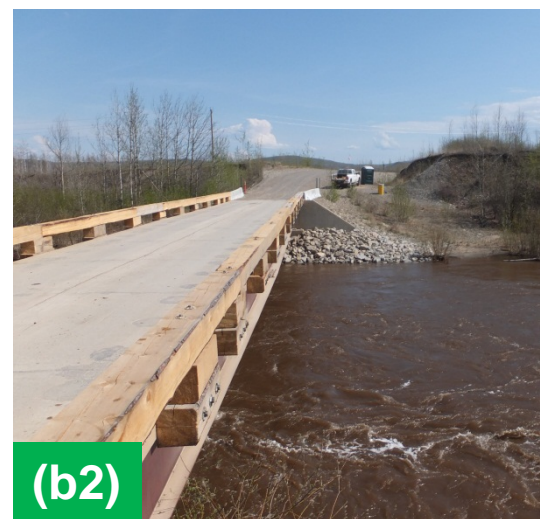
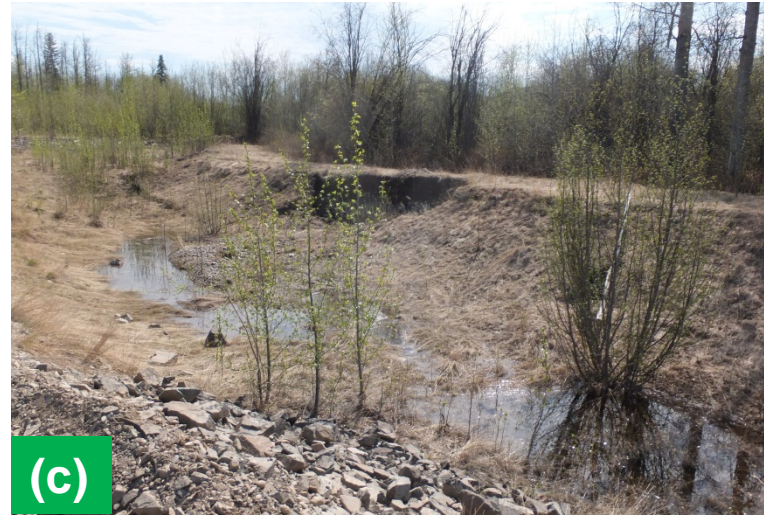
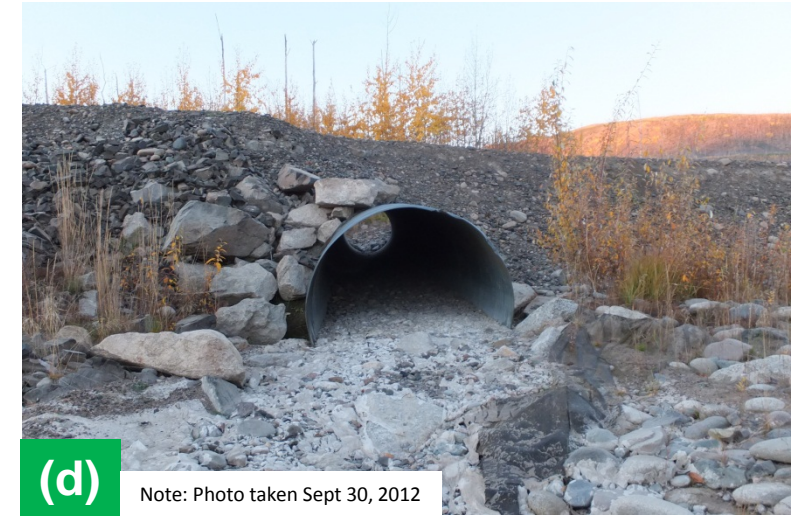
- Photos (a) and (b) show east and west abutments, respectively. The creek water level was high and turbid. The bridge abutments and road approaches are in good condition, no signs of instability were observed.

- Consistent with the 2011 inspection, Ditch Block #1 (closure berm) has not been constructed, Ditch Blocks #2 through #4 are in good condition.
- Ditch Block #5 has overtopped during the on the south side of the rock.

- The first culvert west of the bridge is in satisfactory condition. The culvert was half submerged with water and sediment accumulation was unable to be observed. The north end of the culvert has been dented by a large rock. It appears that a compacted bedding layer has not been placed outside the culvert.

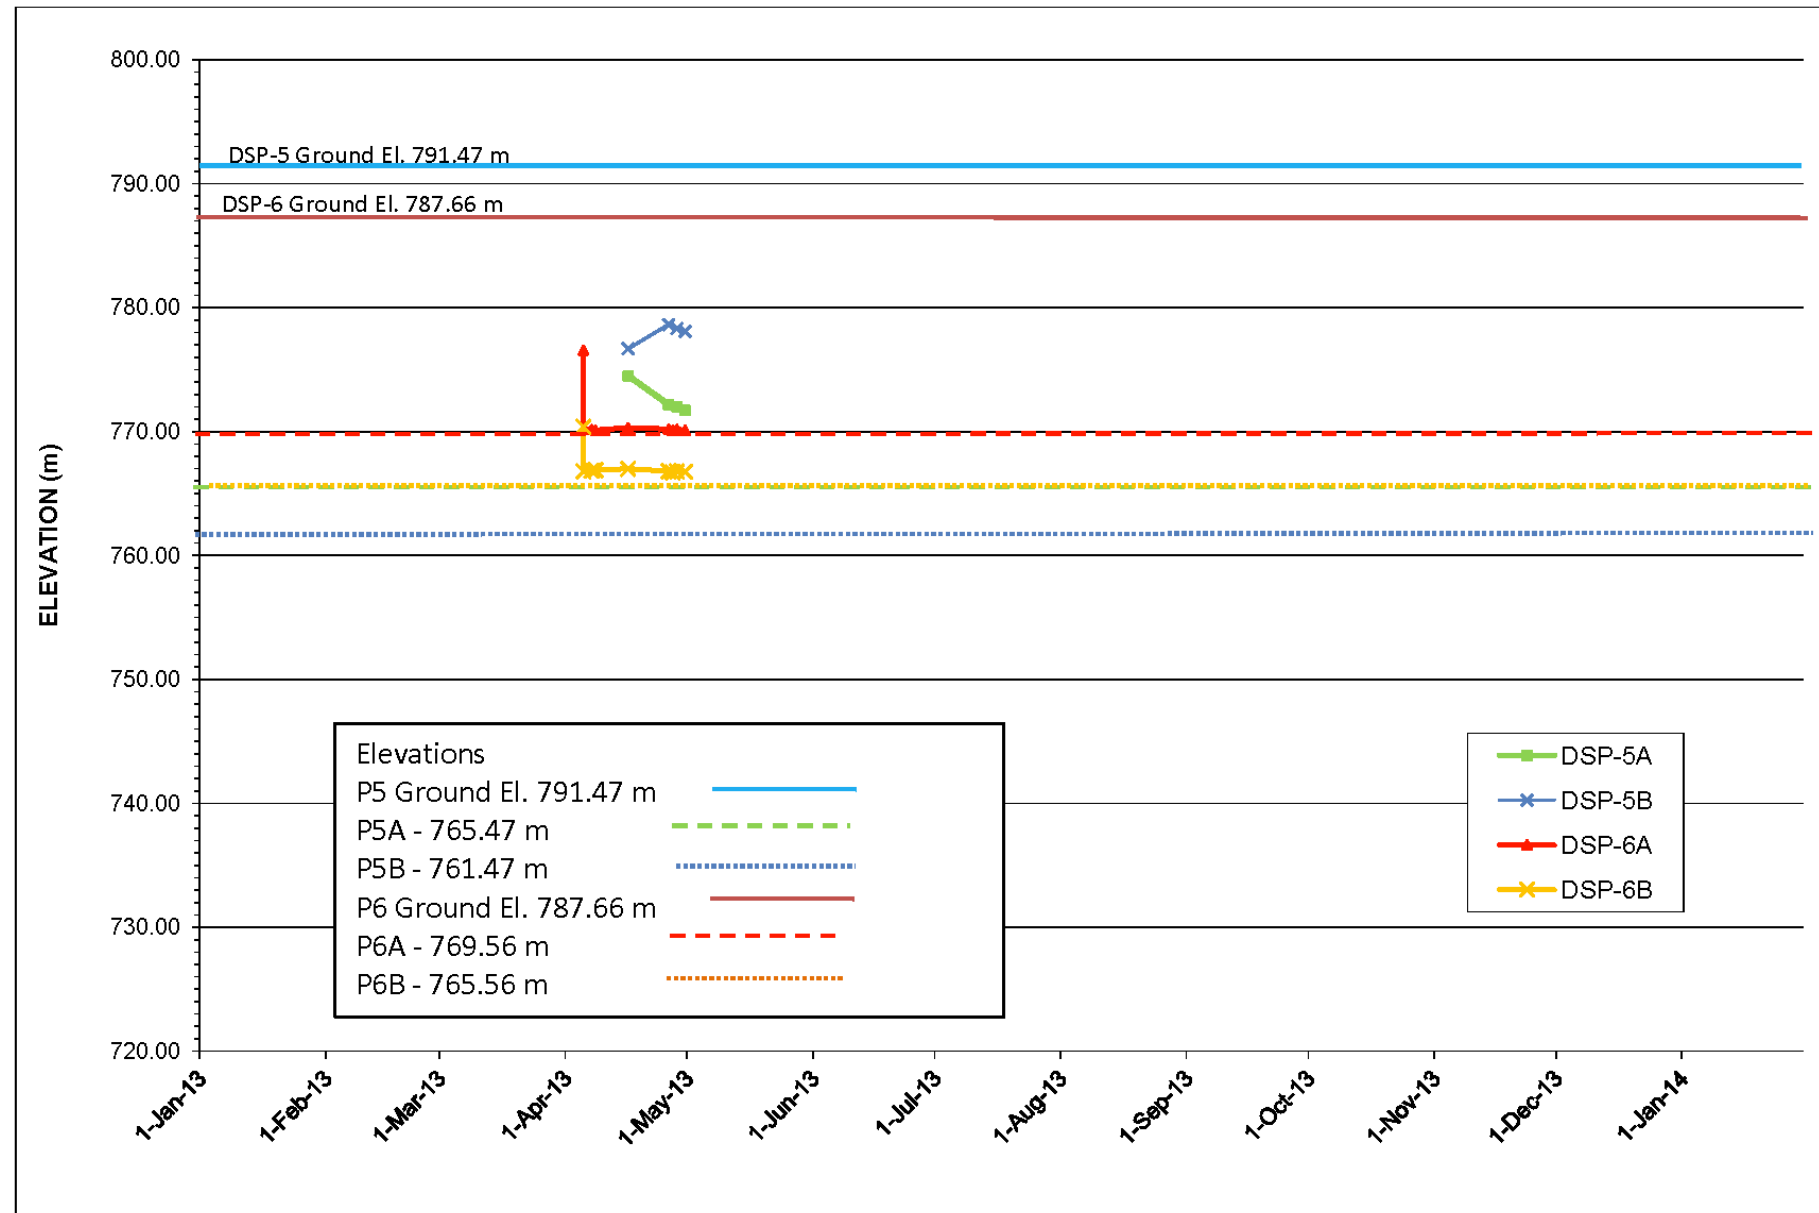
**Dry Stack Tailings Storage Facility  
Instrument Water Elevation - DSP-5A, DSP-5B, DSP-6A, DSP-6B**

- Water elevations may not be accurate. The piezometer sensors are thought to be located in frozen soil, and accurate barometric pressures were not available at the time of reading.
- DSP-5 sensors are installed in the same borehole as the DST-14 ground temperature cable provided in Figure 2.
- DSP-5 piezometer sensors are installed in the same borehole as the DST-11 ground temperature cable provided in Figure 1.

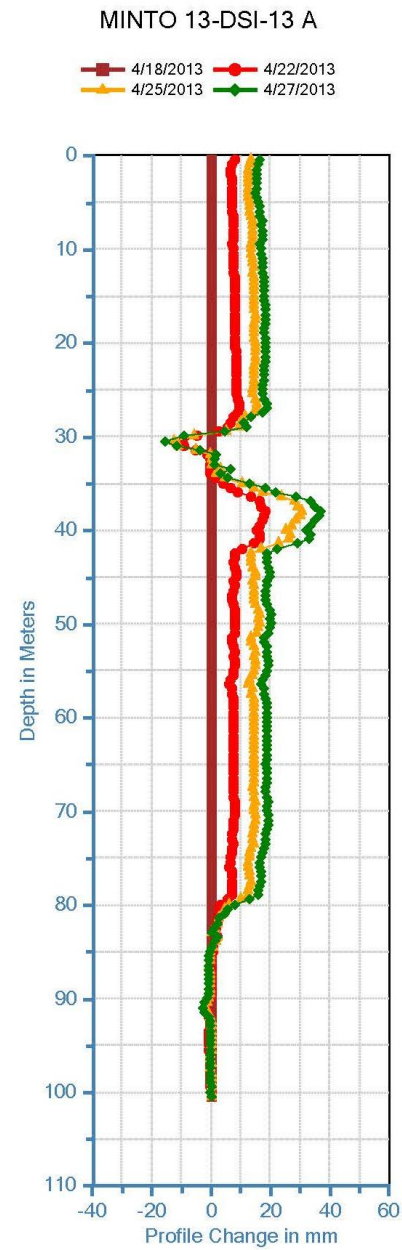
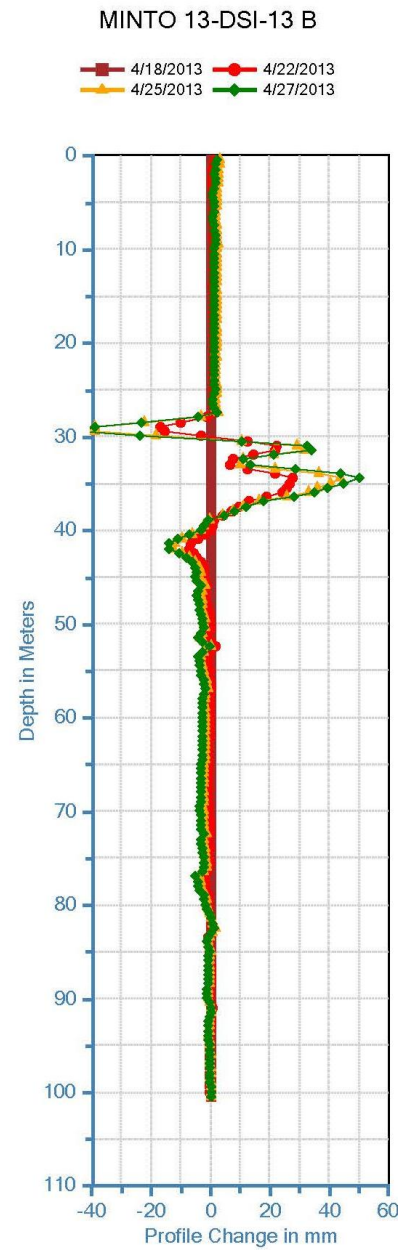
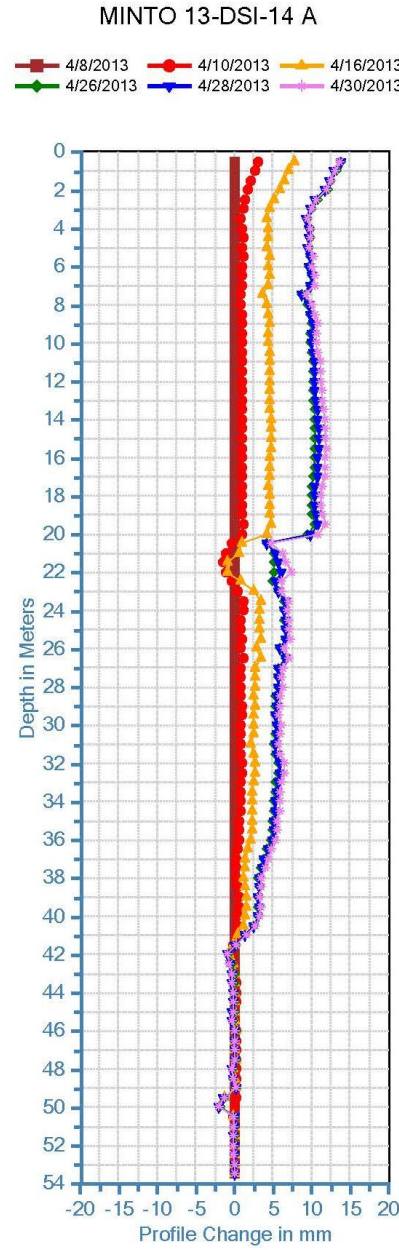
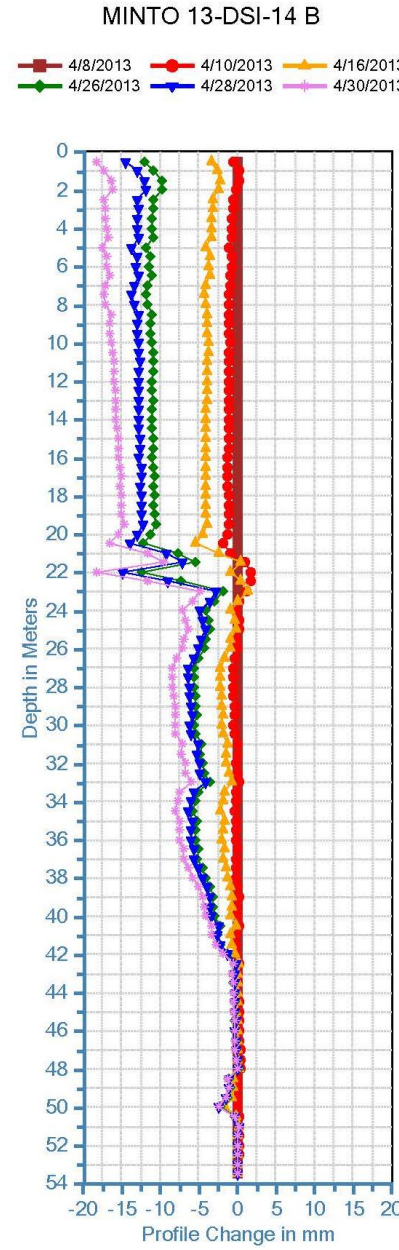
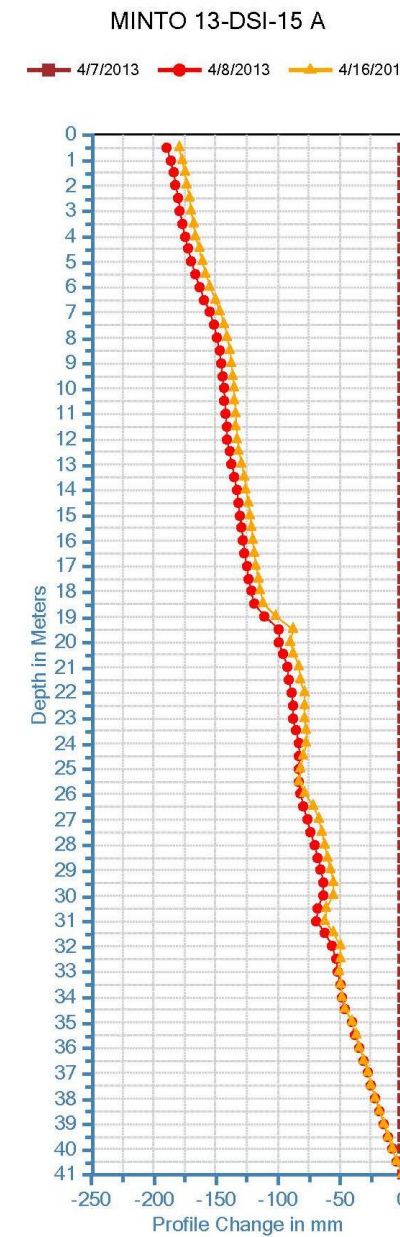
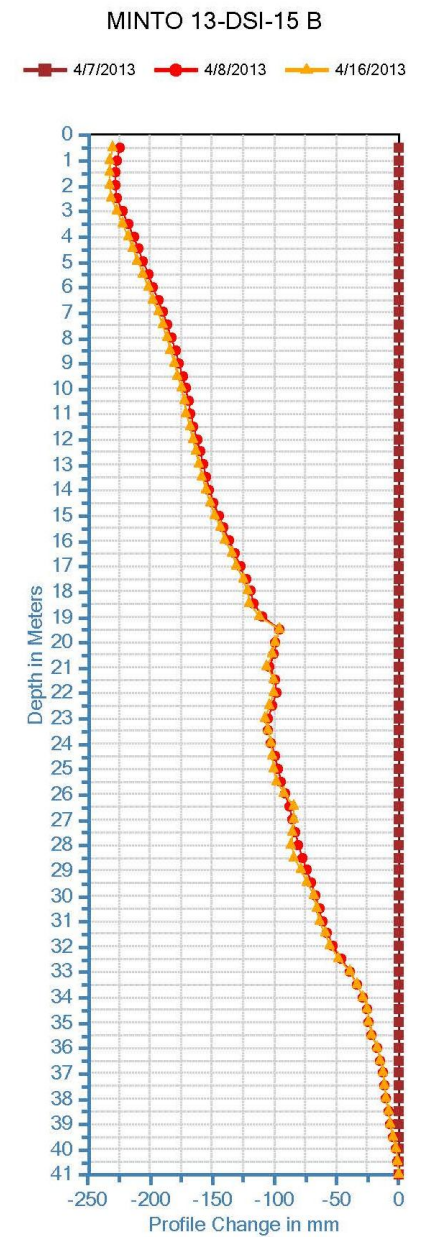
Notes: April 7, 2013 data is erroneous.  
Inclinometer probe got stuck in hole at a depth of 23 m on April 23 with no readings taken since.

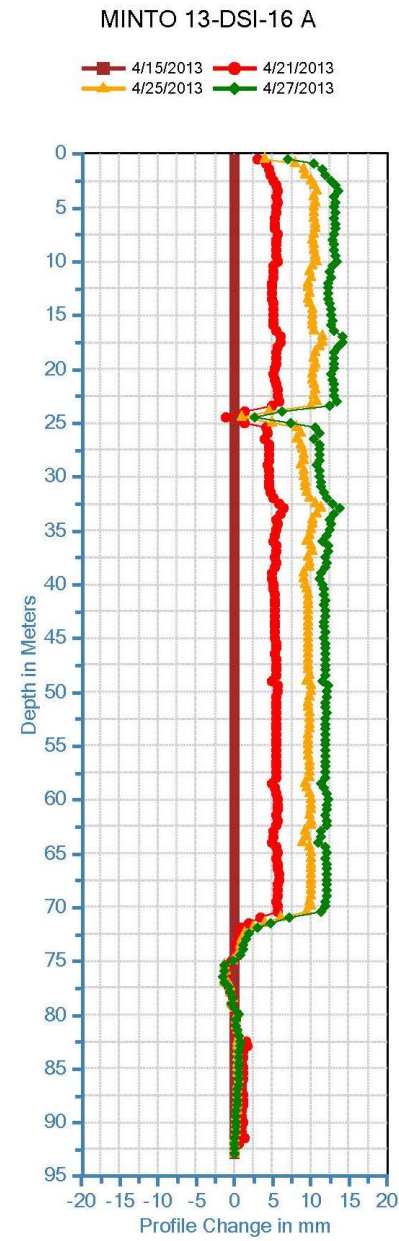
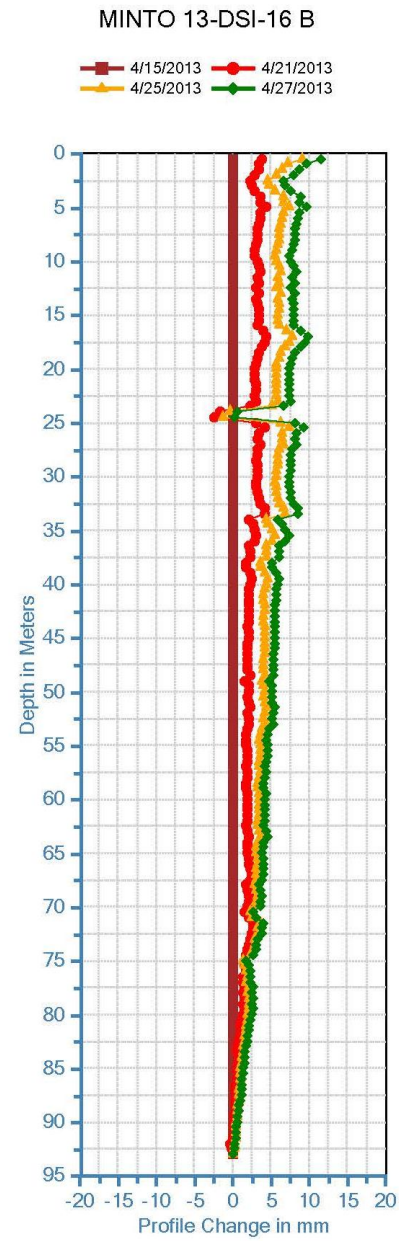
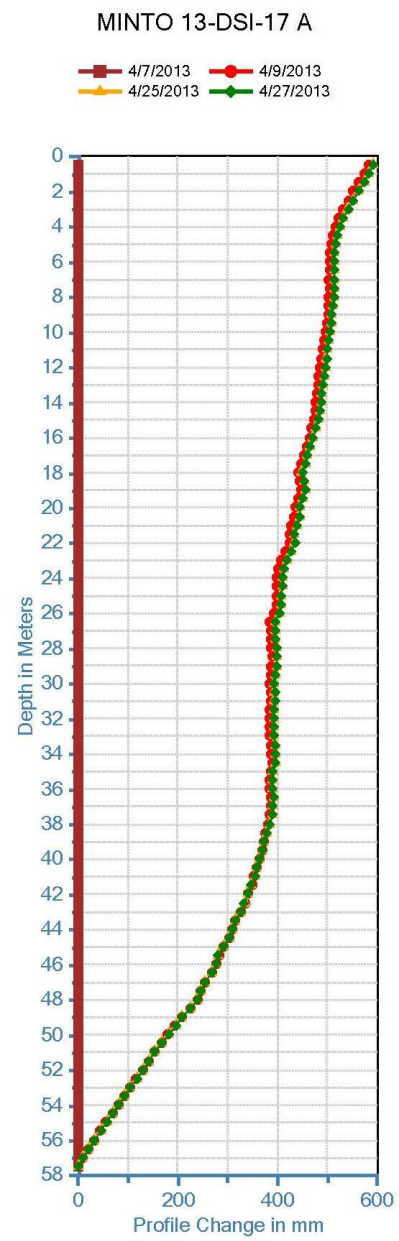
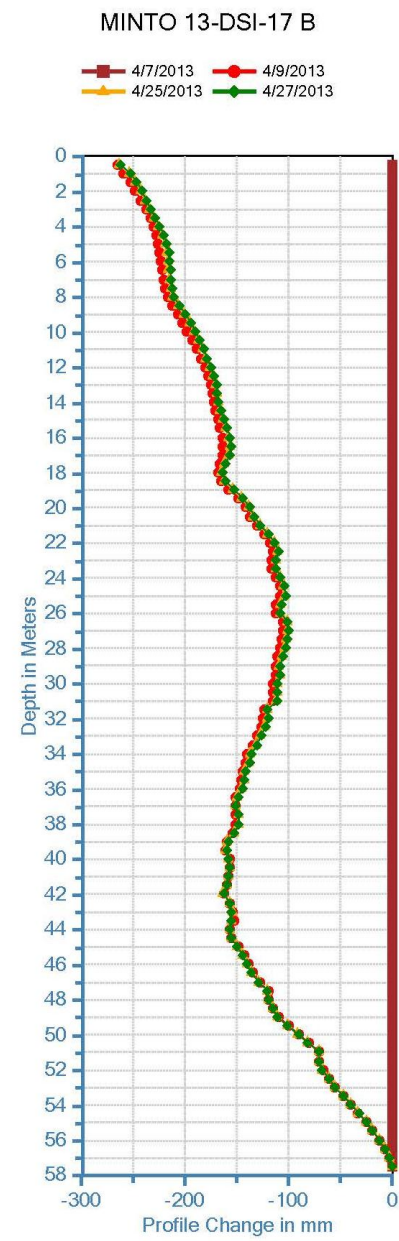
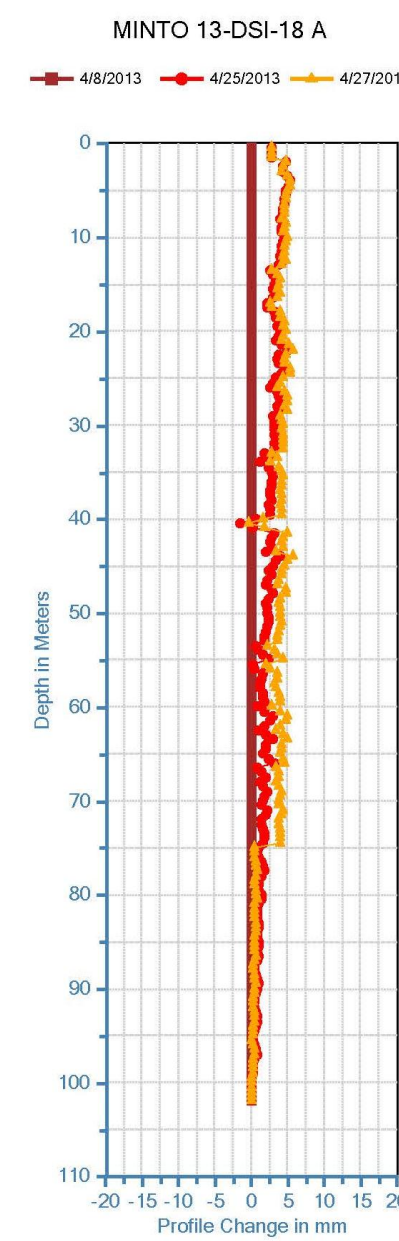
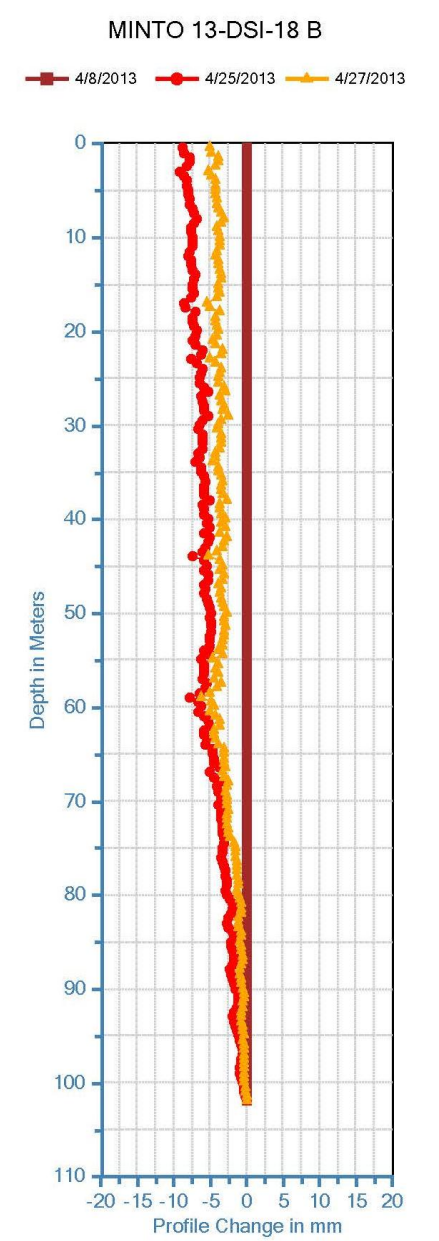
**DSTSF Inclinometers (1 of 3)**

Note: April 7, 2013 data is erroneous

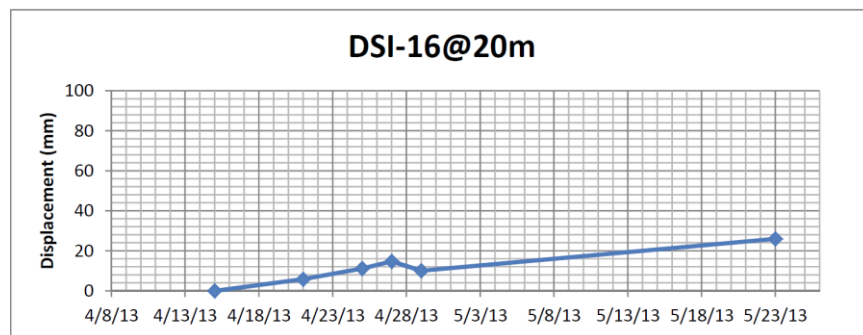
Average velocity: 0.6 mm/day

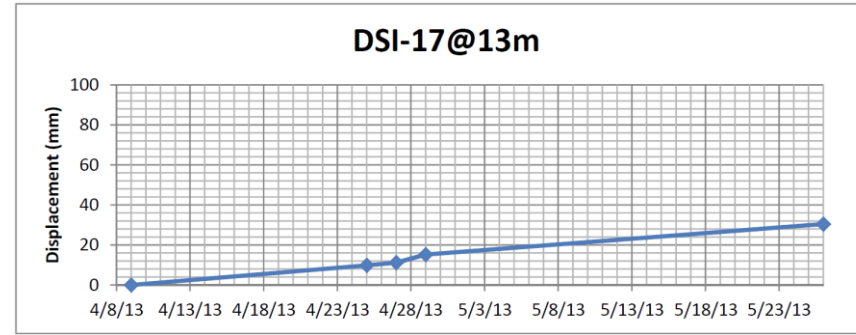
Average velocity: 0.5 mm/day

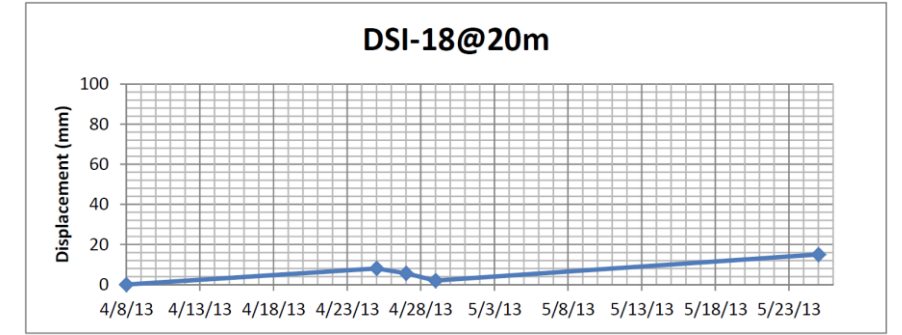
Average velocity: 0.2 mm/day

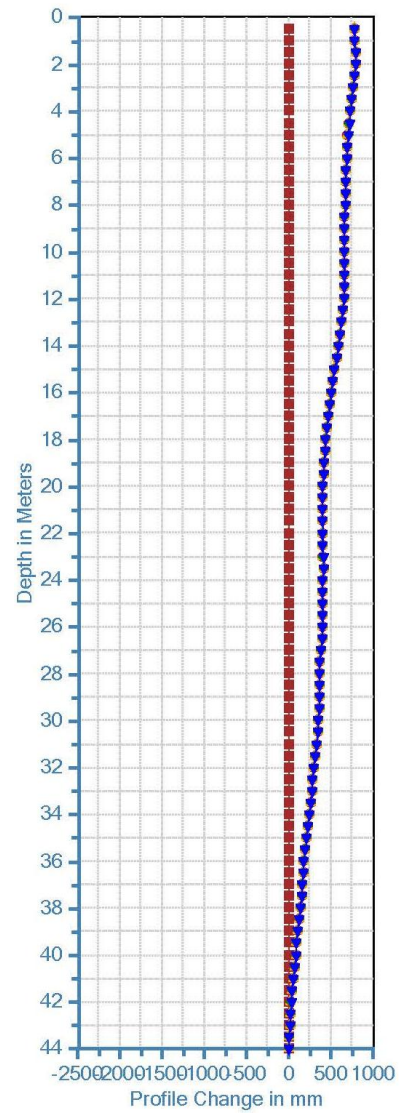
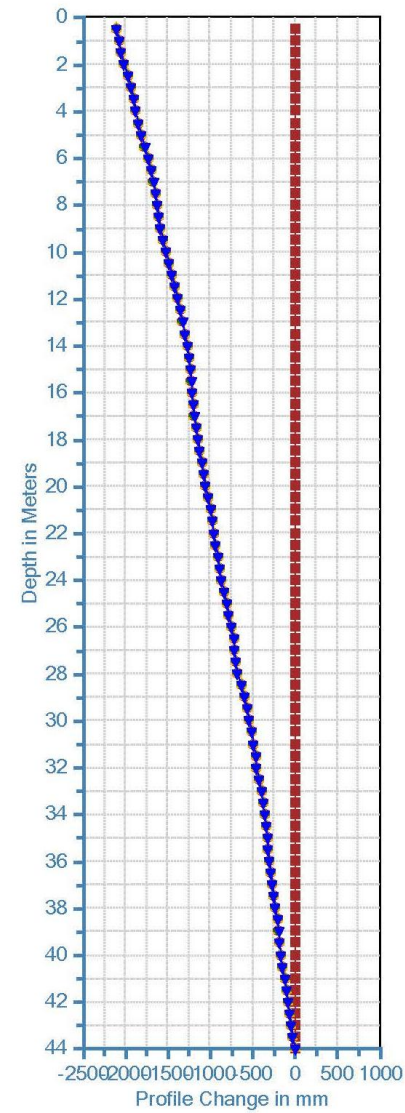
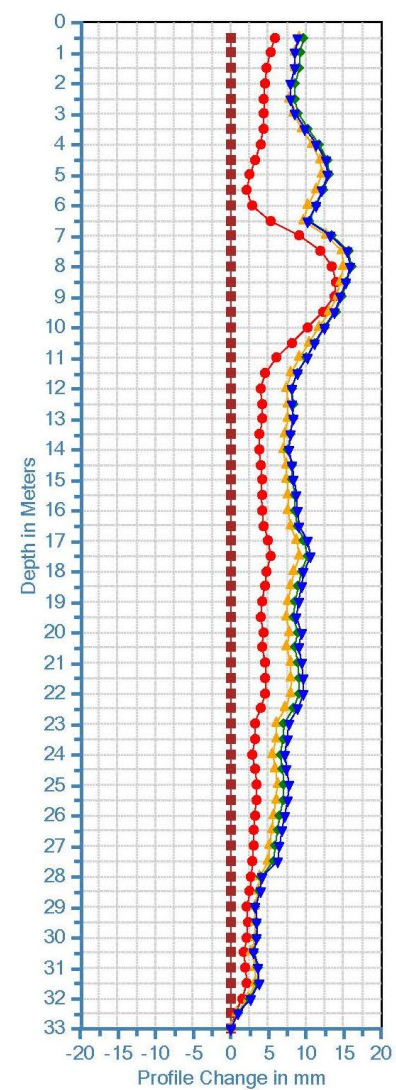
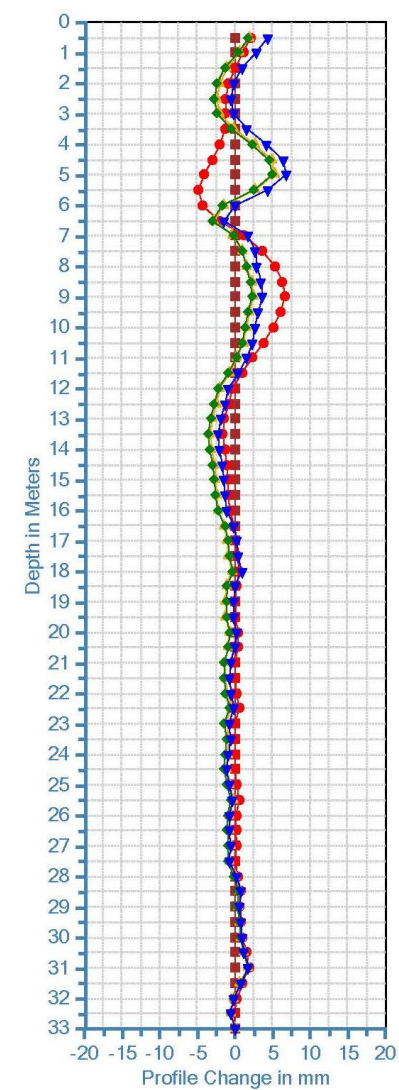
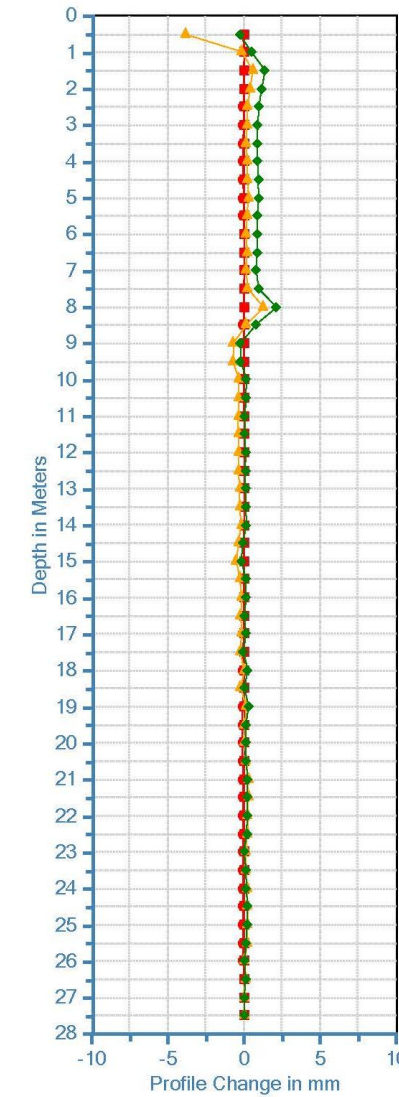
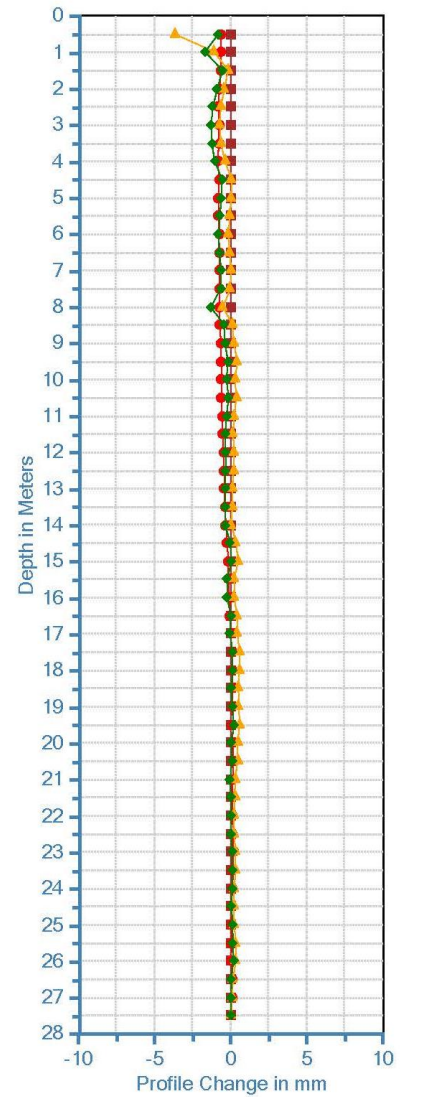
Figure: **5**

Note: April 30, 2013 data is erroneous

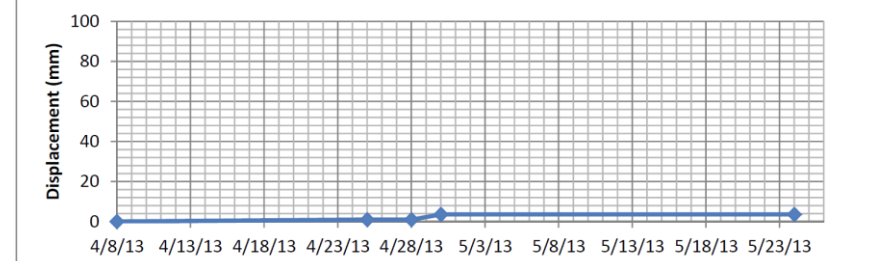
DSI-19@5m

Average velocity: 0.1 mm/day

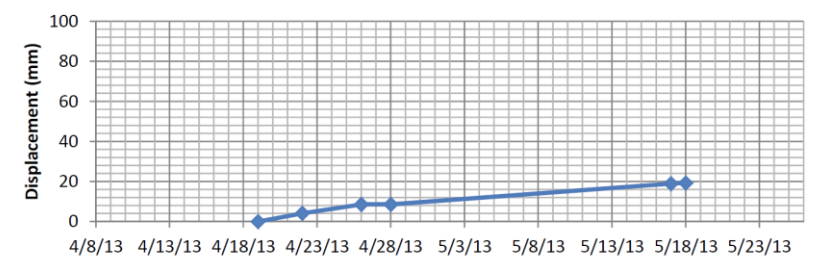
DSI-20@15m

Average velocity: 0.6 mm/day

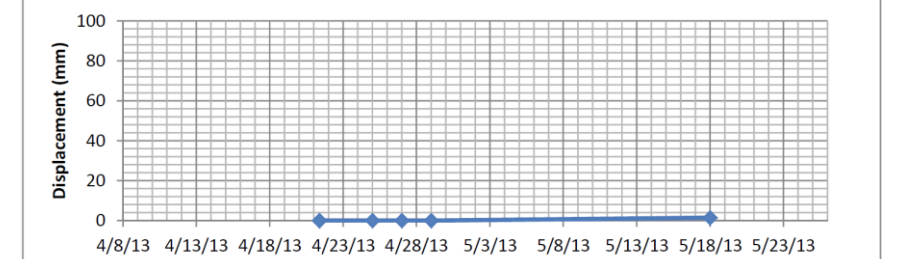
DSI-21@10m

Average velocity: 0.0 mm/day
