2014 Geotechnical Annual Review, Minto Mine, YT

SRK Consulting (Canada) Inc.
1CM002.028
November 2014

Fall 2014 Geotech Inspection		
		Dry Stack Tailings Storage Facility		
Job No: 1CM002.012.028 Filename: Minto 2014 Fall Inspection.pptx	Minto Mine	Date: November 2014	Approved: PHM	Figure: 2

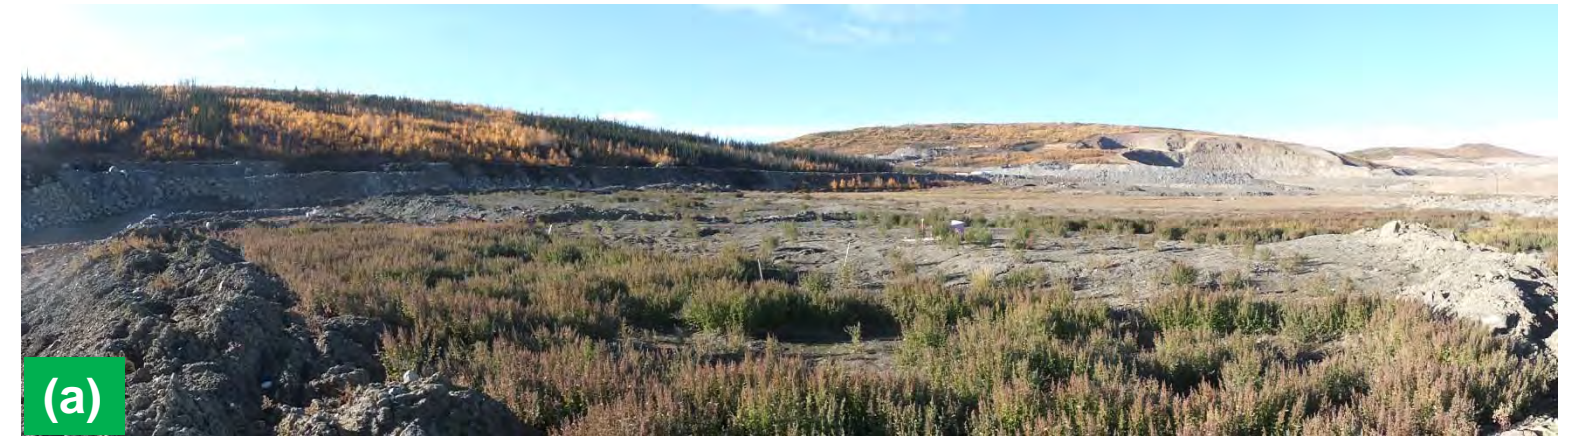
- Photo (a) shows the cover surface from the north east corner.
- Photo (b) shows the cover in the western portion of the DSTSF. There is considerably less vegetation established in the area.
- Photo (c) shows the south edge of the DSTSF where tailings remain exposed at surface on the south slope of the facility adjacent to the Tailings Diversion Ditch. Water was observed to be impounded against the DSTSF on the south side of the facility at various locations. Seep locations and areas where the water was observed to flow beneath the tailings. The water can be attributed to melting snow, recent precipitation and from water not captured by, or flowing under, the Tailings Diversion Ditch.
- Photo (d) shows survey hub DSSH 25, which is experiencing frost heave with approximately 30 cm of cement exposed at its base.

- The remaining areas of exposed tailings should be covered and the uphill area south of the DSTSF should be regraded as required to control surface drainage, avoid ponding, and limit infiltration of water into the tailings as per Clause 36 and 37 of the water license QZ96-006, Amendment 8.
- The condition of all survey hubs on site should be reviewed. Hubs experiencing frost heave should be noted and replaced with hubs that are not susceptible to frost heave.

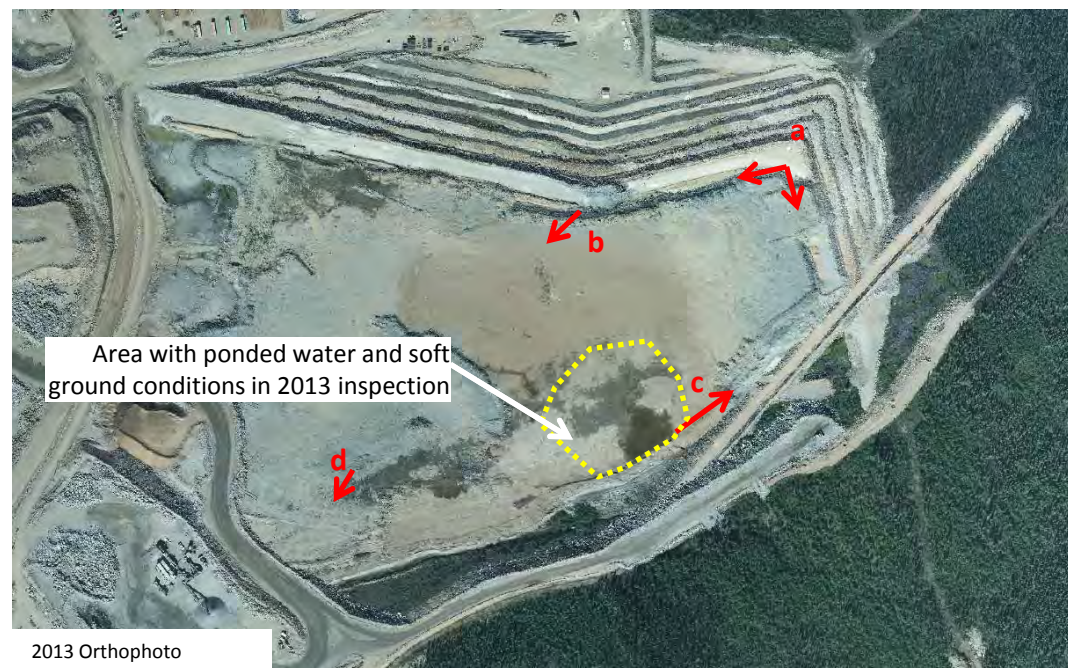
- Approximately 2 to 4 meters of overburden was placed over the tailings as a temporary cover during the winter of 2012-13. The cover was designed with 2% grade to drain to the north.
- There are a significant number of thaw bulbs, surface cracking and differential settlement throughout the cover, which can be expected due to the winter placement of the cover materials.
- Since the last SRK inspection in 2013, significant vegetation growth has occurred in the north east corner of the DSTSF, and the cover is significantly drier. The area that was noted to have soft ground conditions and was unwalkable during the 2013 inspection (noted in the plan below) was able to be walked over during this years inspection.

Area with ponded water and soft ground conditions in 2013 inspection

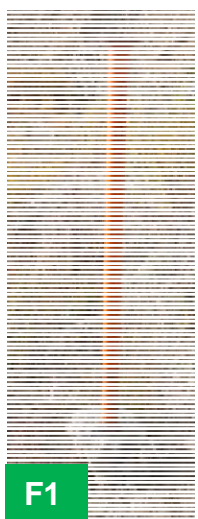
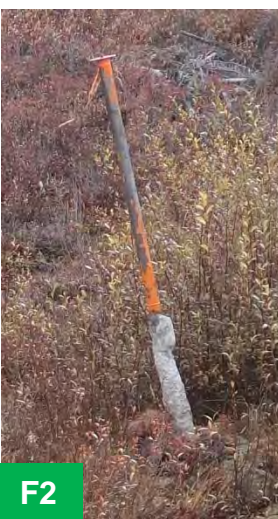
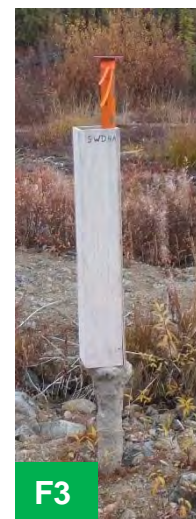
- f) Photos (f1) to (f4) show survey hubs SWD01A, SWD03A, SWD04A and SWD05A. Each are experiencing frost heave as evidenced by the exposed concrete. The length of concrete exposed are: 30 cm, 75 cm, 55 cm, and 90 cm, respectively.

- The tension crack area should be regraded to lessen the dump slope if the north access ramp is to be activated. Regrading of this area is planned as part of the upcoming regrading of the SWD.
- The survey hubs at the toe of the dump should be replaced and installed using a different methodology that will mitigate against frost heave.
- Continue to monitor erosion at the culvert outlet and sediment accumulation within the culvert and maintain a photographic record to inspect for changes in condition.

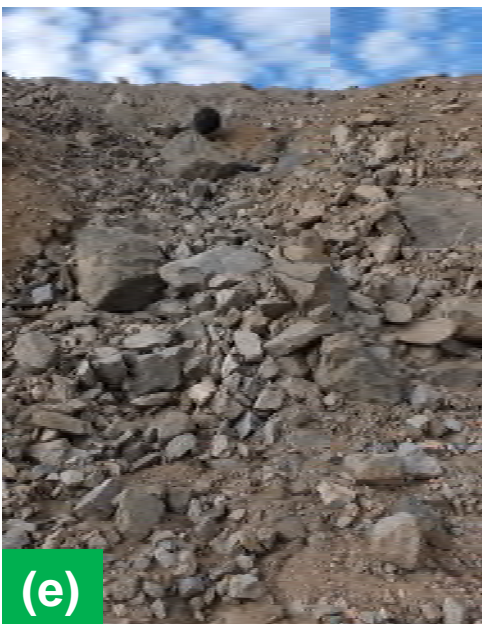
(e)

- e) View of the outlet of the culvert at the NE corner of the dump and east of the Pelly Laydown area. Large diameter boulders have been placed on the slope below the culvert to mitigate erosion. The appearance of the boulders are unchanged compared to previous photos taken in 2012 and 2013. Sediment is accumulating inside of the culvert, with some cobbles present with diameters up to 8 inches observed. No change was observed compared to the 2013 inspection.

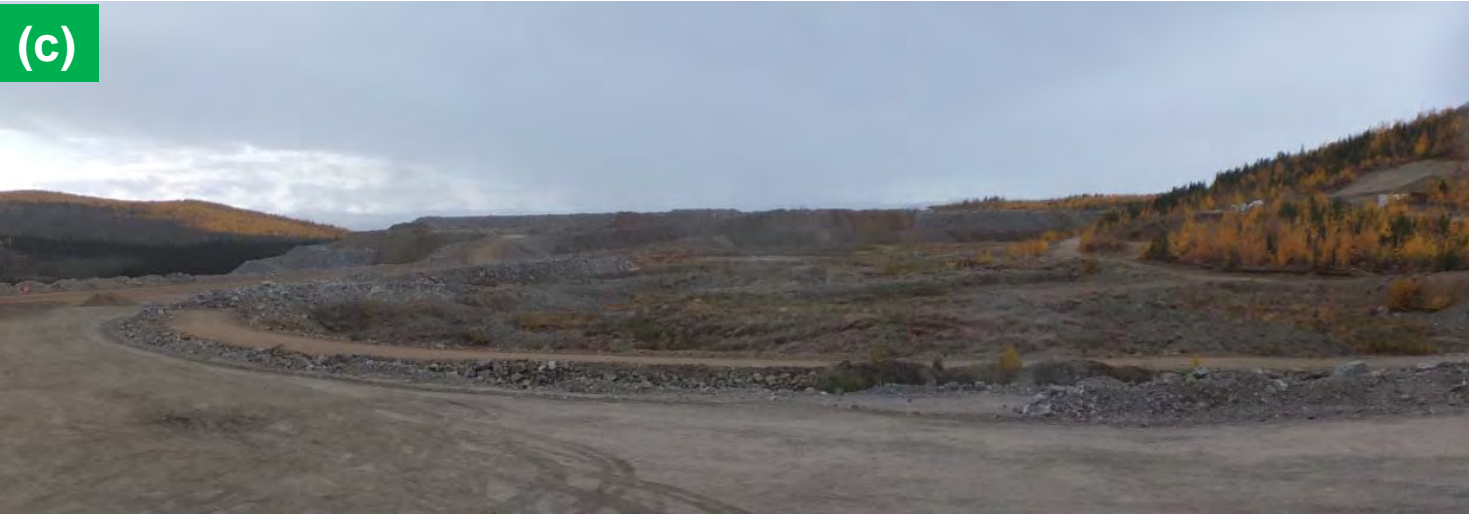
Fall 2014 Geotech Inspection		
		Reclamation and Ice Rich Overburden Dumps		
Job No: 1CM002.012.028 Filename: Minto 2014 Fall Inspection.pptx	Minto Mine	Date: November 2014	Approved: PHM	Figure: 7

- A containment berm constructed of coarse waste rock is present on the north, east and south sides of the dump.
- Since the previous years' inspection, additional waste rock has been placed outside of the berm up to the crest elevation as part of the Southwest Waste Dump Expansion (Zero and Low Grade Waste).
- Photo (c) shows the waste material that has now encapsulating the berm.
- No signs of instability were observed along the containment berm.
- No pooled water was observed against the berm indicating that water inside of the berm is still able to drain through the berm as per the original design intent.

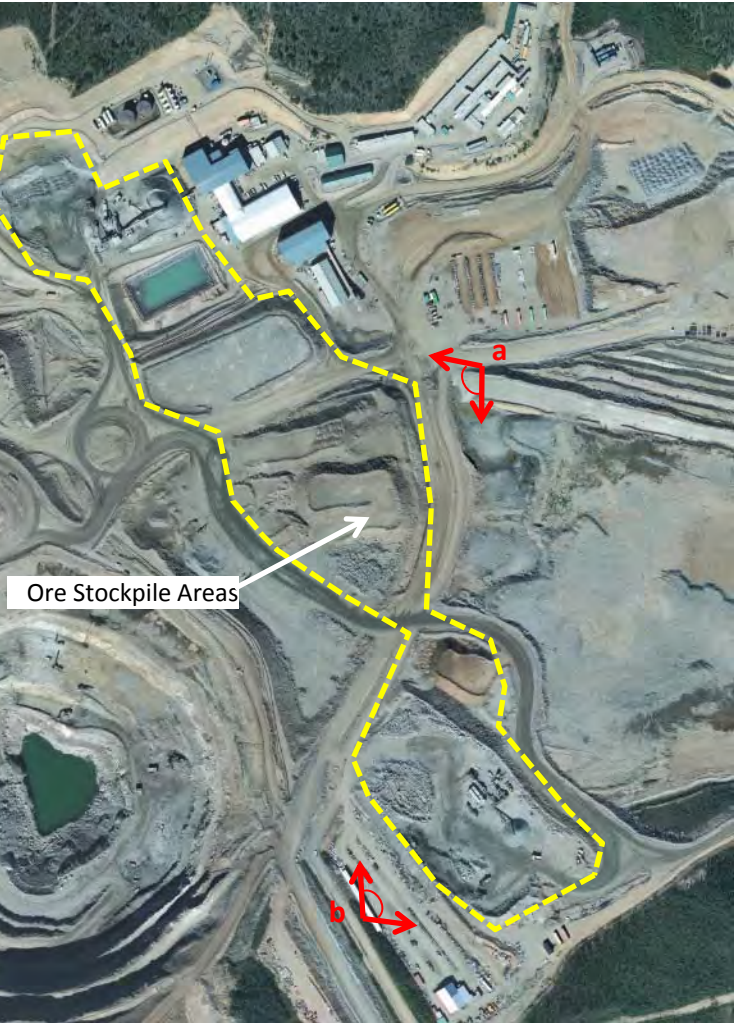
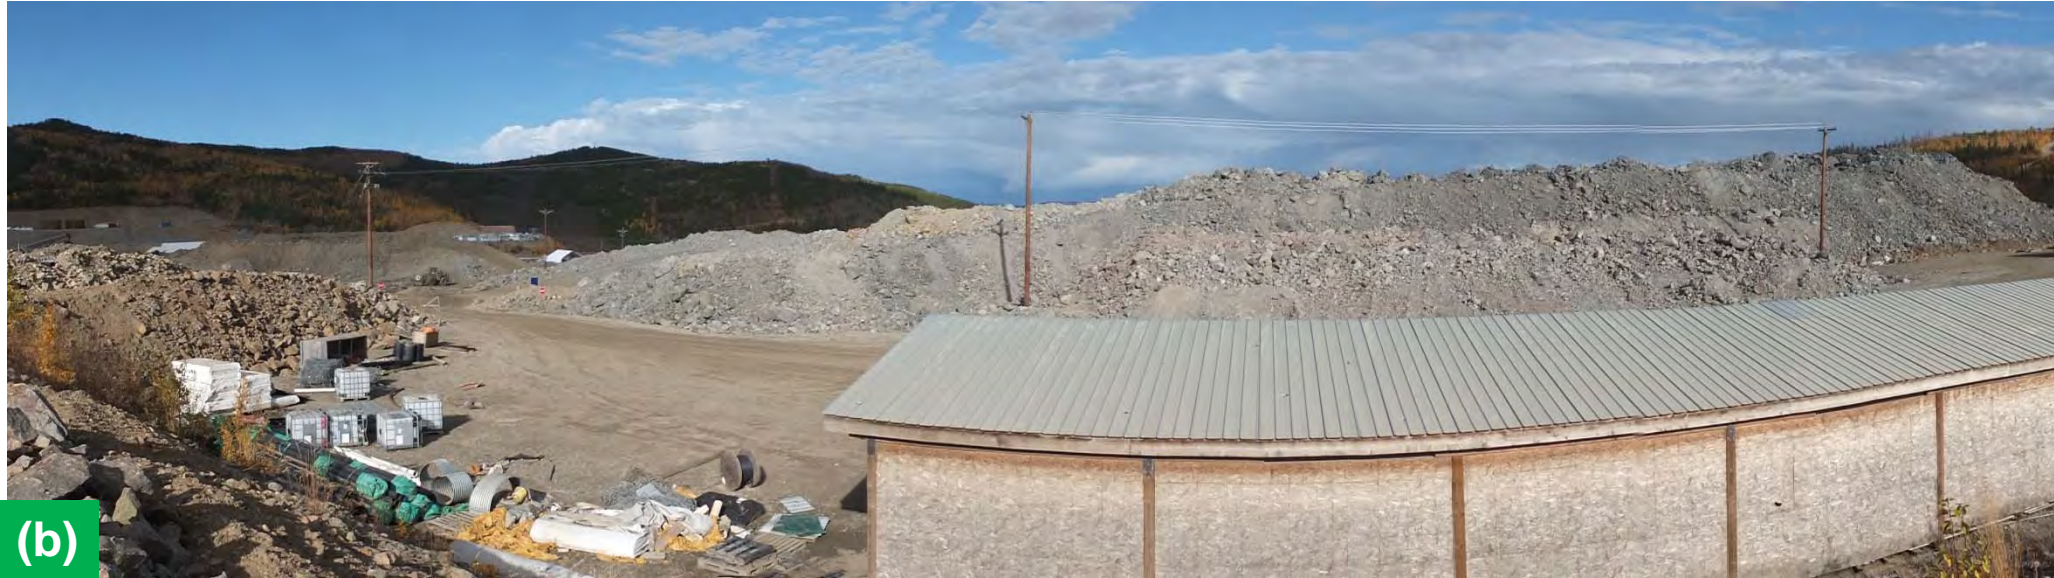
Fall 2014 Geotech Inspection		
		Ore Stockpiles		
Job No: 1CM002.012.028	Minto Mine	Date: November 2014	Approved: PHM	Figure: 8
Filename: Minto 2014 Fall Inspection.pptx

- The ore stockpile area was investigated briefly in passing. All slopes appeared in good condition: no slumping, bulges, cracks, or other signs of instability were observed.

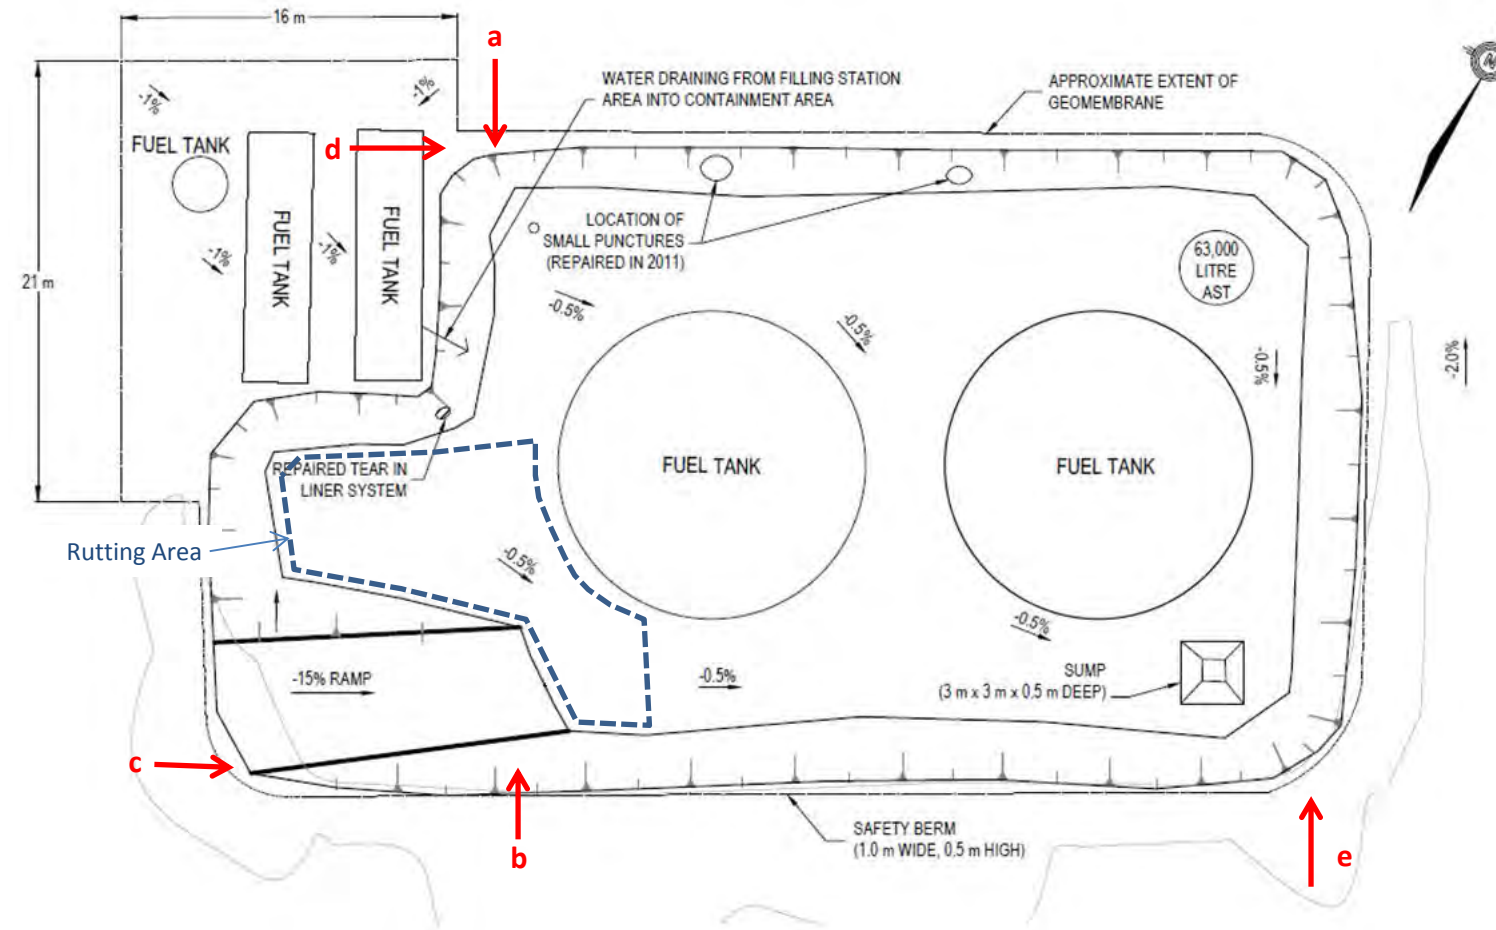
Fall 2014 Geotech Inspection		
		Fuel Containment Facility		
Job No: 1CM002.012.028 Filename: Minto 2014 Fall Inspection.pptx	Minto Mine	Date: November 2014	Approved: PHM	Figure: 13

- Photos (a) to (e) show the condition of the liner on each side of the facility.
- Conditions of the facility appear to be the same as reported in the 2012 review.
- No tears or defects in the liner were observed.
- Minor pooling was observed. The facility appears to drain into containment area as per design.
- No new rutting observed. Ruts are present in the southern half of the facility. Rutting is significant (approximate 2-3 inches deep) between the two tanks where equipment was turning. No liner is exposed as a result of the trafficking.

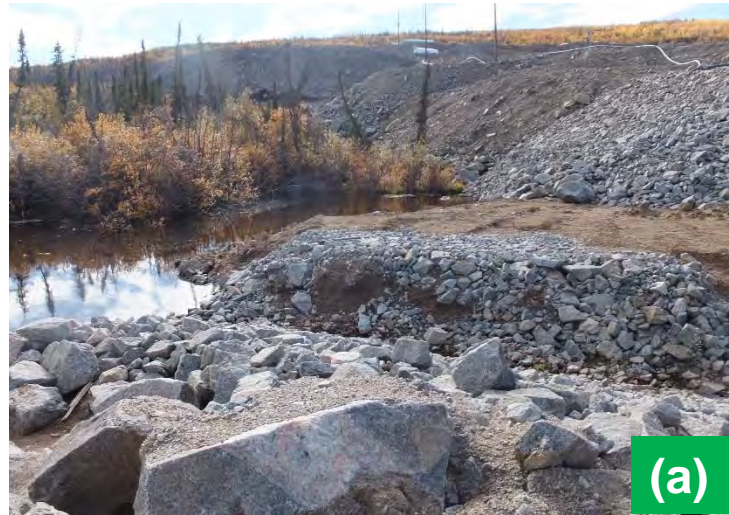
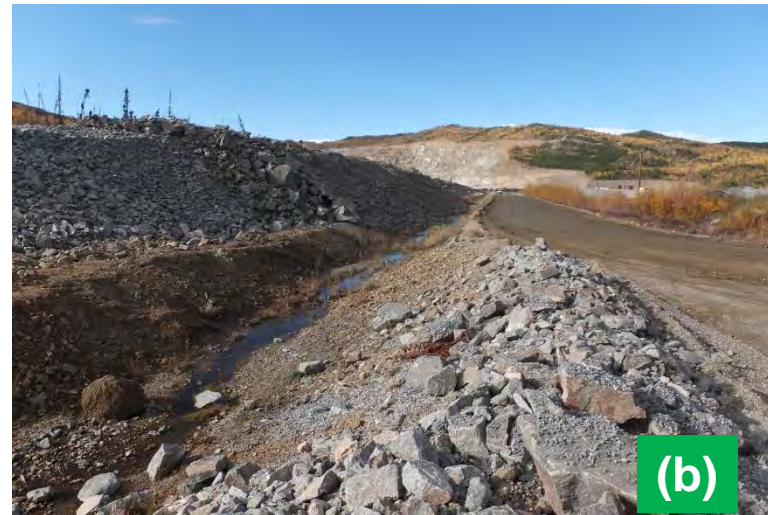
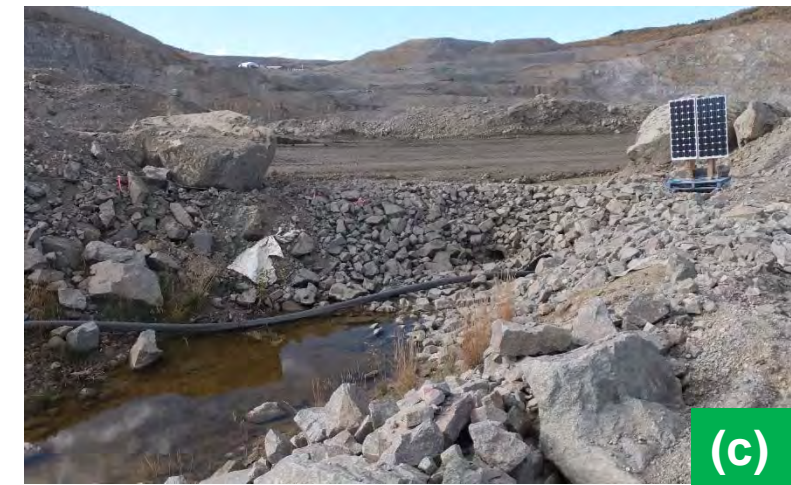
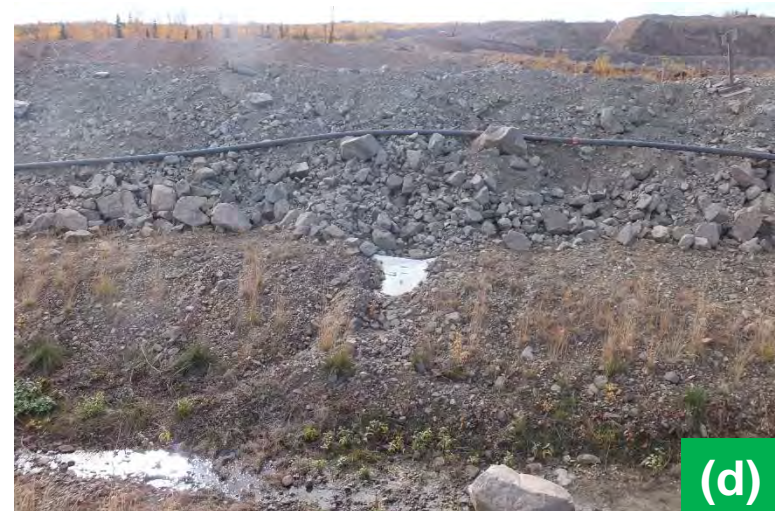
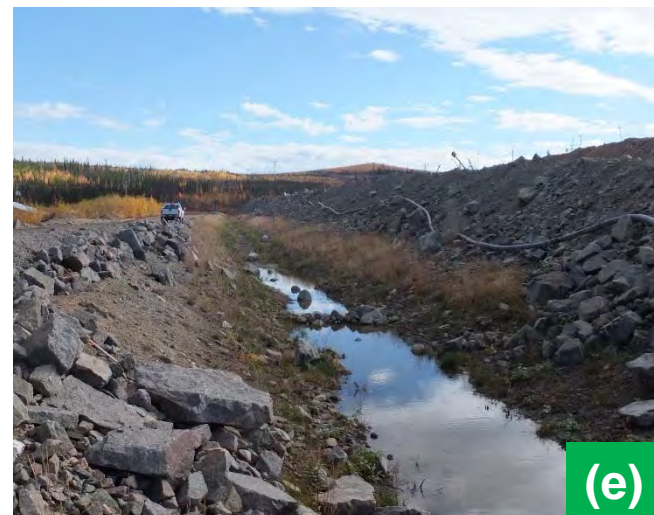
Fall 2014 Geotech Inspection		
		South Diversion Ditch		
Job No: 1CM002.012.028	Minto Mine	Date: November 2014	Approved: PHM	Figure: 14
Filename: Minto 2014 Fall Inspection.pptx

- The South Diversion Ditch was inspected between the areas shown in Photos (a) to (e) adjacent to the Airport Laydown area. The pipeline intake structure at the Photo (c) location diverts water to the confluence area located near the Main Pit. The pipeline alignment was not inspected during the site visit.

- The lined ditch upstream of the intake structure was constructed to the design outlined in the "South Diversion Ditch Collection Pond IFC drawings, Figures SD1 through SD3, dated July 2007.

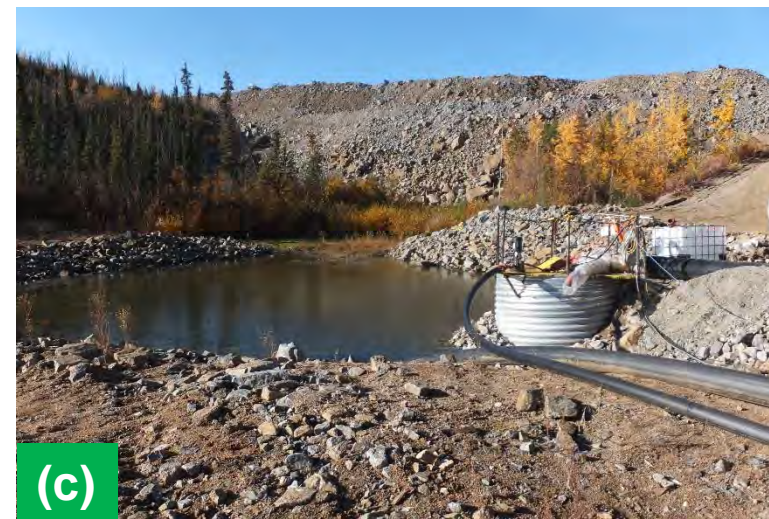
(c)

- c) View of the new intake structure at the northeast corner of the facility.
 - d) View of the overflow spillway looking south. Same as noted in previous inspections, some exposed GCL is present on the upstream side of the spillway.

- Continue regular annual monitoring for further signs of instability or seepage on the downstream slope of the MCDS.

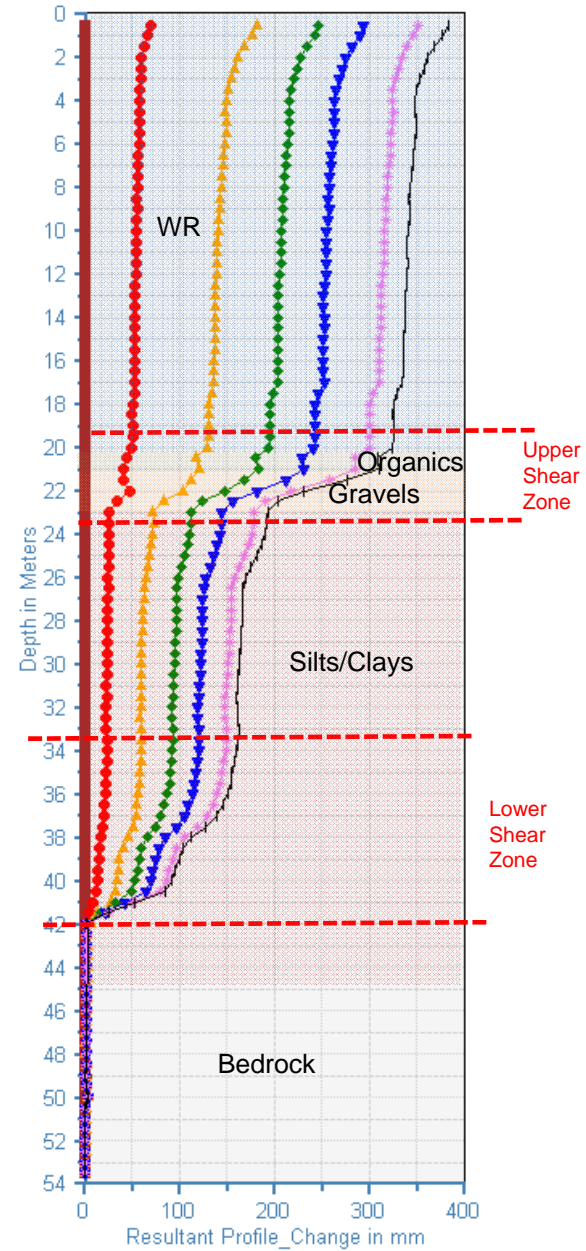
Ice lenses noted in borehole log:

- 10 mm thick at 31m;
- 75 mm thick at 34 m;
- 125 mm thick at 38 m;
- 50 mm thick at 39 m.

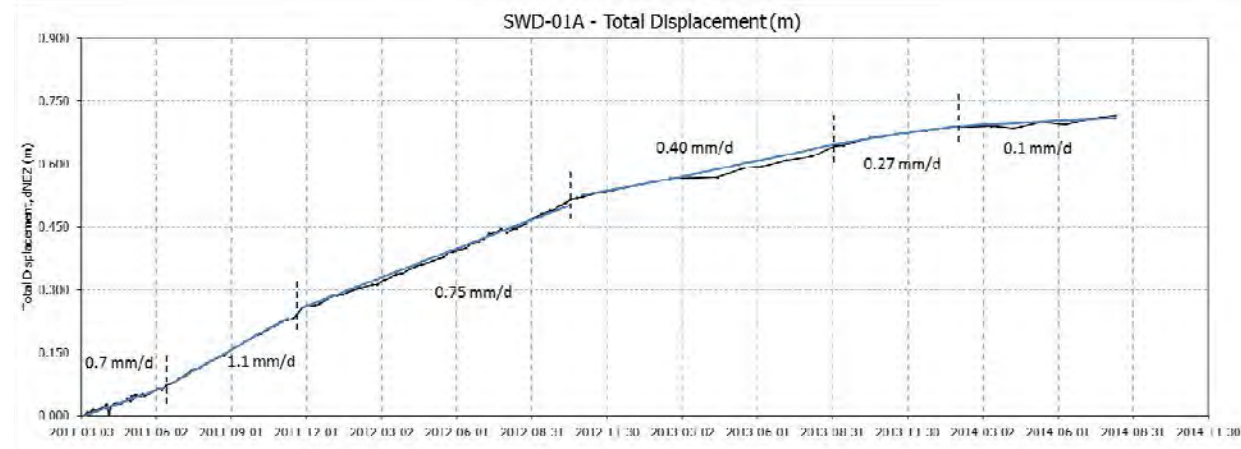
View of SWD-01A; heaved 30 cm out of the ground.

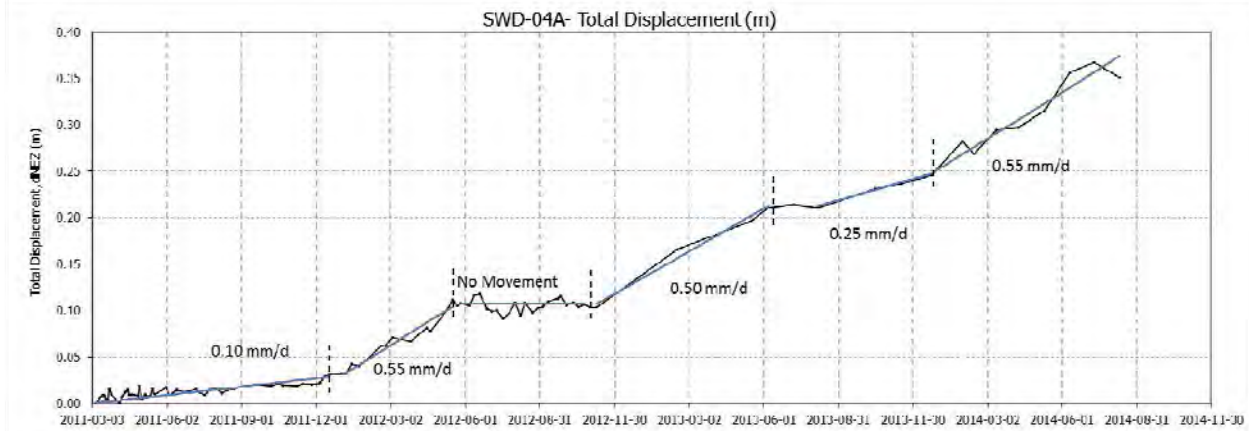
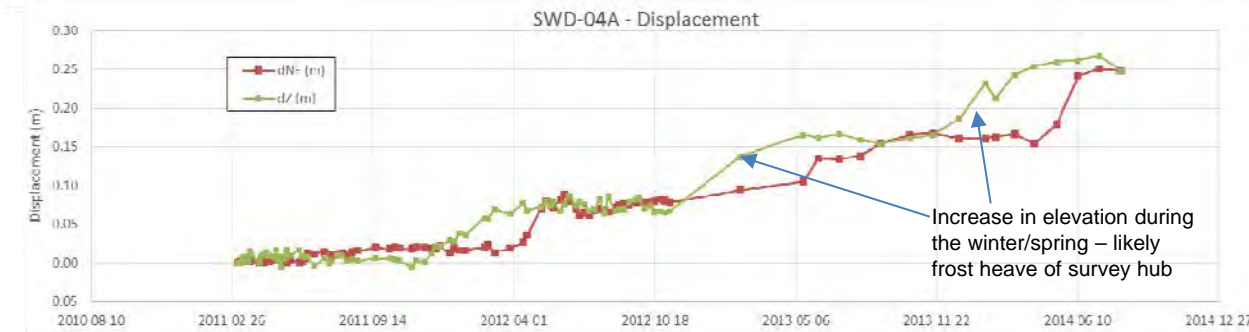
View of SWD-04A; heaved 55 cm out of the ground.

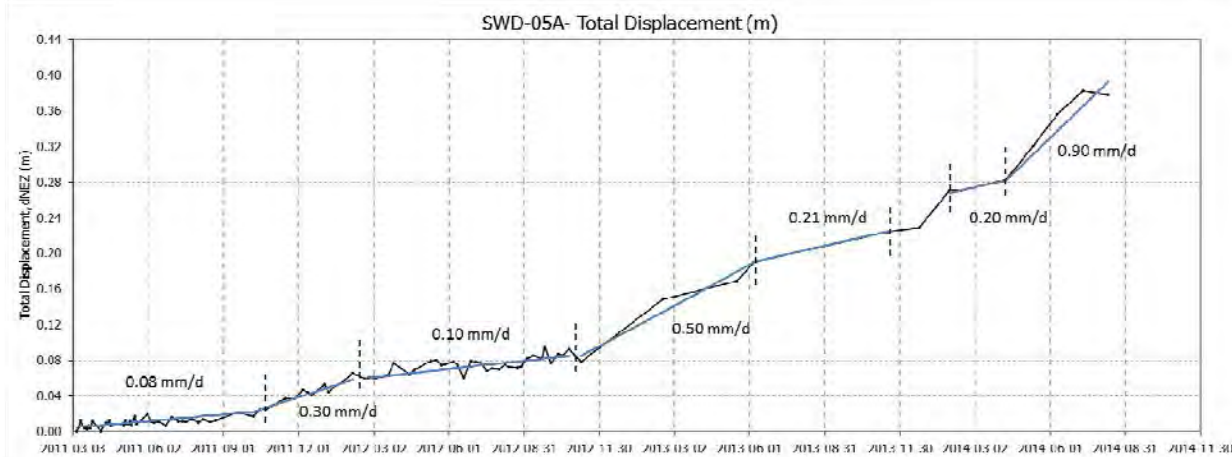
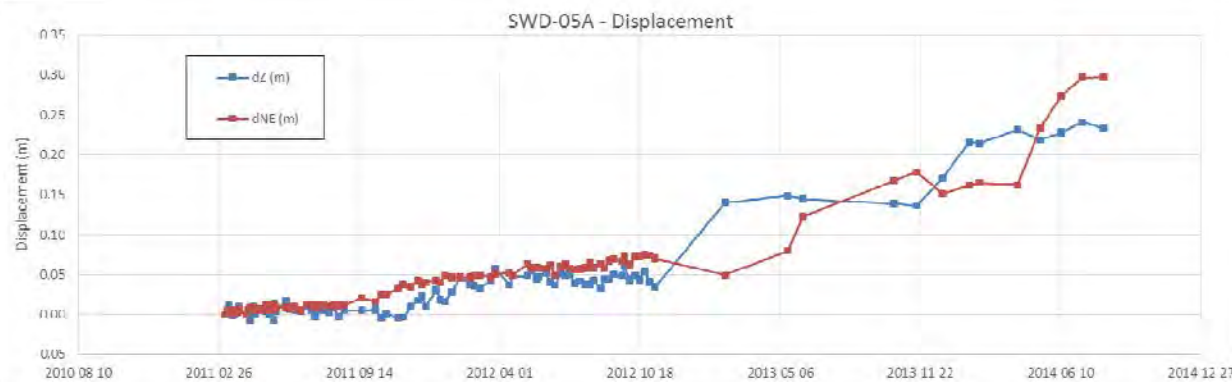
View of SWD-05A; heaved 30 cm out of the ground.

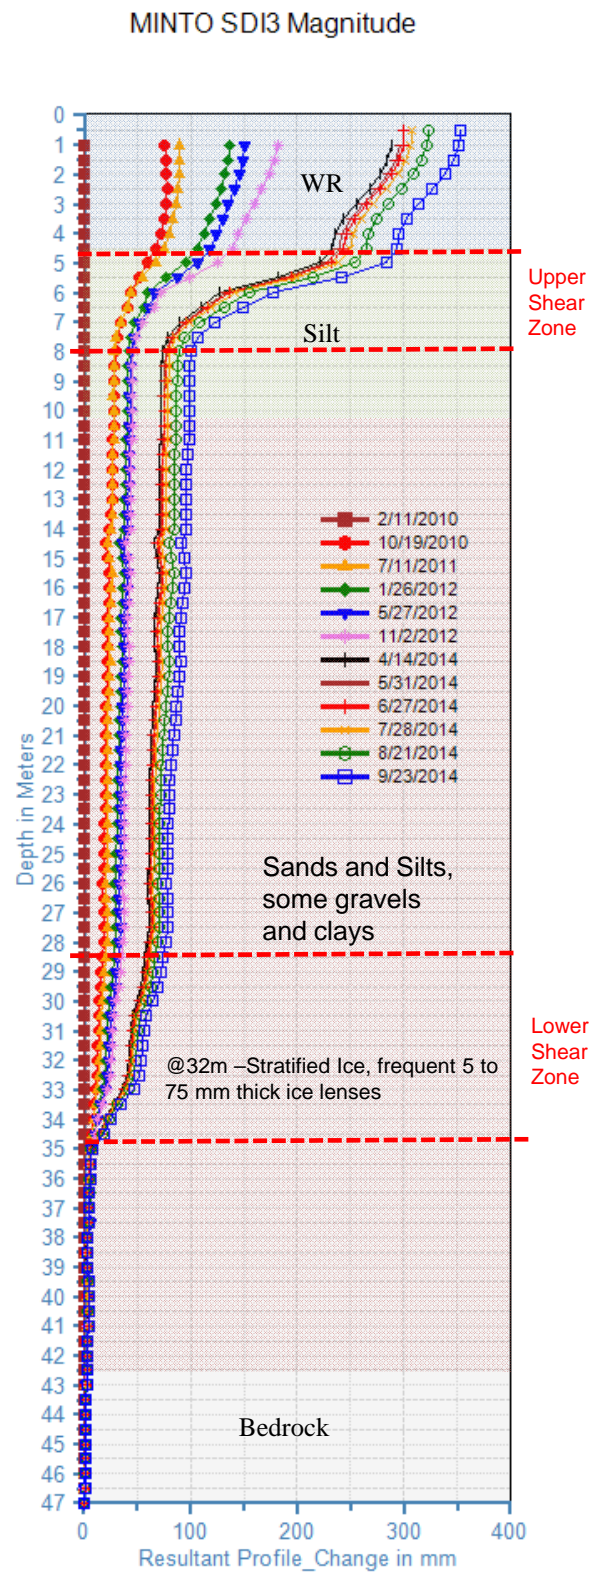
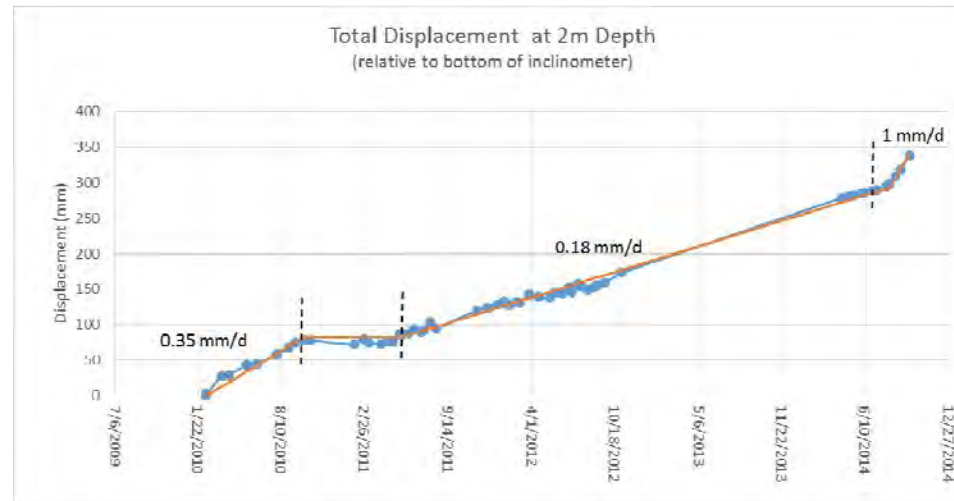
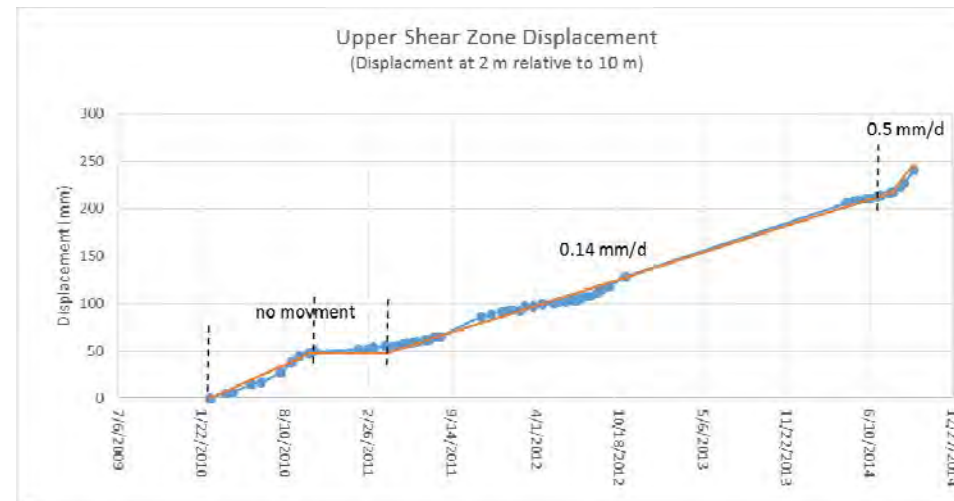
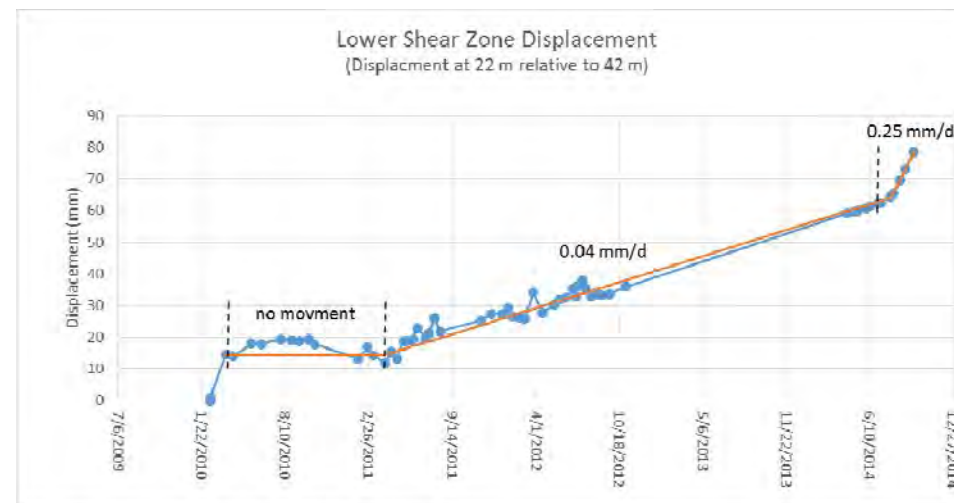
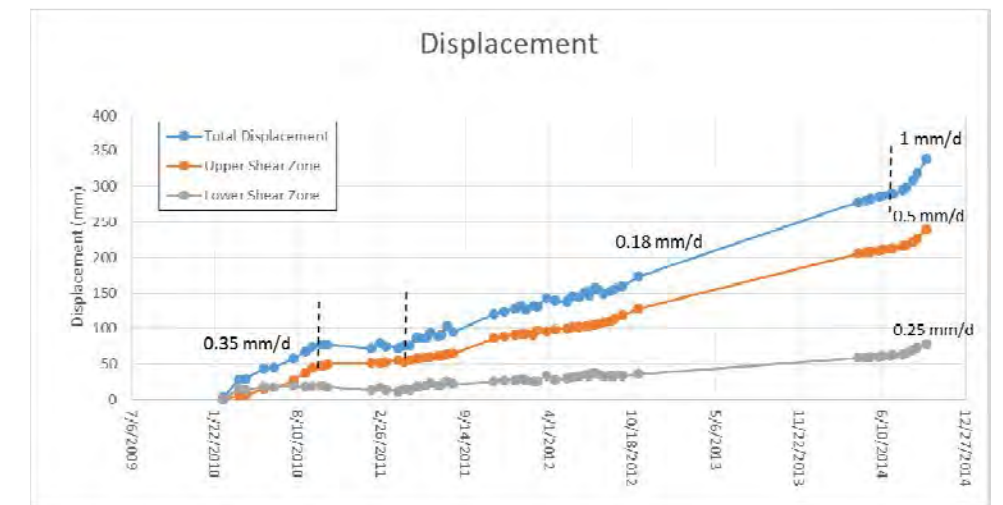
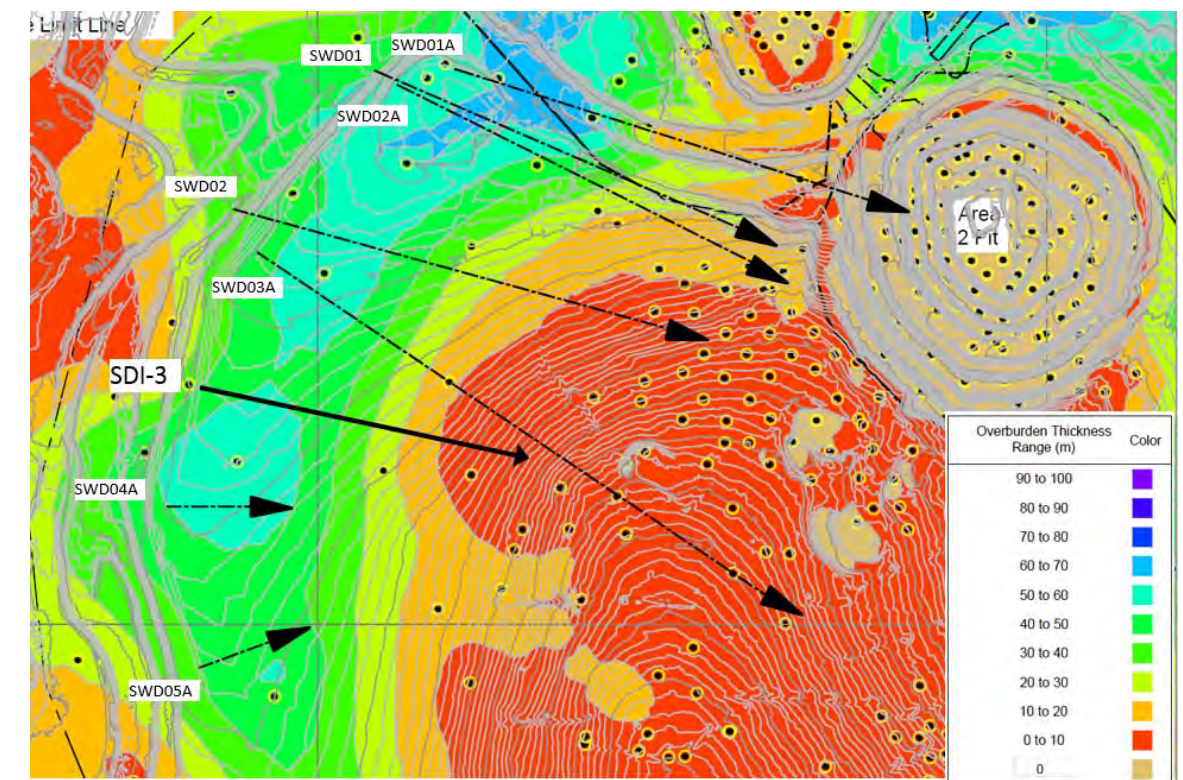
Date: November 2014
 Approved: PHM
 Figure: 12

Summary of the SWD survey hub and SDI-3 inclinometer cumulative displacement vectors.

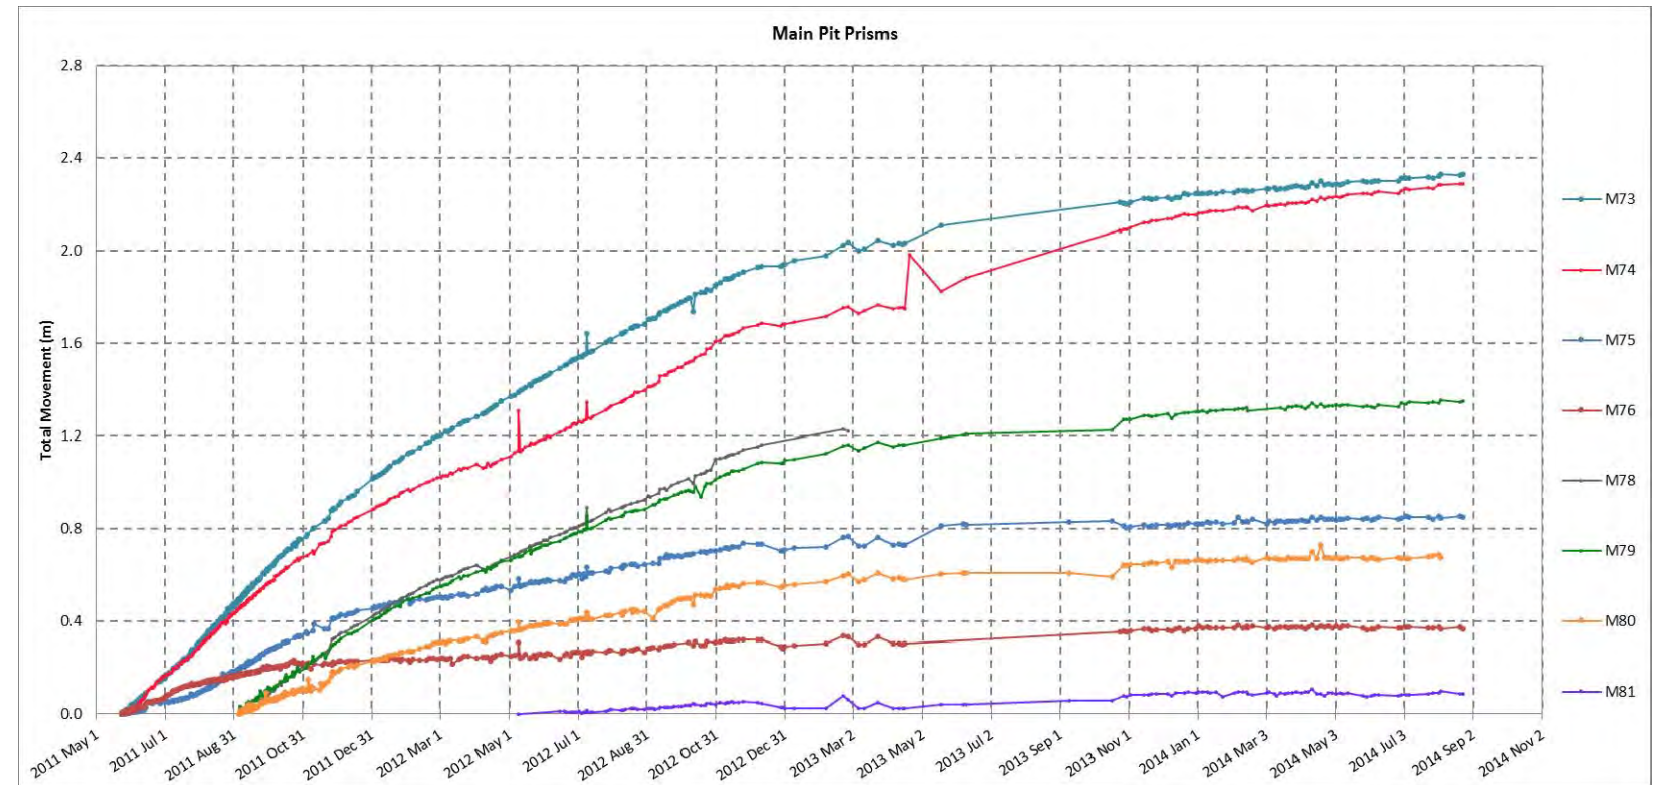
Survey Hub	Current Rate of Movement, dNEZ (mm/day)	Inspection Comment
M73	0.3	
M74	0.5	Heaved approx. 30cm above ground, and leaning towards the pit by ~20cm.
M75	0.1	
M76	no movement	
M79	0.1	Not Inspected.
M80	no movement	Not Inspected.
M81	no movement	Not Inspected.
