2014 Spring Geotechnical Inspection

Prepared by:
Minto Explorations Ltd.
Minto Mine
August, 2014

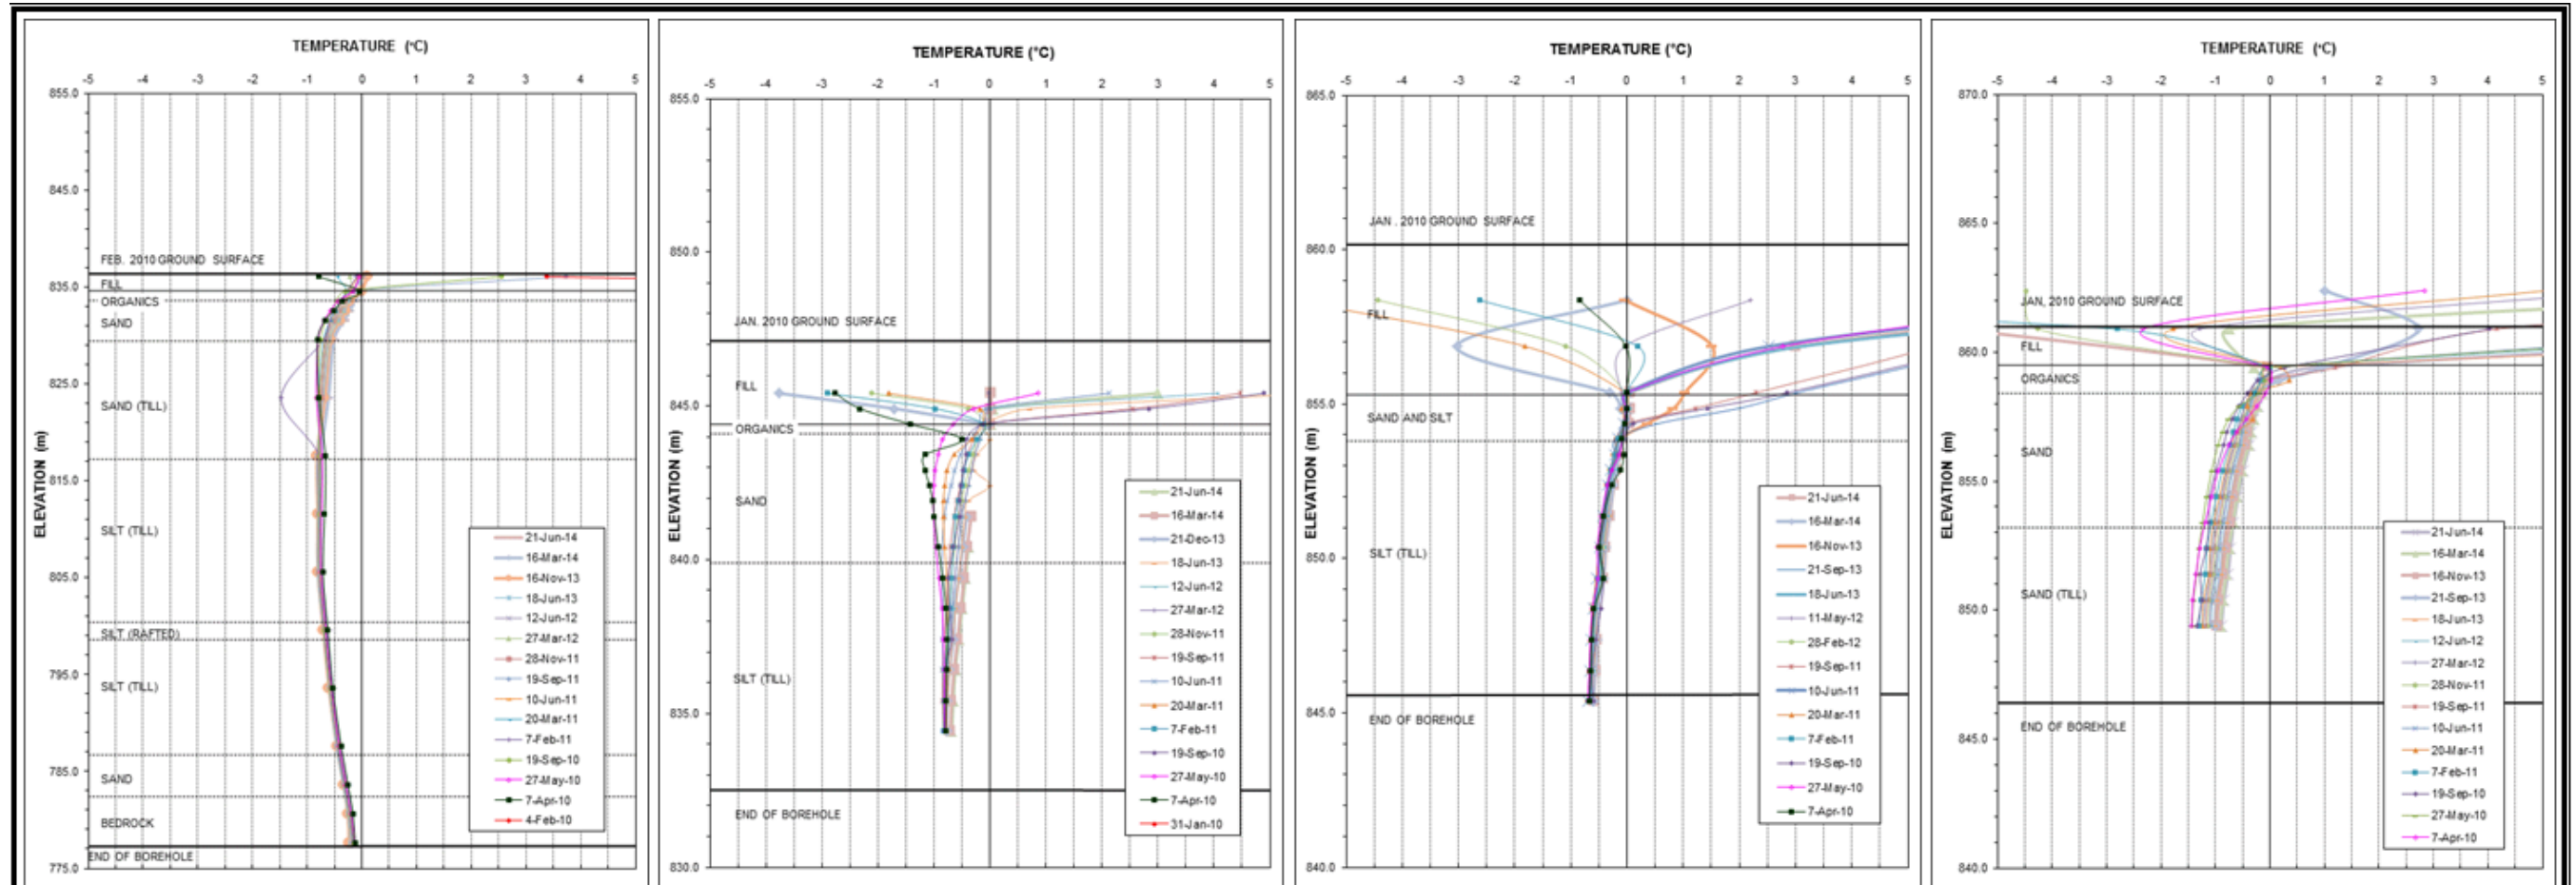
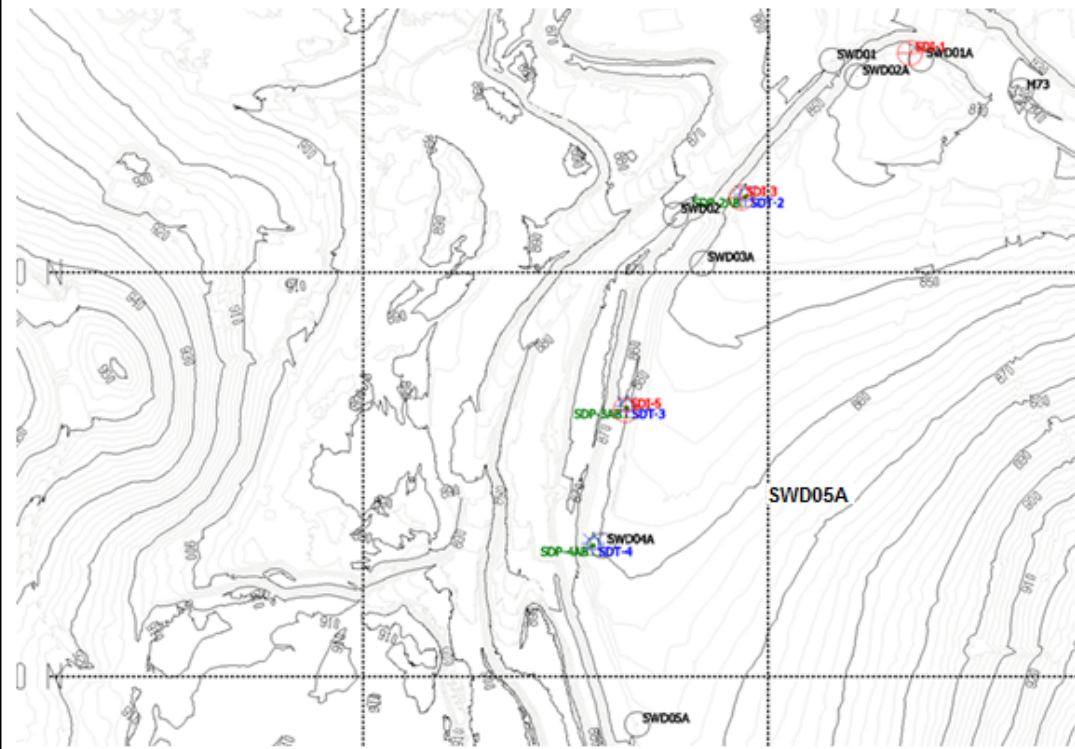
<p>CAPSTONE MINING CORP.</p>	<p>Southwest Waste Dump Thermistor Data</p>	
	<p>June 2014</p>	<p>Figure B.10</p>

Inclinometer SDI-3 is showing small but consistent movement. This may correspond with a slight thawing trend indicated by SDT-2. Temperatures in SDT-2 have increased slightly but are still below zero degrees and within the warm permafrost zone.

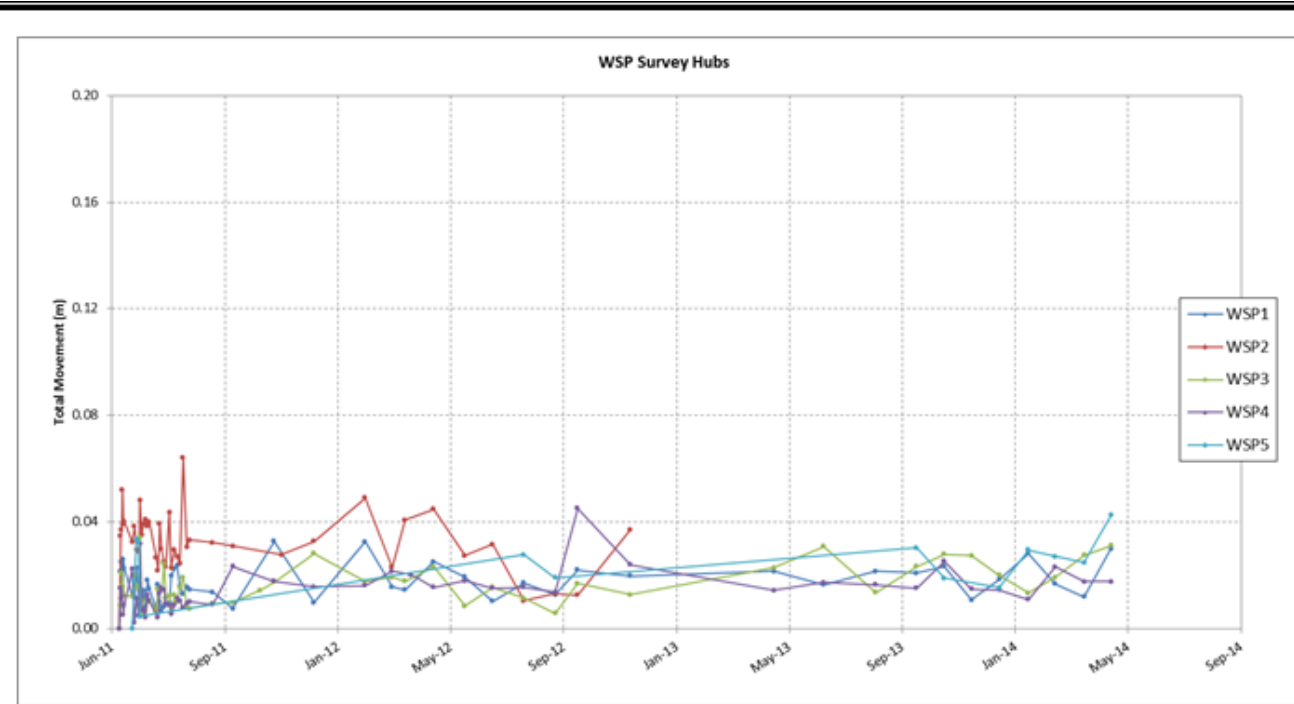
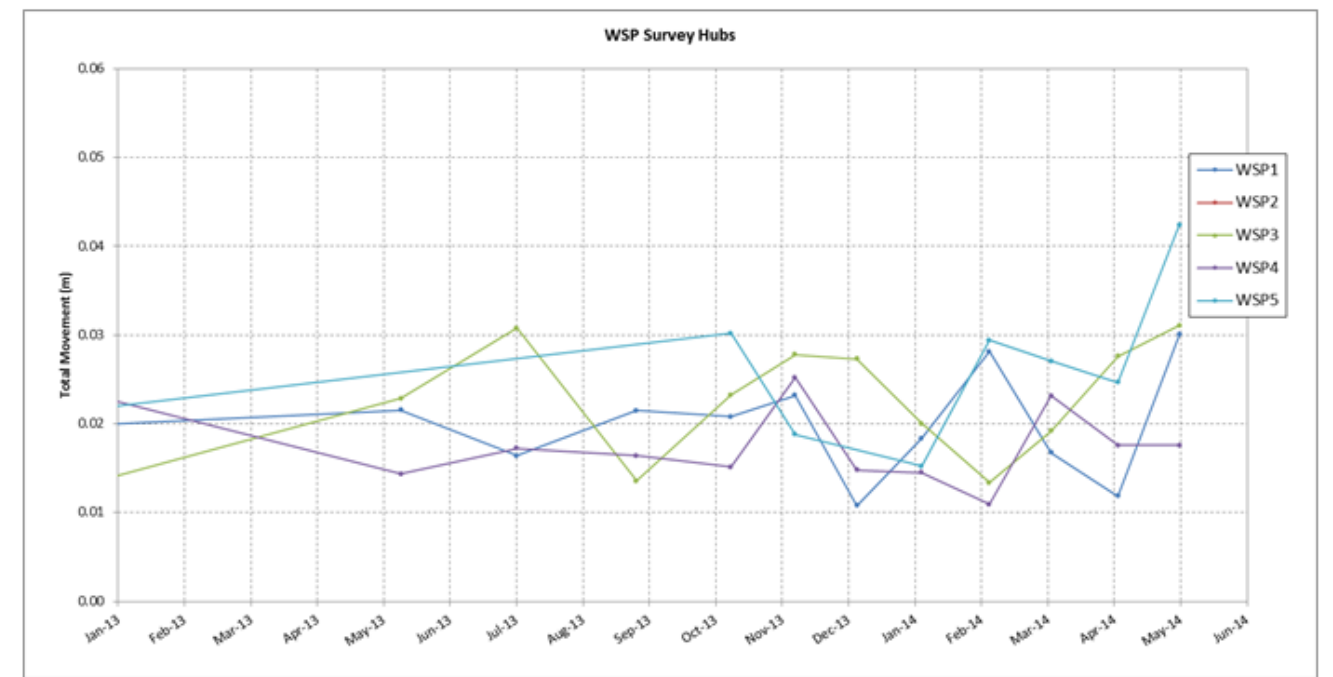
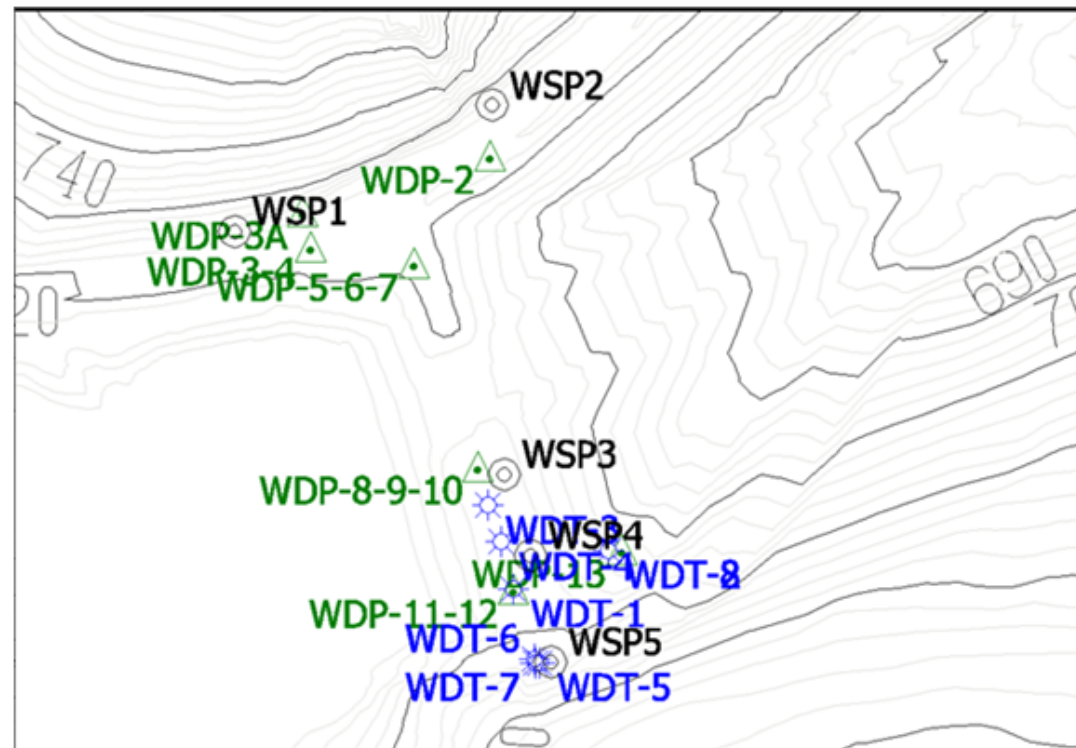
<p>CAPSTONE MINING CORP.</p>	<p>Water Storage Pond Dam Survey Hub Data</p>	
	<p>June 2014</p>	<p>Figure B.11</p>

Notes:
WSP2 is no longer operational
