2015 Geotechnical Annual Review, Minto Mine, YT

SRK Consulting (Canada) Inc.
1CM002.039
August 2015

Project No: 1CM002.039

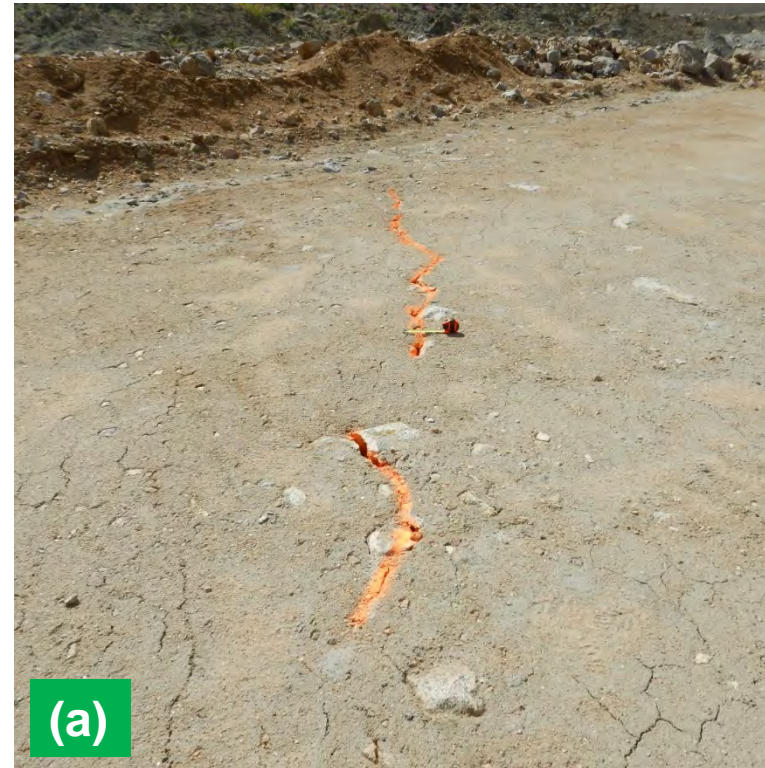
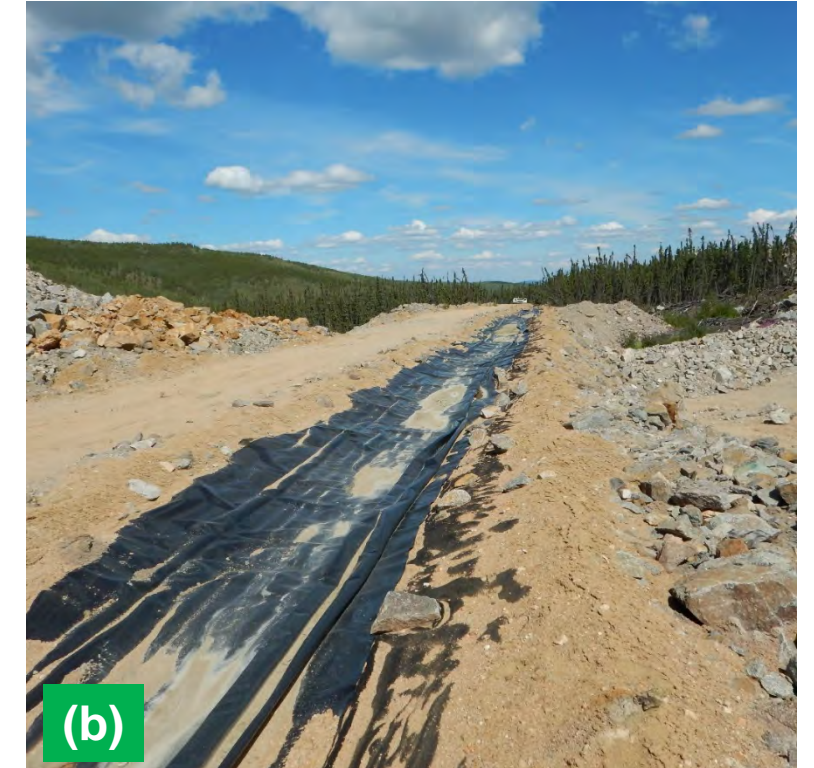
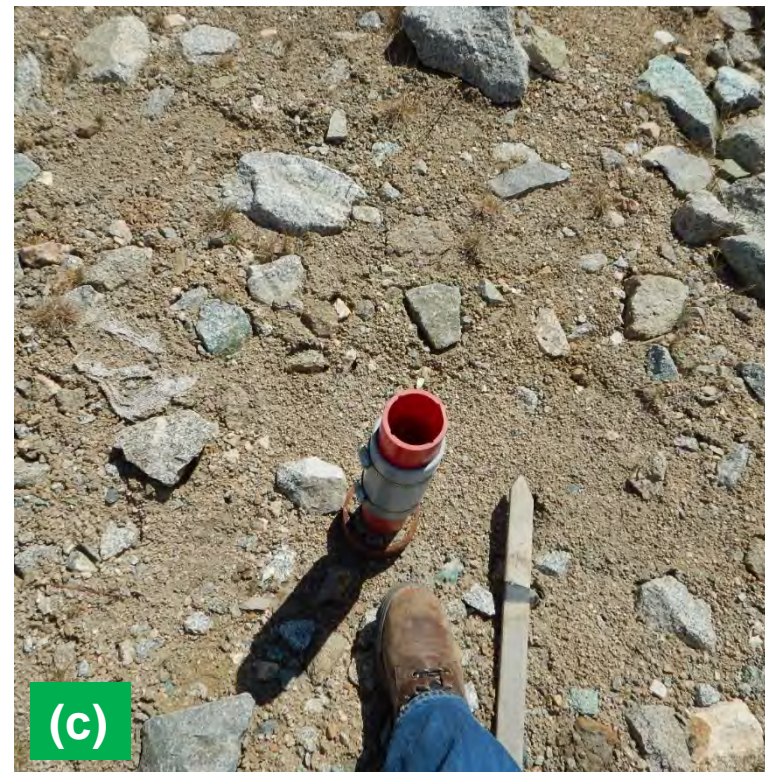
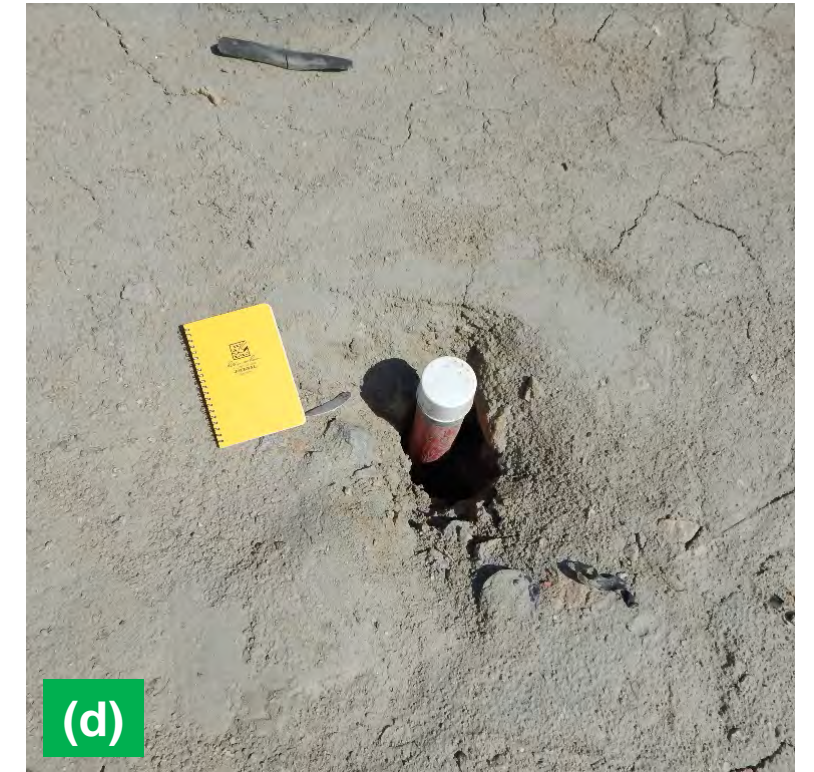
Spring 2015 Geotechnical Inspection		
		Dry Stack Tailings Storage Facility		
Job No: 1CM002.039 Filename: AppA_Minto2015SpringInspection_20150731.pptx	Minto Mine	Date: July 2015	Approved: EK	Figure: 3

1 Dry Stack Tailings Storage Facility - Tailings Diversion Ditch

- In general, the berm and ditch appeared functional, with conditions in the western portion similar to those observed in previous inspections. No signs of instability or ditch obstructions were noted along the ditch alignment.
- The ditch outlet was excavated through placed waste rock. The slopes were steep, and a high amount of finer material was noted along the excavated slopes. This may be susceptible to erosion during large flow events.
- The ditch was completely dry at the time of the inspection.

- (a) View of the diversion ditch. Rip rap is well placed, and compacted, and the ditch is free of debris.
- (b) View of the transition from unarmoured diversion ditch to armoured diversion ditch.
- (c) View of the diversion ditch upstream portion of the channel. The area remains unchanged compared to 2013 inspection.
- (d) View of the downstream face of the diversion ditch. Note steep slopes and large boulders.

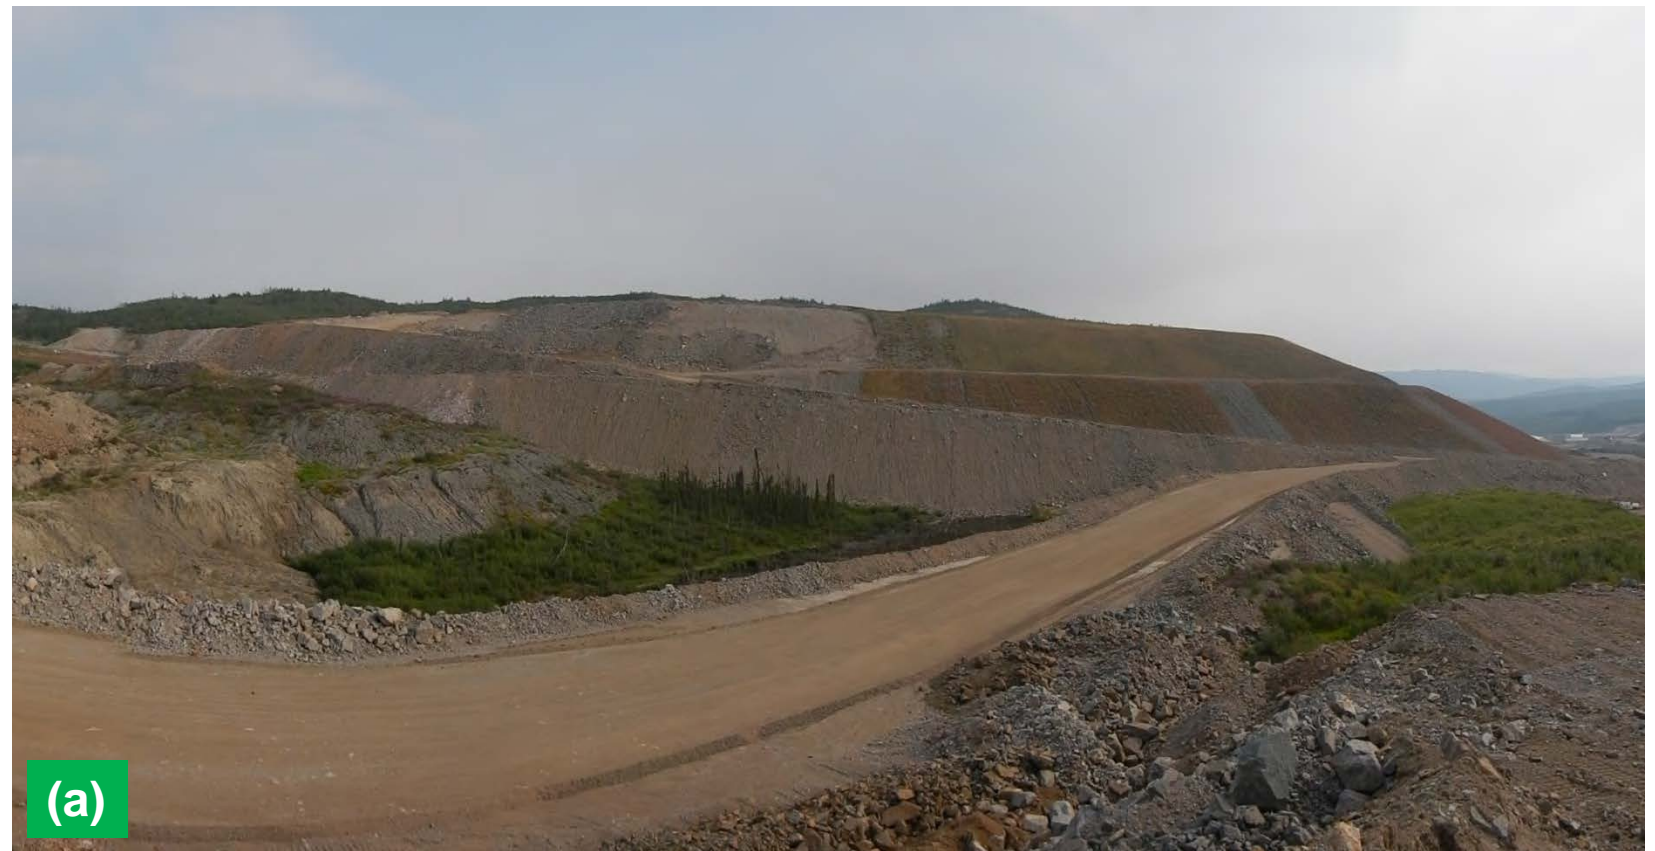
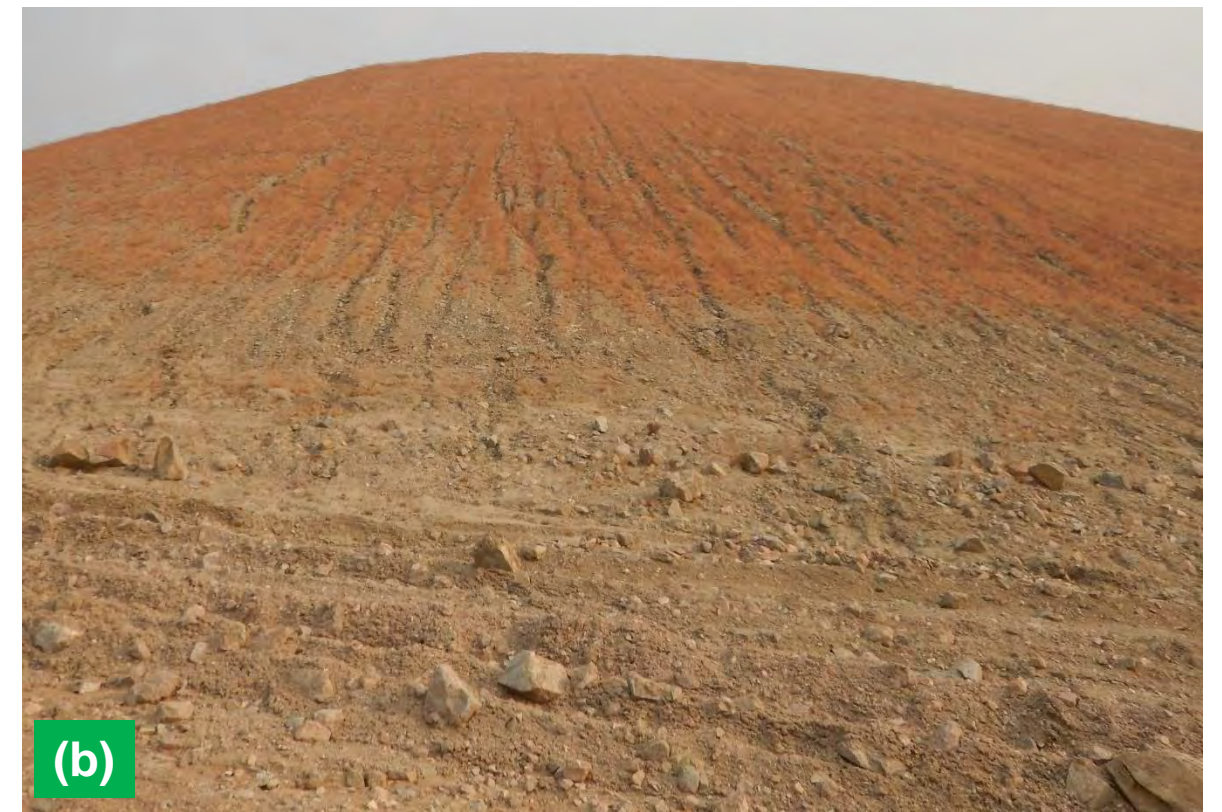
2 Main Waste Dump

- Reclamation activities at the dump were completed between 2011 and 2012 with re-contouring of portions of the dump slopes. The regraded area is noted in the plan below. The regraded slopes have been covered and revegetated with different vegetation prescriptions placed on different portions of the cover.
- No signs of instability were observed.
- Photo (a): Overview of the Main Waste Dump looking northeast.
- Photos (b) View of the erosion visible on the regraded waste rock dump. Minor rills and gullies are present at the base of the regraded slope where vegetation is not yet established. No signs of instability were observed.

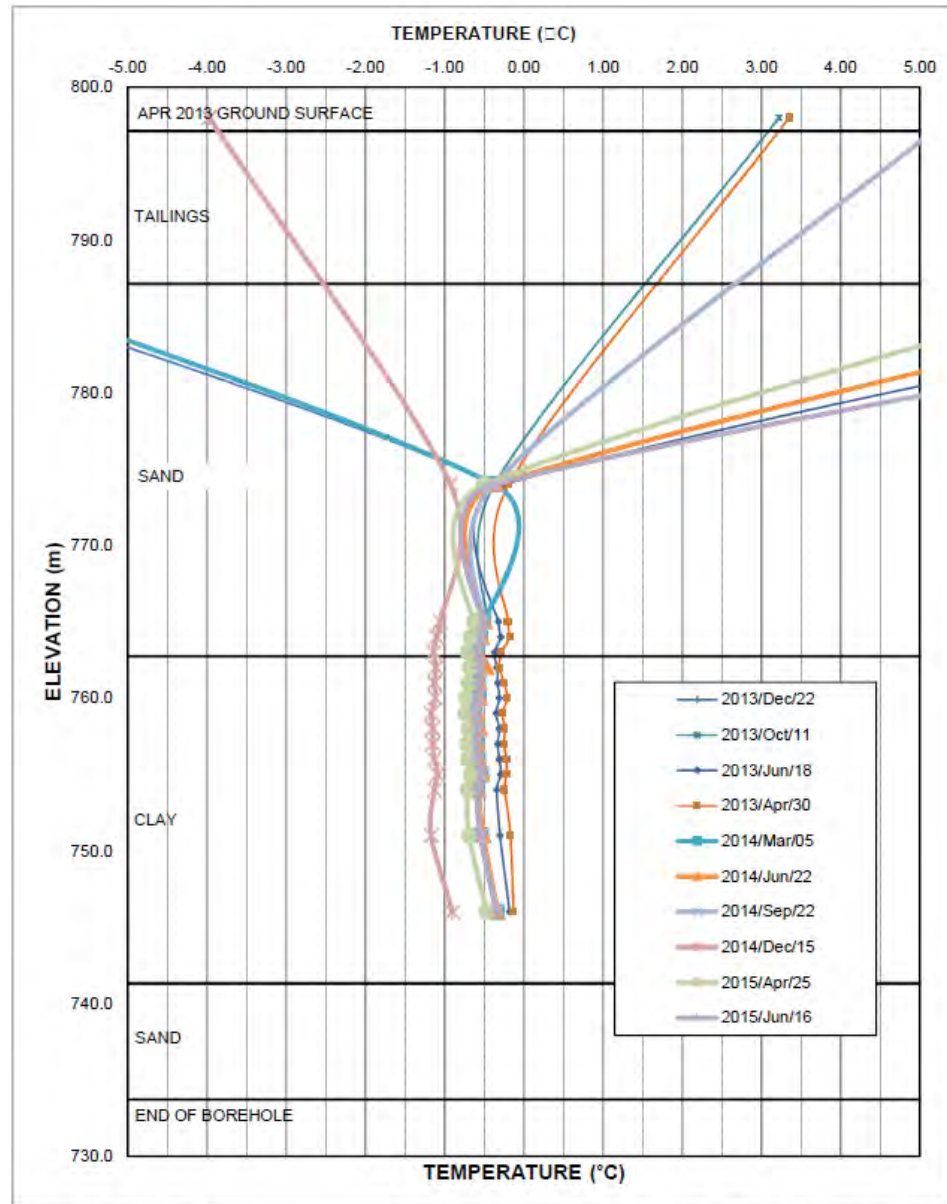
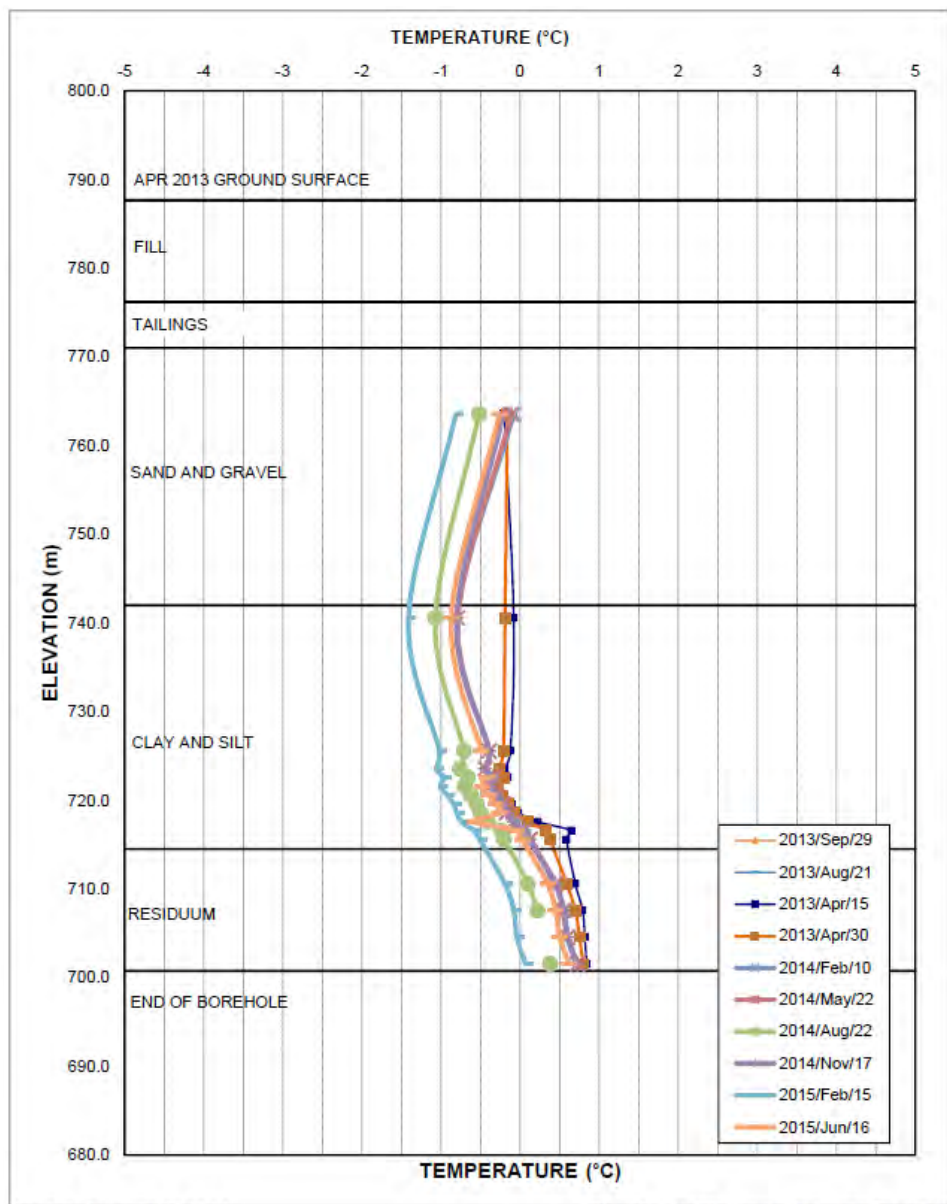
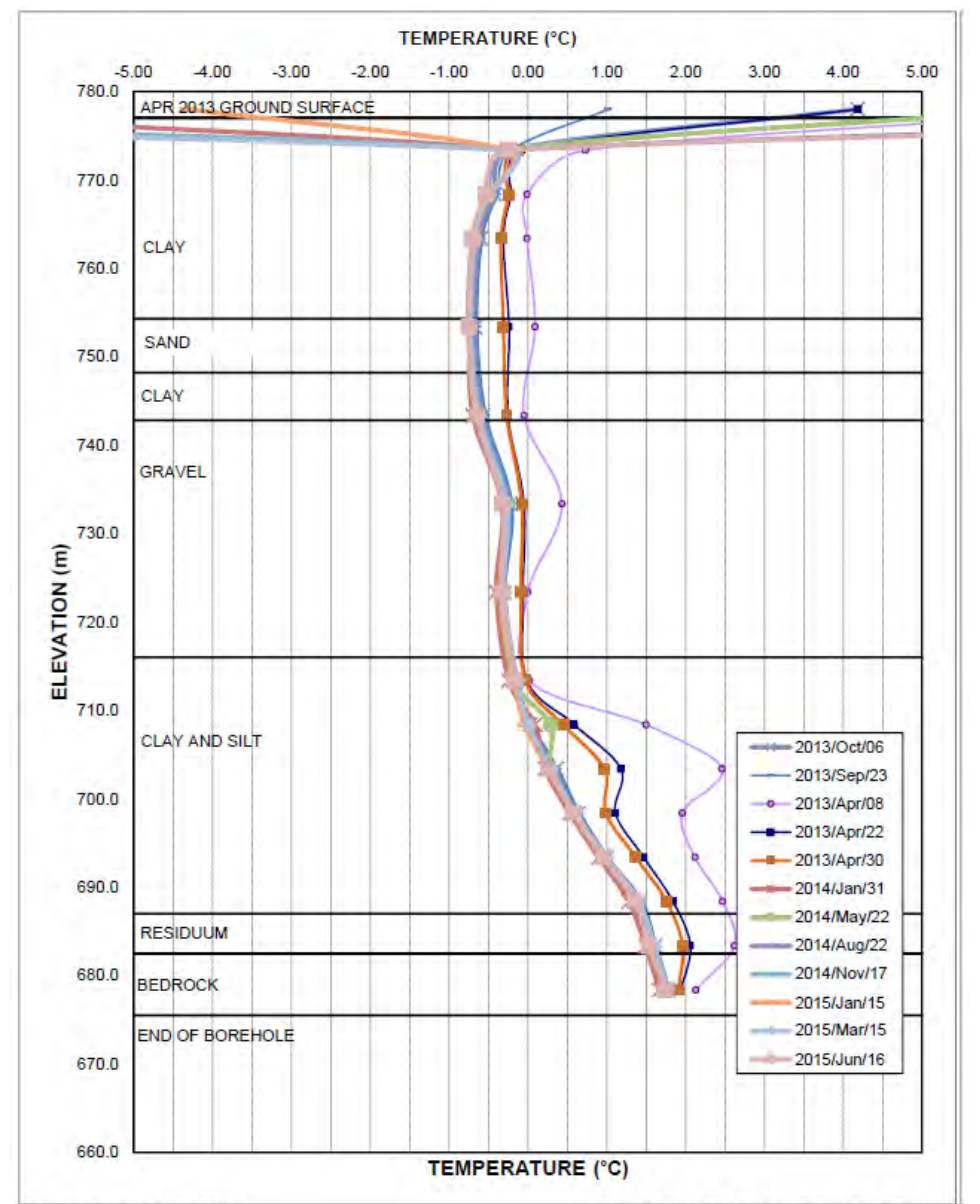
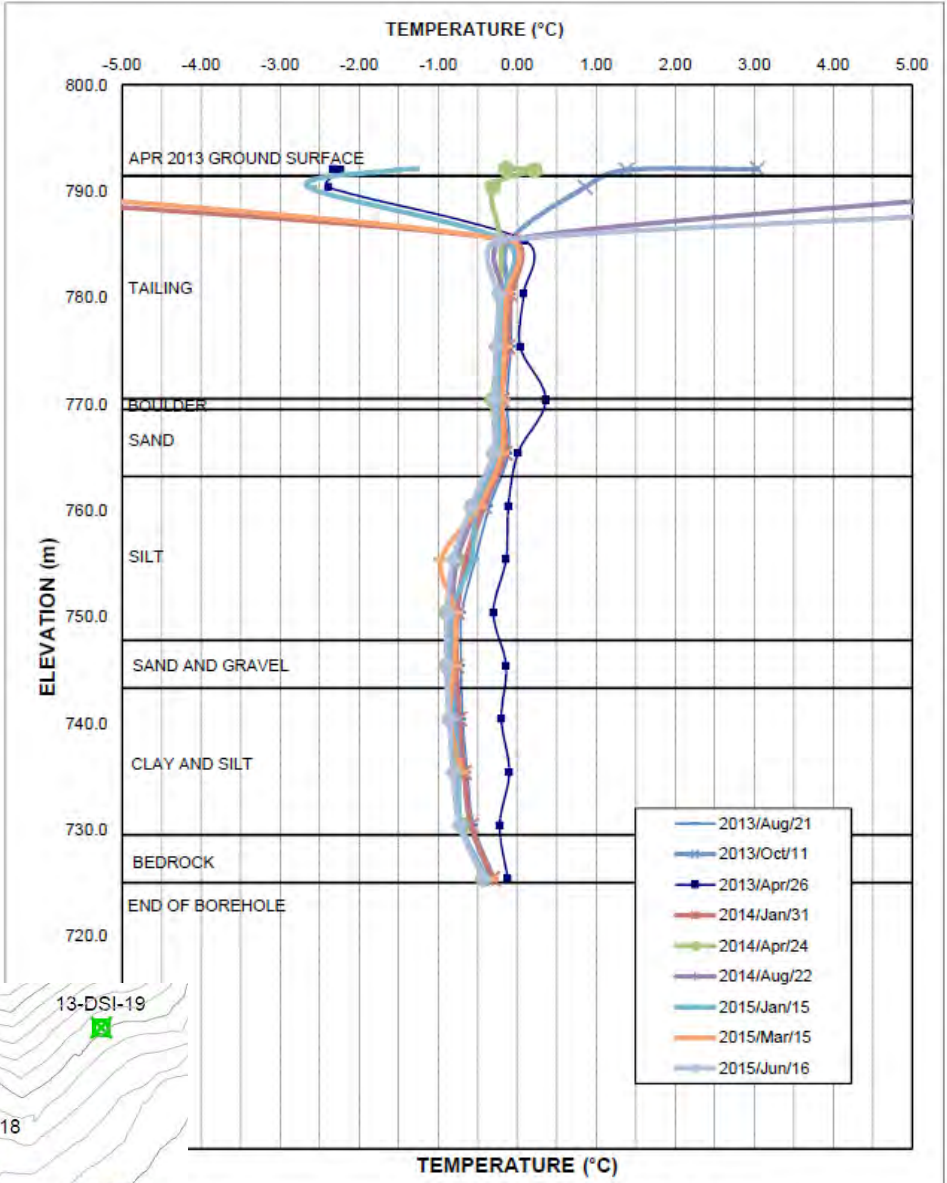
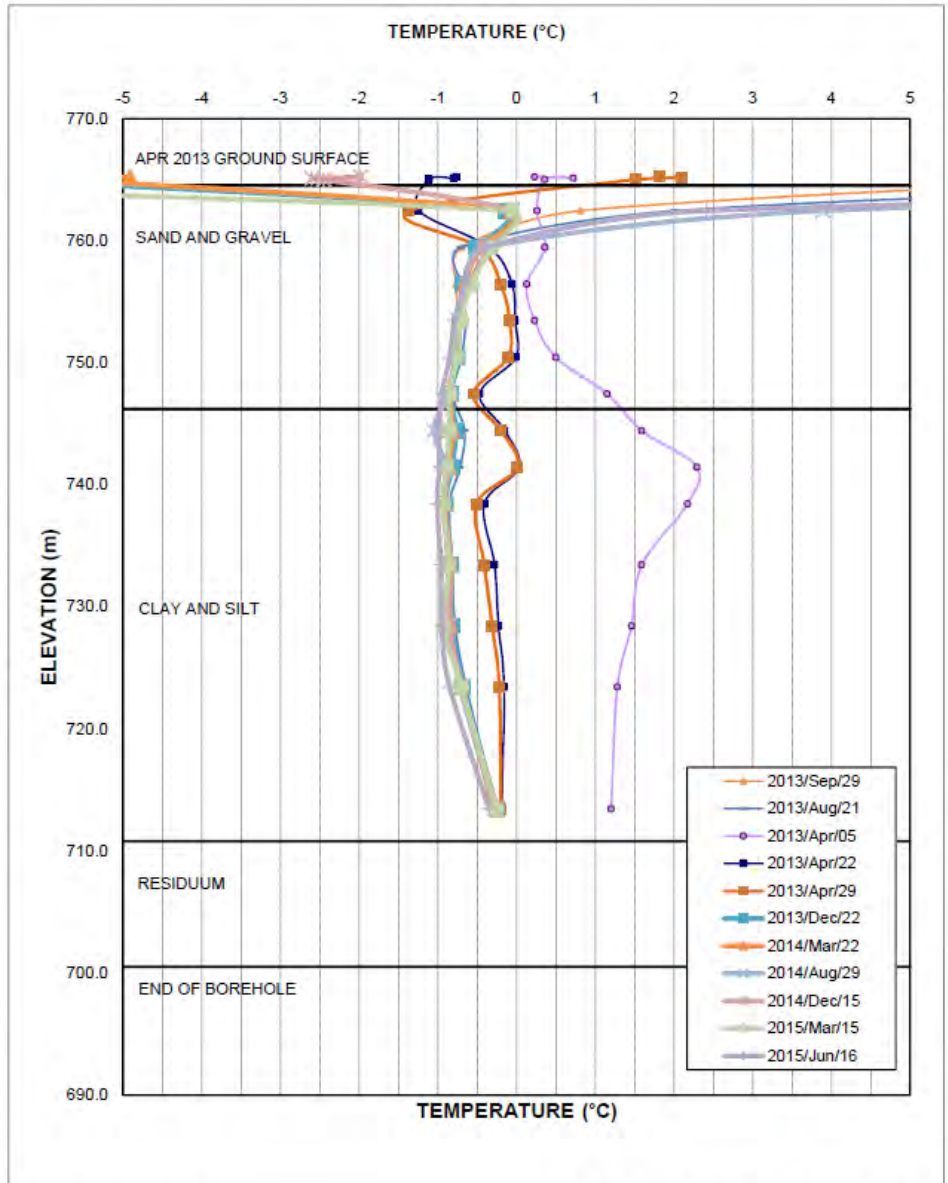
Ground temperature profiles from the functional instrumentation are provided in Figures 1 and 2 of Appendix B. Temperature profiles from previous instrumentation that have malfunctioned are included in previous inspection reports. The temperature readings in the instrumentation installed in 2013 are either still cooling as the sensors approach equilibrium with the surrounding soils, or show no significant trend. The profiles indicate that warm permafrost is present at all locations, except in the lower portions of DST-11 and DST-13. DST-11 is located near the crest of the DSTSF, while DST-13 is located approximately 300 m east of the DSTSF in an undisturbed location.

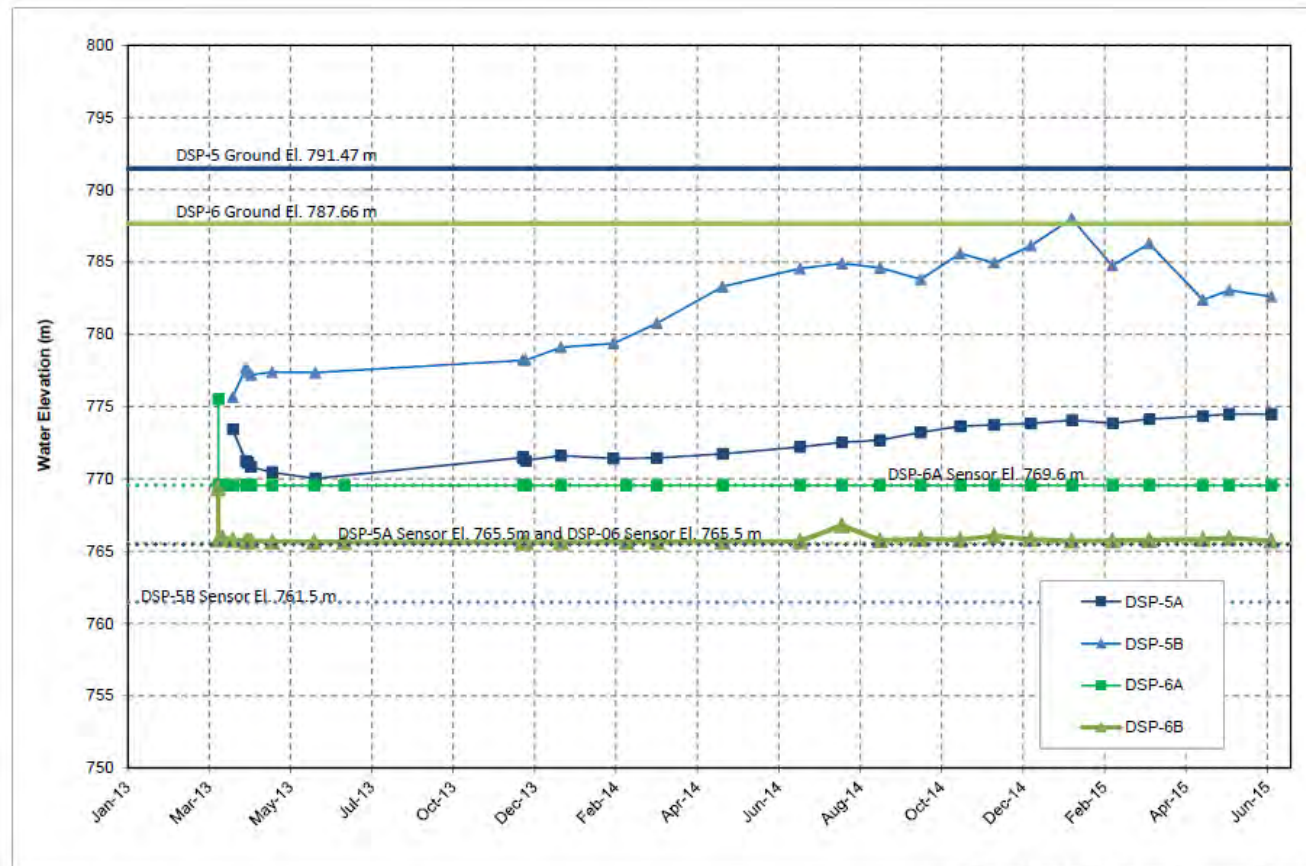
Dry Stack Tailings Storage Facility
Instrument Water Elevation - DSP-5A, DSP-5B, DSP-6A, DSP-6B

Piezometric data from the DSTSF are presented in Figure 3 of Appendix B. The piezometric data includes plots of the pore water pressure ratios (r_u) for each sensor. The r_u is the ratio of pore water pressure to the overburden pressure. A pore water pressure ratio of 0.5 would be similar to the effect of a groundwater table at surface.

The pressures at DSP-6 indicate non-saturated conditions. The pressures at DSP-5 indicate excess pore water pressure conditions with the pore water pressure ratio (r_u) at DSP-5A increasing to 0.2 and the r_u at DSP-5B decreasing from a peak of 0.5 to a ratio of 0.4.

- Water pressure elevations may not be accurate as barometric pressures were estimated and temperature sensors indicate frozen conditions.
- DSP-5 piezometer sensors are installed at the same location as the DST-14 ground temperature cable presented in Figure 2.
- DSP-6 piezometer sensors are installed at the same location as the DST-11 ground temperature cable presented in Figure 1.

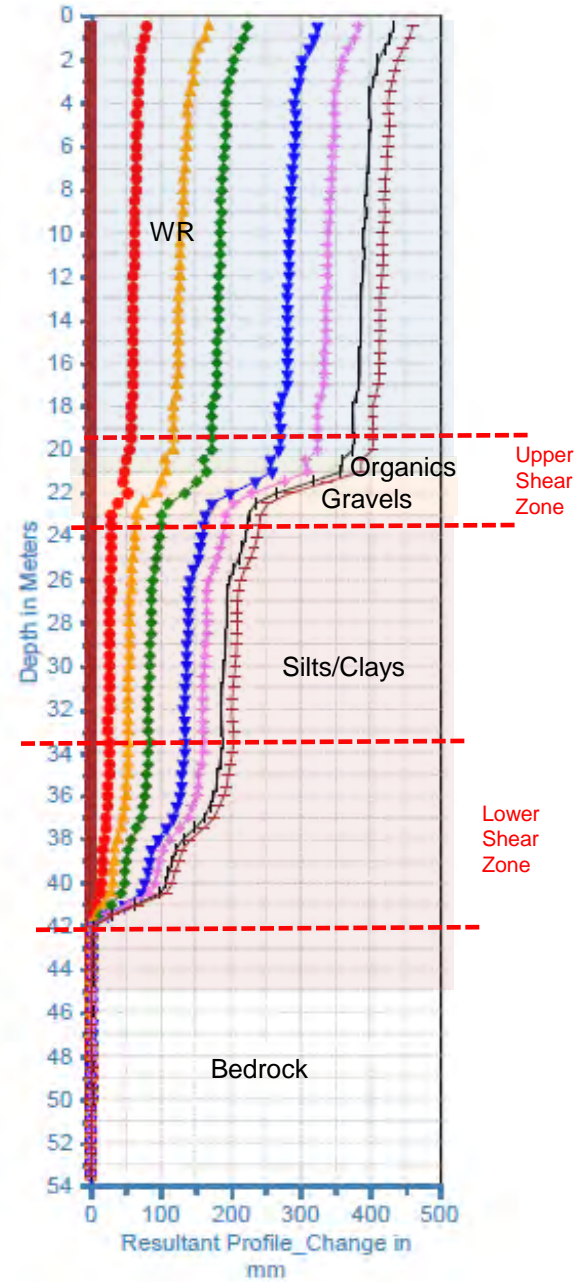
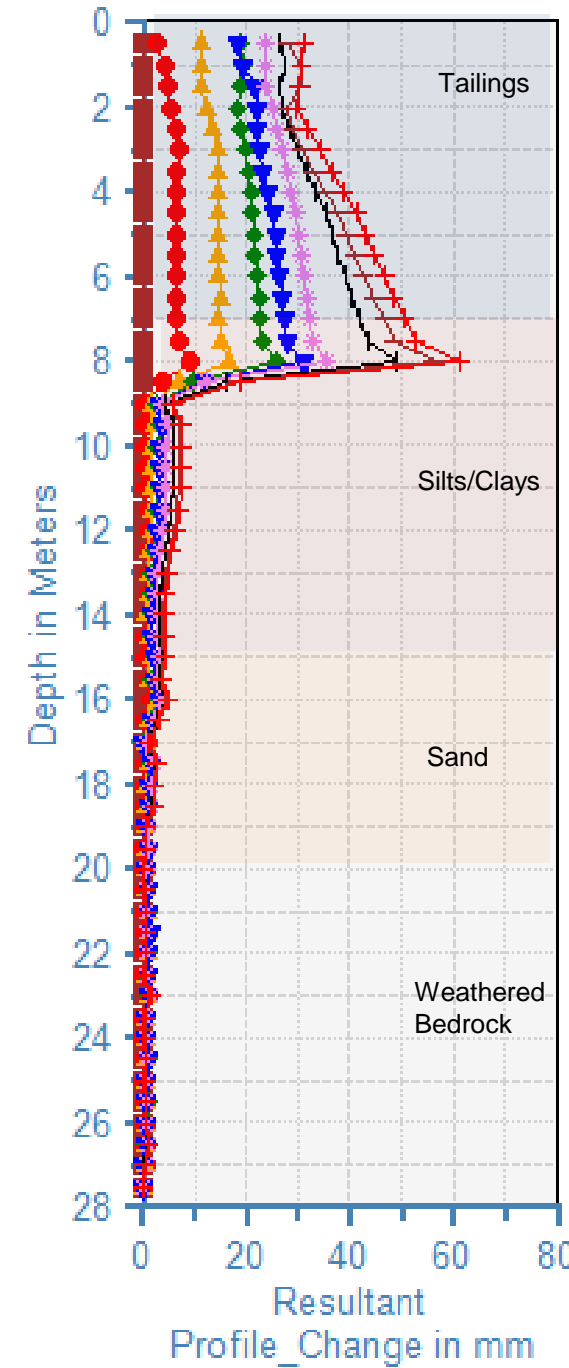
MINTO DSI-14 Magnitude

Profiles and time-displacement plots from inclinometers with additional data since the 2014 Fall Geotechnical Inspection (SRK 2014b) are presented in Figure 4 in Appendix B. The results are consistent to those observed during the 2014 data review with no new shear zones or accelerations in movement detected. Table 4.2 provides a summary of the inclinometer results and observations. The locations of the inclinometers are provided in Figure 2 in Appendix B.

Inclinometer	Comments
DSI-14	<p>Two shear zones are present:</p> <ul style="list-style-type: none"> The upper shear zone is located within the top 4 m of native materials beneath the MVFE. The materials in this zone consist of organics and a loose gravel layer. Since the inclinometer installation, the movement rate has shown a decreasing trend with a current velocity of approximately 0.1 mm/day. The lower shear zone is approximately 3 m above the bedrock contact and consists of ice-rich, medium to high plastic clay materials. Significant ice lenses were noted in the borehole logs within the zone. Movement rates have also decreased with a current velocity of approximately 0.2 mm/day.
DSI-21	<ul style="list-style-type: none"> Shear zone located approximately 11 m above the bedrock contact and 1 m below the tailings. The borehole logs note layered ice and soil in this region with 1 to 2 mm ice lenses spaced 5 mm apart and 20% excess ice. Movement rates of this zone have decreased with a current velocity of approximately 0.03 mm/day.

- Ice lenses noted in borehole log:
- 10 mm thick at 31m;
 - 75 mm thick at 34 m;
 - 125 mm thick at 38 m;
 - 50 mm thick at 39 m.

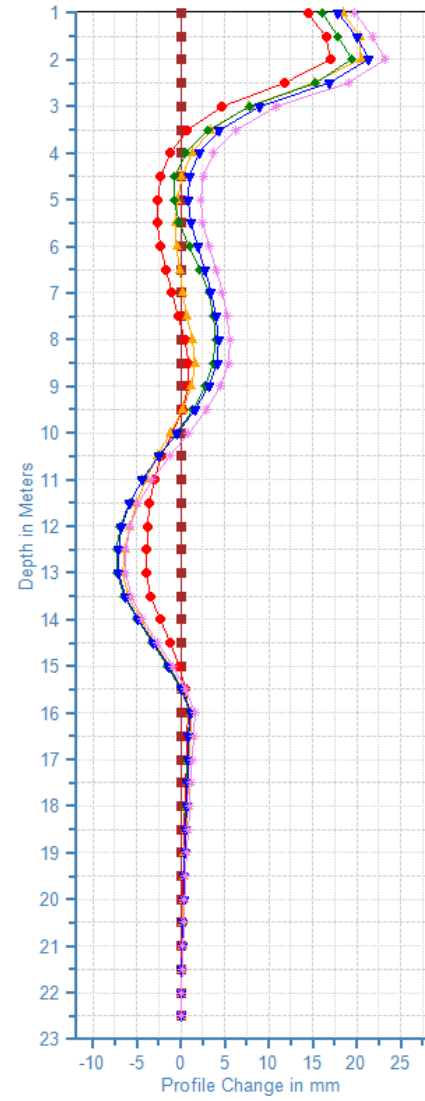
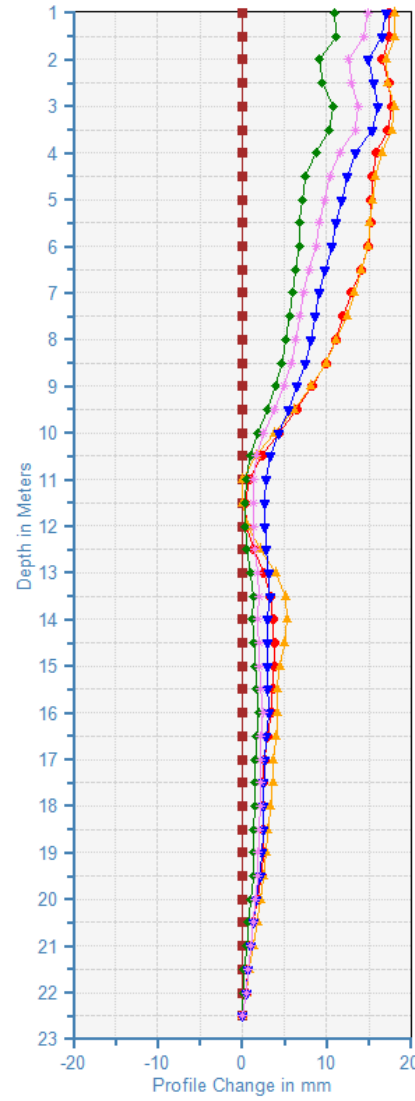
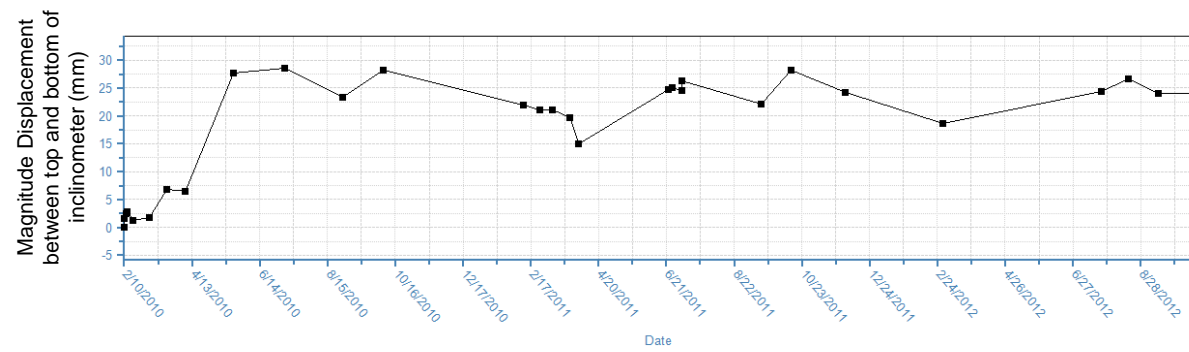
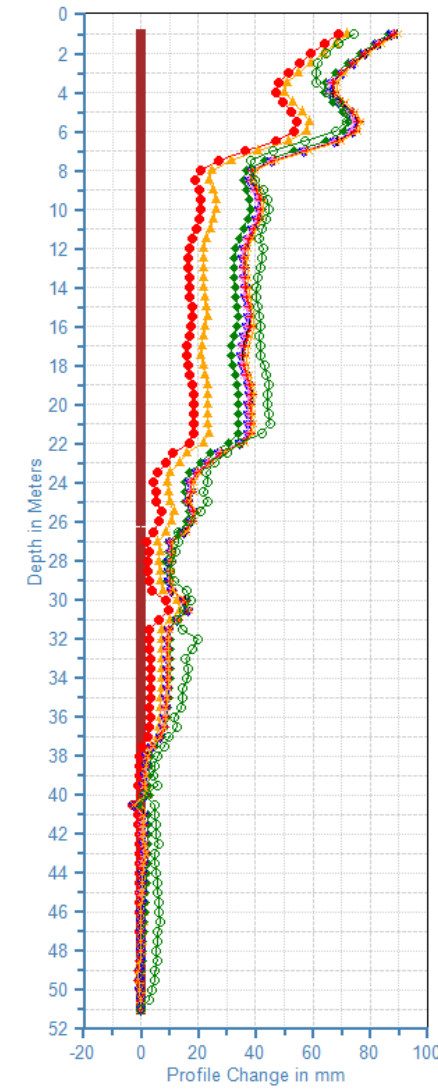
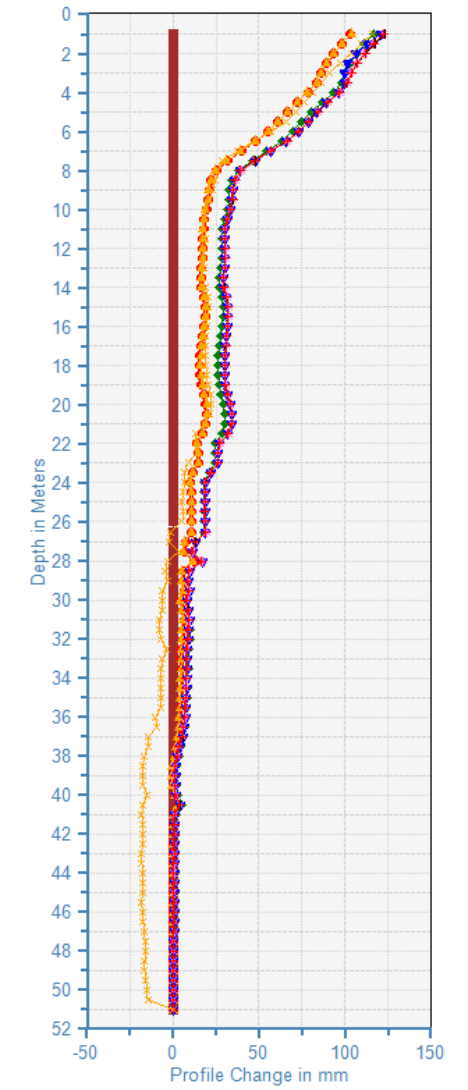
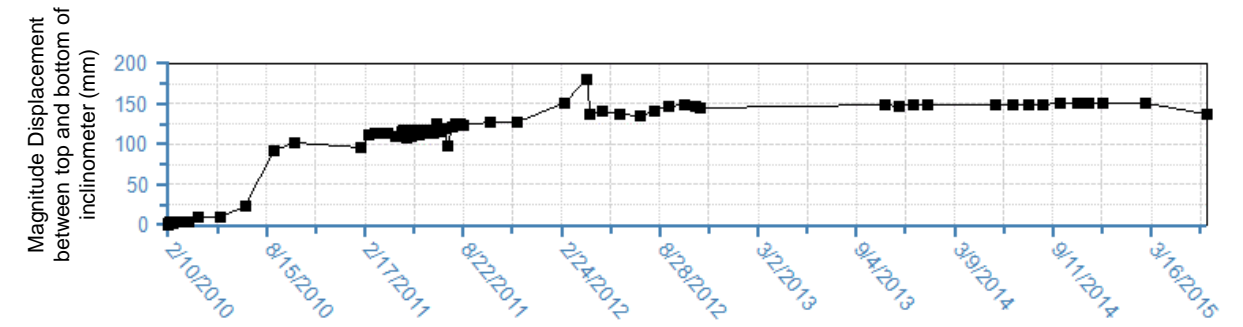
Figure: 9

Profiles and time displacement plots for both inclinometers are presented in Figure 9 of Appendix B. There is no movement trend detected in MDI-2.

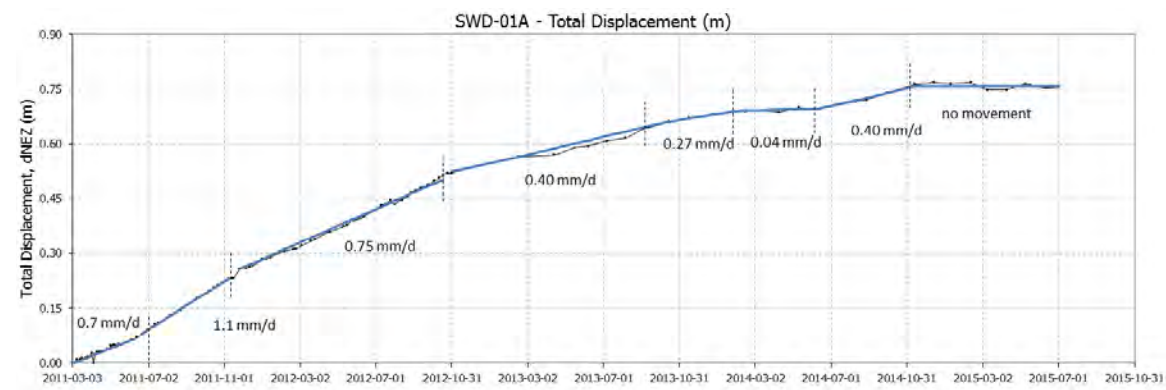
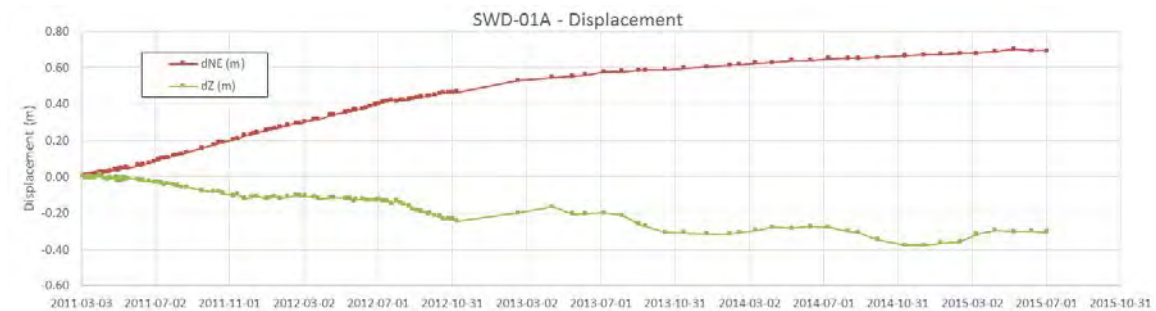
View of SWD-01A; heaved 30 cm out of the ground (Sept. 2014 photo).

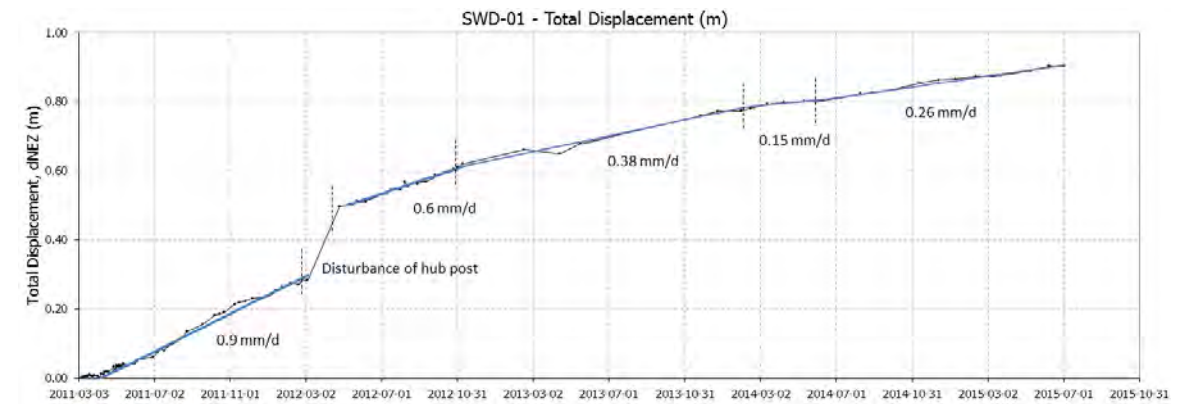
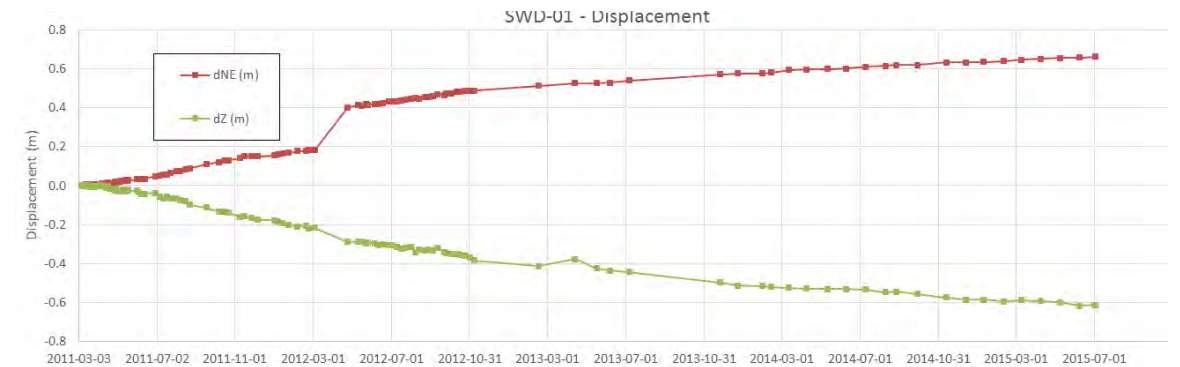
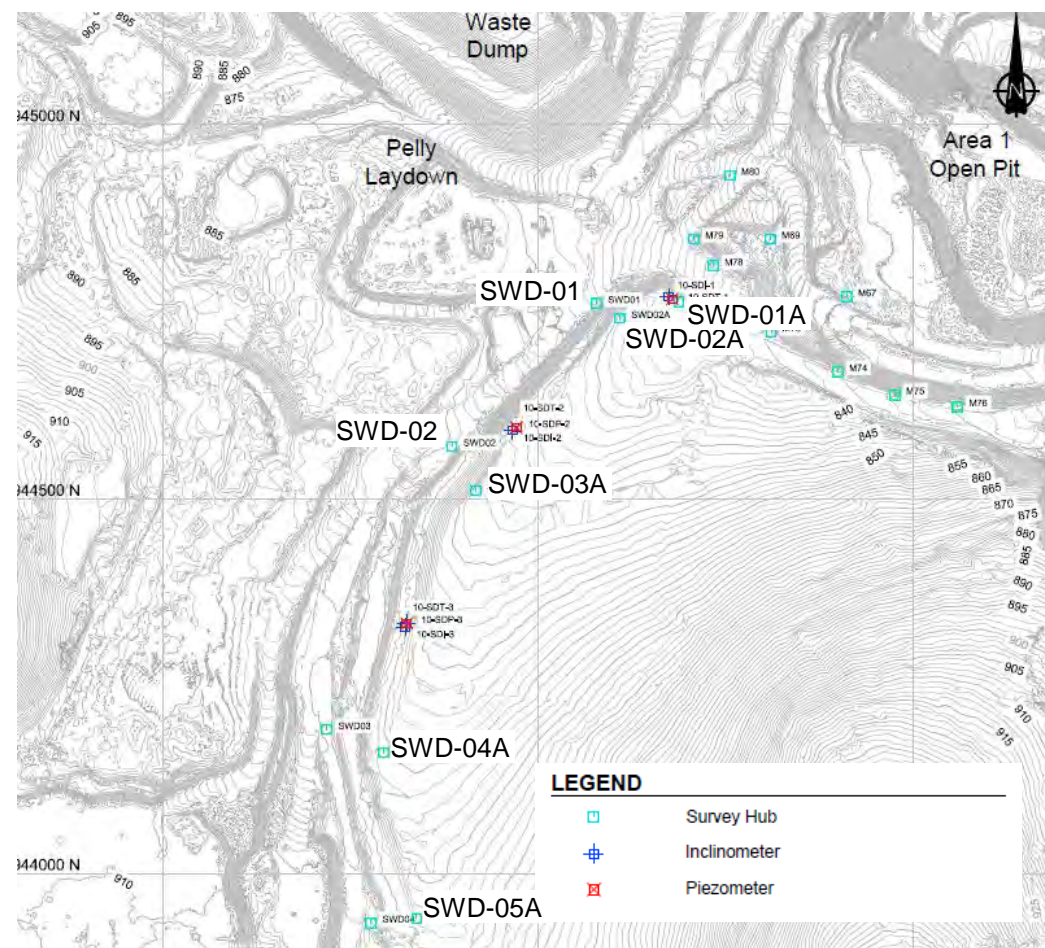
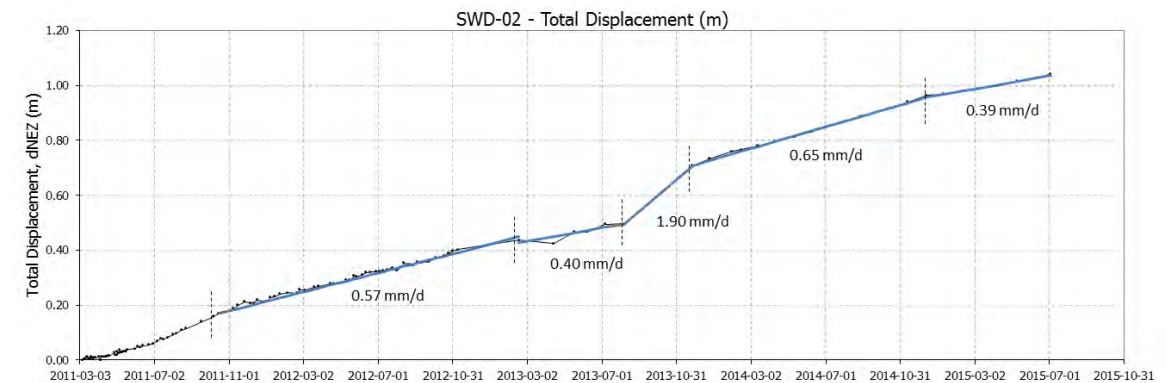
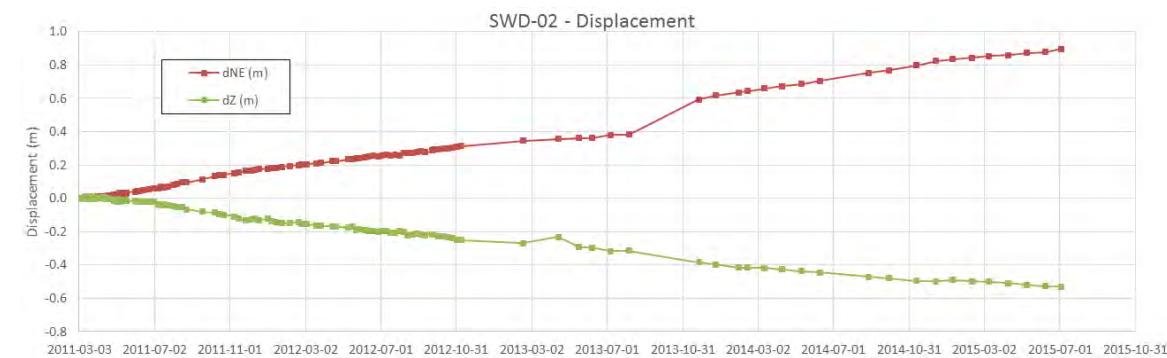
Date: July 2015
 Approved: PHM
 Figure: 10

Survey hub movement data are presented in Figures 10 and 11 of Appendix B. A summary of the current rates of movement compared to 2013 is provided in Table 4.4. Some of these hubs, as noted in the Table 4.4, appear to be disturbed due to heaving caused by frost action as evidenced by exposed concrete. This frost action is also evidenced by the seasonal variability in the movement data. As a result, the movement rates are questionable; however, they are supported by the movement rates observed at SDI-3.

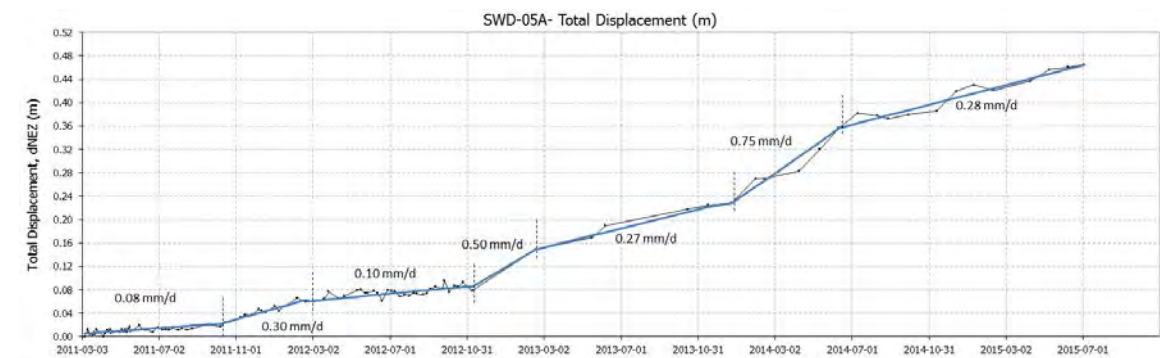
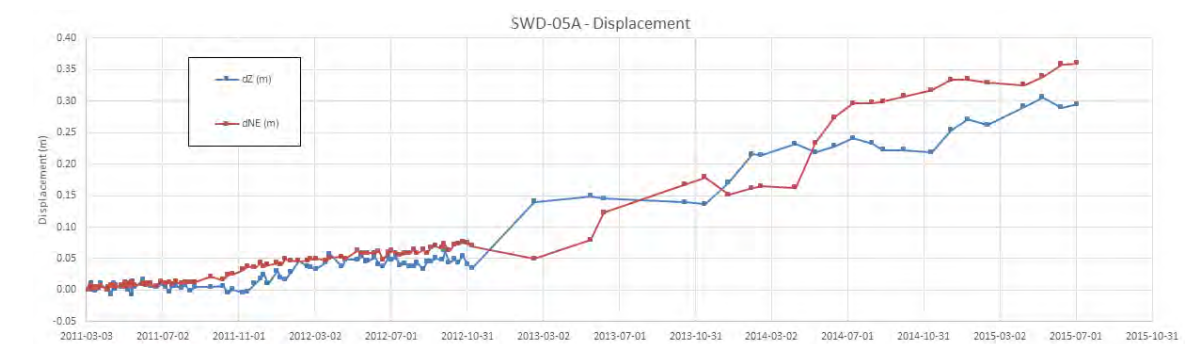
View of SWD-05A; heaved 30 cm out of the ground. (Sept. 2014 photo).
