2015 Geotechnical Annual Review, Minto Mine, YT

SRK Consulting (Canada) Inc.
1CM002.039
August 2015

Project No: 1CM002.039

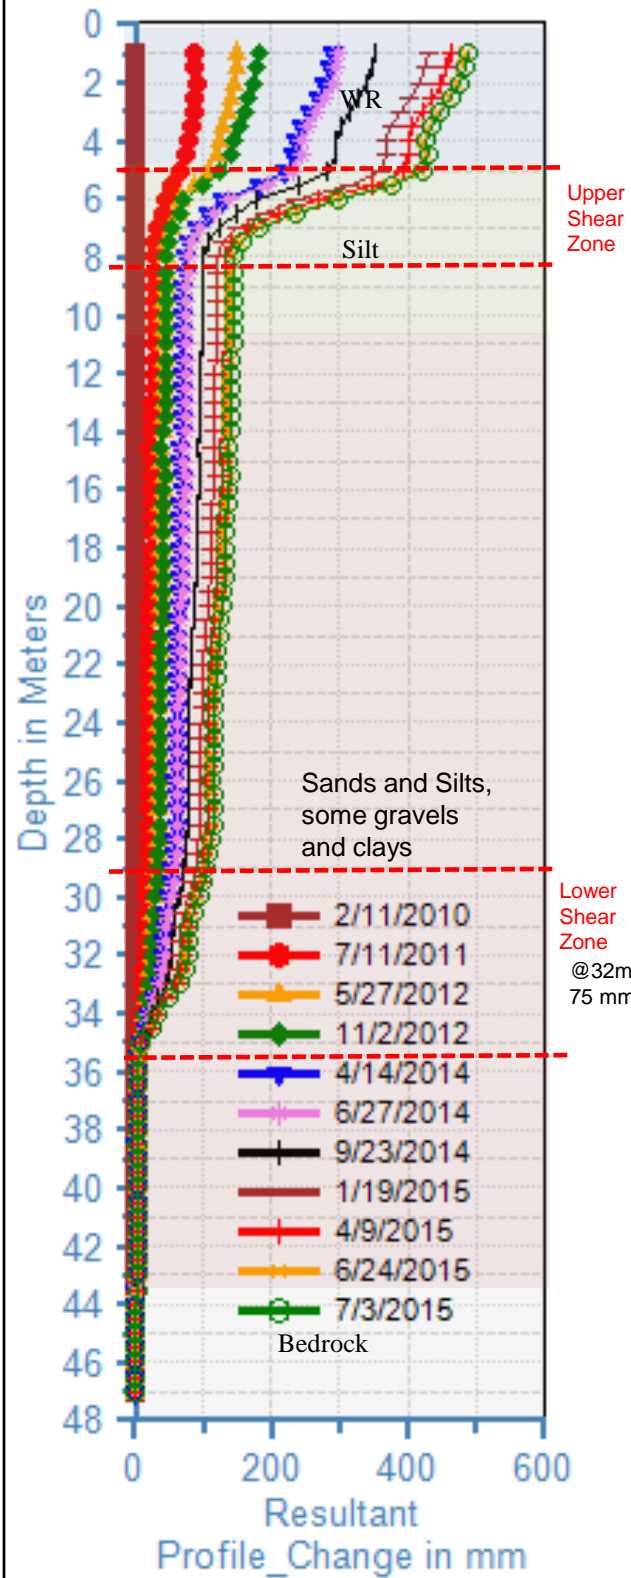
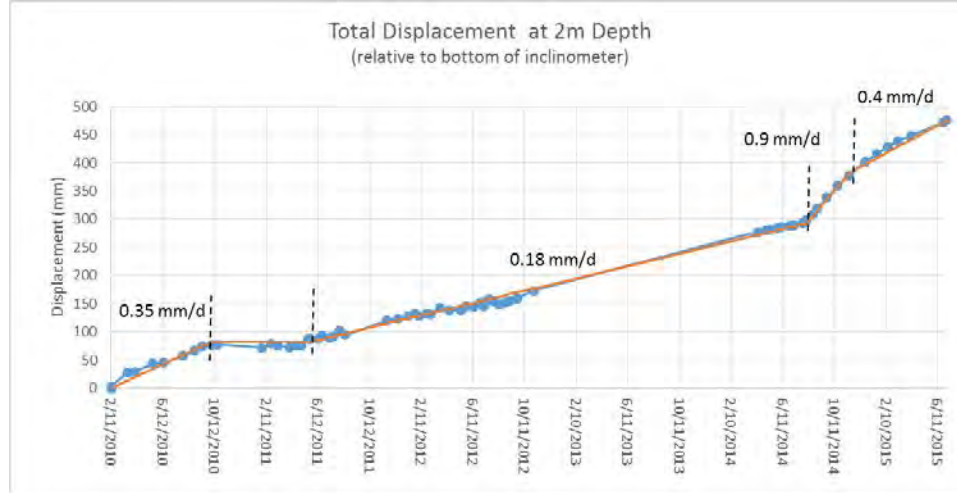
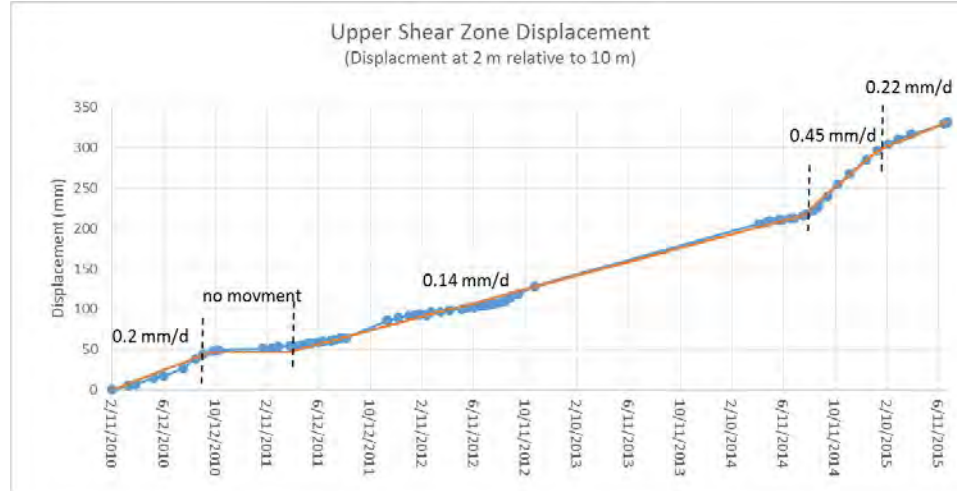
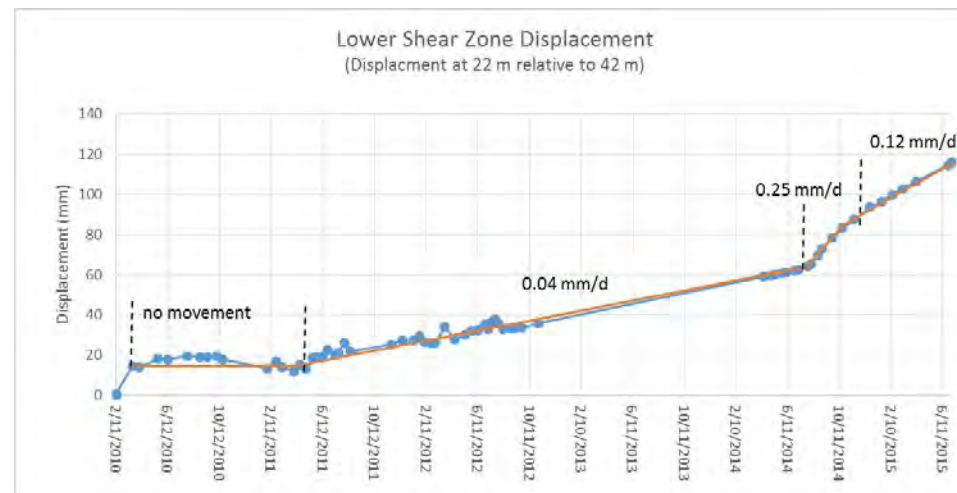
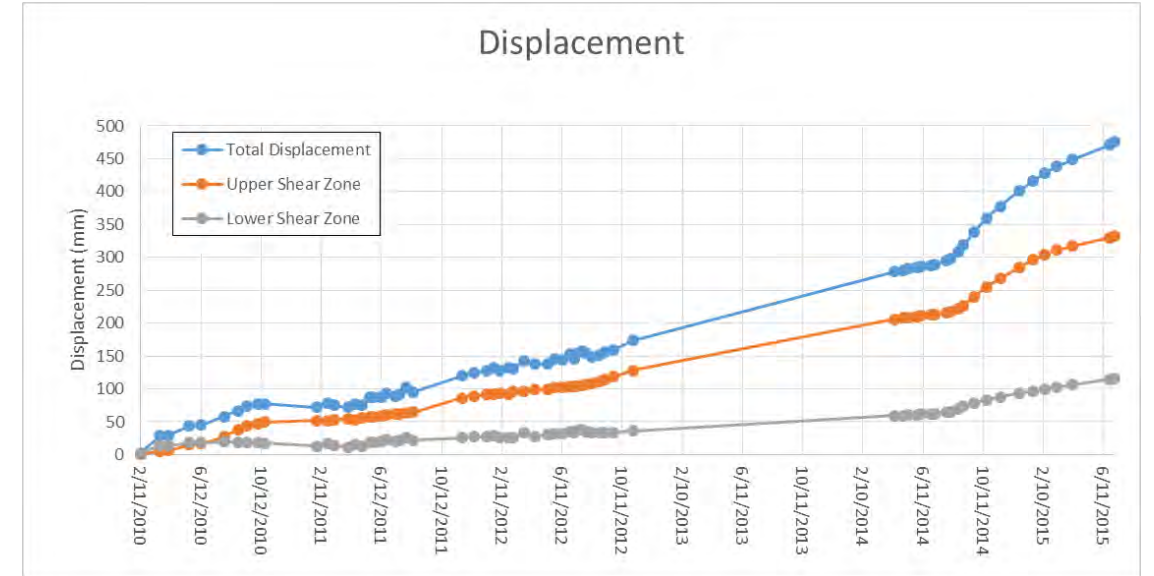
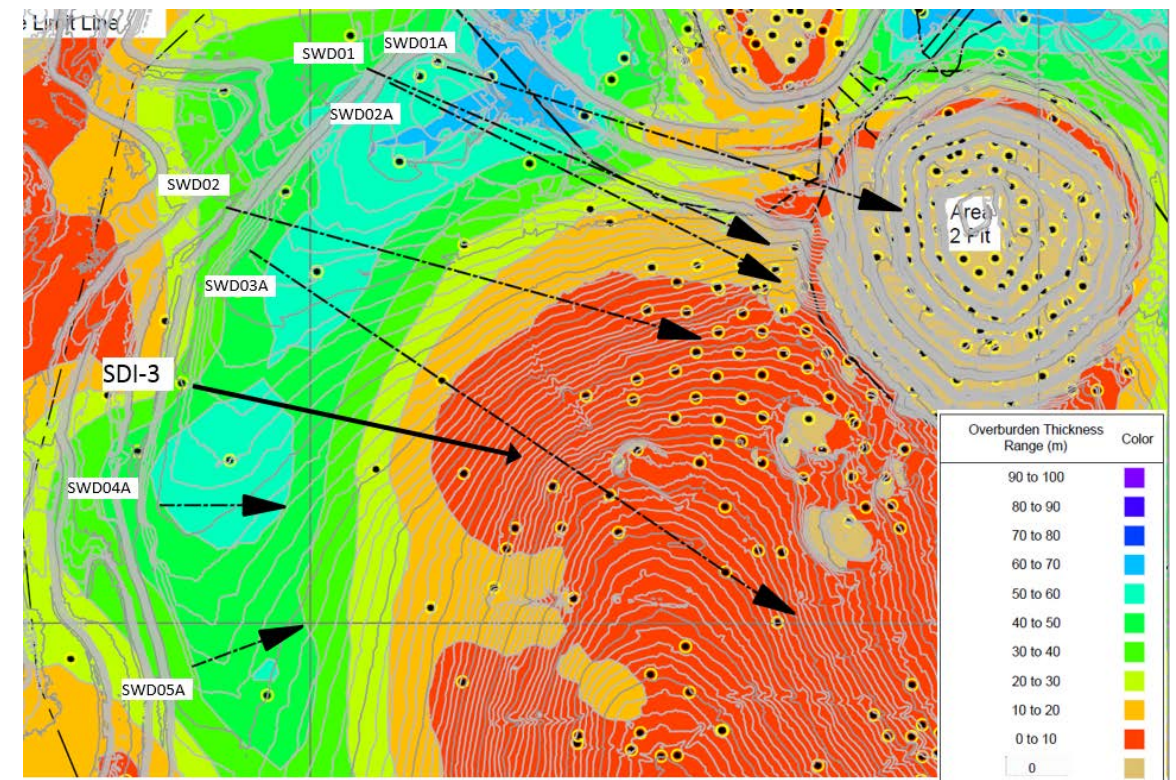
Date: July 2015
 Approved: PHM
 Figure: 12

Monitoring of inclinometer SDI-3 resumed in April 2014 (after the previous reading in 2012). The profile and time-displacement graphs for this inclinometer are presented in Figure 12 of Appendix B. The displacement profile indicates an upper and lower shear zone.

The upper shear zone movement increased in 2014 to up to 0.5 mm/day, the movement rate has decreased by approximately half in 2015. The movement is suspected to be related to thawing of the permafrost colluvium with potentially high excess pore water pressures, which is supported by the slight warming trend in temperature data at SDT-2 and SDT-3 and the high porewater pressure ratio data provided in Figure 14 of Appendix B. The movement rate is also suspected to be associated with waste rock resloping activities completed in the area in 2015. The movement rate of the upper shear zone is expected to decrease as the pore water pressure dissipates.

Summary of the SWD survey hub and SDI-3 inclinometer cumulative displacement vectors.

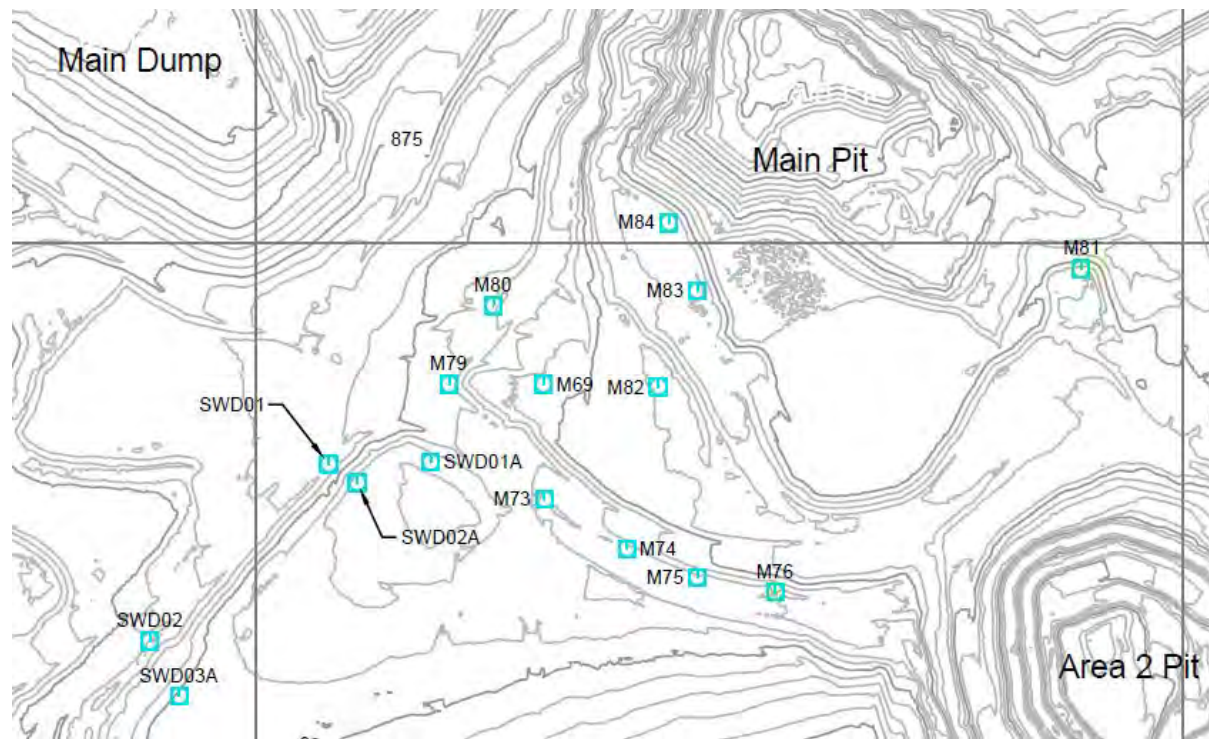
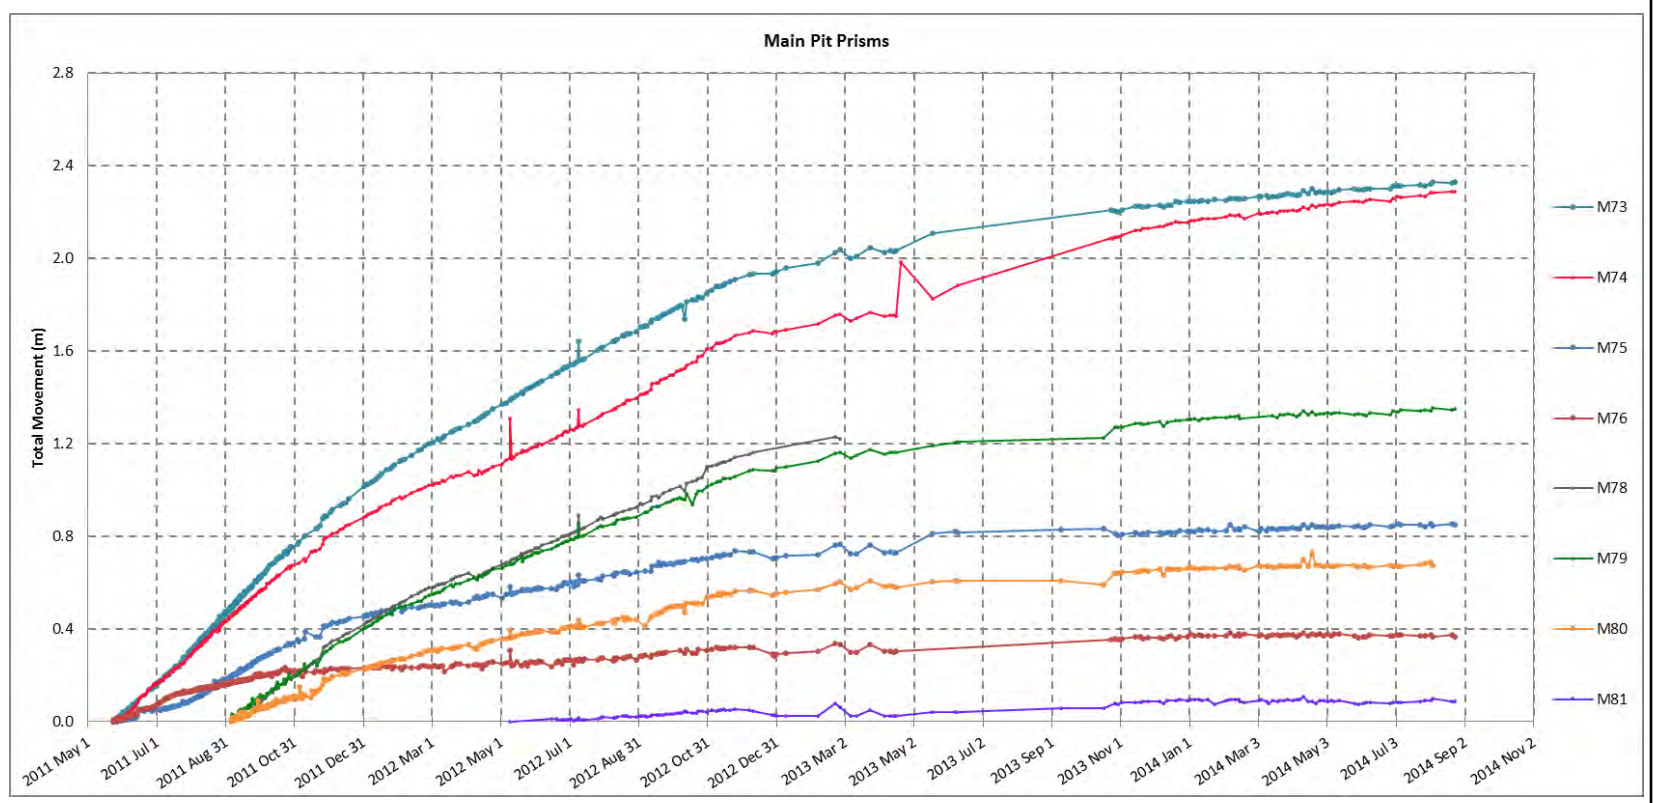
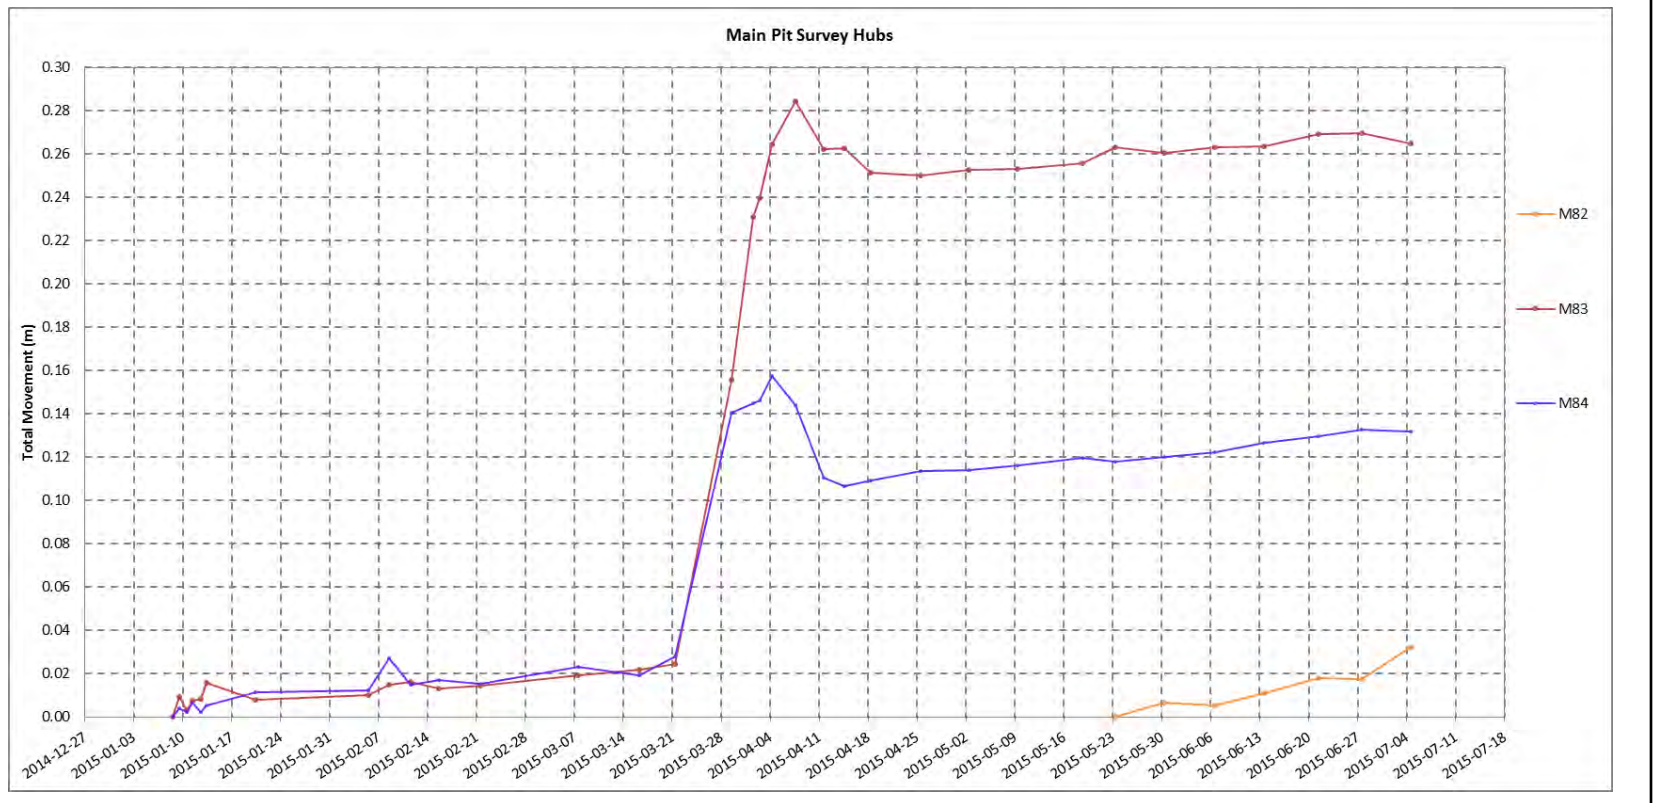
Date: July 2015
 Approved: PHM
 Figure: 15

Survey hub movement data for the Main Pit south wall are presented in Figure 15 of Appendix B. The data indicates that the movement rates have significantly decreased, and are generally showing a decelerating trend.

Survey Hub	Current Rate of Movement, dNEZ (mm/day)
M69	0.3
M73	0.3
M74	0.3
M75	0.1
M76	no movement
M79	0.2
M80	no movement
M81	no movement
M82	0.6
M83	0.2
M84	0.2
