# 2017 Geotechnical Annual Review, Minto Mine, YT

Minto Explorations Ltd.

SRK Consulting (Canada) Inc.  
1CM002.059  
August 2017

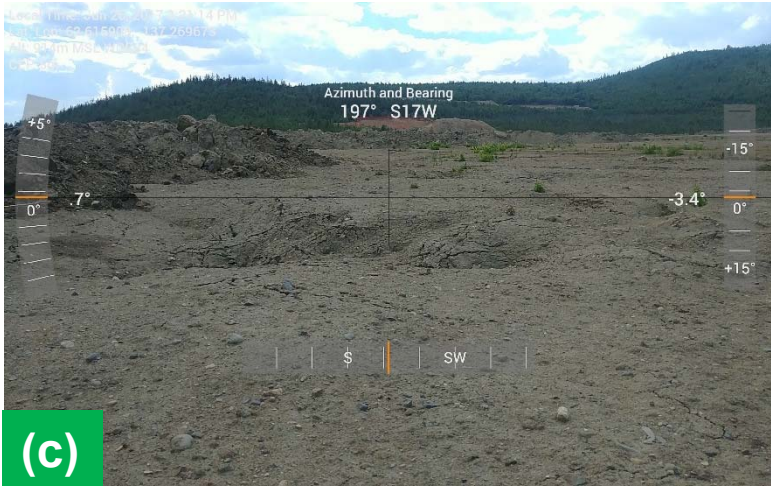
- Photos (c) and (d) show depressions, areas of differential settlement, and cracking of the overburden slope that was placed during the winter.

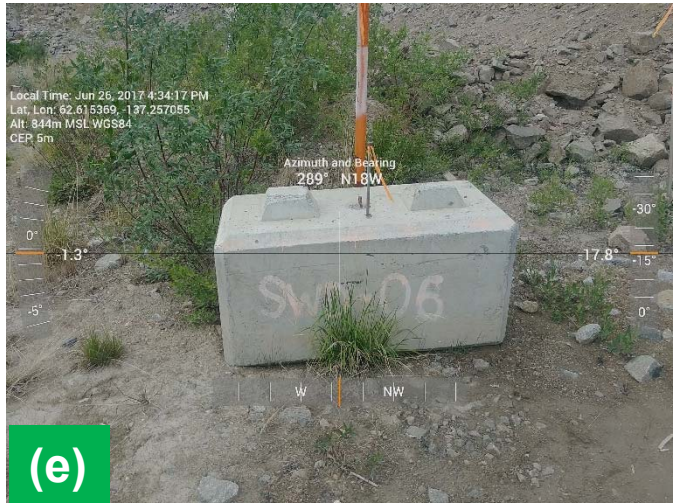
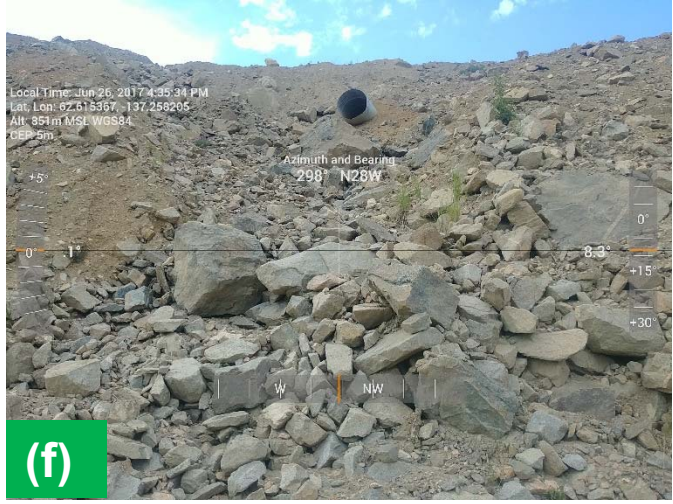
- Photo (e): Survey hub SWD-06 has been installed to replace SWD-01A that was impacted by frost heave. The remainder of the hubs that have experienced frost heave (SWD-02A, -03A, -04A, and -05A) have also been replaced with hubs mounted on lock-blocks or large boulders.
- Photo (f) shows the outlet of the culvert below the Pelly Laydown area. The appearance of the waste rock rip-rap below the culvert appears the same as in previous years inspection photos.

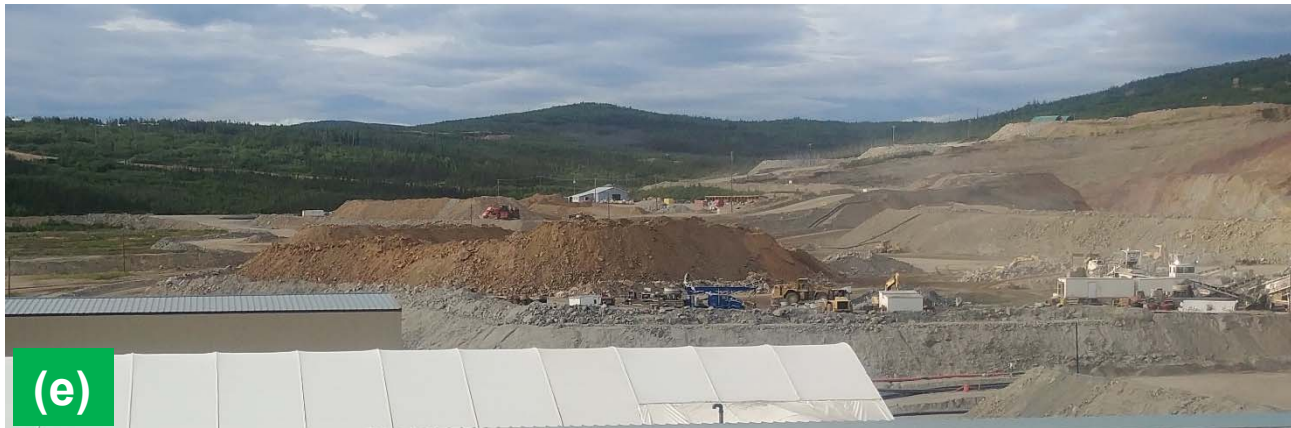
2017 Geotechnical Inspection		
		Mill Site and Ore Stockpiles		
Job No: 1CM002.059 Filename: AppA_2017InspectionPhoto.pptx	Minto Mine	Date: August 2017	Approved: PHM	Figure: 8

- The ore stockpiles were investigated briefly in passing. All slopes appeared in good condition: no slumping, bulges, cracks, or other signs of instability were observed.

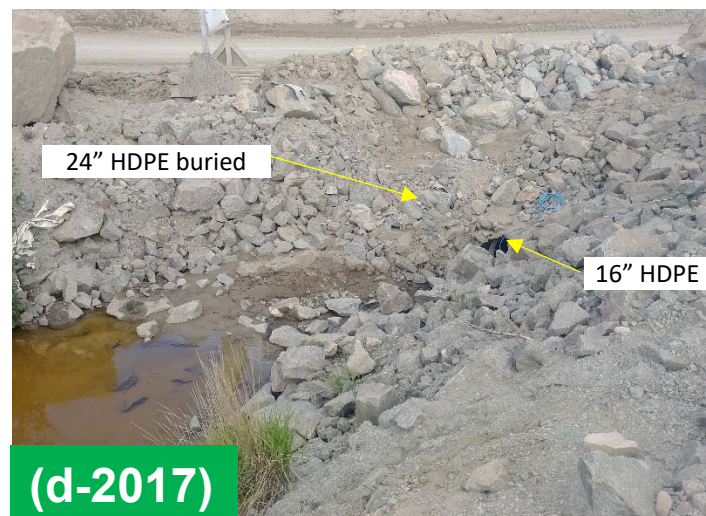
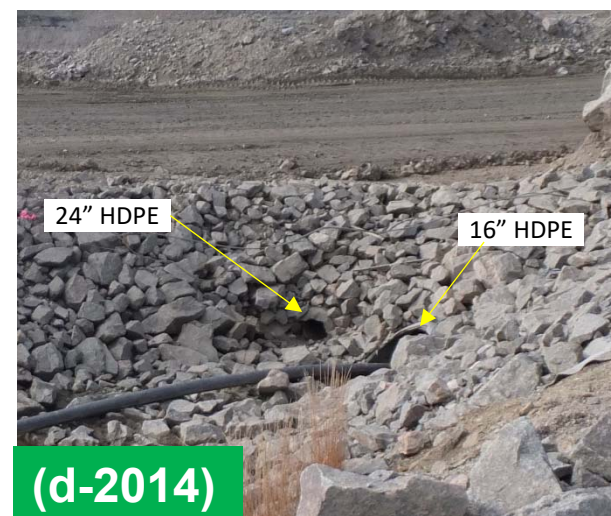
- The South Diversion Ditch was inspected between the overflow spillway and the intake structure. The ditch along the Airport Access road was also inspected. The pipeline alignment between the overflow spillway and the Main Pit Confluence area was not inspected during the site visit.

- No signs of instability were noted along the side-slopes.
- Due to the future development of the Area 2 Stage 3 Pit, the SDD is to be decommissioned with water at the SDD Intake Structure is to be diverted to the Tailings Diversion Ditch (TDD), with any flow that exceeds the TDD capacity, directed into the Area 2 Pit. It is understood that these works will start in August 2017 and be completed prior to the 2018 freshet.

- Photo (d): View of the HDPE pipe intake area in 2017 and 2014. The grading of the UG Portal Access Road has also resulted in the larger 24" HDPE pipe being buried. This greatly reduces the capacity of the piping, and with the current blockage of the overflow spillway, there is a significant risk of overtopping of the SDD. of the west bank. Conditions the same as noted in previous inspections.

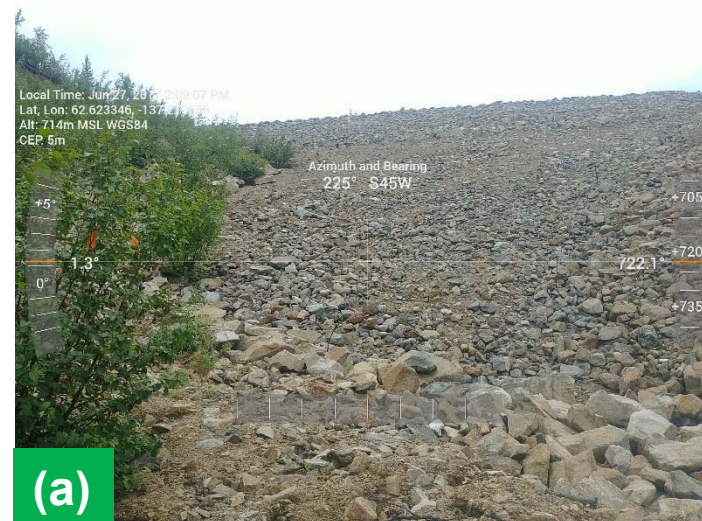
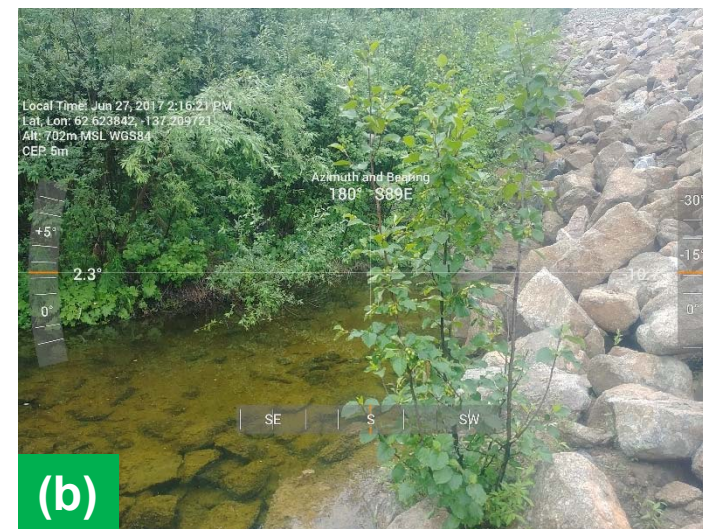
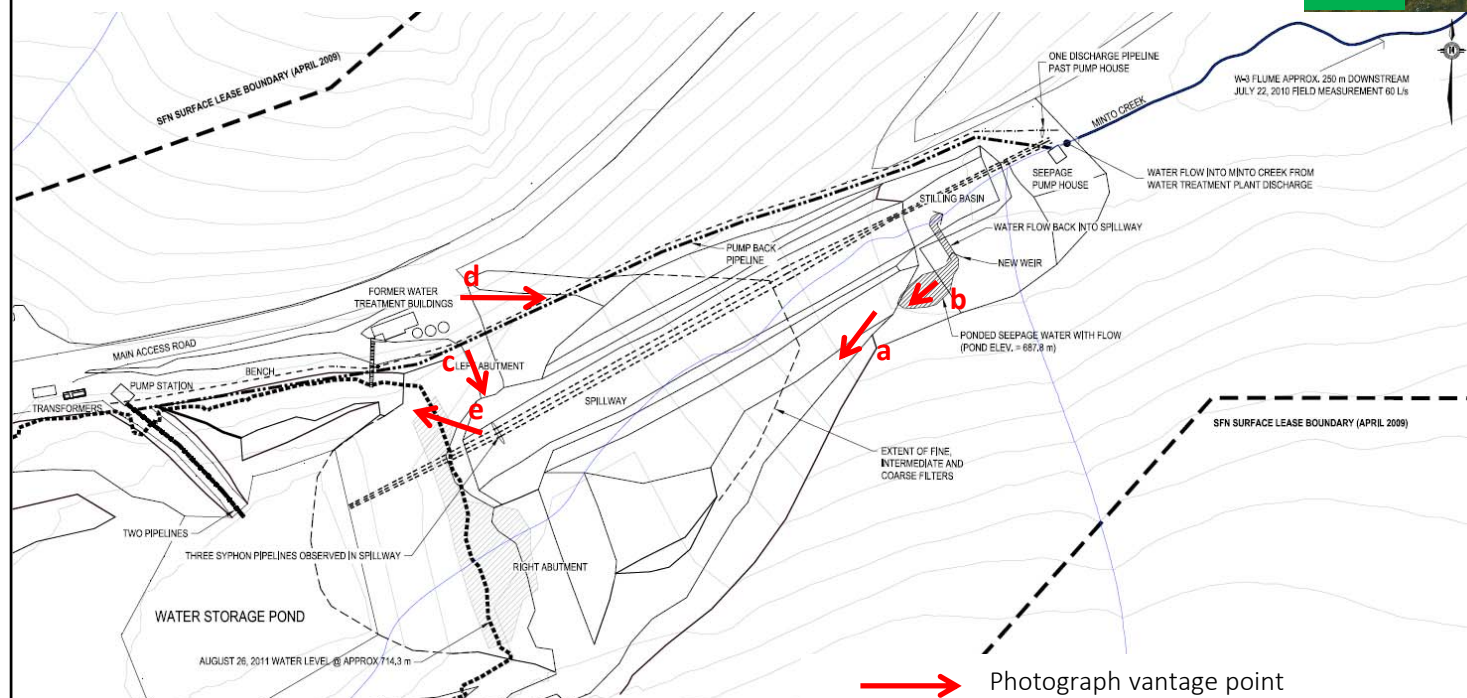
2017 Geotechnical Inspection		
		<b>Water Storage Pond Dam</b>		
Job No: 1CM002.059 Filename: AppA_2017InspectionPhoto.pptx	Minto Mine	Date: August 2017	Approved: PHM	Figure: <b>12</b>

The June 2015 geotechnical inspection reported a large area of erosion on the left (north) abutment of the dam that was exposed as a result of the water level being lower than the normal operating level. The area was repaired in July 2015 by placing additional rip-rap as protection after consulting with the Engineer of Record for the dam, TetraTech EBA. The repaired area could not be observed during in 2016 inspection, as the pond water level was within normal range, but was visible during the 2017 inspection (e).

- Pond elevation during the inspection was approximately 709.5 m (spillway elevation 716.2m)
- No signs of instability along the dam, or at the abutments.
- Seepage water downstream of the dam was clear and no accumulation of sediments was observed.
- The weir present downstream of the dam had an estimated flow rate of <1 L/s. Condition of the seepage water appears unchanged compared to the 2016 inspection. Water flow could not be heard in the rockfill adjacent to the seep. The water was clear with no turbidity.

- Continue regular monitoring of the dam as per the OMS Manual.

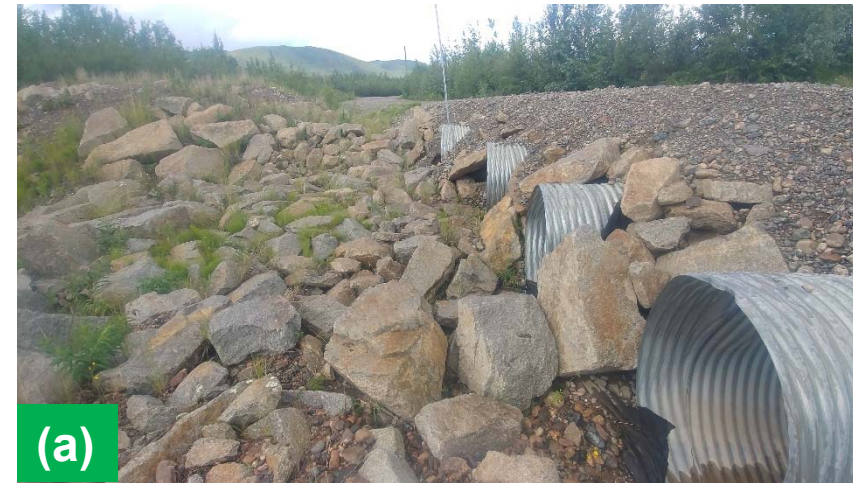
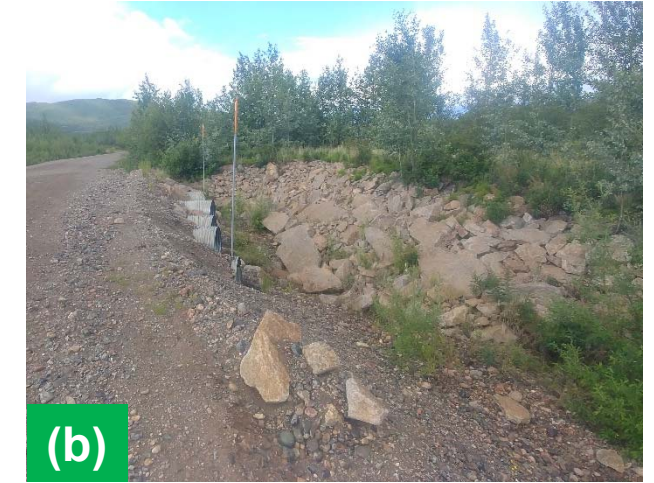
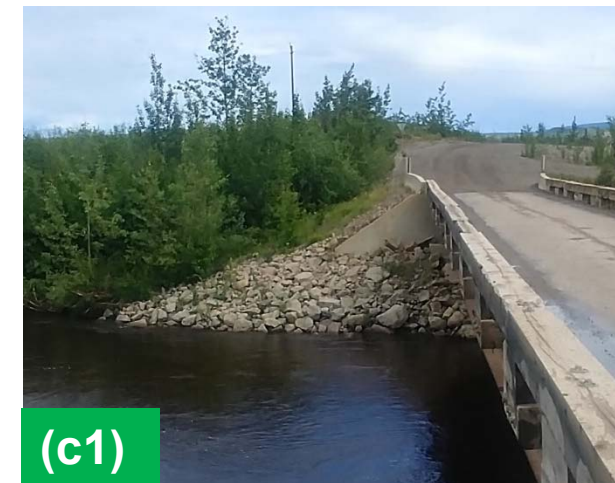
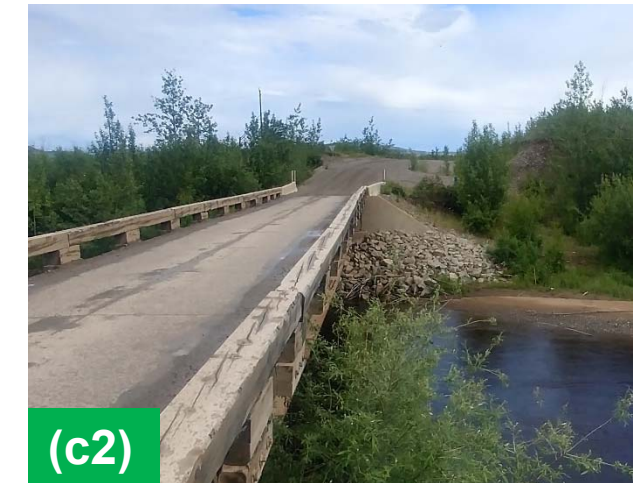
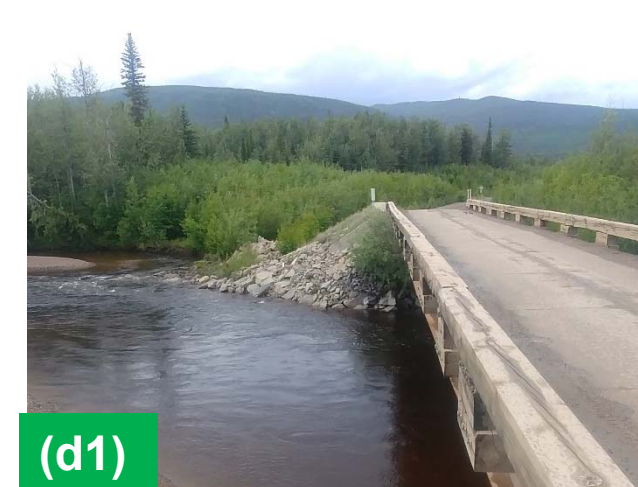
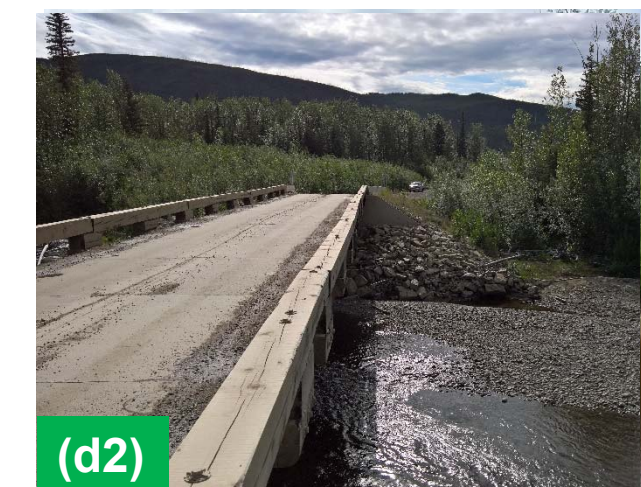
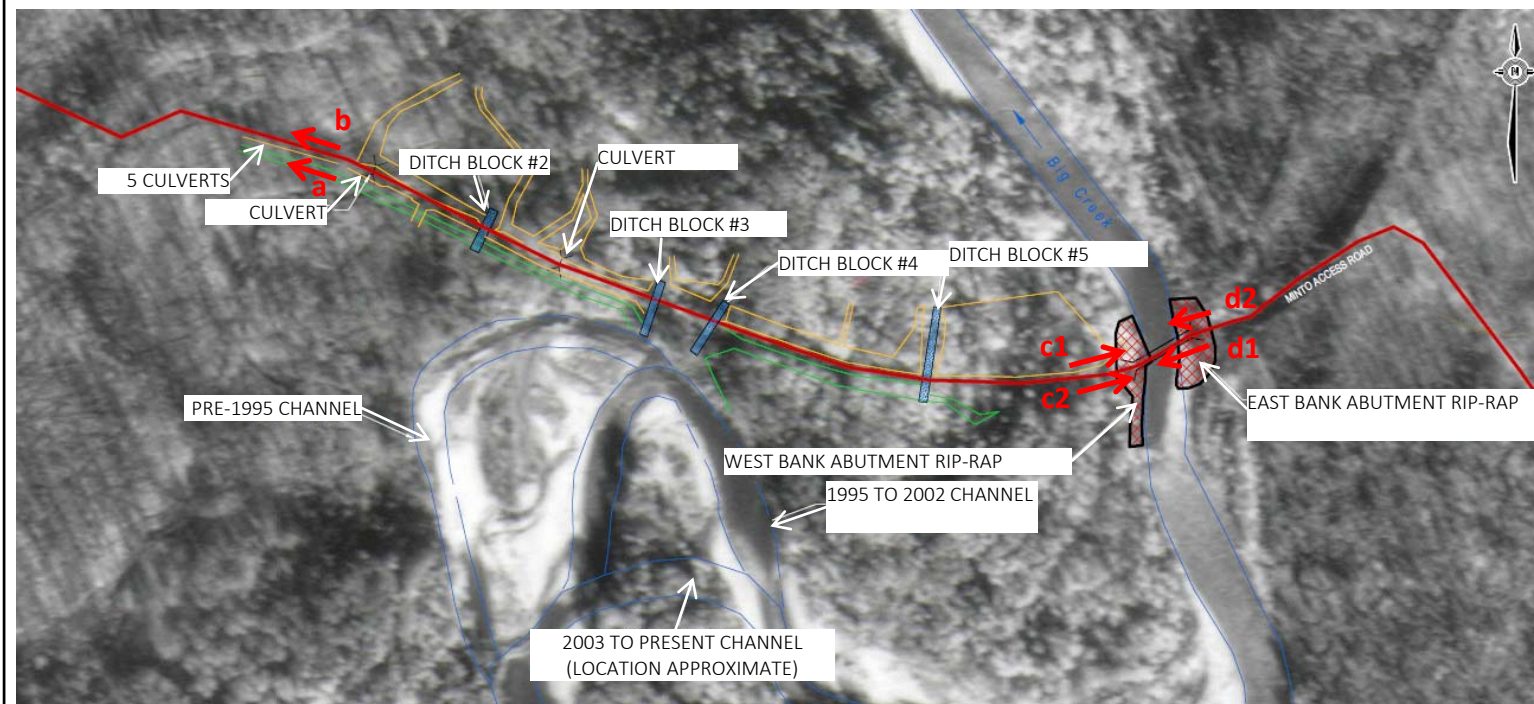
2017 Geotechnical Inspection		
		<b>Big Creek Bridge</b>		
Job No: 1CM002.059 Filename: AppA_2017InspectionPhoto.pptx	Minto Mine	Date: August 2017	Approved: PHM	Figure: <b>13</b>

- Conditions of the culverts are unchanged since the previous June 2016 inspection. All culverts are in satisfactory conditions with no major blockages or sediment accumulation at either end of the culverts. The first culvert west of the bridge is in satisfactory condition.
- Photos (a) and (b) show the upstream and downstream ends of the group of 5 culverts, each with diameter of 1.1 m. The culverts are in satisfactory condition, with no blockages at either end. Small portions of geotextile are exposed at either end, but is not impacting the culvert performance.
- Ditch Blocks #2 to #5 are unchanged from previous inspections and are in satisfactory condition. Ditch Block #1 has not been constructed.
- Photos (c) and (d) show the east and west abutments, respectively. The bridge abutments and road approaches are in good condition, with no signs of instability observed.

- Continue regular annual monitoring of sediment accumulation in the culverts, and clean out if sediments continue to accumulate.

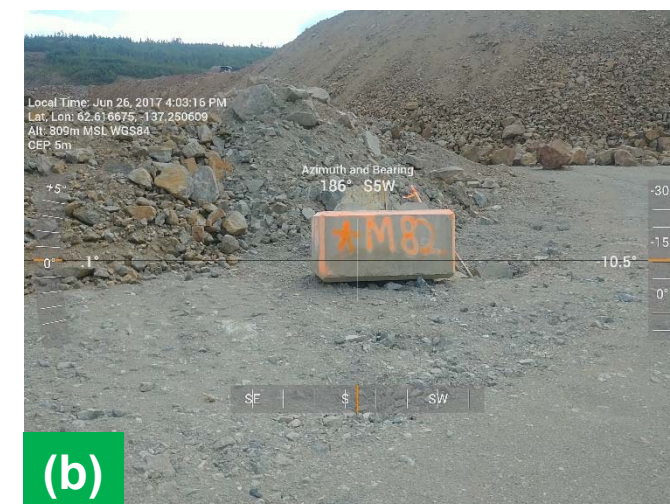
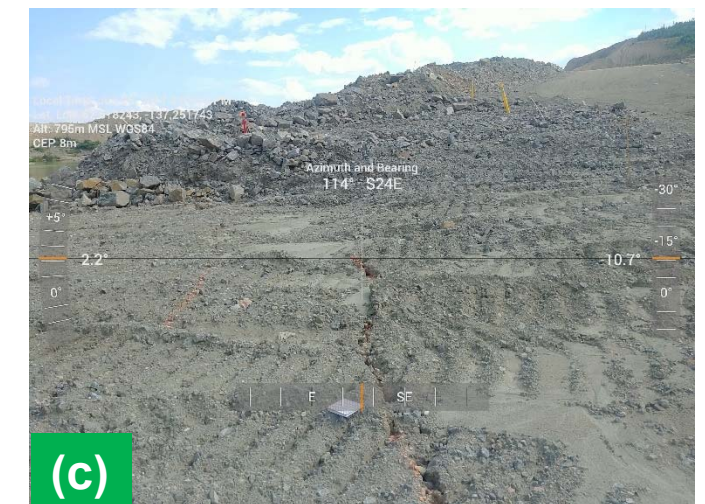
2017 Geotechnical Inspection		
		Main Pit, South Wall Buttress, and In-pit Dumps		
Job No: 1CM002.059 Filename: AppA_2017InspectionPhoto.pptx	Minto Mine	Date: August 2017	Approved: PHM	Figure: 14

measured movement may be due to shifting or rocks beneath the lock-block (see Figure 14, Appendix A).

- No waste rock was placed on the 'in-pit dump' (photo (a)) and no visible changes of the cracking were observed in the with no change in the condition of the cracking observed.
- The cracks noted during the 2016 inspection parallel to the pit wall at the south end of the pit was not observed during the 2017 inspection as a result of construction of an access road over the cracking location. The 2016 cracking was believed to be due to settlement of the waste rock within Main Pit.
- Survey hub M82 (Photo (b)) was observed with rocks underneath its lock block, which is likely the cause of the variability in the survey hub readings.

- Minor cracks were observed parallel to the advancing face of the SAT dump (Photo (c)). The maximum crack width observed was 3 cm. The SAT dump is being advanced in a controlled manner with the dump face advanced 5m, followed by a minimum 7 day tailings consolidation period, and as a result, cracking is to be expected as a result of consolidation of the underlying tailings. The cracks are routinely monitored by Minto staff and spray painted to monitor propagation.
- Tracks from haul trucks were observed close to the dump face – truck traffic should be maintained a minimum of 5 meters away from the dump face, or a spotter should be present.

- **High Priority:** Clear the loose rocks beneath M82
- Continue to limit access to the In-Pit Dump area near M84.
- During SAT material placement, truck traffic should be maintained a minimum of 5 meters away from the dump face, or a spotter should be present.

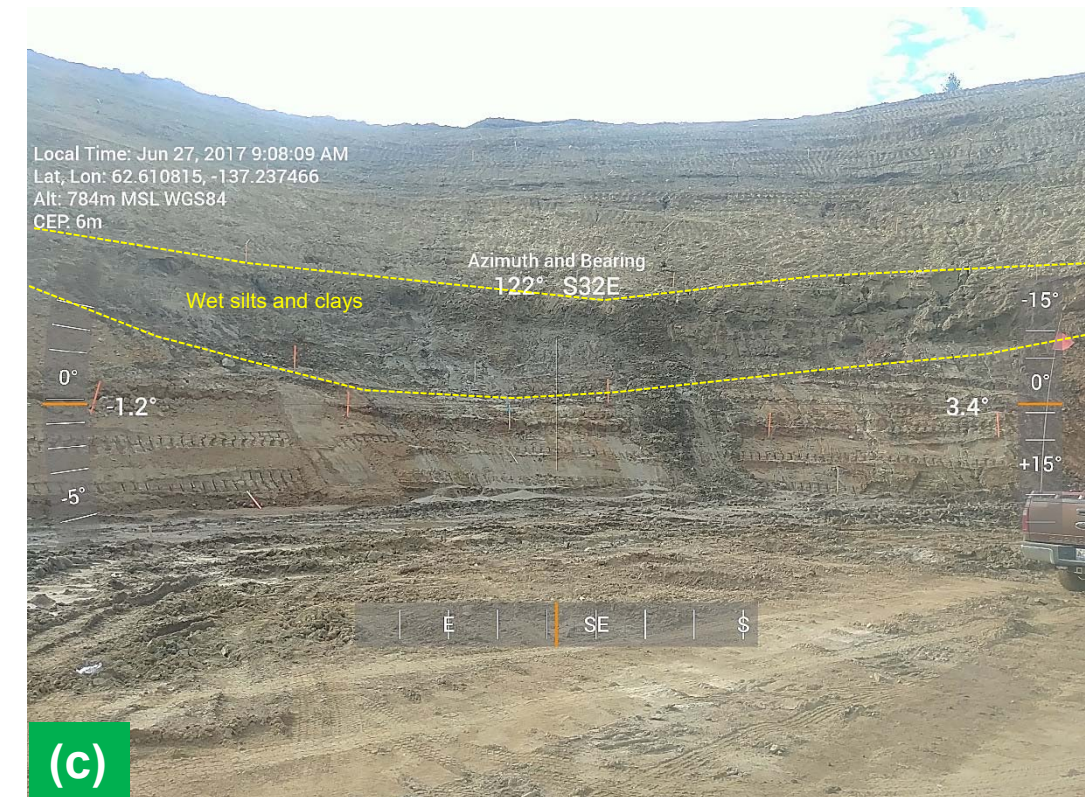
2017 Geotechnical Inspection		
		Area 2 Pit		
Job No: 1CM002.059 Filename: AppA_2017InspectionPhoto.pptx	Minto Mine	Date: August 2017	Approved: PHM	Figure: 15

- Photo (a): View of the Area 2 Stage 2 Pit taken from the north side looking south.
- Photo (b): View of the Area 2 Stage 2 Pit looking north.
- Photo (c): View of the Area 2 Stage 3 overburden slope in the south east corner of the pit. The photo notes a layer of wet, fine grained silts and clays that was thawed at the surface, with melt water draining onto the pit floor. No ice or ice lenses were observed, but the zone likely contains excess ice. The area is likely to be subject to localized instability and sloughing as a result of the melting ice similar to that experienced on the east wall of the Area 2 Stage 2 Pit (photo b), but large scale movement of the slope is a possibility. The area should be closely monitored, and it is recommended that a survey prism be established above the zone to monitor displacement.

- Recommendations:**
- **High Priority:** Review displacement of the slope based on radar (or l-site scanner) data to confirm any areas of movement and the rate of movement. Based on the results of the review, establish a survey prism/hub to monitor displacement of the south wall of the Area 2 Stage 3 Pit.

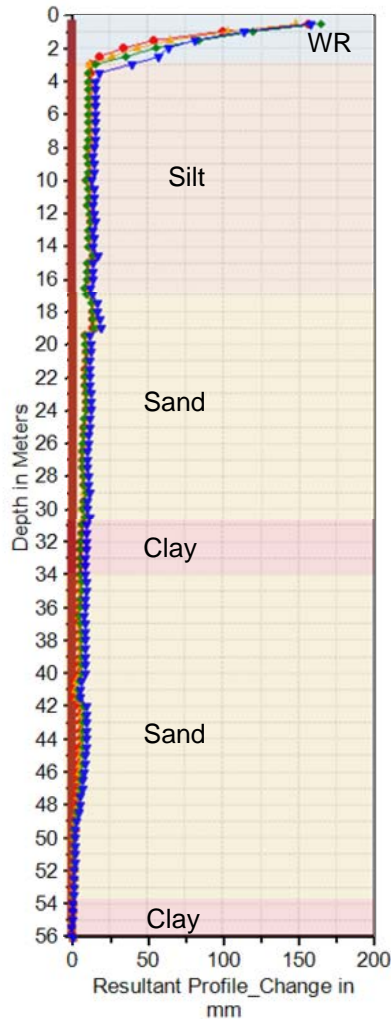
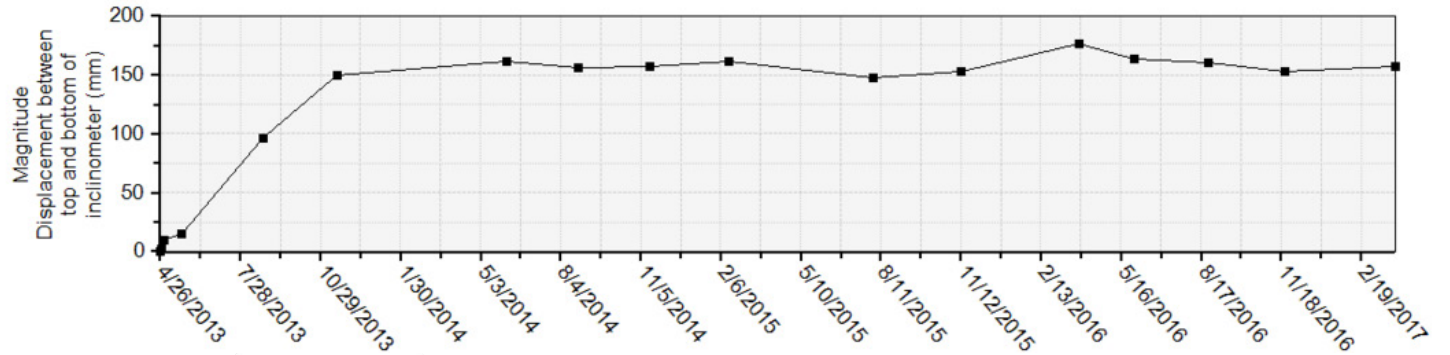
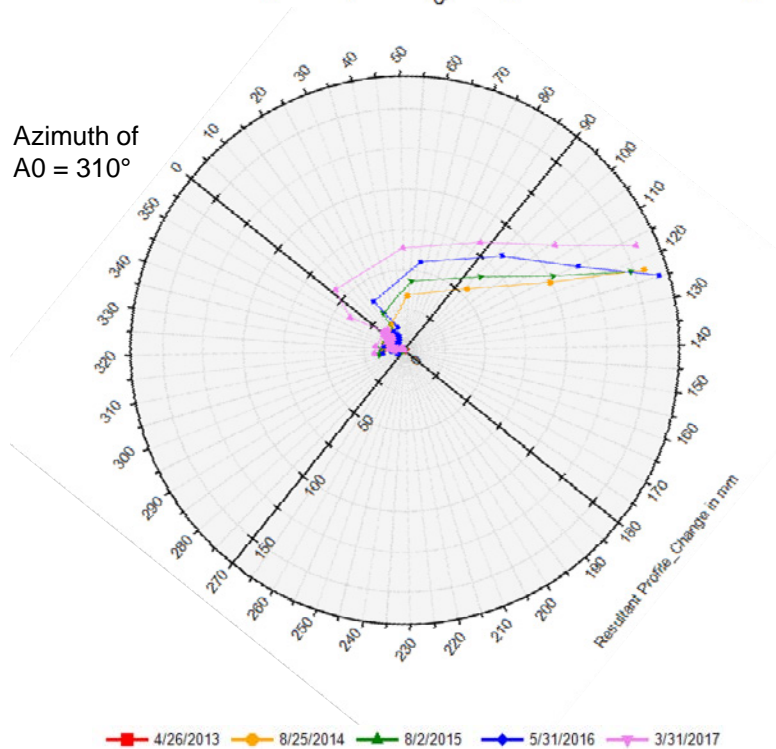
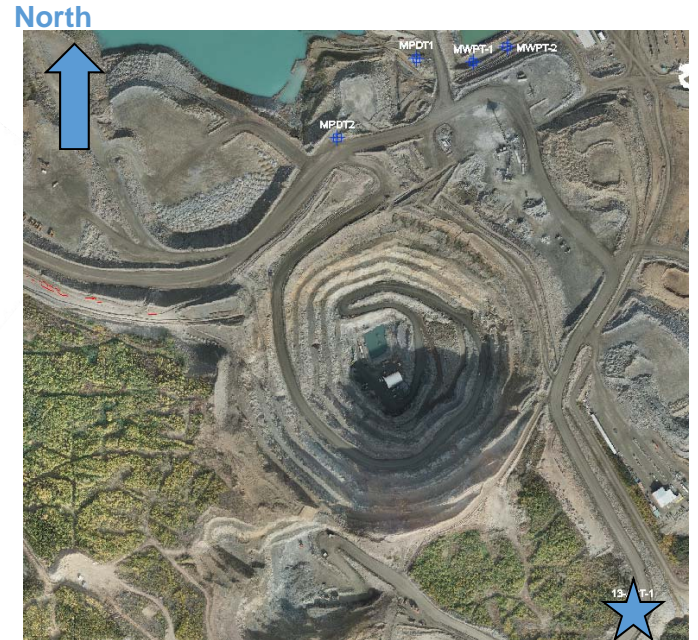
MINTO MINE <small>OPERATED BY MINTO EXPLORATIONS LTD.</small>	Area 2 Pit Instrumentation Data		
		<b>Inclinometer A2I-1</b>		
Job No: 1CM002.059 Filename: ApC_2017Area2Pit.pptx	Minto Mine	Date: August 2017	Prepared by PHM	Figure: <b>1</b>

The inclinometer data is shown in Figure 1 of Appendix C. The data shows a shear occurred within the waste rock fill near the surface during the initial year of data collection, along with some minor displacement at lower depths with no significant movement prior to 2017. The reading collected in March 2017, indicates some movement towards the pit (most visible on the polar plot in Figure 1), which may be related to the excavation of the Area 2 Stage 3 Pit. Additional readings are required to confirm the trends.

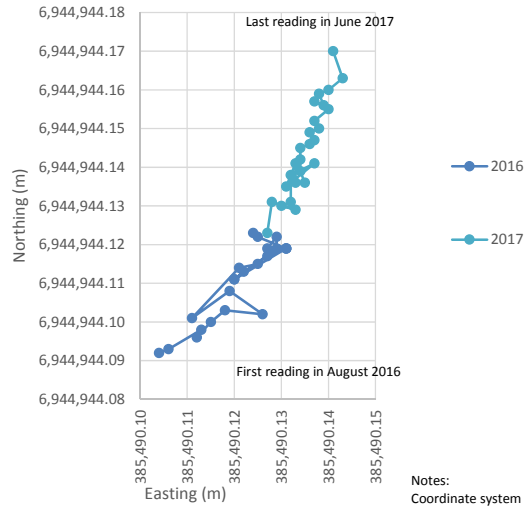
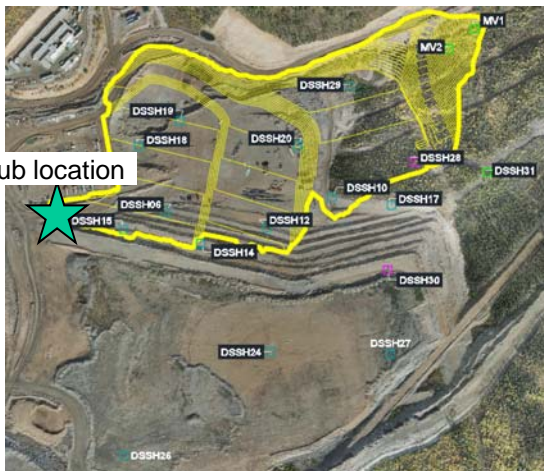
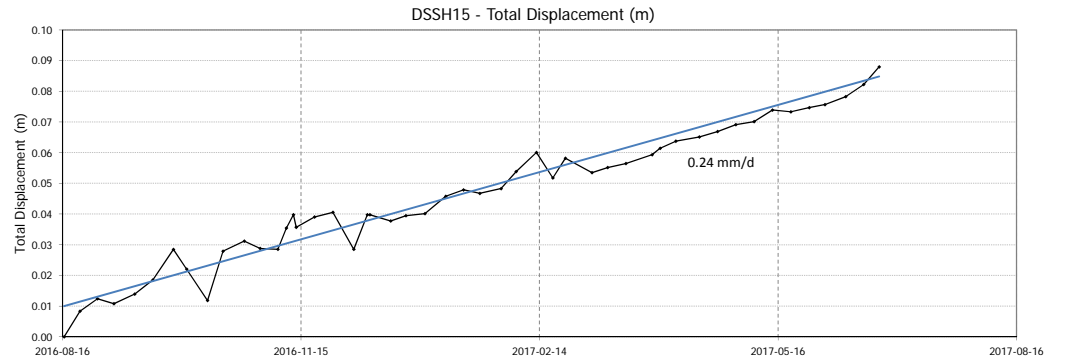
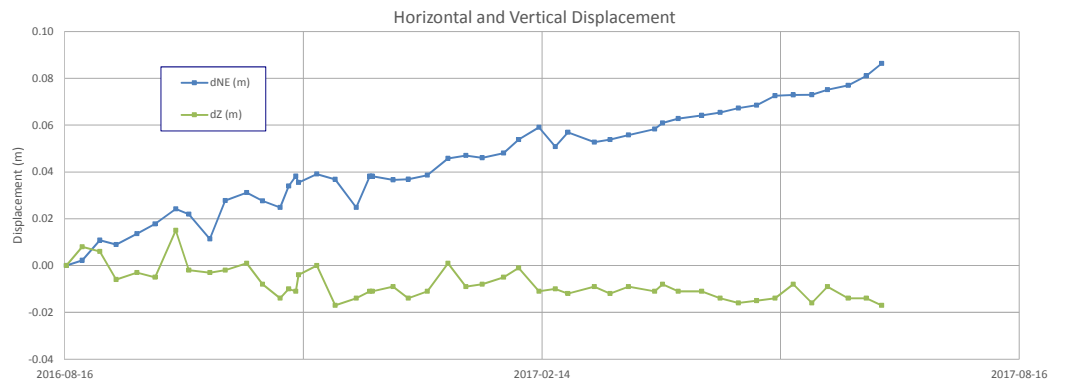
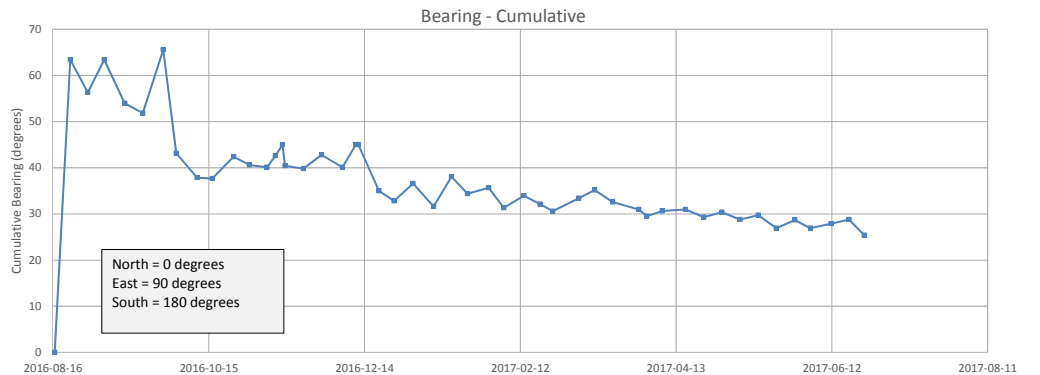
DSTSF Instrumentation Data		
		<b>Survey Hub – DSSH15</b>		
Job No: 1CM002.059 Filename: ApD_2017DSTFLandscape.pptx	Minto Mine	Date: August 2017	Prepared by PHM	Figure: <b>6</b>

- The survey hub was removed in February 2016 prior to MVFES2 construction. The hub was reinstalled in August 2016 following completion of construction.

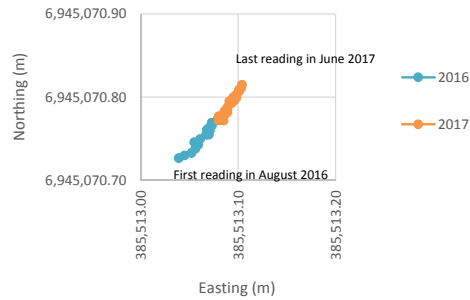
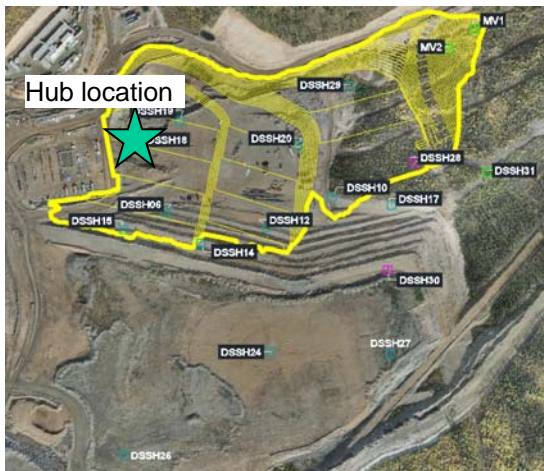
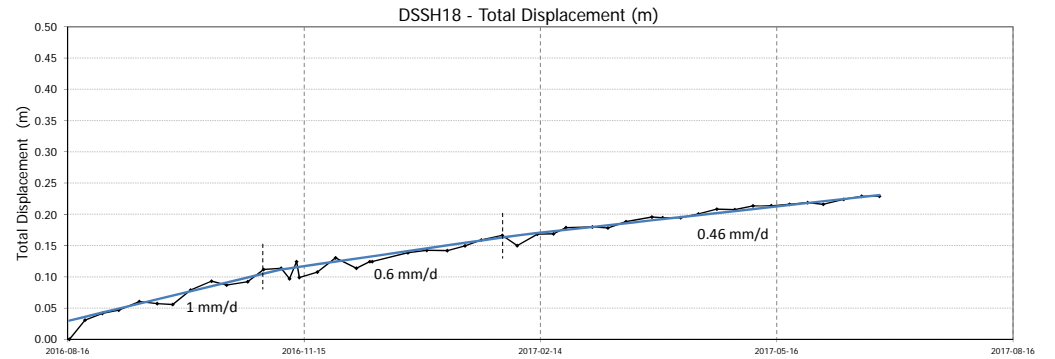
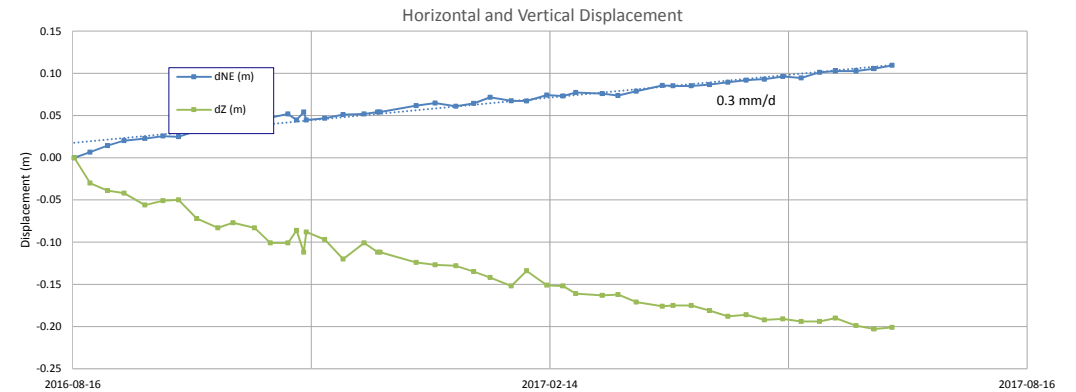
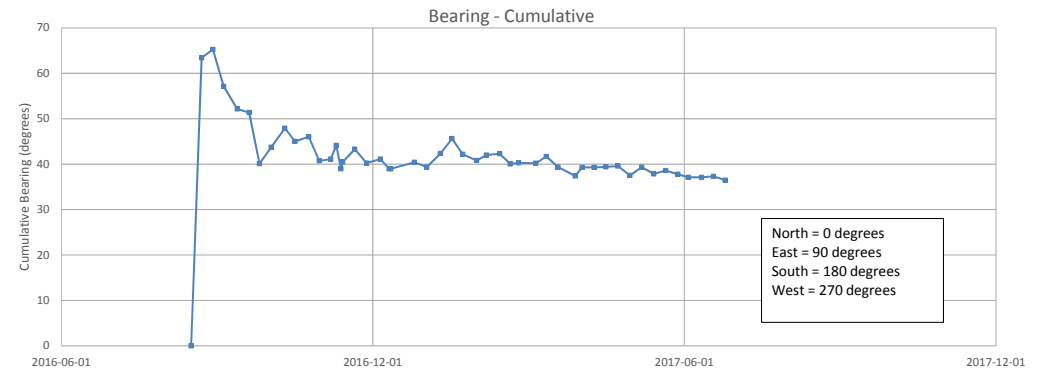
Job No: 1CM002.059 Filename: ApD_2017DSTFLandscape.pptx	  Minto Mine	DSTSF Instrumentation Data		
		<b>Survey Hub – DSSH18</b>		
		Date: August 2017	Prepared by PHM	Figure: <b>8</b>

- The survey hub was removed in December 2015 prior to MVFES2 construction. The hub was reinstalled in August 2016 following completion of construction.

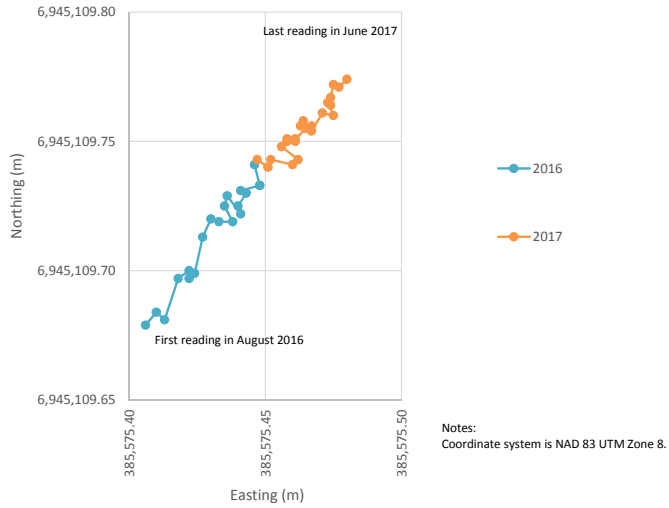
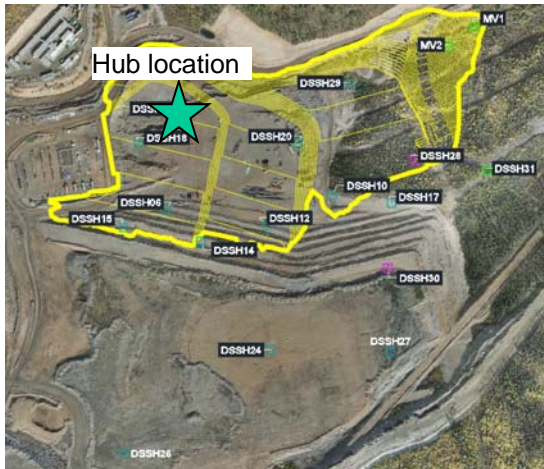
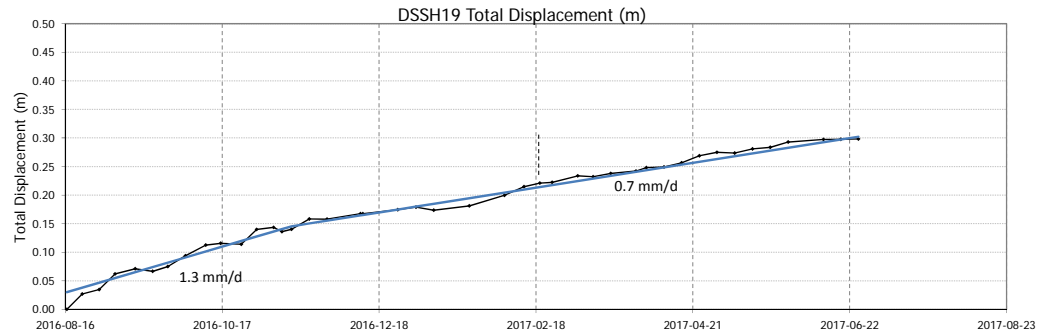
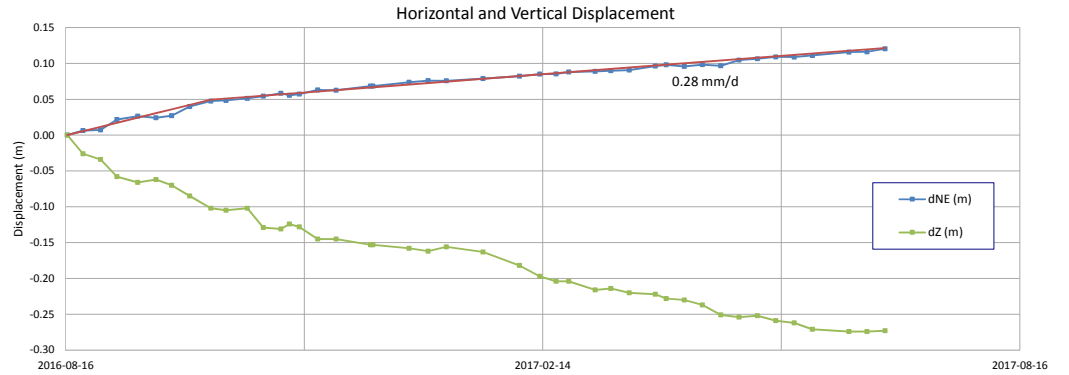
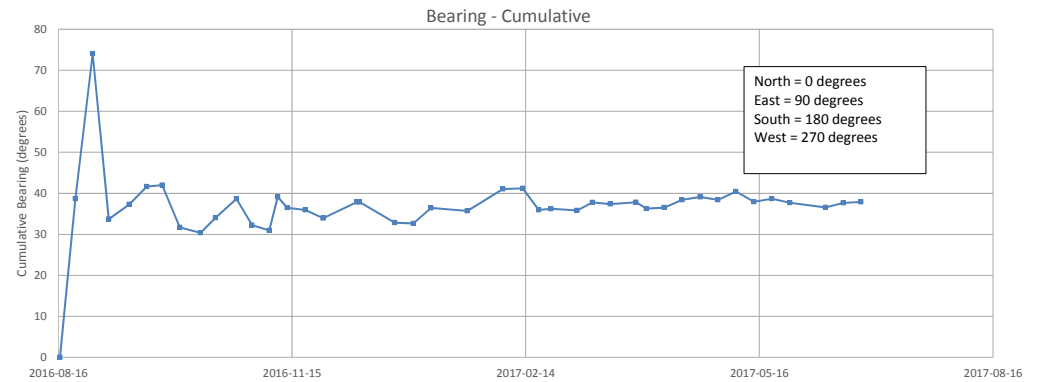
DSTSF Instrumentation Data		
		<b>Survey Hub – DSSH19</b>		
Job No: 1CM002.059 Filename: ApD_2017DSTFLandscape.pptx	<b>Minto Mine</b>	Date: August 2017	Prepared by PHM	Figure: <b>9</b>

- The survey hub was removed in December 2015 prior to MVFES2 construction. The hub was reinstalled in August 2016 following completion of construction.

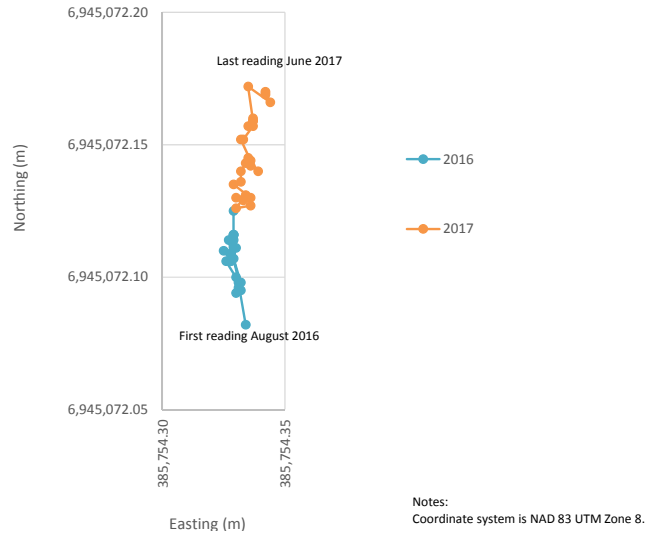
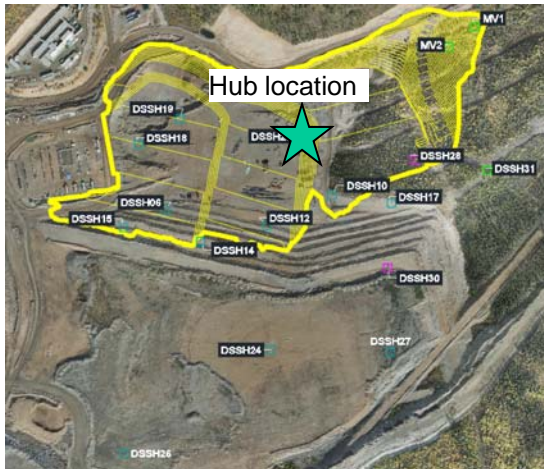
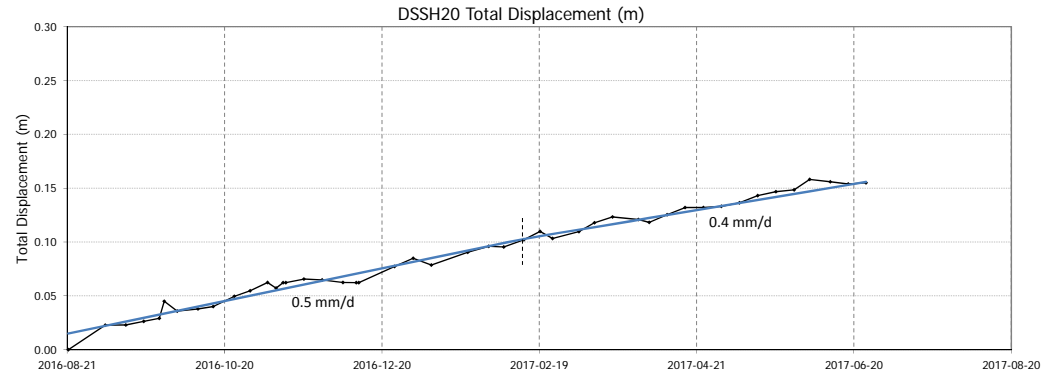
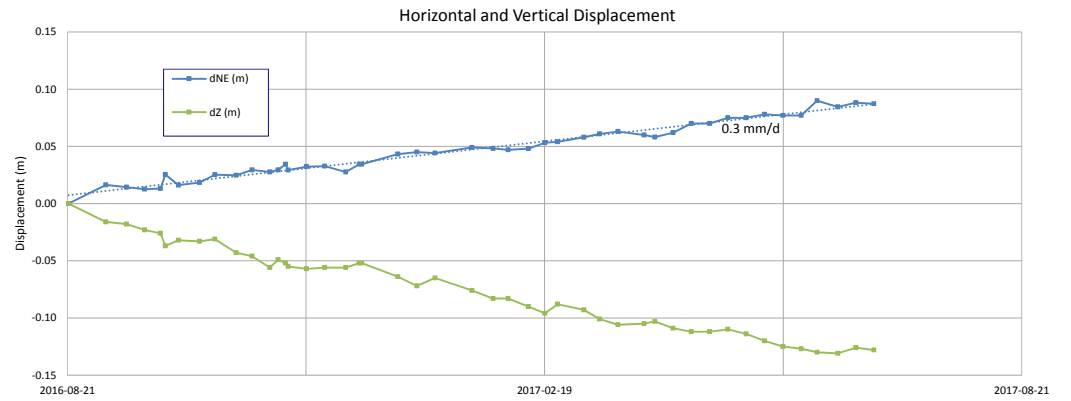
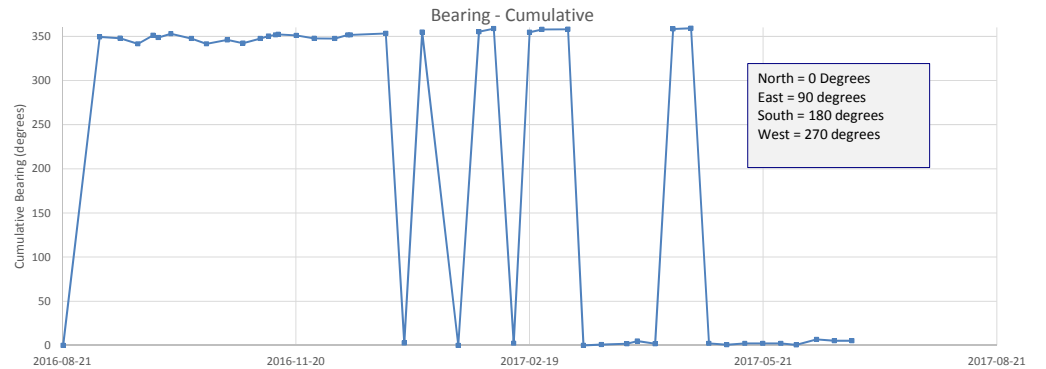
DSTSF Instrumentation Data		
		<b>Survey Hub – DSSH20</b>		
Job No: 1CM002.059 Filename: ApD_2017DSTFLandscape.pptx	Minto Mine	Date: August 2017	Prepared by PHM	Figure: <b>10</b>

- The survey hub was removed in December 2015 prior to MVFES2 construction. The hub was reinstalled in August 2016 following completion of construction.

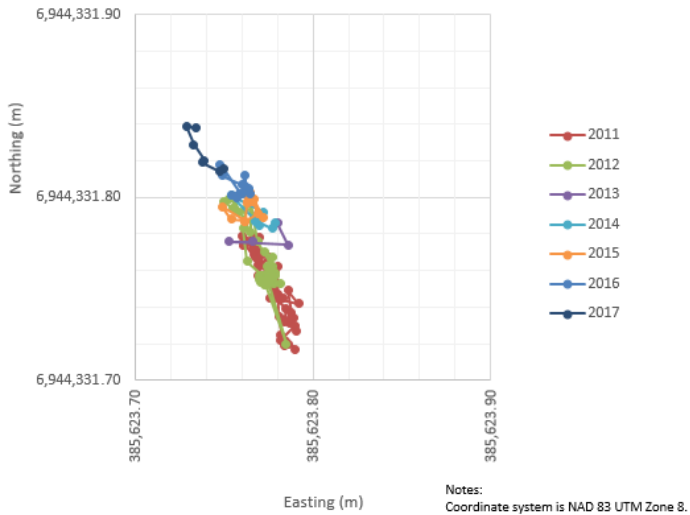
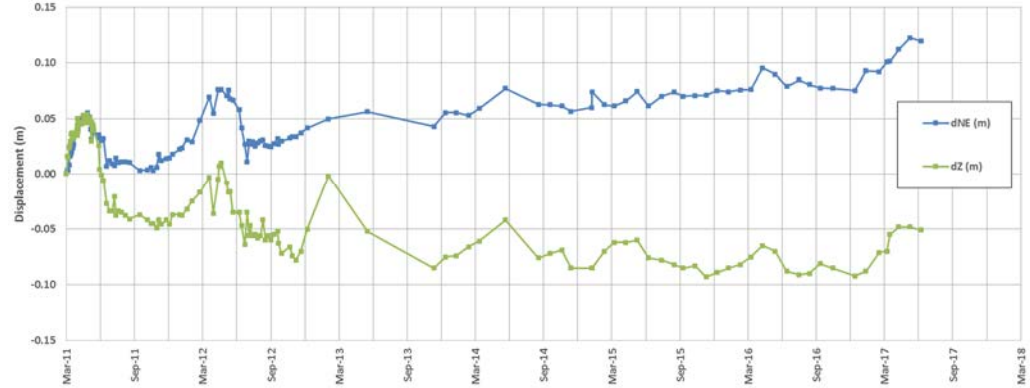
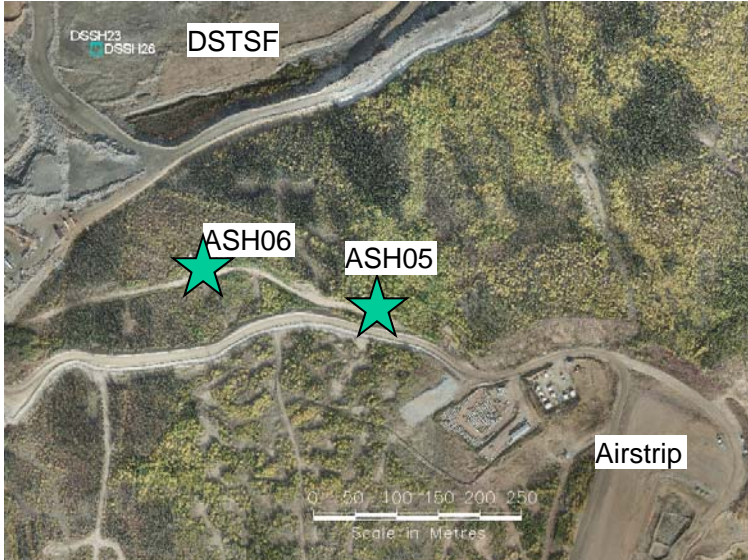
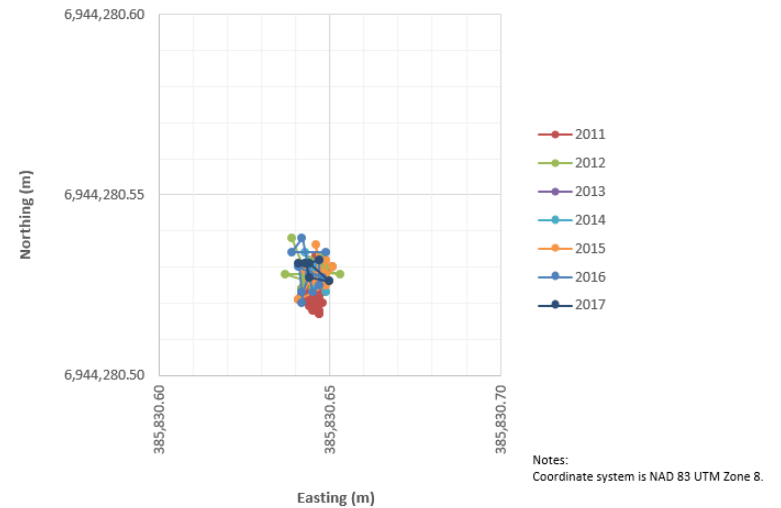
**Survey Hubs – ASH05 and ASH06**

- Notes:
1. Minto's survey reading comments on January 14, 2017 notes ASH06 may have been disturbed as a result of a pipeline installation.

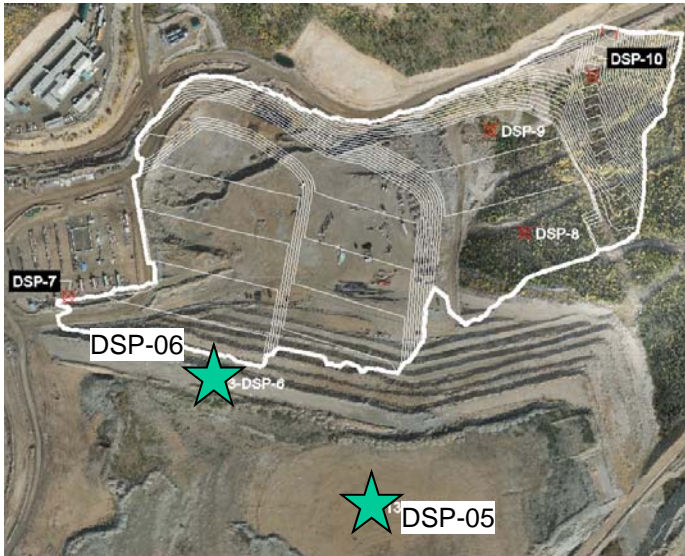
1. The pore pressure sensors at DSP-05 and 06 are located approximately 2 m above original ground in tailings (A) and 2 m below original ground.
2. Sensors at DSP-06 and the top sensor DSP-05A show no significant change in pore pressure in the past year.
3. The bottom sensor at DSP-05 (B) shows an increase in pore pressure. Temperature at the sensor is at the freezing point of water  $-0.5^{\circ}$ . The sensor is located in an area of silt with stratified ice lenses.

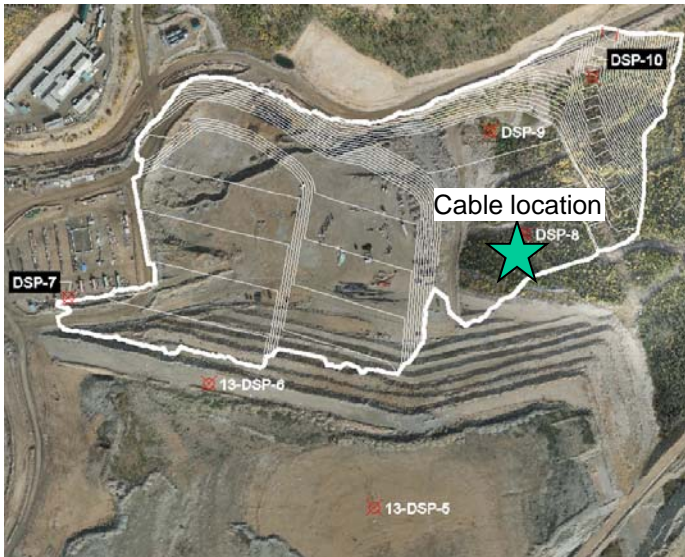
Job No: 1CM002.059 Filename: ApD_2017DSTSFLandscape.pptx	  Minto Mine	DSTSFS Instrumentation Data		
		<b>Piezometer – DSP-08</b>		
		Date: August 2017	Prepared by PHM	Figure: <b>23</b>

1. Negative pressure readings are plotted at the elevation of the sensor in order to indicate dates readings were taken.
2. The pore pressure in Sensor 1 has increased by approx. 700 kPa (700 m of water). This sensor is located closest to surface (depth of 5m). Since the construction was completed, the readings have dissipated. The temperature at Sensor 1 has also dropped significantly compared to the other sensors at DSP-08. The higher pore pressures at Sensor 1 may be the result of freezing and the expansion of pore water into ice.
