# 2017 Geotechnical Annual Review, Minto Mine, YT

Minto Explorations Ltd.

SRK Consulting (Canada) Inc.  
1CM002.059  
August 2017

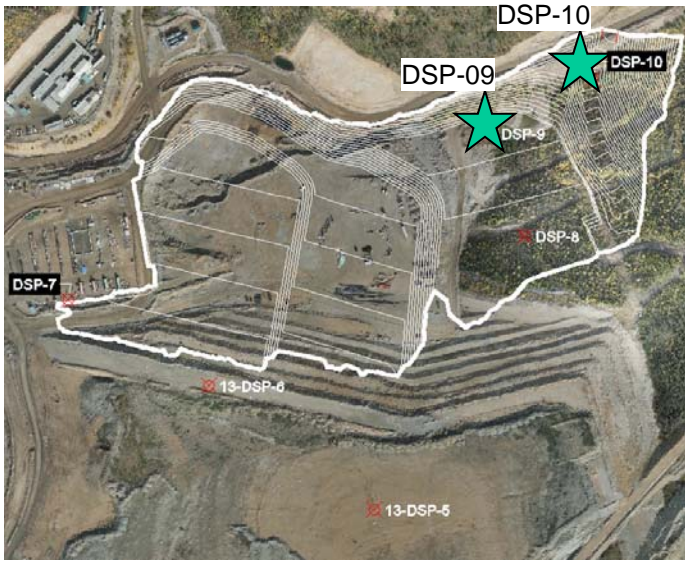
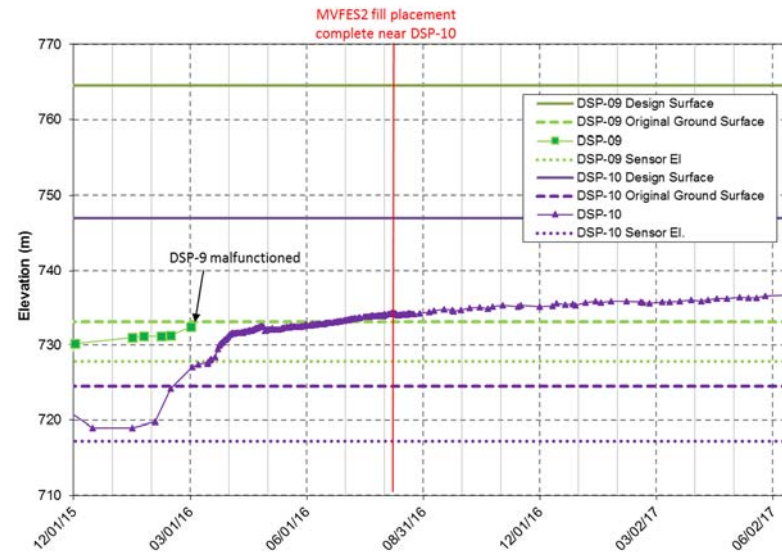
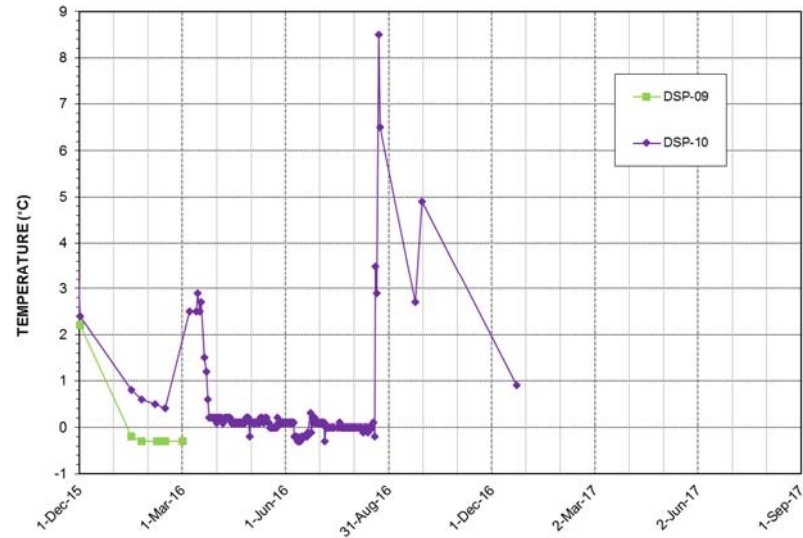
Job No: 1CM002.059 Filename: ApD_2017DSTSF_Landscape.pptx	  Minto Mine	DSTSF Instrumentation Data		
		<b>Piezometers – DSP-09 and DSP-10</b>		
		Date: August 2017	Prepared by PHM	Figure: <b>24</b>

1. The pore pressure sensors at DSP-9 and 10 are located approximately 5 m below original ground.
2. DSP-09 malfunctioned with the last reading on March 1, 2016
3. The large increase in pore pressure at DSP-10 is related to the fill placement over the sensor (approximately 23 m thick).
4. Since fill placement has been completed, the rate of increase in pore pressure is low, but is ongoing.
5. Flow meter readings at the Minto Creek Detention Sump indicate that the blanket drain is functional and no water is building-up at the base of MVFE Stage 2.
6. The temperature readings at DSP-10 show a slight cooling trend up to July 2017. Since July 2017, temperature readings have been infrequently collected and highly variable. The higher temperature may be indicative of the groundwater.

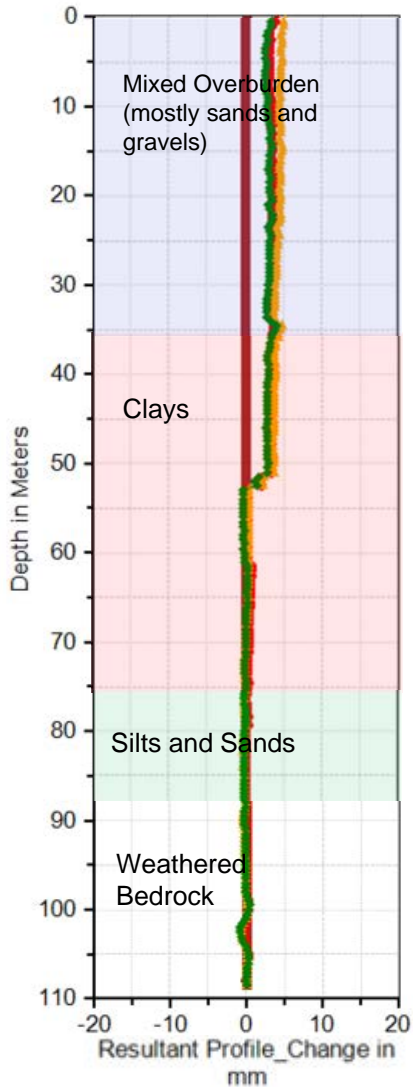
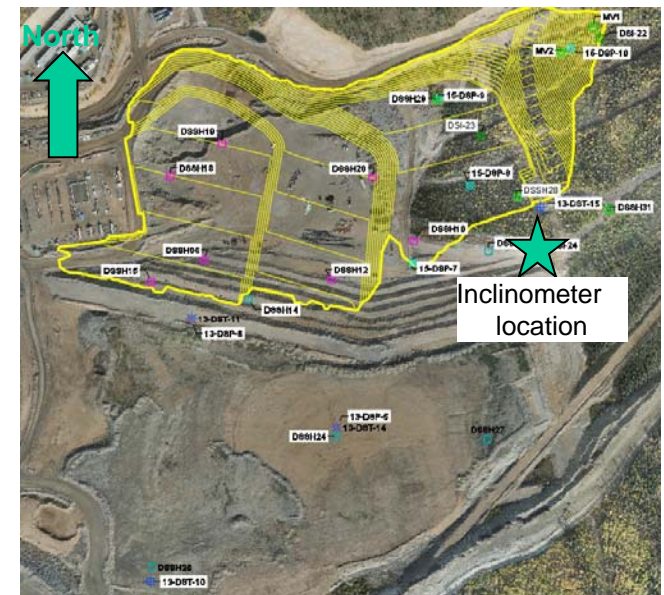
# MINTO DSI-24 B

1. Water/glycol inside the inclinometer casing froze following installation in January 2017 and thawed by the start of July.
2. Four sets readings of readings have been collected in July; however, the data from the A-axis has been inconsistent, with only the readings on July 13 and 27 providing good agreement. These two readings show no significant movement.
3. The profile provided in this figure plots results from the B-axis only.
4. No movement rate plot has been provided as insufficient data has been collected to date.

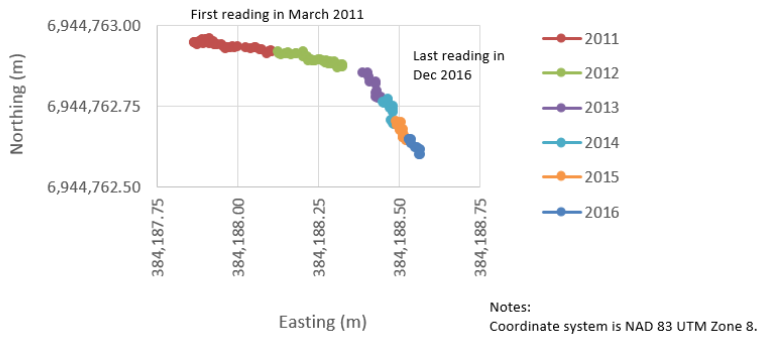
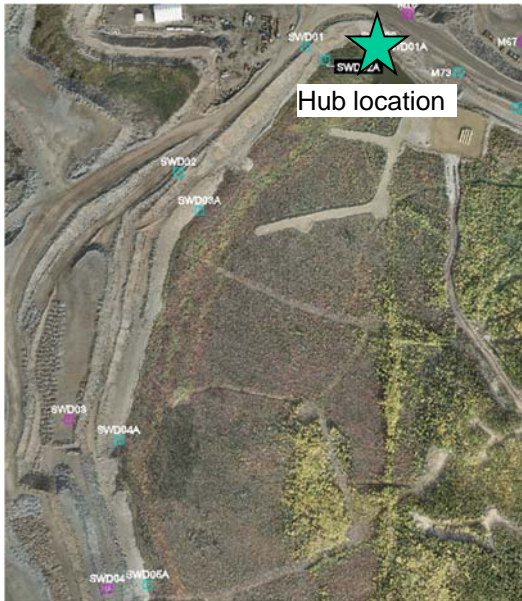
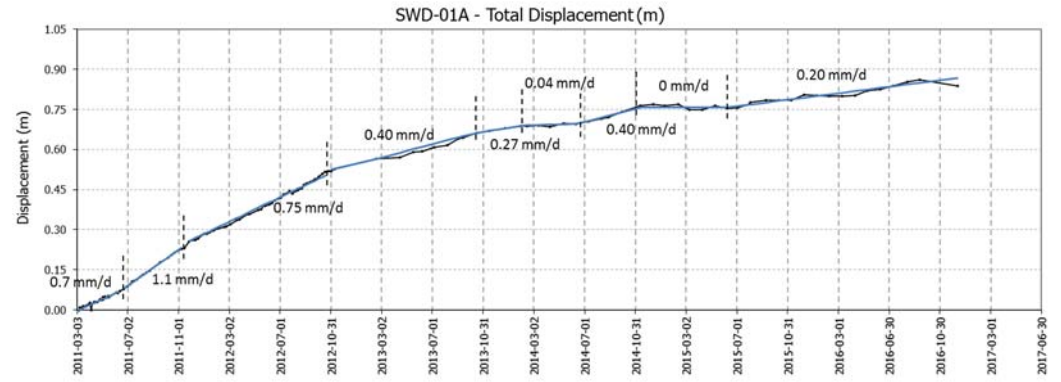
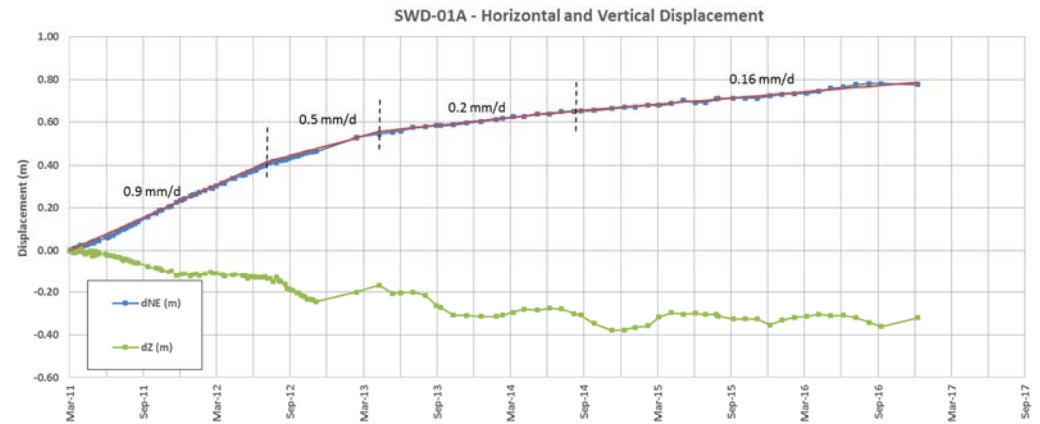
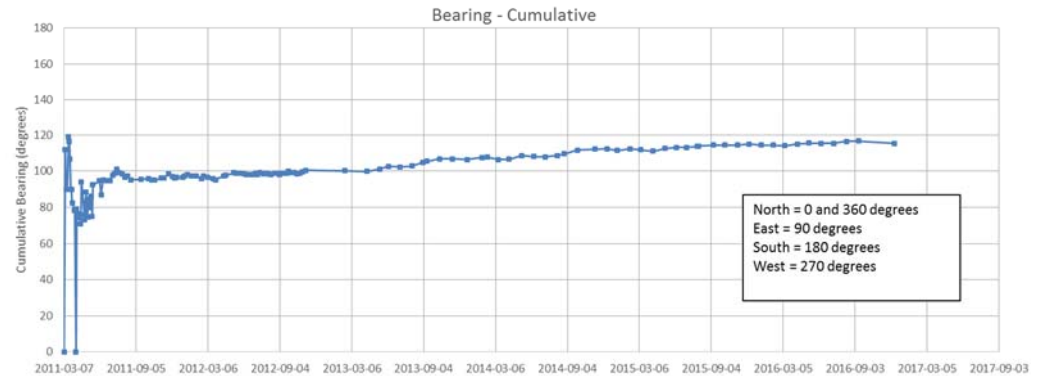
SWD Instrumentation Data		
		<b>Survey Hub – SWD-01</b>		
Job No: 1CM002.059 Filename: ApF_2017SWD Instrumentation.pptx	Minto Mine	Date: August 2017	Prepared by PHM	Figure: <b>2</b>

1. Last reading of hub in December 2016. Hub is replaced by SWD-06.

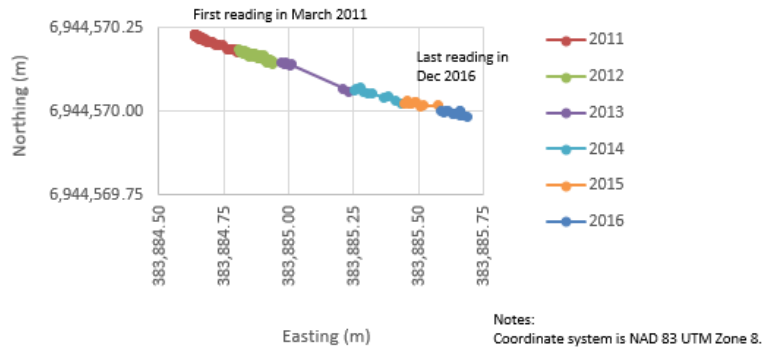
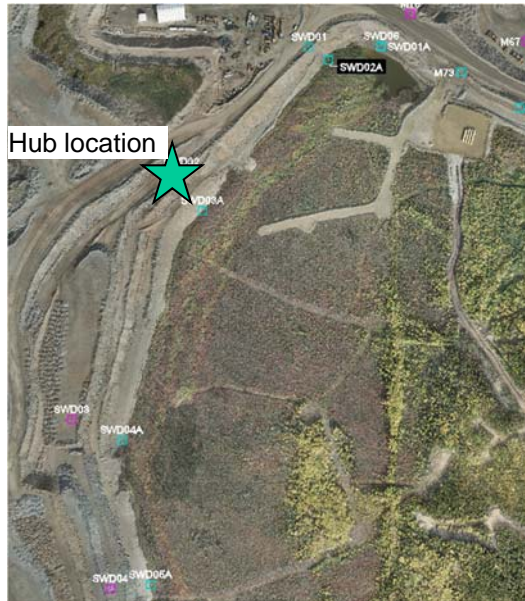
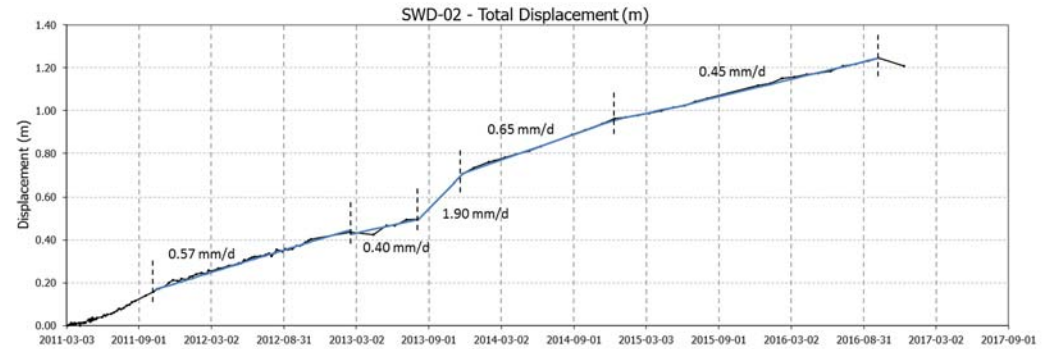
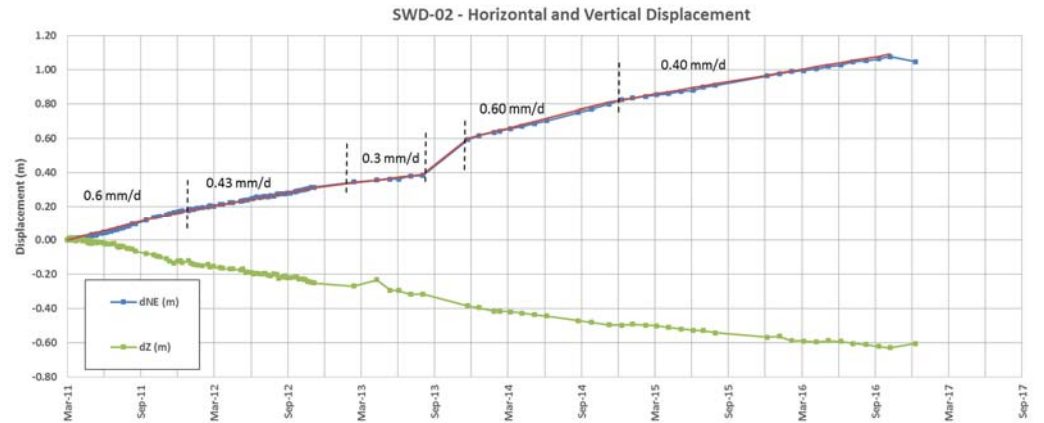
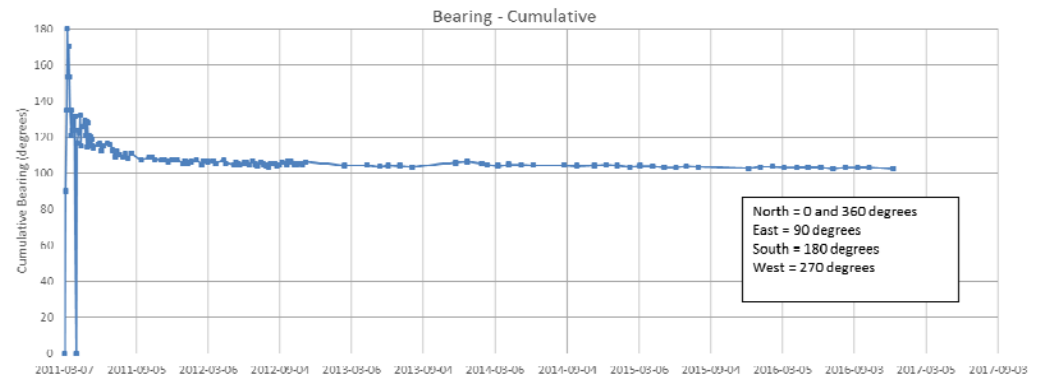
Figure:  
**3**

1. Last reading of hub in December 2016. Hub is replaced by SWD-08.

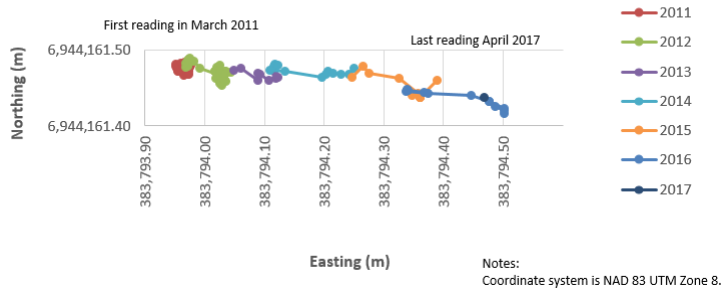
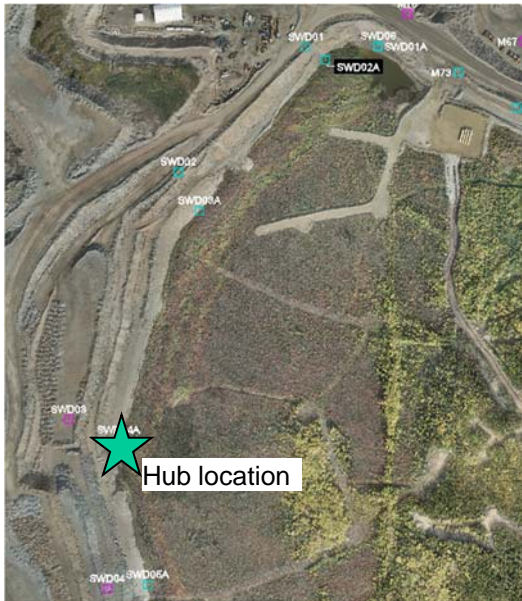
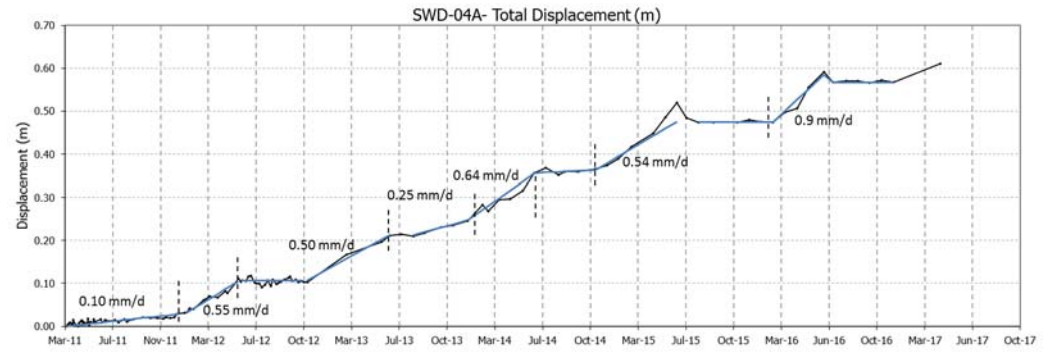
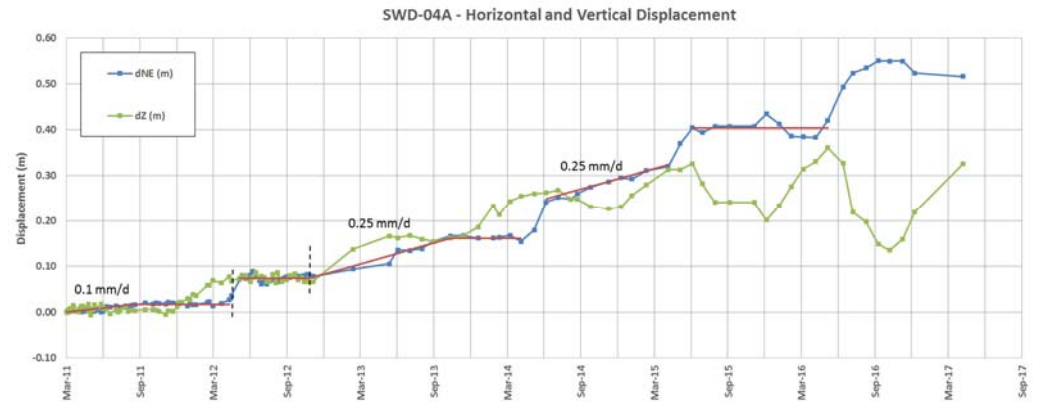
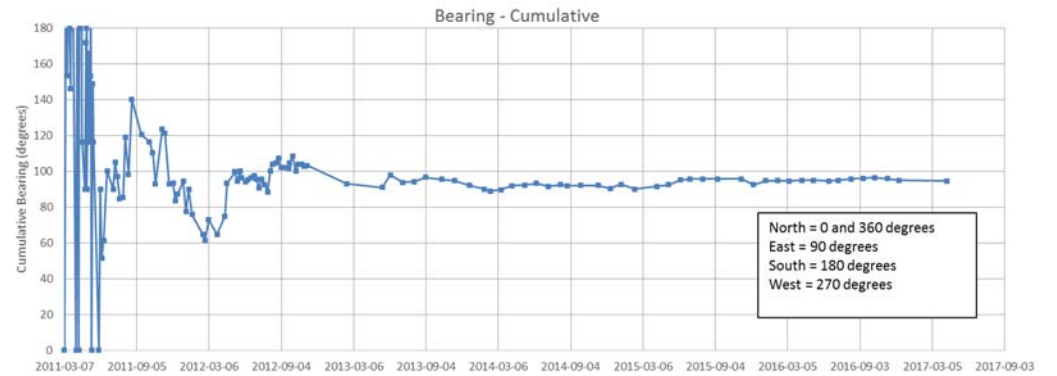
SWD Instrumentation Data		
		Survey Hub – SWD-02A		
Job No: 1CM002.059 Filename: ApF_2017SWD Instrumentation.pptx	Minto Mine	Date: August 2017	Prepared by PHM	Figure: 5

1. Movement of this survey hub is primary due to frost heave. Hub is replaced by SWD-09.

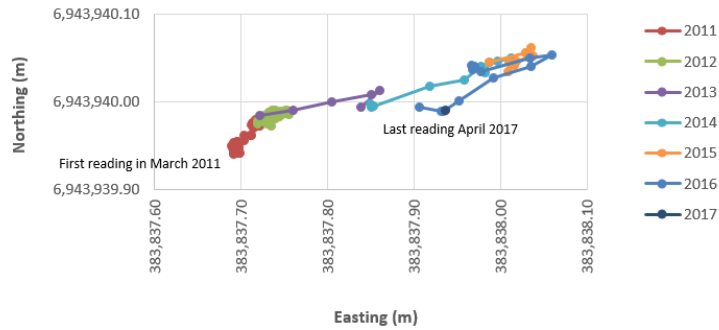
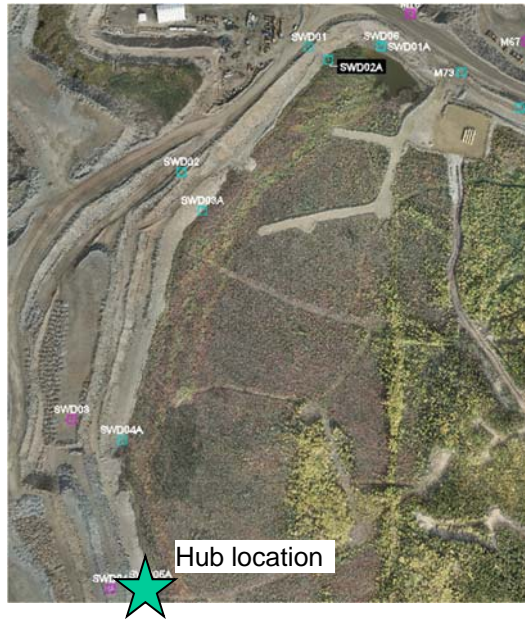
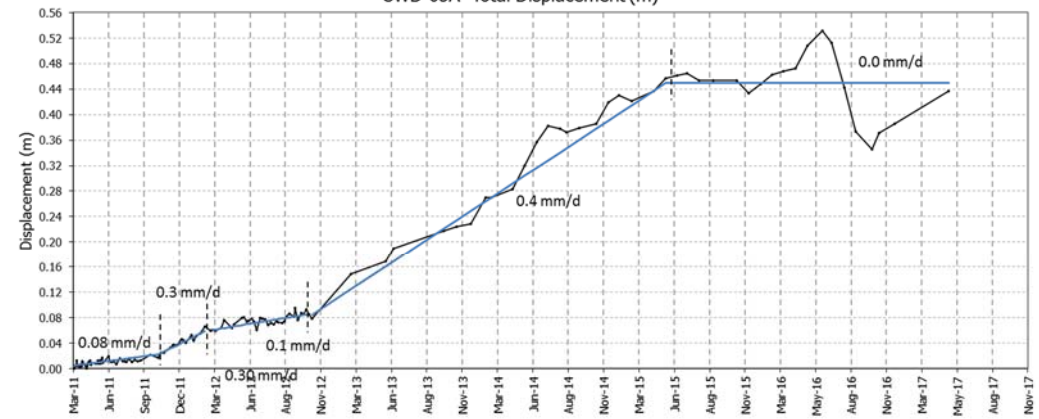
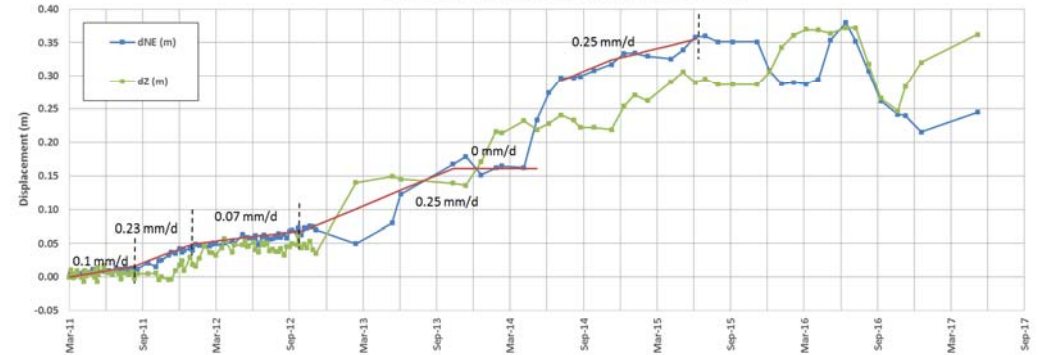
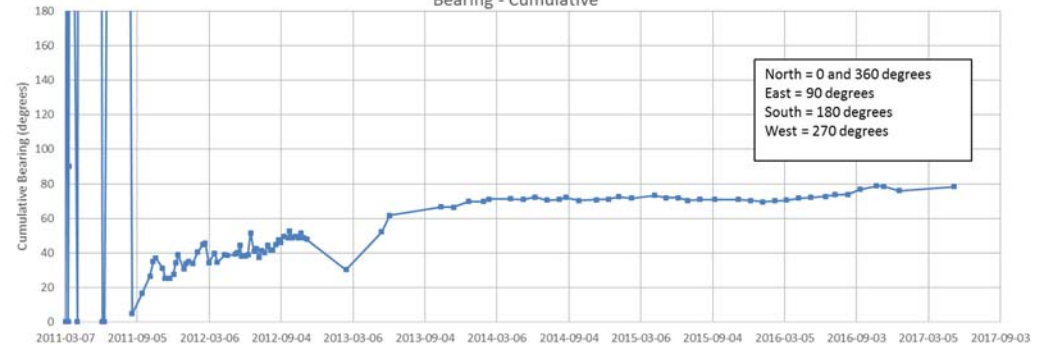
SWD Instrumentation Data		
		<b>Survey Hub – SWD-04A</b>		
Job No: 1CM002.059 Filename: ApF_2017SWD Instrumentation.pptx	Minto Mine	Date: August 2017	Prepared by PHM	Figure: <b>6</b>

1. Movement of this survey hub is primary due to frost heave.

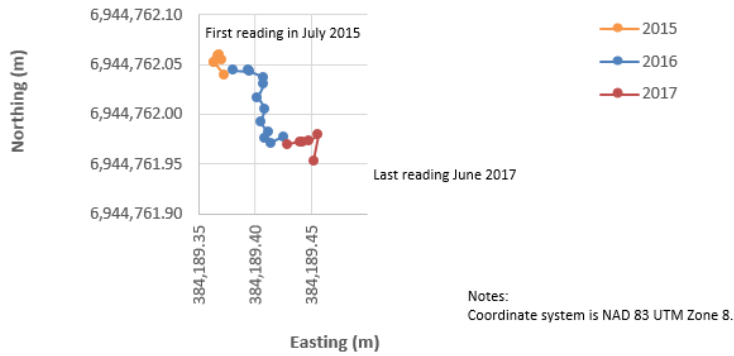
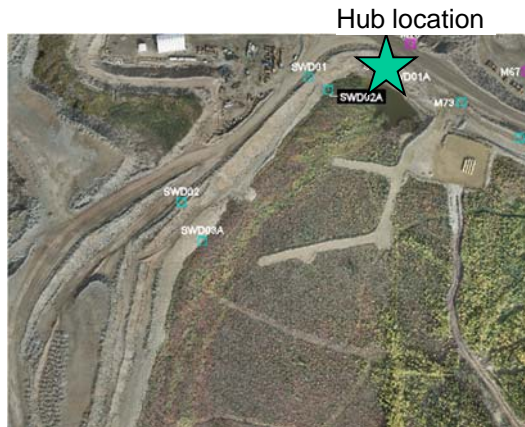
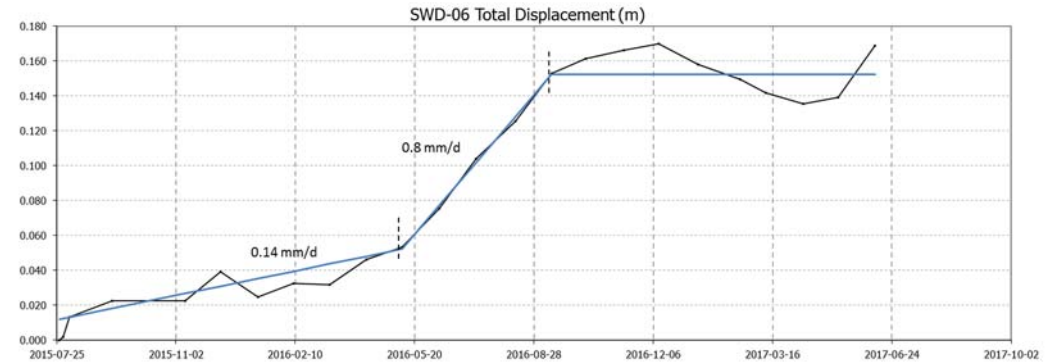
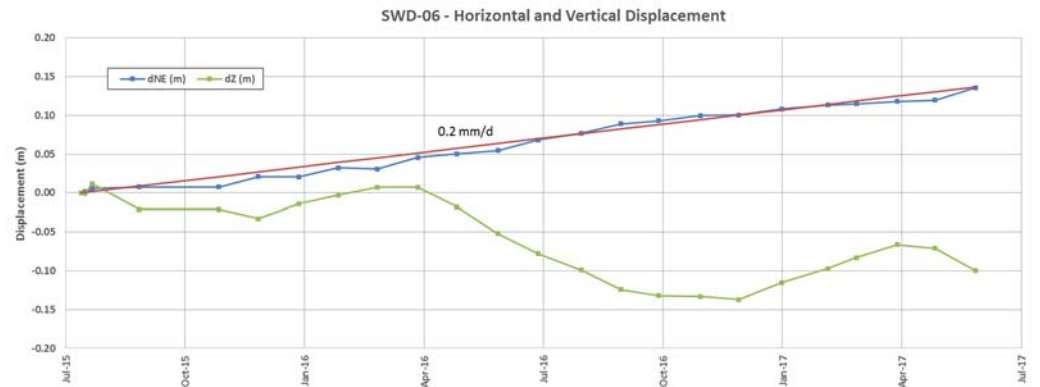
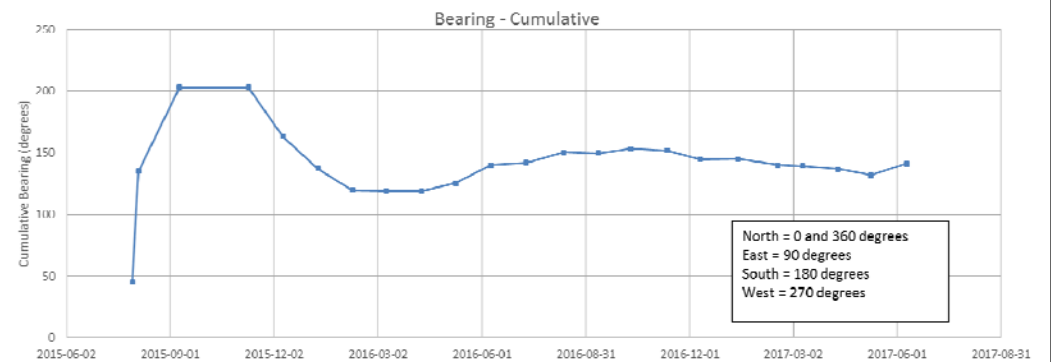
Figure:  
**7**

1. Hub is a replacement for SWD-01A that was disturbed by frost heave.
2. The hub consists of a lock-block on surface, and as a result, seasonal ground movement as a result freeze/thaw cycles may occur that is not indicative of large-scale ground movement. As a result, the horizontal displacement plot is likely to be the most useful plot for monitoring movement.

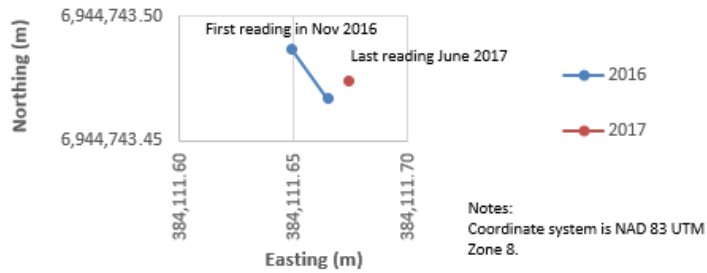
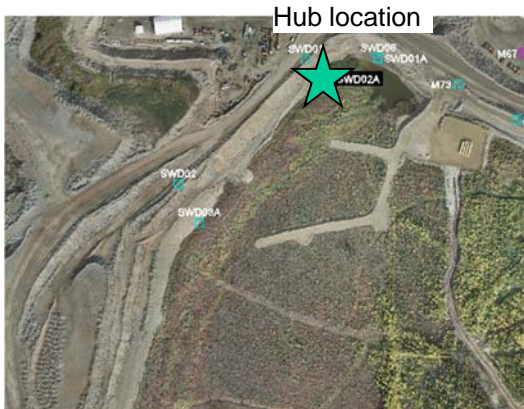
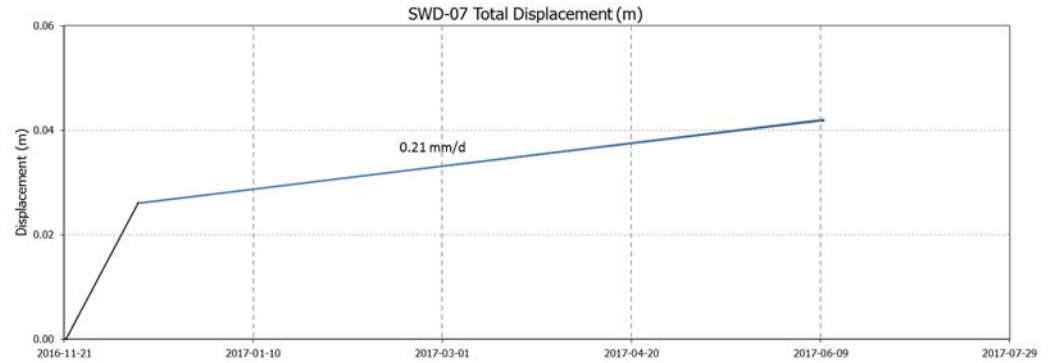
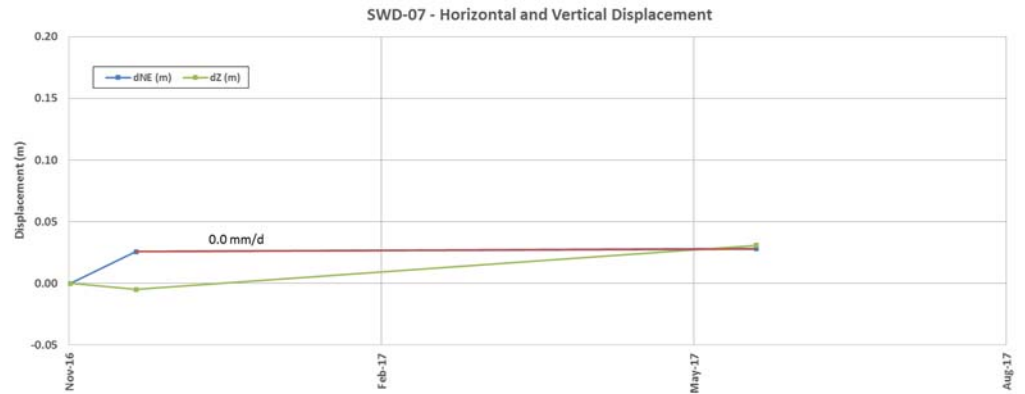
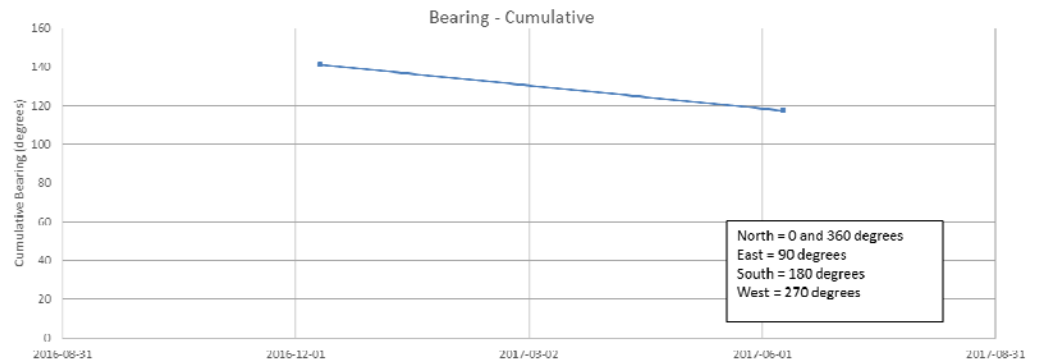
SWD Instrumentation Data		
		<b>Survey Hub – SWD-06</b>		
Job No: 1CM002.059 Filename: ApF_2017SWD Instrumentation.pptx	<b>Minto Mine</b>	Date: August 2017	Prepared by: PHM	Figure: <b>8</b>

- Hub is a replacement for SWD-02A that was disturbed by frost heave.

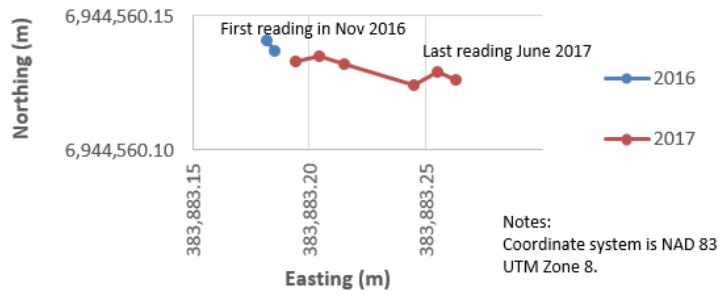
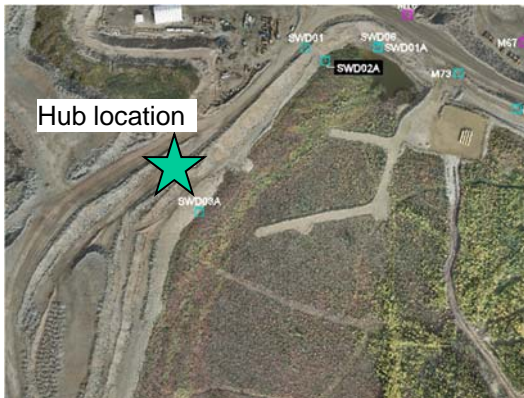
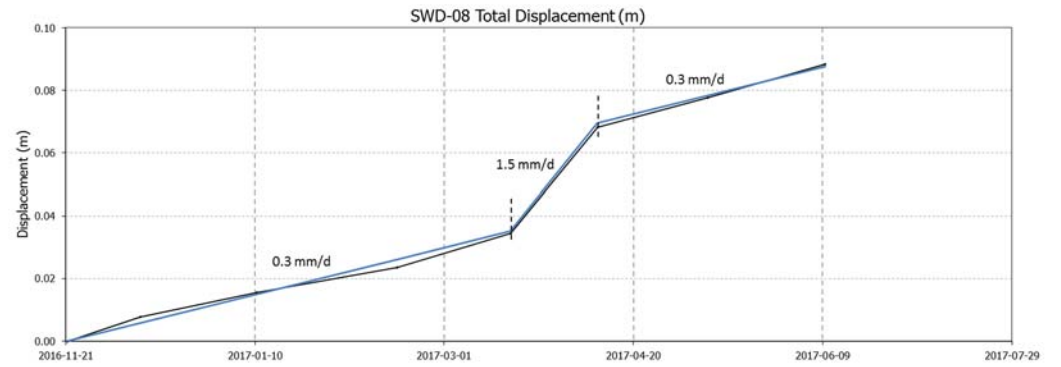
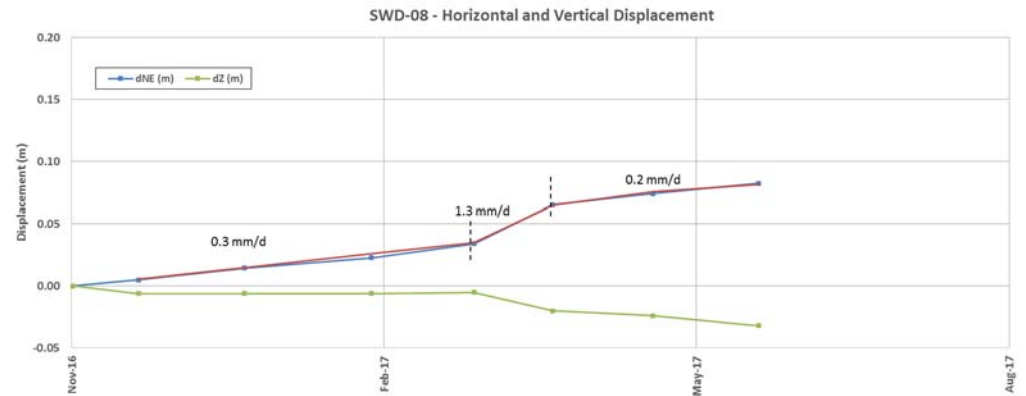
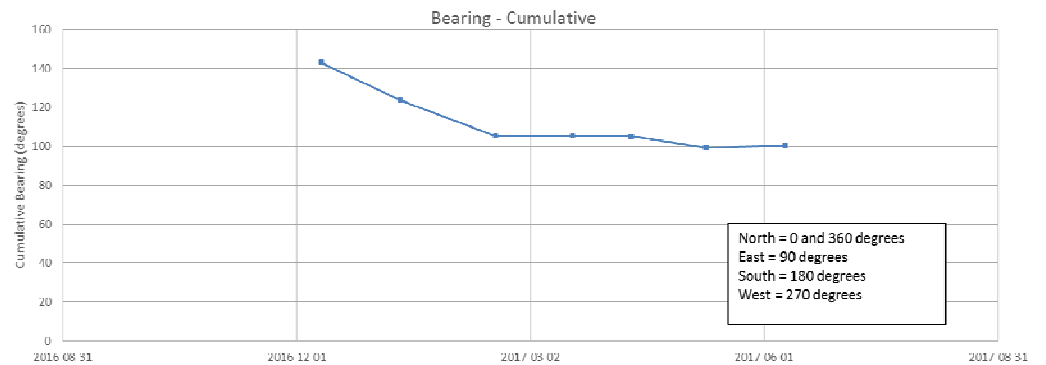
SWD Instrumentation Data		
		<b>Survey Hub – SWD-08</b>		
Job No: 1CM002.059 Filename: ApF_2017SWD Instrumentation.pptx	<b>Minto Mine</b>	Date: August 2017	Prepared by: PHM	Figure: <b>10</b>

1. Hub is a replacement for SWD-02 that was disturbed as a result of regrading of the SWD.

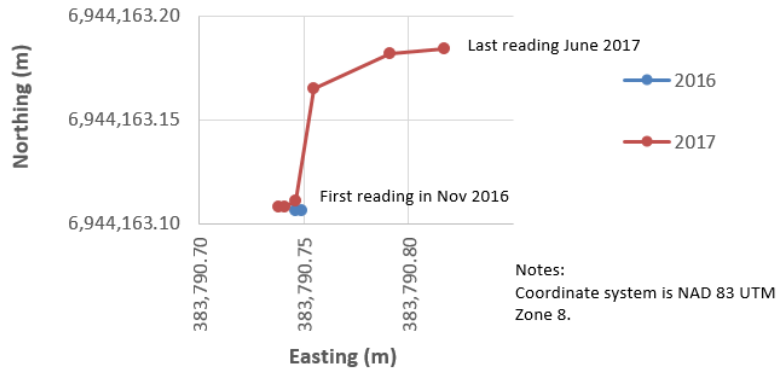
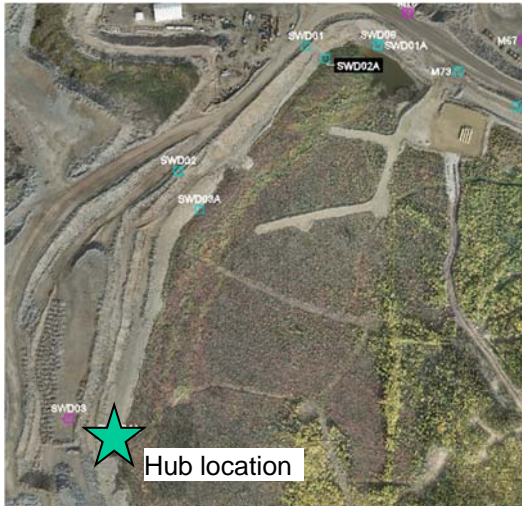
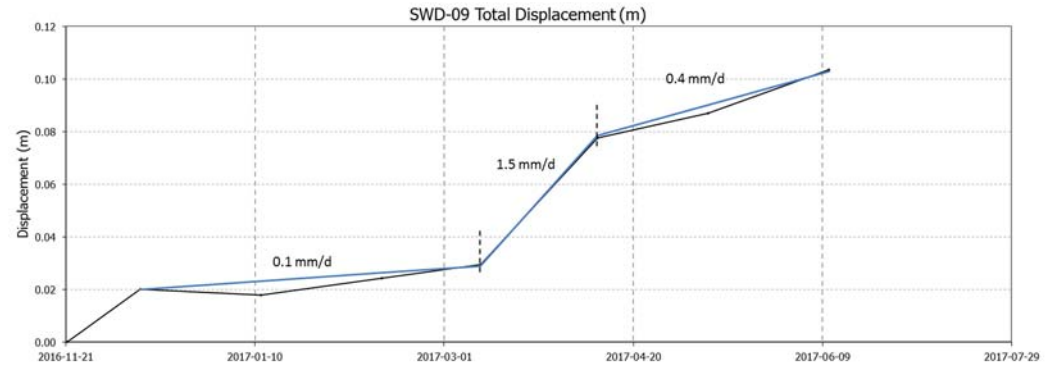
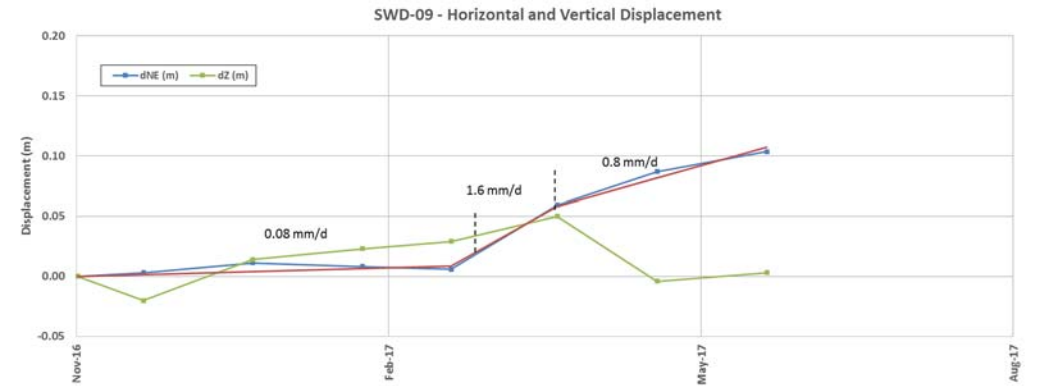
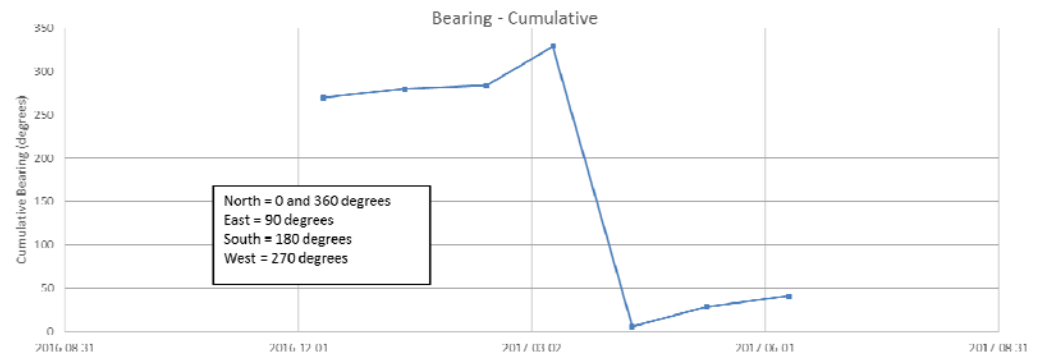
- Hub is a replacement for SWD-04A that was disturbed by frost heave.
- The hub consists of a lock-block on surface, and as a result, seasonal ground movement as a result freeze/thaw cycles may occur that is not indicative of large-scale ground movement. As a result, the horizontal displacement plot is likely to be the most useful plot for monitoring movement.

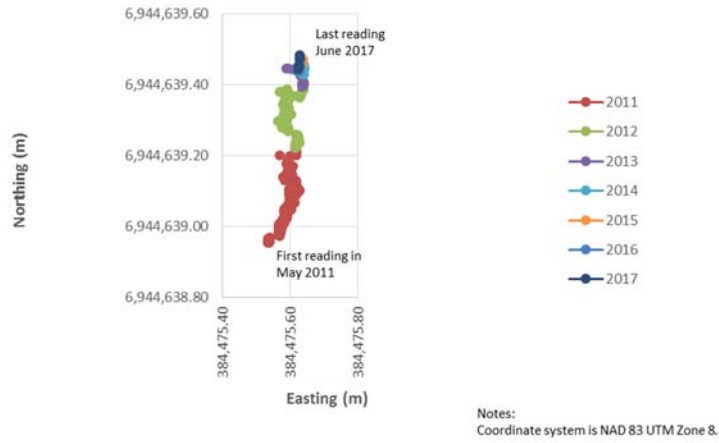
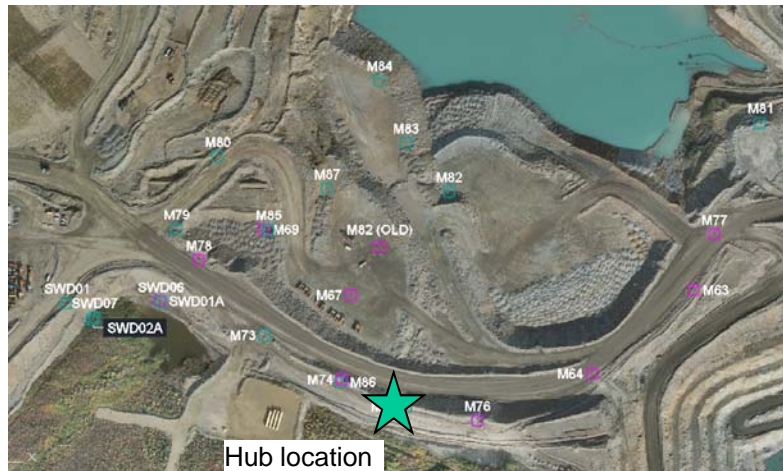
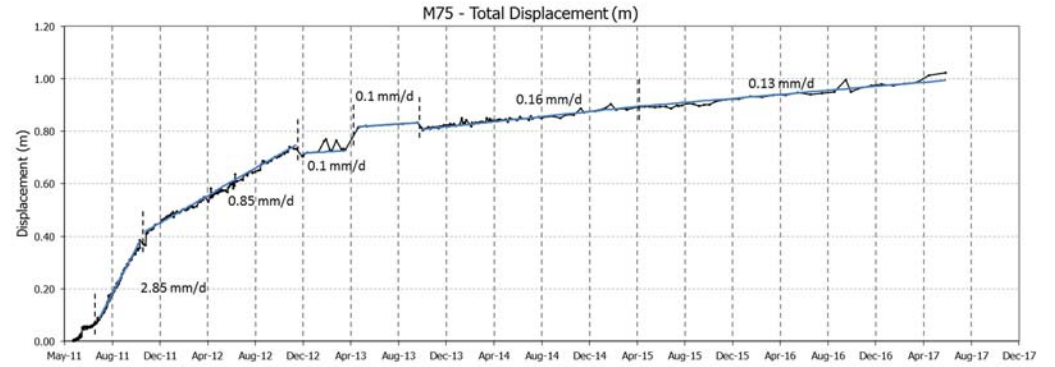
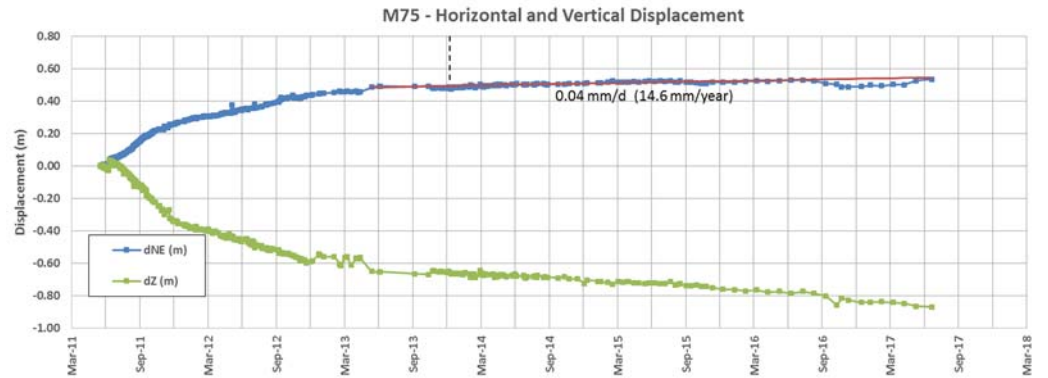
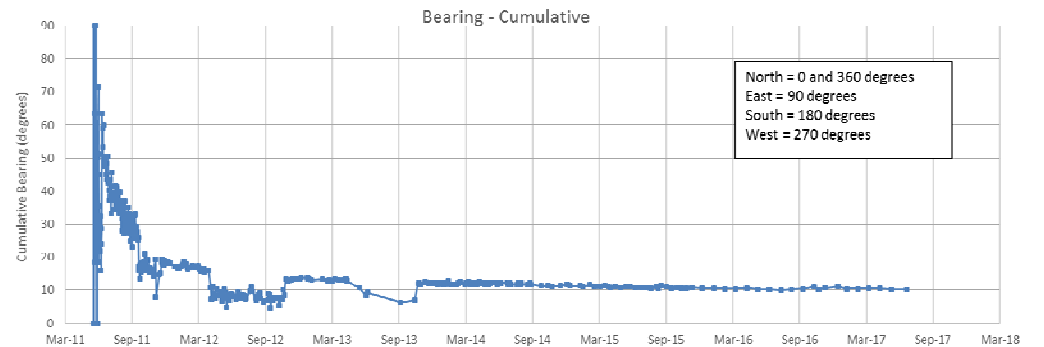
- Hub is to be replaced by M86.

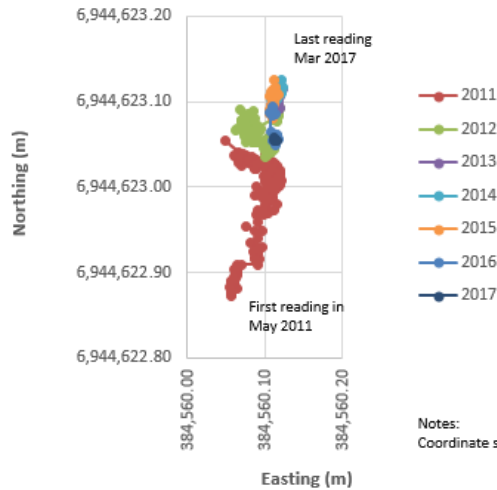
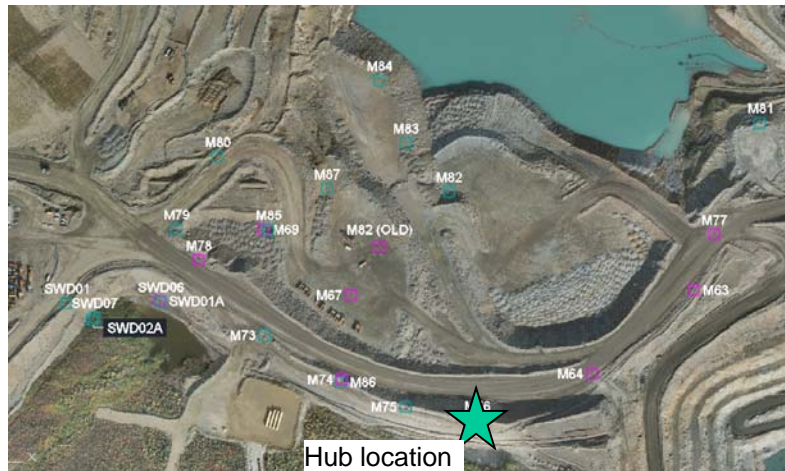
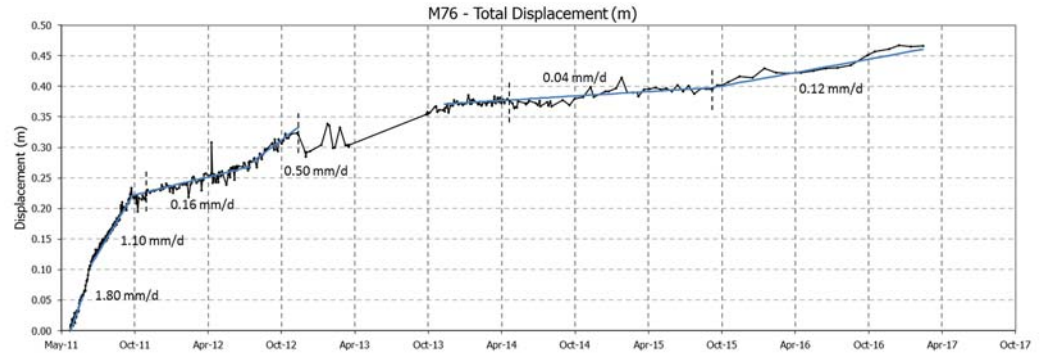
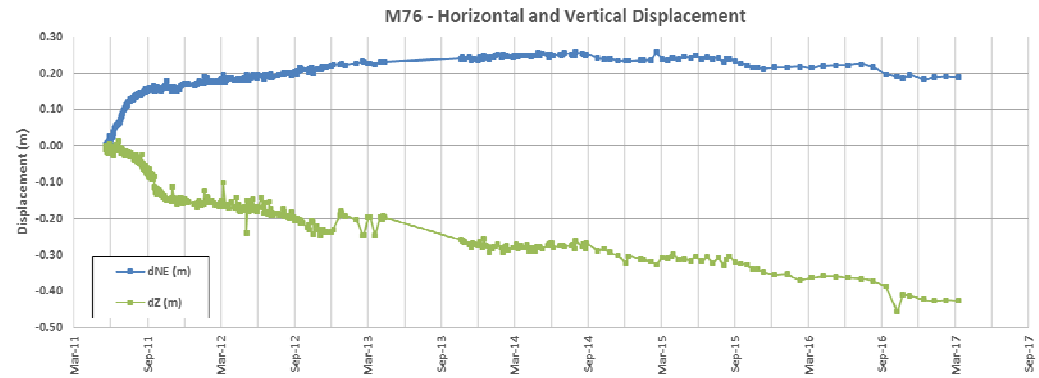
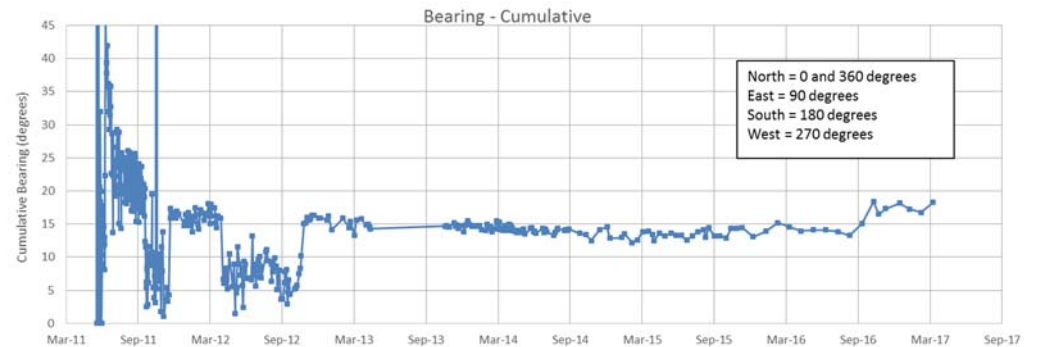
Main Pit Instrumentation Data		
		<b>Survey Hub – M76</b>		
Job No: 1CM002.059 Filename: ApG_2017MainPitInstrumentation.pptx	Minto Mine	Date: August 2017	Prepared by PHM	Figure: <b>4</b>

Survey Hub	Last Reading	Movement Rate (mm/day)		Bearing (Cumulative)	Comments
		June 16	At last reading		
M76	3/12/2017	-	-	14	No significant horizontal movement. Observed movement was likely settlement of fill in Main Pit.

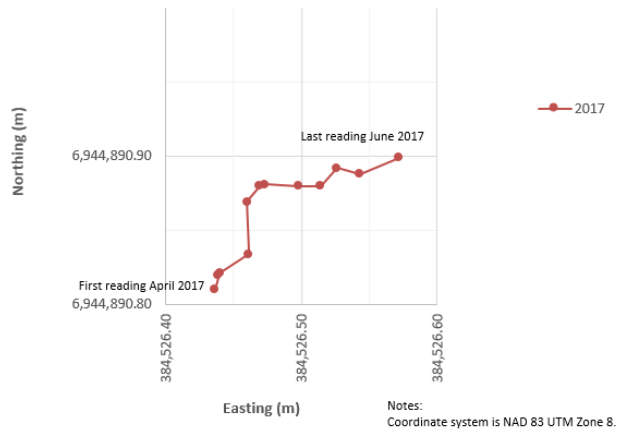
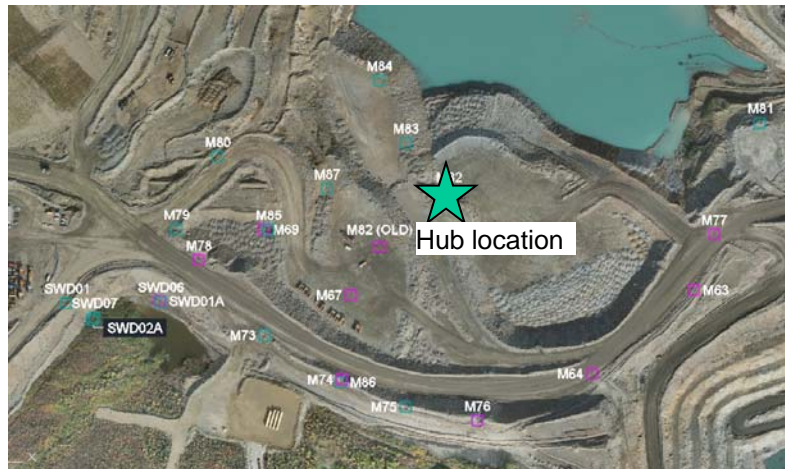
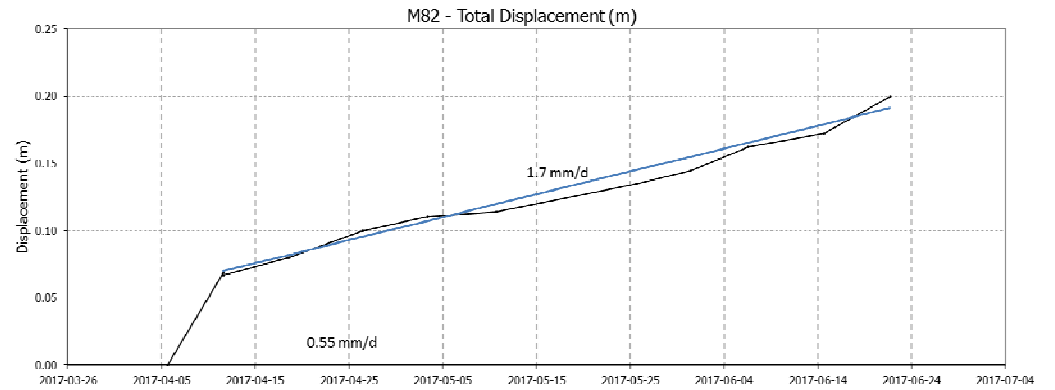
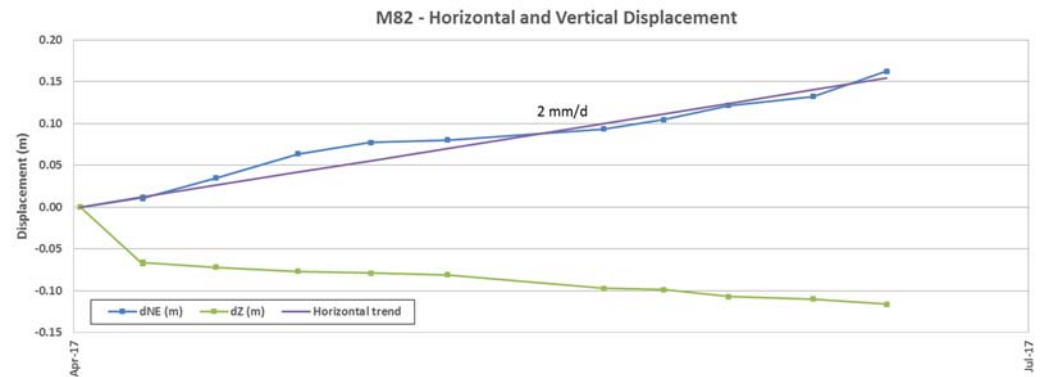
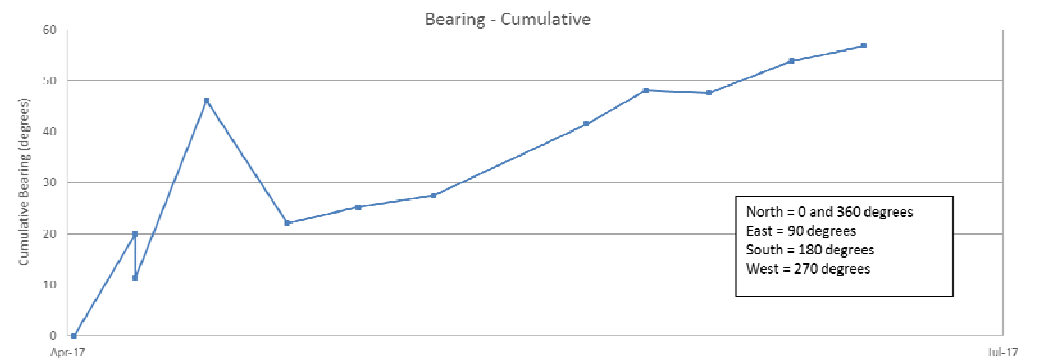
Main Pit Instrumentation Data		
		<b>Survey Hub – M82</b>		
Job No: 1CM002.059 Filename: ApG_2017MainPitInstrumentation.pptx	Minto Mine	Date: August 2017	Prepared by PHM	Figure: <b>8</b>

1. M-82 was moved to be located outside of the MPD footprint.
2. The survey hub is mounted on a lock-block set on surface. The site inspection noted there surface was not levelled with rocks removed when the block was set, and some of the observed movement may be due to shifting of rocks beneath the block (See Figure 14, Appendix A).

- **High Priority:** Clear the loose rocks beneath M82
- Continue to limit access to the In-Pit Dump area near M84.
- During SAT material placement, truck traffic should be maintained a minimum of 5 meters away from the dump face, or a spotter should be present.
