# 2017 Geotechnical Annual Review, Minto Mine, YT

Minto Explorations Ltd.

SRK Consulting (Canada) Inc.  
1CM002.059  
August 2017

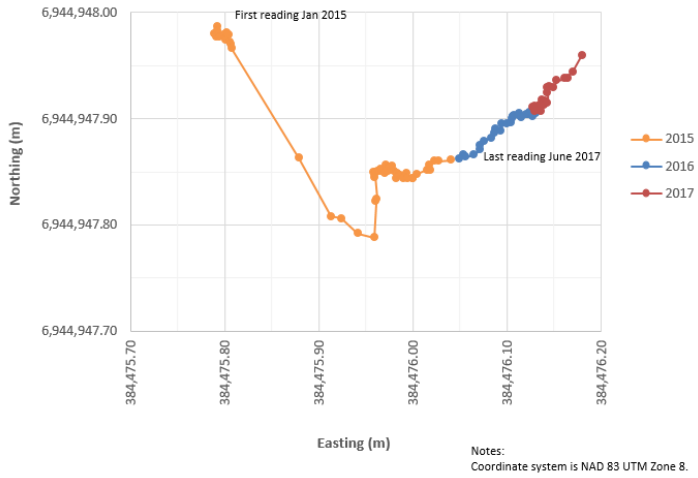
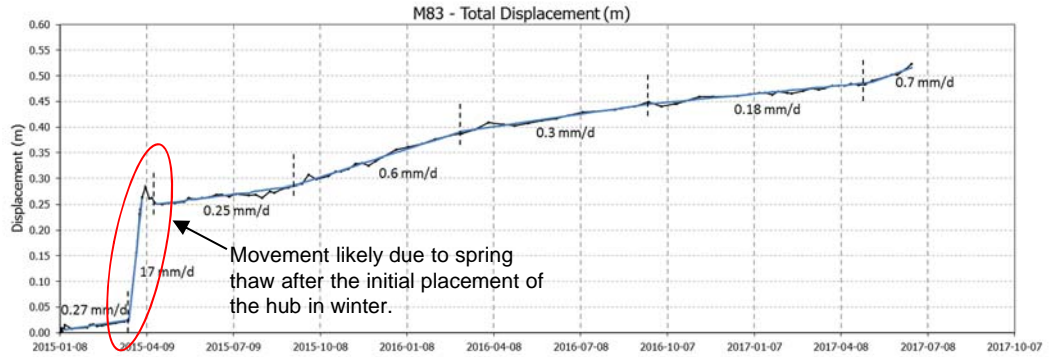
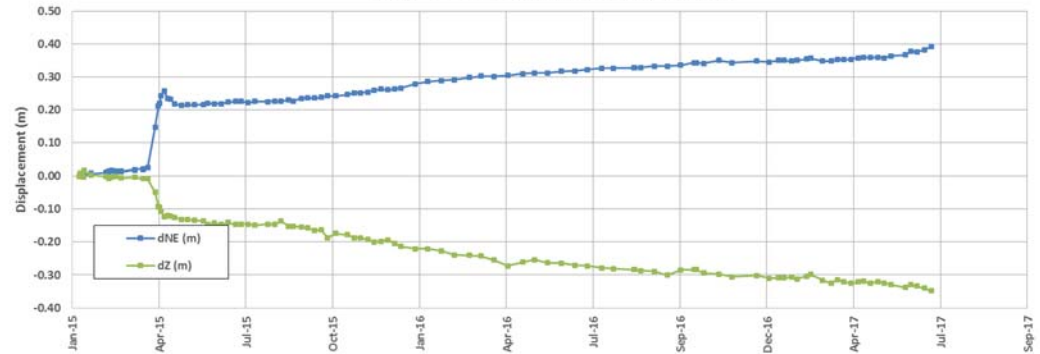
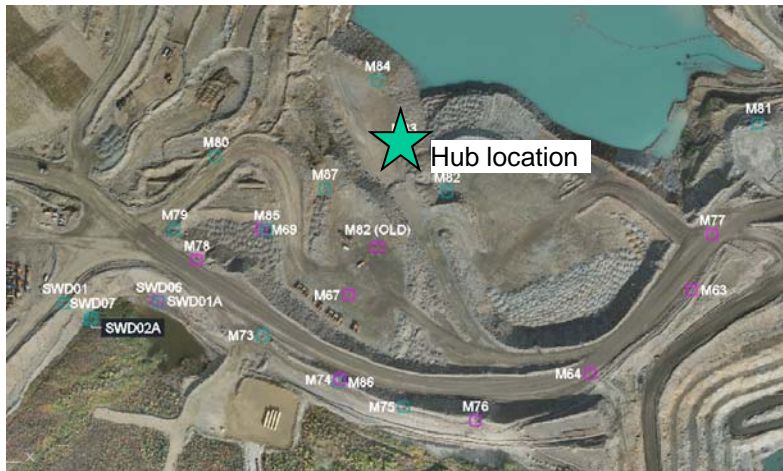
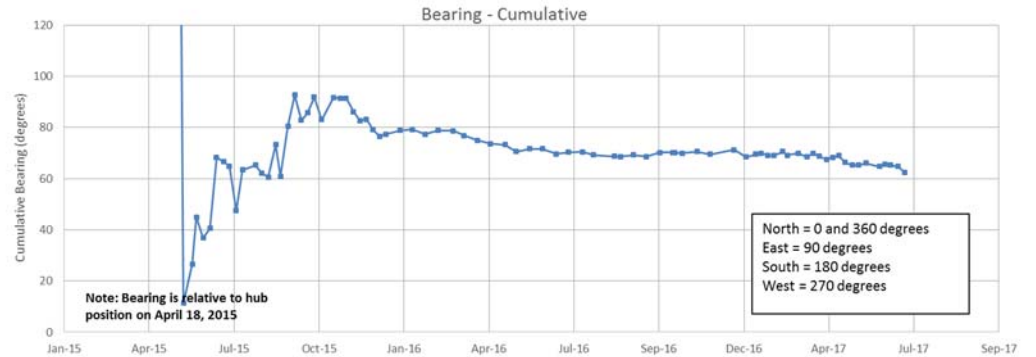
Main Pit Instrumentation Data		
		<b>Survey Hub – M83</b>		
Job No: 1CM002.059 Filename: ApG_2017MainPitInstrumentation.pptx	Minto Mine	Date: August 2017	Prepared by PHM	Figure: <b>9</b>

Survey Hub	Last Reading	Movement Rate (mm/day)		Bearing (Cumulative)	Comments
		June 16	June 17		
M73	6/12/2017	0.3	0.2	65	Slight deceleration trend observed on graph of total displacement
M75	6/23/2017	-	-	10	Minor movement and bearing with a very slight deceleration trend observable. Hub is located on fill placed inside of the ultimate Main Pit crest. Observed movement suspected to be related to settlement of fill in the pit.
M79	6/12/2017	0.2	0.2	100	Horizontal Movement Rate listed. Slight deceleration trend can be observed in the total displacement graph.
M80	6/12/2017	0.1	0.1	107	Slight deceleration trend
M81	6/12/2017	0.0	0.0	52	No significant horizontal movement. Observed movement is largely fill settlement.
M82	6/21/2017	0.7	2.0	44	Increase in movement rate, likely the result of MPD construction, and new survey hub installation
M83	6/21/2017	0.3	0.7	72	<b>Increase in movement rate starting in May 2017.</b>

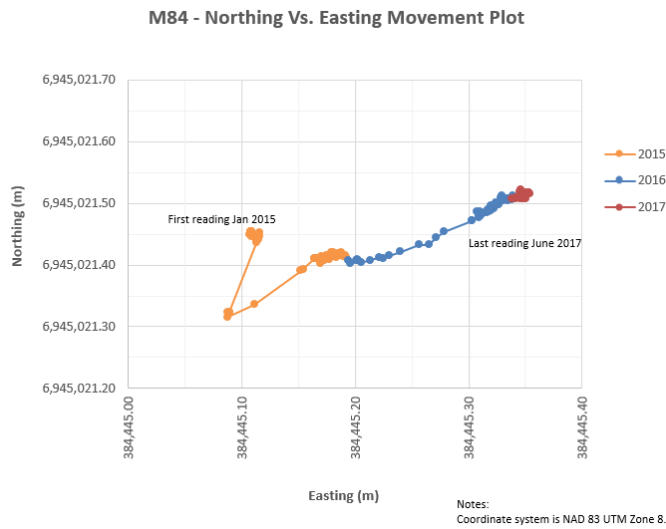
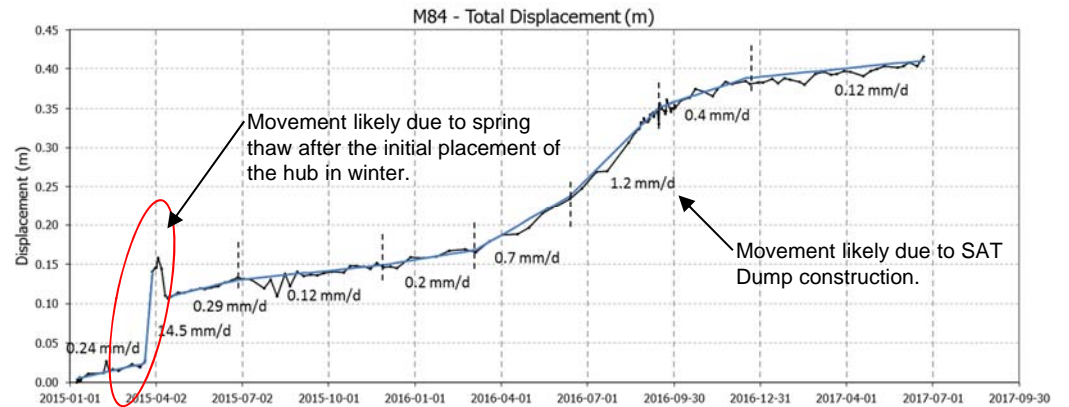
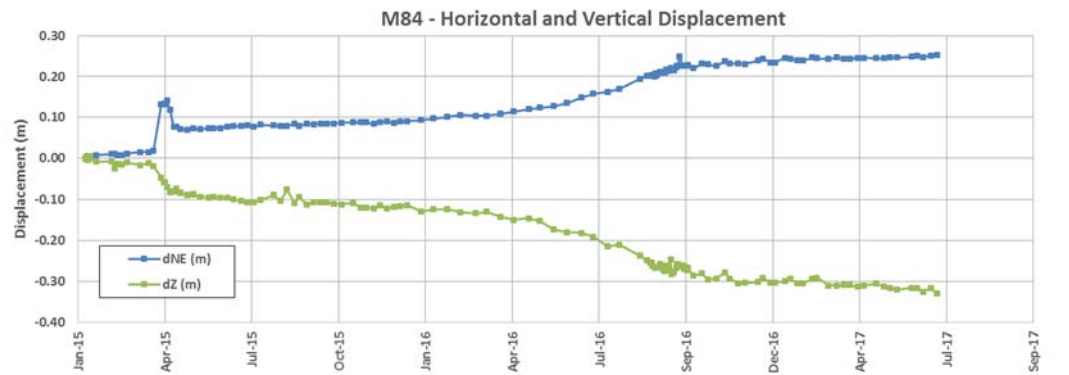
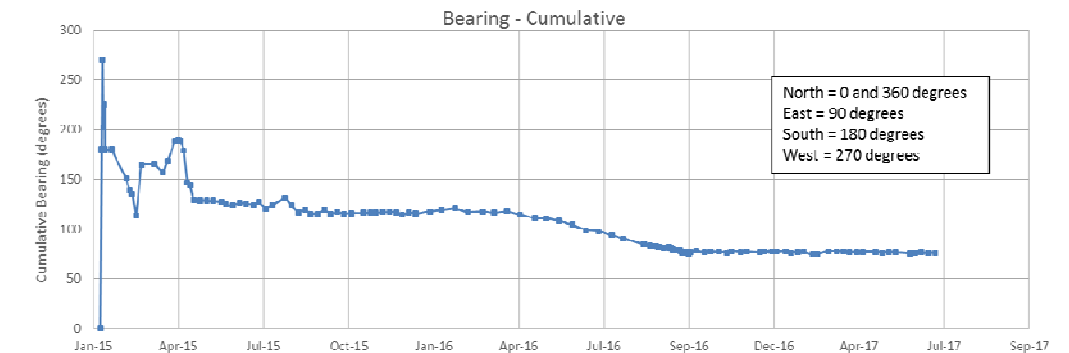
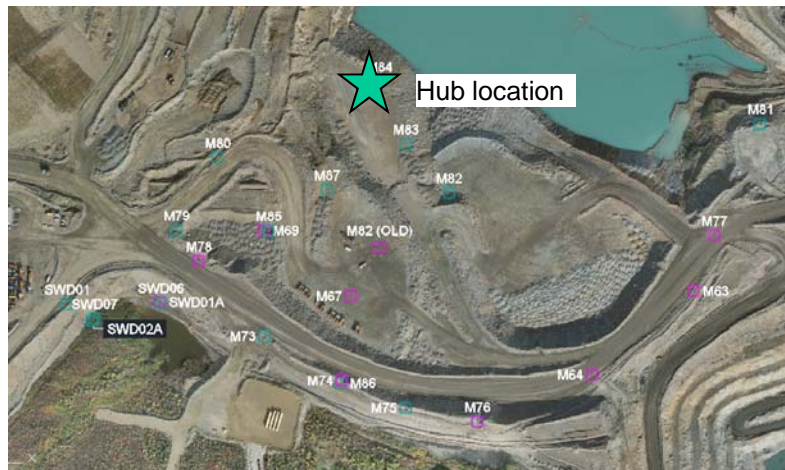
<b>MINTO MINE</b> <small>OPERATED BY MINTO EXPLORATIONS LTD.</small>	Main Pit Instrumentation Data		
		<b>Survey Hub – M84</b>		
Job No: 1CM002.059 Filename: ApG_2017MainPitInstrumentation.pptx	Minto Mine	Date: August 2017	Prepared by PHM	Figure: <b>10</b>

M84	6/21/2017	0.7	0.1	76	Decelerating trend. The increased movement rate in 2016 is believed to be due to construction of the SAT Dump.
M85	5/12/2017	0.4	0.3	74	Slight deceleration trend observable in the horizontal displacement graph.
M86	6/12/2017	0.2	0.6	47	Increase in movement rate. Hub is located on fill placed inside of the ultimate Main Pit crest. Observed movement suspected to be related to settlement of fill in the pit. The hub was replaced in April 2017 - additional data needed to confirm movement trend.
M87	3/15/2017	0.5	0.4	71	Slight deceleration trend observable.

- **High Priority:** Clear the loose rocks beneath M82
- Continue to limit access to the In-Pit Dump area near M84.
- During SAT material placement, truck traffic should be maintained a minimum of 5 meters away from the dump face, or a spotter should be present.

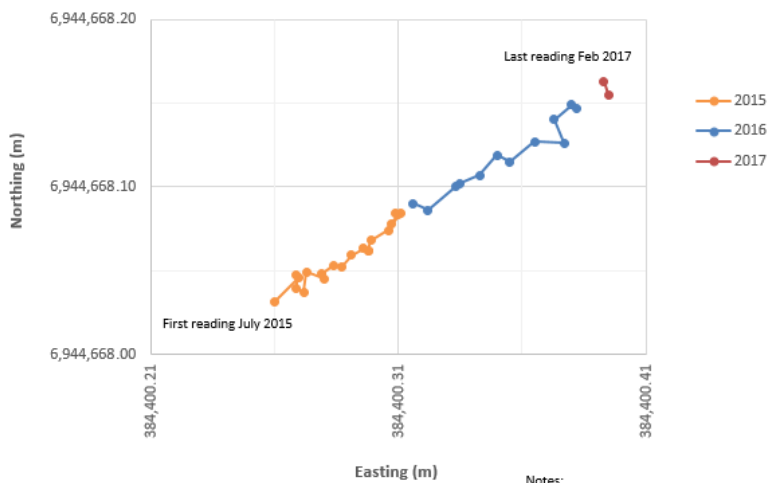
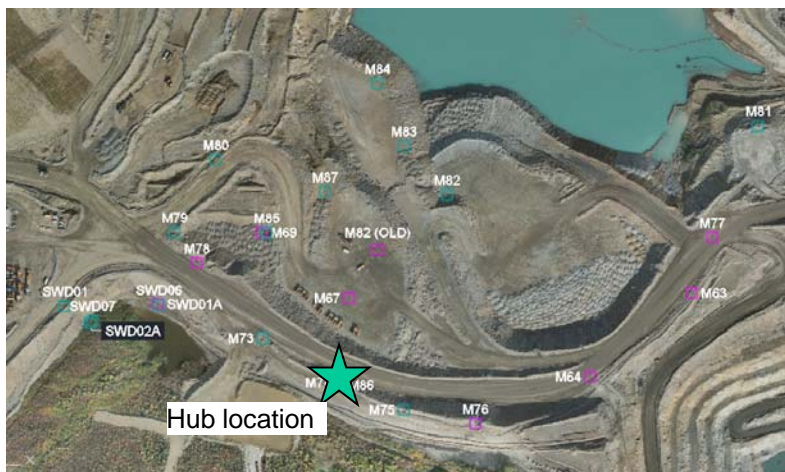
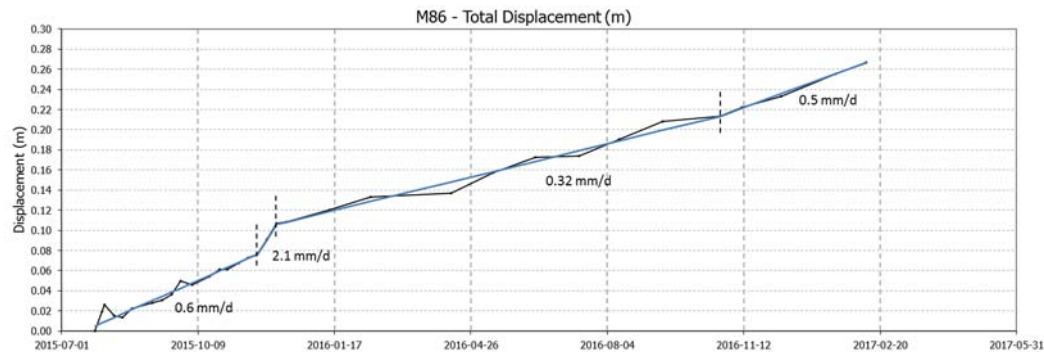
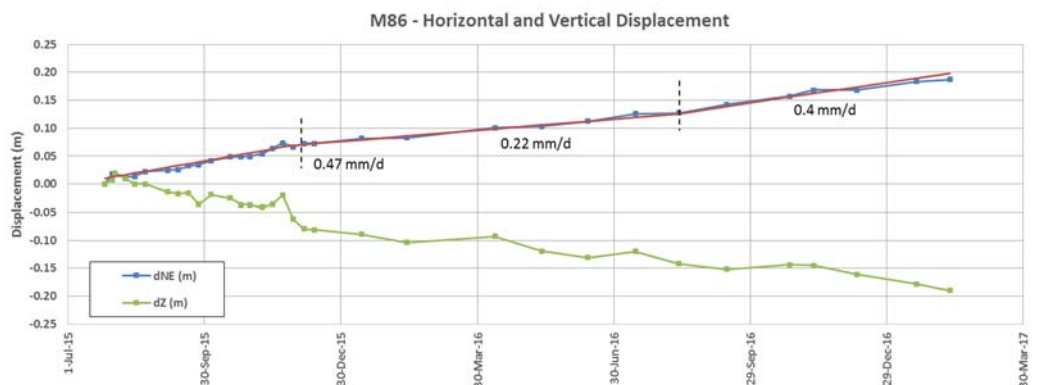
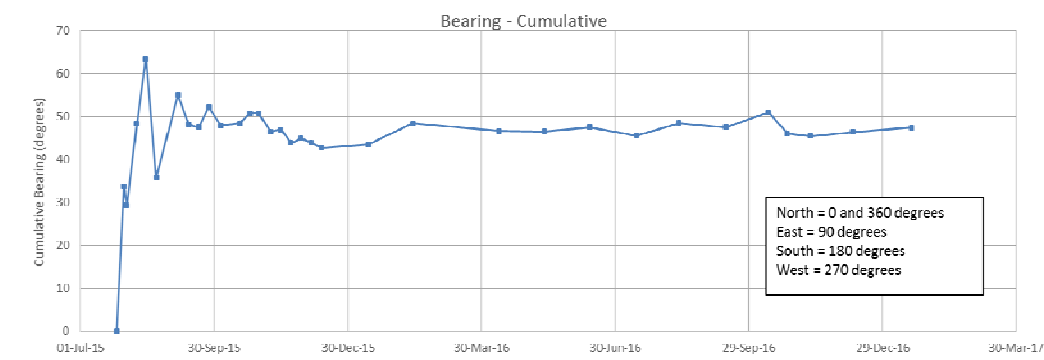
Job No: 1CM002.059 Filename: ApG_2017MainPitInstrumentation.pptx	  Minto Mine	Main Pit Instrumentation Data		
		<b>Survey Hub – M85</b>		
		Date: August 2017	Prepared by PHM	Figure: <b>11</b>

- Hub is a replacement of M75
- Hub destroyed in February 2017 and re-installed in April 2017.

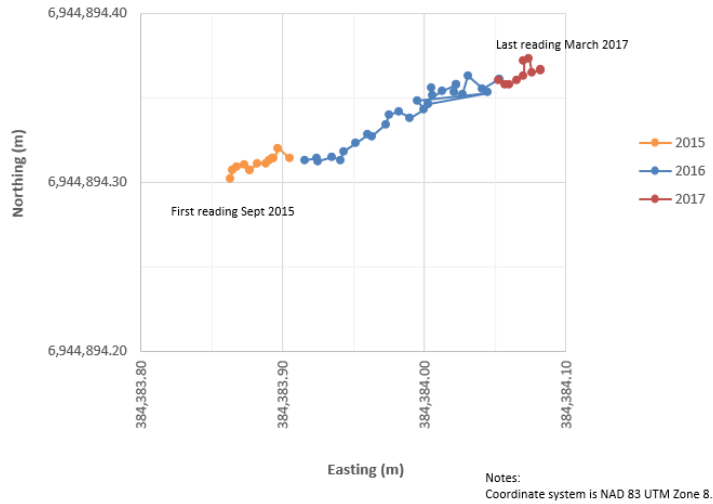
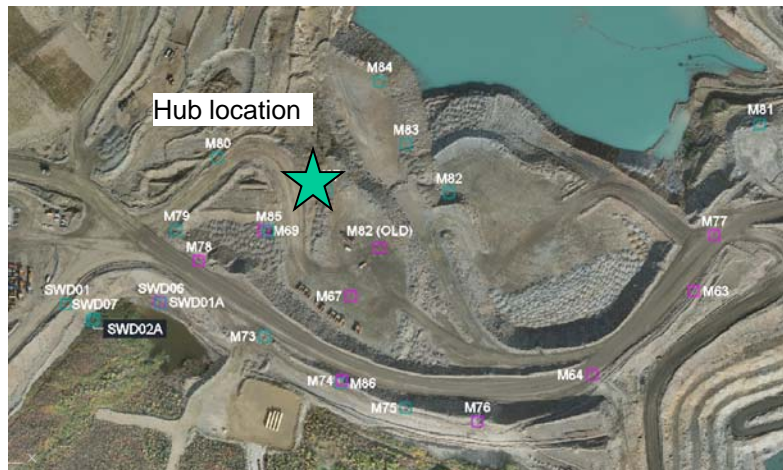
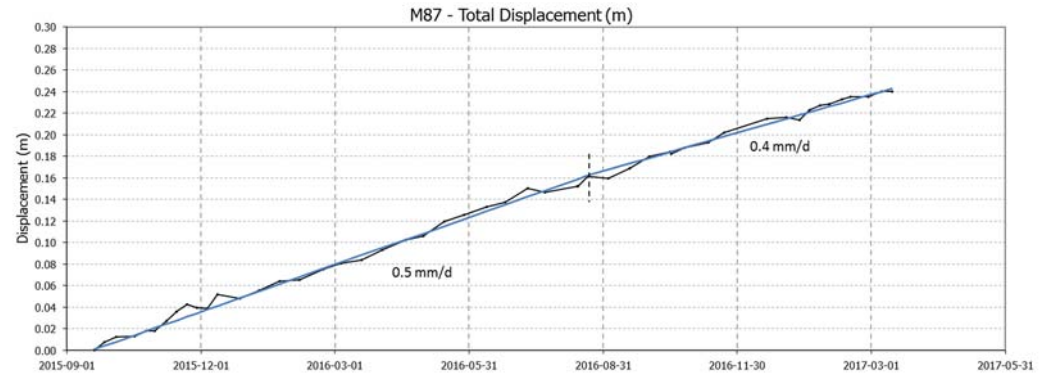
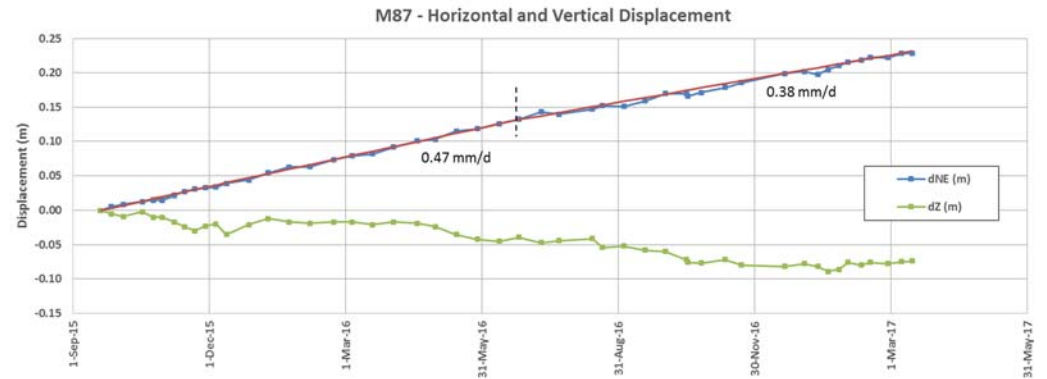
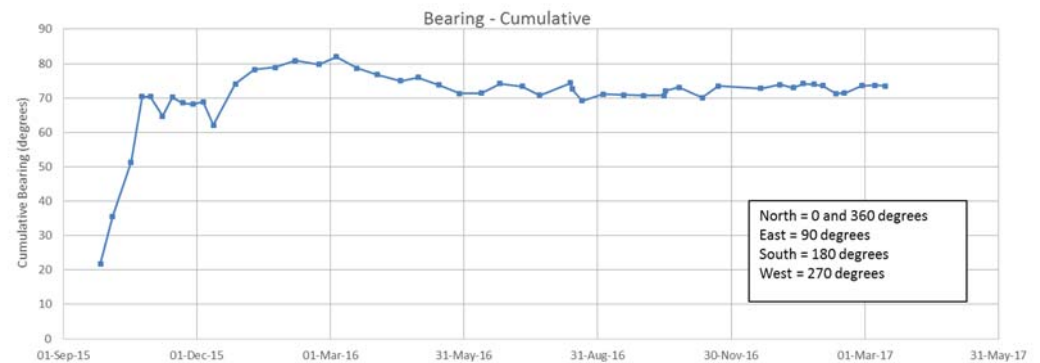
Figure:  
**13**

1. Hub destroyed in March 2017.

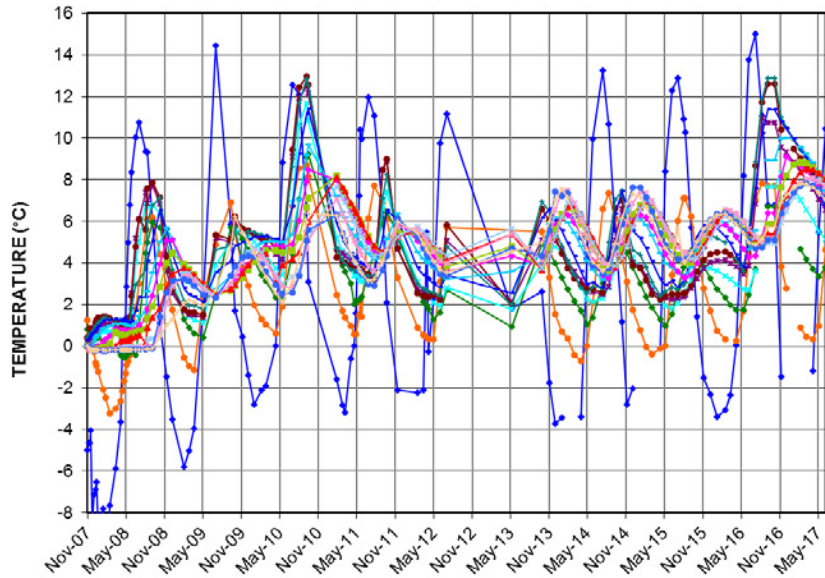
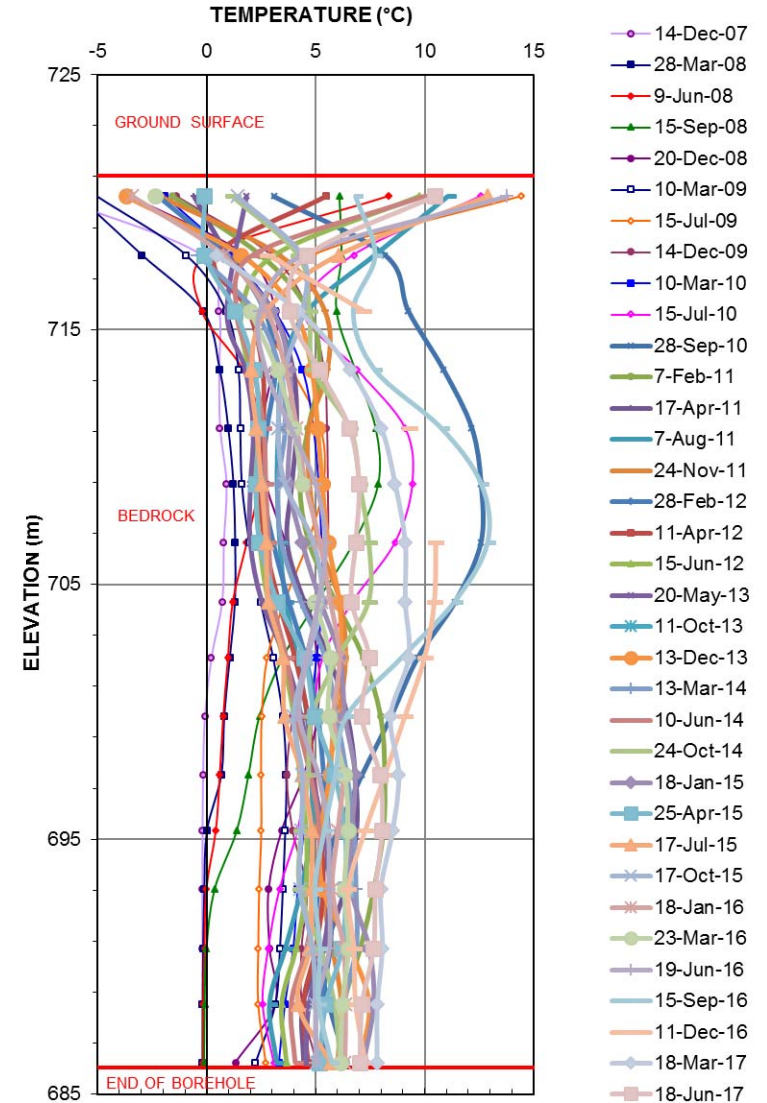
**Temperature Cable – WDT-5**

Ground temperature data are presented in Figures 3 to 10 of Appendix H. All temperature sensors are above zero and show an increasing trend. WDT-5 shows an approximate 2 degree increase in temperatures in the two deepest sensors located in bedrock. The temperatures are within the range of observed groundwater temperatures in Westbays MW-12-05 and MW-12-06
