# 2018 Geotechnical Annual Review, Minto Mine, YT

SRK Consulting (Canada) Inc.  
1CM002.063  
August 2018

On June 26-27, 2018, SRK Consulting (Canada) Inc. completed a geotechnical inspection of the Minto Mine site. The purpose of the inspection was to document the physical condition of the site based on visual observations and to provide geotechnical assessment, noting potential signs of physical instability such as erosion, differential settlement, sloughing or bulging of material, seepage, etc. The inspection is documented in the photographic compilation provided in Appendix A. This report summarizes the findings and recommendations.

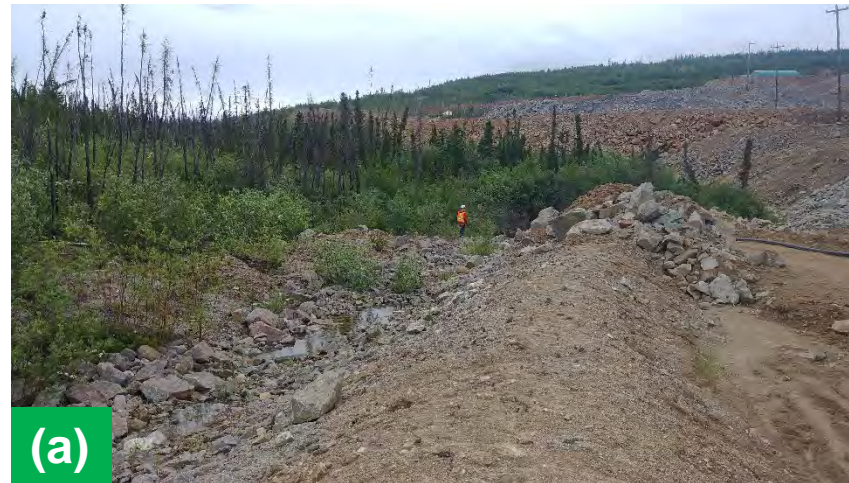
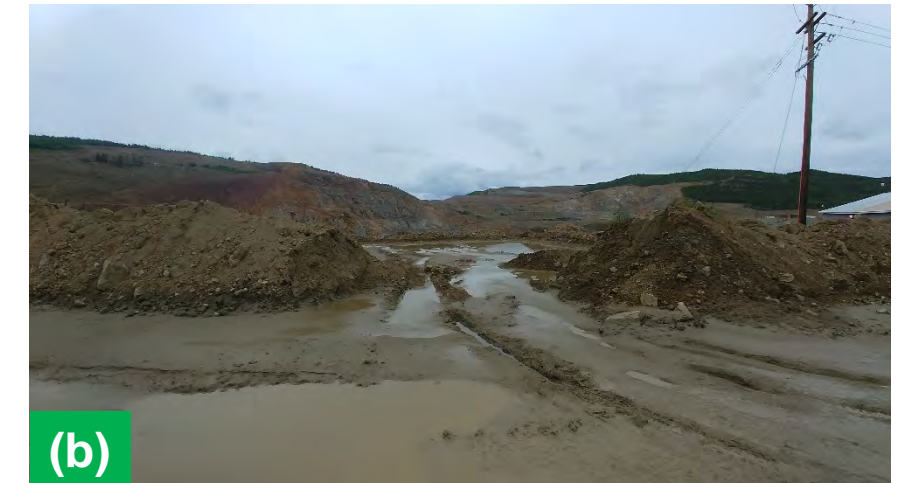
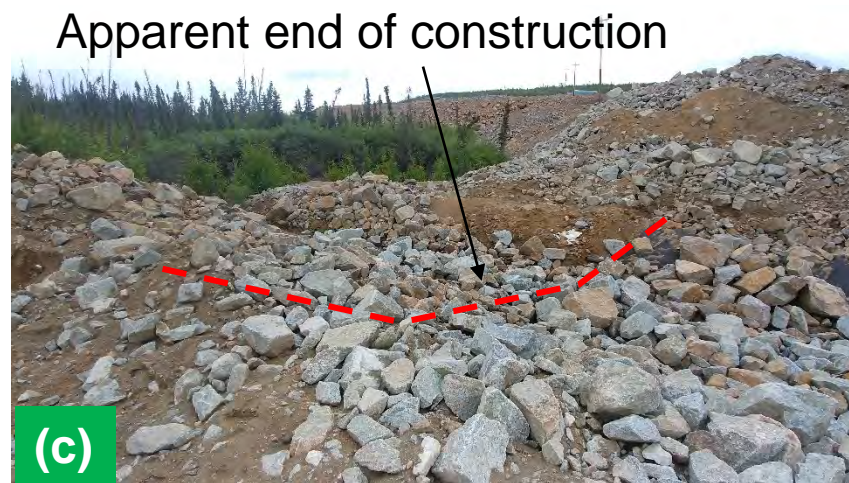
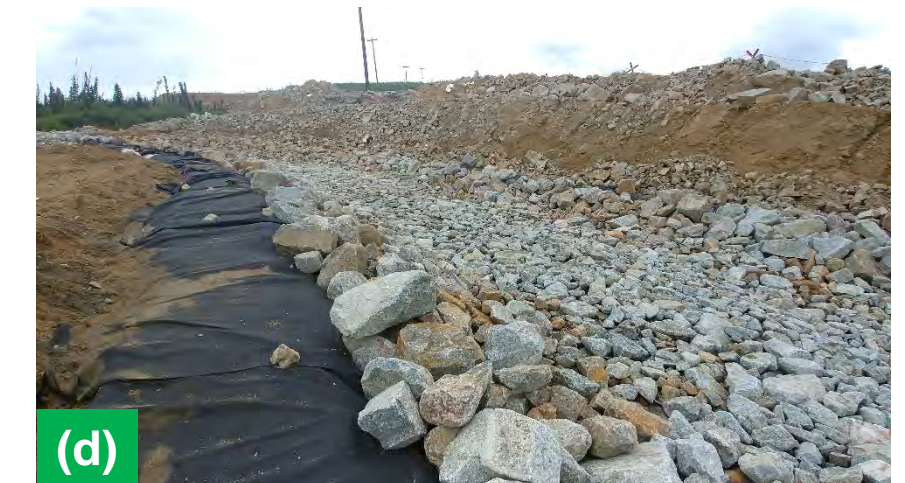
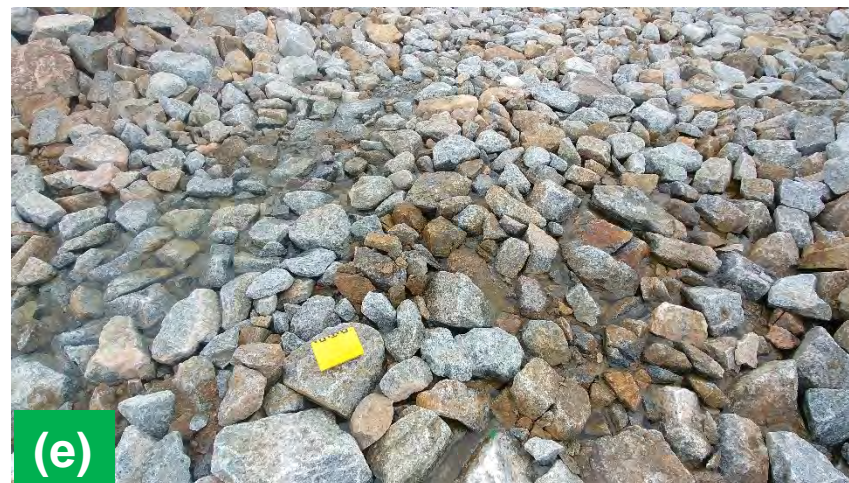
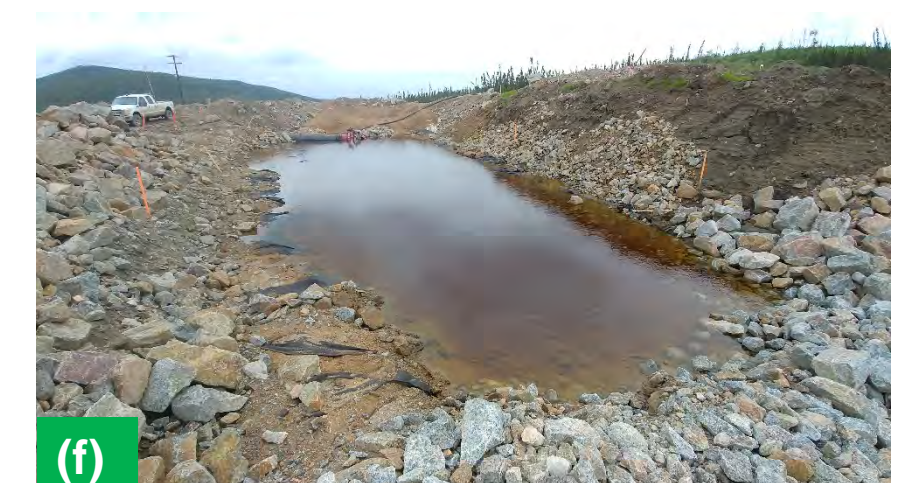
<b>Minto Explorations Ltd.</b>	2018 Geotechnical Inspection		
		<b>Tailings Diversion Ditch Intake Structure and Overflow Spillway</b>		
Job No: 1CM002.063 Filename: AppA_2018InspectionPhoto.pptx	Minto Mine	Date: August 2018	Approved: PHM	Figure: <b>5</b>

Apparent end of construction

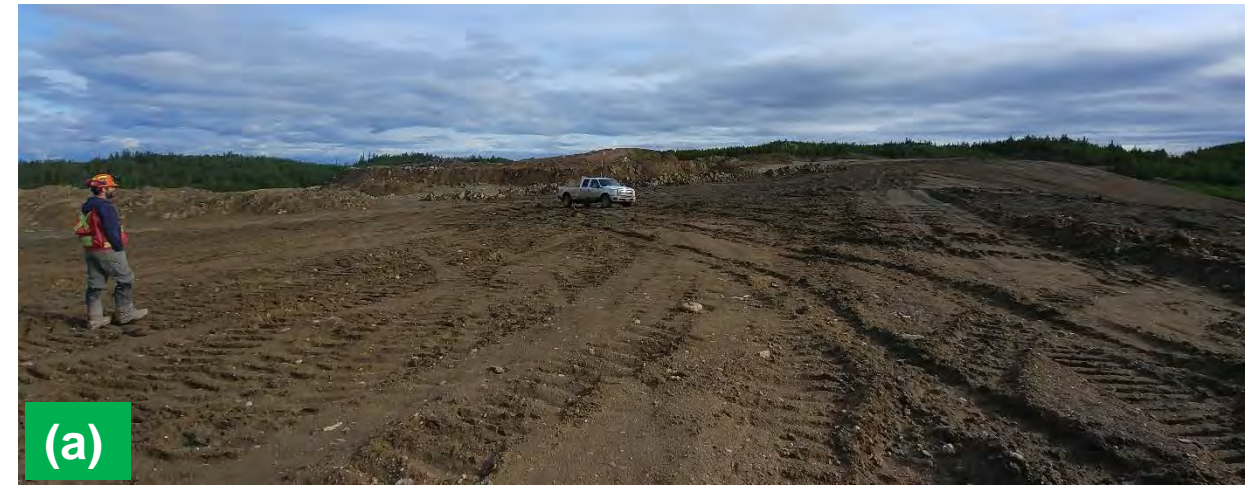
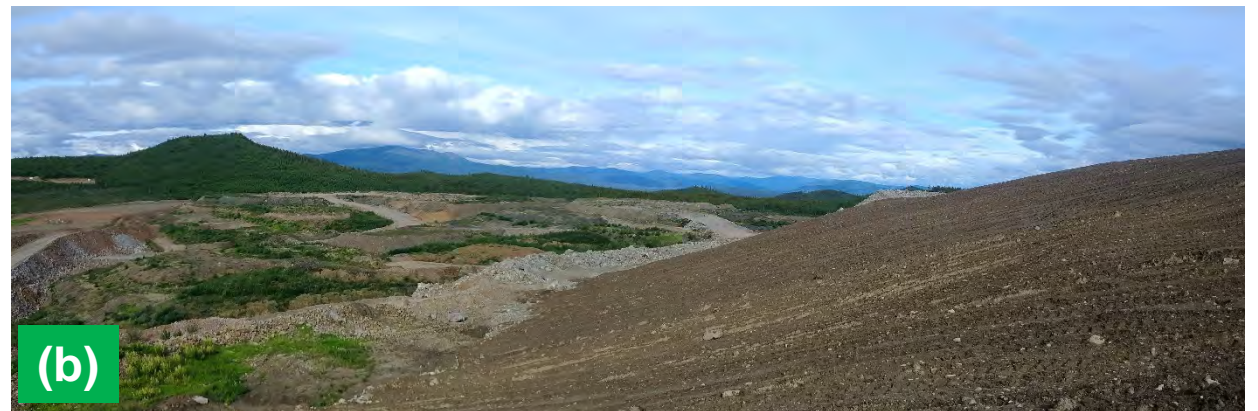
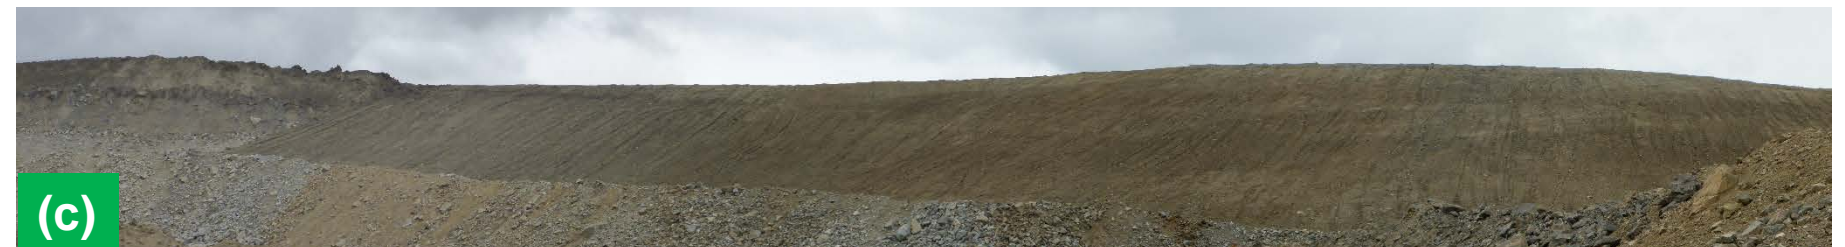
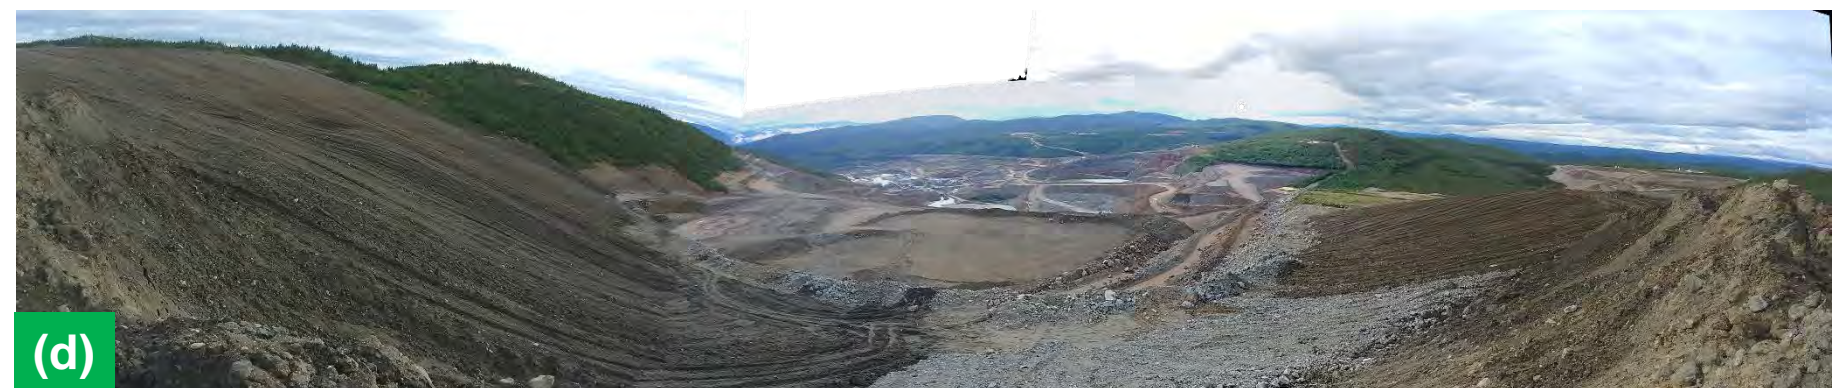
<b>Minto Explorations Ltd.</b>	2018 Geotechnical Inspection		
		<b>Main Waste Dump</b>		
Job No: 1CM002.063 Filename: AppA_2018InspectionPhoto.pptx	Minto Mine	Date: August 2018	Approved: PHM	Figure: <b>6</b>

- Photo A: View of the regraded and covered top of the MWDE.
- Photo B: View of the regraded and covered west side of the MWDE.
- Photo C: Panoramic view of the south eastern face of the MWD where overburden has been placed

- Photo D: Panoramic view of the current regraded upper MWDE slopes with overburden places on the right and left side of the photo, and exposed regrading awaiting overburden placement in the center.

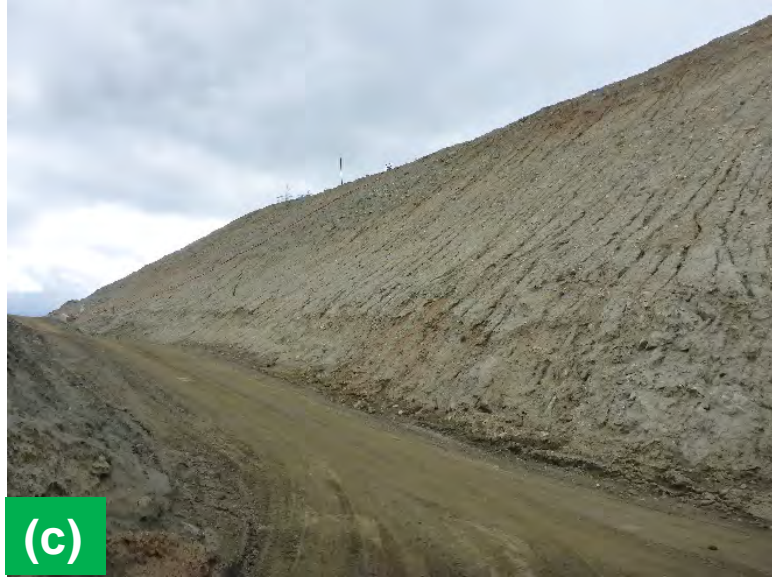
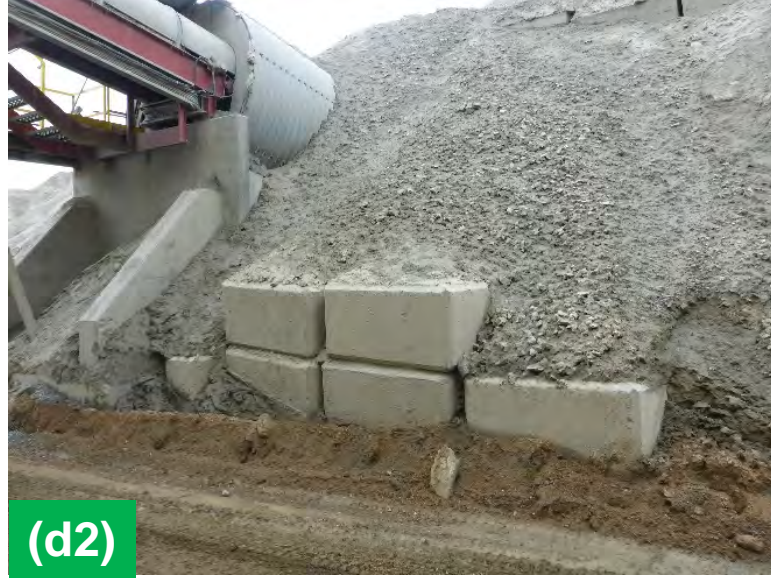
<b>Minto Explorations Ltd.</b>	2018 Geotechnical Inspection		
		<b>Mill Site and Ore Stockpiles</b>		
Job No: 1CM002.063 Filename: AppA_2018InspectionPhoto.pptx	Minto Mine	Date: August 2018	Approved: PHM	Figure: <b>11</b>

Conditions of the mill area are similar to those observed in the 2017 inspection. Minor ongoing erosion was again noted on the slope to the north of the mill (Photos A, B1, B2, and C). Fallen rocks appear to have been cleared as needed from the road and walkway on an as needed basis (Photos B and C).

Photos D1 and D2 show the mill feed stockpile. The lock-blocks located beneath the mill feed conveyor are bulging toward the road.

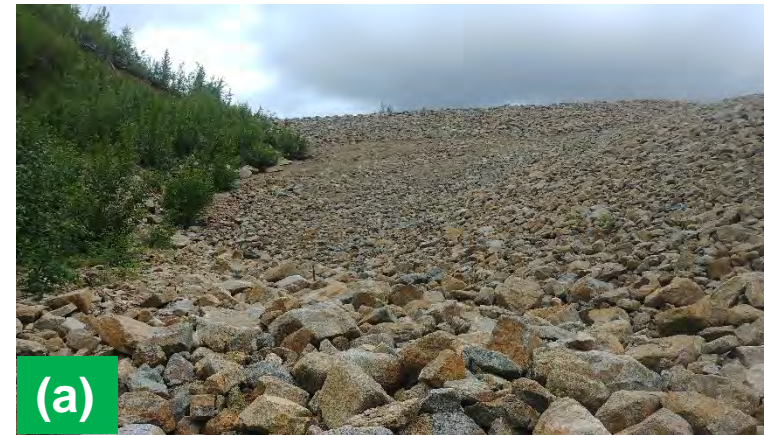
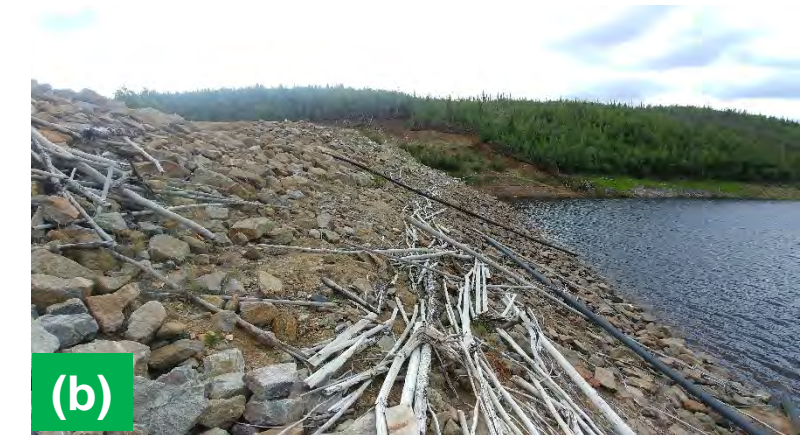
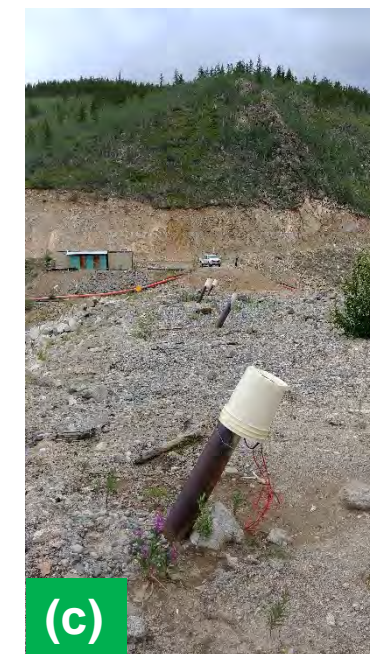
<b>Minto Explorations Ltd.</b>	2018 Geotechnical Inspection		
		<b>Water Storage Pond Dam</b>		
Job No: 1CM002.063 Filename: AppA_2018InspectionPhoto.pptx	Minto Mine	Date: August 2018	Approved: PHM	Figure: <b>14</b>

- Similar to 2017, the pond elevation during the inspection was approximately 709.5 m (spillway elevation 716.2m)
- No signs of instability along the dam, or at the abutments.
- Seepage water downstream of the dam was clear and no accumulation of sediments was observed. Flow could not be heard through the rockfill near the previously identified seep.
- The weir present downstream of the dam had an estimated flow rate of approximately 1 L/s. Condition of the seepage water appears unchanged from the 2017 inspection. The water through the seep was clear, (no visual turbidity).
- Some sedimentation was apparent in the rockfill on the upstream left abutment. It appears this is sediment laden runoff from the mine site access road and former water treatment plant pad.

Photo A: View of the downstream slope taken from the ponded seepage water area looking towards the right abutment.  
 Photo B: Upstream side of the dam with the high water mark indicated by the line of wood debris.  
 Photo C: View of the piezometers along the crest of the dam  
 Photo D: View of the downstream slope of the dam taken from the right abutment.  
 Photo E: View of the upstream slope at the left abutment, near the previous repair, also showing the apparent sediment buildup.

- Continue regular monitoring of the dam as per the OMS Manual.
- Consider installation of sediment control near the former water treatment pad to limit deposition of fines within the rockfill.

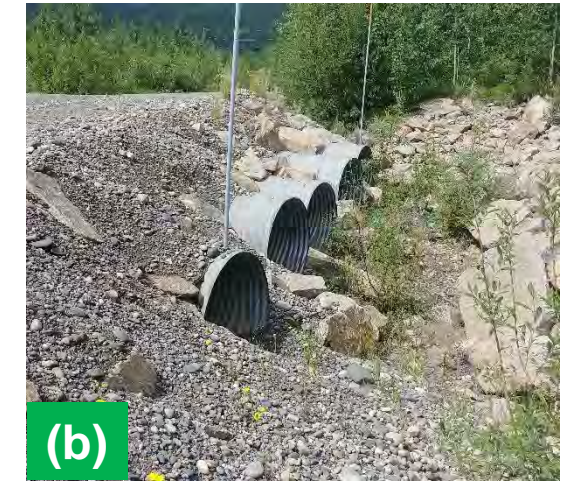
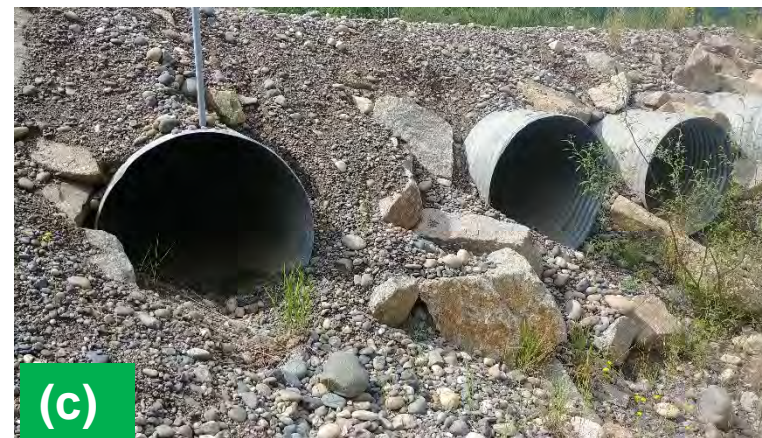
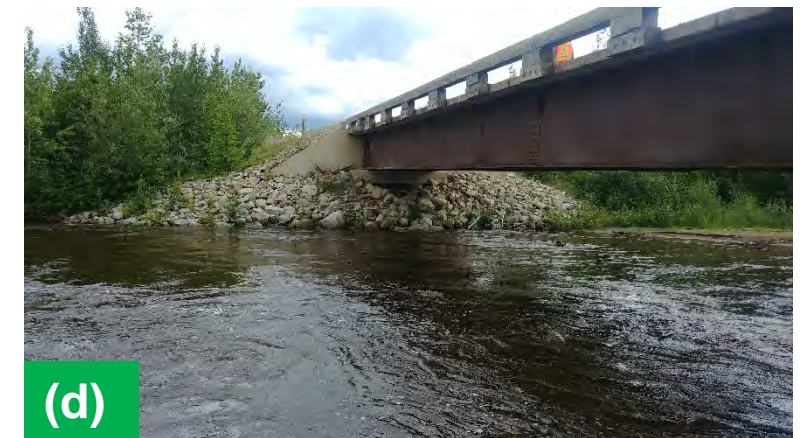
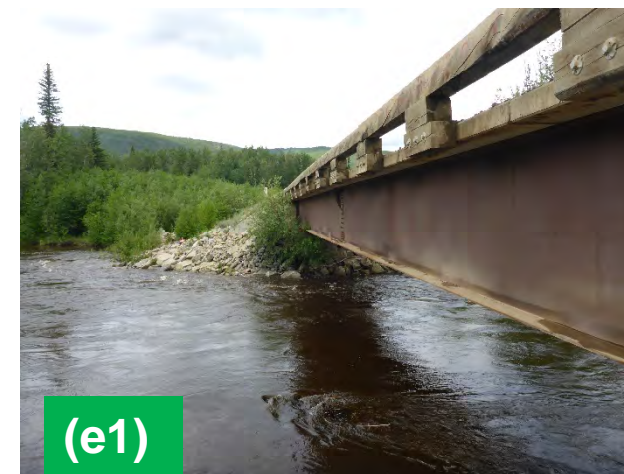
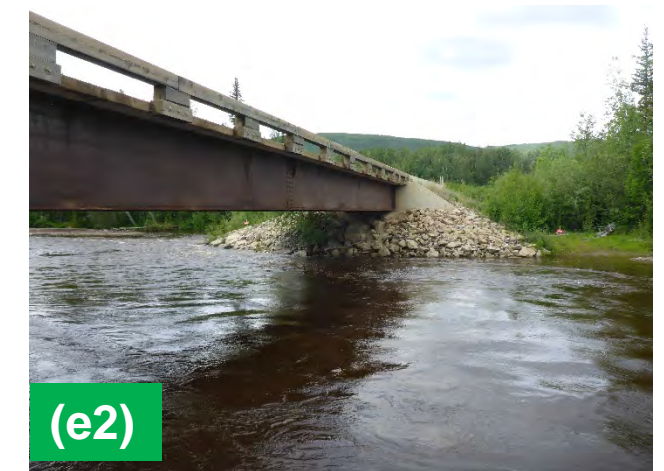
<b>Minto Explorations Ltd.</b>	2018 Geotechnical Inspection		
		<b>Big Creek Bridge</b>		
Job No: 1CM002.063 Filename: AppA_2018InspectionPhoto.pptx	Minto Mine	Date: August 2018	Approved: PHM	Figure: <b>15</b>

- Conditions of the culverts are unchanged since the previous June 2017 inspection. All culverts are in satisfactory conditions with no major blockages or sediment accumulation at either end of the culverts. The first culvert west of the bridge is in satisfactory condition.

- Photos A and B show the upstream and downstream ends of the group of 5 culverts, each with diameter of 1.1 m. The culverts are in satisfactory condition, with no blockages at either end. Small portions of geotextile are exposed at either end, but is not impacting the culvert performance.

- Some material buildup around the end of the culverts indicate the road gravel has been graded out and is starting to block some of the culvert.
- Ditch Blocks #2 to #5 are unchanged from previous inspections and are in satisfactory condition. Ditch Block #1 has not been constructed.

- The bridge abutments and road approaches are in good condition, with no signs of instability observed.

- Continue regular annual monitoring of sediment accumulation in the culverts, and clean out if sediments continue to accumulate.
- Limit the material graded from the road at the culvert locations, or muck out some of the gravel buildup, taking care not to damage the culvert
- If the alignment of Big Creek changes and it appears that the culverts may be utilized, tree clearing and sediment removal immediately upstream and downstream of the culverts is recommended.

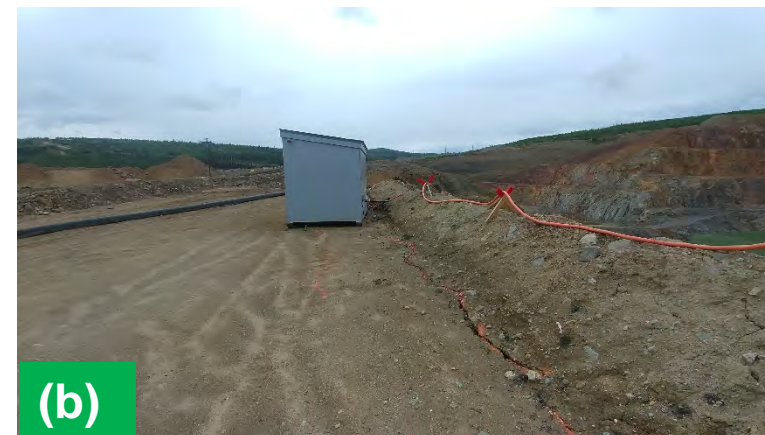
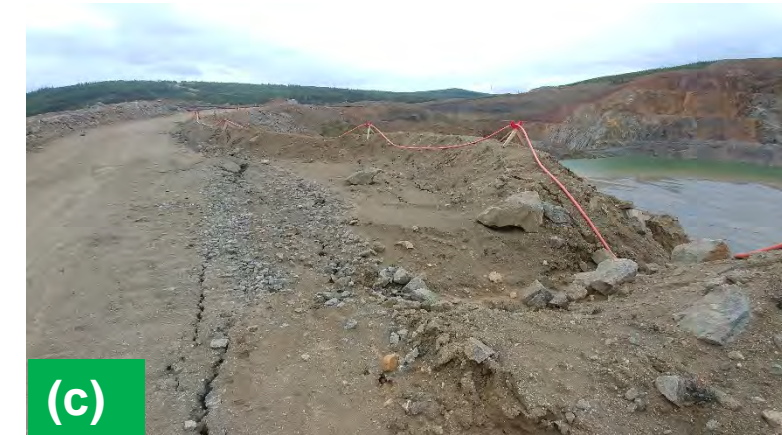
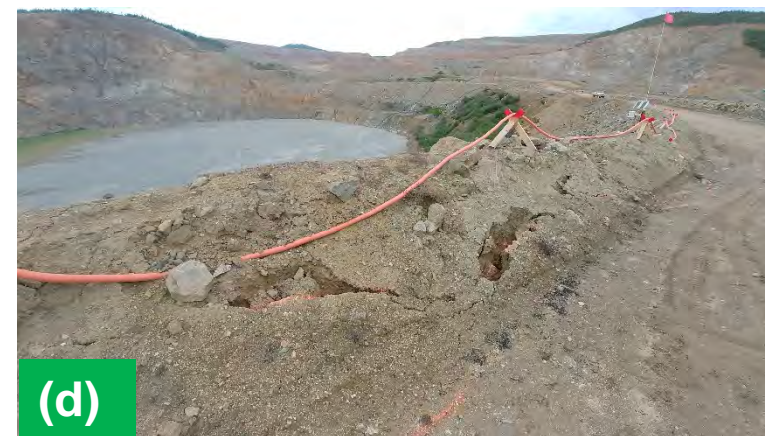
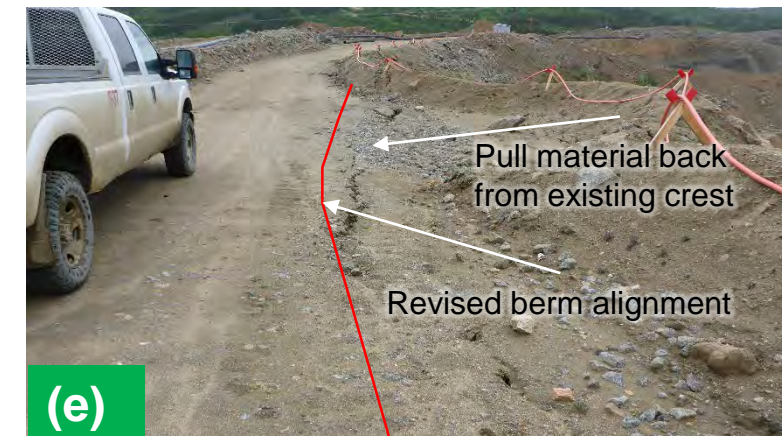
- Photo A: View of the Area 2 Stage 2 Pit taken from the road between Stage 2 and Stage 3 looking north. The conditions of the highwall on the south, west, and north sides of the pit appear unchanged compared to the 2017 inspection photographs
- Photo B, C, D: Cracking was observed on the north east side of the Stage 2 Pit parallel to the access road.
  - An electric cable and transformer are located on the pit-side of the cracks are at risk should the overburden material slough into the pit.
  - The vehicle pull-out area is experiencing the greatest amount of cracking and deformation,
- Photo E provides an additional view of the cracking with an overlay of a potential remedial measures to move the infrastructure away from the edge and construct a new berm further away from the pit.

- **High Priority:** Move the transformer shed further from the crest and away from the observed cracks in the road.
- The safety berm should be pulled back uphill of the cracking (Photo E). Alternatively, access to the pit rim road should be limited and the utility lines be moved further to the north.

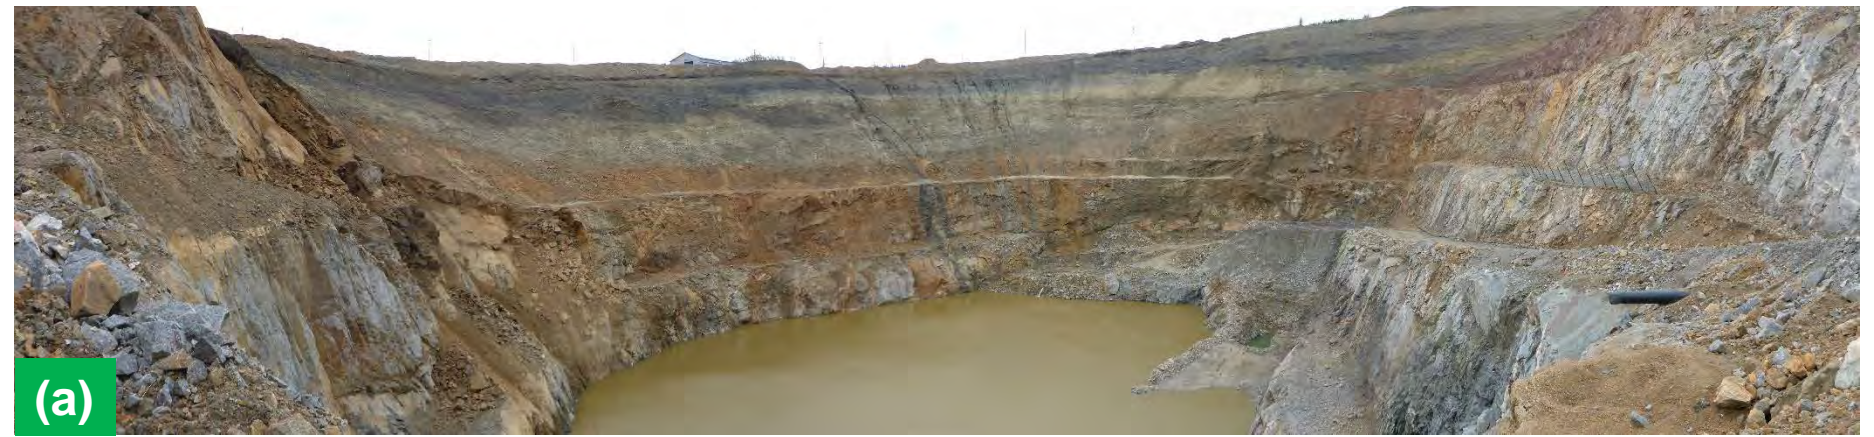
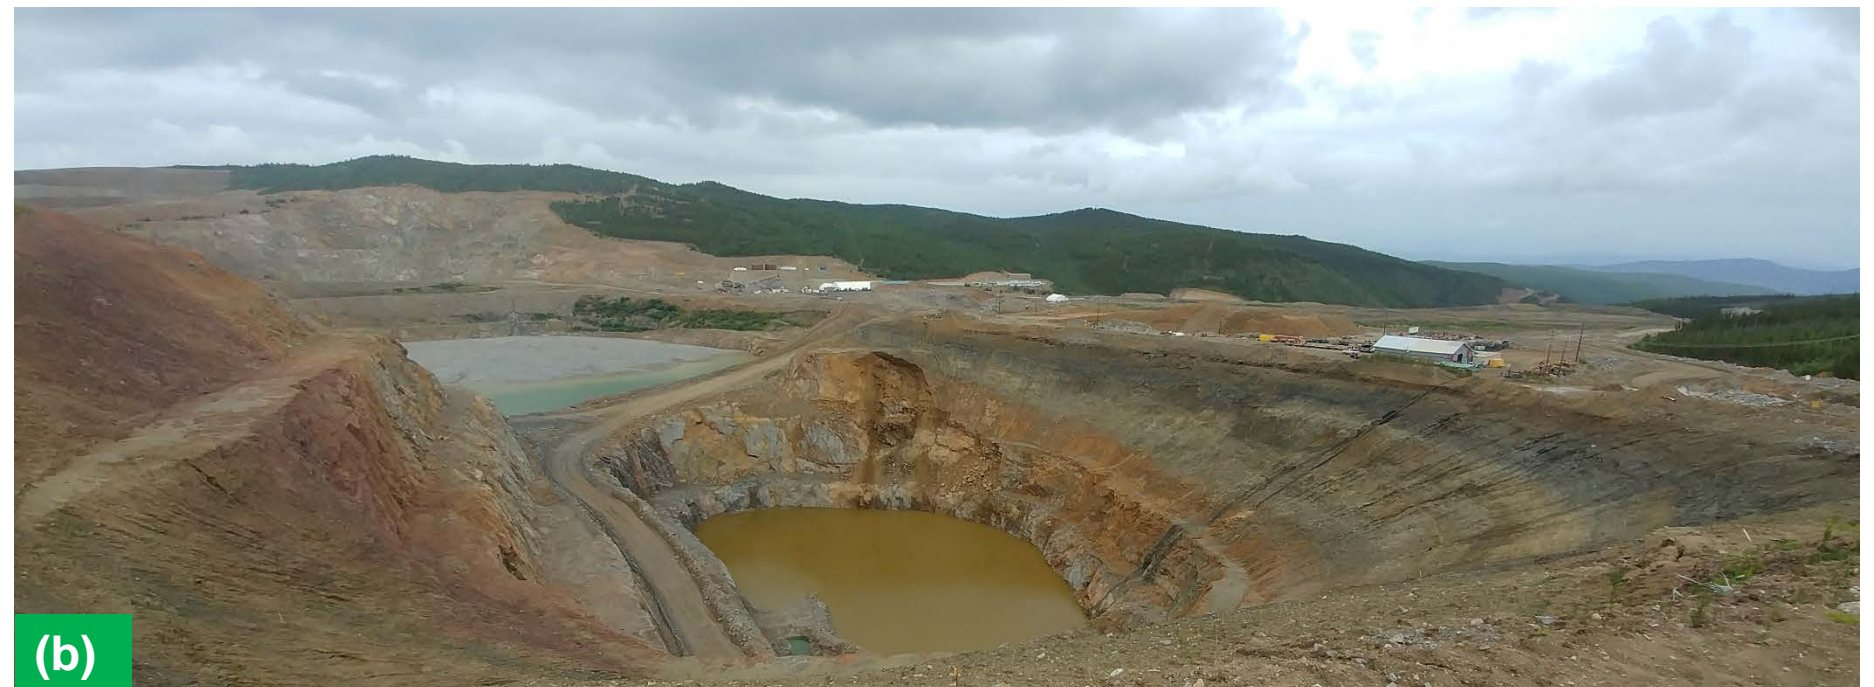
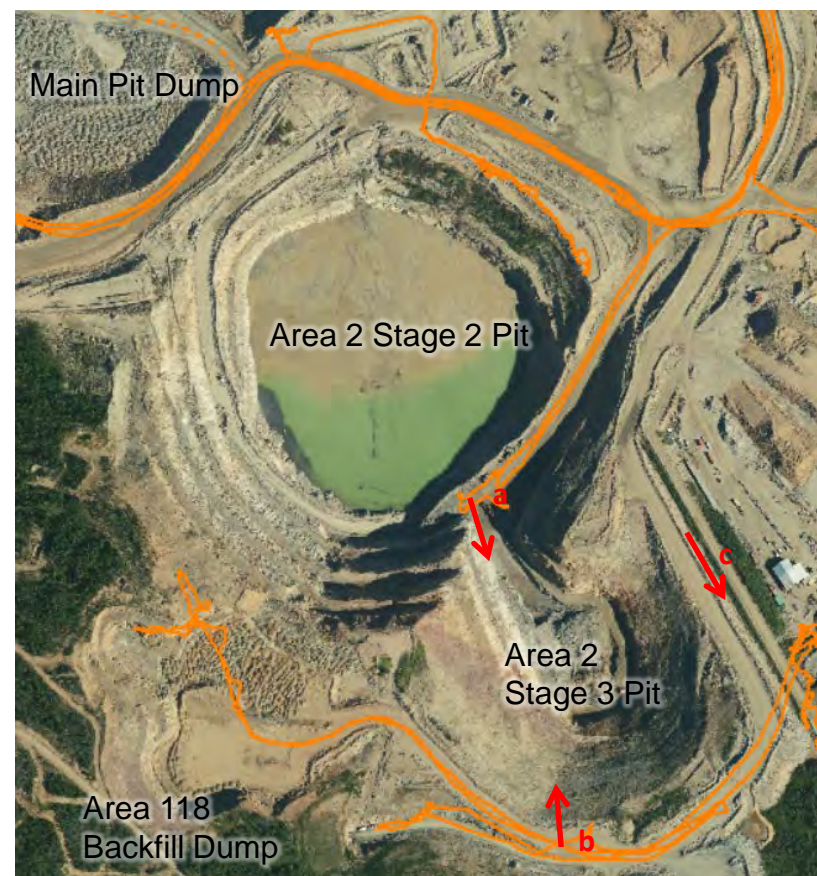
- Photo A: View of the Area 2 Stage 3 Pit taken from the road between Stage 2 and Stage 3 looking southwest.
- Photo B: View of the Area 2 Stage 3 pit with the Stage 2 pit in the background, there was an active rockfall on the 'bull-nose' between the two pits at the time of inspection.

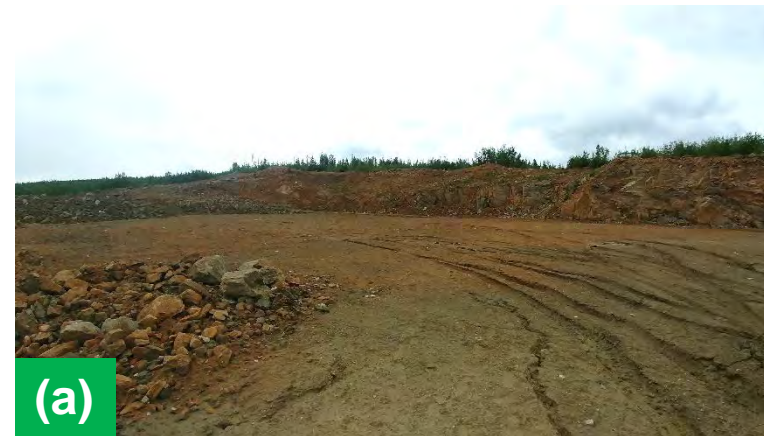
Photo (a): View of the Area 118 Pit looking west.

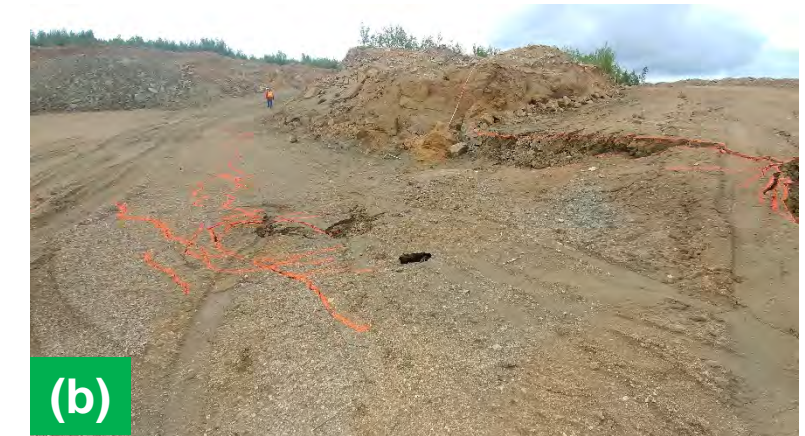
A number of sinkholes and cracks have formed on the surface of the backfill due to differential settlement of the placed fill. While not a stability risk, soft ground, sinkholes and cracking may pose a trafficability risk. Access to this area should be limited.

Photo (b): View of some of the cracking and sinkholes near the north edge of the pit.

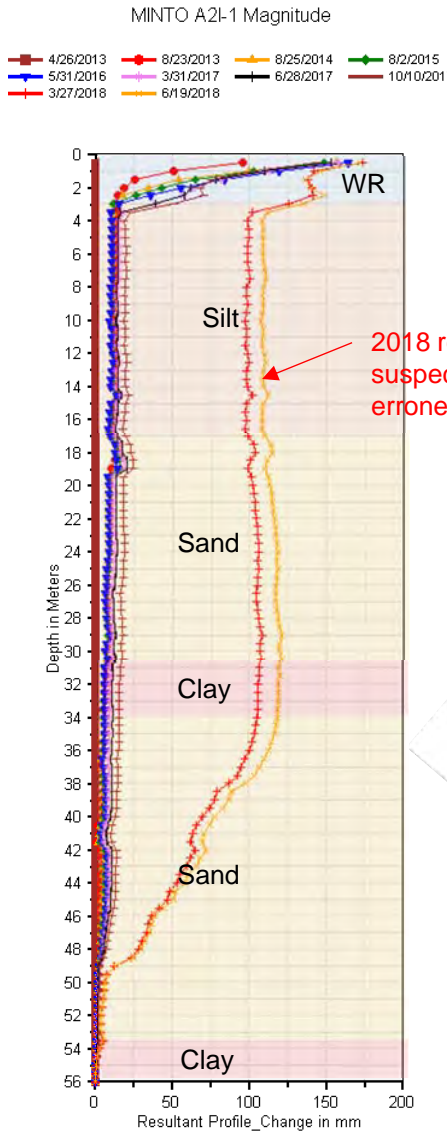
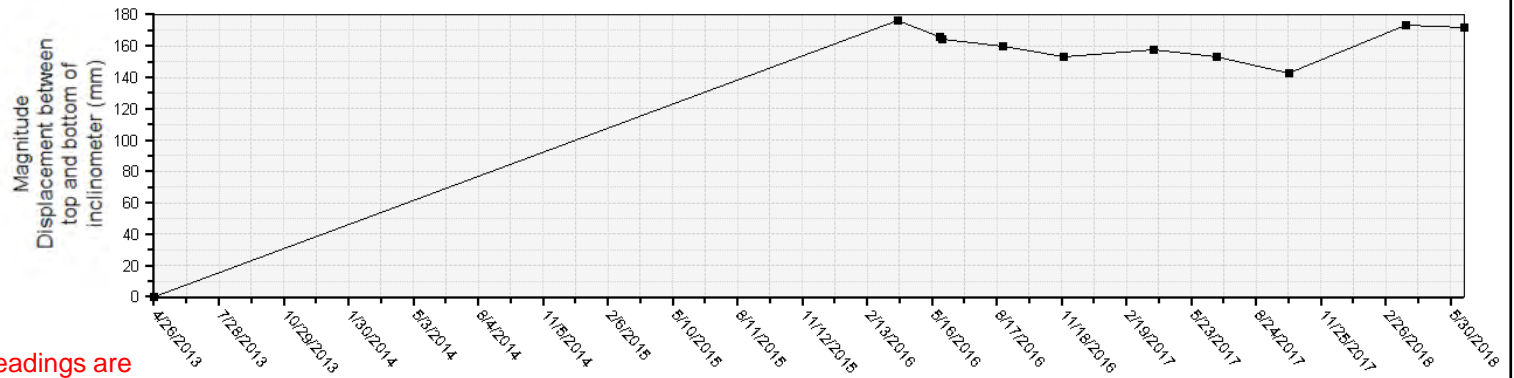
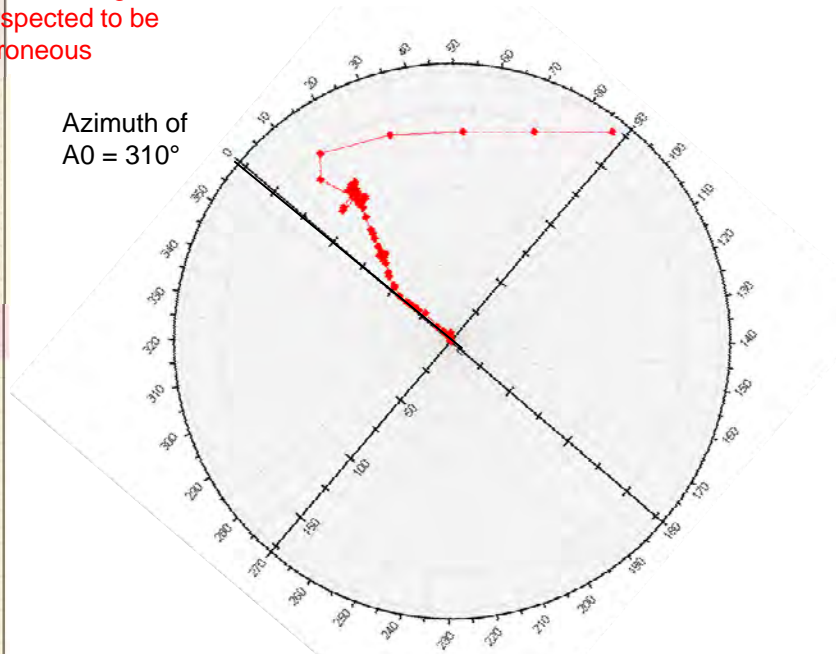
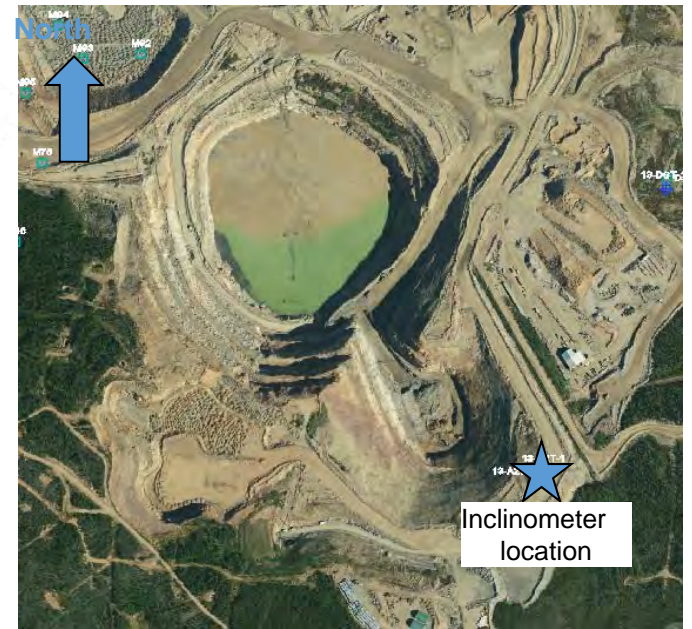
The inclinometer data is shown in Figure 1 of Appendix C. The data shows a shear occurred within the waste rock fill near the surface during the initial year of data collection, along with some minor displacement at lower depths with no significant movement prior to 2017. The reading collected since October 2018 appear to be erroneous with high check-sum values indicating the readings are of poor quality. The inclinometer probe is recommended to be inspected by a qualified technician, and additional training be provided to staff collecting readings to monitor the 'check-sum' values to ensure quality data is collected.

1. Surveys plotted in 2018 are suspect as the data 'check-sum' values are high.
2. Inclinometer software (DigiPro2 v2.12.4) plots A0 as 0 degrees. The plot above has been rotated such that the orientation matches the plan (north is up).

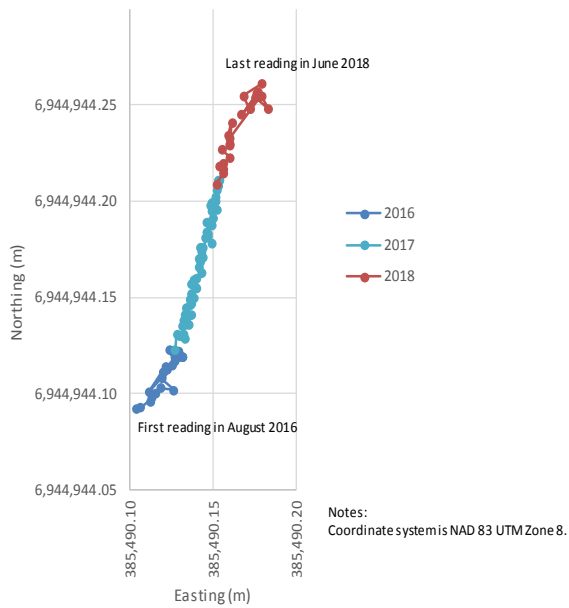
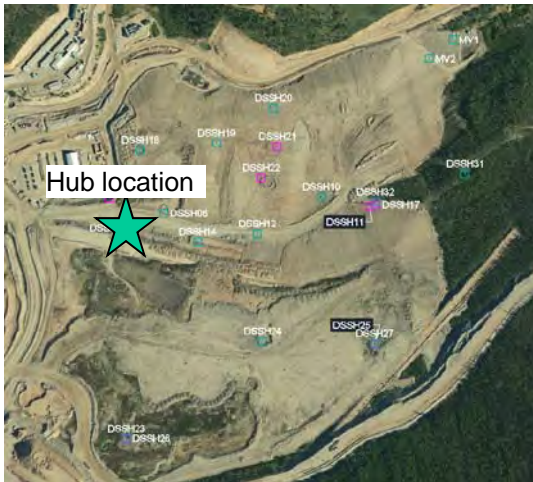
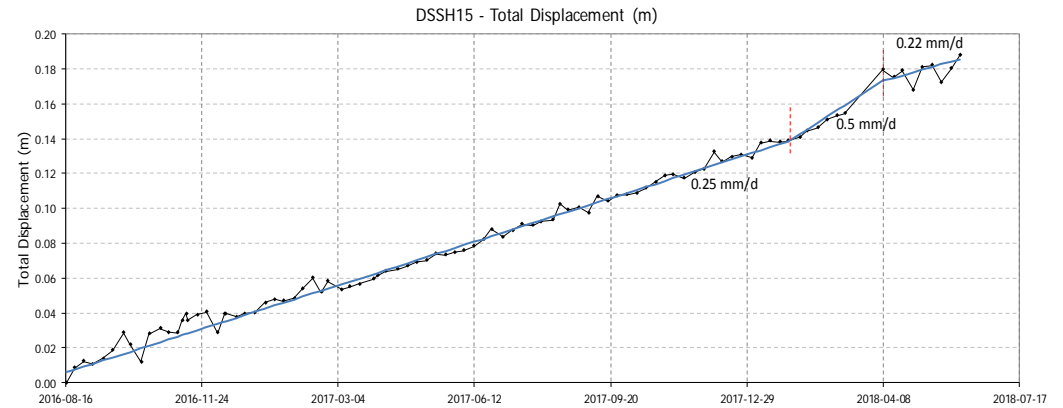
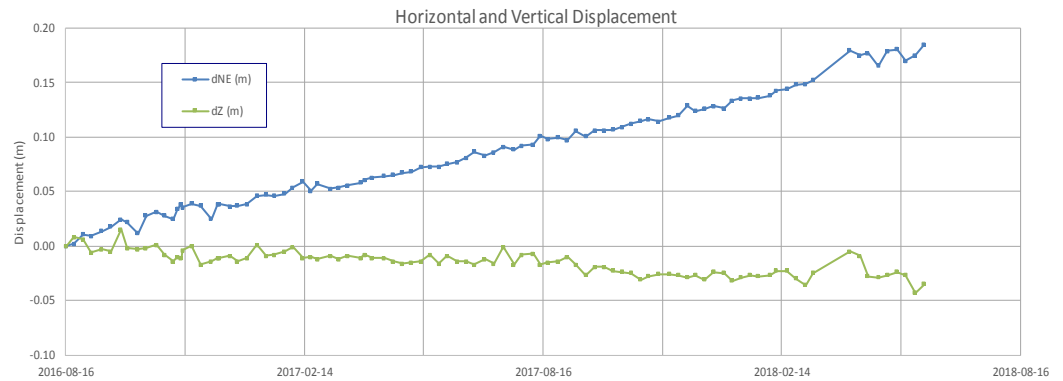
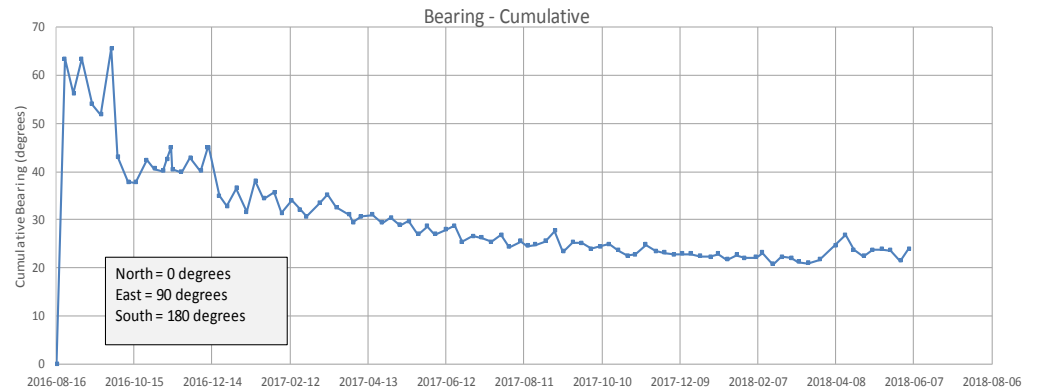
Minto Explorations Ltd.		DSTSF Instrumentation Data	
	Minto Mine		Survey Hub – DSSH14	
Job No: 1CM002.063 Filename: ApD_2018DSTFLandscape.pptx	Date: August 2018	Prepared by: PHM	Figure: 5

- The survey hub was removed in February 2016 prior to MVFES2 construction. The hub was reinstalled in August 2016 following completion of construction.

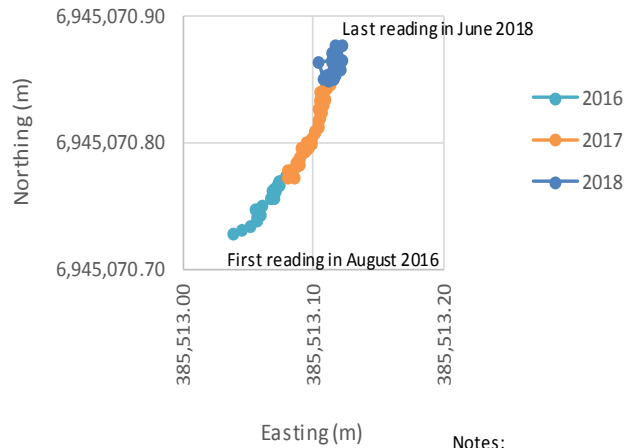
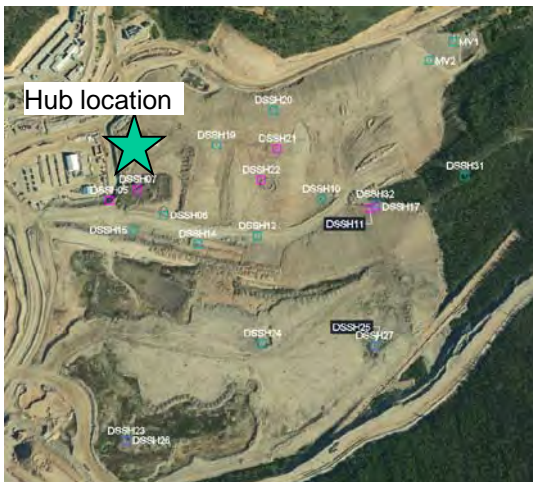
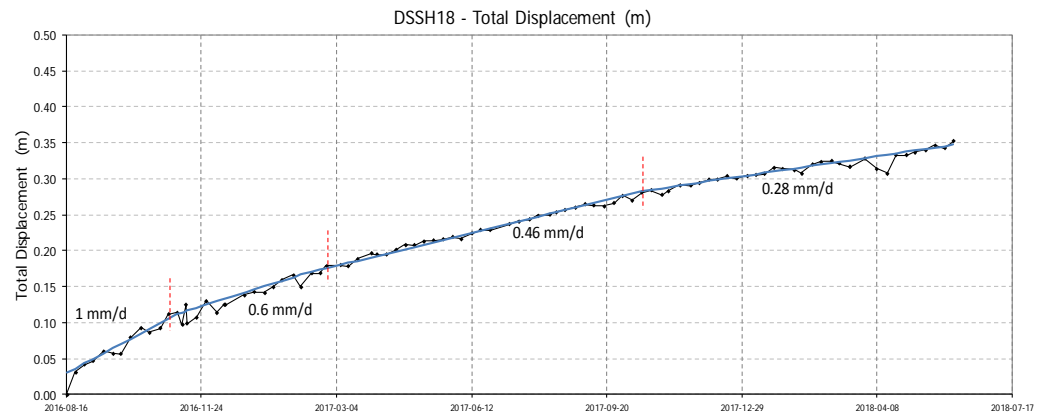
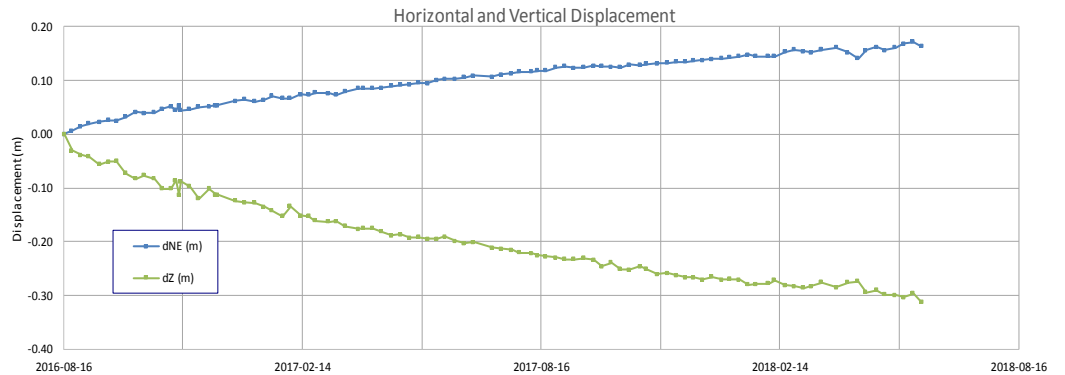
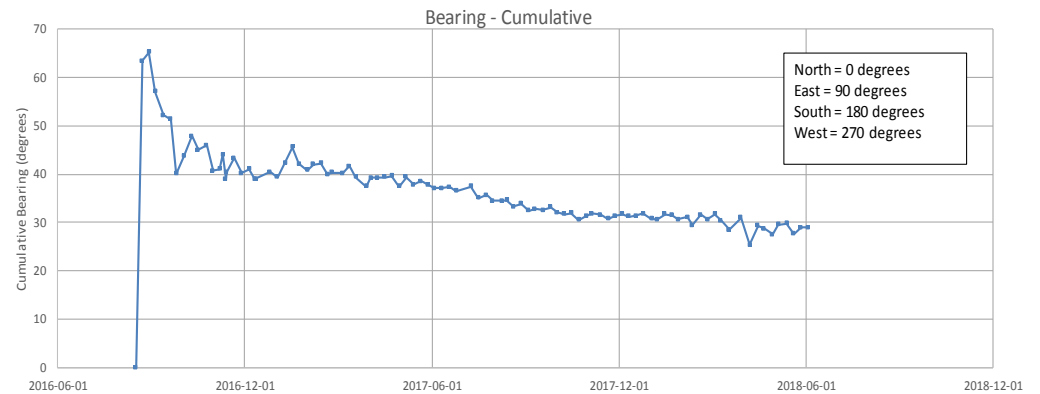
Figure:  
**6**

- The survey hub was removed in December 2015 prior to MVFES2 construction. The hub was reinstalled in August 2016 following completion of construction.
