# 2018 Geotechnical Annual Review, Minto Mine, YT

SRK Consulting (Canada) Inc.  
1CM002.063  
August 2018

On June 26-27, 2018, SRK Consulting (Canada) Inc. completed a geotechnical inspection of the Minto Mine site. The purpose of the inspection was to document the physical condition of the site based on visual observations and to provide geotechnical assessment, noting potential signs of physical instability such as erosion, differential settlement, sloughing or bulging of material, seepage, etc. The inspection is documented in the photographic compilation provided in Appendix A. This report summarizes the findings and recommendations.

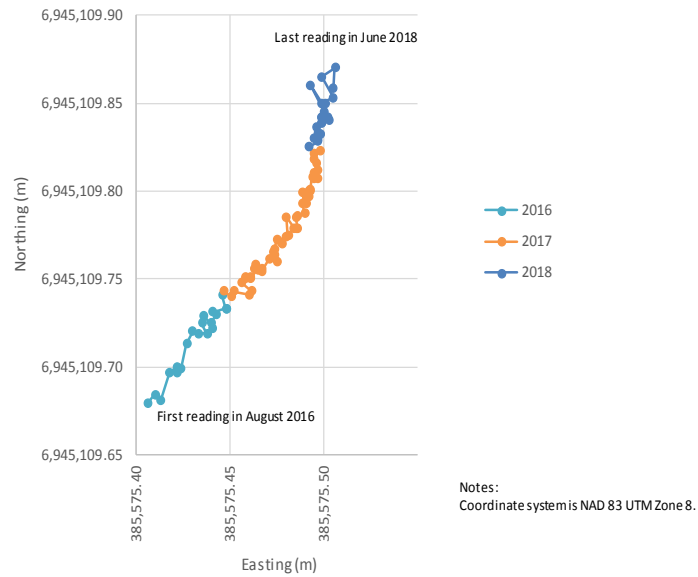
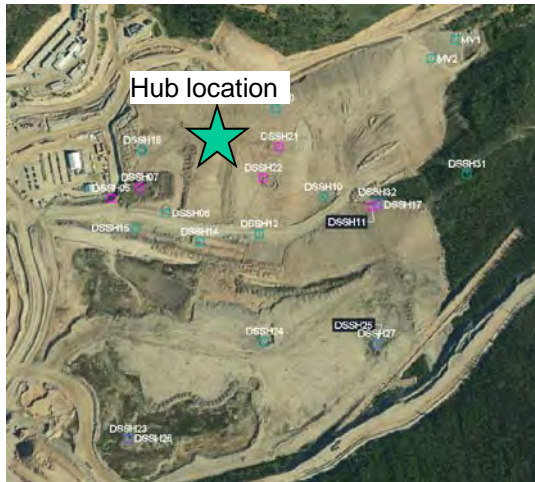
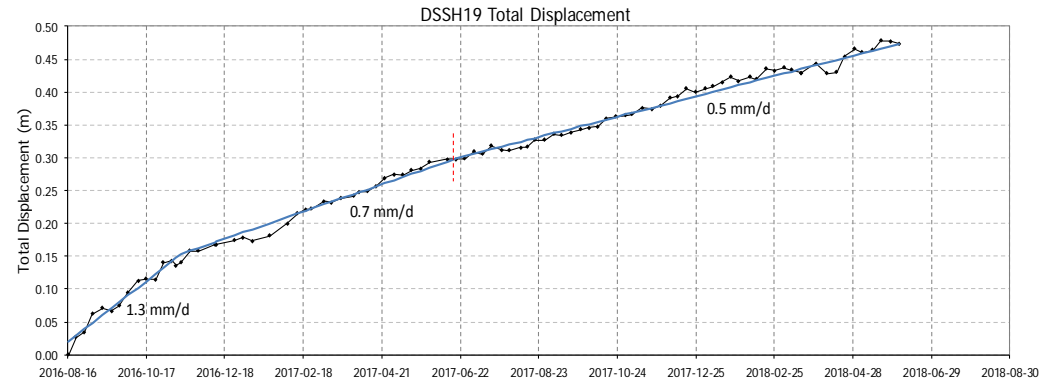
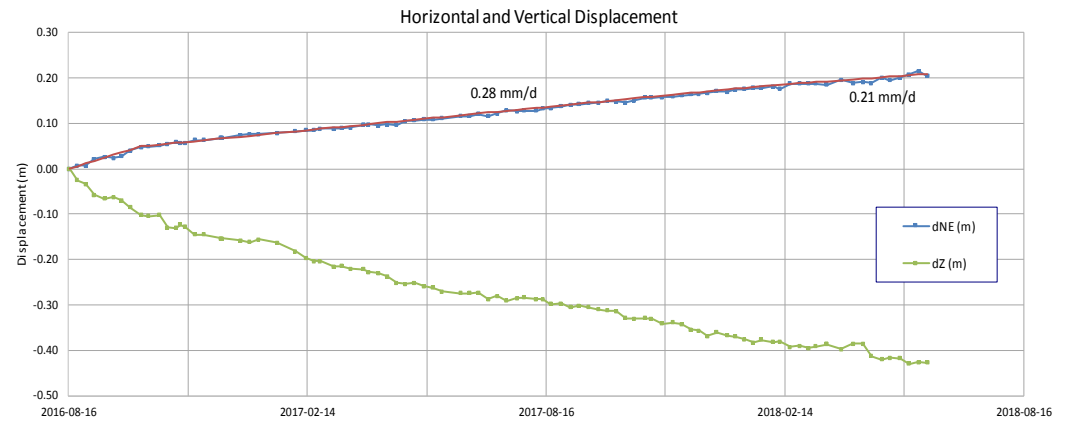
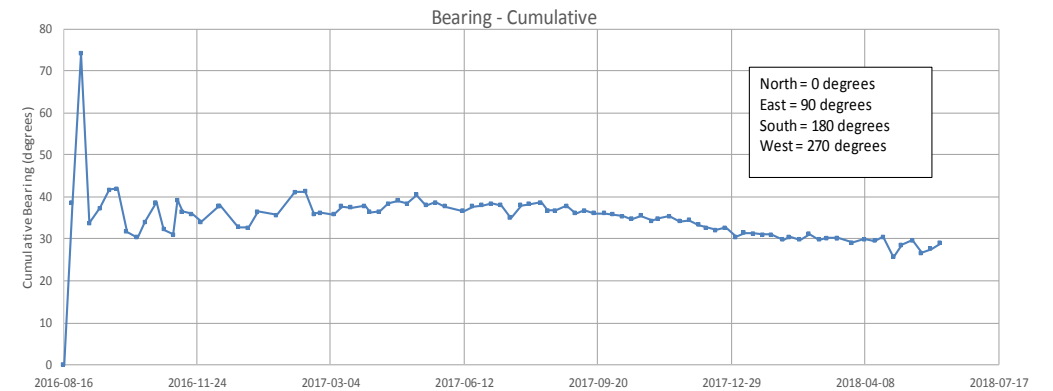
<b>Minto Explorations Ltd.</b>		DSTSF Instrumentation Data		
			<b>Survey Hub – DSSH18</b>		
Job No: 1CM002.063 Filename: ApD_2018DSTFLandscape.pptx	Minto Mine		Date: August 2018	Prepared by PHM	Figure: <b>7</b>

- The survey hub was removed in December 2015 prior to MVFES2 construction. The hub was reinstalled in August 2016 following completion of construction.

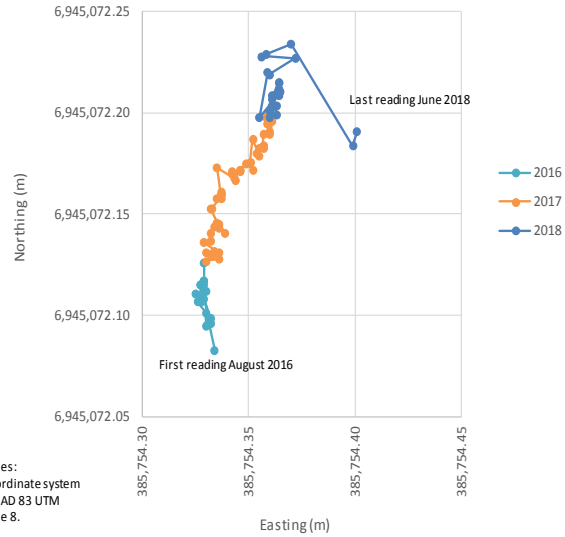
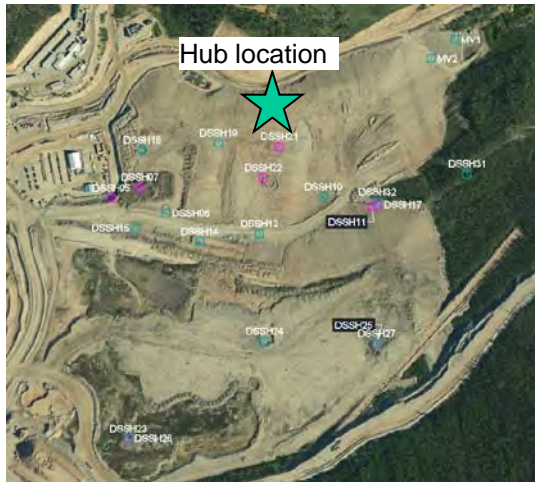
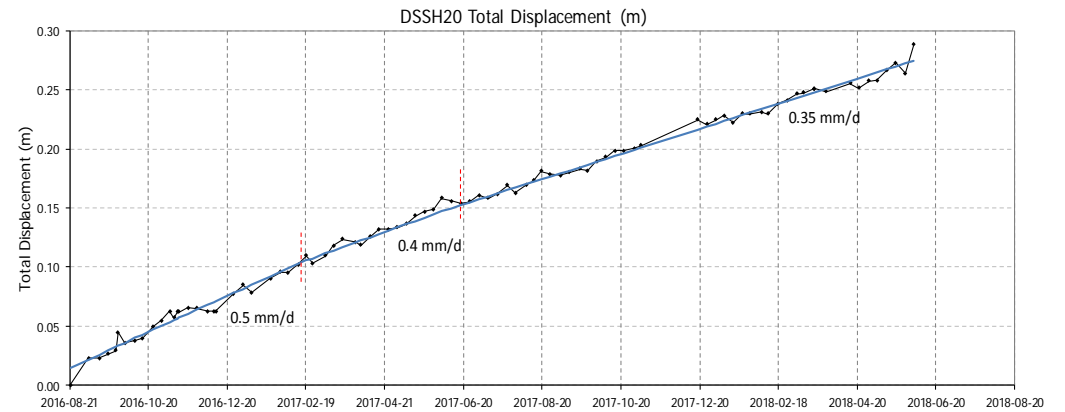
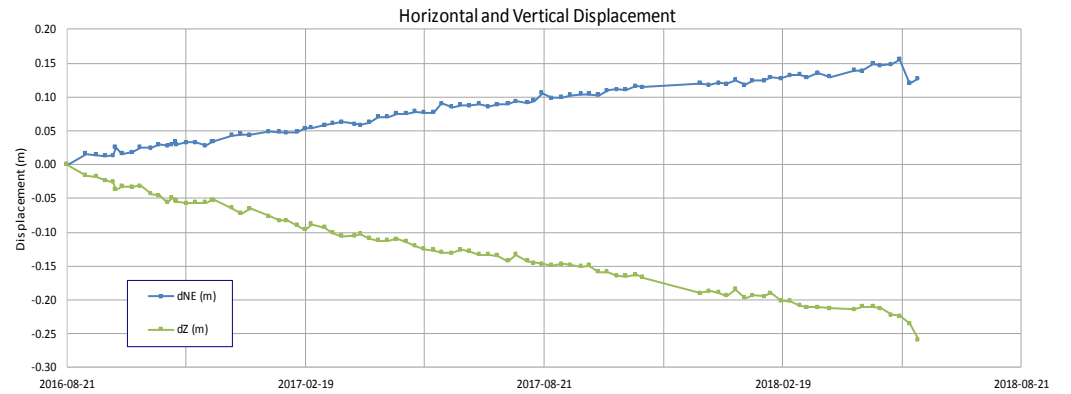
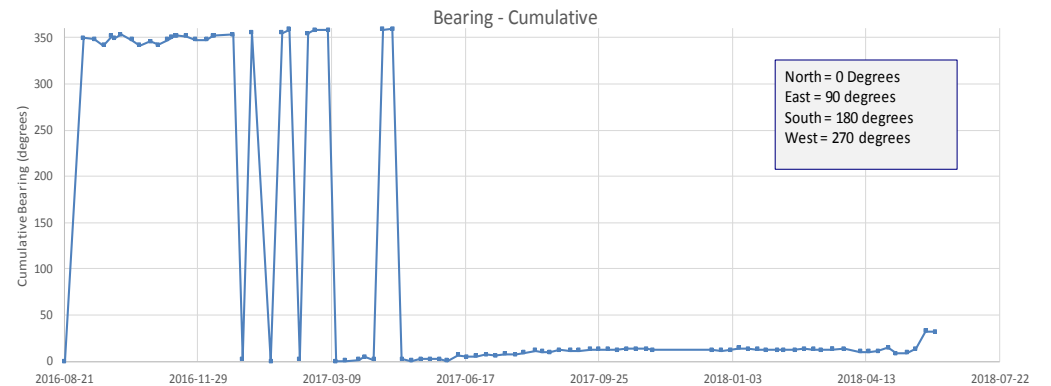
Figure:  
**8**

- The survey hub was removed in December 2015 prior to MVFES2 construction. The hub was reinstalled in August 2016 following completion of construction.

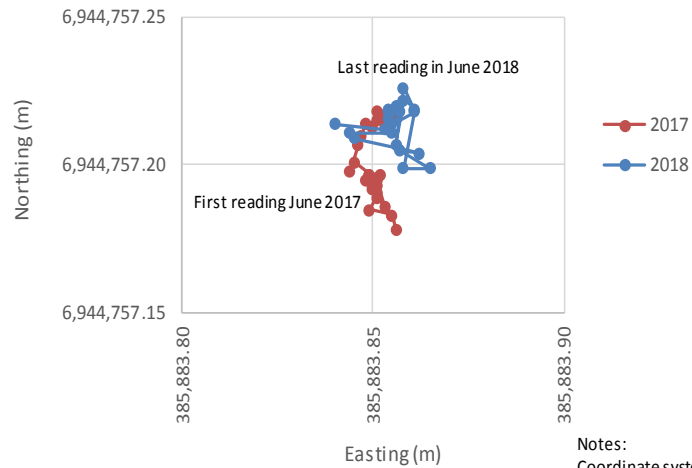
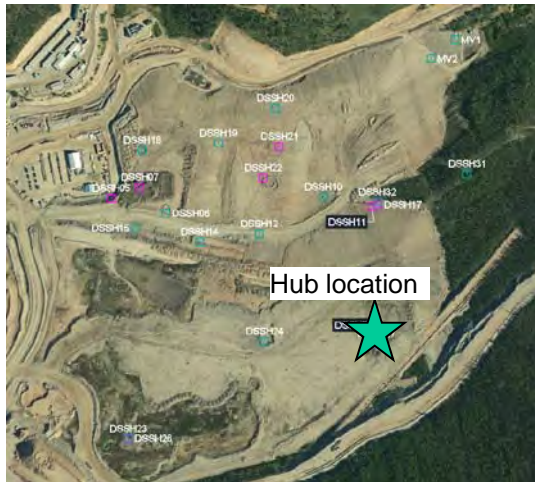
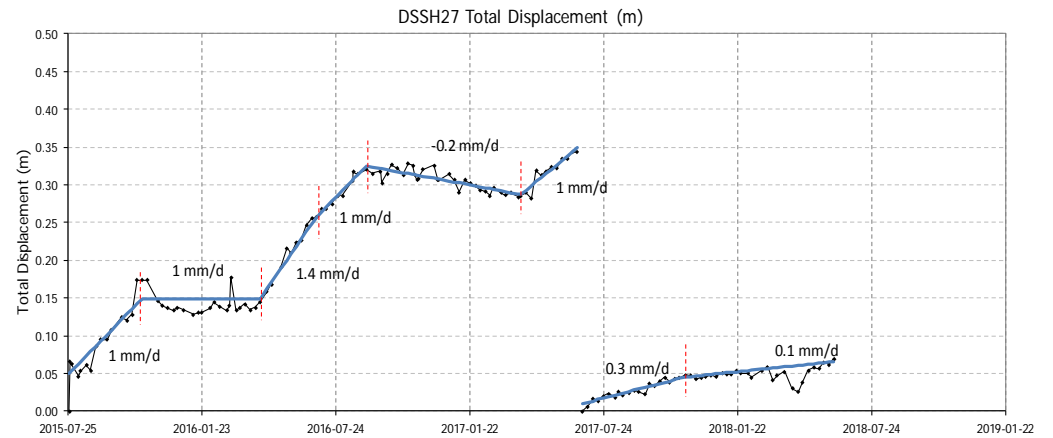
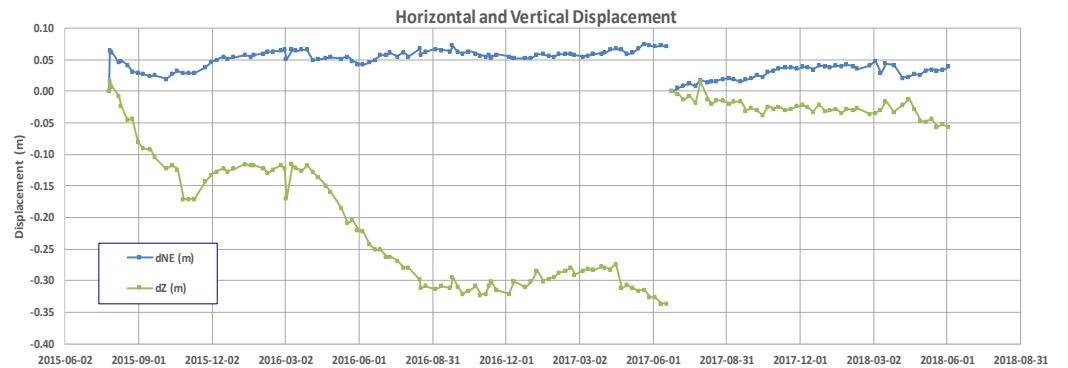
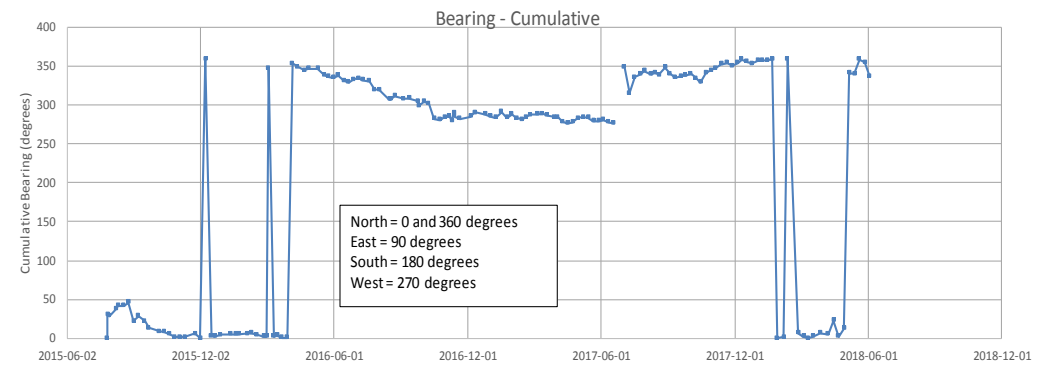
Figure: 11

- Note:  
1. The survey hub was repositioned in June 2017.

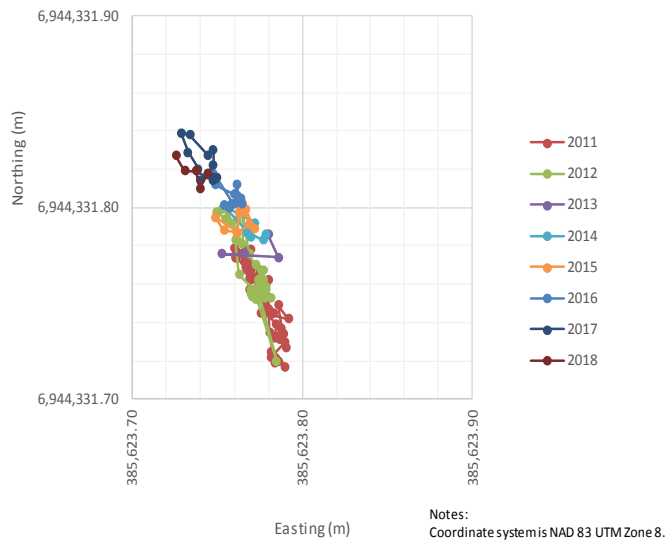
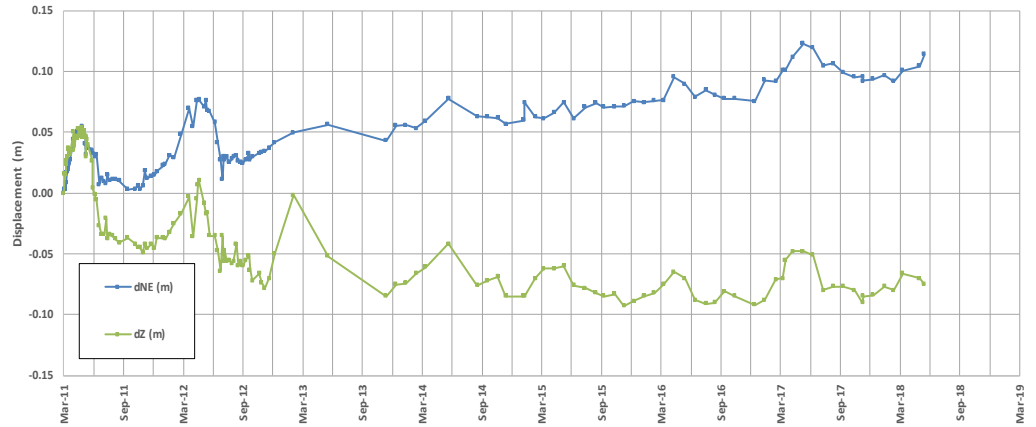
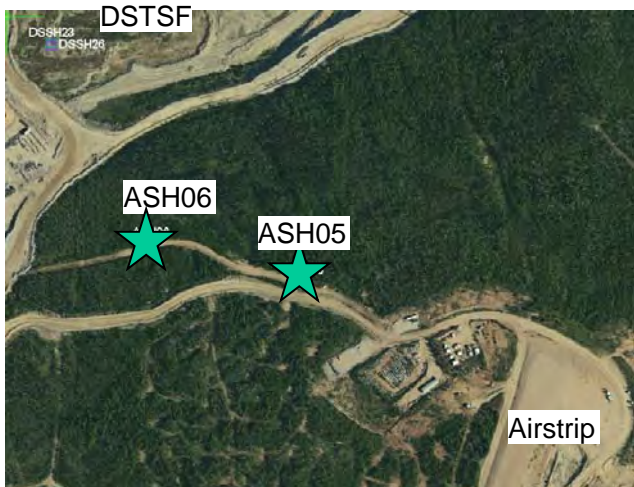
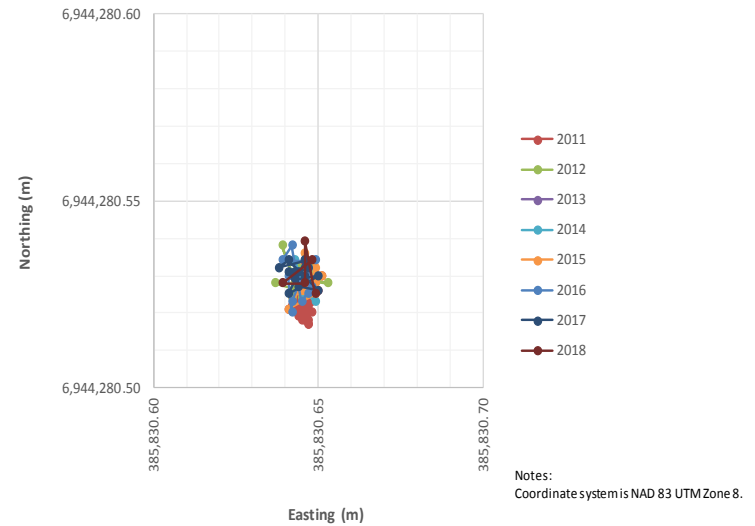
Figure:  
**18**

1. Minto's survey reading comments on January 14, 2017 notes ASH06 may have been disturbed as a result of a pipeline installation.

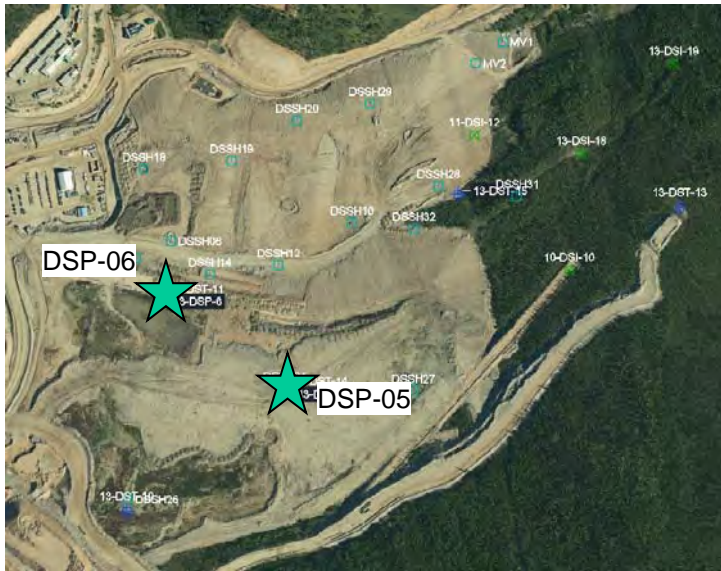
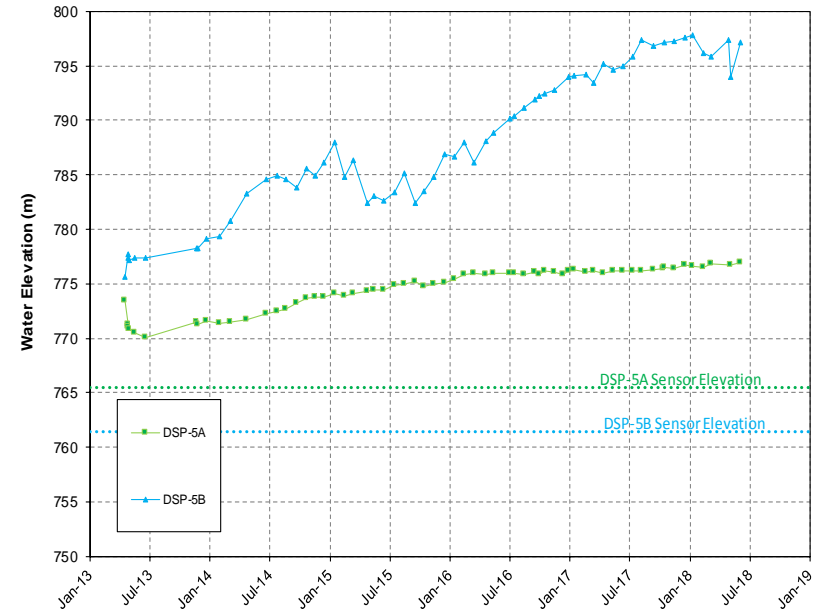
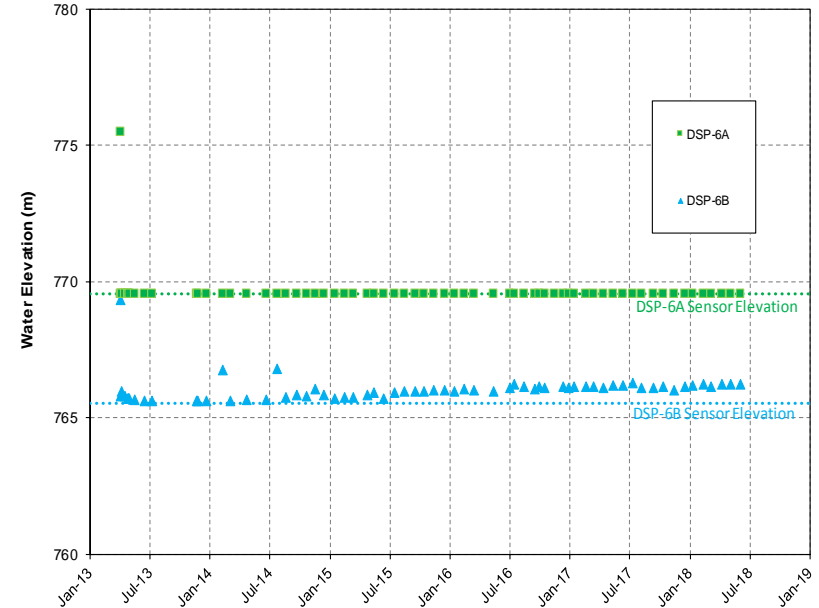
Figure:  
19

1. The pore pressure sensors at DSP-05 and 06 are located approximately 2 m above original ground in tailings (A) and 2 m below original ground.
2. The bottom sensor at DSP-05 (B) shows an increase in pore pressure that appears to have peaked within the past year. Temperature at the sensor is at the freezing point of water  $-0.5^{\circ}$ . The sensor is located in an area of silt with stratified ice lenses.
3. Sensors at DSP-05A and DSP-06B both show gradual increasing pore pressure trends, while DSP-06A shows no pore pressure (pore pressure equal to the sensor elevation).

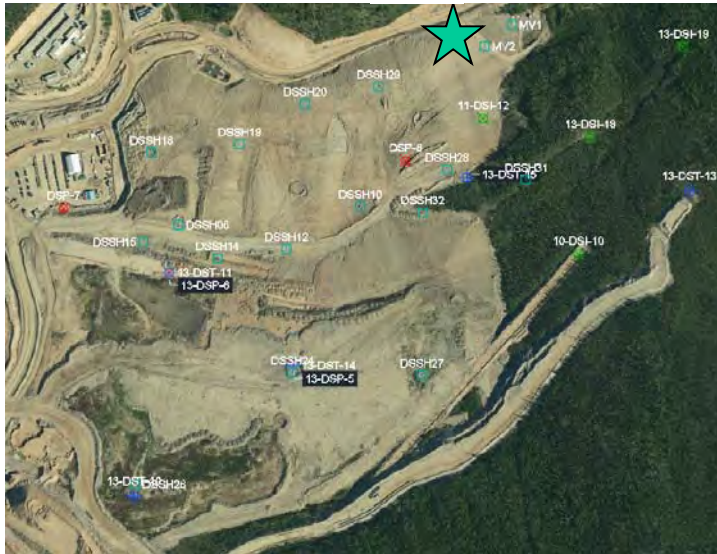
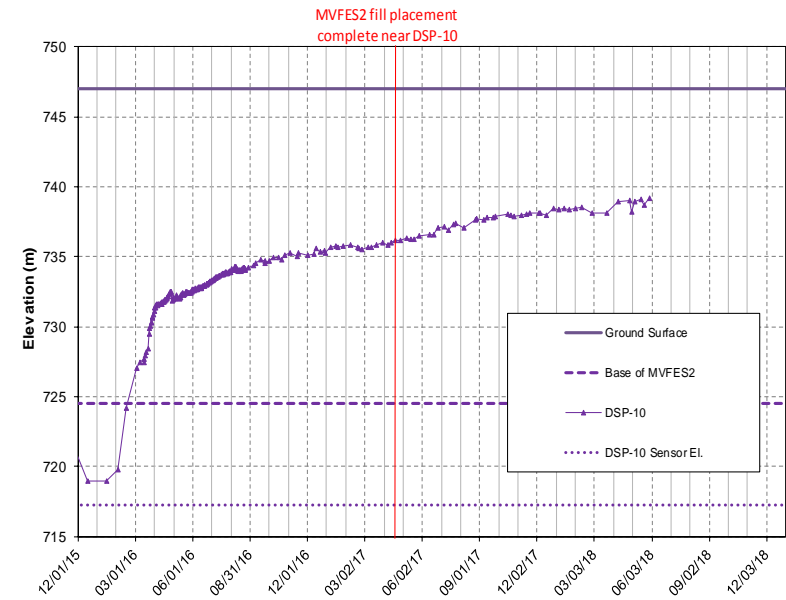
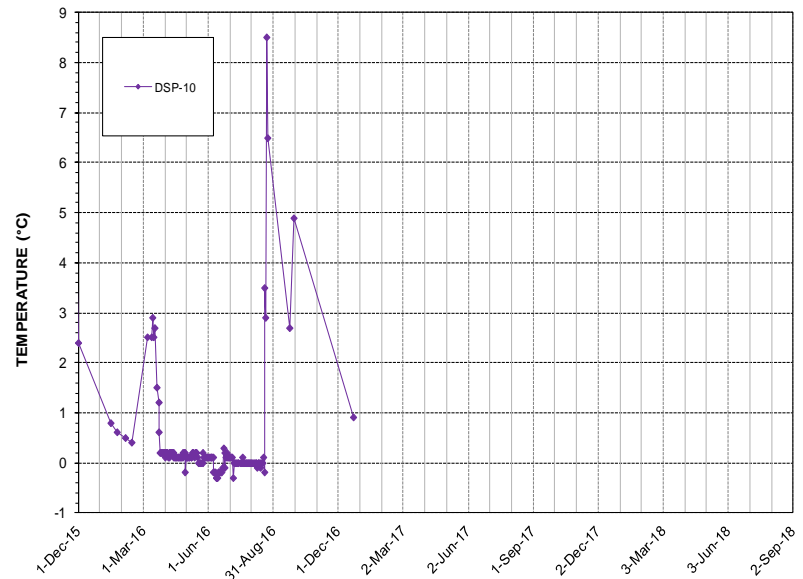
<b>Minto Explorations Ltd.</b>		DSTSF Instrumentation Data		
			<b>Piezometers – DSP-09 and DSP-10</b>		
Job No: 1CM002.063 Filename: ApD_2018DSTSLandscape.pptx	Minto Mine		Date:	Prepared by:	Figure:
			August 2018	PHM	23

1. The pore pressure sensor at DSP-10 is located approximately 5 m below the original ground surface below the MVFE Stage 2.
2. The increase in pore pressure at DSP-10 is related to the fill placement over the sensor (approximately 23 m thick).
3. Since fill placement has been completed, the rate of increase in pore pressure is low, but is ongoing.
4. Flow meter readings at the Minto Creek Detention Sump indicate that the blanket drain is functional and no water is building-up at the base of MVFE Stage 2.
5. The temperature readings at DSP-10 show a slight cooling trend up to July 2017. Between July and December 2017, temperature readings were above 0 degrees and highly variable. Since December 2017, the temperatures sensor has malfunctioned.

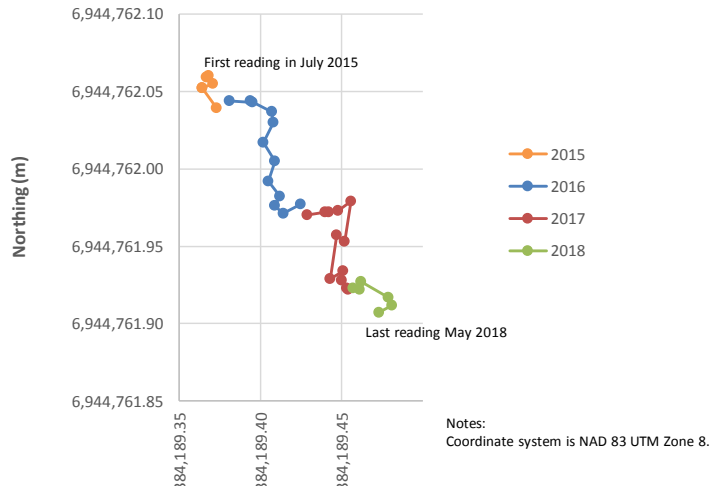
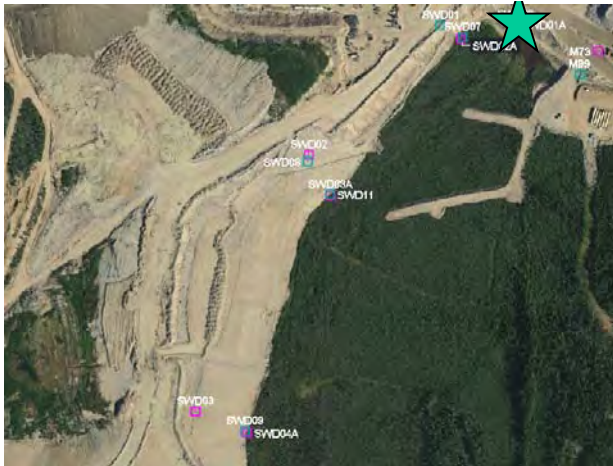
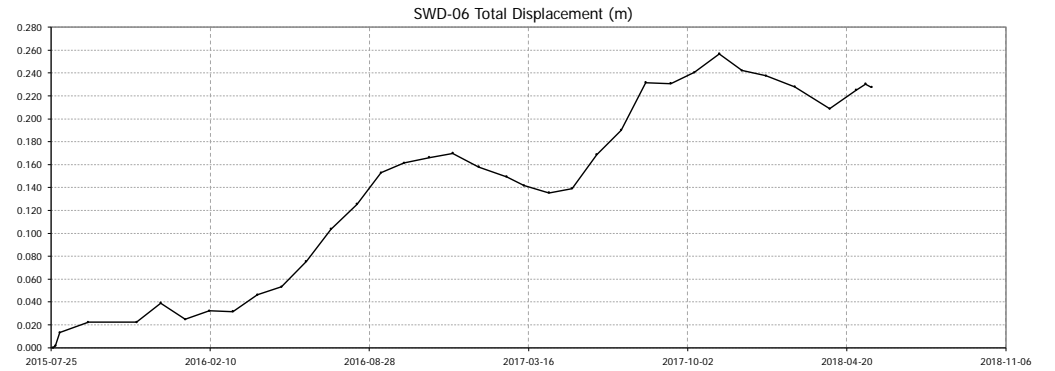
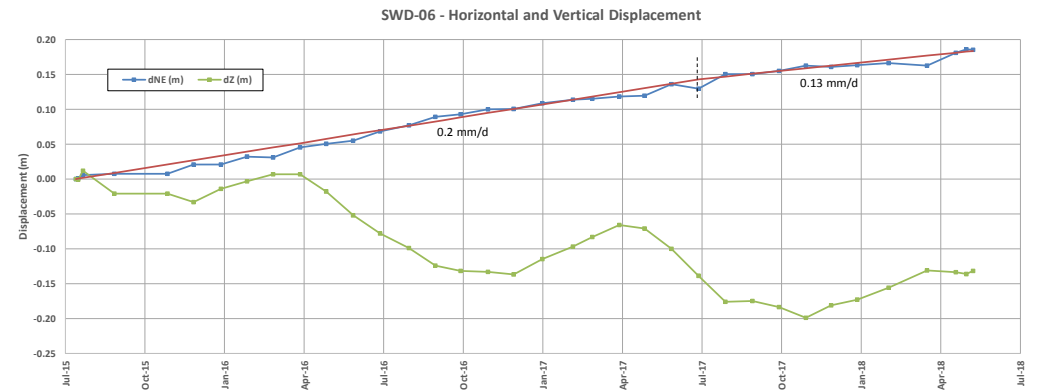
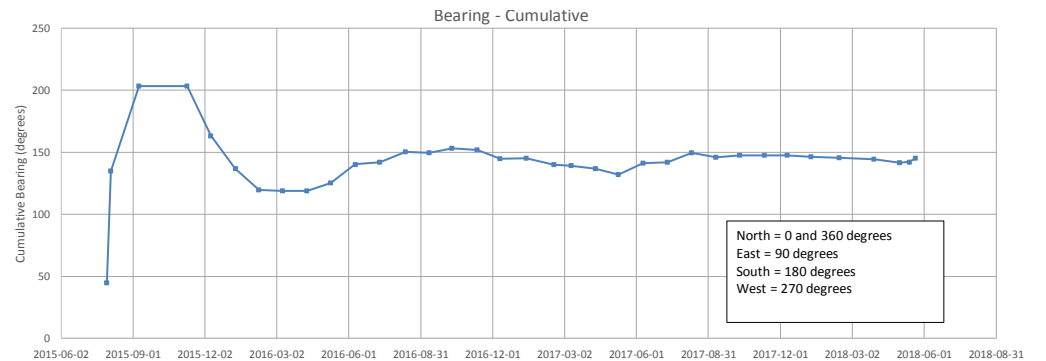
### SWD06 - Northing Vs. Easting Movement Plot

1. Hub is a replacement for SWD-01A that was disturbed by frost heave.
2. The hub consists of a lock-block on surface, and as a result, seasonal ground movement as a result freeze/thaw cycles may occur that is not indicative of large-scale ground movement. As a result, the horizontal displacement plot is likely to be the most useful plot for monitoring movement.

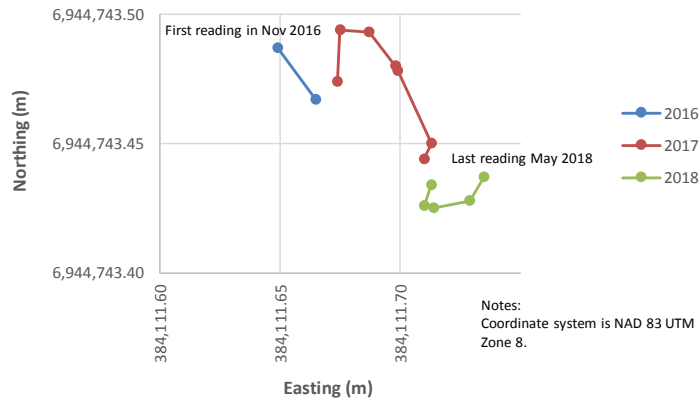
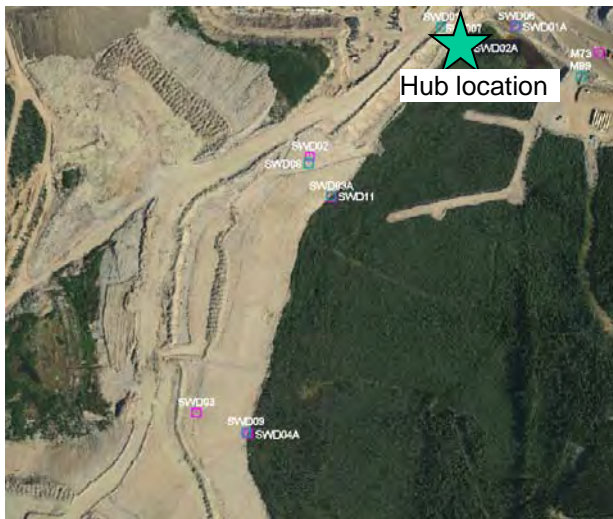
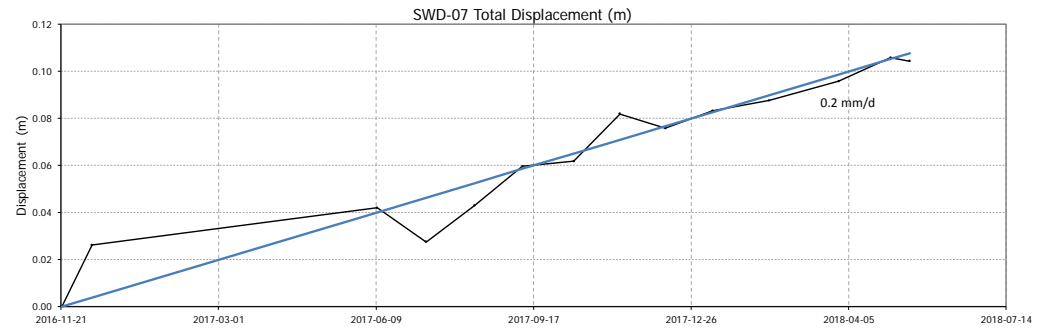
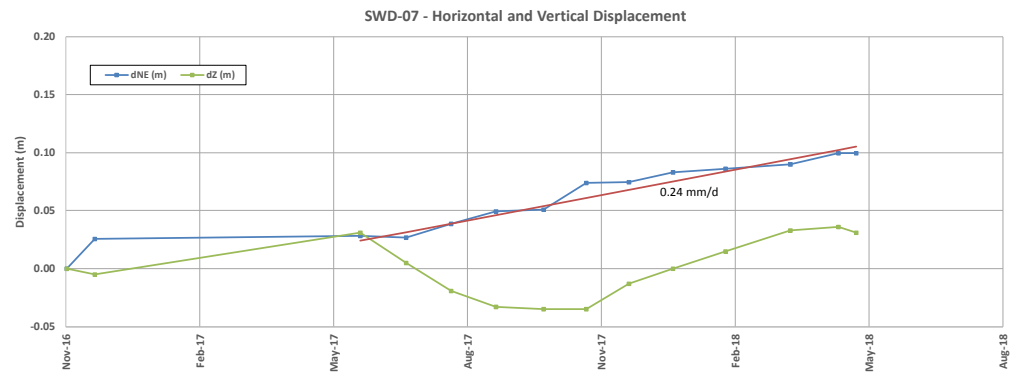
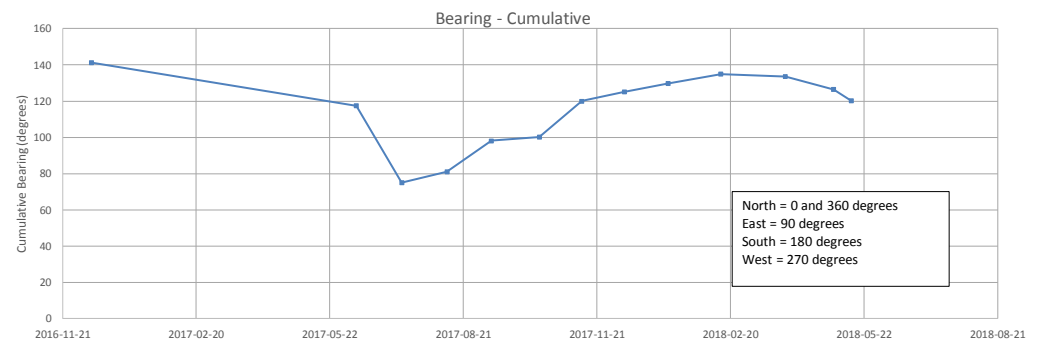
### SWD07 - Northing Vs. Easting Movement Plot

- Hub is a replacement for SWD-02A that was disturbed by frost heave.

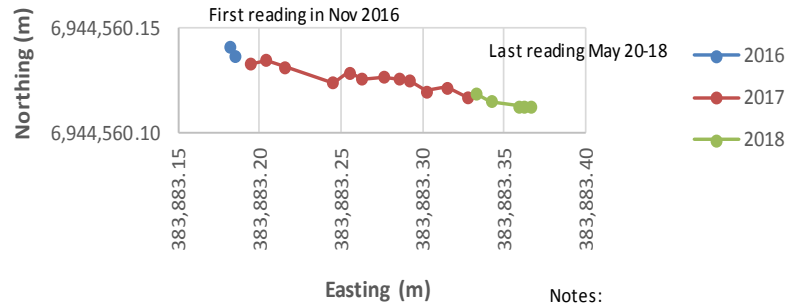
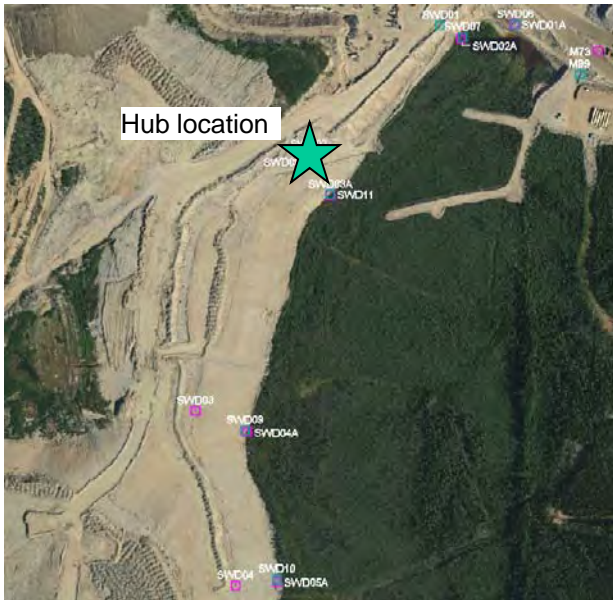
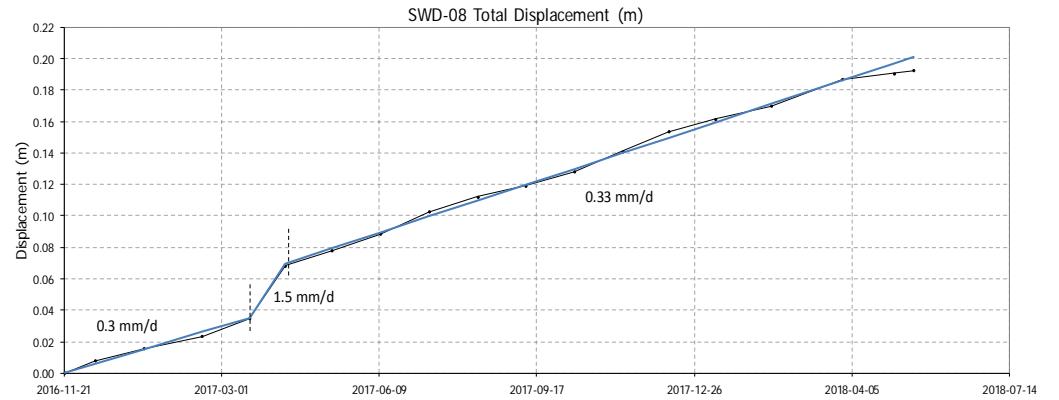
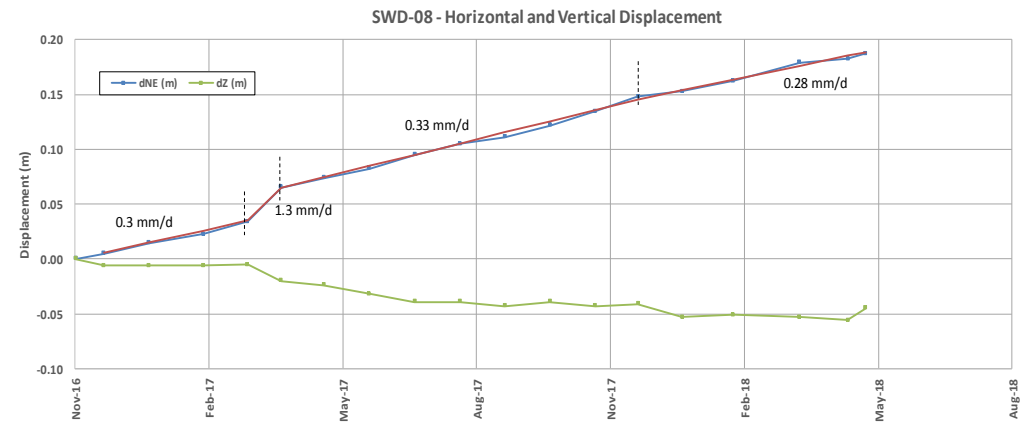
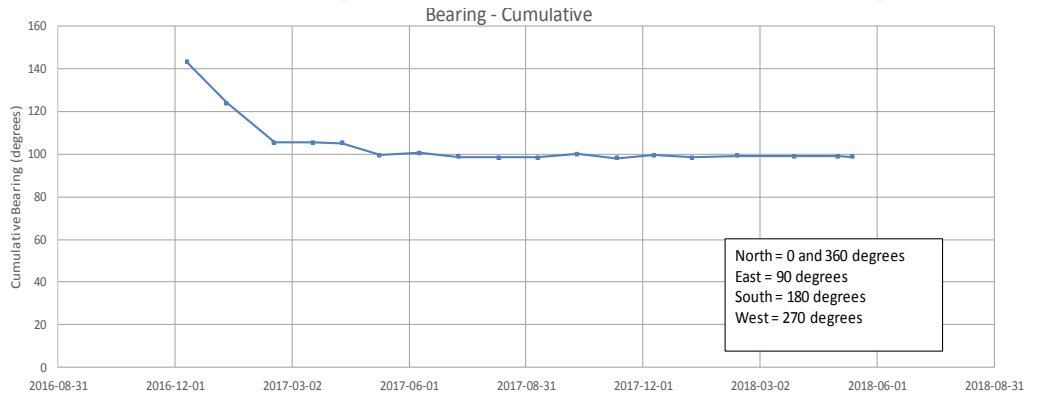
## SWD08 - Northing Vs. Easting Movement Plot

1. Hub is a replacement for SWD-02 that was disturbed as a result of regrading of the SWD.

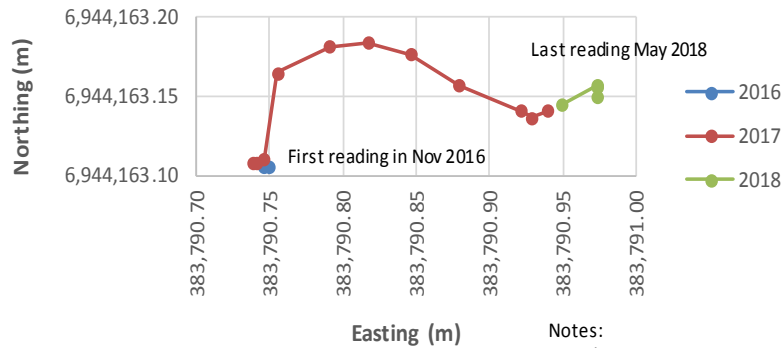
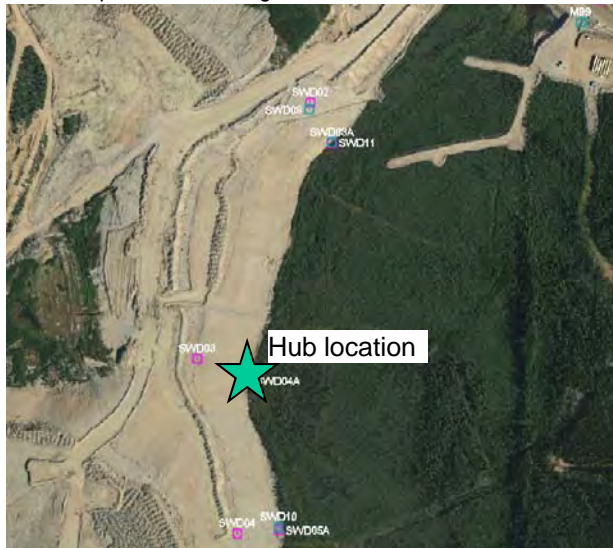
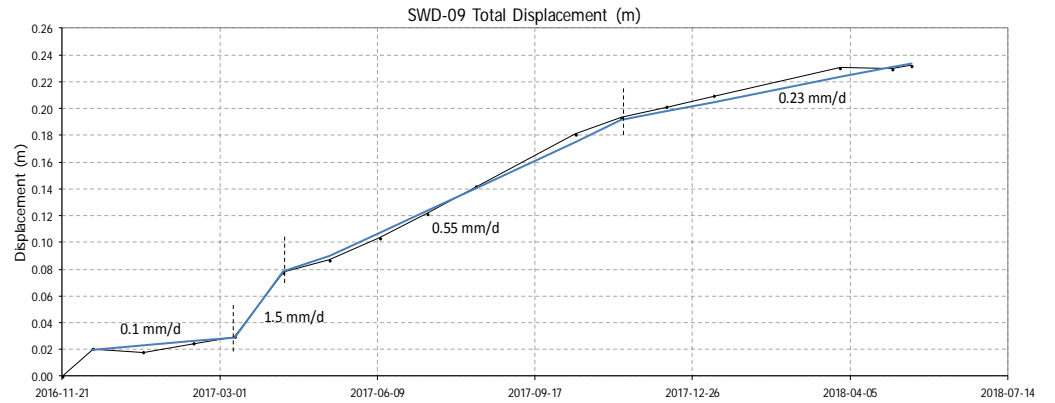
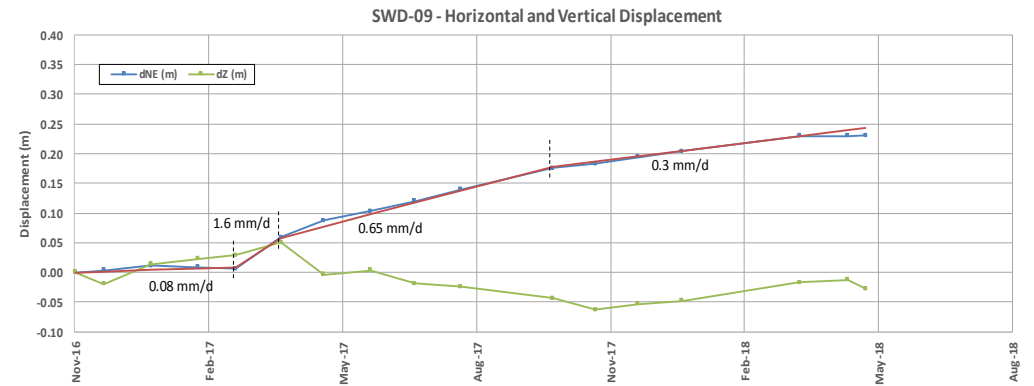
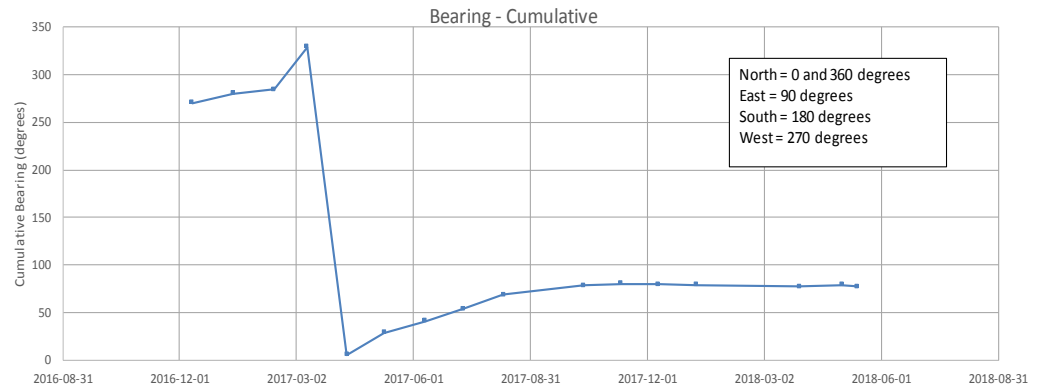
## SWD09 - Northing Vs. Easting Movement Plot

1. Hub is a replacement for SWD-04A that was disturbed by frost heave.
2. The hub consists of a large boulder on surface, and as a result, seasonal ground movement as a result freeze/thaw cycles may occur that is not indicative of large-scale ground movement. As a result, the horizontal displacement plot is likely to be the most useful plot for monitoring movement.

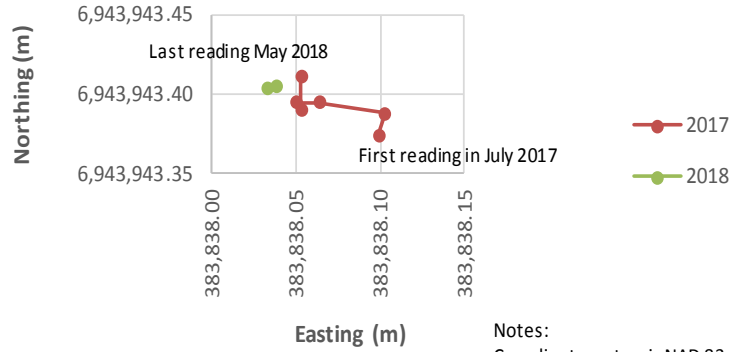
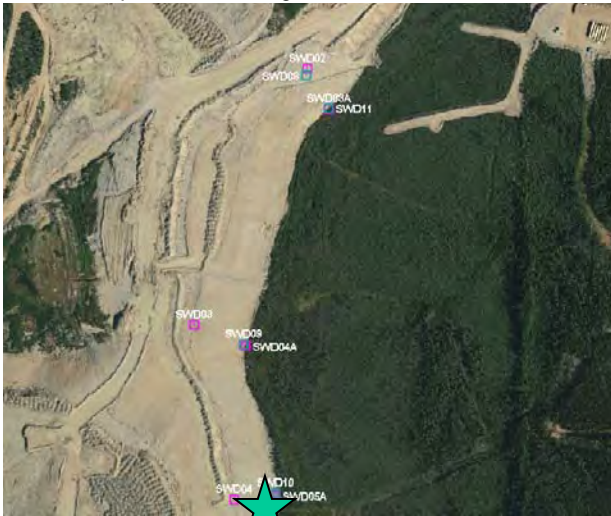
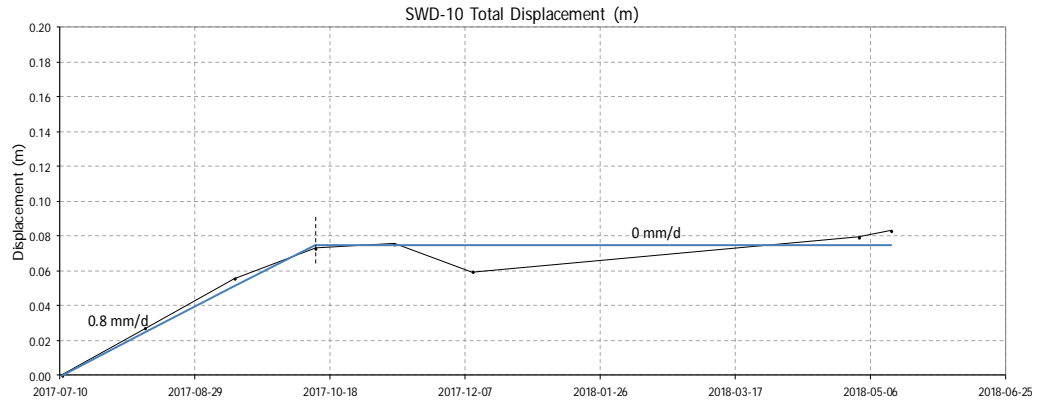
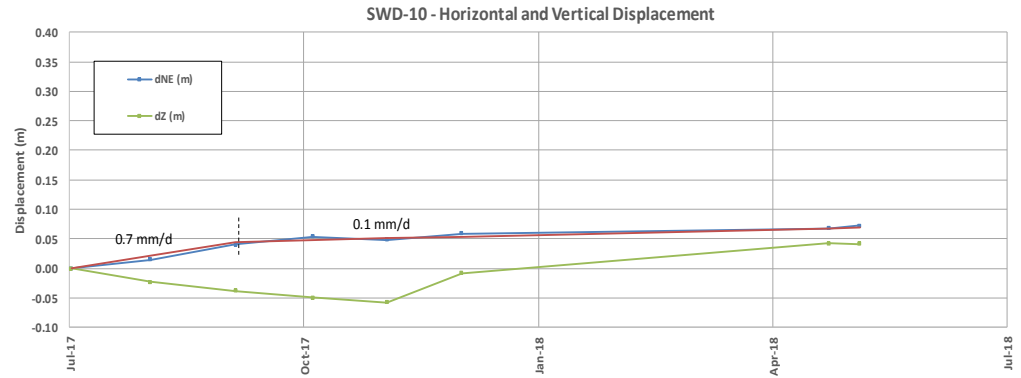
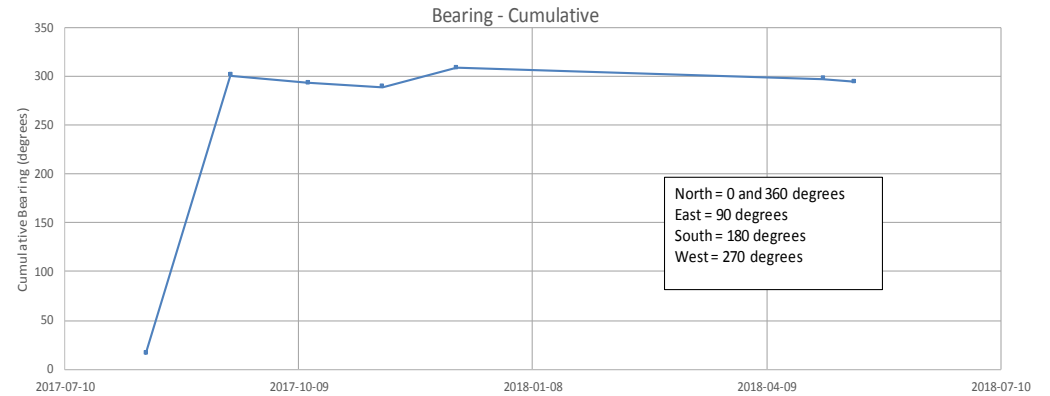
# SWD10 - Northing Vs. Easting Movement Plot

1. Hub is a replacement for SWD-05A that was disturbed by frost heave.
2. The hub consists of a large boulder on surface, and as a result, seasonal ground movement as a result freeze/thaw cycles may occur that is not indicative of large-scale ground movement. As a result, the horizontal displacement plot is likely to be the most useful plot for monitoring movement.

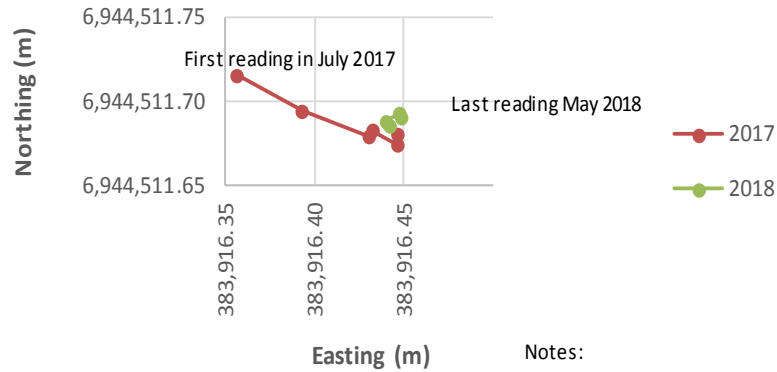
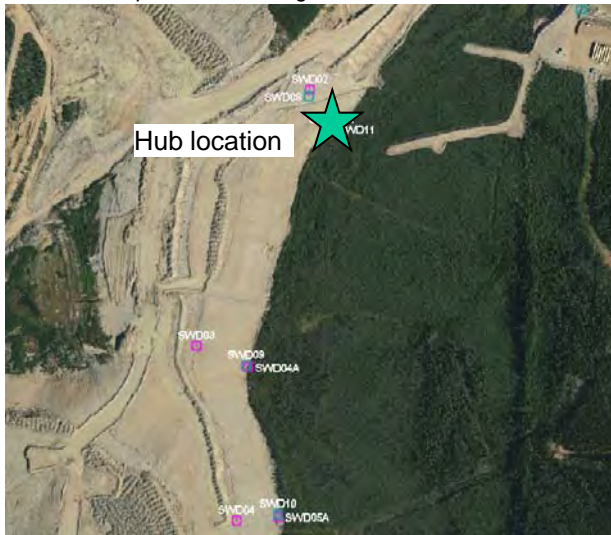
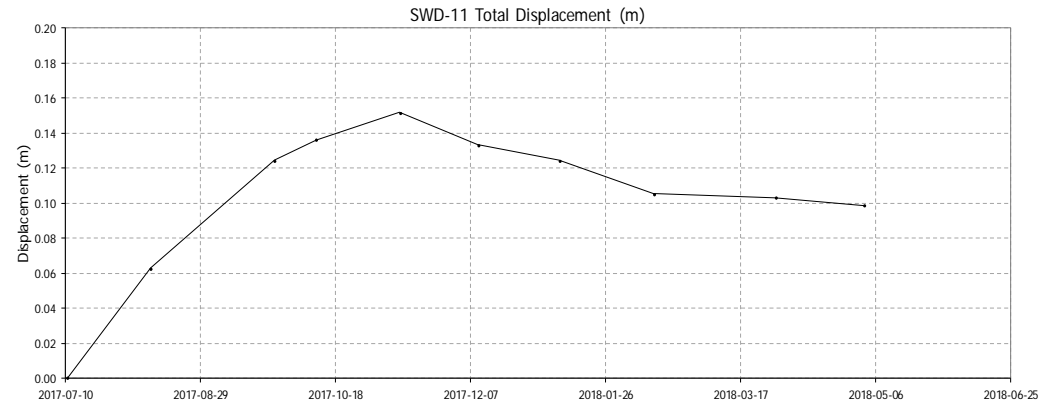
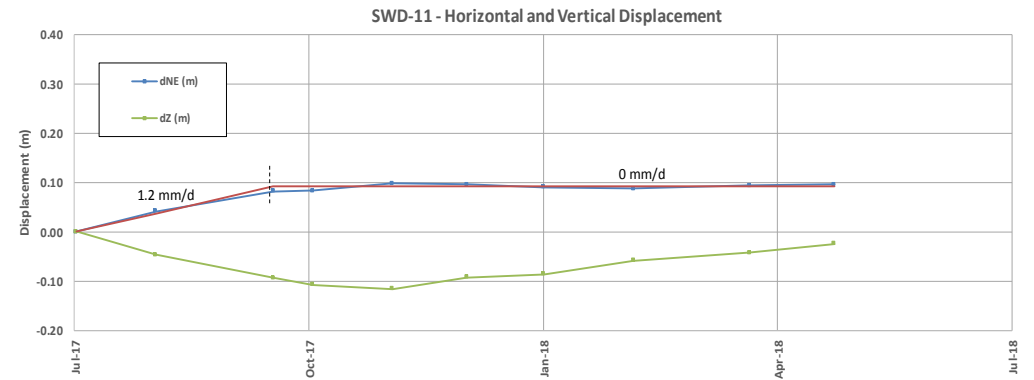
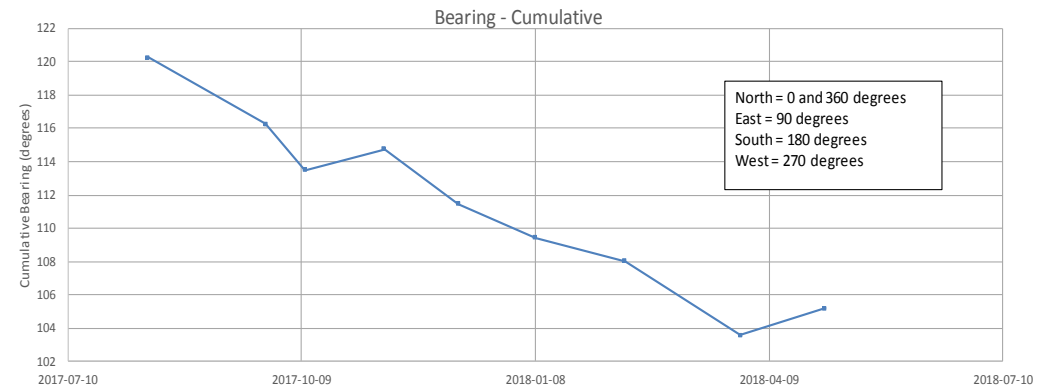
## SWD11 - Northing Vs. Easting Movement Plot

1. Hub is a replacement for SWD-03A that was disturbed by frost heave.
2. The hub consists of a large boulder on surface, and as a result, seasonal ground movement as a result freeze/thaw cycles may occur that is not indicative of large-scale ground movement. As a result, the horizontal displacement plot is likely to be the most useful plot for monitoring movement.
