# 2018 Geotechnical Annual Review, Minto Mine, YT

SRK Consulting (Canada) Inc.  
1CM002.063  
August 2018

On June 26-27, 2018, SRK Consulting (Canada) Inc. completed a geotechnical inspection of the Minto Mine site. The purpose of the inspection was to document the physical condition of the site based on visual observations and to provide geotechnical assessment, noting potential signs of physical instability such as erosion, differential settlement, sloughing or bulging of material, seepage, etc. The inspection is documented in the photographic compilation provided in Appendix A. This report summarizes the findings and recommendations.

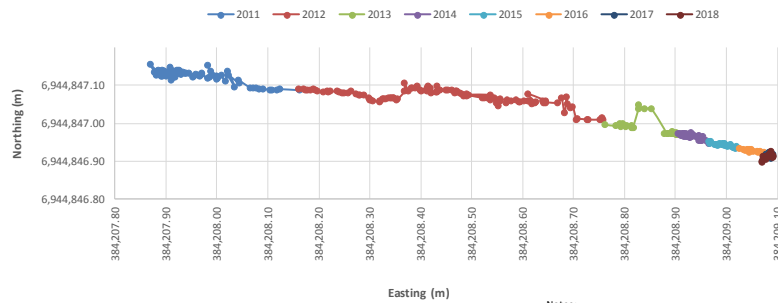
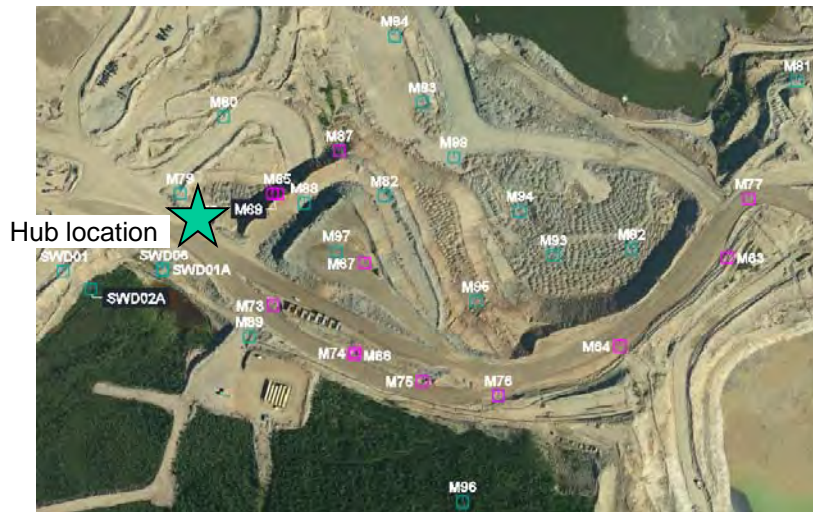
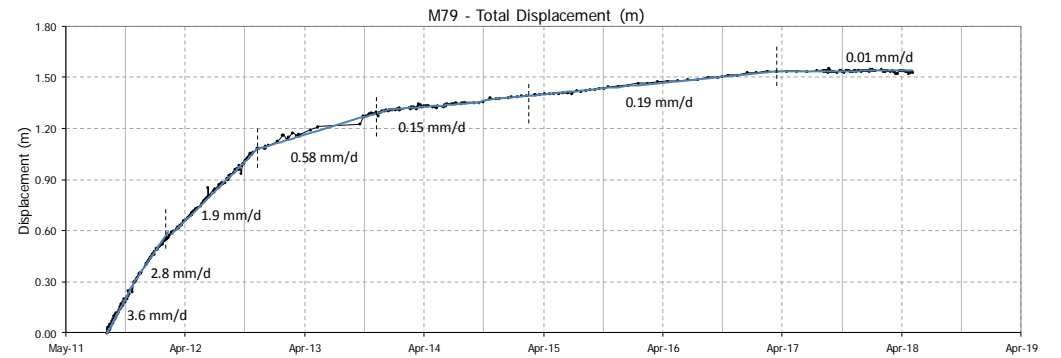
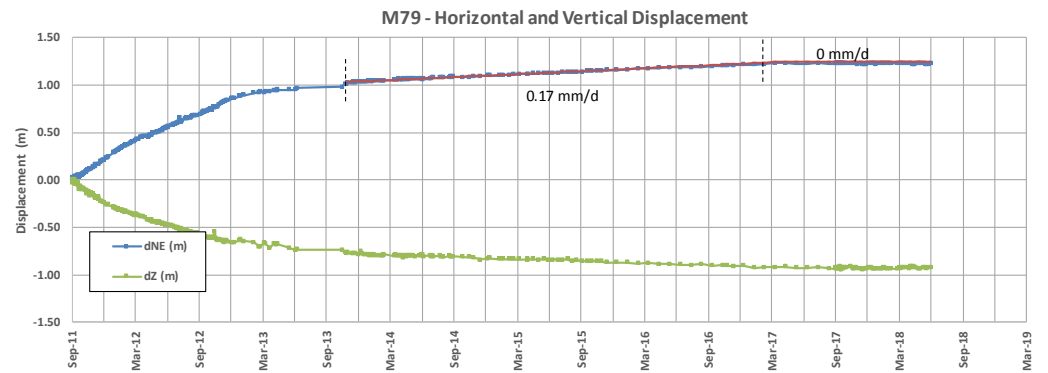
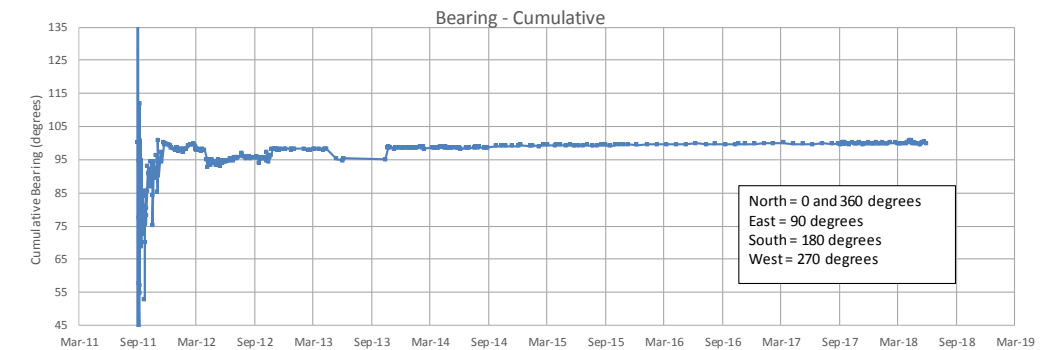
M79 - Northing Vs. Easting Movement

Survey Hub	Last Reading	Movement Rate (mm/day)		Bearing (Cumulative)	Comments
		June 17	June 18		
M79	6/1/2018	0.2	0.0	100	No significant movement.
M80	6/4/2018	0.04	0.03	10	Minor movement and with deceleration trend observable.
M81	5/25/2018	0.0	0.0	100	No significant horizontal movement. Observed movement is largely fill settlement.
M82	6/4/2018	2.0	3.3	105	Increase in movement related to the construction of the MPD. Movement rate has decreased since completion of the dump.
M83	6/4/2018	0.7	1.5	52	Movement turning towards North, likely related to loading from MPD construction. Movement decelerating since completion of MPD construction
M84	6/4/2018	0.1	0.2	64	Accelerated slightly compared to 2017(possibly due to MPD construction), movement rate has been steady since October 2017.
M88	6/4/2018	-	3.0	40	Decelerating.
M89	6/4/2018	-	0.0	-	No significant movement.
M92	6/4/2018	-	0.2	27	Additional data needed to evaluate trends. It is possible no movement is occurring with the hub settling as a result of the spring thaw.

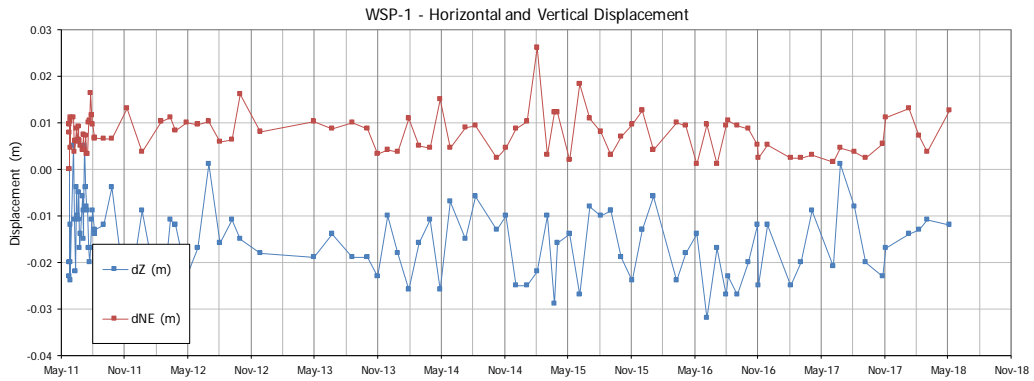
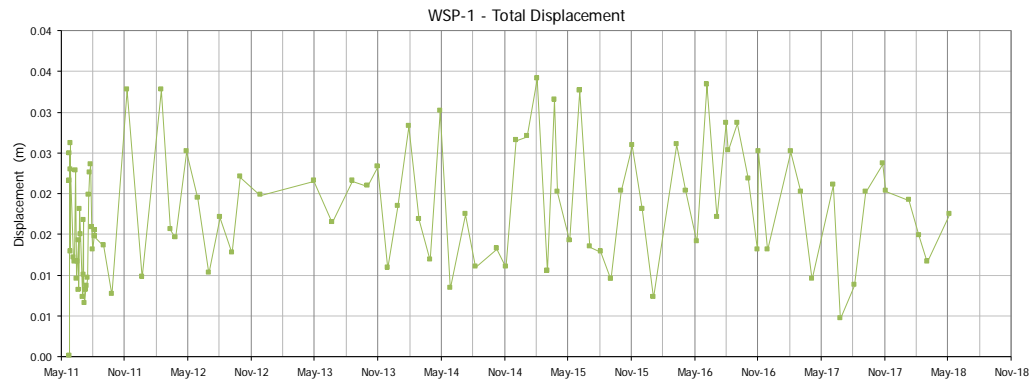
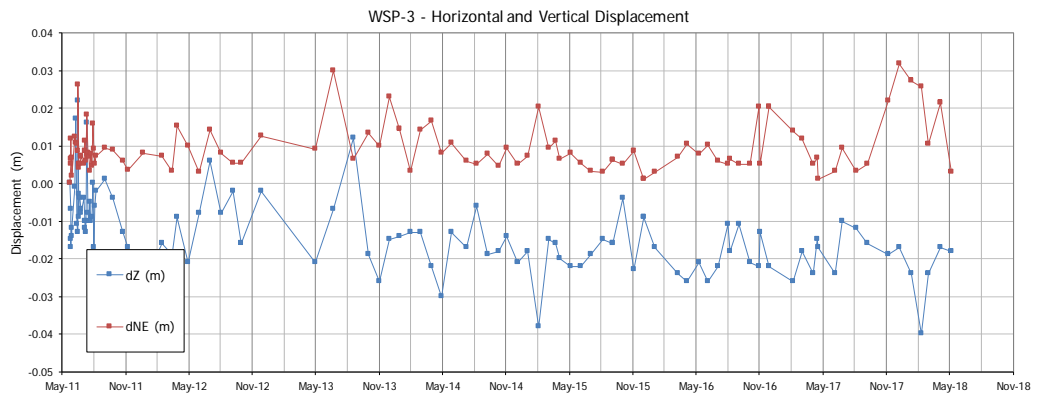
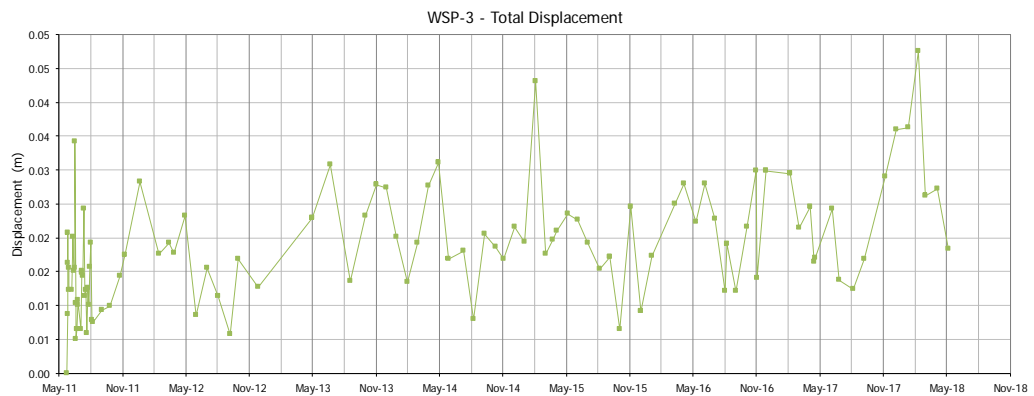
Water Storage Pond Data		
		<b>Survey Hubs – WSP-1 and WSP-3</b>		
Job No: 1CM002.063	Minto Mine	Date: August 2018	Prepared by: PHM	Figure: 1
Filename: ApH_WaterStoragePondPort2018.pptx

Survey hub movement data are presented in Figure 1 and 2 of Appendix H. No significant movement was observed.

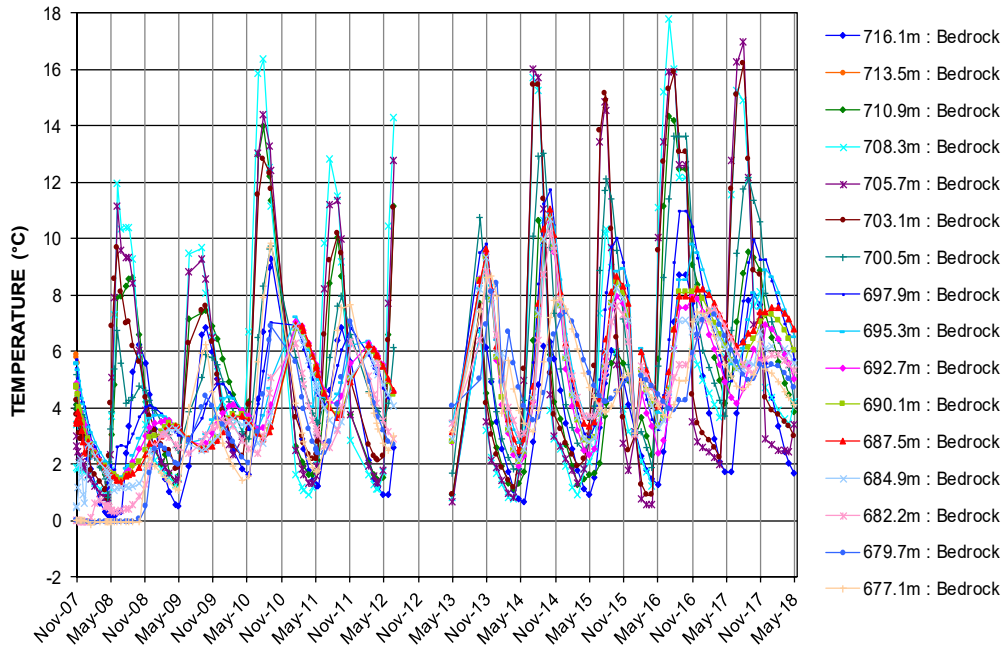
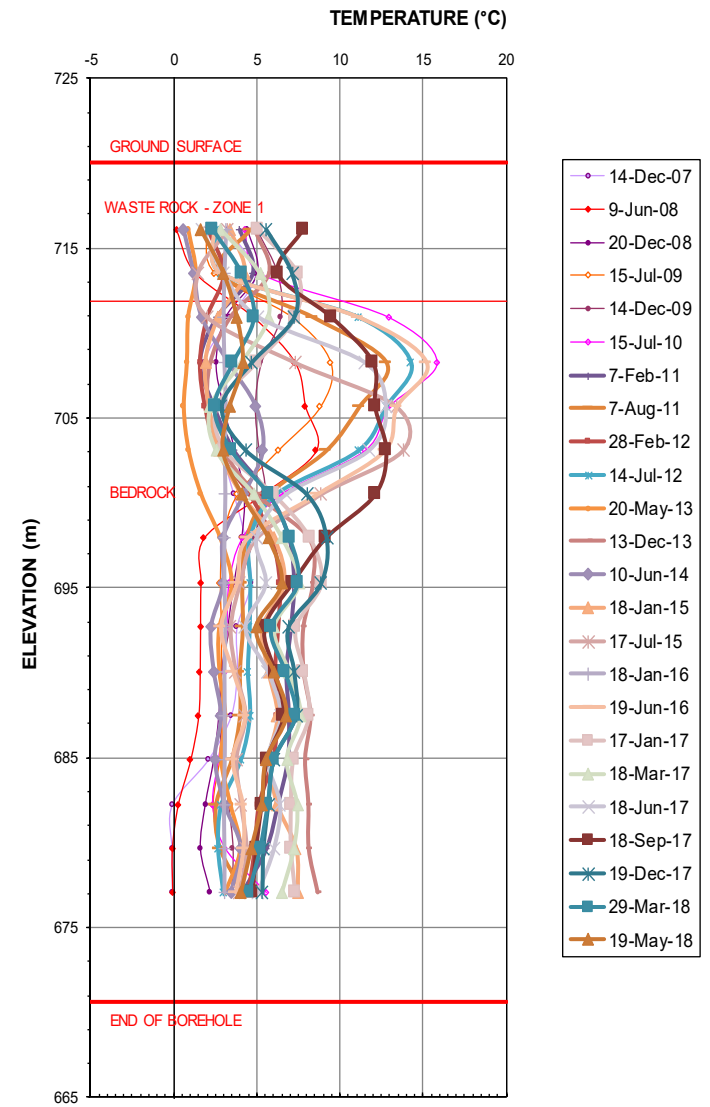
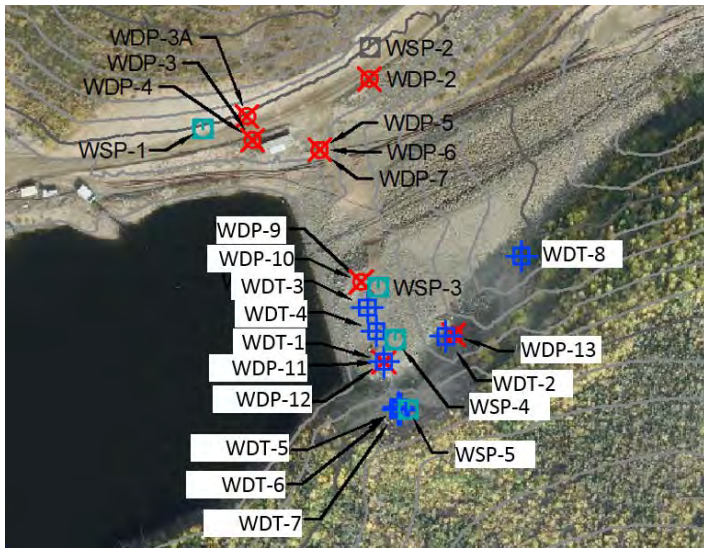
Figure: 3

Ground temperature data are presented in Figures 3 to 10 of Appendix H. All temperature sensors are above zero and have shown an increasing trend since installation that appears to be stabilizing. Temperatures at depth are typically within the range of observed groundwater temperatures in nearby Westbays MW-12-05 and MW-12-06.
