# 2019 Geotechnical Annual Review, Minto Mine, YT

Minto Explorations Ltd.

SRK Consulting (Canada) Inc.  
1CM002.066  
August 2019

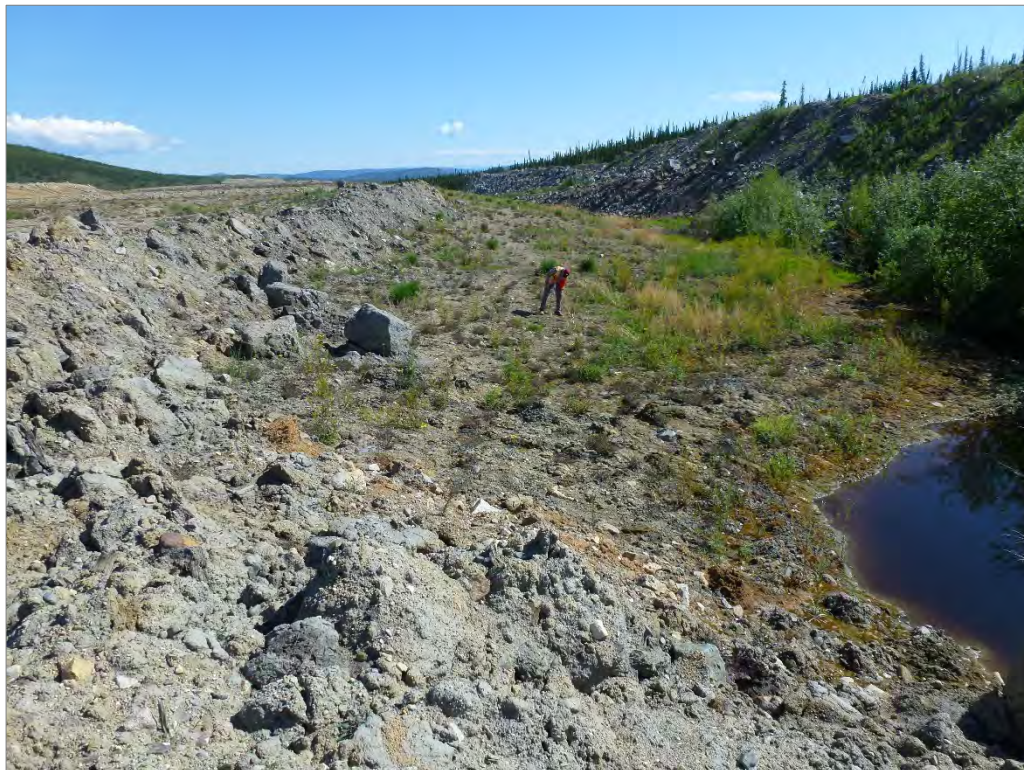
Photo 7: Portion of dry stack requiring regrading to 4H:1V closure slope (looking east)

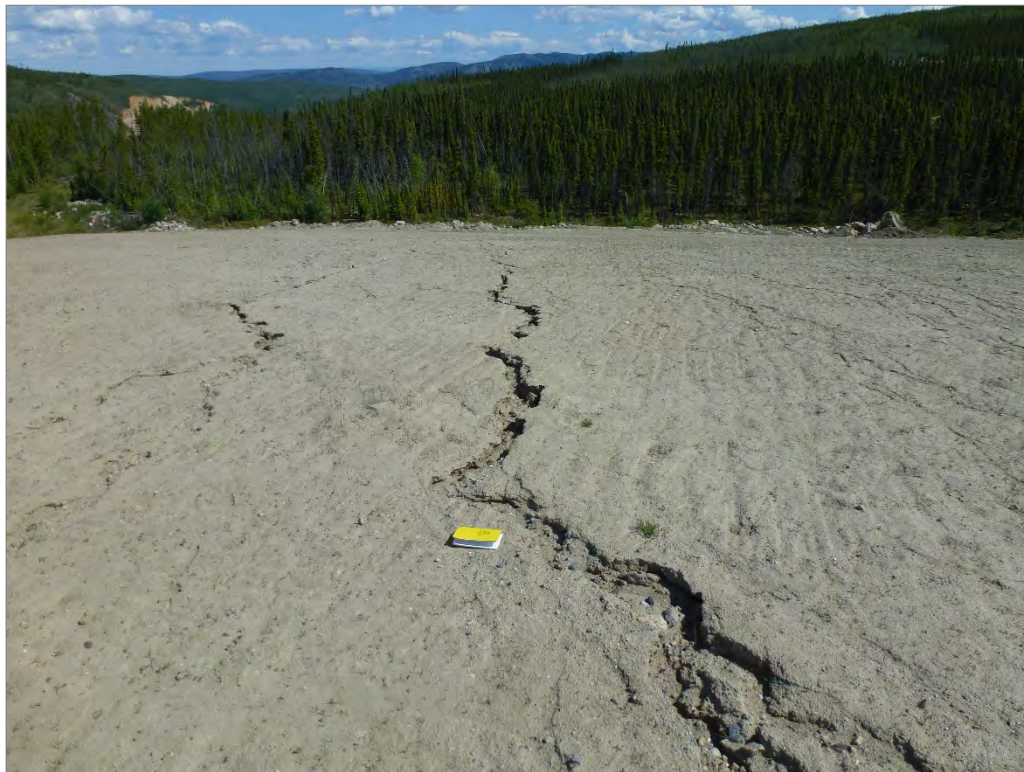
Photo 11: Erosion gully forming on closure cover (looking east)

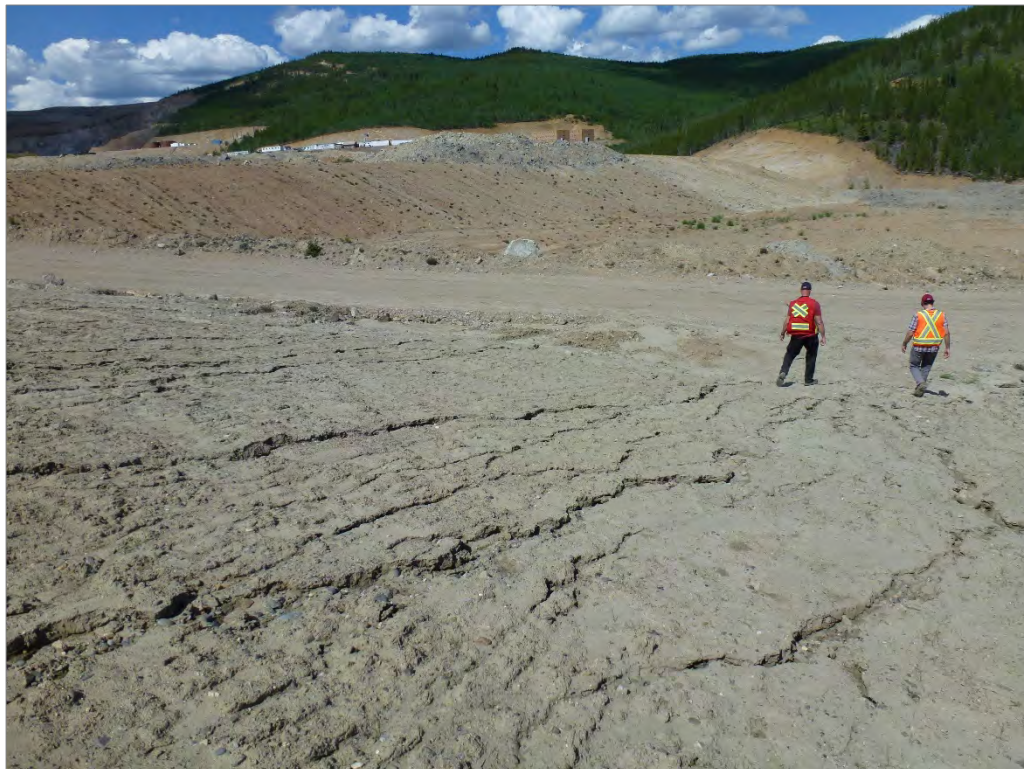
Photo 12: Multiple erosion gullies forming on closure cover (looking northwest)

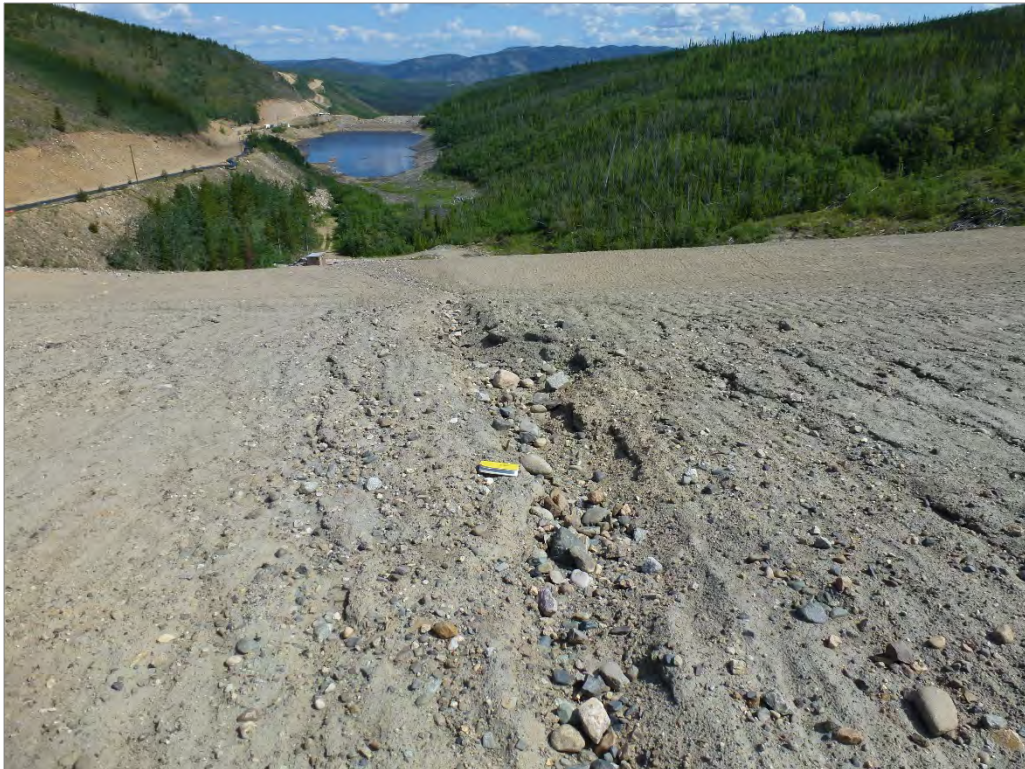
Photo 14: Erosion gullies – looking east towards the WSP

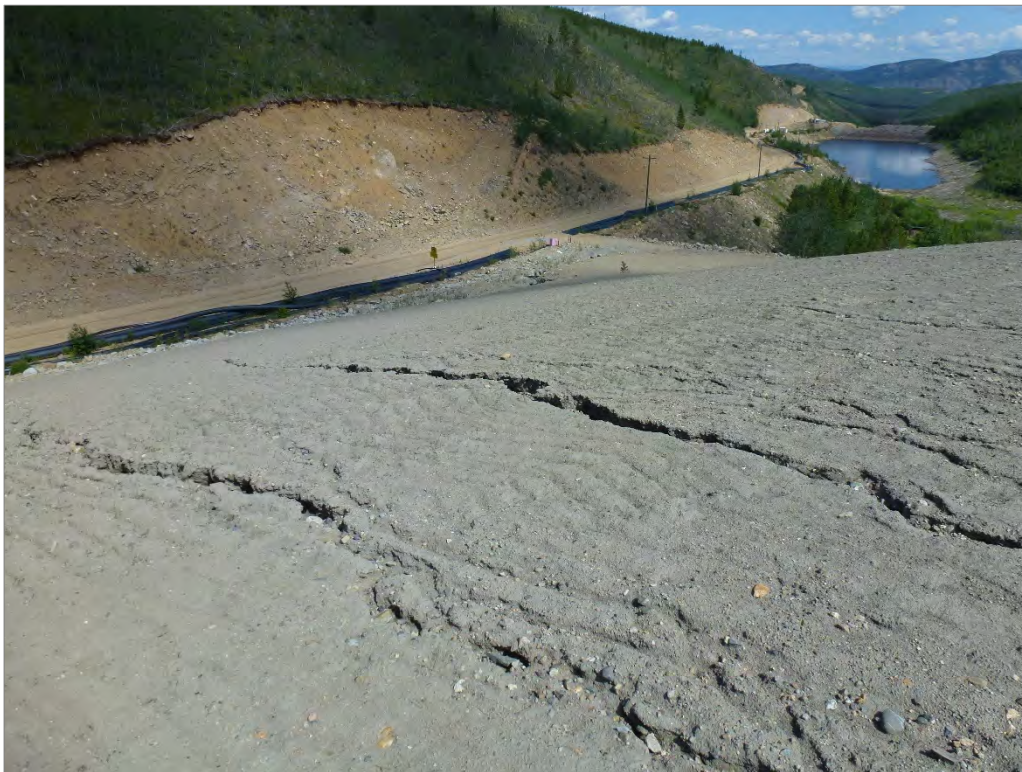
Photo 15: Erosion gullies (looking northeast)

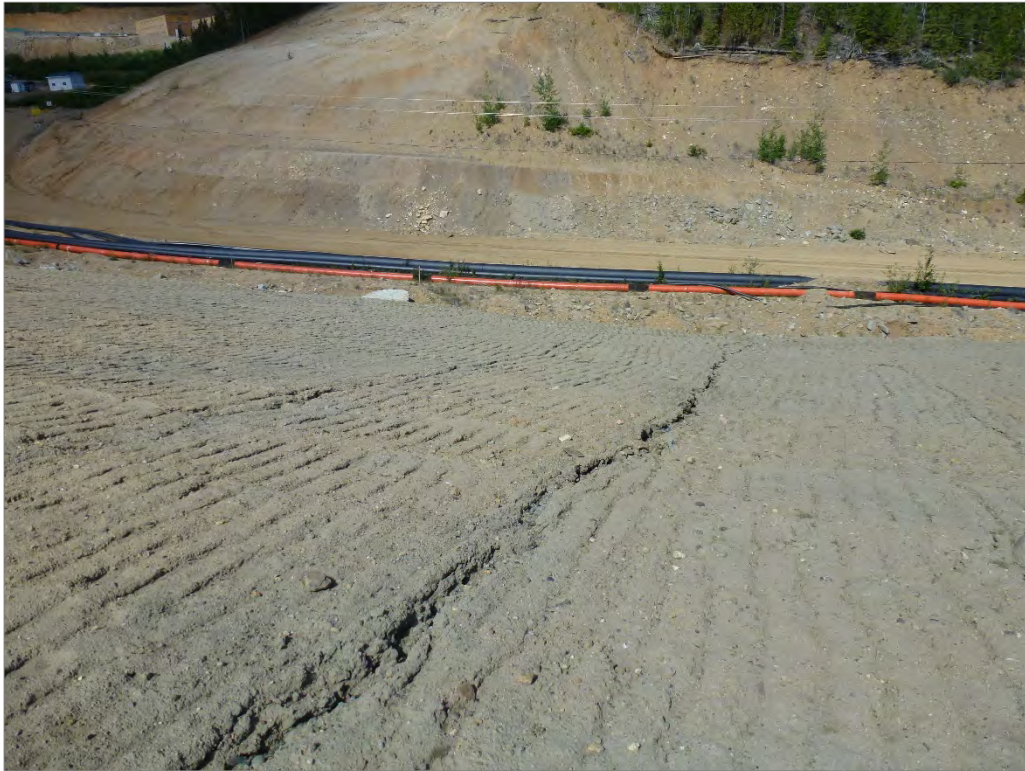
Photo 17: Erosion gully (looking north)

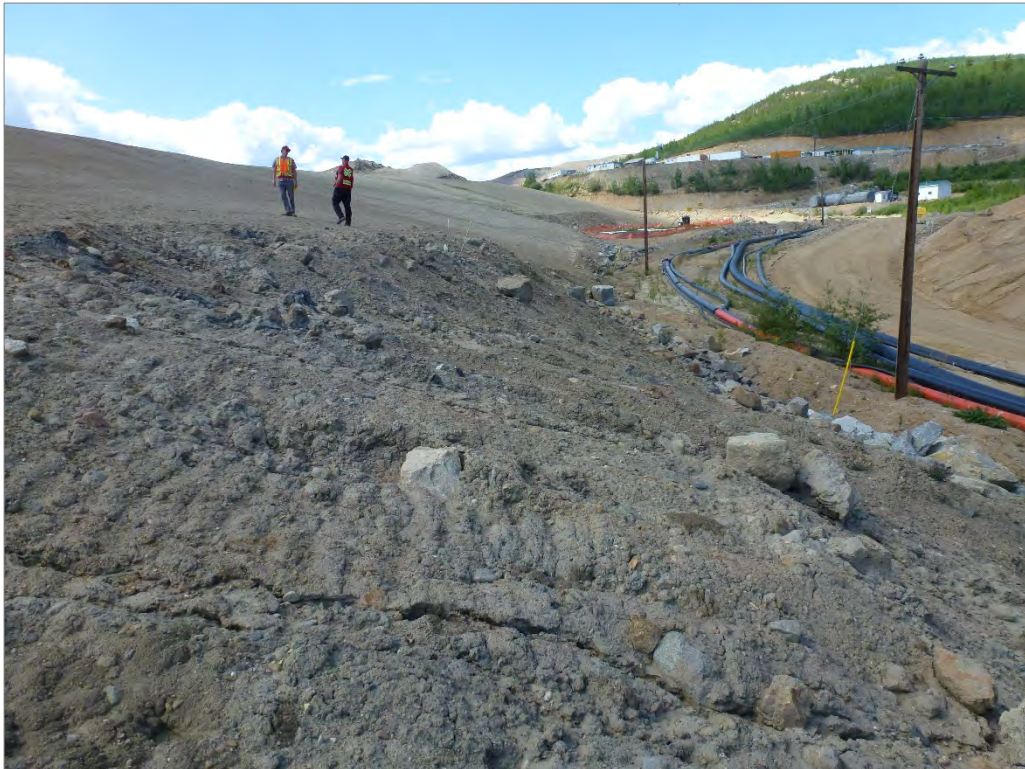
Photo 18: Area still to be regraded close to the toe (looking west)

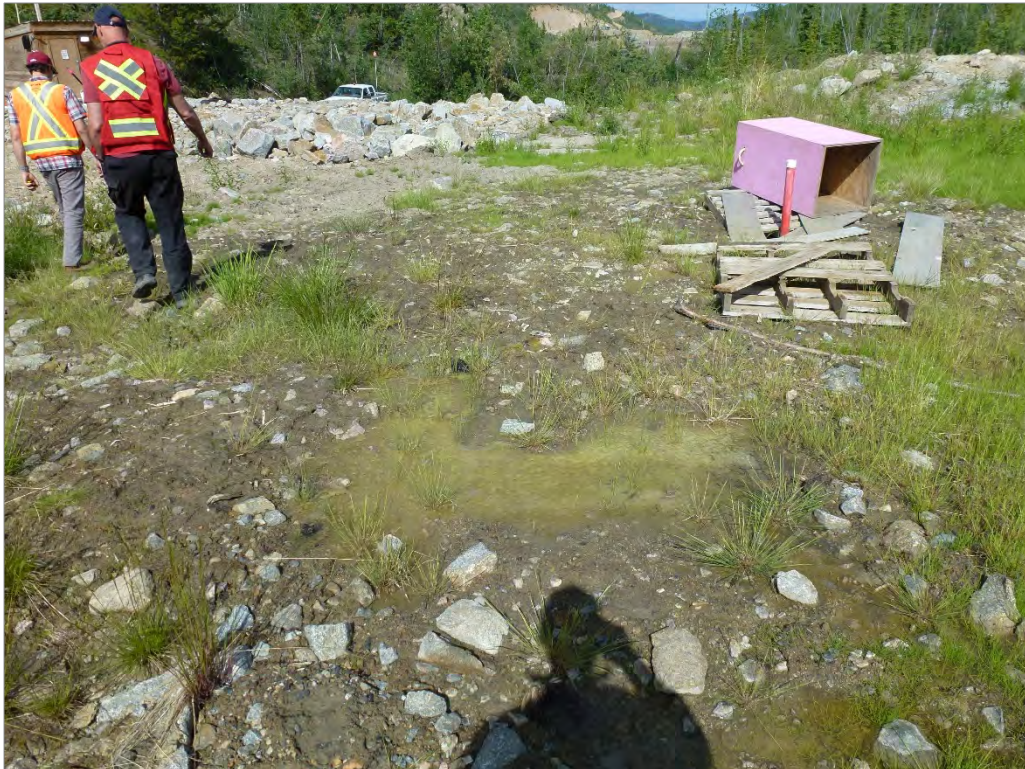
Photo 22: Potential seepage at the toe of the MVFE (but still upstream of seepage collection system)

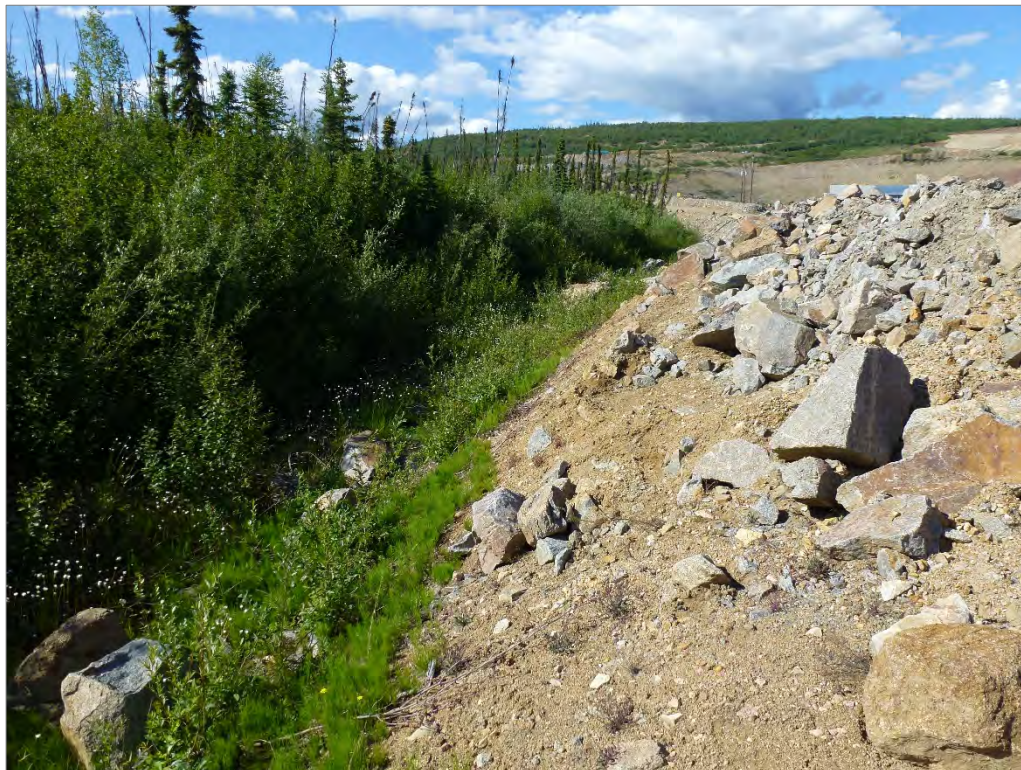
Photo 23: Vegetation in TDD – looking upstream to the west

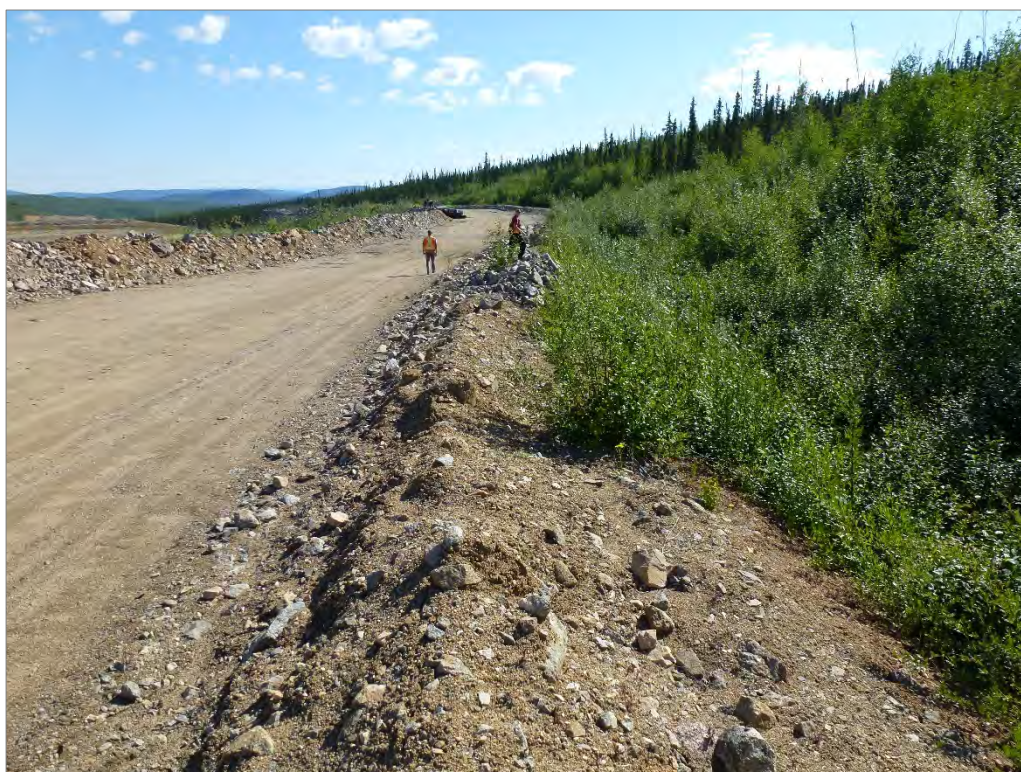
Photo 24: Vegetation in TDD – looking downstream to the east

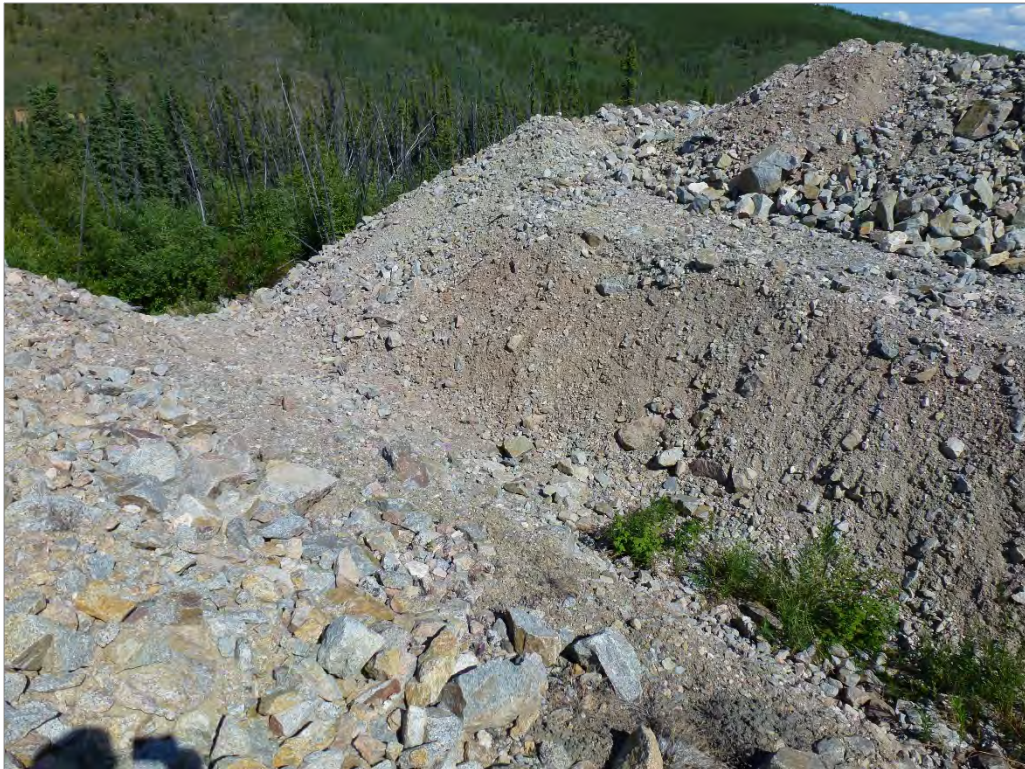
3	Tailings Diversion Ditch (TDD)	<ul style="list-style-type: none"> <li>• Observations were consistent with previous years' inspection.</li> <li>• Construction of the TDD Intake Structure and Overflow Spillway into the Area 2 Stage 3 Pit remains incomplete. The flow from the South Diversion Ditch has been diverted to the TDD, but construction of the intake channel side-slopes and riprap remains incomplete.</li> <li>• The road grading along the Overflow Spillway has resulted in berms across the spillway and the flow capacity may not meet the design criteria.</li> <li>• No major obstructions or signs of instability along the TDD were observed.</li> <li>• Vegetation was observed in the upper portion of the unarmoured ditch which may reduce flow capacity (see Photo 23 and 24, Appendix A).</li> <li>• Remaining armoured portion of the ditch was generally free from vegetation (see Photo 25, Appendix A).</li> <li>• TDD outlet showed no signs of instability or obstructions (see Photo 26, Appendix A).</li> </ul>

Photo 26: TDD outlet

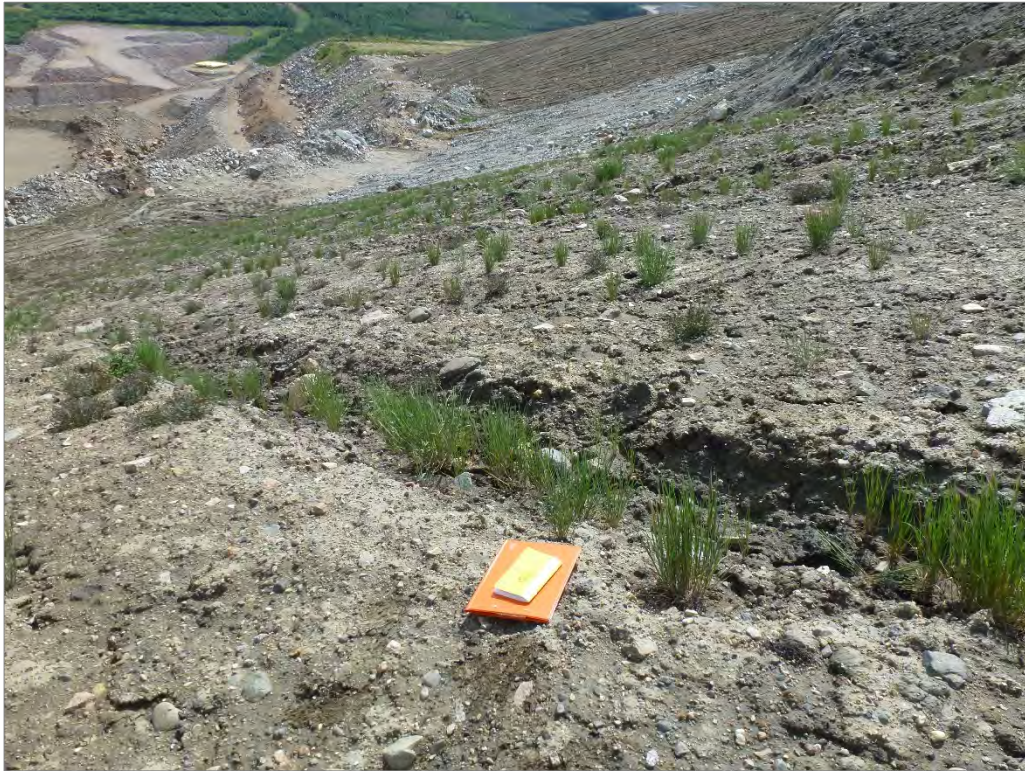
Inspection Area Number	Inspection Area Name	SRK Observations
4	Main Waste Dump (MWD)	<ul style="list-style-type: none"> <li>• No observations of global instability.</li> <li>• Erosion gullies observed in cover material (see Photo 29, Appendix A) .</li> <li>• Longitudinal cracking observed in the re-sloped area above the former PAG Oxide stockpile (see Photo 30, Appendix A). Cracking is approx. 50 m long. Area below the cracking appears to have been regraded with a concave slope, but the area has likely settled.</li> <li>• Minor vegetation has established on the cover slopes</li> </ul>
5	Main Waste Dump (MWD) Wrap	<ul style="list-style-type: none"> <li>• No observations of global instability.</li> <li>• Observations were consistent with previous years' inspection.</li> <li>• Cracking prevalent on the top bench that appear to follow the alignment of the old crest of the Main Waste Dump (see Photo 32 and 33, Appendix A).</li> <li>• Differential settlement and small sinkholes also prevalent on the top bench, likely attributed to snow within the fill during winter construction (see Photo 34 – 36, Appendix A).</li> </ul>

Photo 29: Erosion gully on MWD

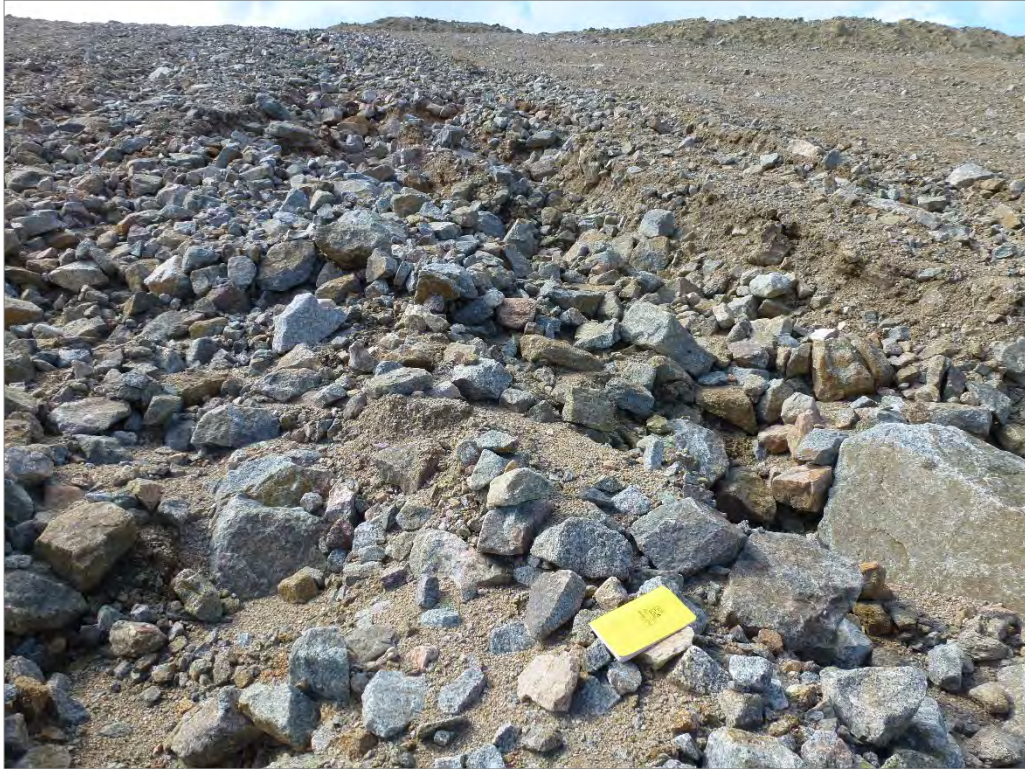
6	Southwest Waste Dump (SWD)	<ul style="list-style-type: none"> <li>• No observations of global instability.</li> <li>• Observed an eroded portion on the regraded slope, likely due to the 2016 dewatering of ponded water from the area west of the dump and south of the former Ice-rich Overburden Dump (see Photo 43, Appendix A).</li> <li>• Crack approx. 110 m long observed along the access road immediately west (upslope) of areas where overburden stockpiles are present. Crack is up to 25 cm wide and approx. 0.6 m deep. See Photo 45 and 46, Appendix A. The crack should be visually monitored as part of routine inspections for any change in condition. Any large-scale slope deformation would be expected to be detected by SWD012 located downslope of the crack.</li> </ul>
7	Reclamation Overburden Dump	<ul style="list-style-type: none"> <li>• Conditions are the same as noted in previous years' inspections.</li> <li>• Vegetation has firmly established across the dump area (see Photo 37 and 38, Appendix A).</li> <li>• Previous notes include: <ul style="list-style-type: none"> <li>○ Slumping, settlement and tension cracks are expected in the dump as it is constructed with frozen overburden and thawing is expected</li> <li>○ Discontinuous tension cracks and differential settlement have been observed along the perimeter crest</li> <li>○ Ground undulation is typically 0.3 m and is prevalent throughout the facility</li> </ul> </li> <li>• This area was not inspected on foot during the 2019 inspection</li> </ul>

Photo 43: Eroded portion of the regraded slope due to the 2016 dewatering of ponded water from the area west of SWD and south of the former Ice-rich Overburden Dump

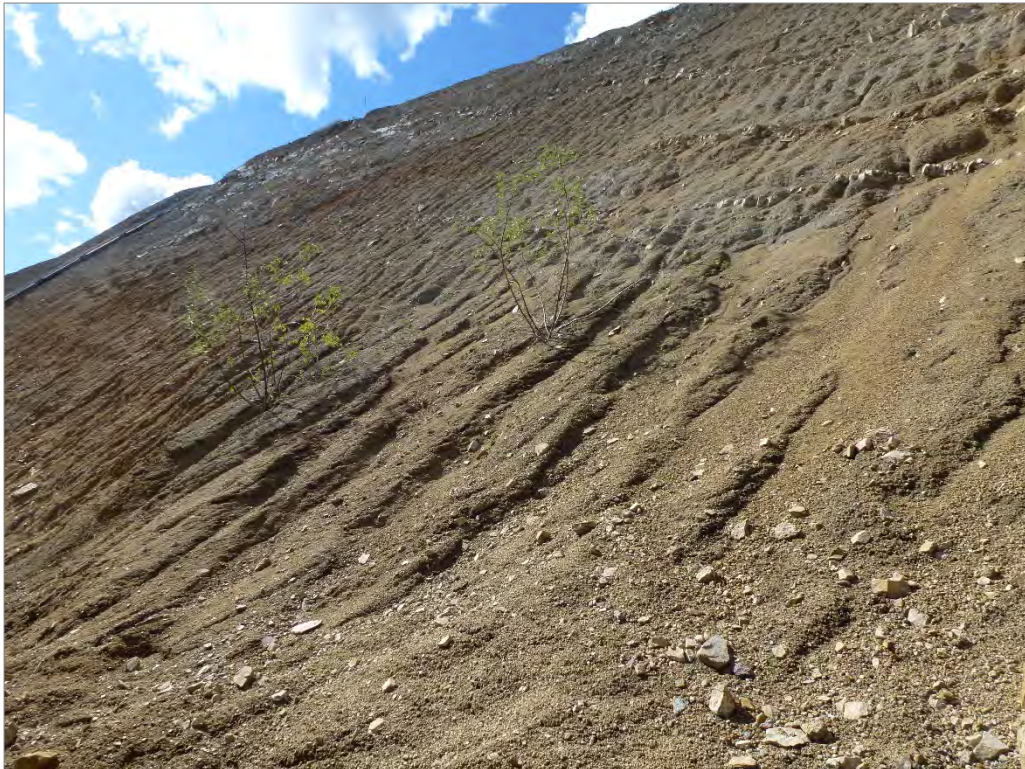
Photo 48: Minor slope erosion on the highwall

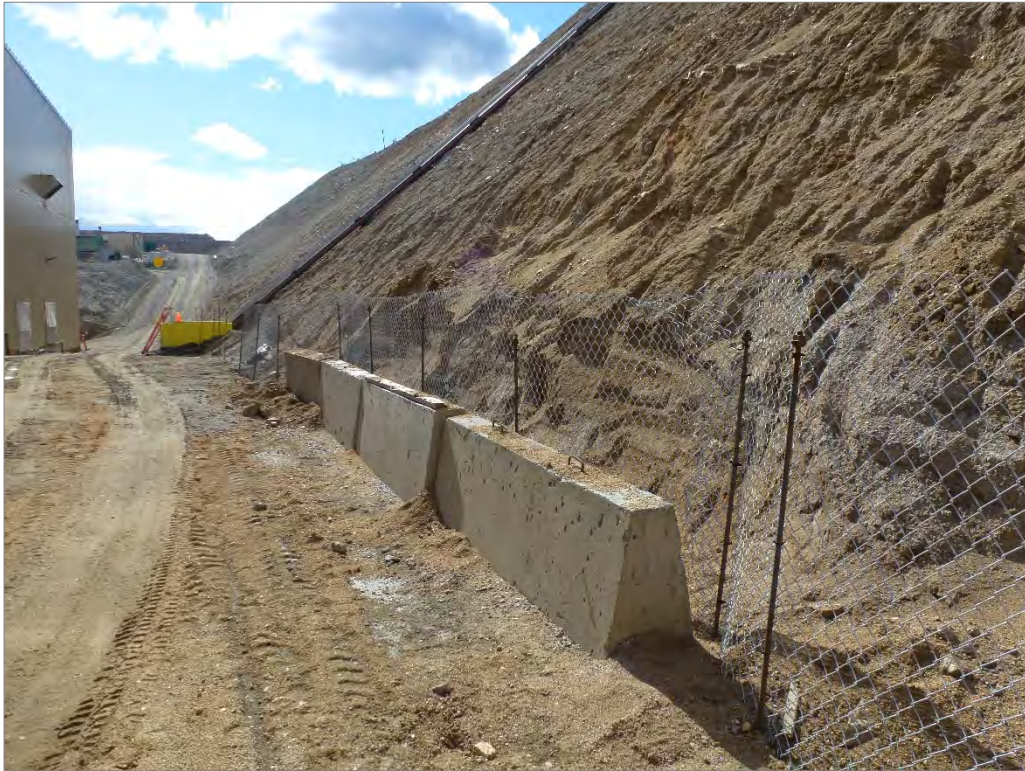
Photo 49: Newly installed concrete jersey barriers. Note over-excavated highwall toe.

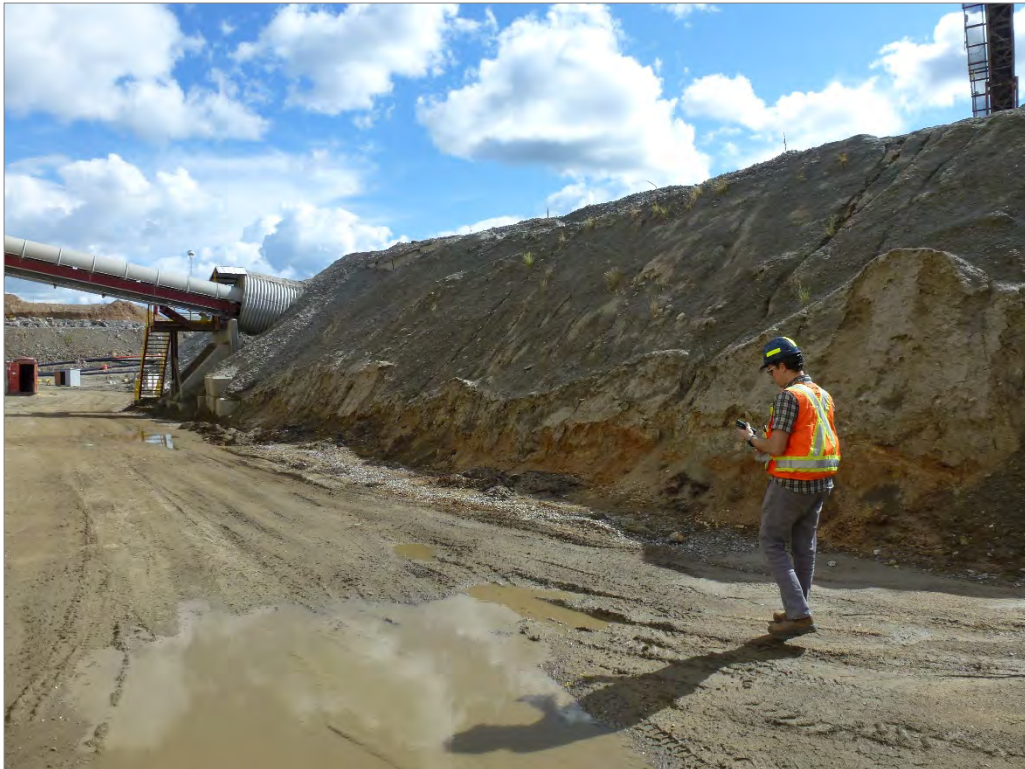
Inspection Area Number	Inspection Area Name	SRK Observations
8	Ore Stockpiles	<ul style="list-style-type: none"> <li>This ore stockpiles were investigated briefly in passing and appeared to be in good condition. No obvious signs of instability were noted.</li> </ul>
9	Mill Site	<ul style="list-style-type: none"> <li>No observations of global instability of the highwall north of the mill were observed Minor erosion and spalling of loose rocks is ongoing (see Photo 48, Appendix A).</li> <li>The rocks appear to have been recently cleared from the road prior to the inspection with concrete jersey barriers currently being installed with chain-linked fences intended to catch loose rocks from the highwall. It was observed that the highwall toe has been over-excavated as part of the installation (see Photo 49, Appendix A). The over-excavation has resulted in steepening of the slope which could lead to instability and increased erosion, weathering, and rock spalling.</li> <li>The toe of the mill feed stockpile pad was observed to be over-excavated (see Photo 50, Appendix A).</li> </ul>

Photo 50: Mill feed stockpile pad

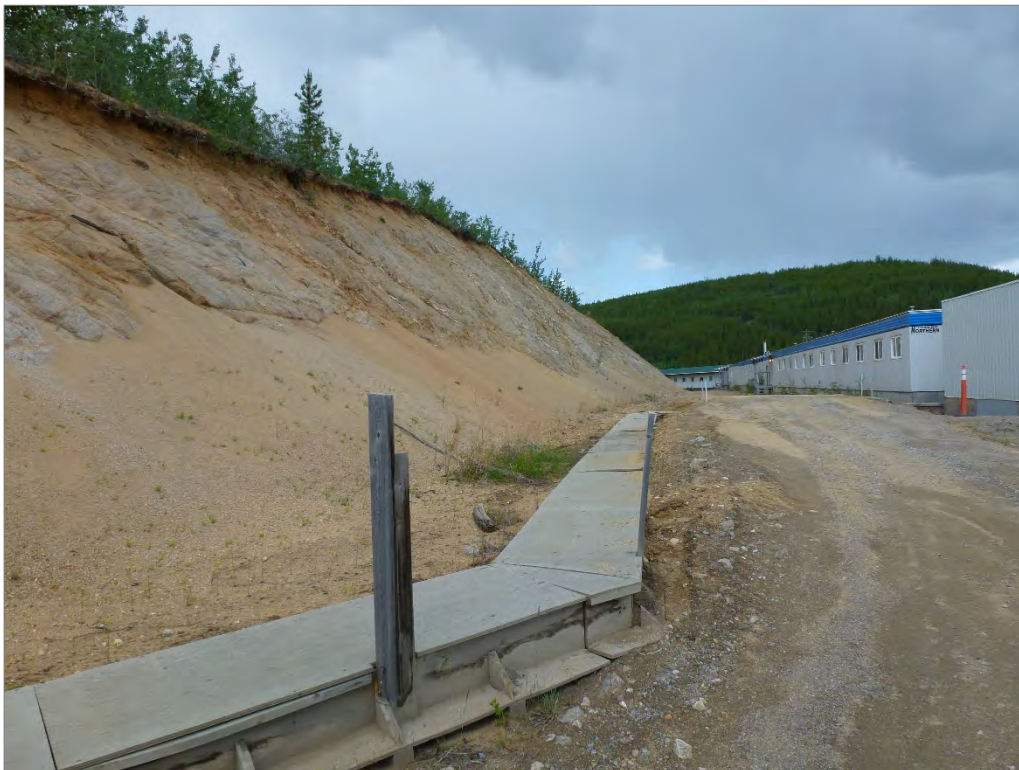
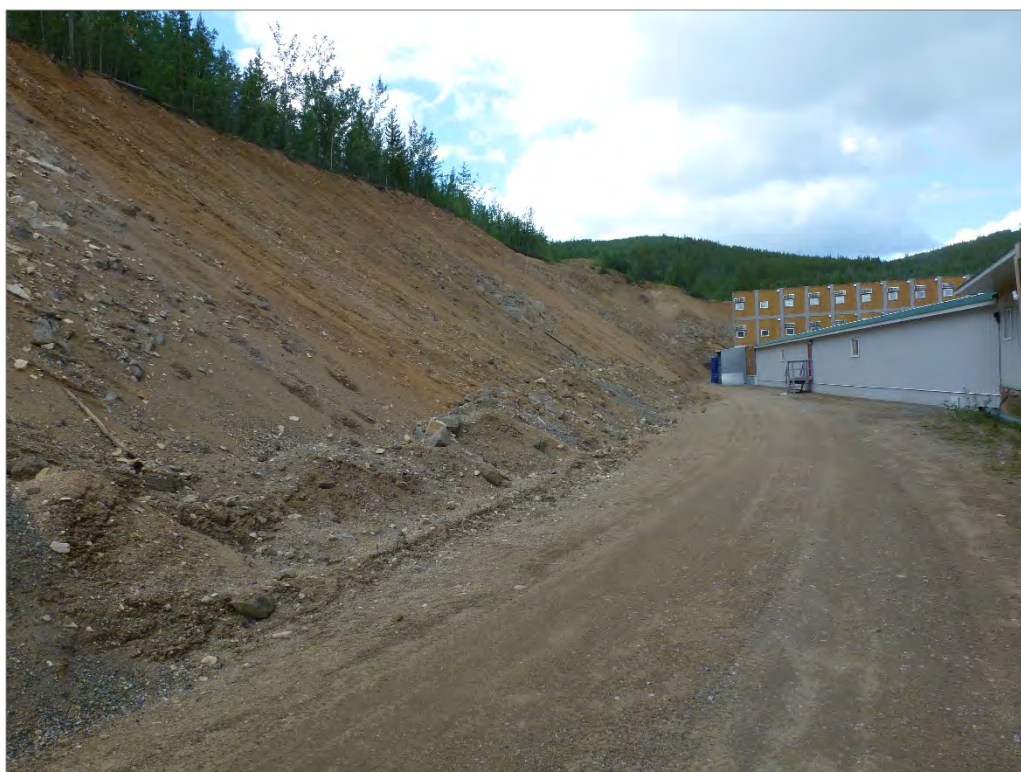
10	Camp Site	<ul style="list-style-type: none"> <li>Observations were generally consistent with previous years' inspection.</li> <li>Minor on-going erosion was observed on the highwall north of the camp (see Photo 53 and 54, Appendix A).</li> <li>No observations of global instability of the highwall were observed.</li> <li>The outlet channel from the natural spring north of the Selkirk Towers was observed to be free of blockages (see Photo 55, Appendix A).</li> <li>Erosion gullies in the slopes of the camp pad (i.e. south of camp) appear to have increased in size since the previous year (see Photo 56 – 58, Appendix A).</li> </ul>
11	Fuel Containment Facility	<ul style="list-style-type: none"> <li>Observations were generally consistent with previous years' inspection.</li> <li>No tears or defects in the liner were observed (see Photo 59 – 61, Appendix A).</li> <li>The facility appears to drain towards the sump and is holding runoff water, indicating that the liner is functioning as designed.</li> <li>The highwall to the north of the facility did not show signs of global instability (see Photo 62, Appendix A)</li> </ul>

Photo 53: Highwall behind Camp Site (looking northeast)

Photo 54: Highwall behind Camp Site (looking north)

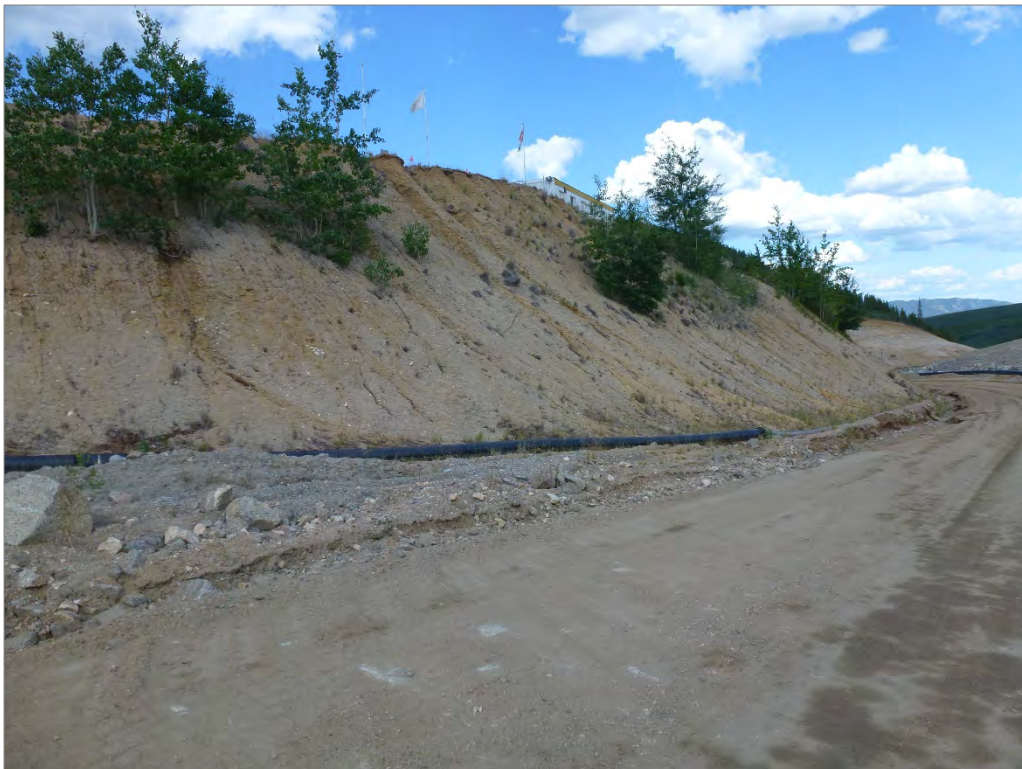
Photo 56: Erosion gullies on the slopes of the Camp Site pad (looking northeast)

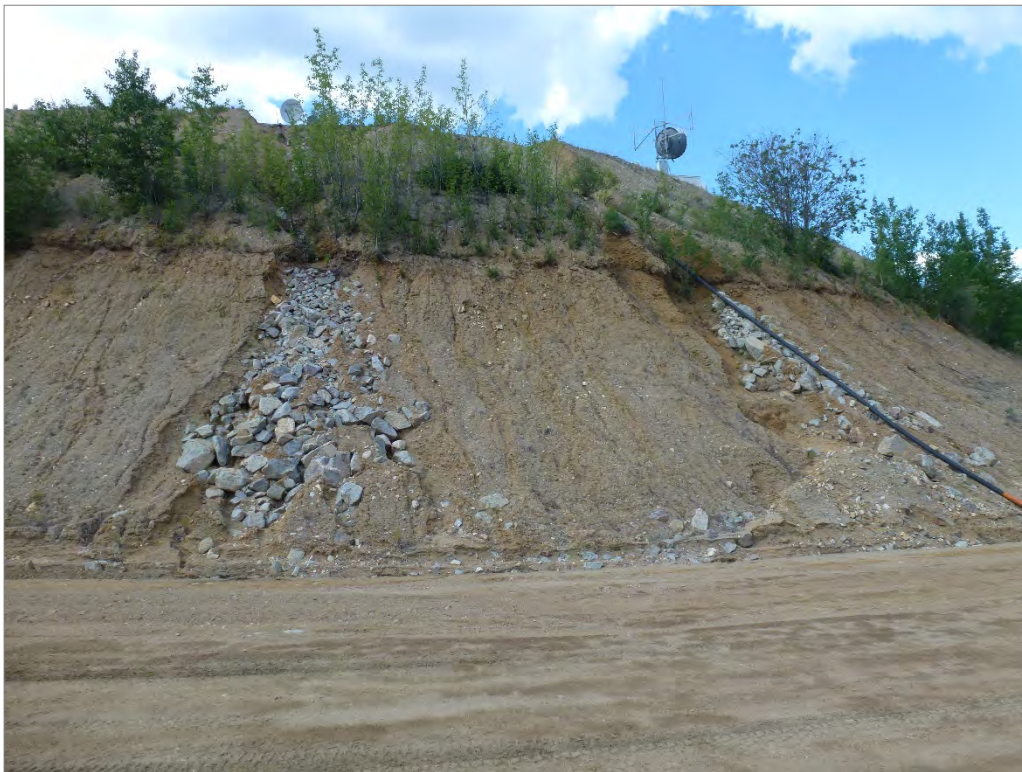
Photo 57: Erosion gullies with rockfill armoring on the slopes of the Camp Site pad (looking north)

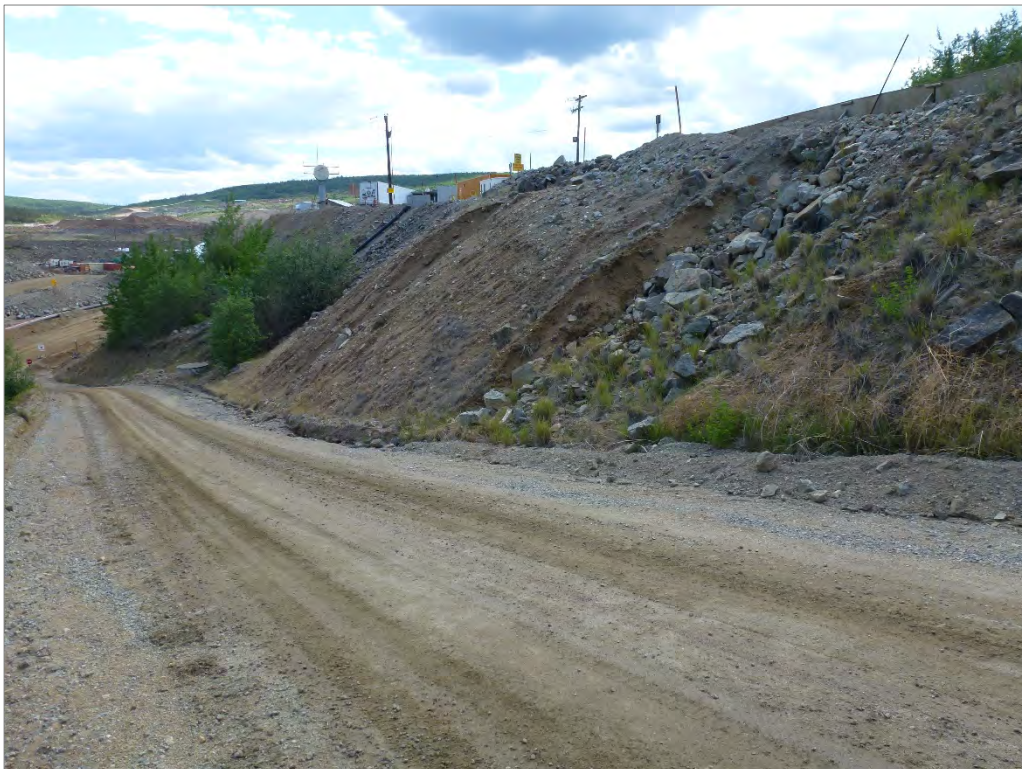
Photo 58: Erosion gullies on the slopes of the Camp Site pad (looking south)

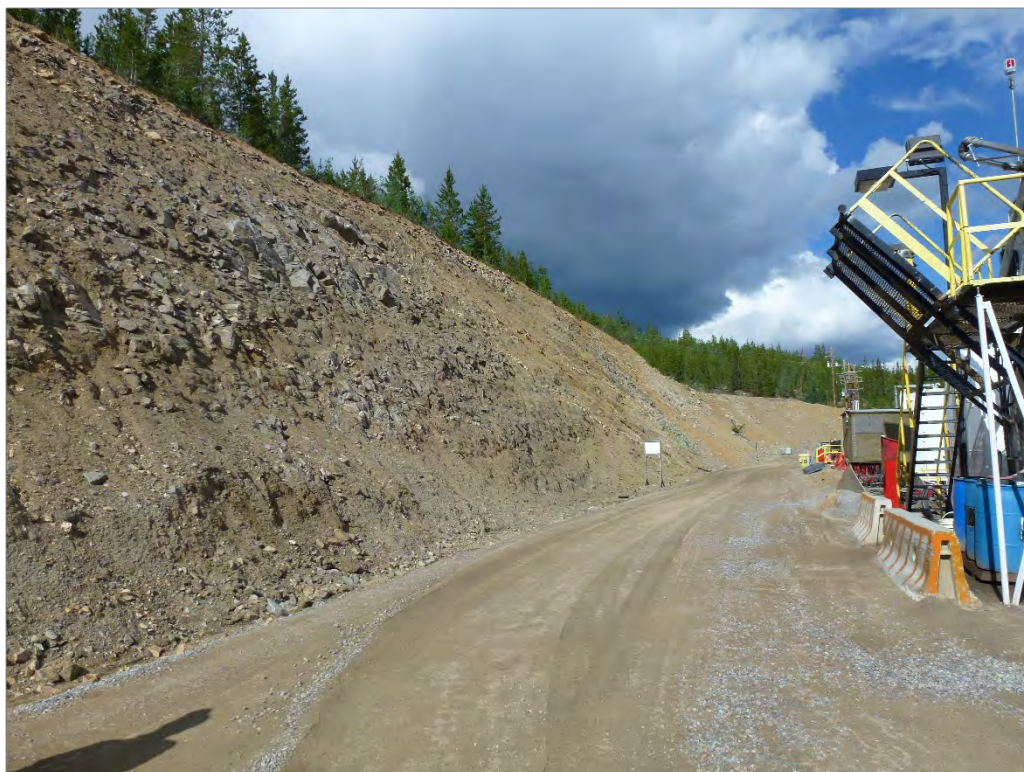
Photo 62: Highwall behind Fuel Containment Facility (looking east)

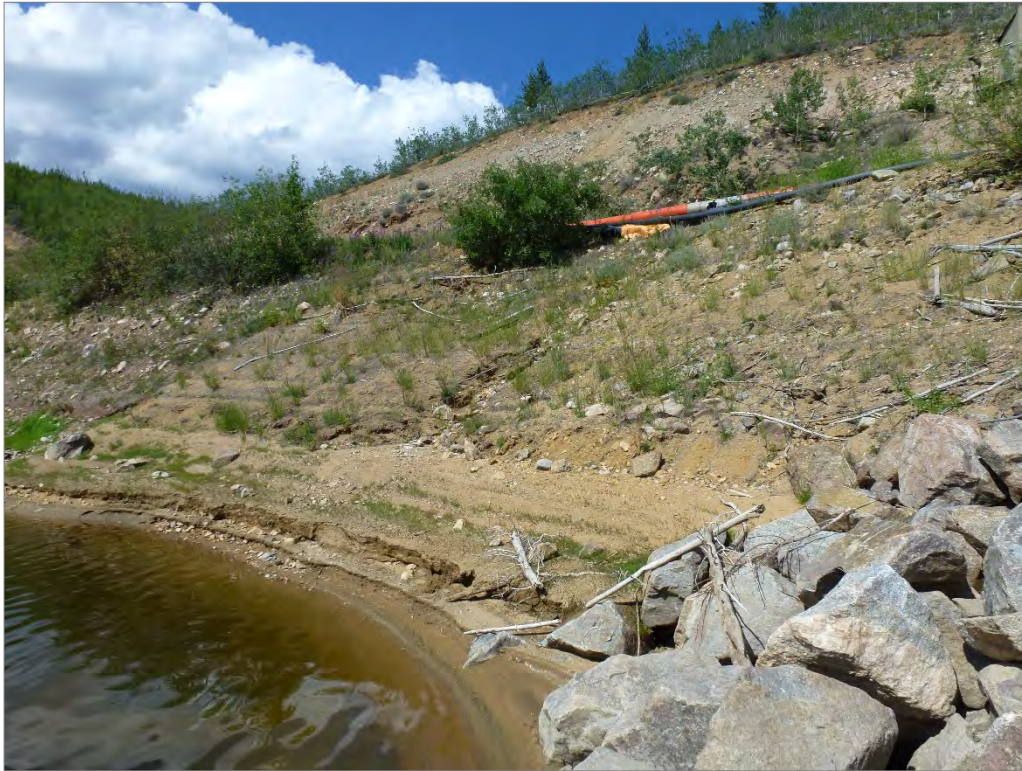
12	Water Storage Pond (WSP) Dam	<ul style="list-style-type: none"> <li>Observations were generally consistent with previous years' inspection.</li> <li>No observations of global instability.</li> <li>The historical area of erosion on the upstream face towards the north abutment of the dam (repaired in 2015) showed no indication of new erosion.</li> <li>Minor erosion observed upstream of the dam in natural slope close to the north abutment (see Photo 65, Appendix A).</li> </ul>

Photo 65: Minor erosion upstream of the WSP dam close to the north abutment

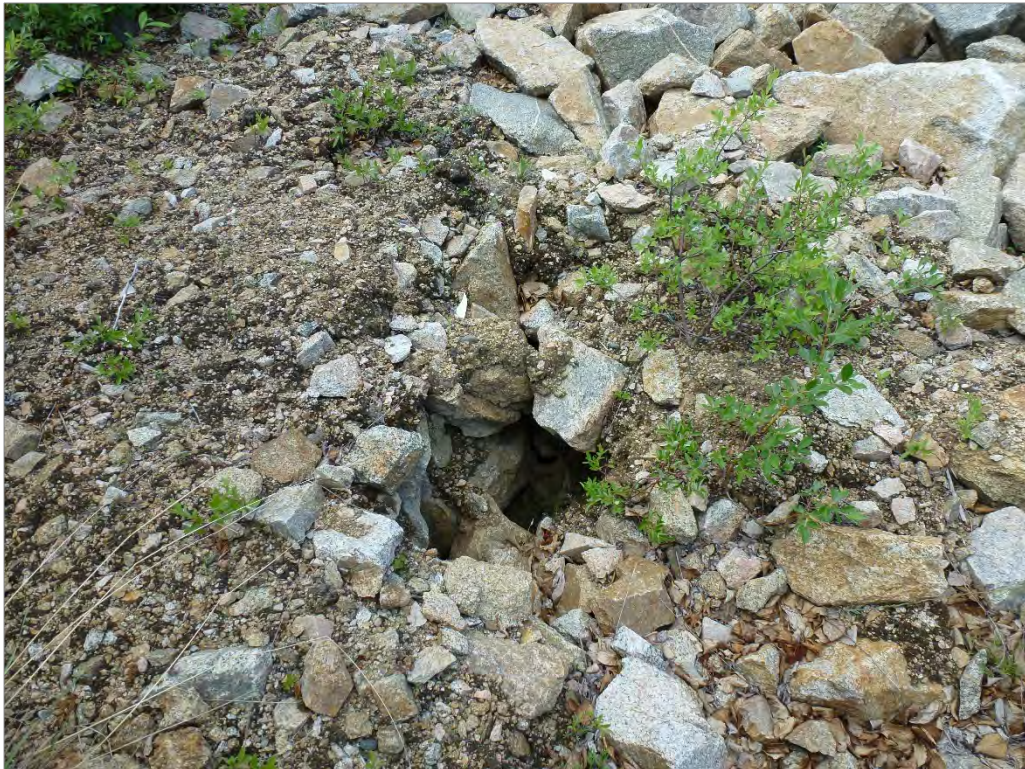
Inspection Area Number	Inspection Area Name	SRK Observations
		<ul style="list-style-type: none"> <li>• Some of the rip rap used to armour the upstream and downstream slopes was observed to be weak and friable.</li> <li>• A small potential sinkhole was observed in the downstream slope, approximately halfway towards the downstream toe and on the southern edge of the slope. Located 5 m NW of WSPT-8. Dimensions are approximately 0.3 m diameter and was able to lower measuring tape to ~ 1.4m below ground surface. See Photo 72, Appendix A.</li> <li>• Seepage water downstream of the dam was clear and no accumulation of sediments was observed (see Photo 73, Appendix A).</li> <li>• Seepage flow at the V-notch weir outlet was estimated to be less than 1 L/s and was clear with no signs of turbidity (see Photo 74, Appendix A).</li> <li>• Seepage flow was faintly audible through the rockfill close to the seepage collection system (see Photo 75, Appendix A).</li> </ul>

Photo 72: Potential minor sink hole

WSP Dam	<ul style="list-style-type: none"> <li>• <b>(High Priority) During routine instrumentation readings, inspect and photograph the identified potential sinkhole located 5 m NW of WSPT-8 (See Photo 72 in Appendix A) to monitor for any change in condition.</b></li> </ul>

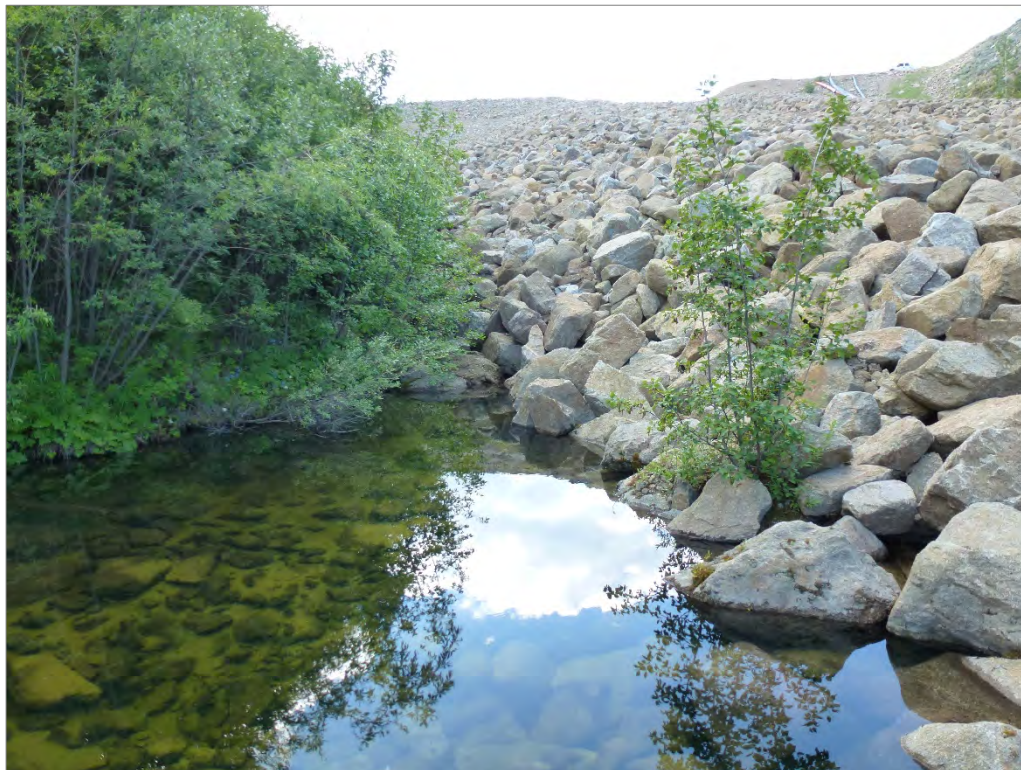
Photo 73: Ponding seepage downstream of WSP Dam – looking back towards the downstream slope.
