# 2019 Geotechnical Annual Review, Minto Mine, YT

Minto Explorations Ltd.

SRK Consulting (Canada) Inc.  
1CM002.066  
August 2019

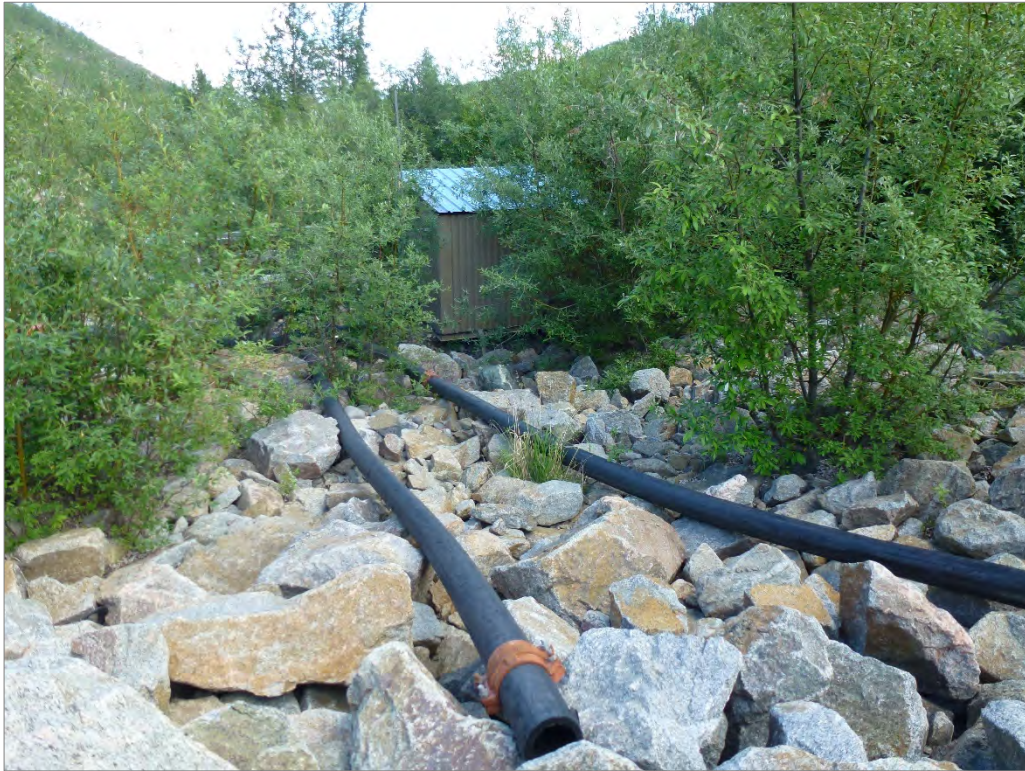
Inspection Area Number	Inspection Area Name	SRK Observations
		<ul style="list-style-type: none"> <li>• Some of the rip rap used to armour the upstream and downstream slopes was observed to be weak and friable.</li> <li>• A small potential sinkhole was observed in the downstream slope, approximately halfway towards the downstream toe and on the southern edge of the slope. Located 5 m NW of WSPT-8. Dimensions are approximately 0.3 m diameter and was able to lower measuring tape to ~ 1.4m below ground surface. See Photo 72, Appendix A.</li> <li>• Seepage water downstream of the dam was clear and no accumulation of sediments was observed (see Photo 73, Appendix A).</li> <li>• Seepage flow at the V-notch weir outlet was estimated to be less than 1 L/s and was clear with no signs of turbidity (see Photo 74, Appendix A).</li> <li>• Seepage flow was faintly audible through the rockfill close to the seepage collection system (see Photo 75, Appendix A).</li> </ul>

Photo 75: Looking downstream towards the seepage collection system

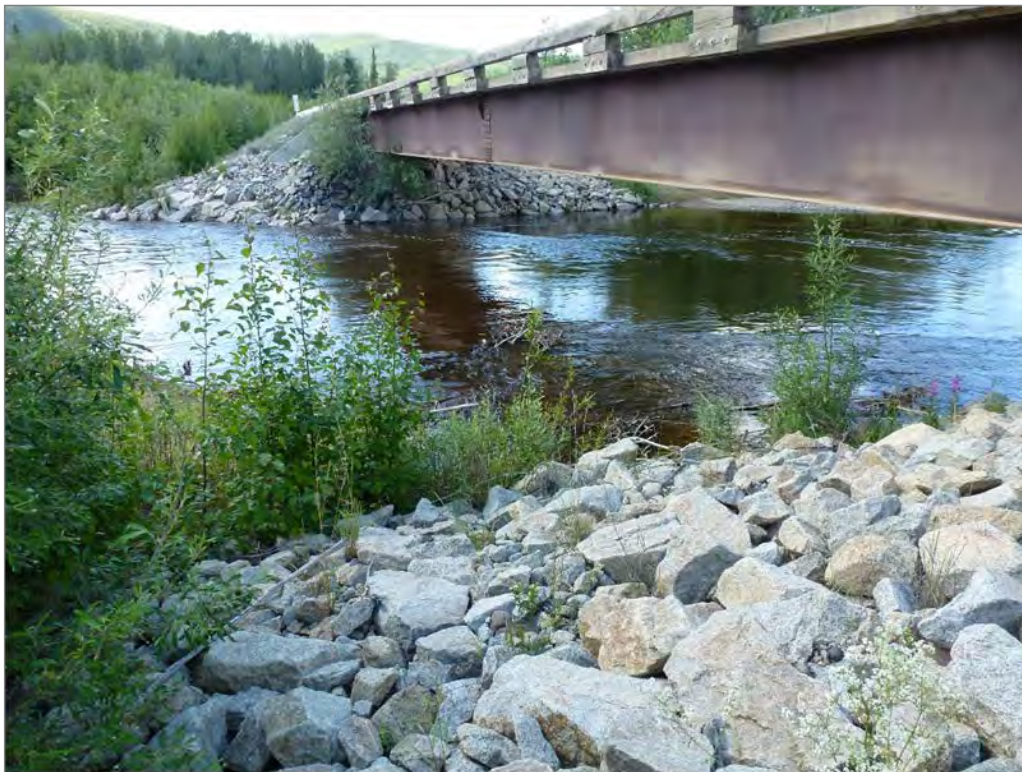
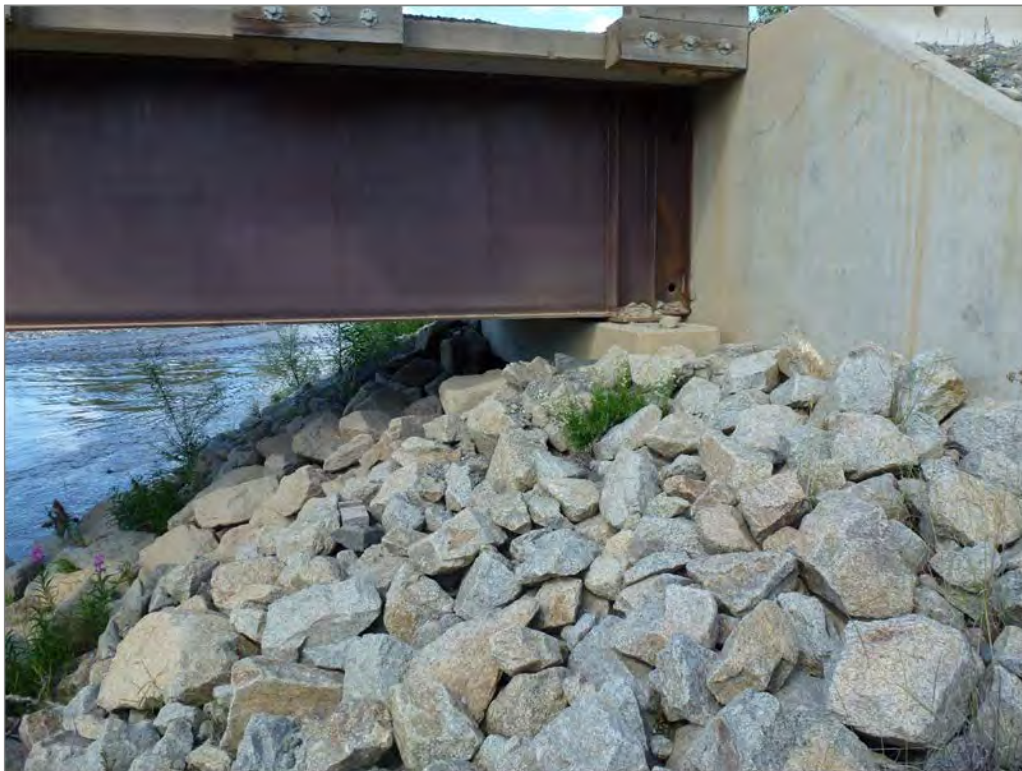
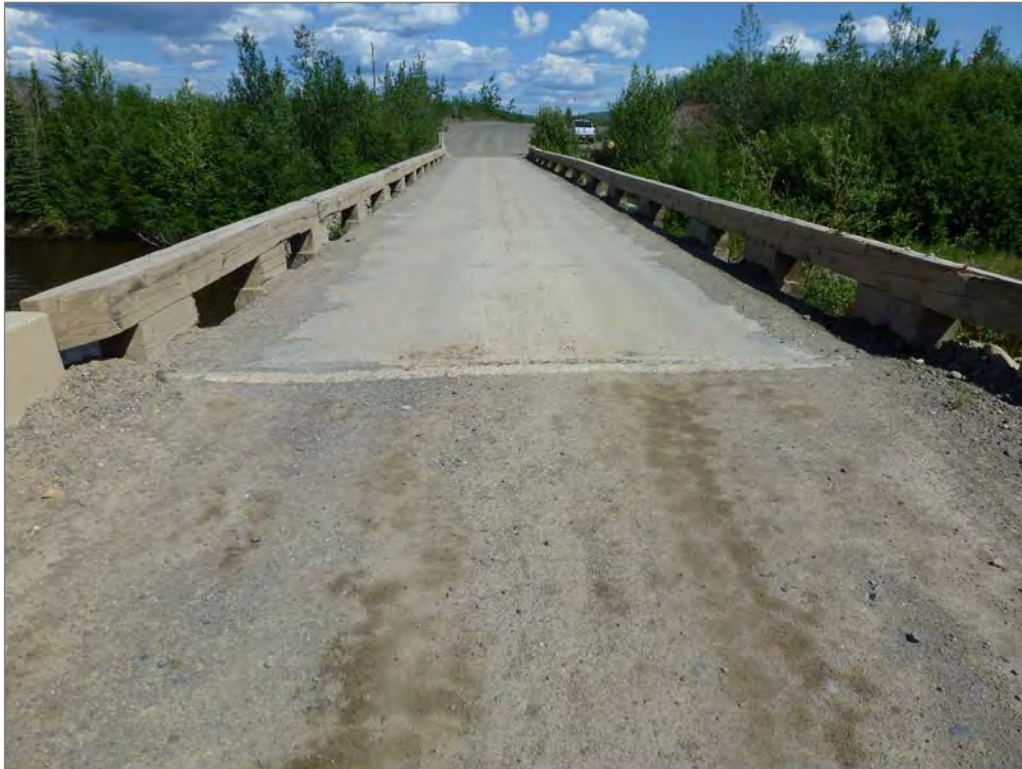
13	Big Creek Bridge	<ul style="list-style-type: none"> <li>• Observations of the bridge and road culverts were generally consistent with previous years' inspection</li> <li>• The bridge abutments and road approaches are in good condition, with no signs of instability observed (see Photo 77 – 79, Appendix A).</li> <li>• In general, all culverts are in satisfactory condition with no major blockages or sediment accumulation at either end of the culverts (see Photo 80 – 82, Appendix A).</li> <li>• Tree growth near the inlet of some of the culverts is continuing and may reduce the capacity of the culvert or lead to a blockage.</li> <li>• One of the culverts in the group of four culverts has been partially damaged and deformed (see Photo 83, Appendix A).</li> </ul>
14	Main Pit Dump, SAT Dump & In-Pit Dumps	<ul style="list-style-type: none"> <li>• Observations were generally consistent with previous years' inspection.</li> <li>• No observations of global instability.</li> <li>• SAT dump did not show signs of cracking or movement (see Photo 86, Appendix A).</li> <li>• Longitudinal cracking was observed on the crest of the In-Pit Dump (see Photo 87, Appendix A).</li> <li>• Erosion gullies observed in the highwall above the In-Pit Dump (see Photo 88, Appendix A).</li> <li>• Settlement cracking was observed in the crest of the dump and is up to 20 cm wide at its widest in the access ramp (see Photo 90, 91 and 93, Appendix A).</li> <li>• Top bench of the Main Pit Dump has an undulating surface with some differential settlement.</li> </ul>

Photo 77: Side view of Big Creek Bridge (looking west)

Photo 78: Big Creek Bridge eastern abutment

Photo 79: Top view of Big Creek Bridge (looking west)

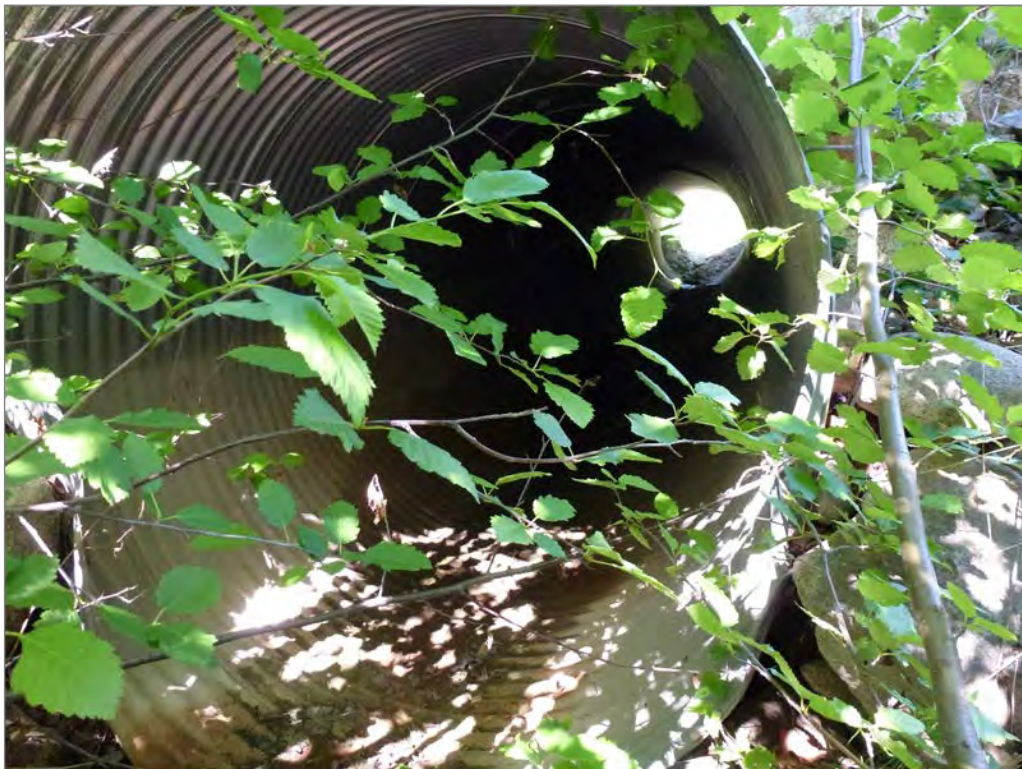
Photo 80: Single road culvert

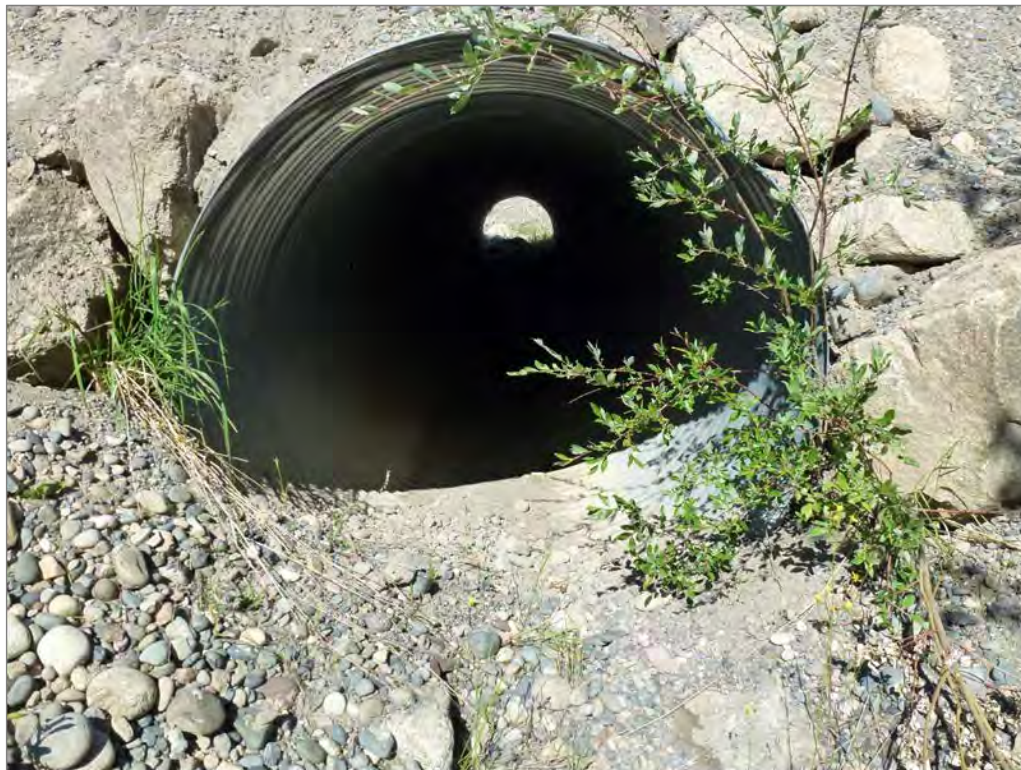
Photo 81: Single road culvert

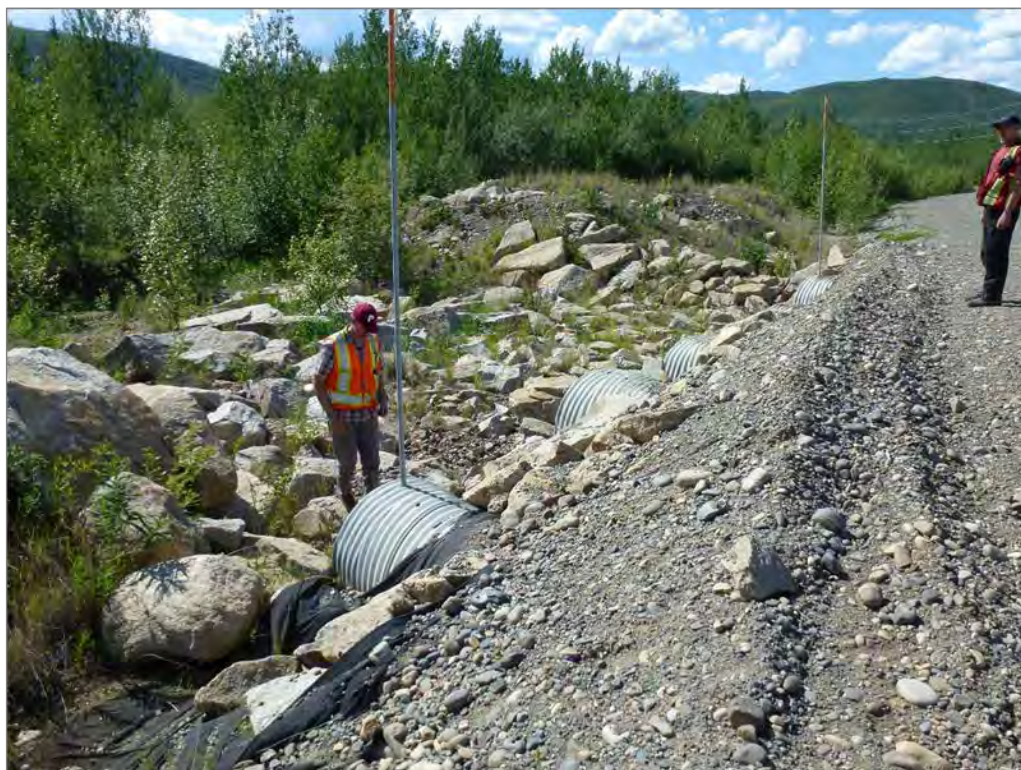
Photo 82: Four road culverts

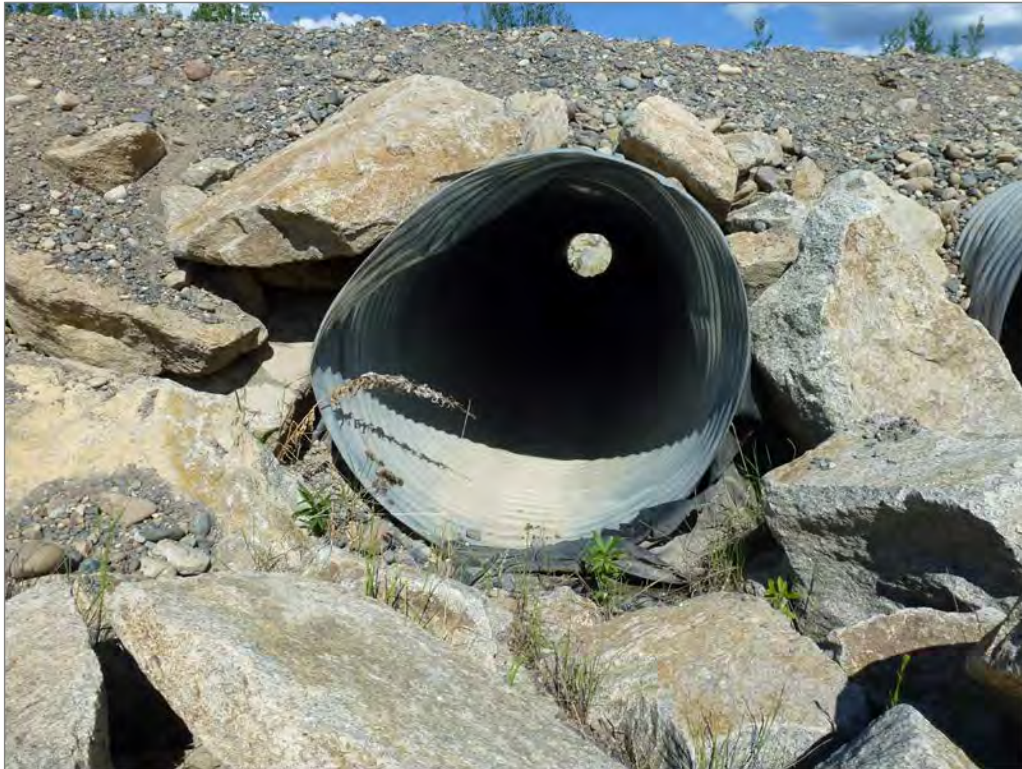
Photo 83: One of the four road culverts partially deformed

Area	Recommendations
Big Creek Bridge	<ul style="list-style-type: none"> <li>• Continue regular annual monitoring of sediment accumulation in the culverts and clean out if sediments continue to accumulate.</li> <li>• Limit the material graded from the road at the culvert locations, or muck out some of the gravel buildup, taking care not to damage the culvert.</li> <li>• If the alignment of Big Creek changes and it appears that the culverts may be utilized, tree clearing and sediment removal immediately upstream and downstream of the culverts is recommended.</li> </ul>
Main Pit Dump, SAT Dump, & In-Pit Dumps	As part of the routine visual inspections, continue to monitor the extent of the long crack in the Main Pit Dump Ramp for any changes in condition:
Area 2 Pit	<p>Stage 2</p> <ul style="list-style-type: none"> <li>• Continue to monitor the crests and slopes as part of the monthly visual inspection for signs of worsening cracking to determine if any slope stabilization measures are required.</li> </ul> <p>Stage 3</p> <ul style="list-style-type: none"> <li>• <b>(Medium Priority) Implement measures to redirect runoff from the Underground Access Road away from the erosion gully that has formed into the pit (e.g. re-grade the road). Longer-term, the erosion gully should be stabilized and armored.</b></li> <li>• <b>(High Priority) When the Underground Shop begins to be used again, the inspection frequency of the "Dumas Shop" survey hubs (DS-1 to DS-4) should be increased to weekly. Hubs DS-1 and DS-2 need to be repaired and recommissioned for use.</b></li> <li>• <b>(Medium Priority) The Underground Shop should be inspected by a suitably qualified structural engineer to ensure it remains suitable for use.</b></li> <li>• Continue to monitor the pit for any changes i.e. further slumping/cracking due to permafrost thaw and further instability at the area of the historical rockfall.</li> </ul>

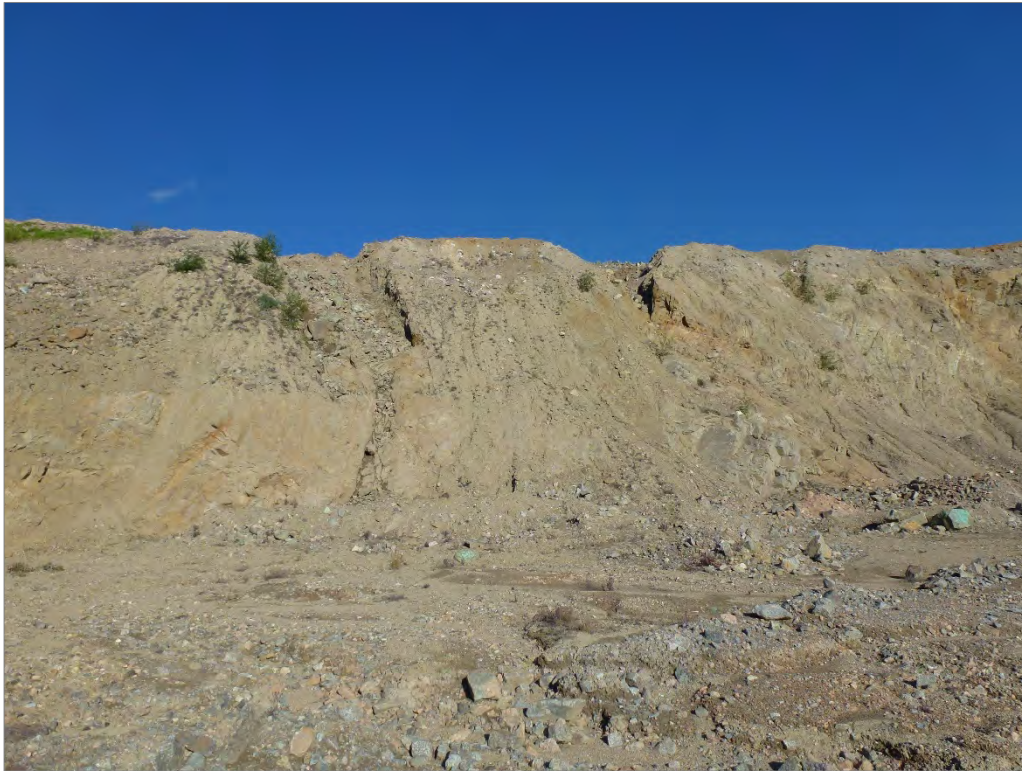
Photo 88: Highwall above In-Pit Dump with erosion gullies

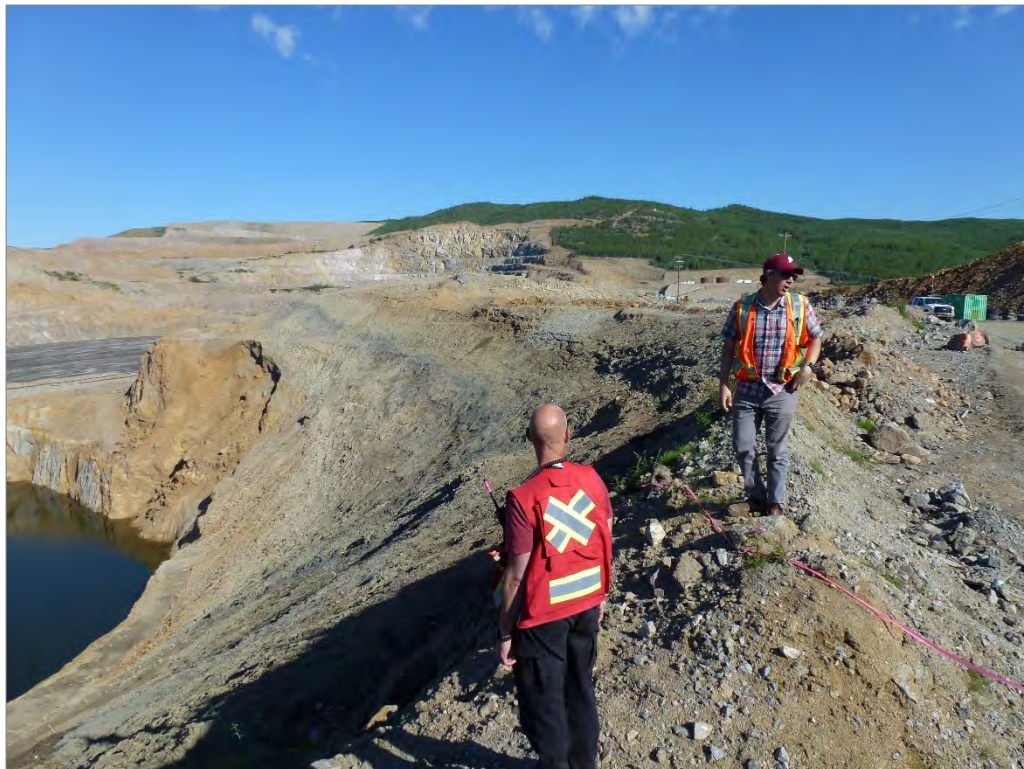
Photo 103: Area 2 Pit Stage 3 pit wall (looking northwest)

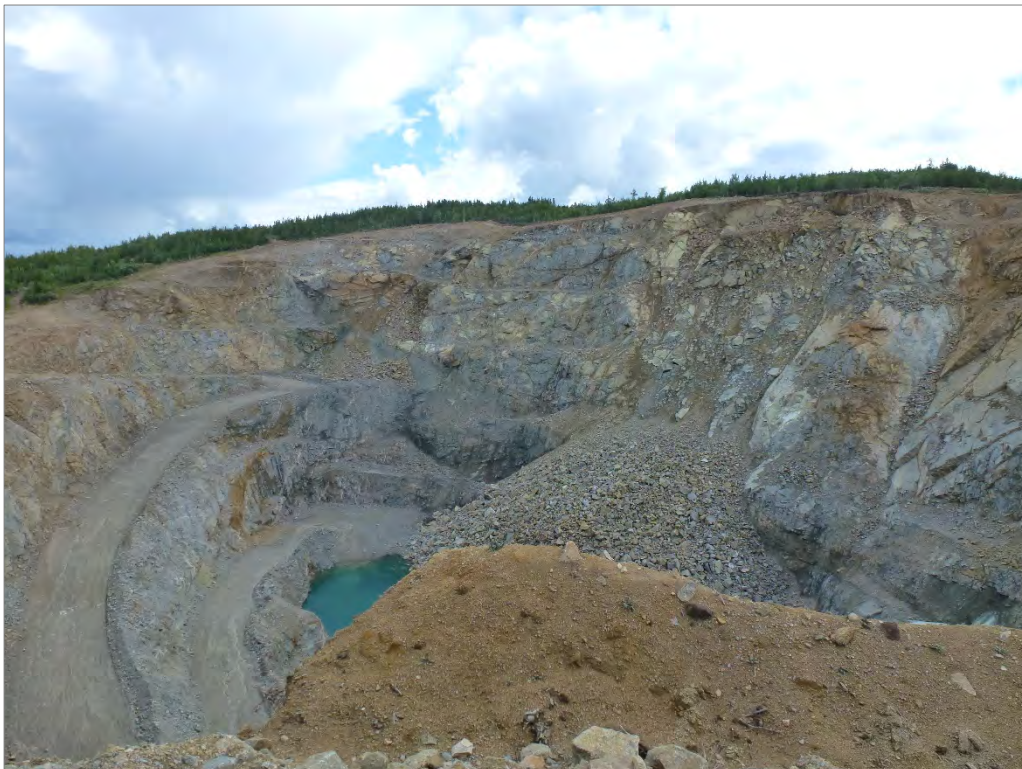
Photo 113: Minto North Pit (looking east)

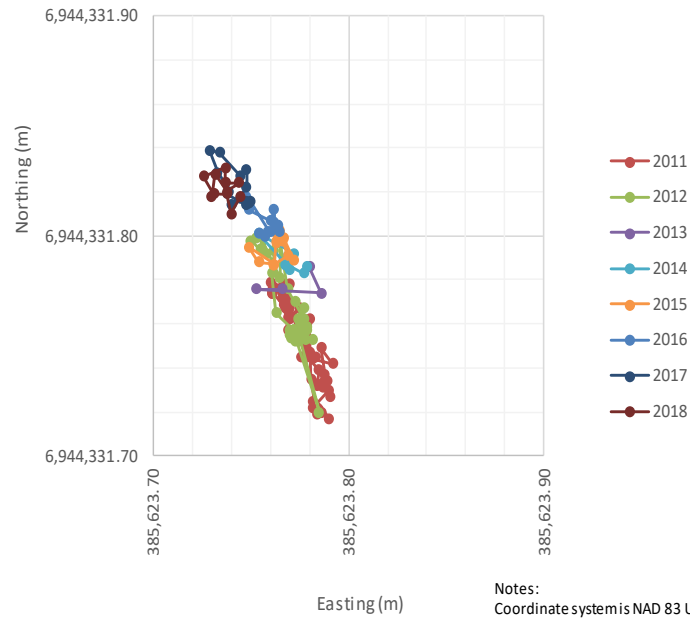
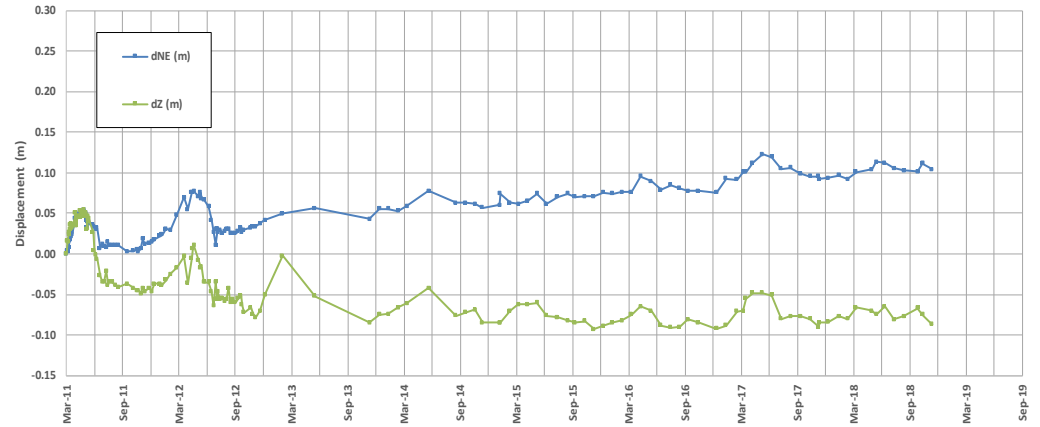
### ASH06 - Northing Vs. Easting Movement Plot

- Minto's survey reading comments on January 14, 2017 notes ASH06 may have been disturbed as a result of a pipeline installation.

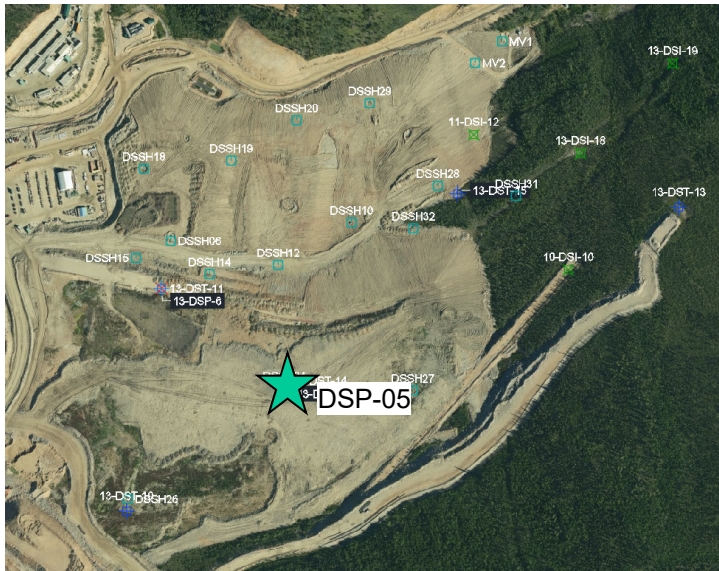
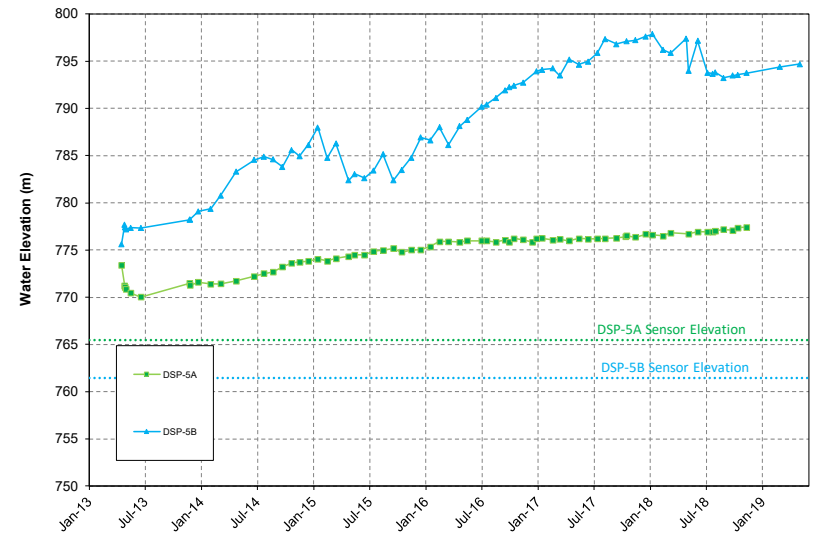
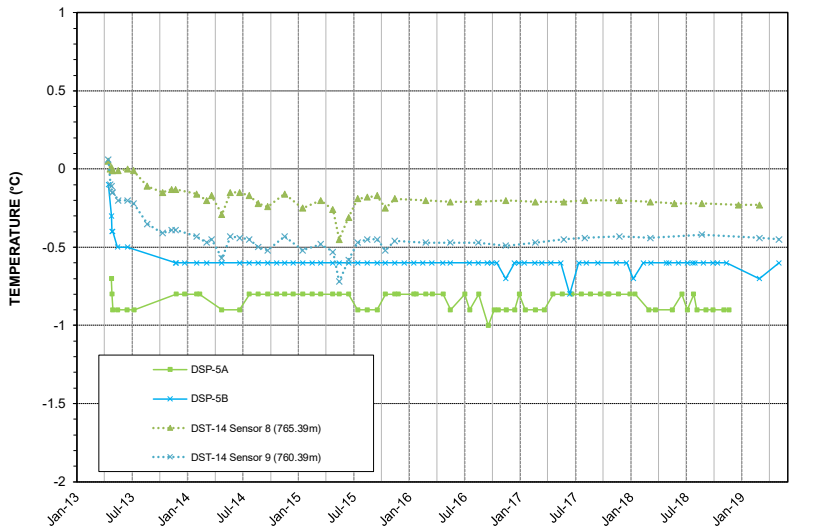
<b>Minto Explorations Ltd.</b>		DSTSF Instrumentation Data		
			<b>Piezometer – DSP-05</b>		
Job No: 1CM002.066 Filename: ApD_2019DSTFLandscape.pptx	Minto Mine		Date: August 2019	Prepared by PHM	Figure: <b>20</b>

1. The pore pressure sensors at DSP-05 are located approximately 2 m above original ground in tailings (A) and 2 m below original ground.
2. The bottom sensor at DSP-05 (B) shows an increase in pore pressure that appears to have peaked in 2018. The sensor is located in an area of silt with stratified ice lenses and the temperature at the sensor is at the freezing point of water  $-0.5^{\circ}$ . The temperature plot also shows thermistor data from nearby ground temperature cable DST-14 for sensors at similar elevations.
3. Sensors at DSP-05A also shows gradual increasing pore pressure trend.

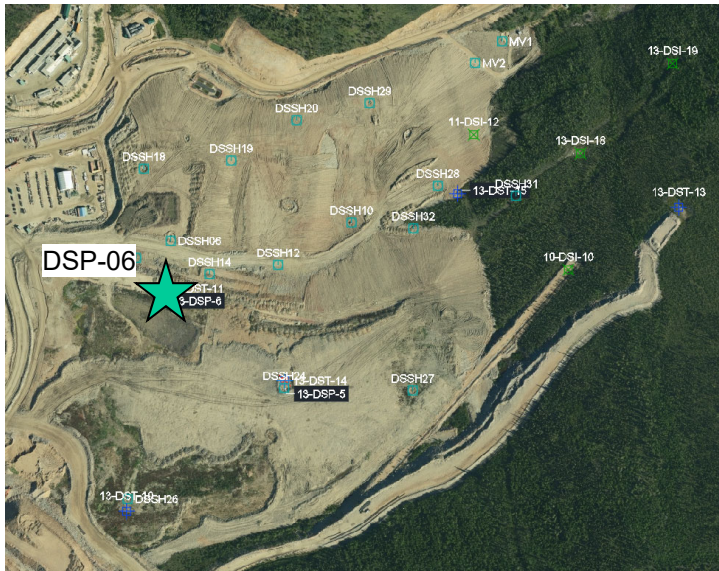
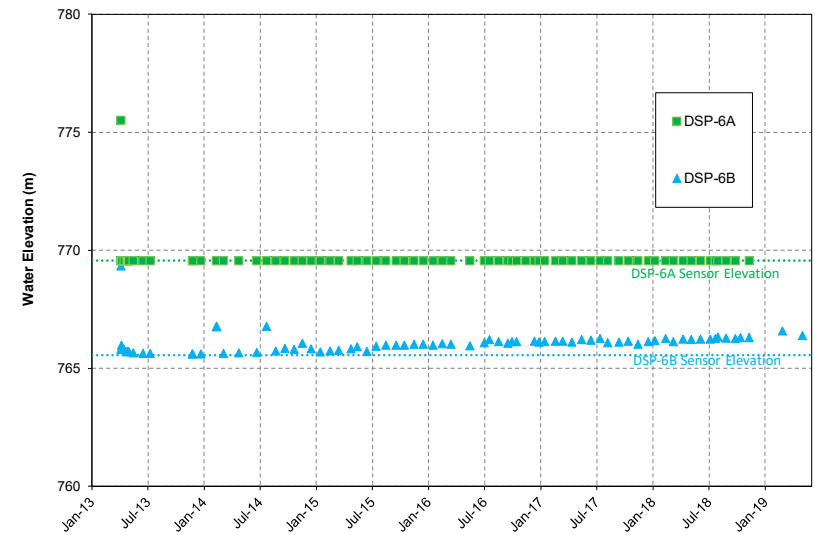
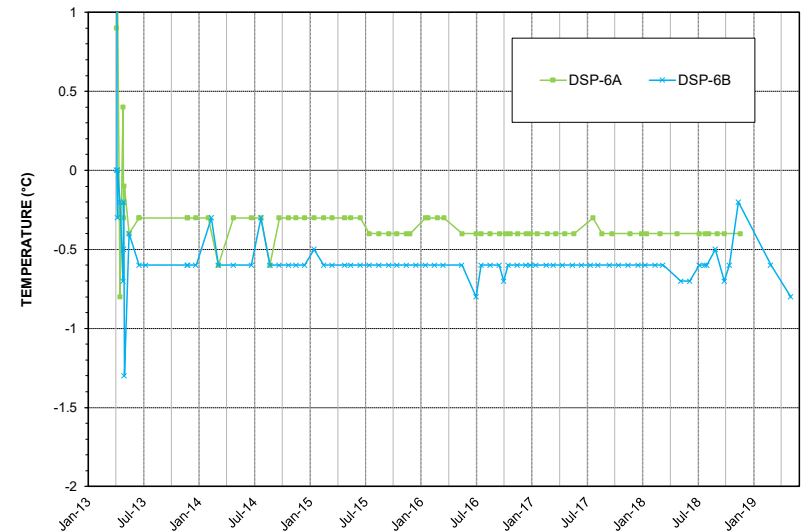
Minto Explorations Ltd.		DSTSF Instrumentation Data		
			<b>Piezometer – DSP-06</b>		
Job No: 1CM002.066 Filename: ApD_2019DSTFSLandscape.pptx	Minto Mine		Date: August 2019	Prepared by PHM	Figure: <b>21</b>

1. The pore pressure sensors at DSP-06 are located approximately 2 m above original ground in tailings (A) and 2 m below original ground (B).
2. DSP-06A shows no pore pressure (pore pressure equal to the sensor elevation). This sensor stopped producing readings in November 2018.
3. The bottom sensor at DSP-06B shows a gradual increasing pore pressure trend.

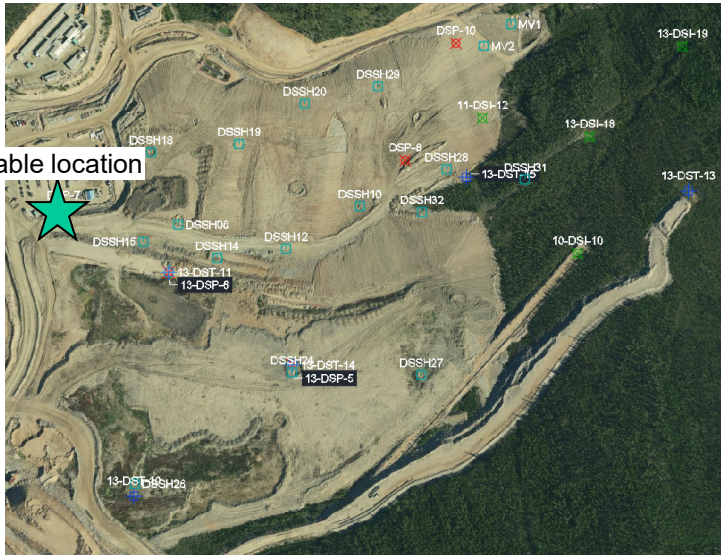
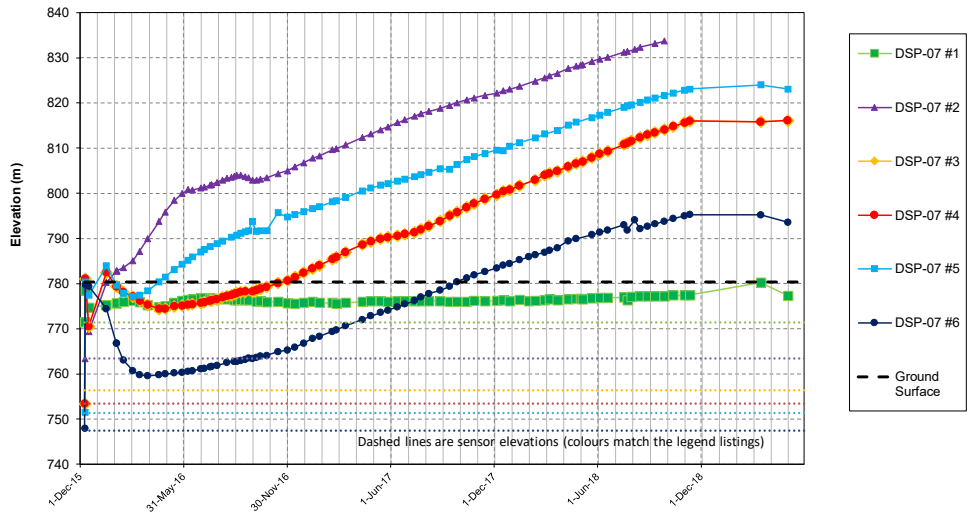
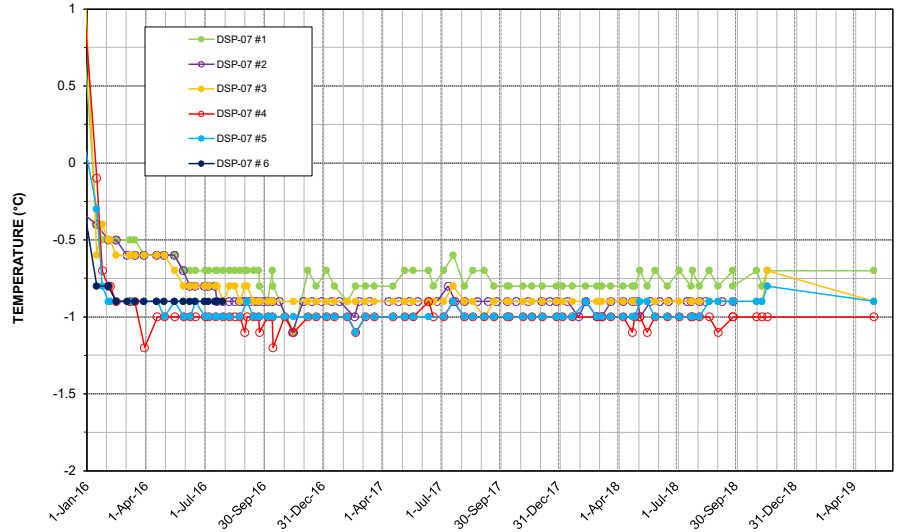
Minto Explorations Ltd.		DSTSF Instrumentation Data		
			Piezometer – DSP-07		
Job No: 1CM002.066 Filename: ApD_2019DSTFSLandscape.pptx	Minto Mine		Date: August 2019	Prepared by PHM	Figure: 22

Similarly, all sensors at DSP-07 (Figure 22, Appendix D) have shown continued increases in pore pressure since their installation in 2015, but the readings appear to be stabilizing in 2019. These sensors are in zones with significant amounts of ground ice with ground temperatures ranging from -1° to -0.6°. Survey hubs in the vicinity of these sensors also show decelerating movement.

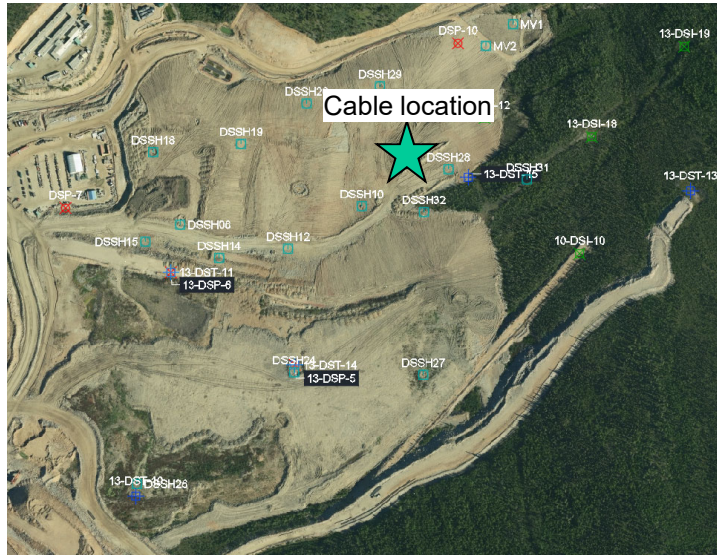
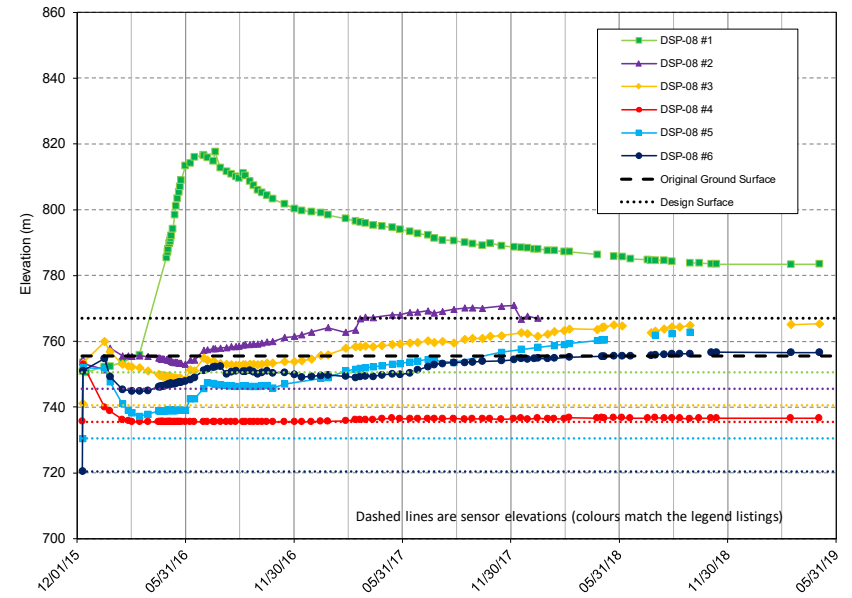
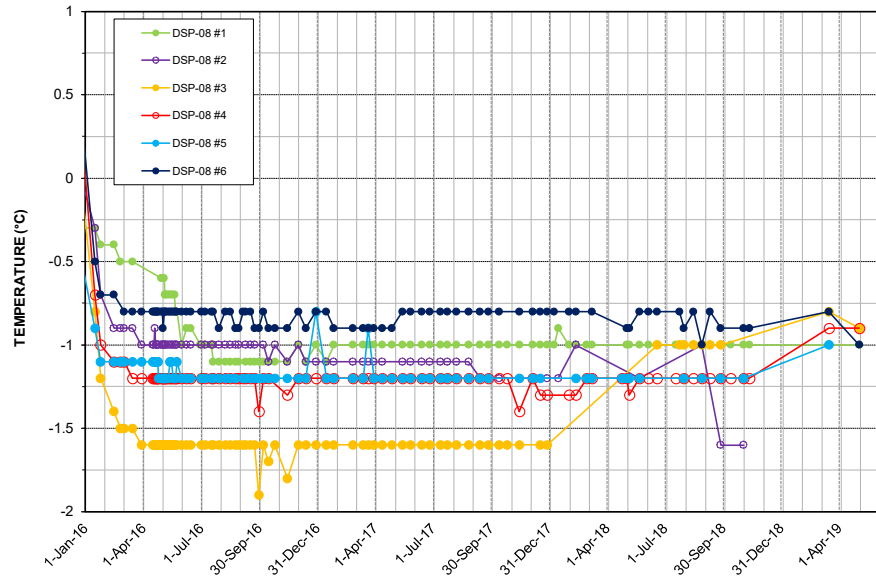
Minto Explorations Ltd.		DSTSF Instrumentation Data	
	Minto Mine		<b>Piezometer – DSP-08</b>	
Job No: 1CM002.066 Filename: ApD_2019DSTFLandscape.pptx		Date: August 2019	Prepared by PHM	Figure: <b>23</b>

1. Negative pressure readings are plotted at the elevation of the sensor in order to indicate dates readings were taken.
2. The pore pressure in Sensor 1 has increased by approx. 700 kPa (70 m of water). This sensor is located closest to surface (depth of 5m). Since the construction was completed, the readings have dissipated. The temperature at Sensor 1 has also dropped significantly compared to the other sensors at DSP-08. The higher pore pressures at Sensor 1 may be the result of freezing and the expansion of pore water into ice.

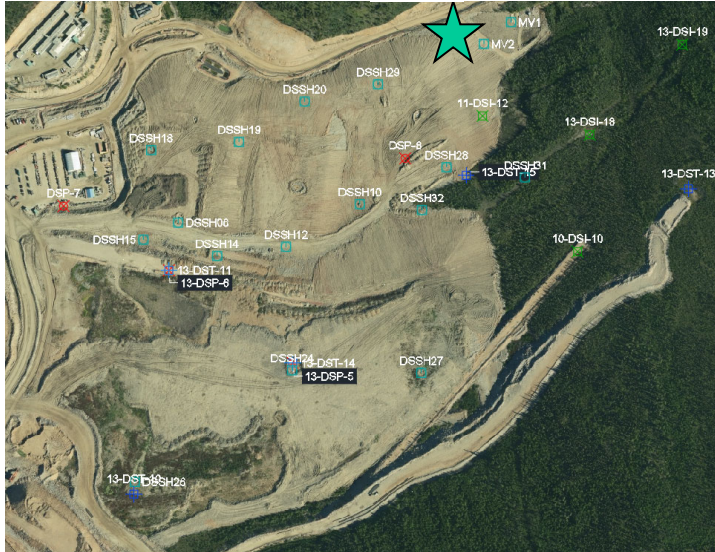
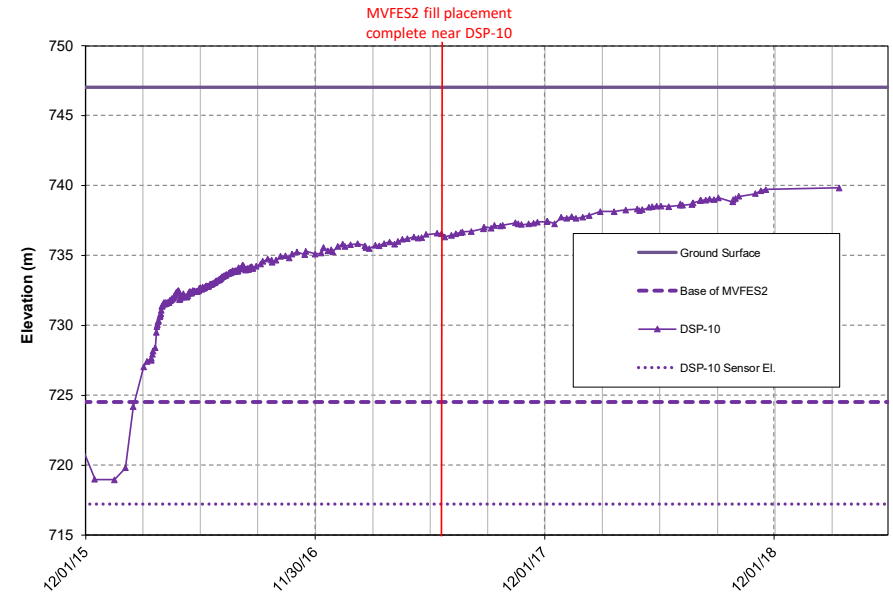
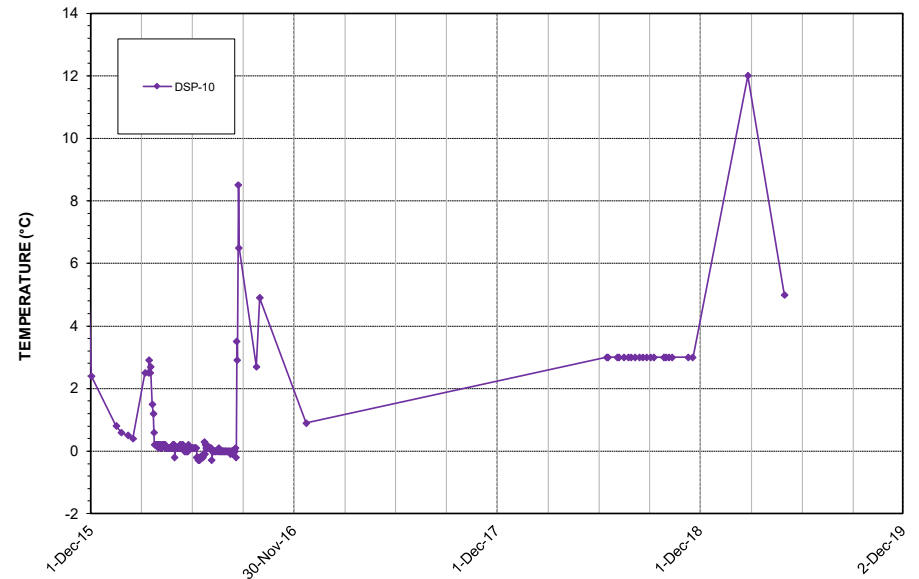
Figure:  
**24**

1. The pore pressure sensor at DSP-10 is located approximately 5 m below the original ground surface below the MVFE Stage 2.
2. The increase in pore pressure at DSP-10 is related to the fill placement over the sensor (approximately 23 m thick).
3. Since fill placement has been completed, the rate of increase in pore pressure is low and appears to be decreasing.
4. Flow meter readings at the Minto Creek Detention Sump indicate that the blanket drain is functional and no water is building-up at the base of MVFE Stage 2.
5. The temperature readings at DSP-10 show a slight cooling trend up to July 2017. Between July and December 2017, temperature readings were above 0 degrees and highly variable.

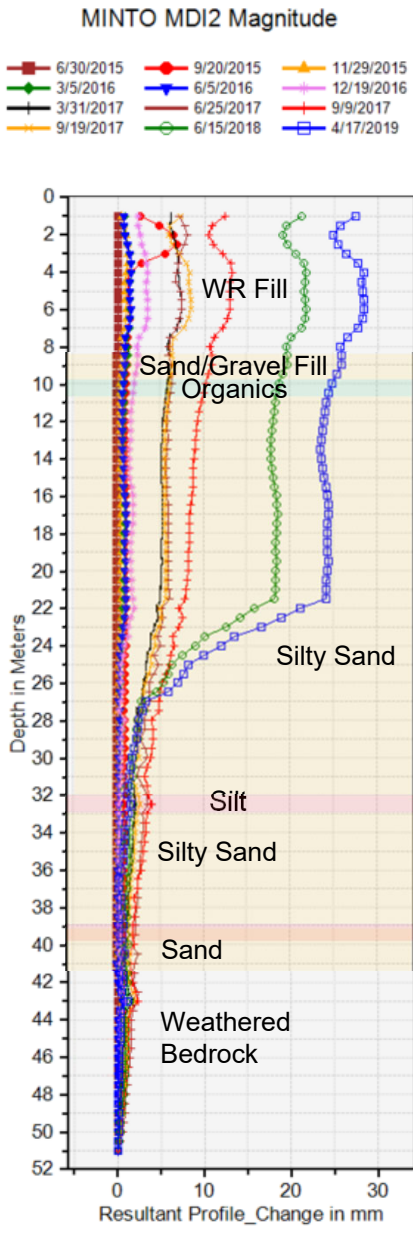
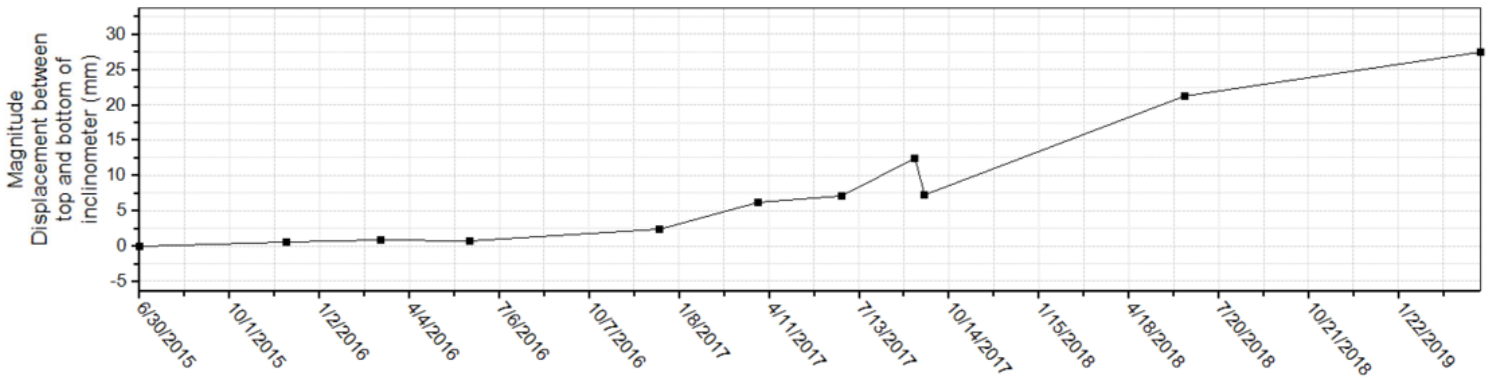
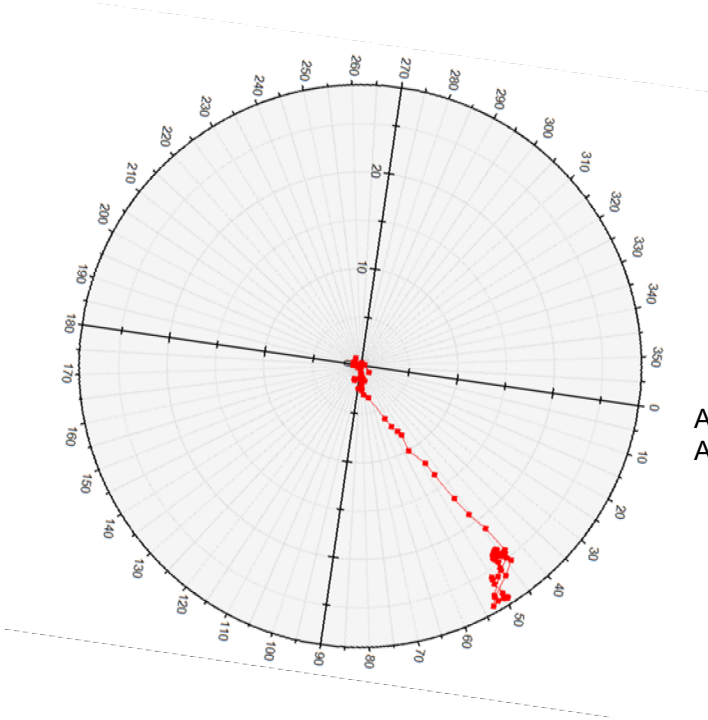
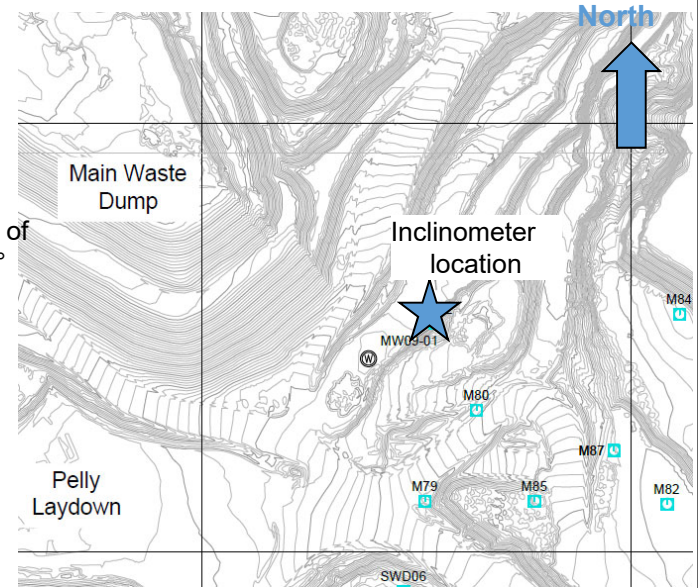
Minto Explorations Ltd.	MWD Instrumentation Data		
		<b>Inclinometer – MDI-2</b>		
Job No: 1CM002.066 Filename: ApE_2019MWDInstrumentation.pptx	Minto Mine	Date: August 2019	Prepared by PHM	Figure: <b>1</b>

Note: Inclinometer software (DigiPro2 v2.12.4) plots A0 as 0 degrees. The plot above has been rotated such that the orientation matches the plan (north is up).

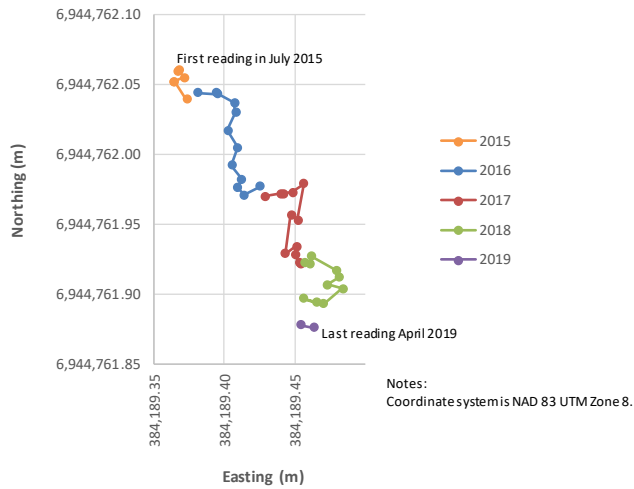
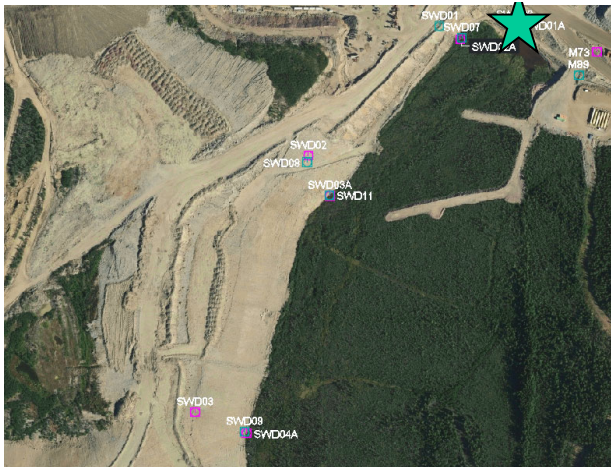
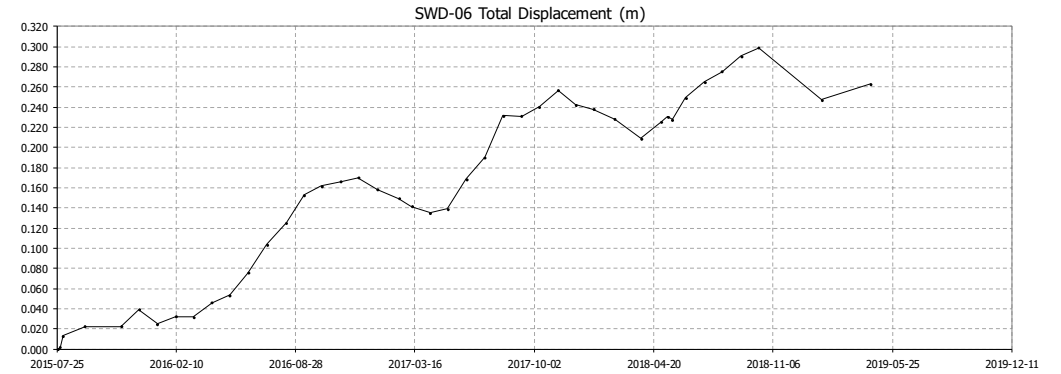
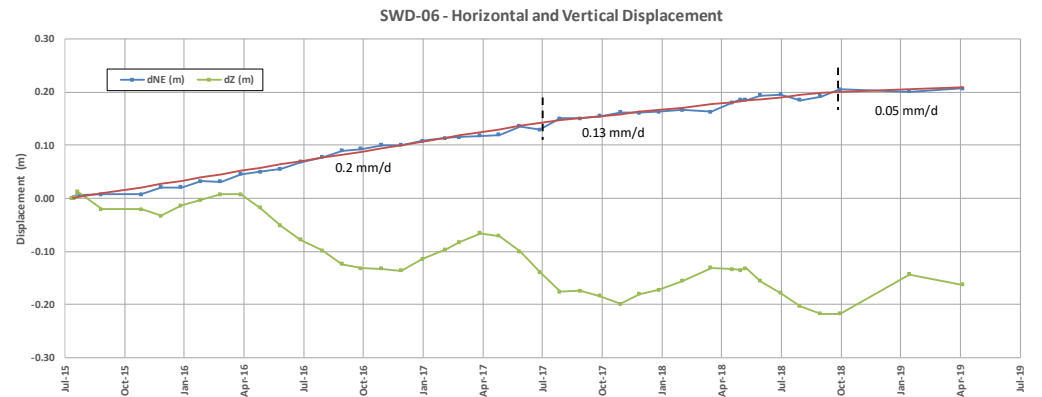
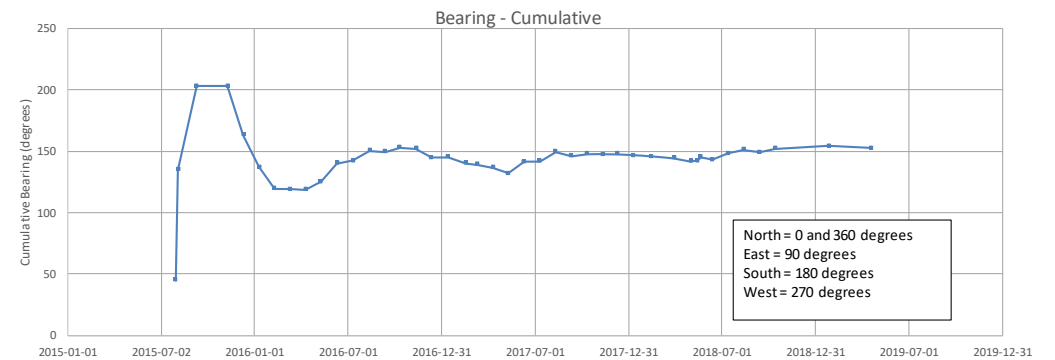
### SWD06 - Northing Vs. Easting Movement Plot

1. Hub is a replacement for SWD-01A that was disturbed by frost heave.
2. The hub consists of a lock-block on surface, and as a result, seasonal ground movement as a result freeze/thaw cycles may occur that is not indicative of large-scale ground movement. As a result, the horizontal displacement plot is likely to be the most useful plot for monitoring movement.
