# 2019 Geotechnical Annual Review, Minto Mine, YT

Minto Explorations Ltd.

SRK Consulting (Canada) Inc.  
1CM002.066  
August 2019

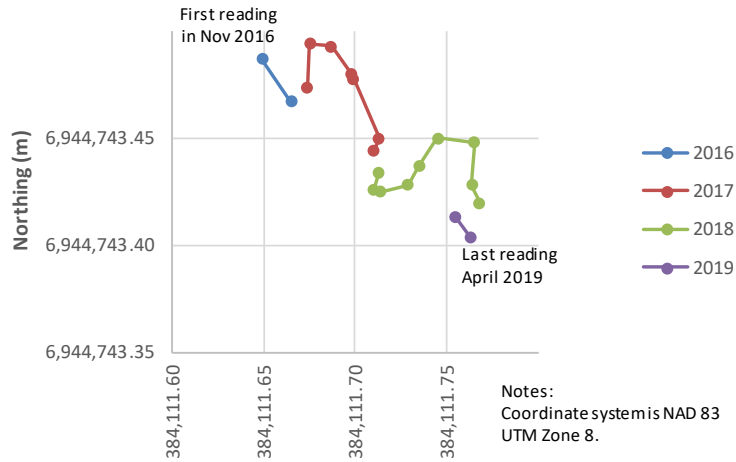
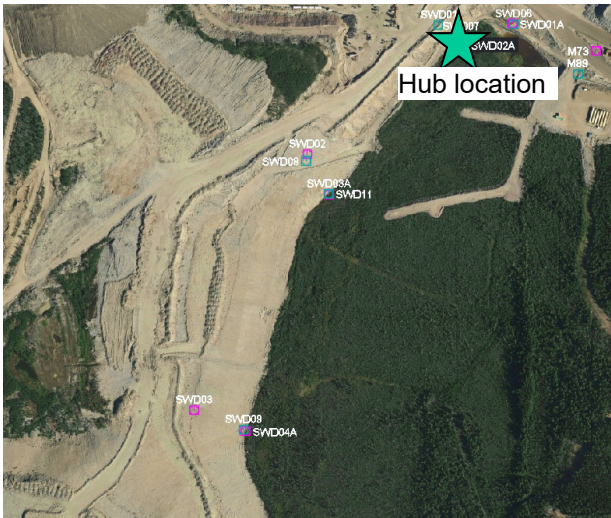
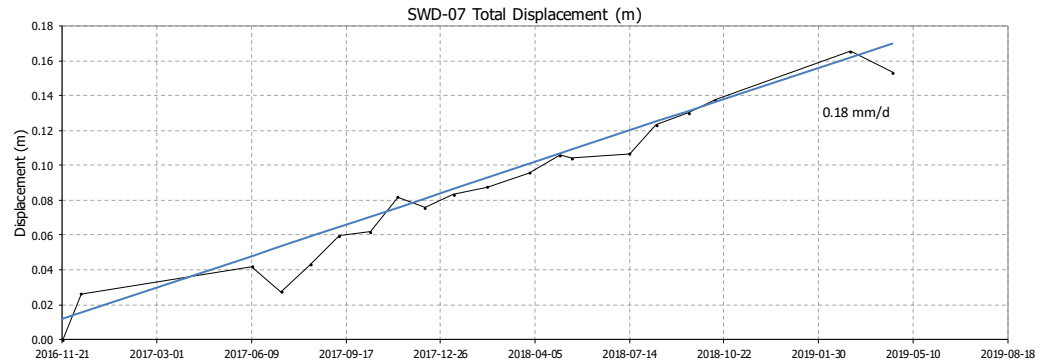
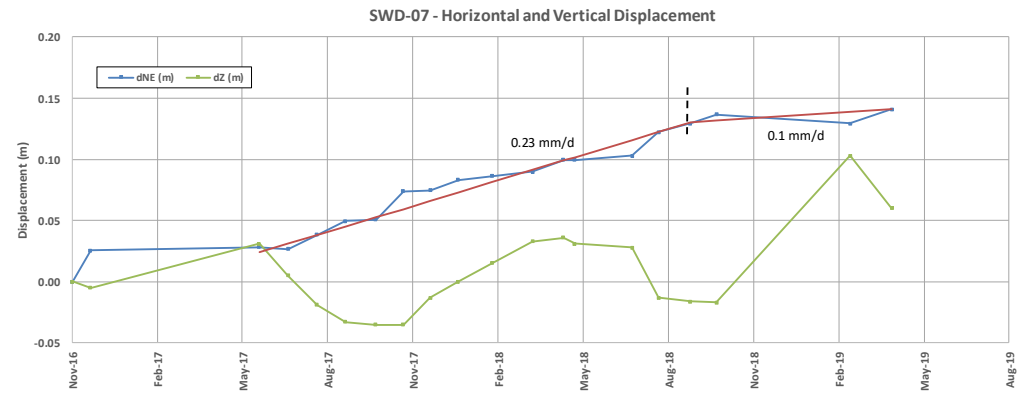
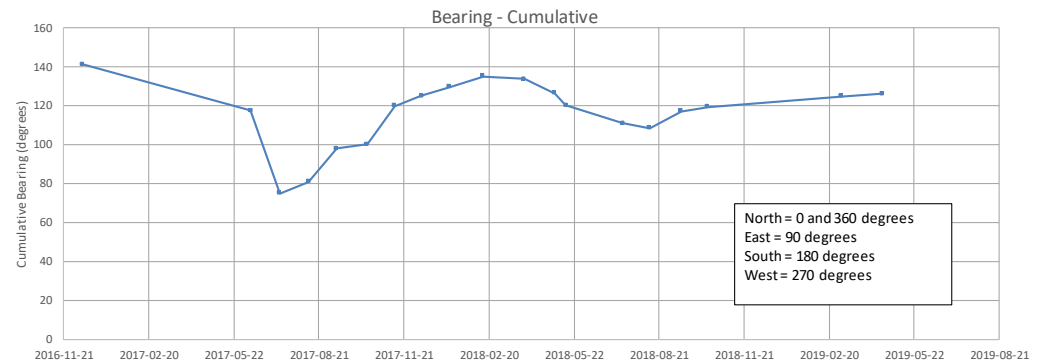
# SWD07 - Northing Vs. Easting Movement Plot

- Hub is a replacement for SWD-02A that was disturbed by frost heave.

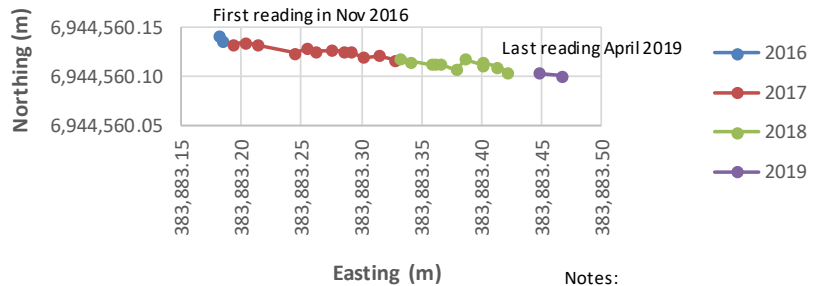
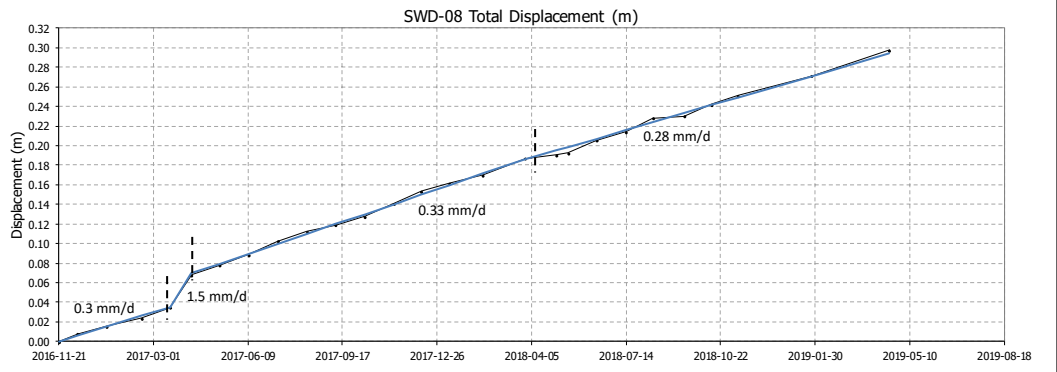
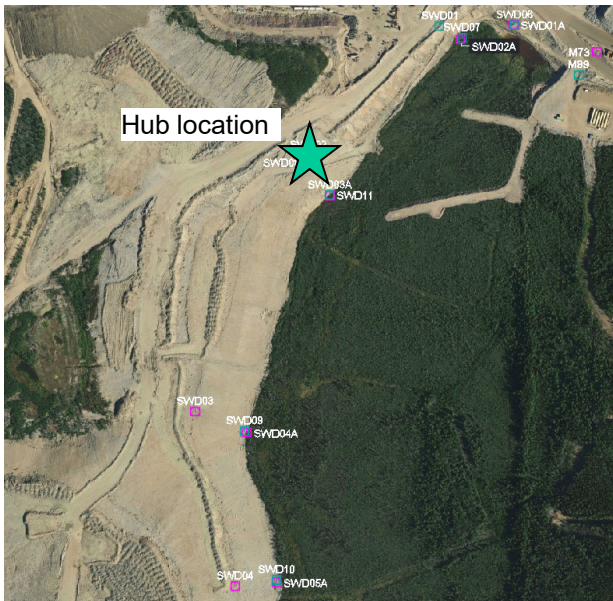
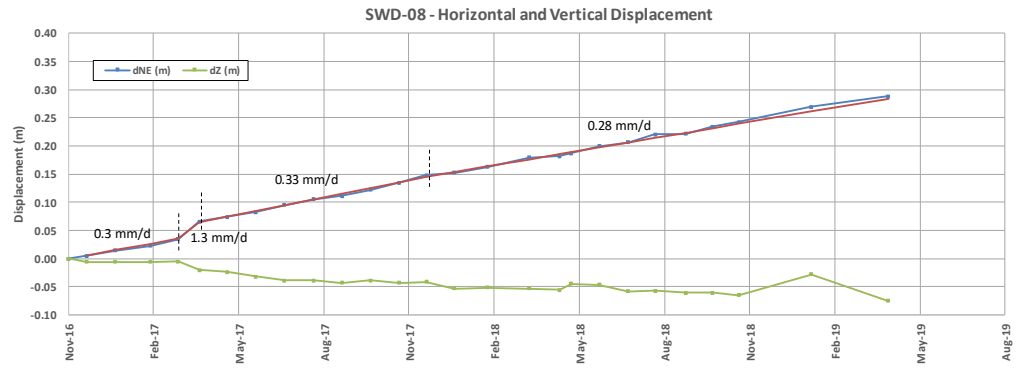
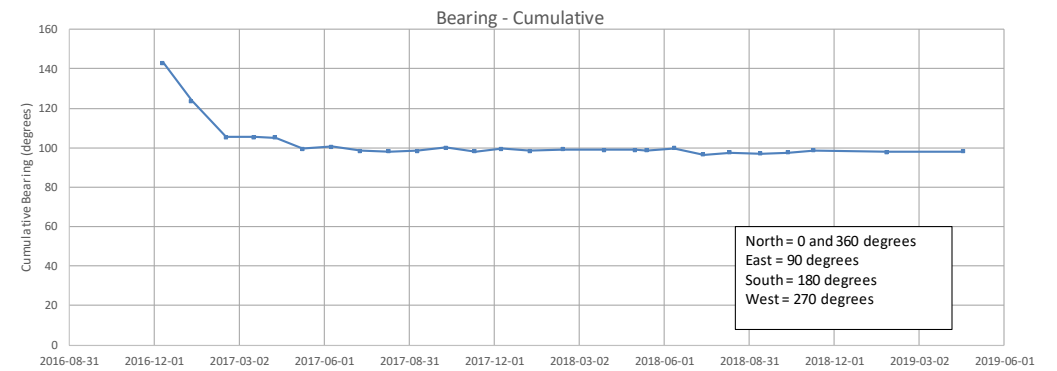
# SWD08 - Northing Vs. Easting Movement Plot

- Hub is a replacement for SWD-02 that was disturbed as a result of regrading of the SWD.

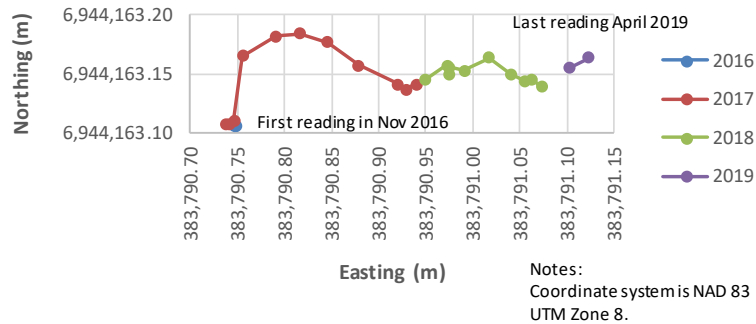
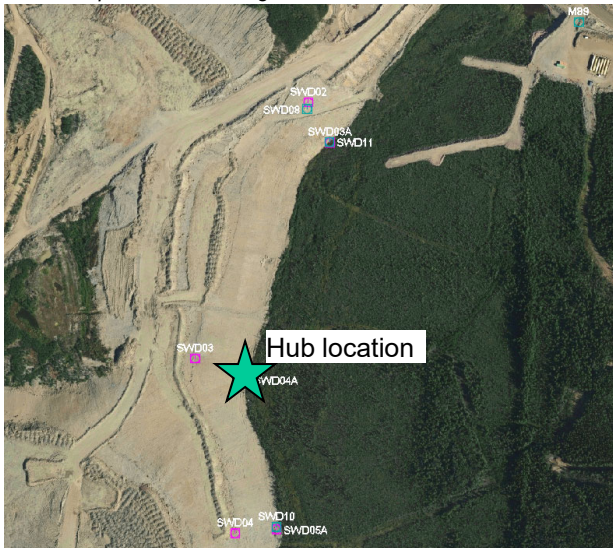
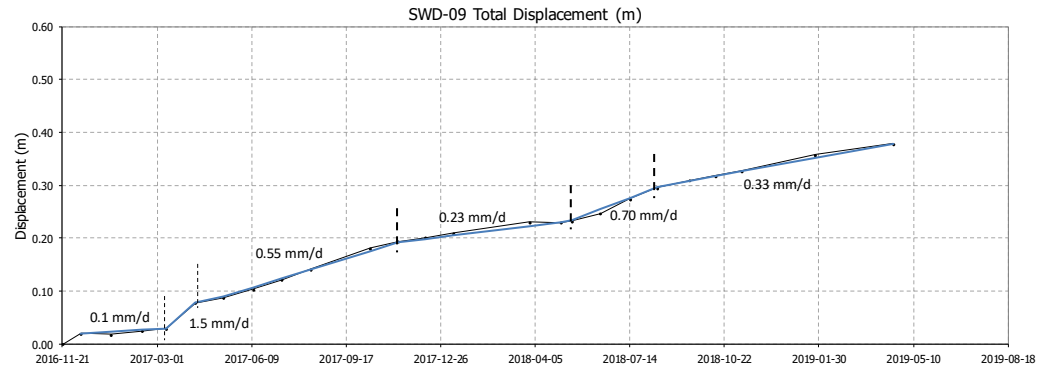
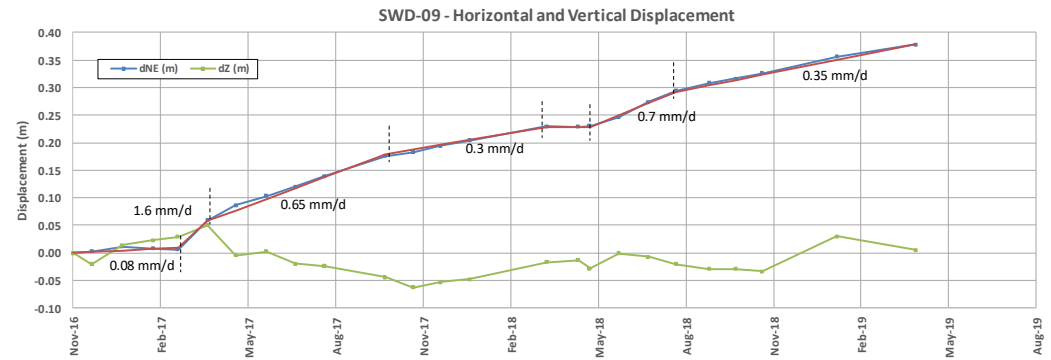
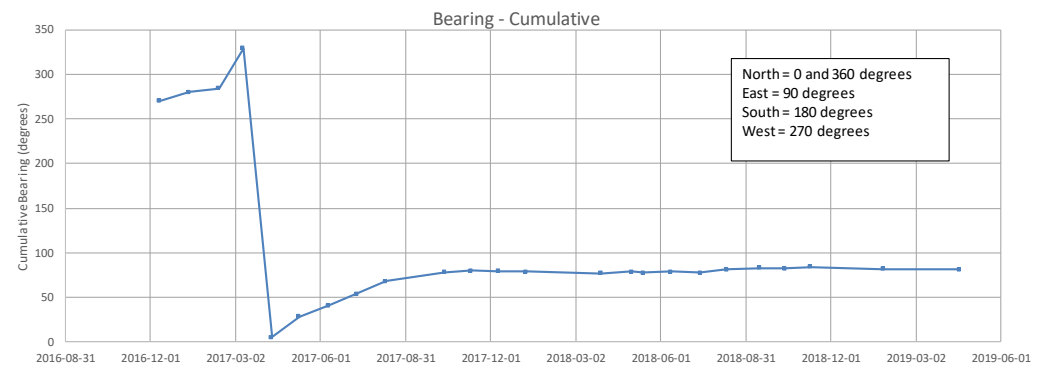
### SWD09 - Northing Vs. Easting Movement Plot

- Hub is a replacement for SWD-04A that was disturbed by frost heave.
- The hub consists of a large boulder on surface, and as a result, seasonal ground movement as a result freeze/thaw cycles may occur that is not indicative of large-scale ground movement. As a result, the horizontal displacement plot is likely to be the most useful plot for monitoring movement.

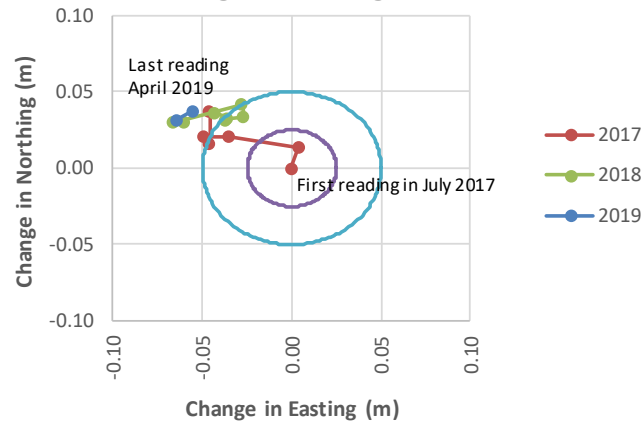
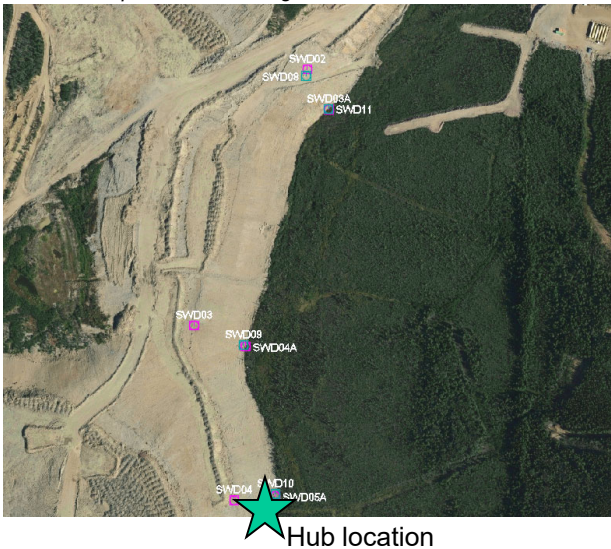
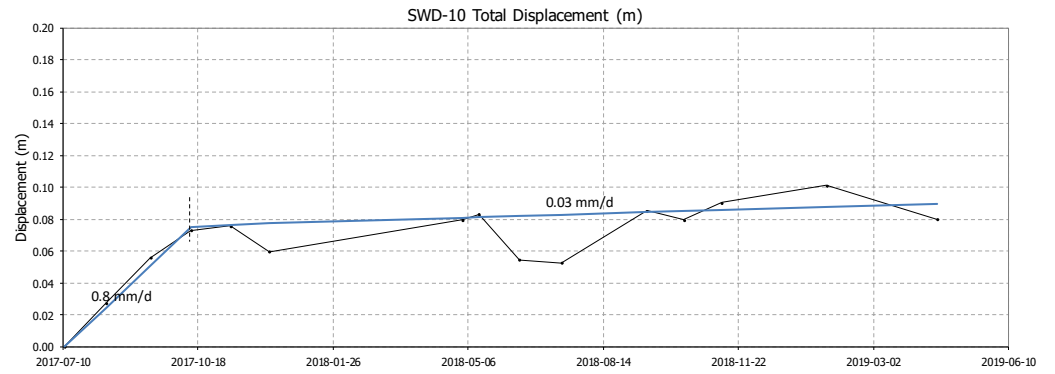
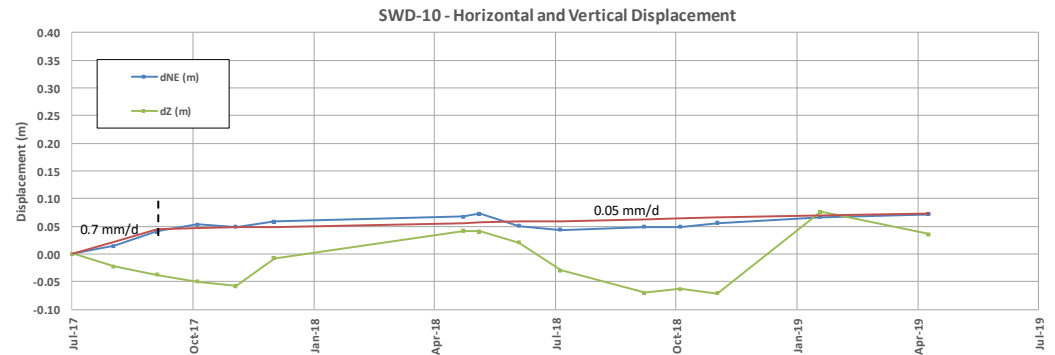
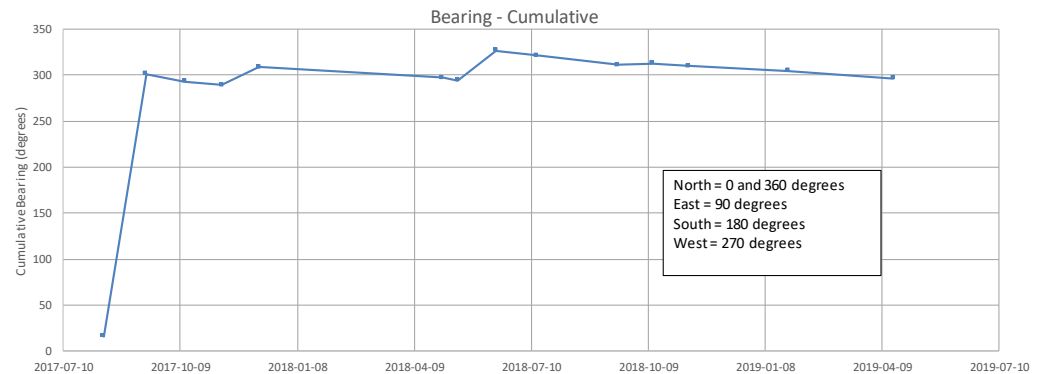
### SWD10 - Northing Vs. Easting Movement Plot

1. Hub is a replacement for SWD-05A that was disturbed by frost heave.
2. The hub consists of a large boulder on surface, and as a result, seasonal ground movement as a result freeze/thaw cycles may occur that is not indicative of large-scale ground movement. As a result, the horizontal displacement plot is likely to be the most useful plot for monitoring movement.

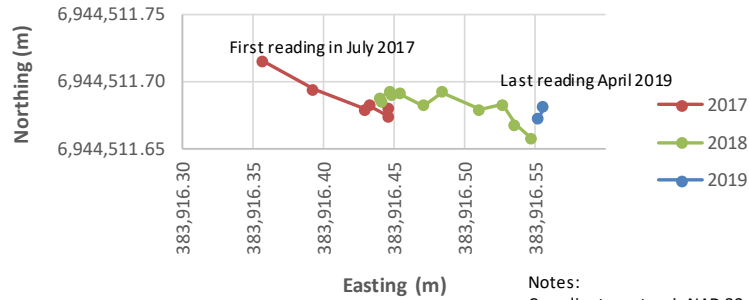
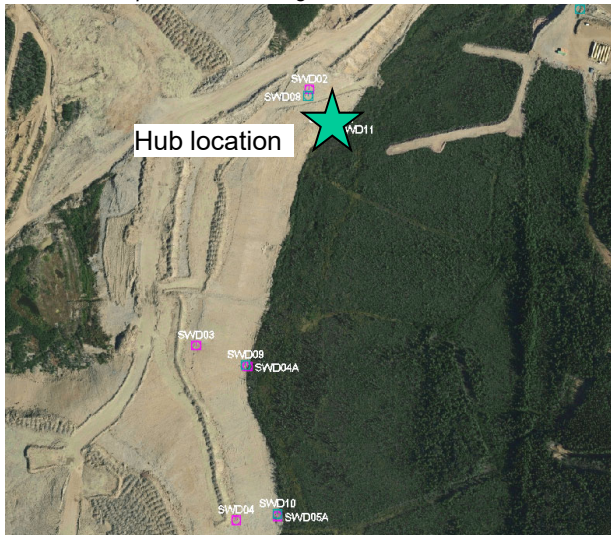
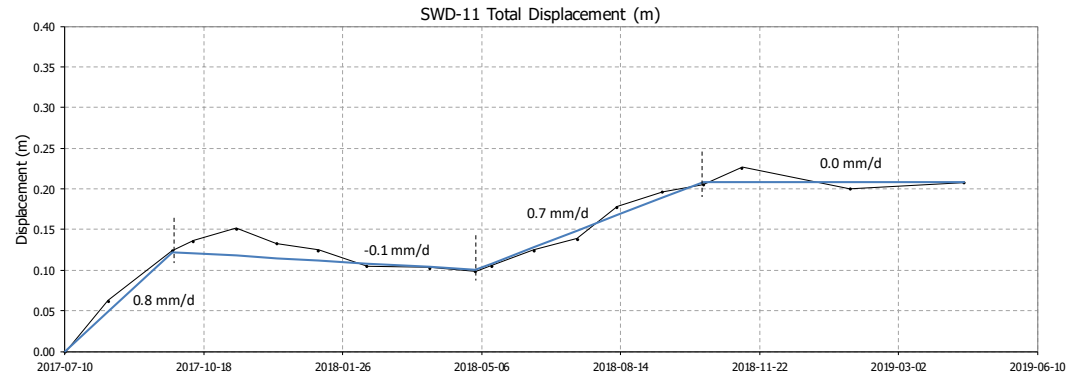
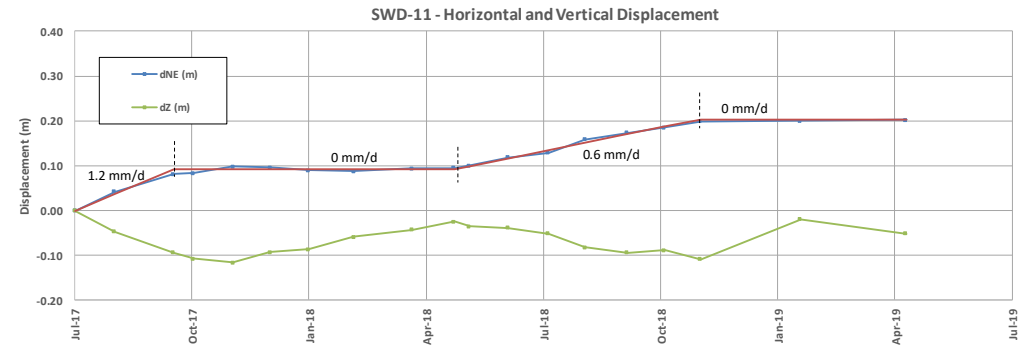
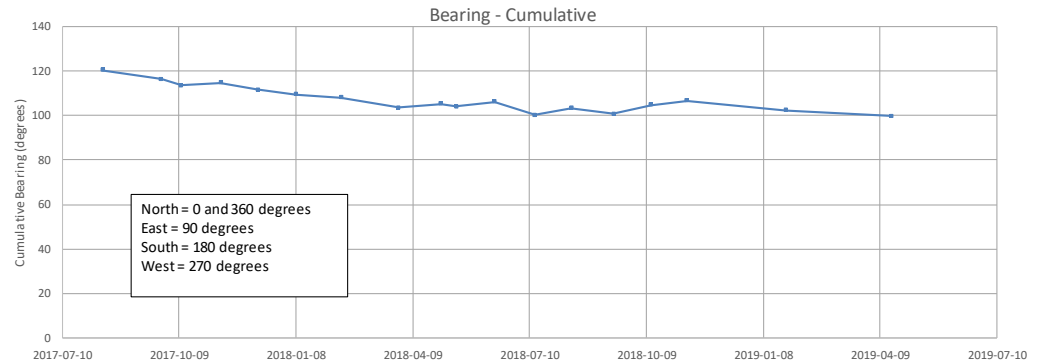
## SWD11 - Northing Vs. Easting Movement Plot

1. Hub is a replacement for SWD-03A that was disturbed by frost heave.
2. The hub consists of a large boulder on surface, and as a result, seasonal ground movement as a result freeze/thaw cycles may occur that is not indicative of large-scale ground movement. As a result, the horizontal displacement plot is likely to be the most useful plot for monitoring movement.

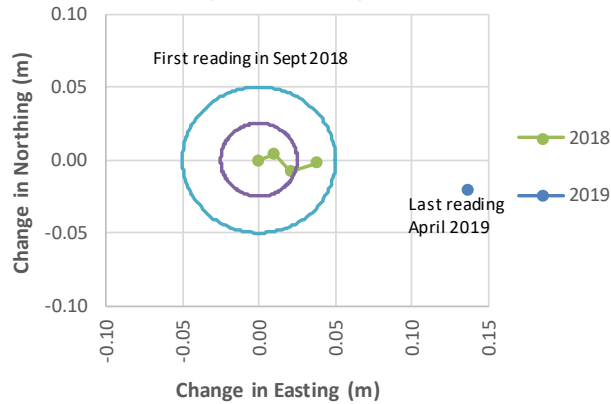
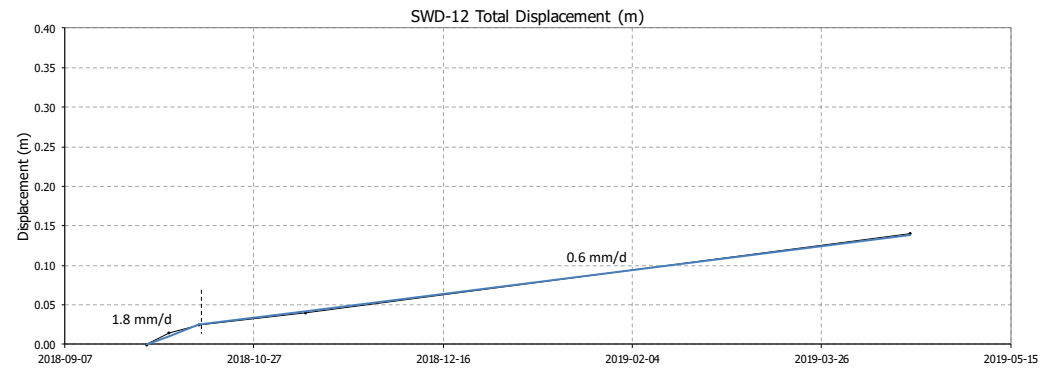
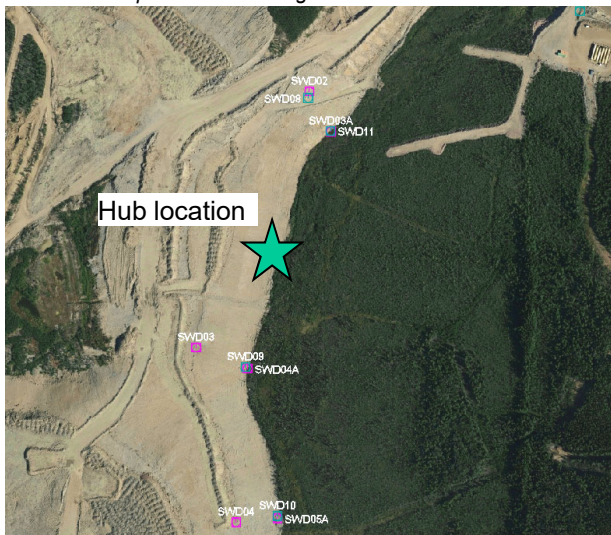
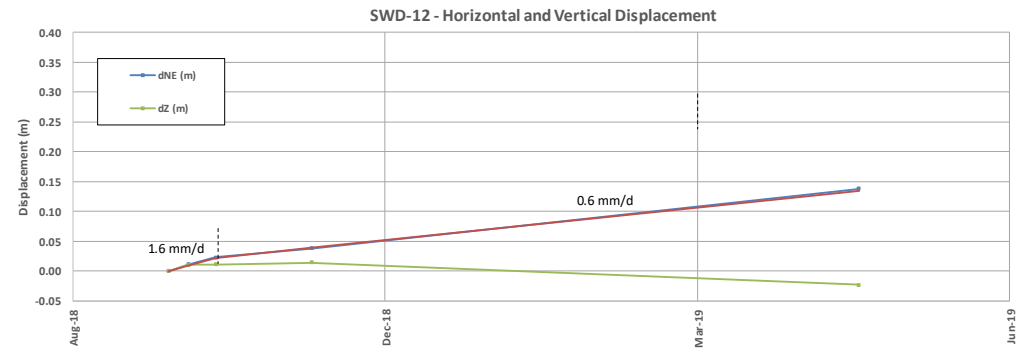
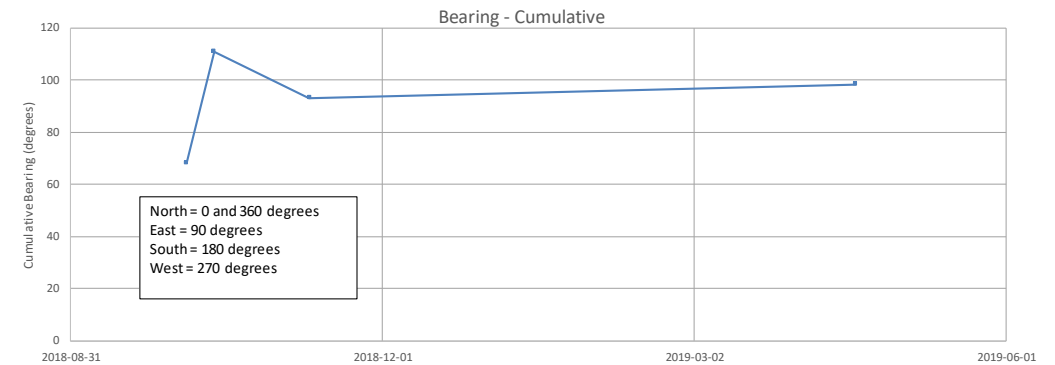
### SWD12 - Northing Vs. Easting Movement Plot

1. Hub is a replacement for inclinometer SDI-3 that sheared off in August 2017.
2. The hub consists of a large boulder on surface, and as a result, seasonal ground movement as a result freeze/thaw cycles may occur that is not indicative of large-scale ground movement. As a result, the horizontal displacement plot is likely to be the most useful plot for monitoring movement.
