MINTO
EXPLORATIONS

Spring 2020 Geotechnical Inspection

Minto Mine

June 2020

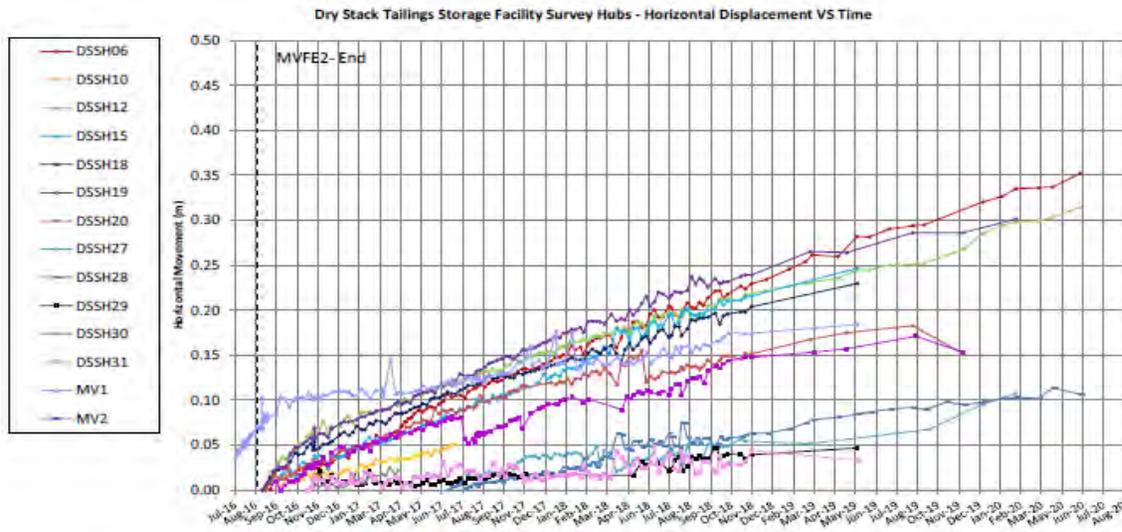
Chart 1: Survey Hub Data

- No instability concerns. No bulging toes or slumping of slopes seen.
- Several locations of rilling or runoff erosion on MVFE2 Self-Armouring but depth to Waste rock should be confirmed where possible.
- Cracking on southern crest of DSTSF has two extensometers both of which have shown no movement. One extensometer has broken from exposure and rusting.
- No ponding of water seen on DSTSF.
- TDD intake construction mostly complete, some work from 2018 still remains. Water in TDD flowing at time of inspection. TDD Brush removal completed in 2019.

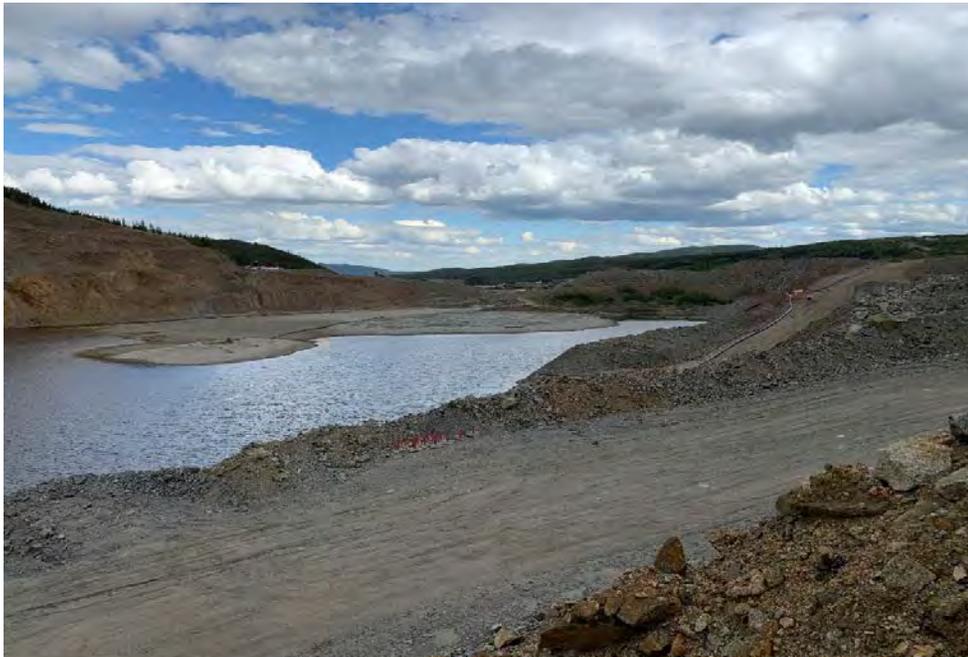
- No activity in this area since October 2018.
- No observed changes to rockfall on walls of Main Pit.
- No concerns noted.

Photo 2: Looking East.

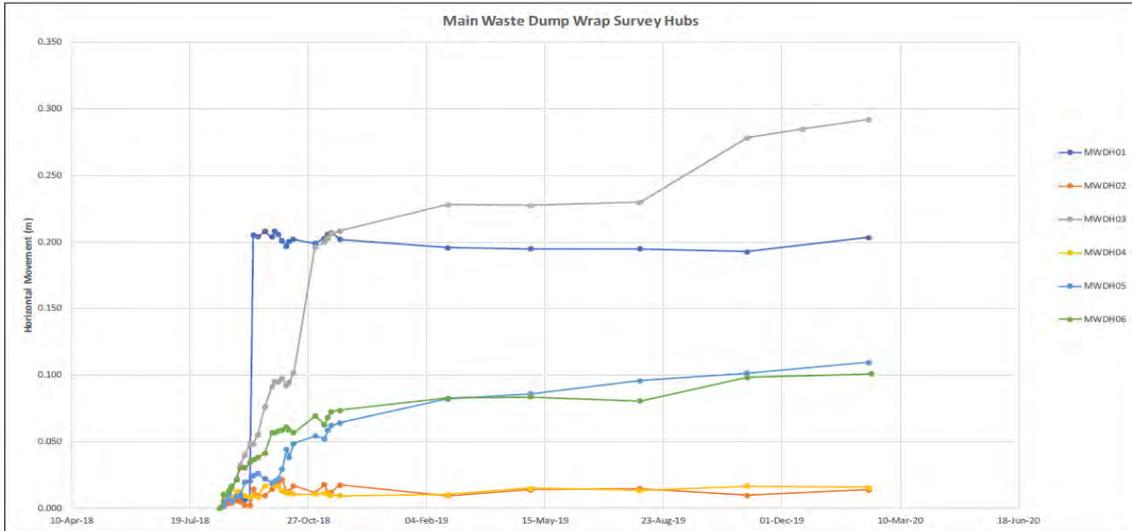
Chart 1: Survey hub data for hubs MWDH01 to MWDH06

- Settlement on side of road on west wide of wrap looks like it has stabilized.
- Significant ponding of water on top of MWD, has found away to breakthrough and drain itself. No significant signs of erosion resulting.
- No visible change to cracking and settlement on top tier of wrap.
- No progression of bulging seen by SRK in Spring 2019.

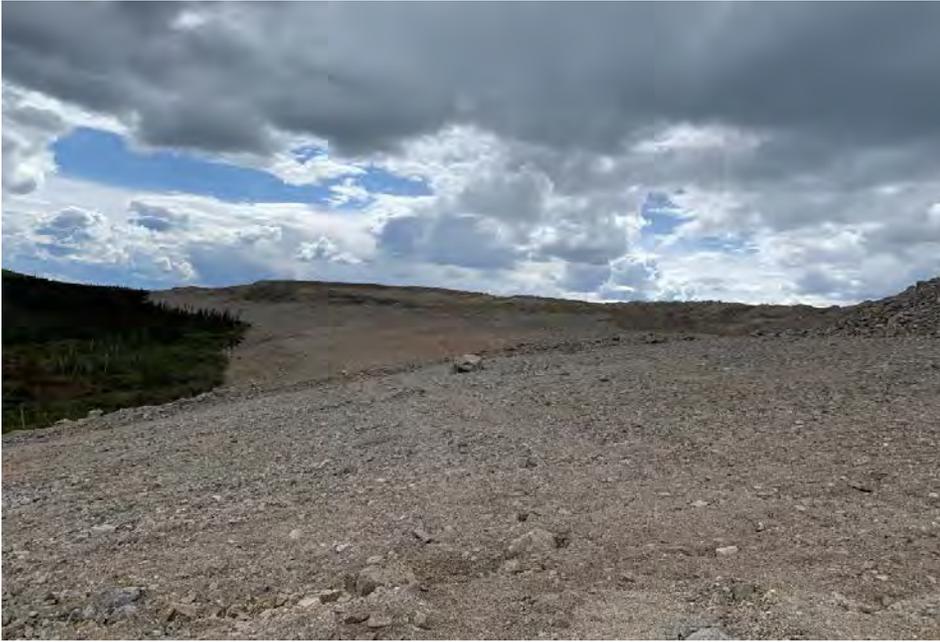
Photo 1: Looking southwest.

- No stability concerns.
- No new cracking observed. The large crack observed in 2019 has not changed.

- Monitor crack on north crest of dump. - Currently measured at 150 m in length, no apparent widening or new cracking since 2019

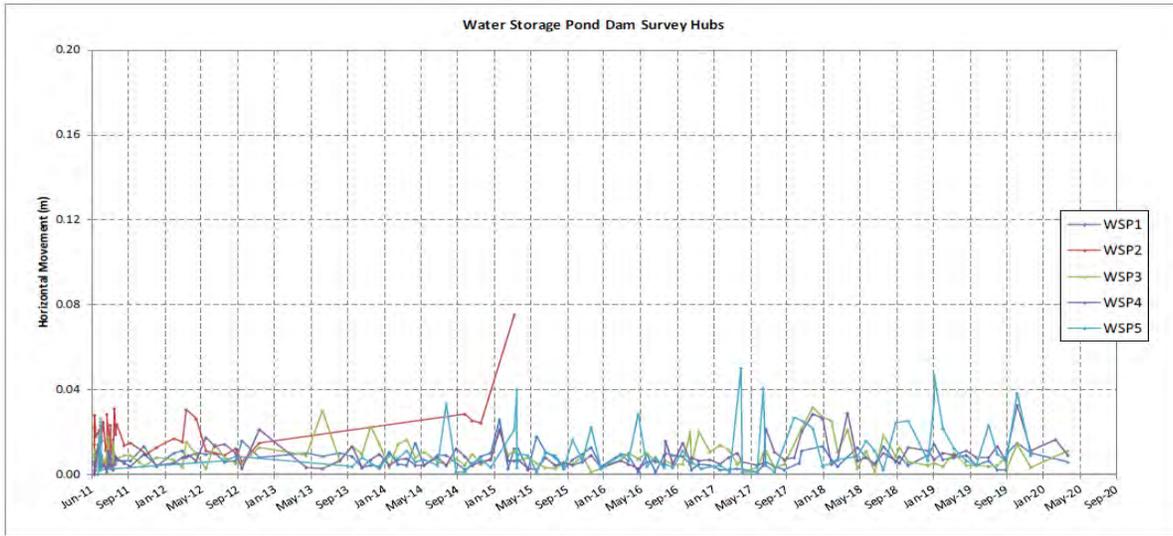
Chart 1: Survey Hubs

- Pond level is still low, wave action seen in Q2 2019 not significant.
- Left abutment erosion from draining the WSP Discharge line still present and could be considered for armouring.
- Pails covering the piezometers, and thermistors have been replaced.
