Minto Mine
Water Licence QZ96-006

Mine Waste Structures
Deformation Monitoring Plan and Report

Prepared by:
Minto Mine
December 2012

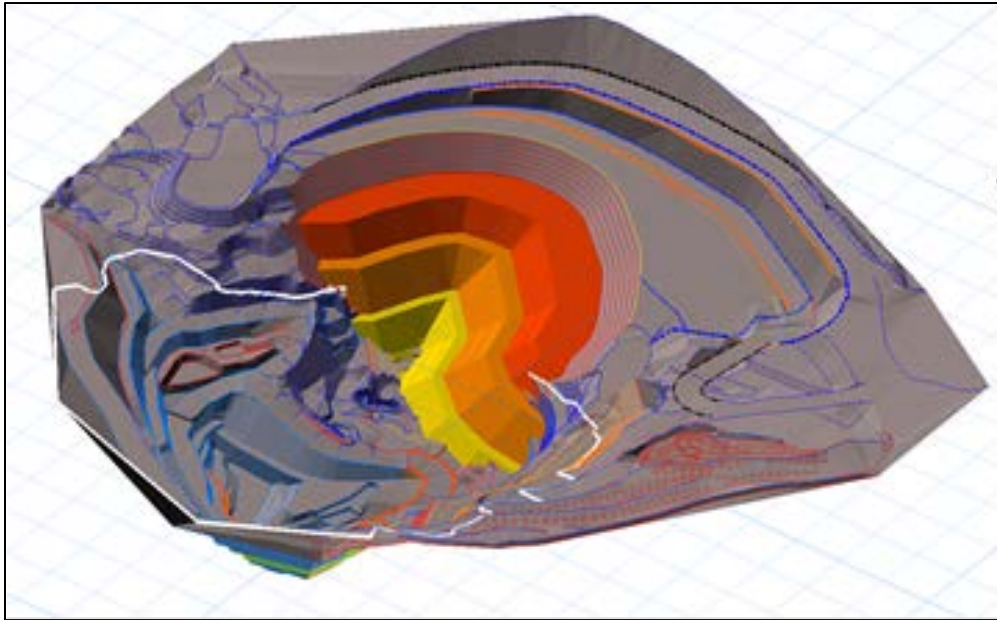
Figure 6-6: Original buttress concept, to be built after completion of the Area 1 pit (perspective view, looking southeast).

Construction of the wraparound buttress pictured in Figure 6-6 began shortly after the slope failure and continued until May 30, 2011, at which time the dump advanced to a point where it could not be safely constructed using the original design. This, and concerns about the ability of the design to stabilize the slope,

necessitated a new analysis of the data and a new design, which EBA Engineering (EBA) performed in July of 2011.

This analysis showed that considerably larger buttress would be required to halt the movement of the overburden slope.

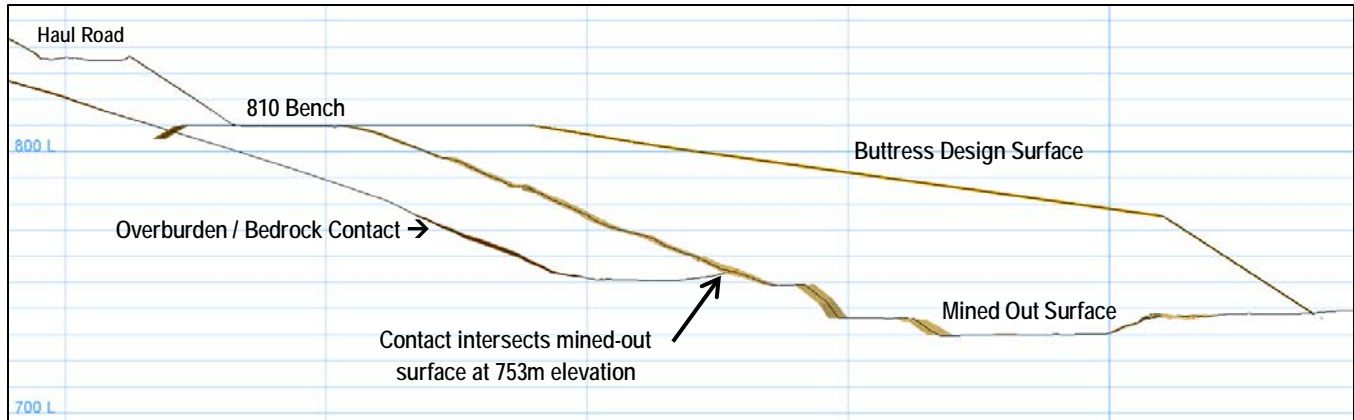
Figure 6-9: Detailed section view through centerline of buttress at 0.00° Azimuth, looking west.

The intersection of the overburden contact with the final pre-failure as-built of the south wall is shown in Figure 6-8. It can be seen that the overburden contact intersects the south wall as low as 740m at the south corner of the pit, and as high as the 770m elevation at the west corner of the pushback. This is also illustrated in a section view of the buttress, shown in Figure 6-9.

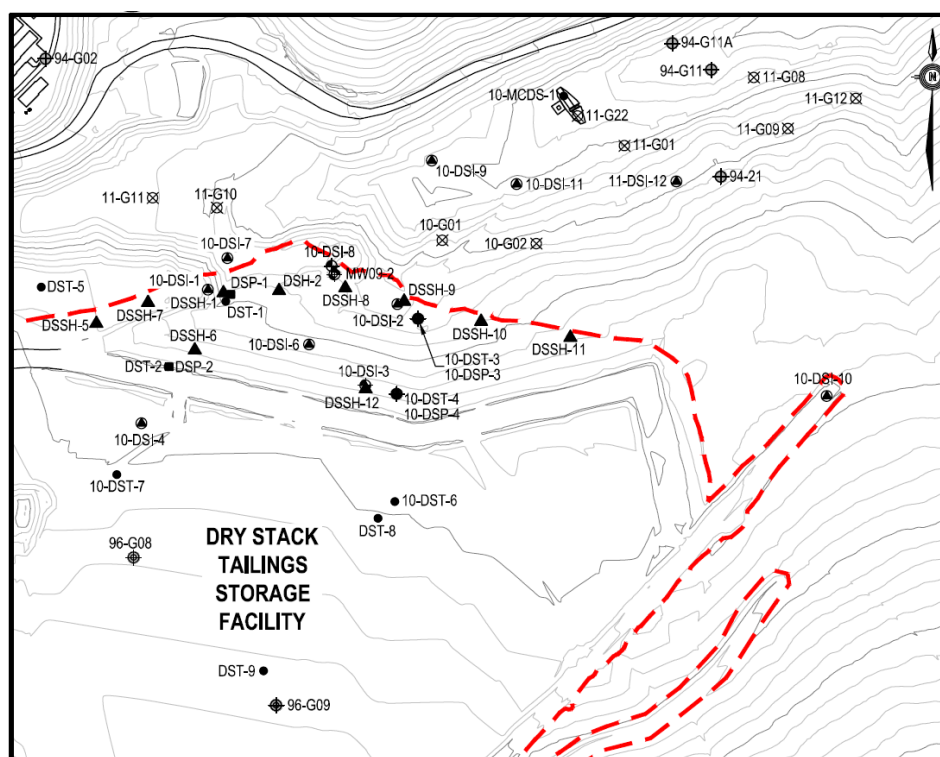
Figure 7-1: Dry Stack Tailings Storage Facility monitoring instruments

The Dry Stack Tailings Storage Facility has been undergoing slow creep movement along a foundational ice rich clay slip plane, several meters above bedrock. In response, Minto has constructed a buttress, the Mill Valley Fill Extension, to provide long term stability for the material. Numerous monitoring instruments have also been installed, as shown in Figure 7-1.

Ongoing monitoring has shown a slowing of the movement of the Dry Stack Tailings Storage Facility. Movement rates at November 10th, 2012 are shown below.
