OPERATED BY MINTO EXPLORATIONS LTD.

## South Wall Buttress As-built Report

January 2015

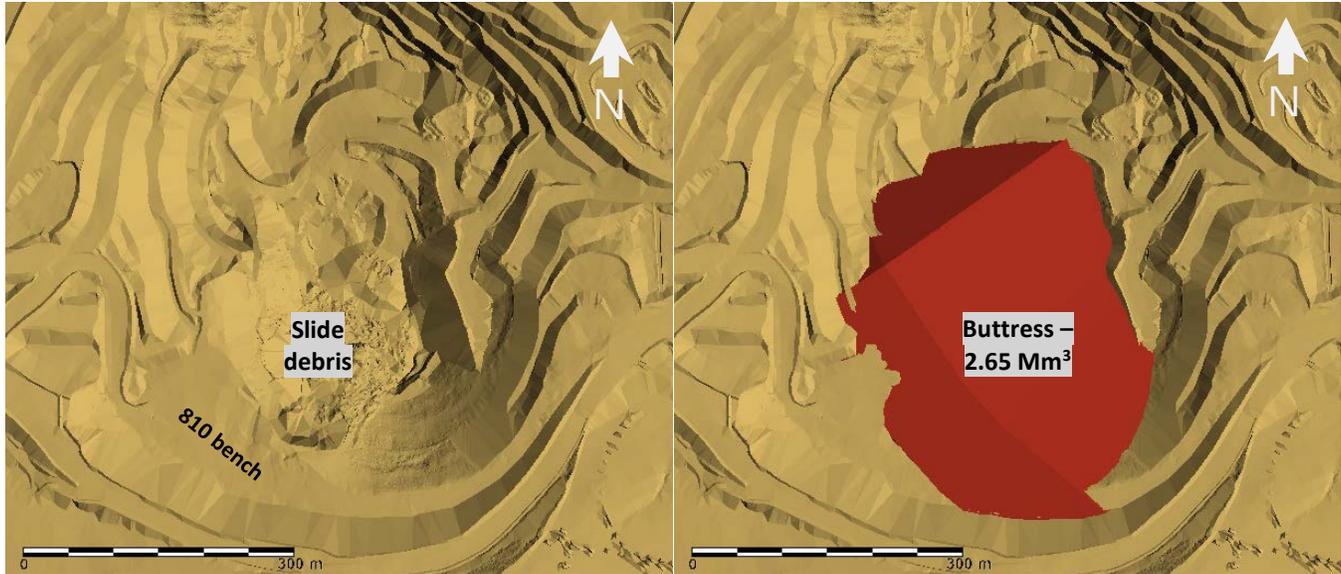
Figure 2-1: Post-failure survey of the Main pit (left) and final buttress design for the south wall of the Main pit (right).

EBA's analysis concluded that a 2.65 Mm<sup>3</sup> buttress with a 4:1 front face slope, the toe of which would butt up against existing rockfill in the pit, would stabilize the south wall. The side slope of the buttress was designed at 1.5:1 H:V. The figure below shows an overview of the design; sections are available in the Section 4 of this document and in EBA's design report.

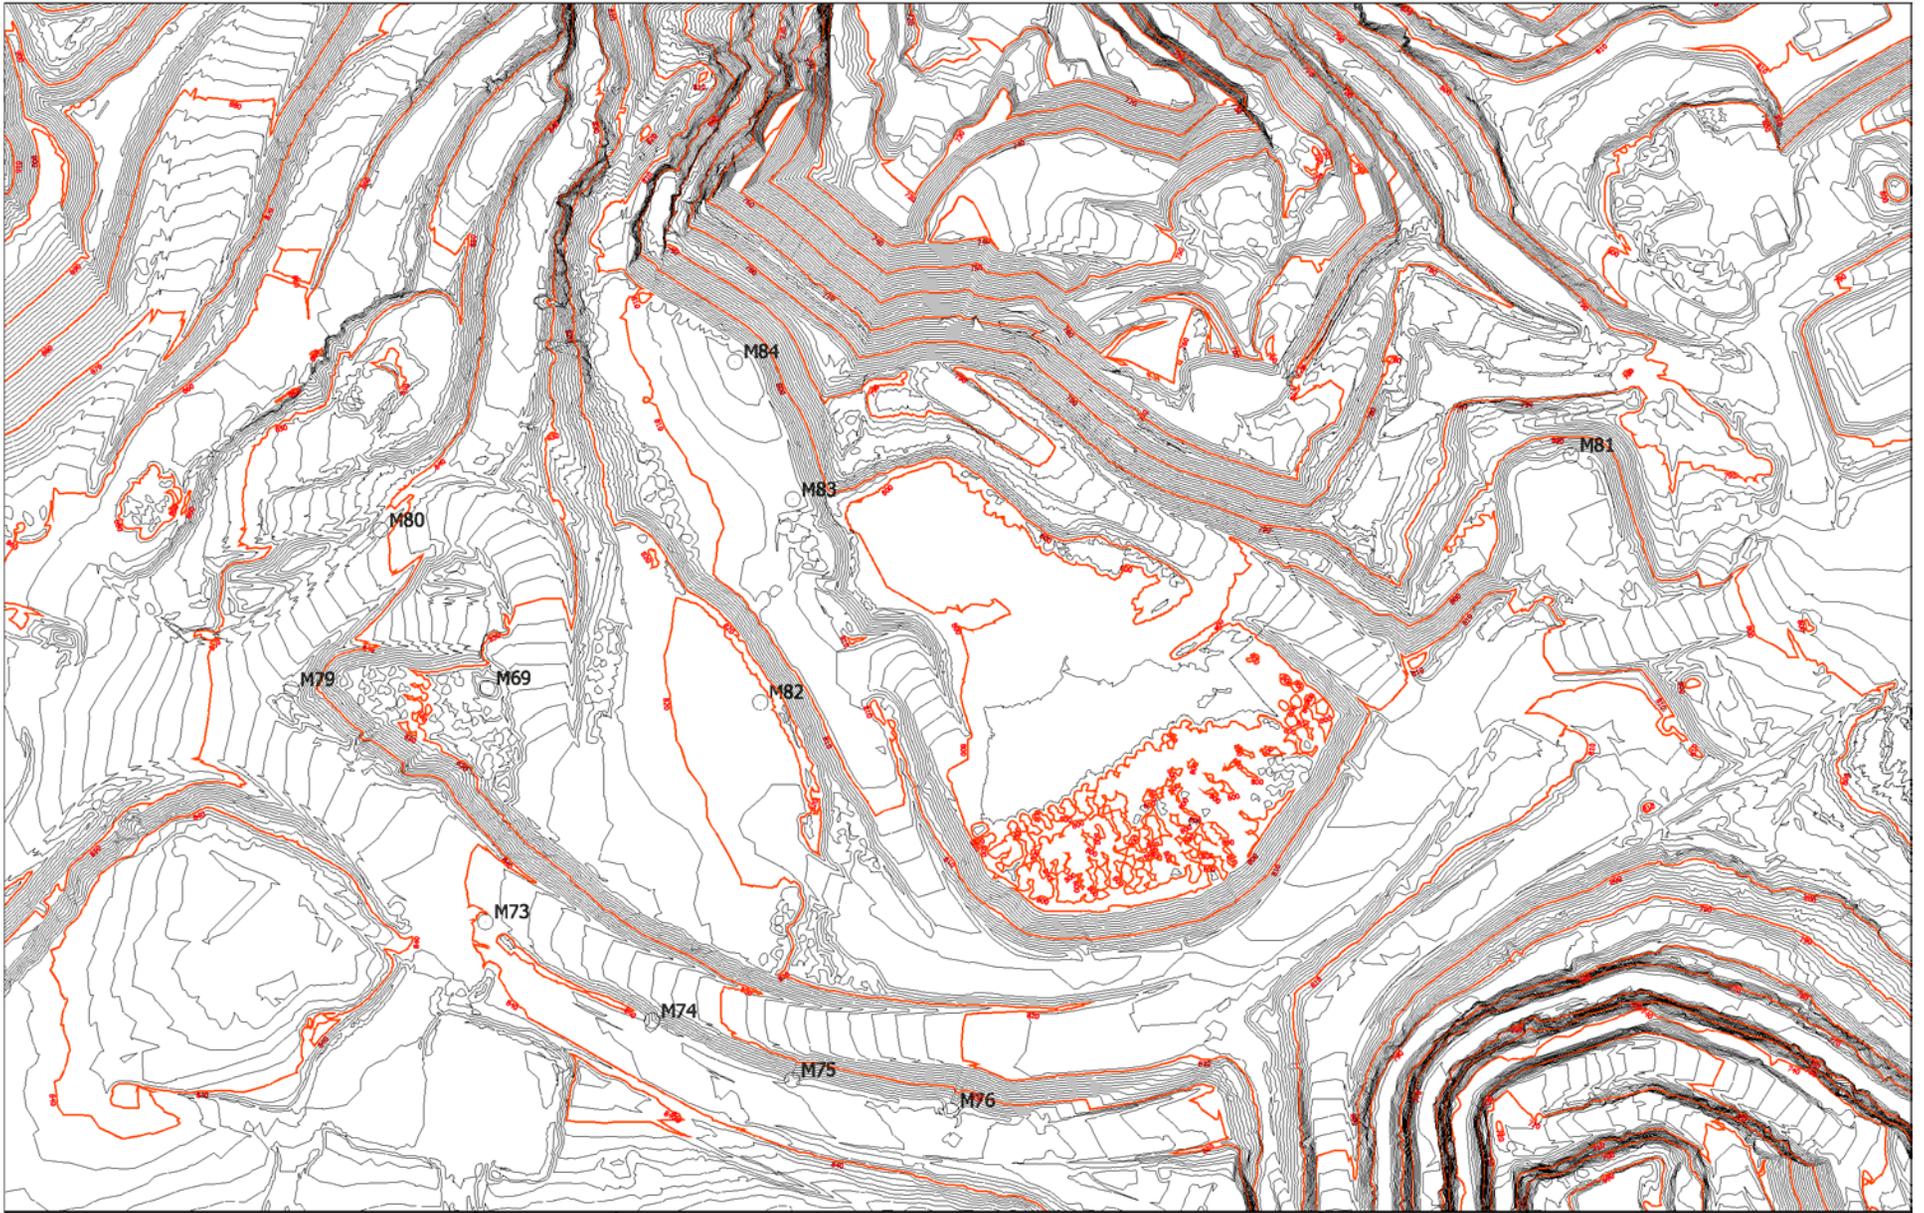
Figure 5-2: South Wall Buttress survey hubs

In January 2015, three additional hubs, M82 (behind tension cracks), M83 and M84 (near crest within tension cracked area at the northwest corner) were installed on the west side of the buttress to monitor

tension cracking on the 810 bench of the in-pit dump. Although data is only available for a short time period, early results indicate movement is no longer occurring, or is very marginal.
