REPORT ON

Sä Dena Hes Mine 2009 Dam Safety Review

Submitted to:
Teck Metals Ltd.
Sä Dena Hes Mine
c/o Bag 2000
Kimberley, BC V1A 2E1

Project Number: 09-1427-0023

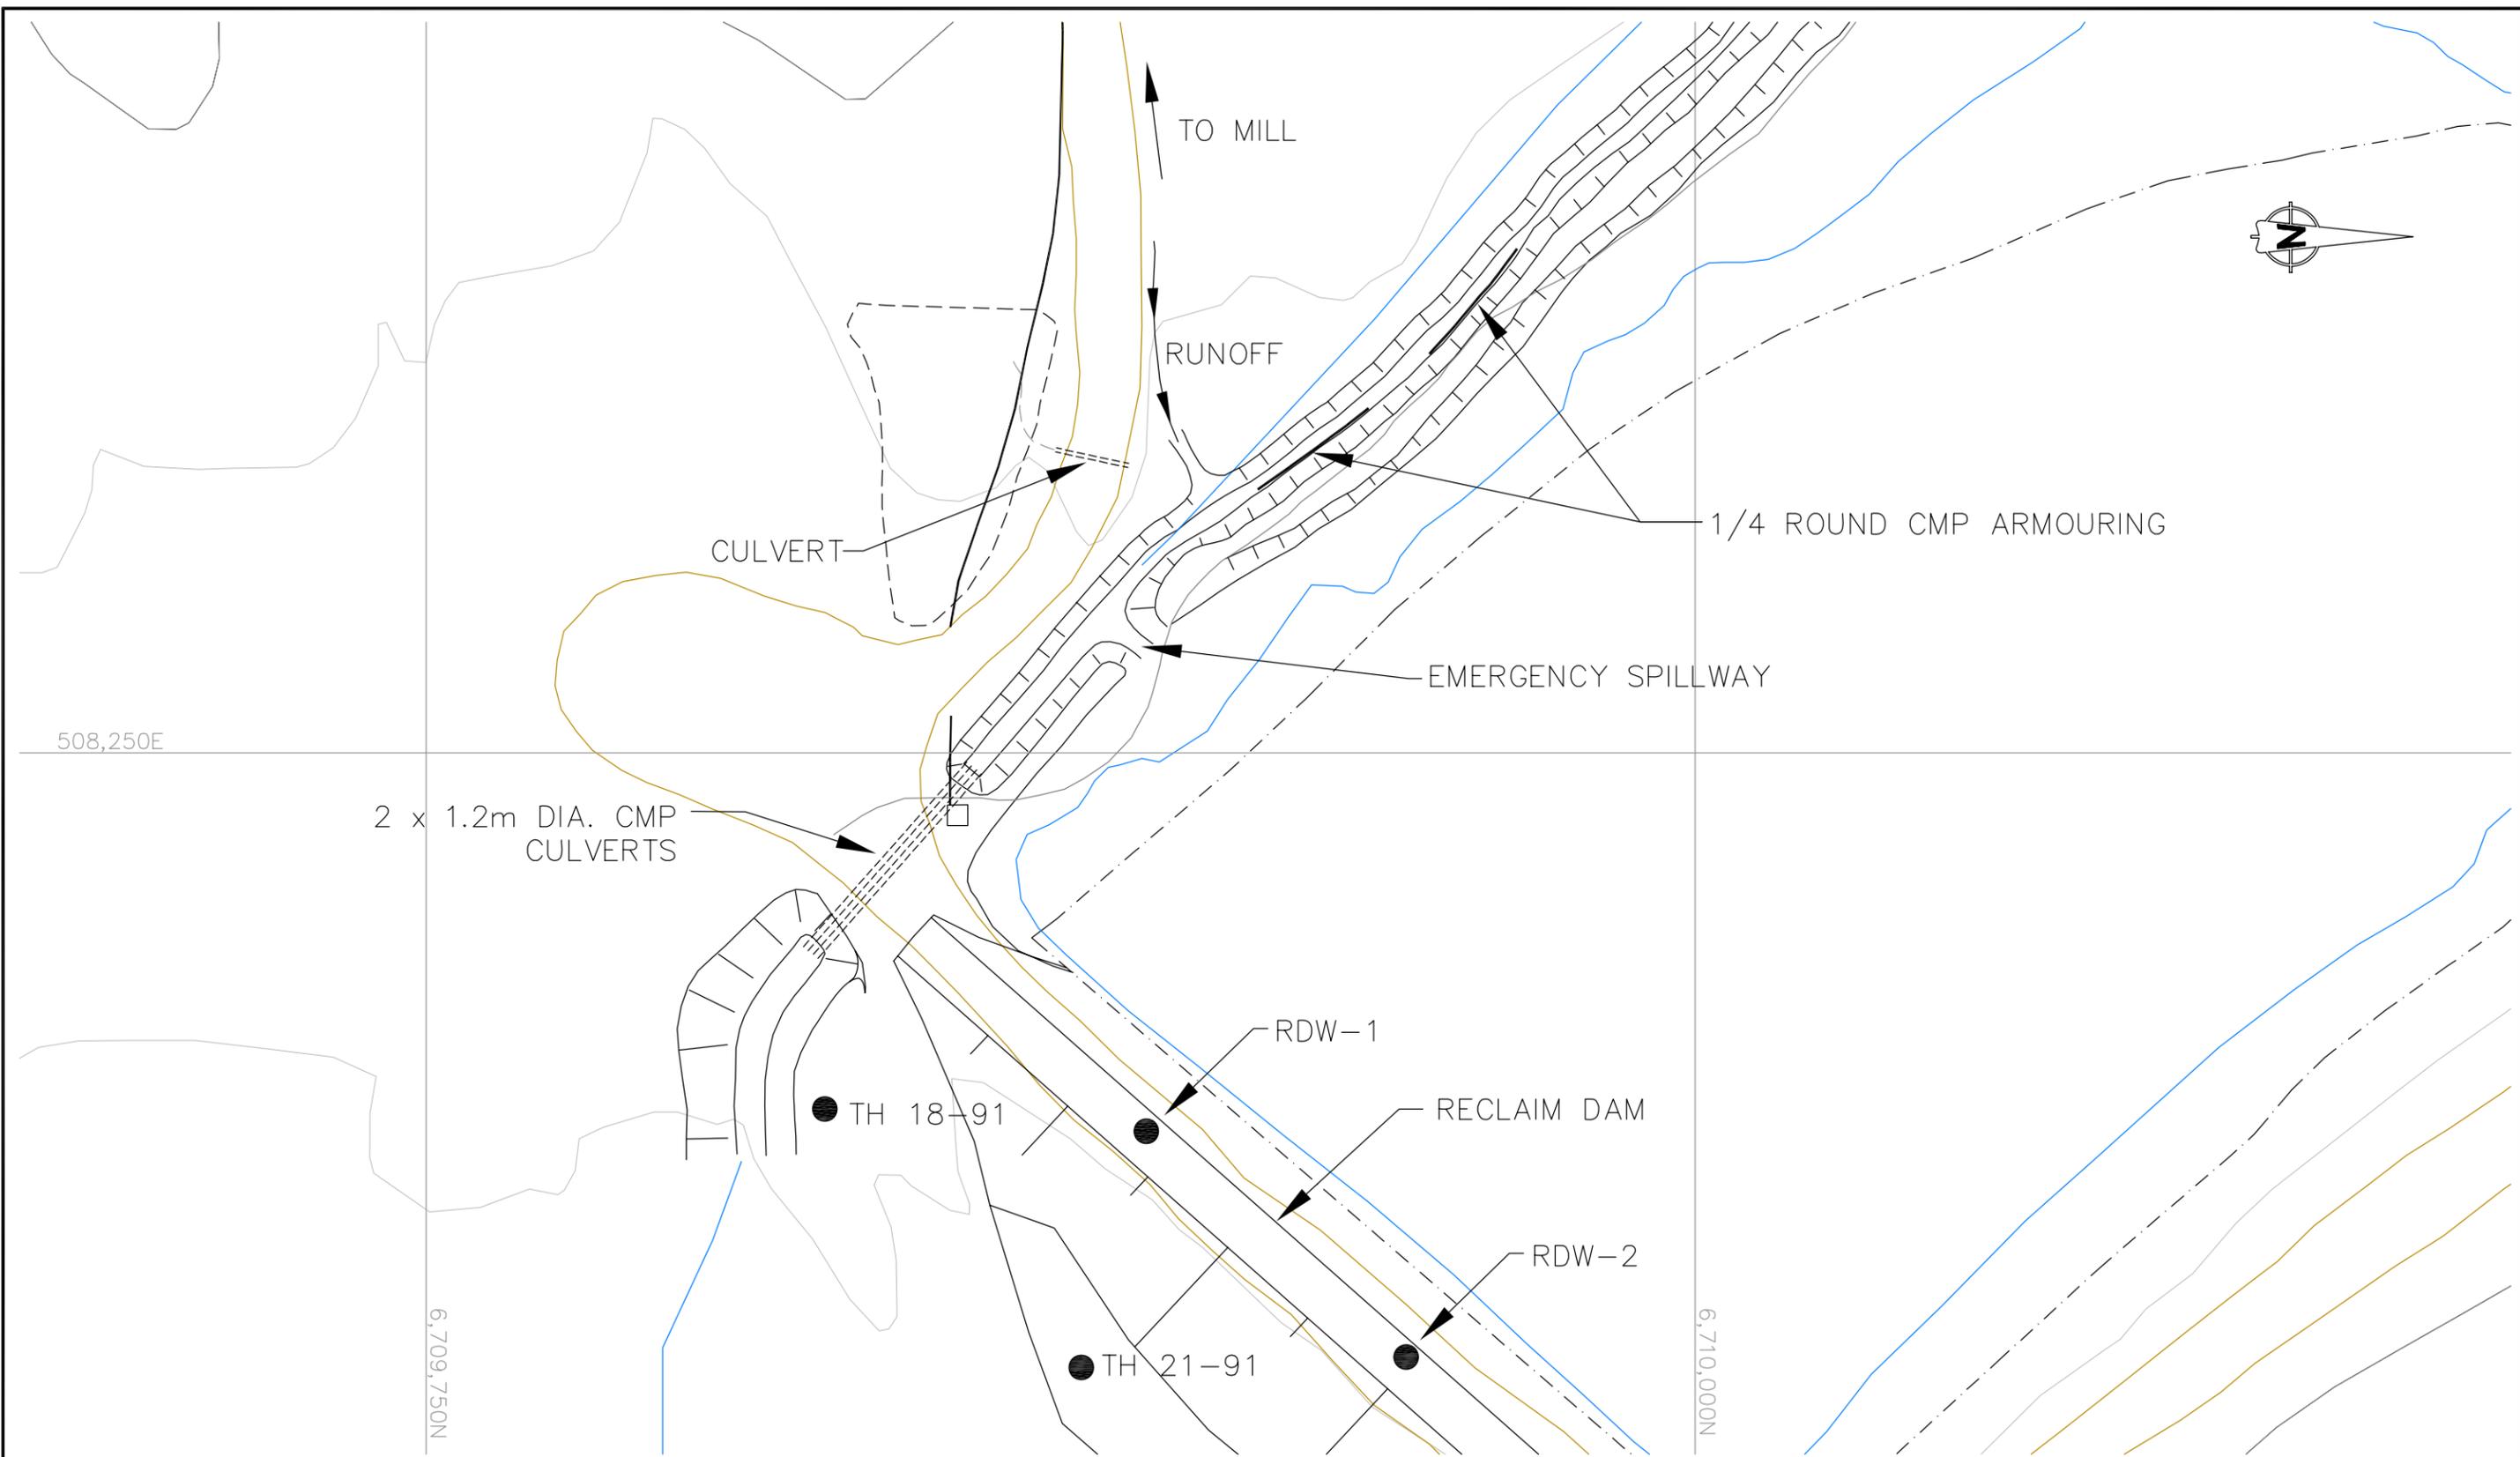
Figure10
 Camp Creek Diversion (SRK 2009)

Lining for erosion protection was installed at the Reclaim Dam spillway and two sections within the diversion channel (1/4 round CMP armoring, Figure 10). The channel of Camp Creek Diversion is otherwise unlined.
