Sä Dena Hes 2020 Annual Mine Waste Facilities Inspection

Teck Resources Limited

SRK Consulting (Canada) Inc.
1CT008.073
October 2020

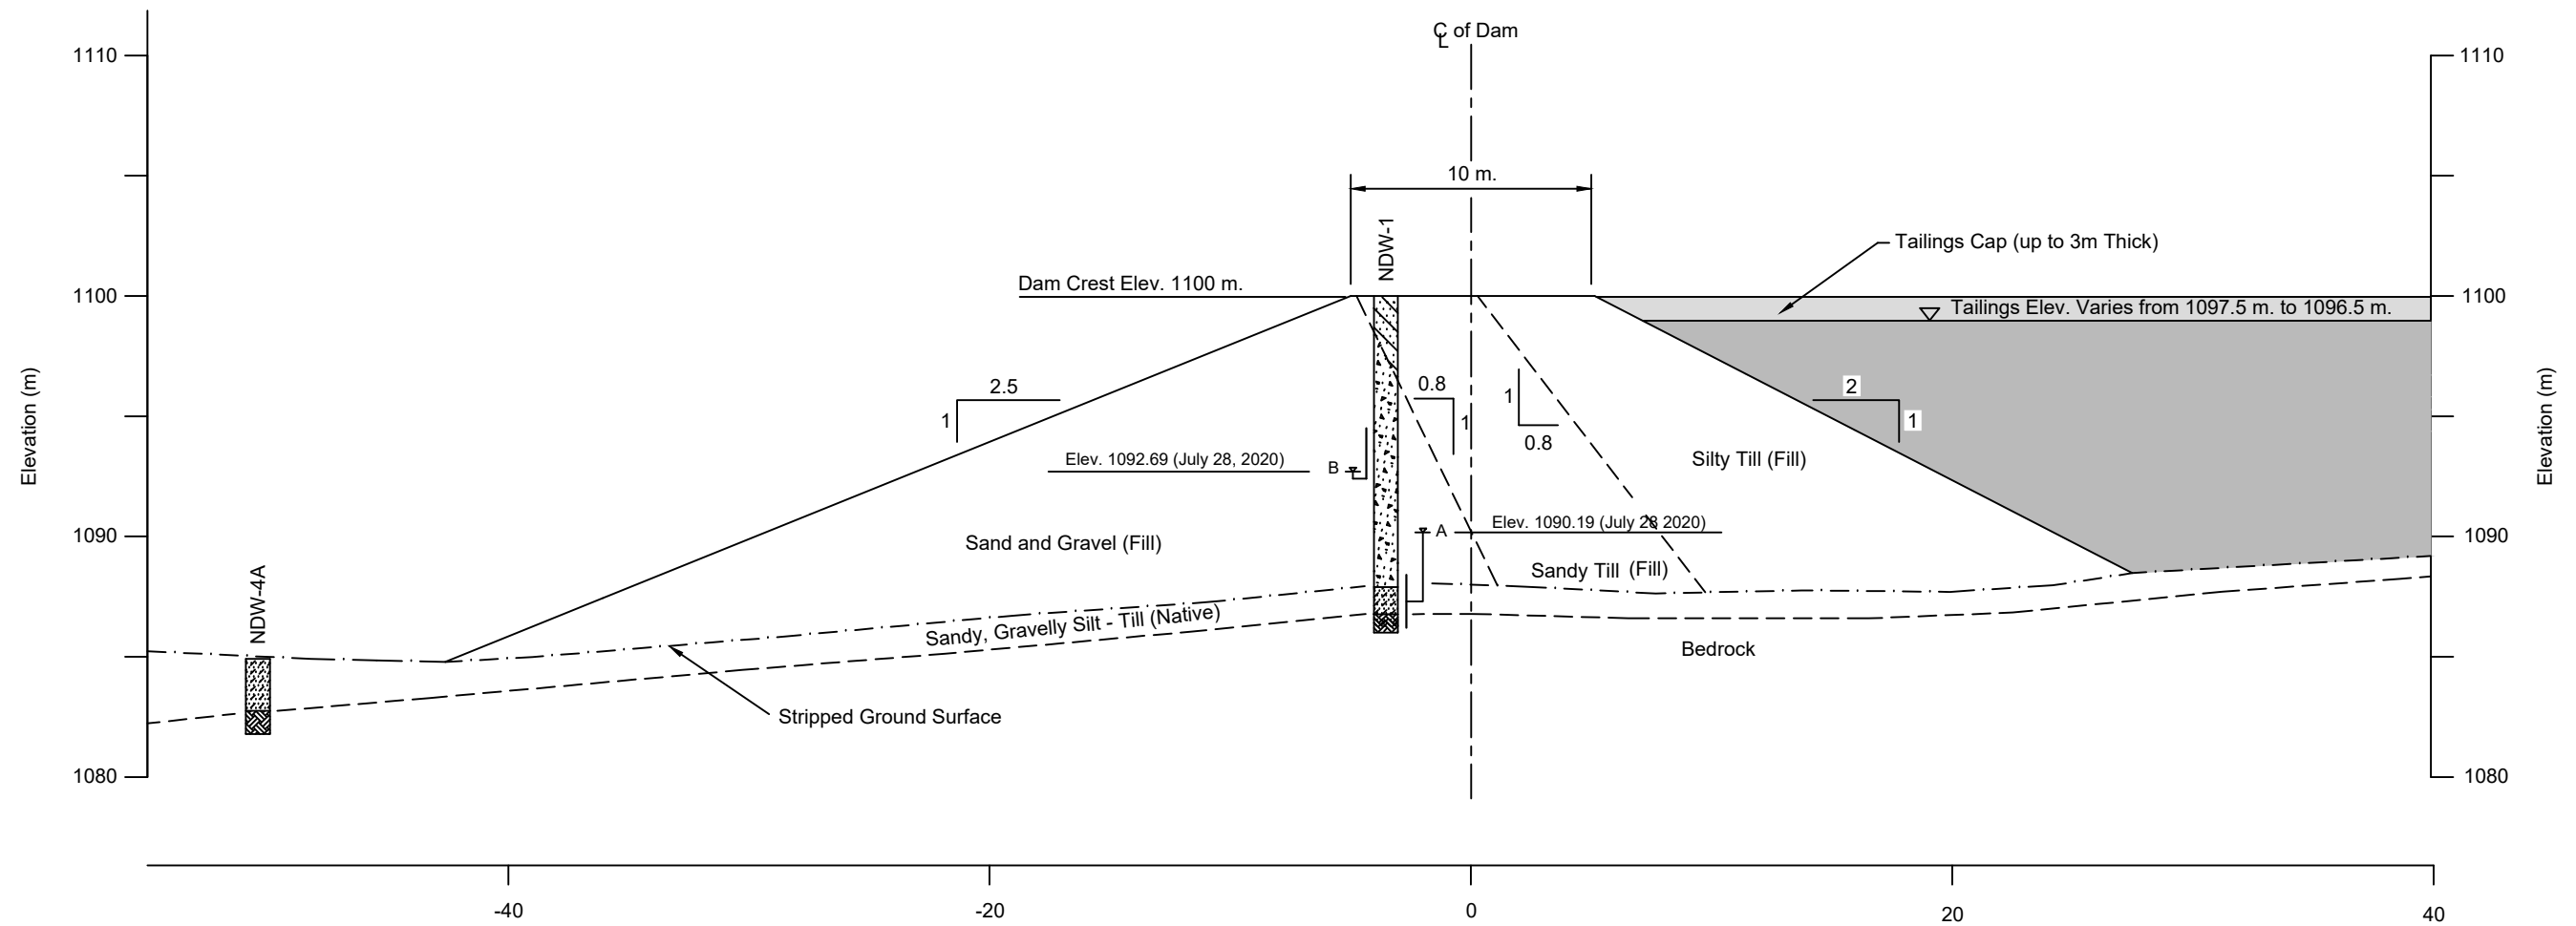
2020 Dam Safety Inspection	
		North Dam Section 0+400	
SRK JOB NO.: 1CT008.073	Sä Dena Hes Project	DATE: August 2020	APPROVED: PMH
FILE NAME: 1CT008_073_fig_04 - North Dam-XS.dwg		FIGURE: 4

The peak levels recorded in June 2020 are plotted on the dam section shown on Figure 4.

Date	Piezometer	Borehole depth 1990 (mBTOC)	Piezometer Interval 1990 (mBTOC)	Soil Type	Top of Casing Elev. (mamsl)	Ground Elevation (mamsl)	Water Reading (mBTOC)	Top of water (mamsl)	Depth to Bottom (2020) (mBTOC)	Bottom of hole (mamsl)	Piezometer Interval (mamsl)
28-Jul-20	NDW-1A	14.44	12.34-14.44	Bedrock	1100.74	1100.00	10.55	1090.19	14.44	1086.30	1086.3-1088.4
28-Jul-20	NDW-1B	8.30	6.2-8.3	Sandy Till	1100.70	1100.00	8.01	1092.69	8.03	1092.67	1092.4-1094.5

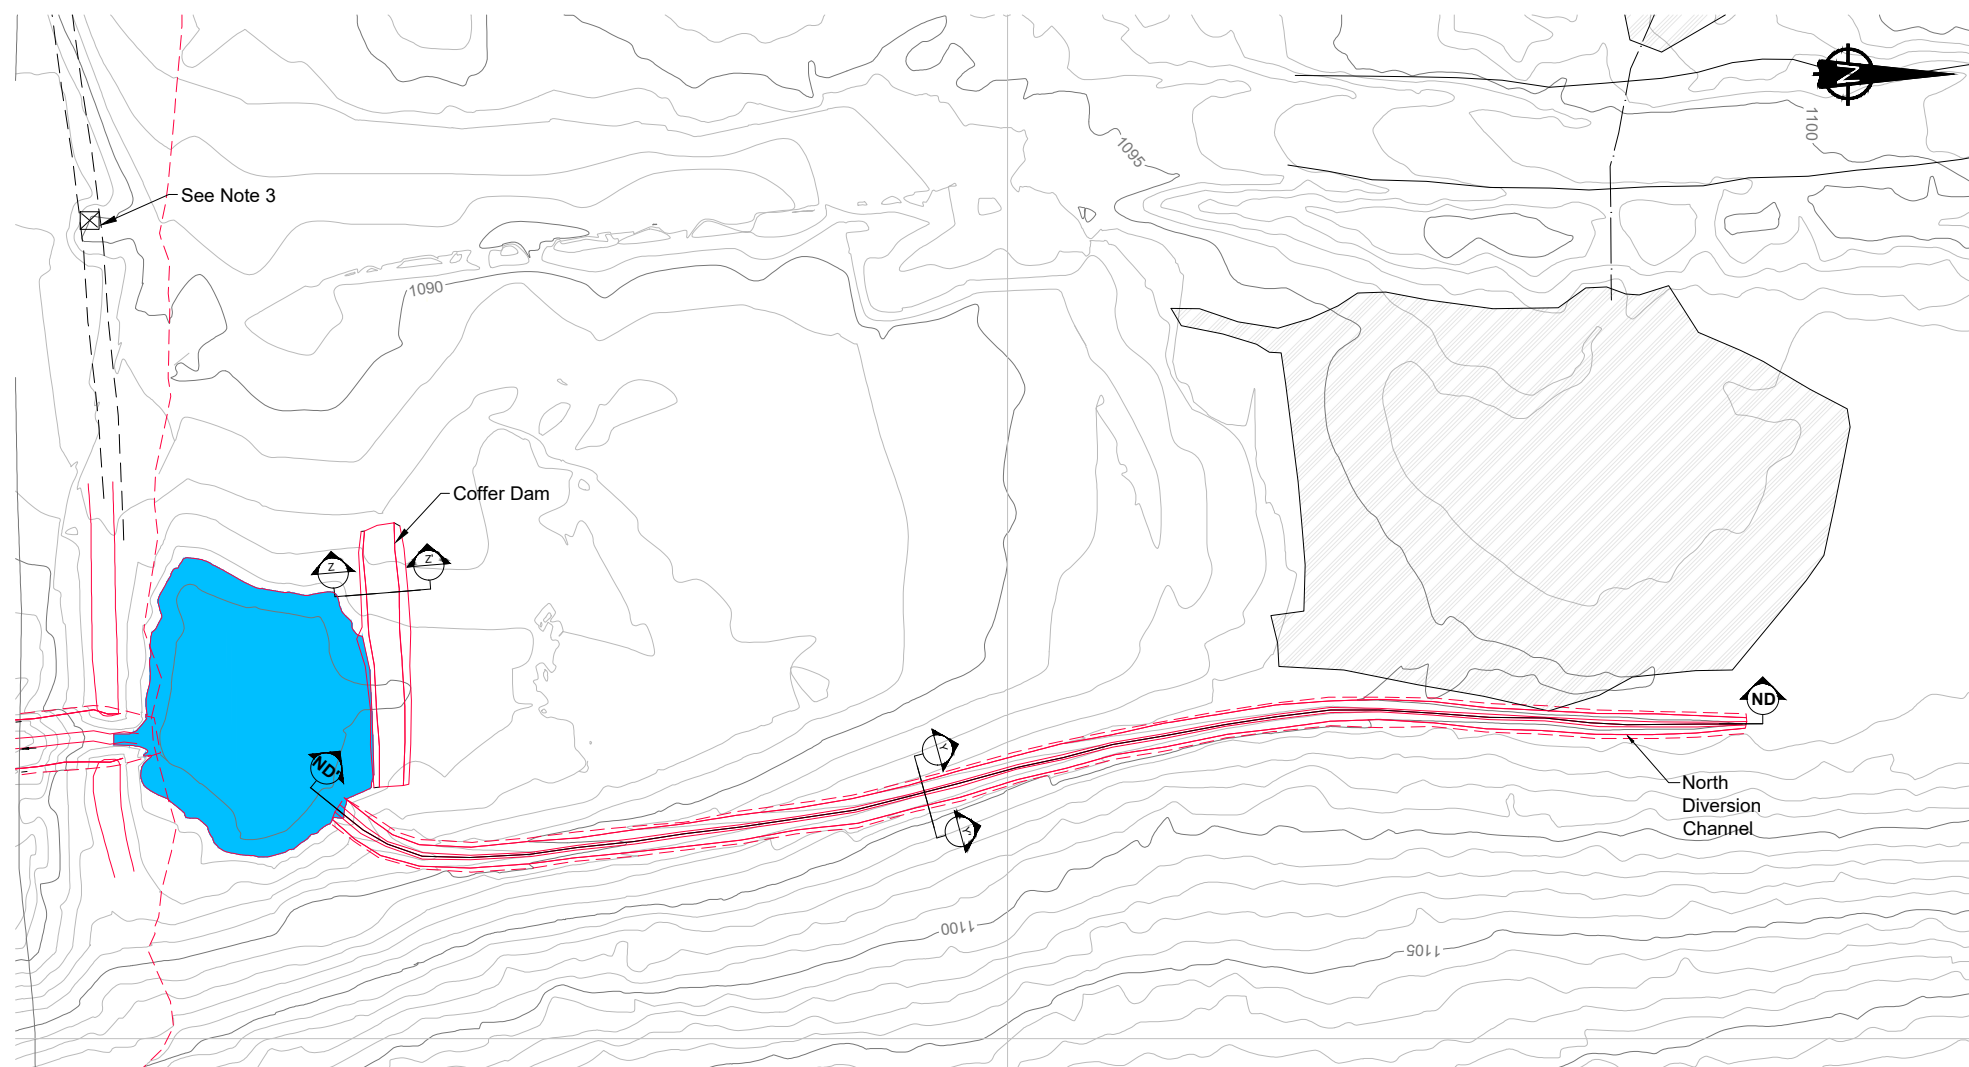
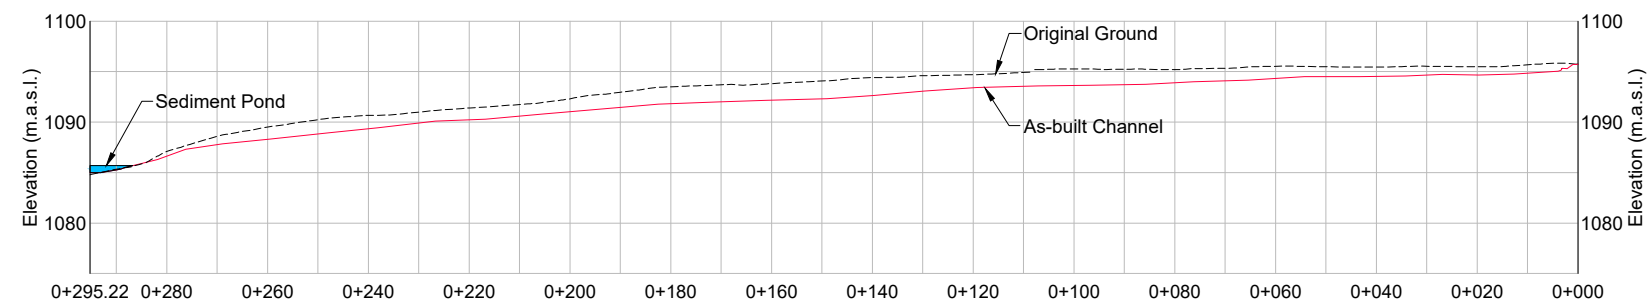
2020 Dam Safety Inspection		
		DRAWING TITLE: North Drainage Channel Plan, Profile and Section		
SRK JOB NO: 1CT008.073 FILE NAME: 1CT008_073_fig_08-09-AB_Asbuilt.dwg	Sä Dena Hes Project	DATE: August 2020	APPROVED: PMH	FIGURE NO. 9

The North Drainage channel upstream of the SRS (Photo 10) was built to divert as much runoff as possible away from the tailings and soil cover during the first few years after the cover placement. Most the channel remains in stable condition except for a subsidence that has occurred about 50 m upstream of the channel outlet. (see Photos 11 and 12). It appears that seepage from the hillside above the channel triggered the subsidence and threatens to undermine the structure at that location. While this is not considered a risk to the SRS dike and once the SRS is removed and the vegetation on the cover takes hold, no maintenance of the channel will be required. However, as no immediate plans are in place to breach the SRS, the subsidence should be repaired by buttressing with riprap borrowed from the downstream portion of the North Drainage channel.

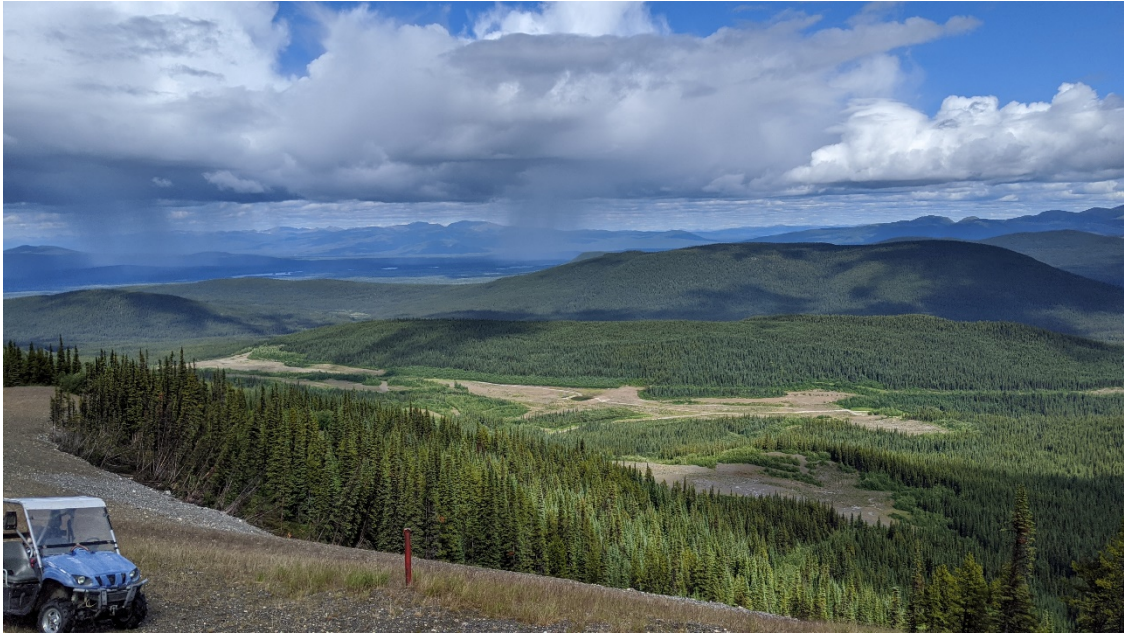
A view of the TMA from the Jewelbox dump is shown in Photo 19.

Photo 19 View north with the TMA in the background

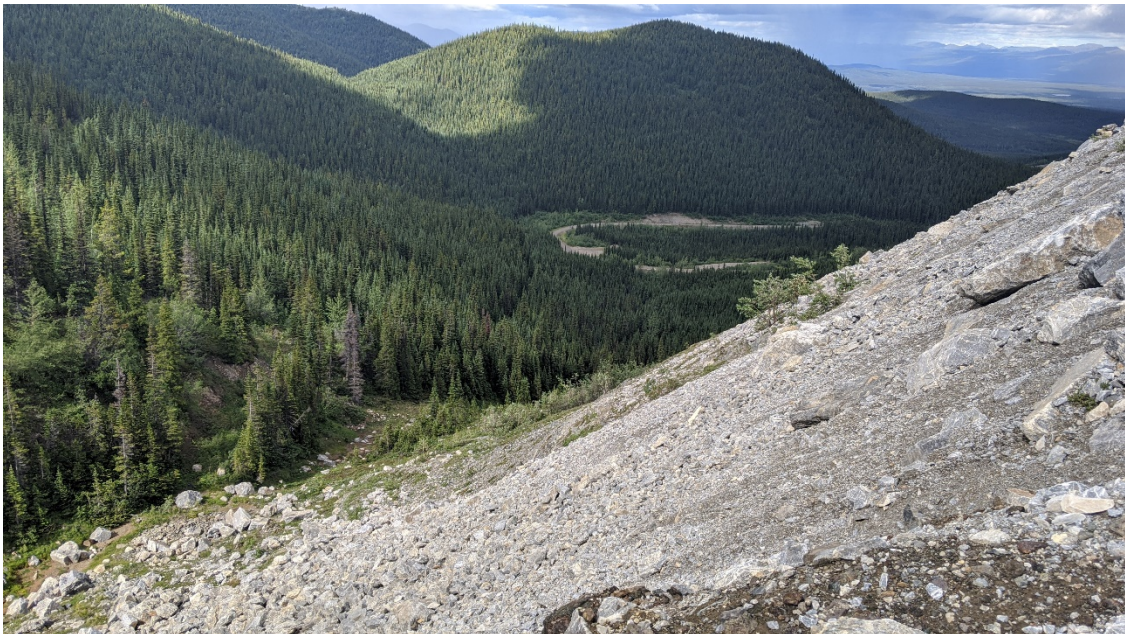
Photo 22 View looking north over the headwater of Camp Creek
