April 4, 2016

Re: **Sä Dena Hes Mine – Quartz Mining License QML-0004 – 2015 Detailed Decommissioning and Reclamation Plan Report**

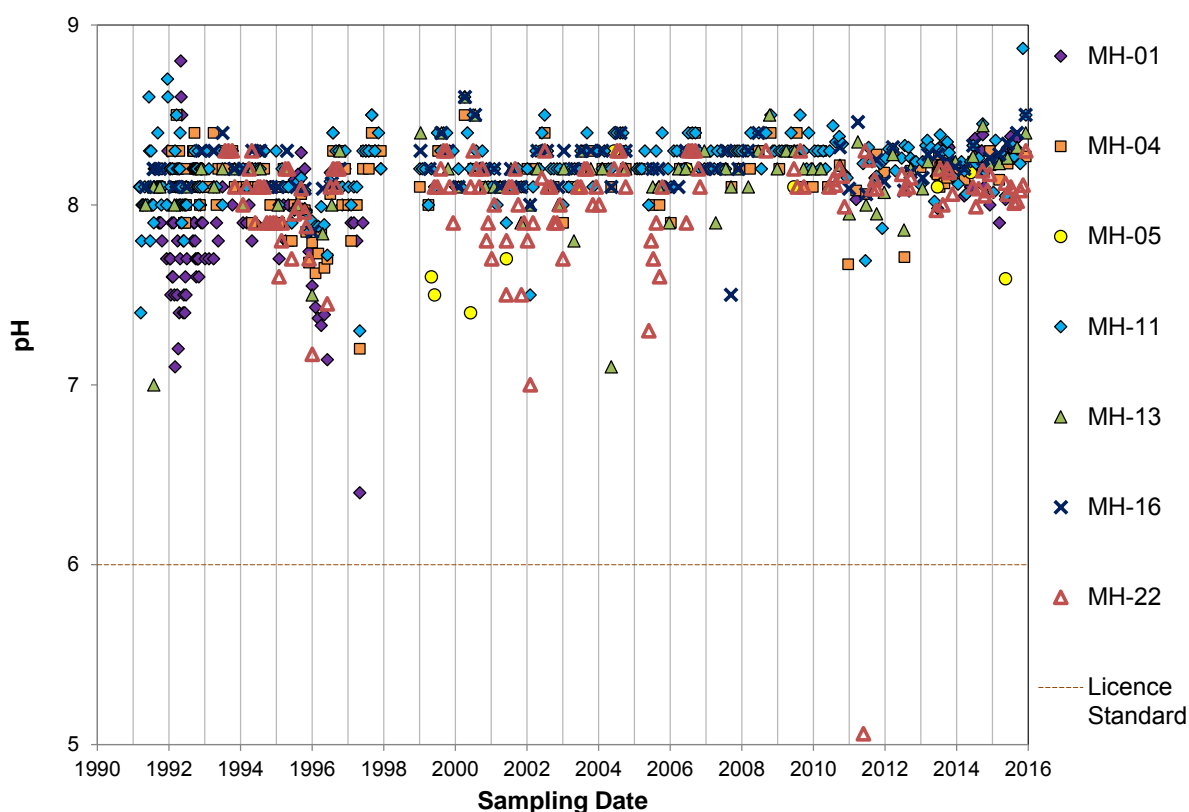
**Figure 4-3: Sä Dena Hes Long Term pH Levels**

With one exception, the pH levels was at or just above 8 in 2015 samples at all stations. The one measurement of 8.9 at MH-11 was anomalously high, however the field pH was 8.3, which is comparable to the overall data set. The pH levels have been relatively stable since 1996 at the South Tailings Outflow (MH-01), Lower Camp Creek and False Canyon Creek stations (MH-04, MH-11, MH-13, and MH-16) and since 2007 for the Burnick 1200 Portal discharge (MH-22). Prior to these dates, pH was similar to current levels but occasionally was as low as 7, particularly at MH-01.

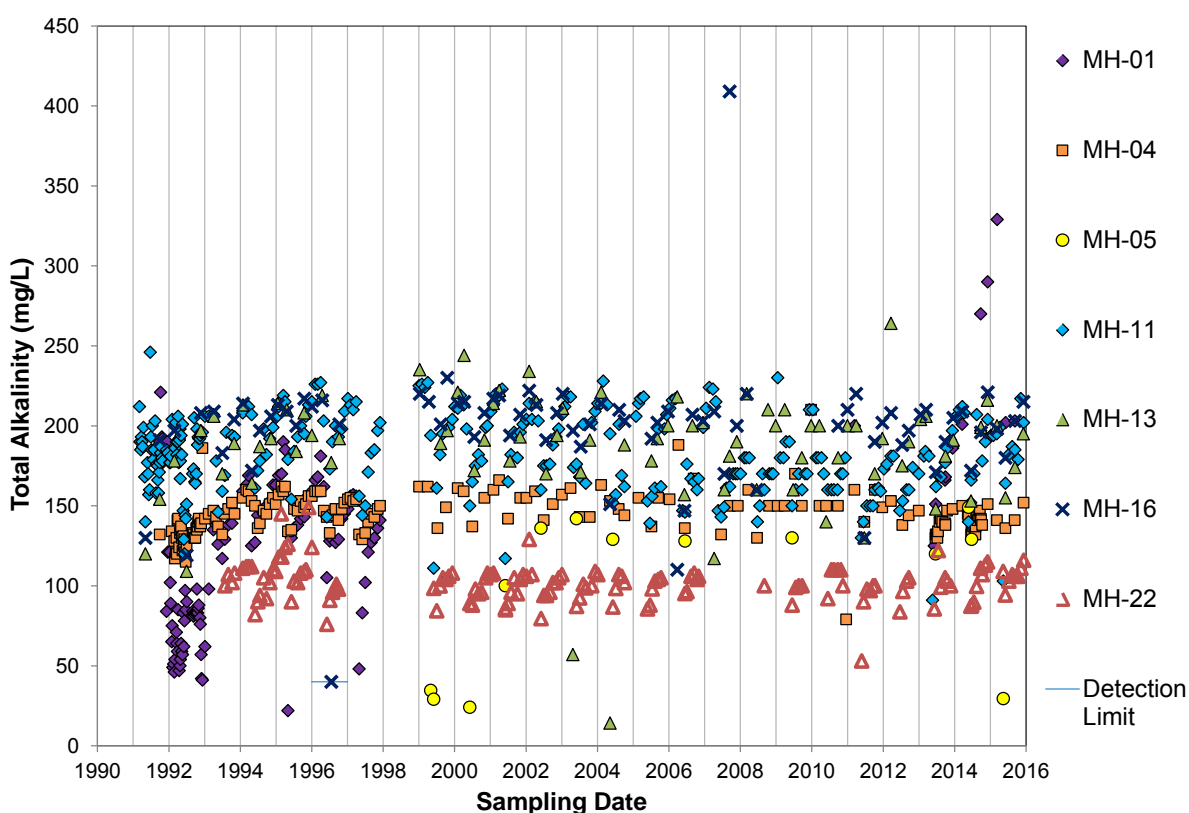
**Figure 4-4: Sä Dena Hes Long Term Total Alkalinity Concentrations**

Total alkalinity concentrations have generally been greater than 150 mg/L at all three False Canyon Creek stations (MH-11, MH-13, and MH-16). In Lower Camp Creek (MH-04) and Portal Creek (MH-05) concentrations have generally ranged between 100 and 150 mg/L. Three samples for Portal Creek (MH-05) from 1999 and 2000 were lower, below 35 mg/L. Alkalinity in the Burnick 1200 Portal discharge (MH-22) has consistently been around 100 mg/L. Total alkalinity concentrations were within historical ranges in 2015 at these stations.

Historically, the South Tailings Outflow (MH-01) generally has had levels of alkalinity between 40 and 190 mg/L. Since 2011, total alkalinity levels have been higher, ranging from 95 to 330 mg/L.

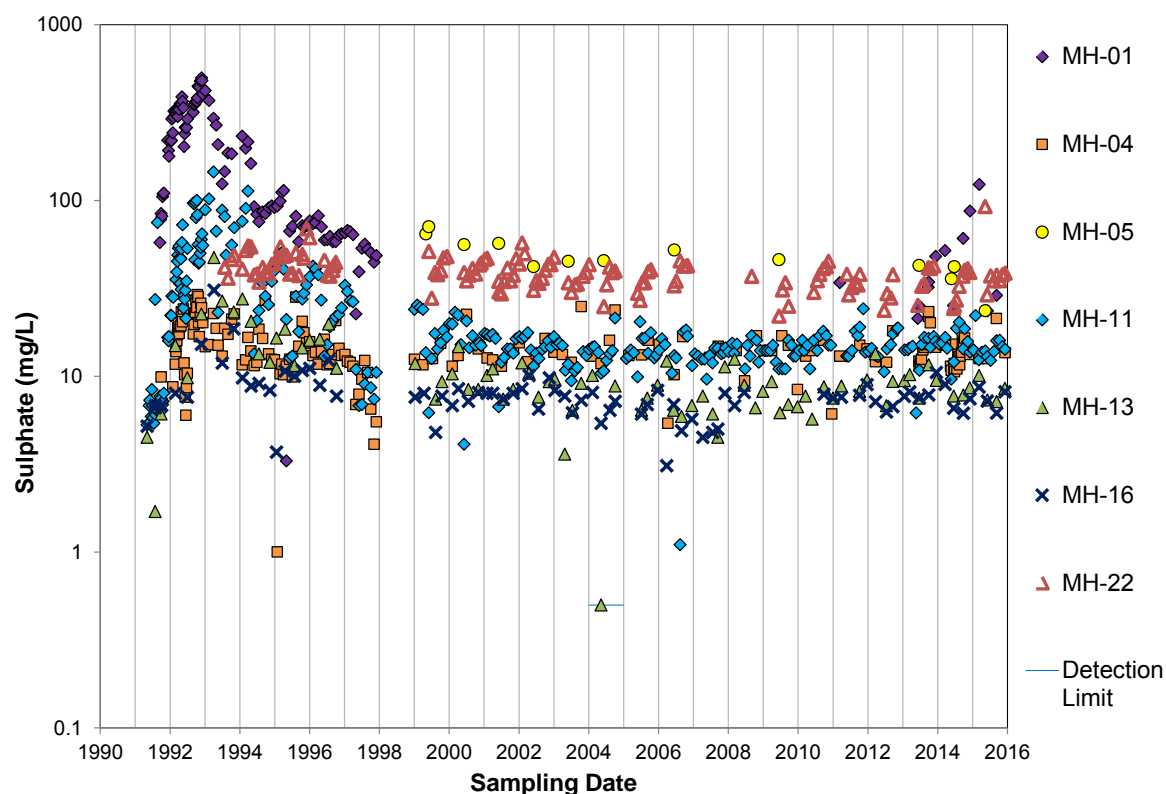
**Figure 4-5: Sä Dena Hes Long Term Sulphate Concentrations**

Sulphate levels were within historical ranges at the seven stations that were sampled in 2015. Concentrations generally decrease within increasing downstream distance from the SDH mine site. In 2015, concentrations were:

- South Tailings Outflow (MH-01): between 18 and 123 mg/L;
- Burnick 1200 Portal discharge (MH-22): between 29 and 92 mg/L ;
- Lower Camp Creek (MH-04): between 13 and 21 mg/L;
- Portal Creek (MH-05): 24 mg/L (sampled once);
- Upper False Canyon Creek (MH-11): between 12 and 22 mg/L; and
- Further downstream on False Canyon Creek (MH-13 and MH-16): between 6 and 10 mg/L.

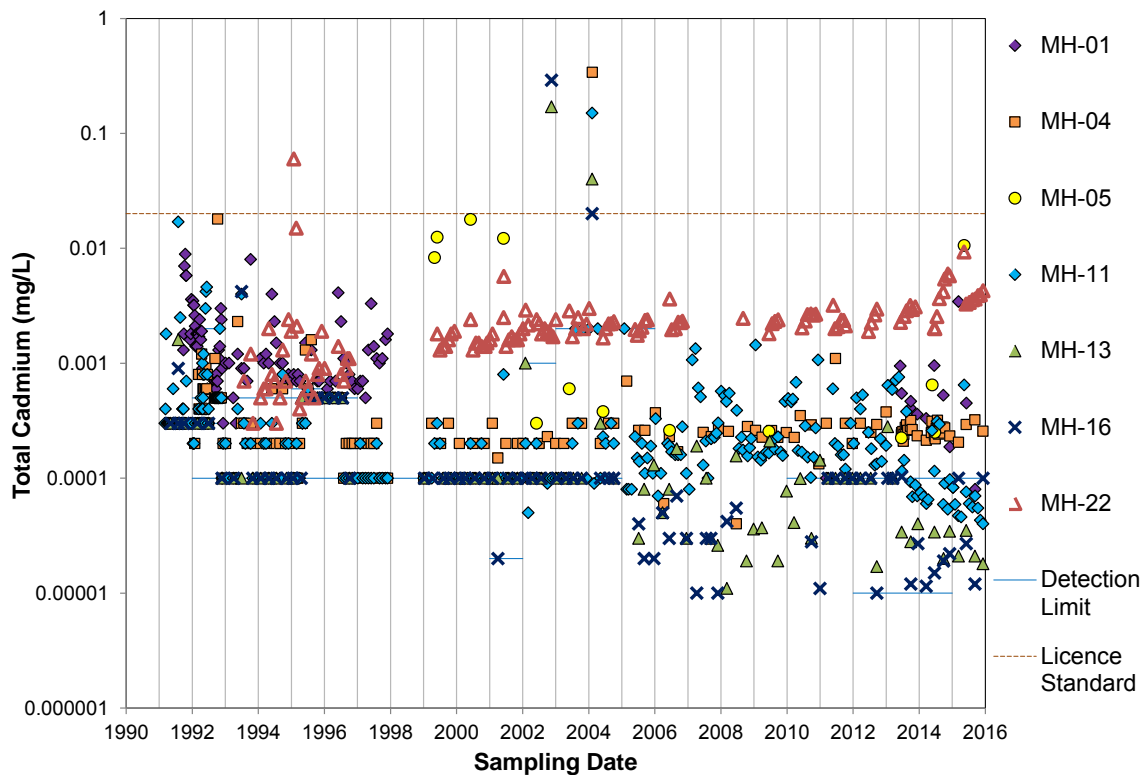
**Figure 4-9: Sä Dena Hes Long Term Total Cadmium Concentrations**

None of the samples from 2015 exceeded the licence standard. Total cadmium concentrations at the 1200 Burnick Portal (MH-22) ranged from 0.0033 and 0.0093 mg/L in 2015. Cadmium trends at MH-22 have slowly increased since the early 1990s and in the past two years appear to be possibly trending upward. Additional monitoring data are required to confirm this trend. At the South Tailings Outflow (MH-01), total cadmium levels ranged from 0.0034 to 0.0040 mg/L and are within the range of historical levels.

Total cadmium at the Portal Creek station (MH-05) was higher than 2014 but within historical ranges. Lower Camp Creek (MH-04) concentrations were below 0.0003 mg/L and were consistent with the historical data. In False Canyon Creek, concentrations progressively decreased downstream with MH-11, MH-13 and MH-16 having average 2015 concentrations of 0.00065 mg/L, 0.000035 mg/L and <0.0001 mg/L, respectively. For MH-16, the maximum concentration above the level of analytical detection was 0.000027 mg/L.

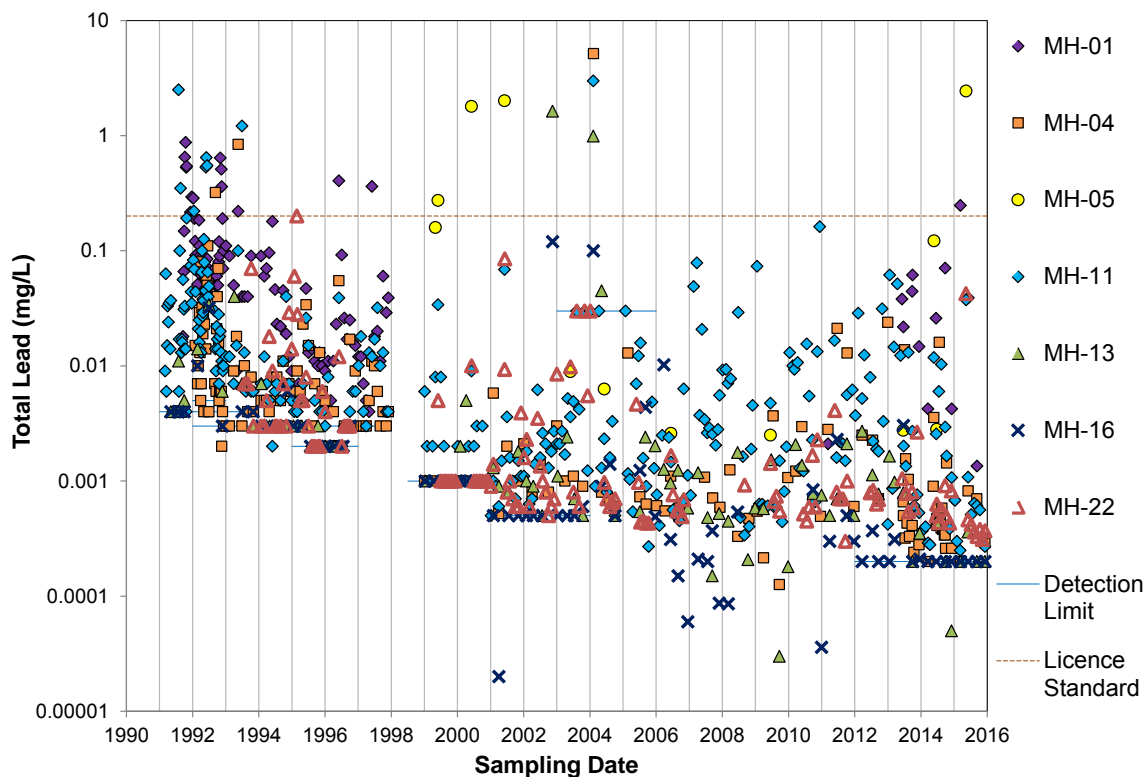
**Figure 4-10: Sä Dena Hes Long Term Total Lead Concentrations**

All samples from the Burnick 1200 Portal discharge (MH-22) were below licence limits. With the exception of one sample, MH-22 concentrations were below 0.0005 mg/L. The first freshet sample collected in May had levels of 0.04 mg/L. The overall lead trend at MH-22 is decreasing levels since 1993 with stable levels since approximately 2004.

Lower Camp Creek (MH-04) concentrations in 2015 were ranged from below analytical detection (<0.0002 mg/L) to 0.00082 mg/L and were on the lower end of historical ranges. Total lead concentrations in Portal Creek (MH-05) were 2.4 mg/L, which was higher than 2014 but within historical ranges. Upper False Canyon Creek (MH-11) concentrations ranged more than an order of magnitude in 2014 reaching a maximum of 0.038 mg/L, which is consistent with the data since approximately 1994. Further downstream in False Canyon Creek (MH-13 and MH-16), concentrations of lead were near or below the analytical detection limit. Concentrations at MH-13 and MH-16 have been stable since approximately 2005. Prior to that, trends could not be assessed due to high detection limits.

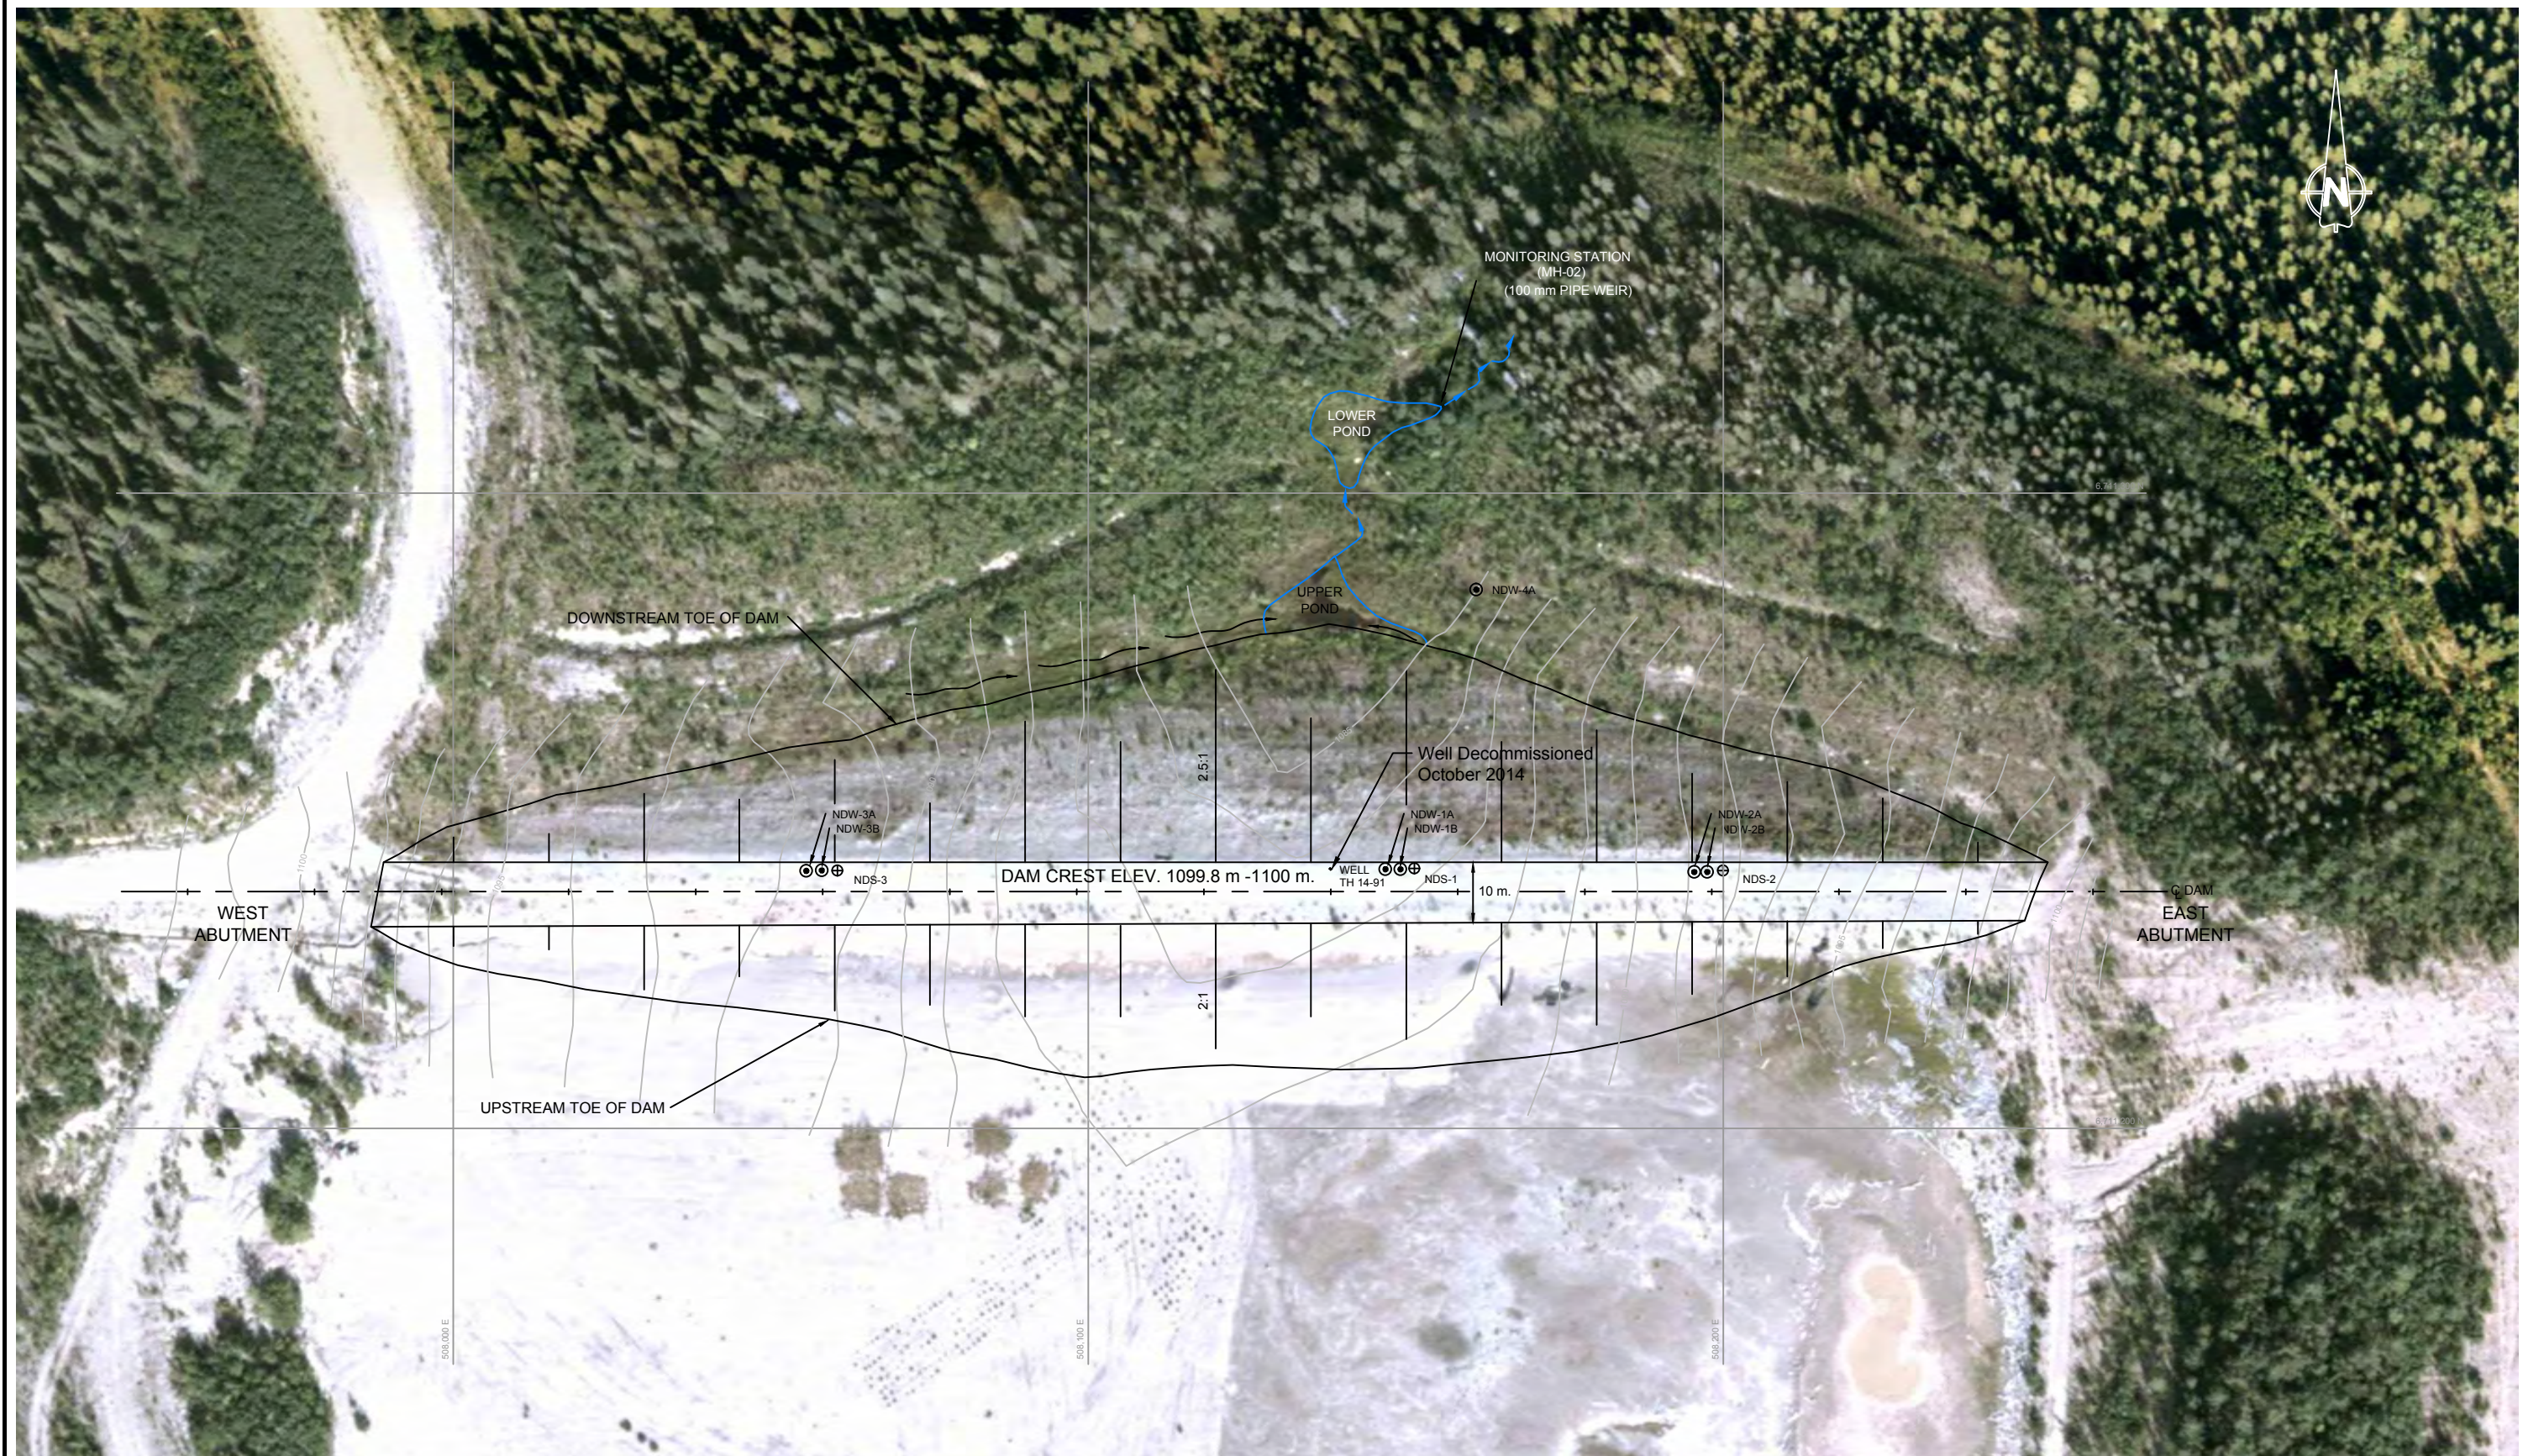
FIGURE:  
3

A site plan of the North Dam is presented on Figure 3 and a view of the TMA looking south is shown in Photo 2.

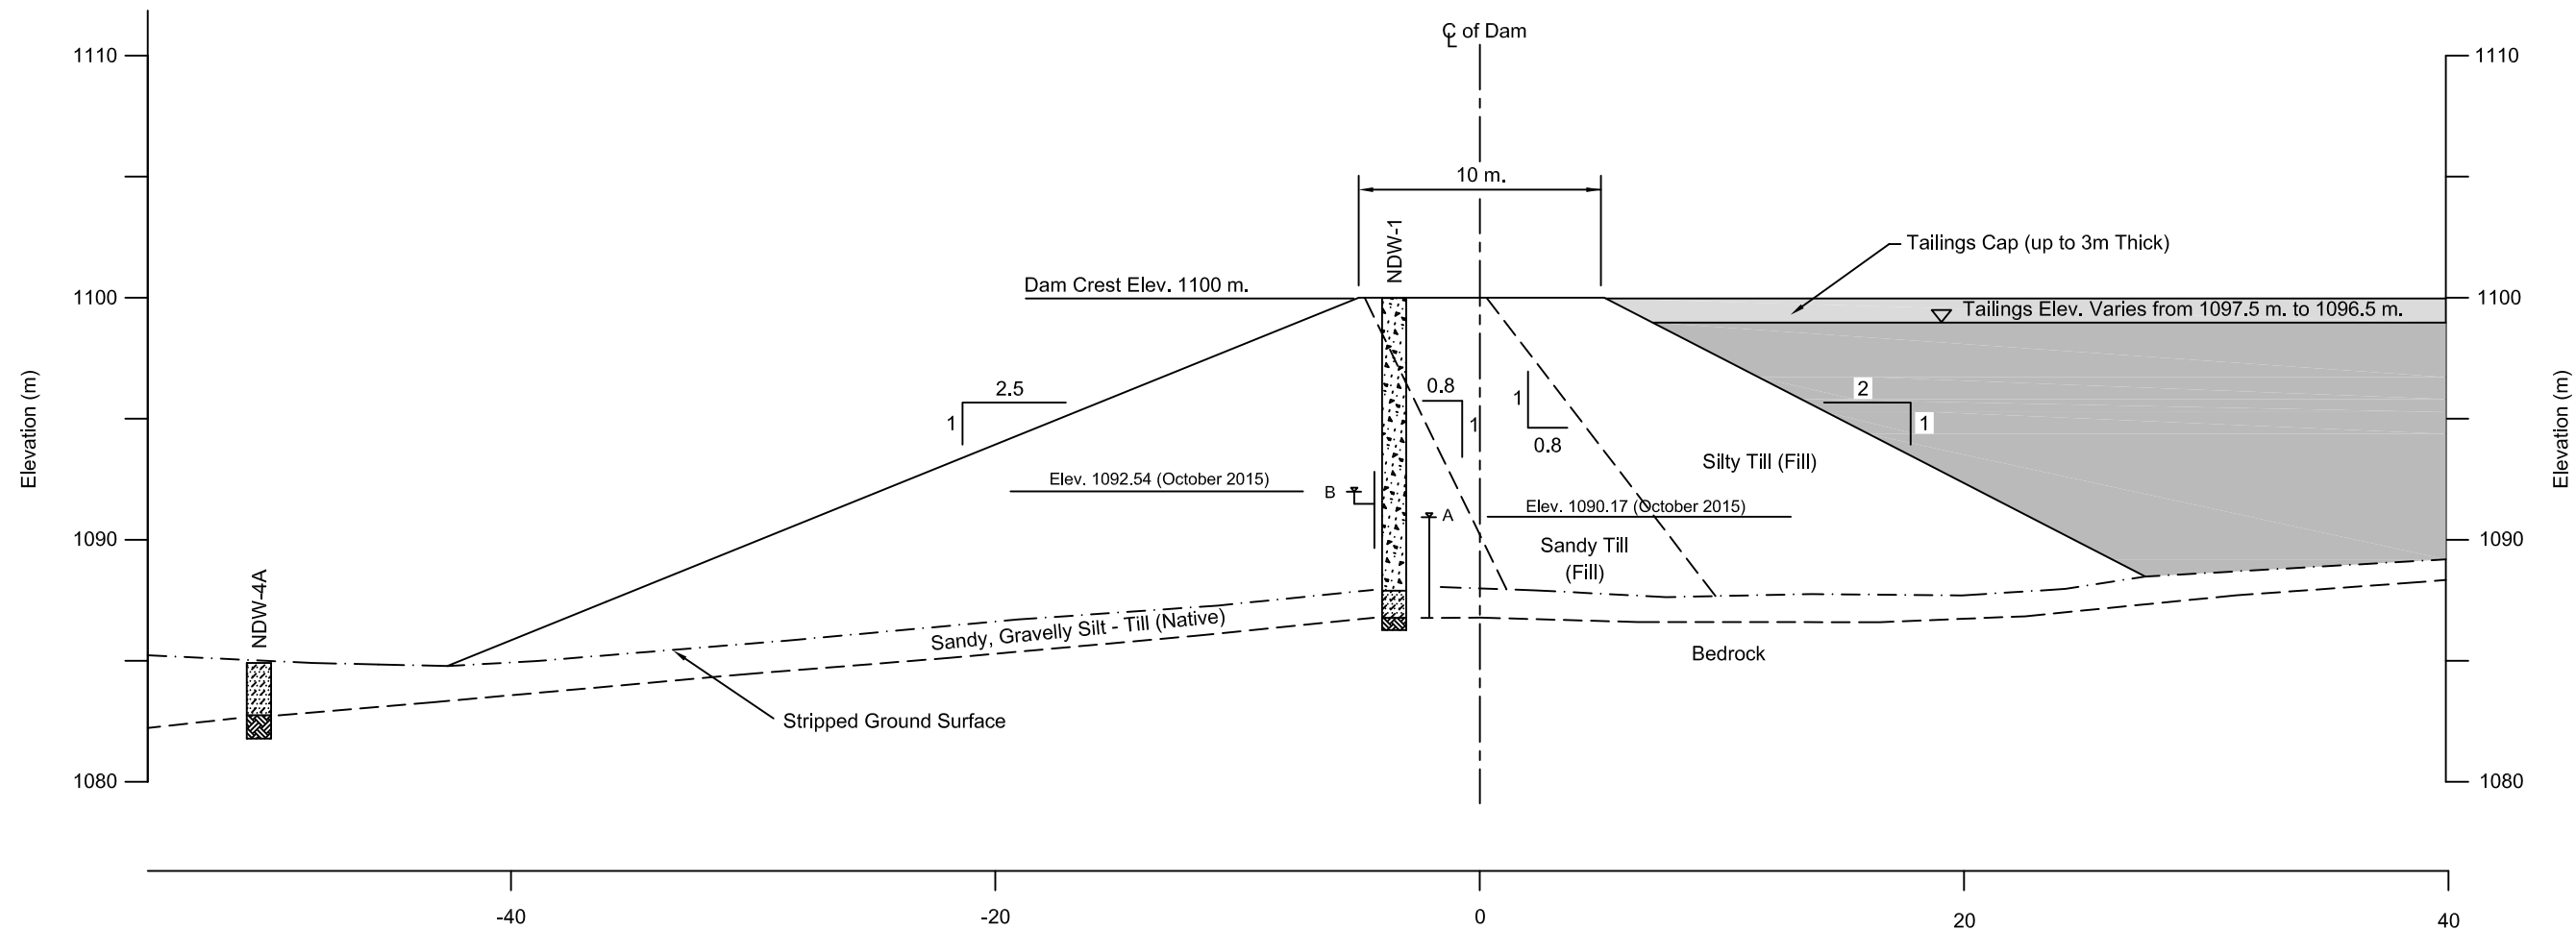
2015 Geotechnical Inspection	
			North Dam Section 0+400	
			DATE: November 2015	APPROVED: PMH
SRK JOB NO.: 1CT008.053	Sä Dena Hes Project		FIGURE: 4	
FILE NAME: 1CT008.053 - North Dam XS.dwg

DATE	T.O.P.	READING	ELEV.
NDW-1B	October 2015	1100.57	8.03	1092.54
NDW-1A	October 2015	1100.69	10.52	1090.17

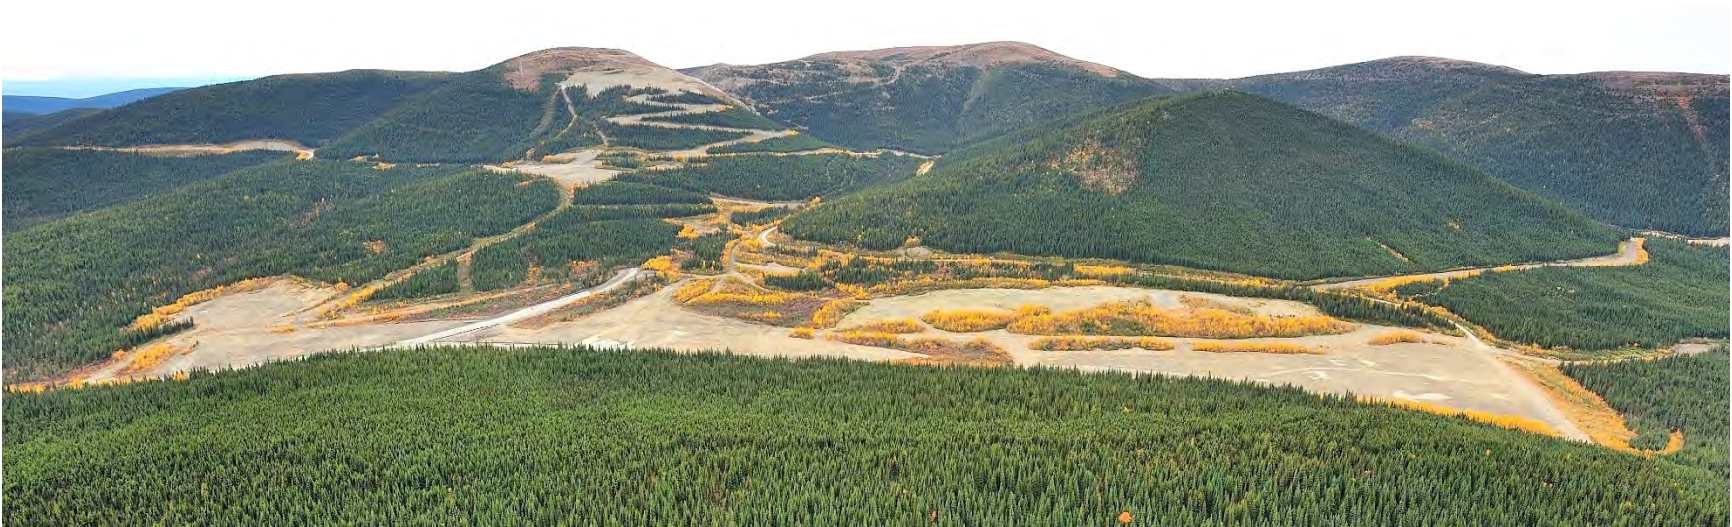
**Photo 1: View west over the Mine Site**

A map showing the overall mine site is provided on Figure 1. The general arrangement map of the TMA is provided in Figure 2. Photo 1 shows a view west over the entire mine site.

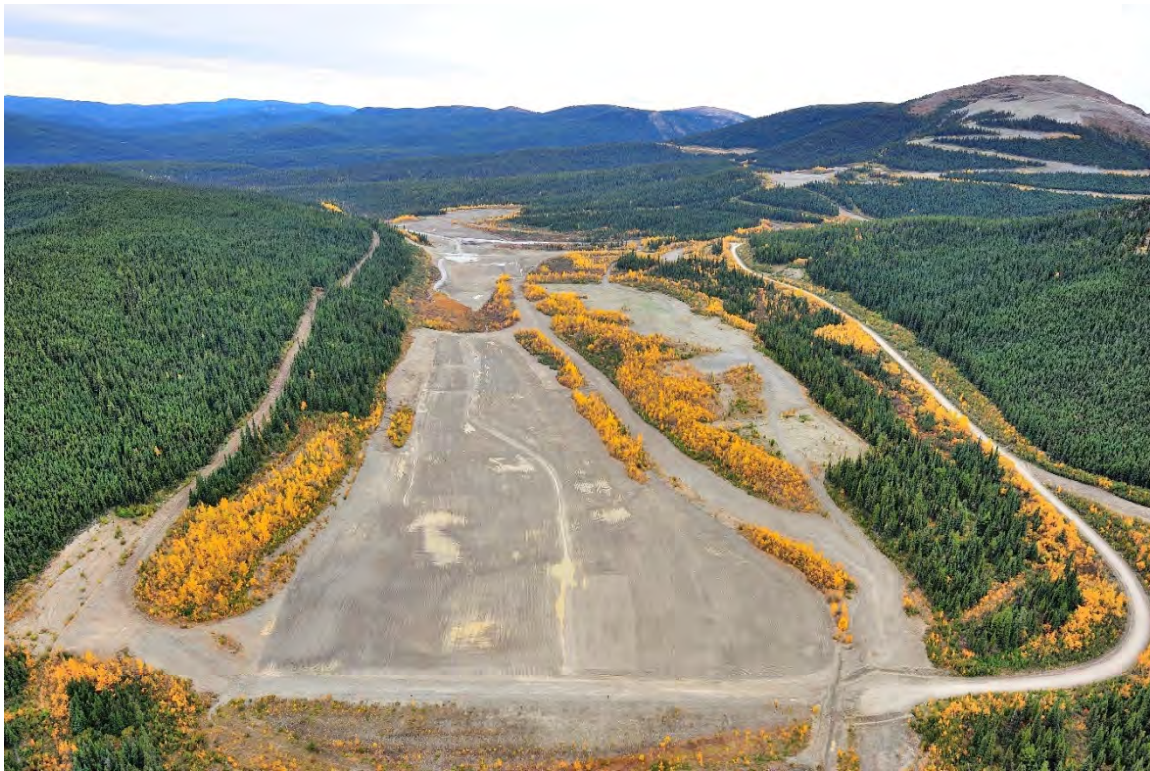
**Photo 2: View south over the Tailings Management Area**

Photos 2 and 5 show the soil cover that was placed in 2014 and 2015 in the TMA. Photo 10 indicates the depth of the cover in one location.

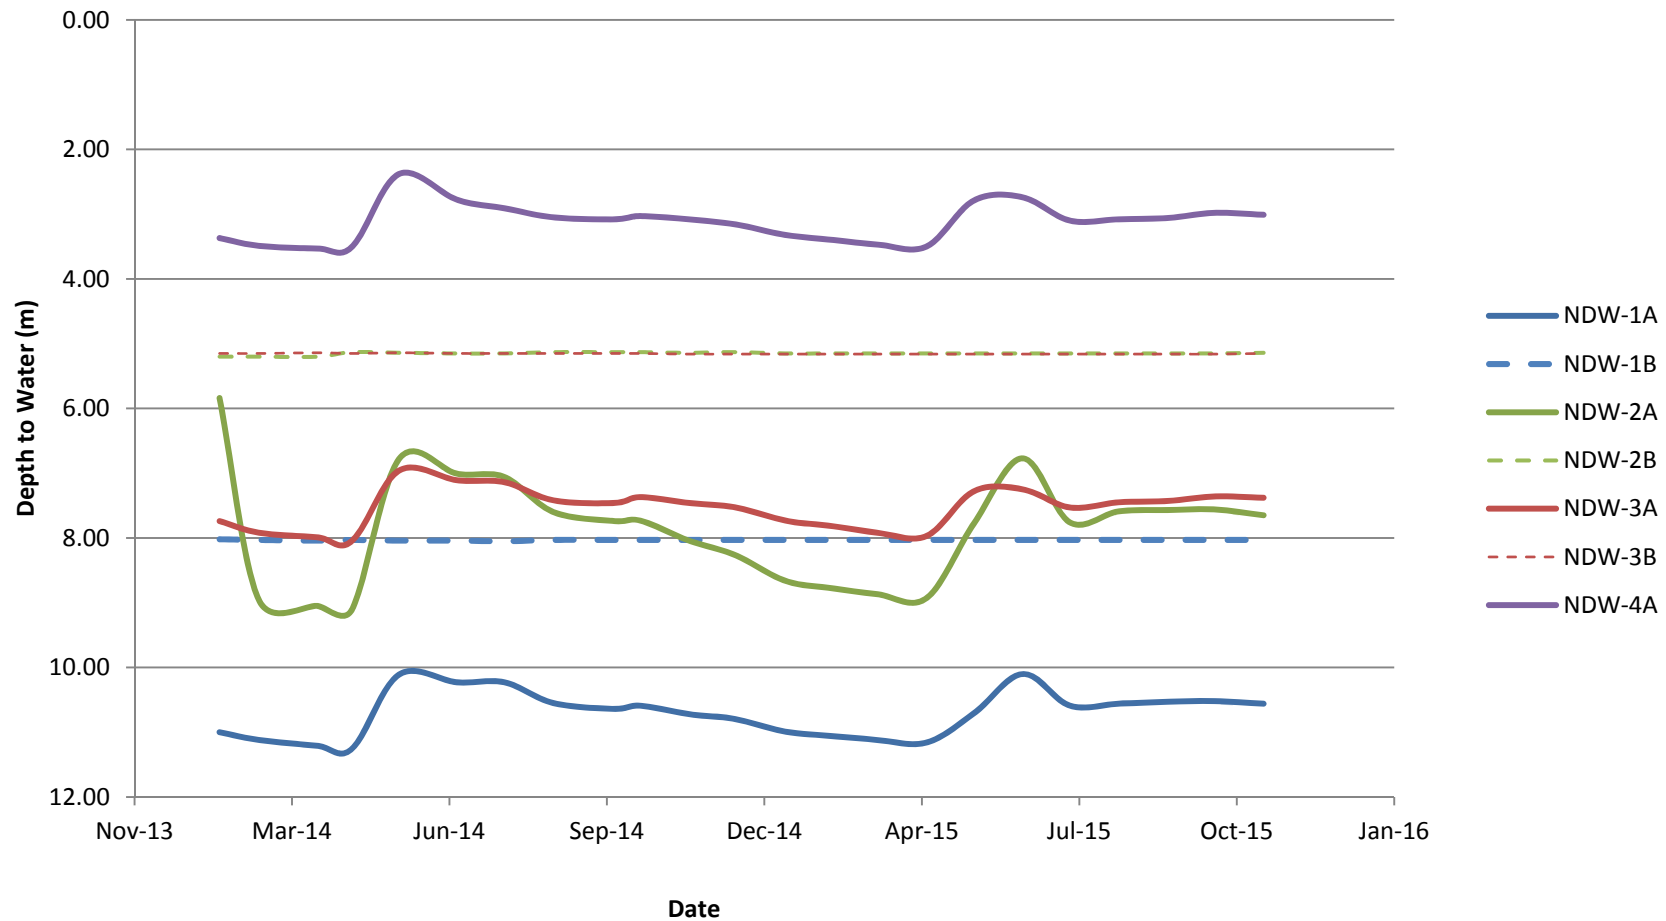
## Depth to Water - North Dam Crest Piezometers 2014-15

The water levels in the piezometers are recorded monthly and the 2015 data are presented in Appendix B. Figure B1 in Appendix B shows the seasonal water level fluctuation within the dam over the last two years. These levels preceded the completion of the till cover placement and reflect the water that seasonally ponded on the tailings surface during the freshet. Levels recorded in October, 2015 are plotted on the dam section shown on Figure 4. The seasonal fluctuations recorded this year in the piezometers are generally consistent with those in previous years and are within acceptable tolerance limits.
