Tantalus Butte Coal Property

Preliminary Site Assessment

Prepared for: Government of Yukon
Department of Energy, Mines and Resources

September 2007

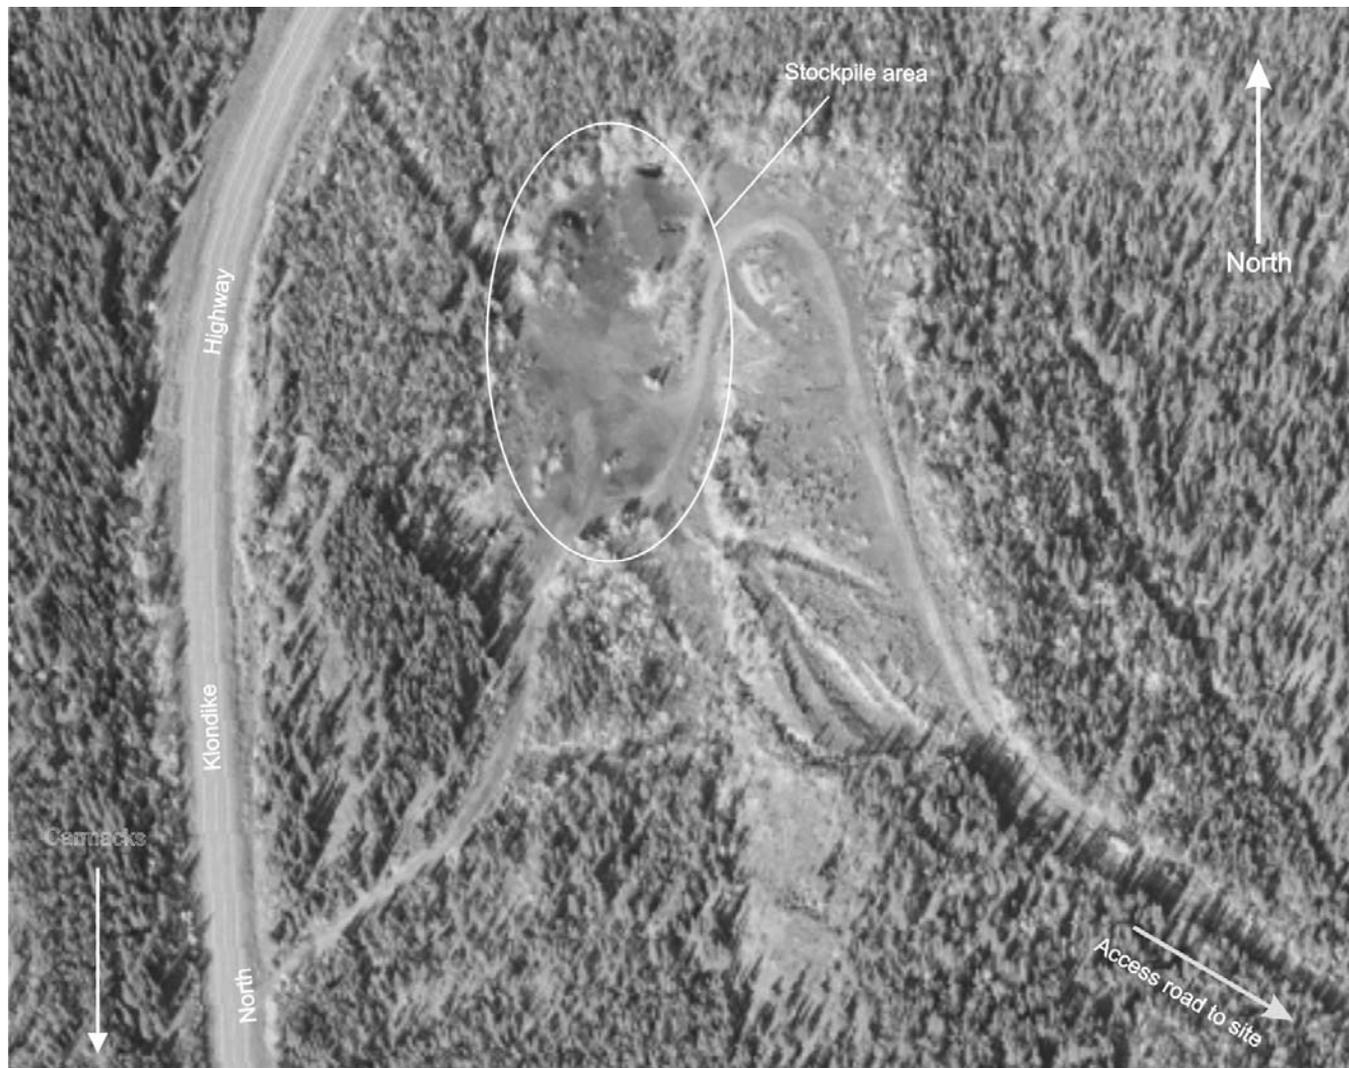
Figure 6 - Aerial photograph of the northern load out area (early fall, 2003)

The stockpile and loadout area are shown in Figure 6. This location is found approximately 100m from the mouth of the northern entrance on the north side of the access road. The area consists of 2 main piles of coal. Photo 5 shows the piles of coal which are approximately 20m long x 15m wide x 5m high (approx. 1500m³ per pile). The remains of wooden structures most likely used to support dumping equipment were located along the access road which travels around the south side of the load out area.
