August 14, 2013

ISSUED FOR USE  
EBA FILE: W14103229-01

**Subject:** 2013 Annual Observations of the On-site Earth Structures  
Wolverine Mine Site, South Eastern Yukon

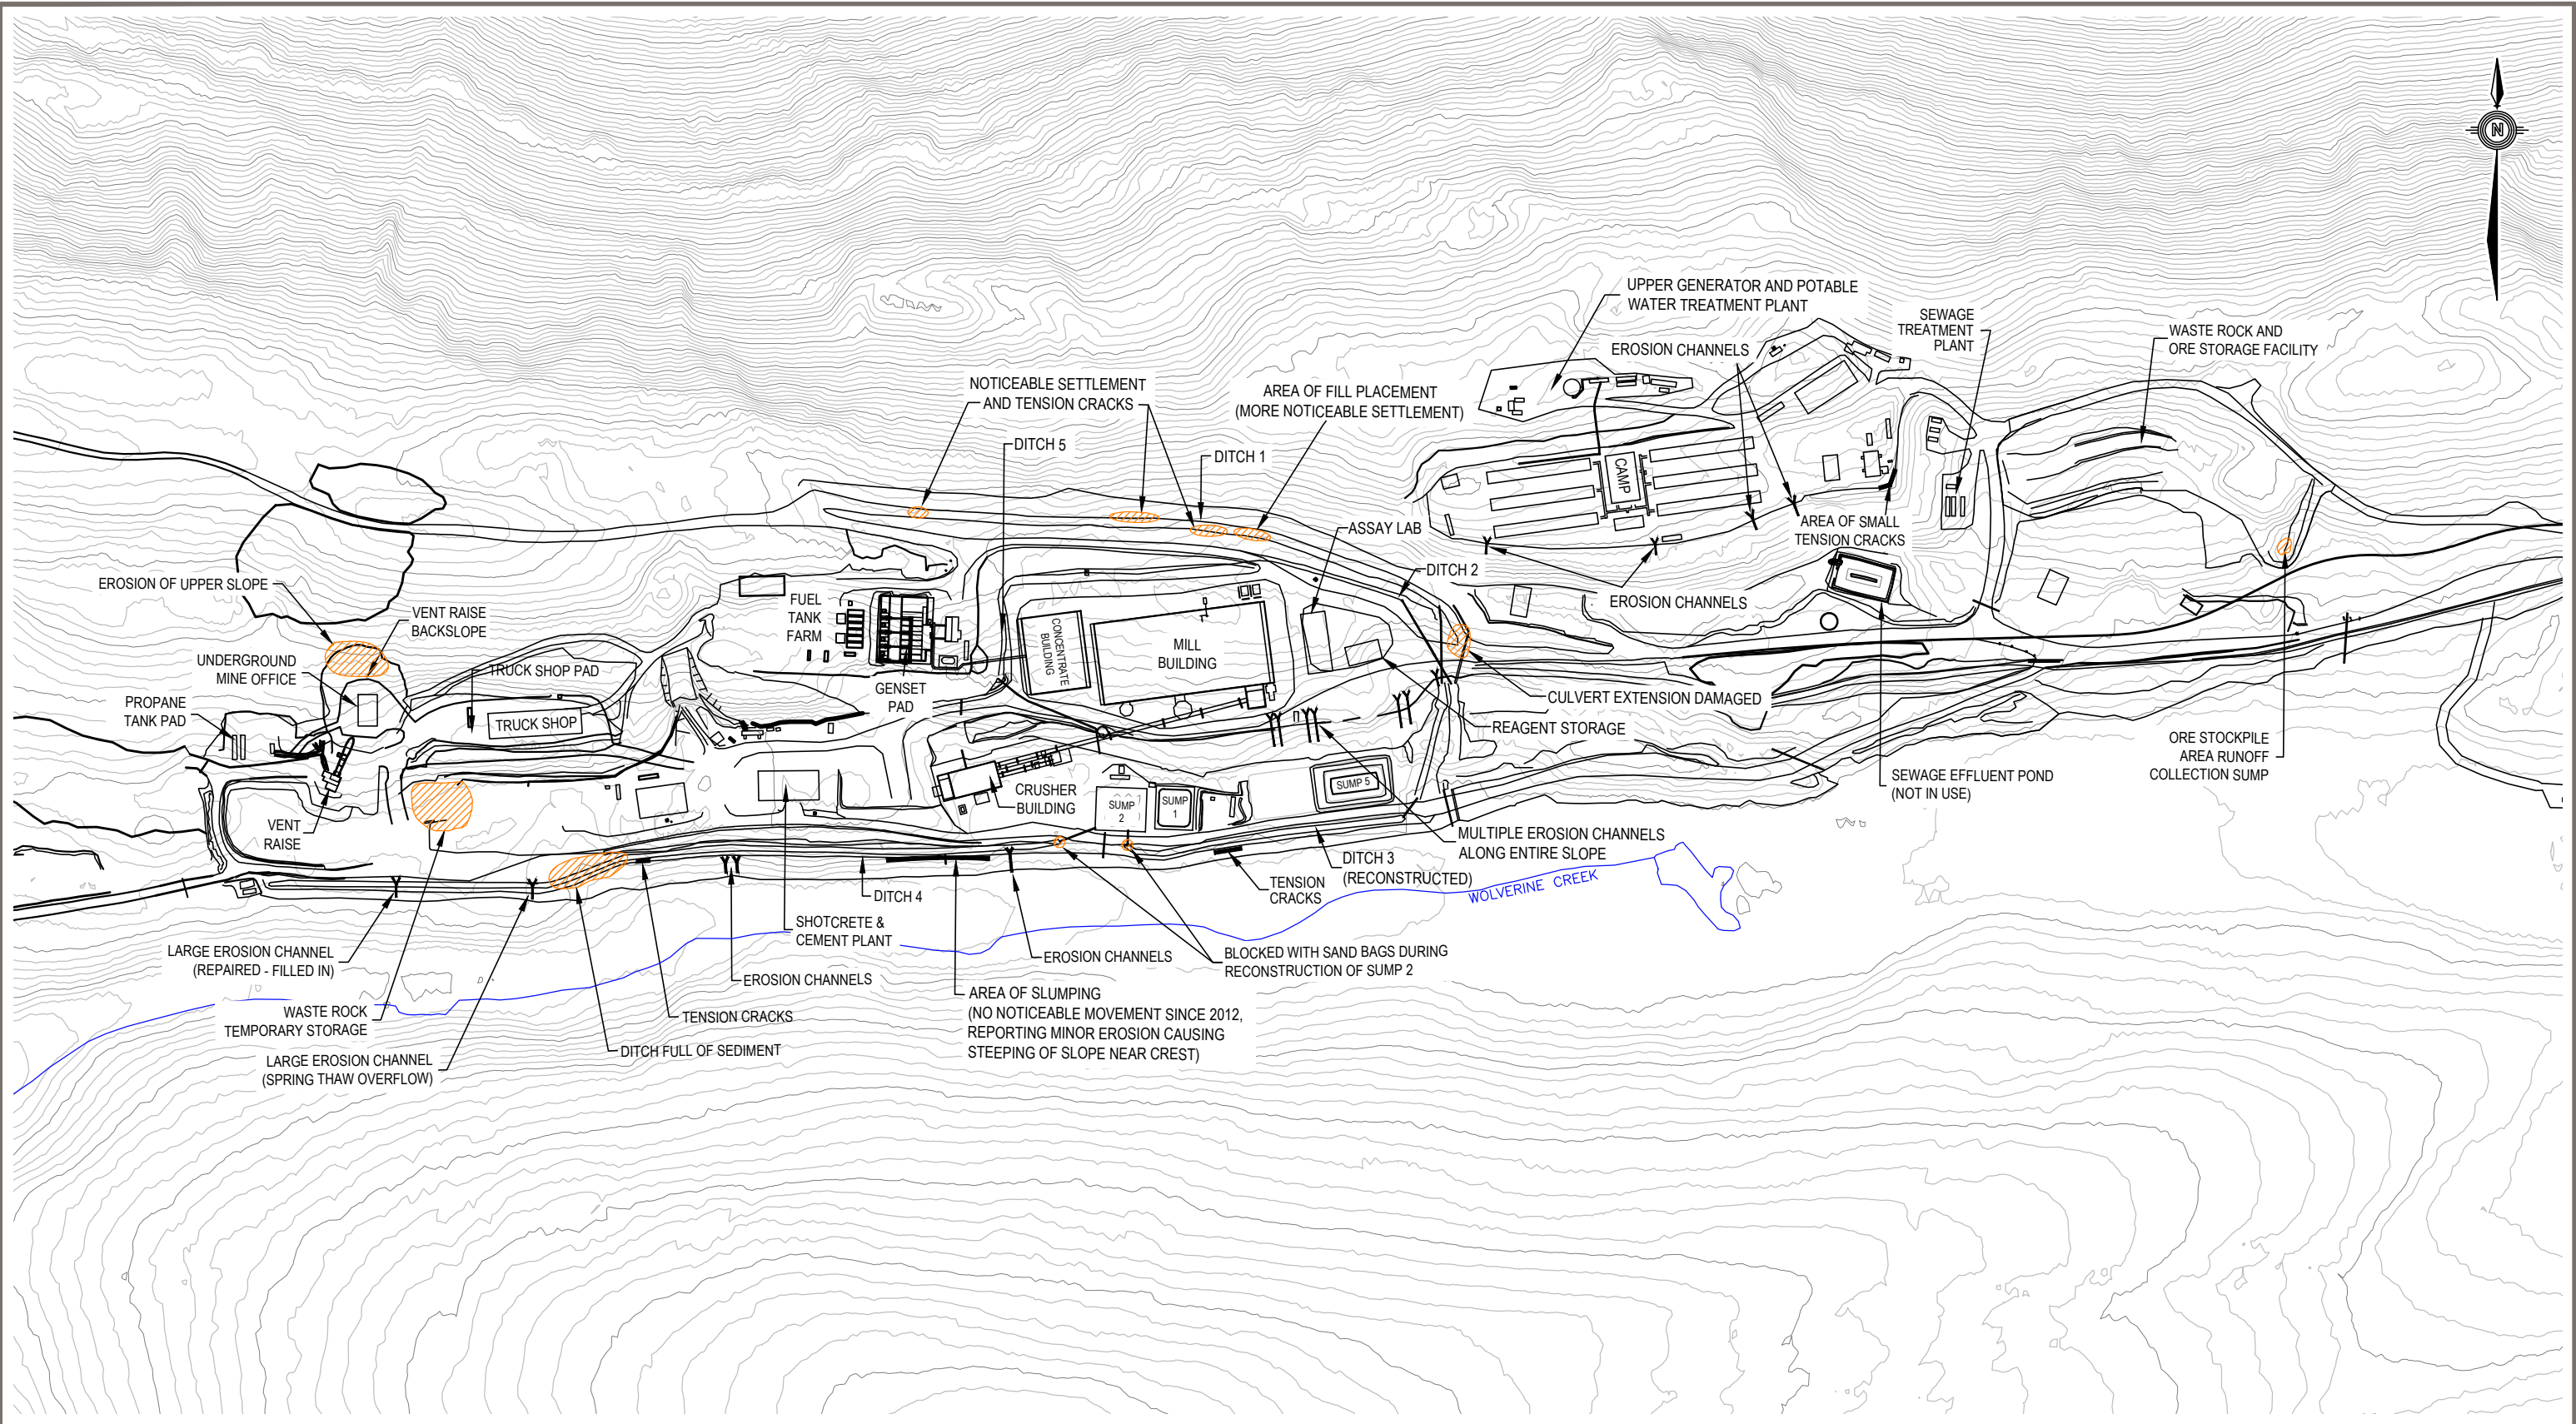
<b>LEGEND:</b> - TENSION CRACKS - EROSION CHANNEL - WATER COURSE - AREAS OF INTEREST (APPROXIMATE)	<b>STATUS</b> ISSUED FOR USE	 	<b>WOLVERINE MINE ANNUAL OBSERVATION REPORT</b> <b>WOLVERINE MINE, SOUTH EASTERN YUKON</b>				<b>Figure 1</b>										
			<b>SITE PLAN SHOWING ON-SITE EARTH STRUCTURES</b>														
 Scale: 1: 4 000 (metres)		<table border="1"> <tr> <td>PROJECT NO.</td> <td>DWN</td> <td>CKD</td> <td>REV</td> </tr> <tr> <td>W14103229-01</td> <td>CB</td> <td>CPC</td> <td>0</td> </tr> </table>		PROJECT NO.	DWN	CKD	REV	W14103229-01	CB	CPC	0	<table border="1"> <tr> <td>OFFICE</td> <td>DATE</td> </tr> <tr> <td>EBA-WHSE</td> <td>August 13, 2013</td> </tr> </table>		OFFICE	DATE	EBA-WHSE	August 13, 2013
PROJECT NO.	DWN	CKD	REV														
W14103229-01	CB	CPC	0														
OFFICE	DATE																
EBA-WHSE	August 13, 2013
