July 16, 2014

ISSUED FOR USE  
FILE: W14103418-01

**Subject:** 2014 Annual Observations of the On-site Earth Structures  
Wolverine Mine Site, Southeastern Yukon

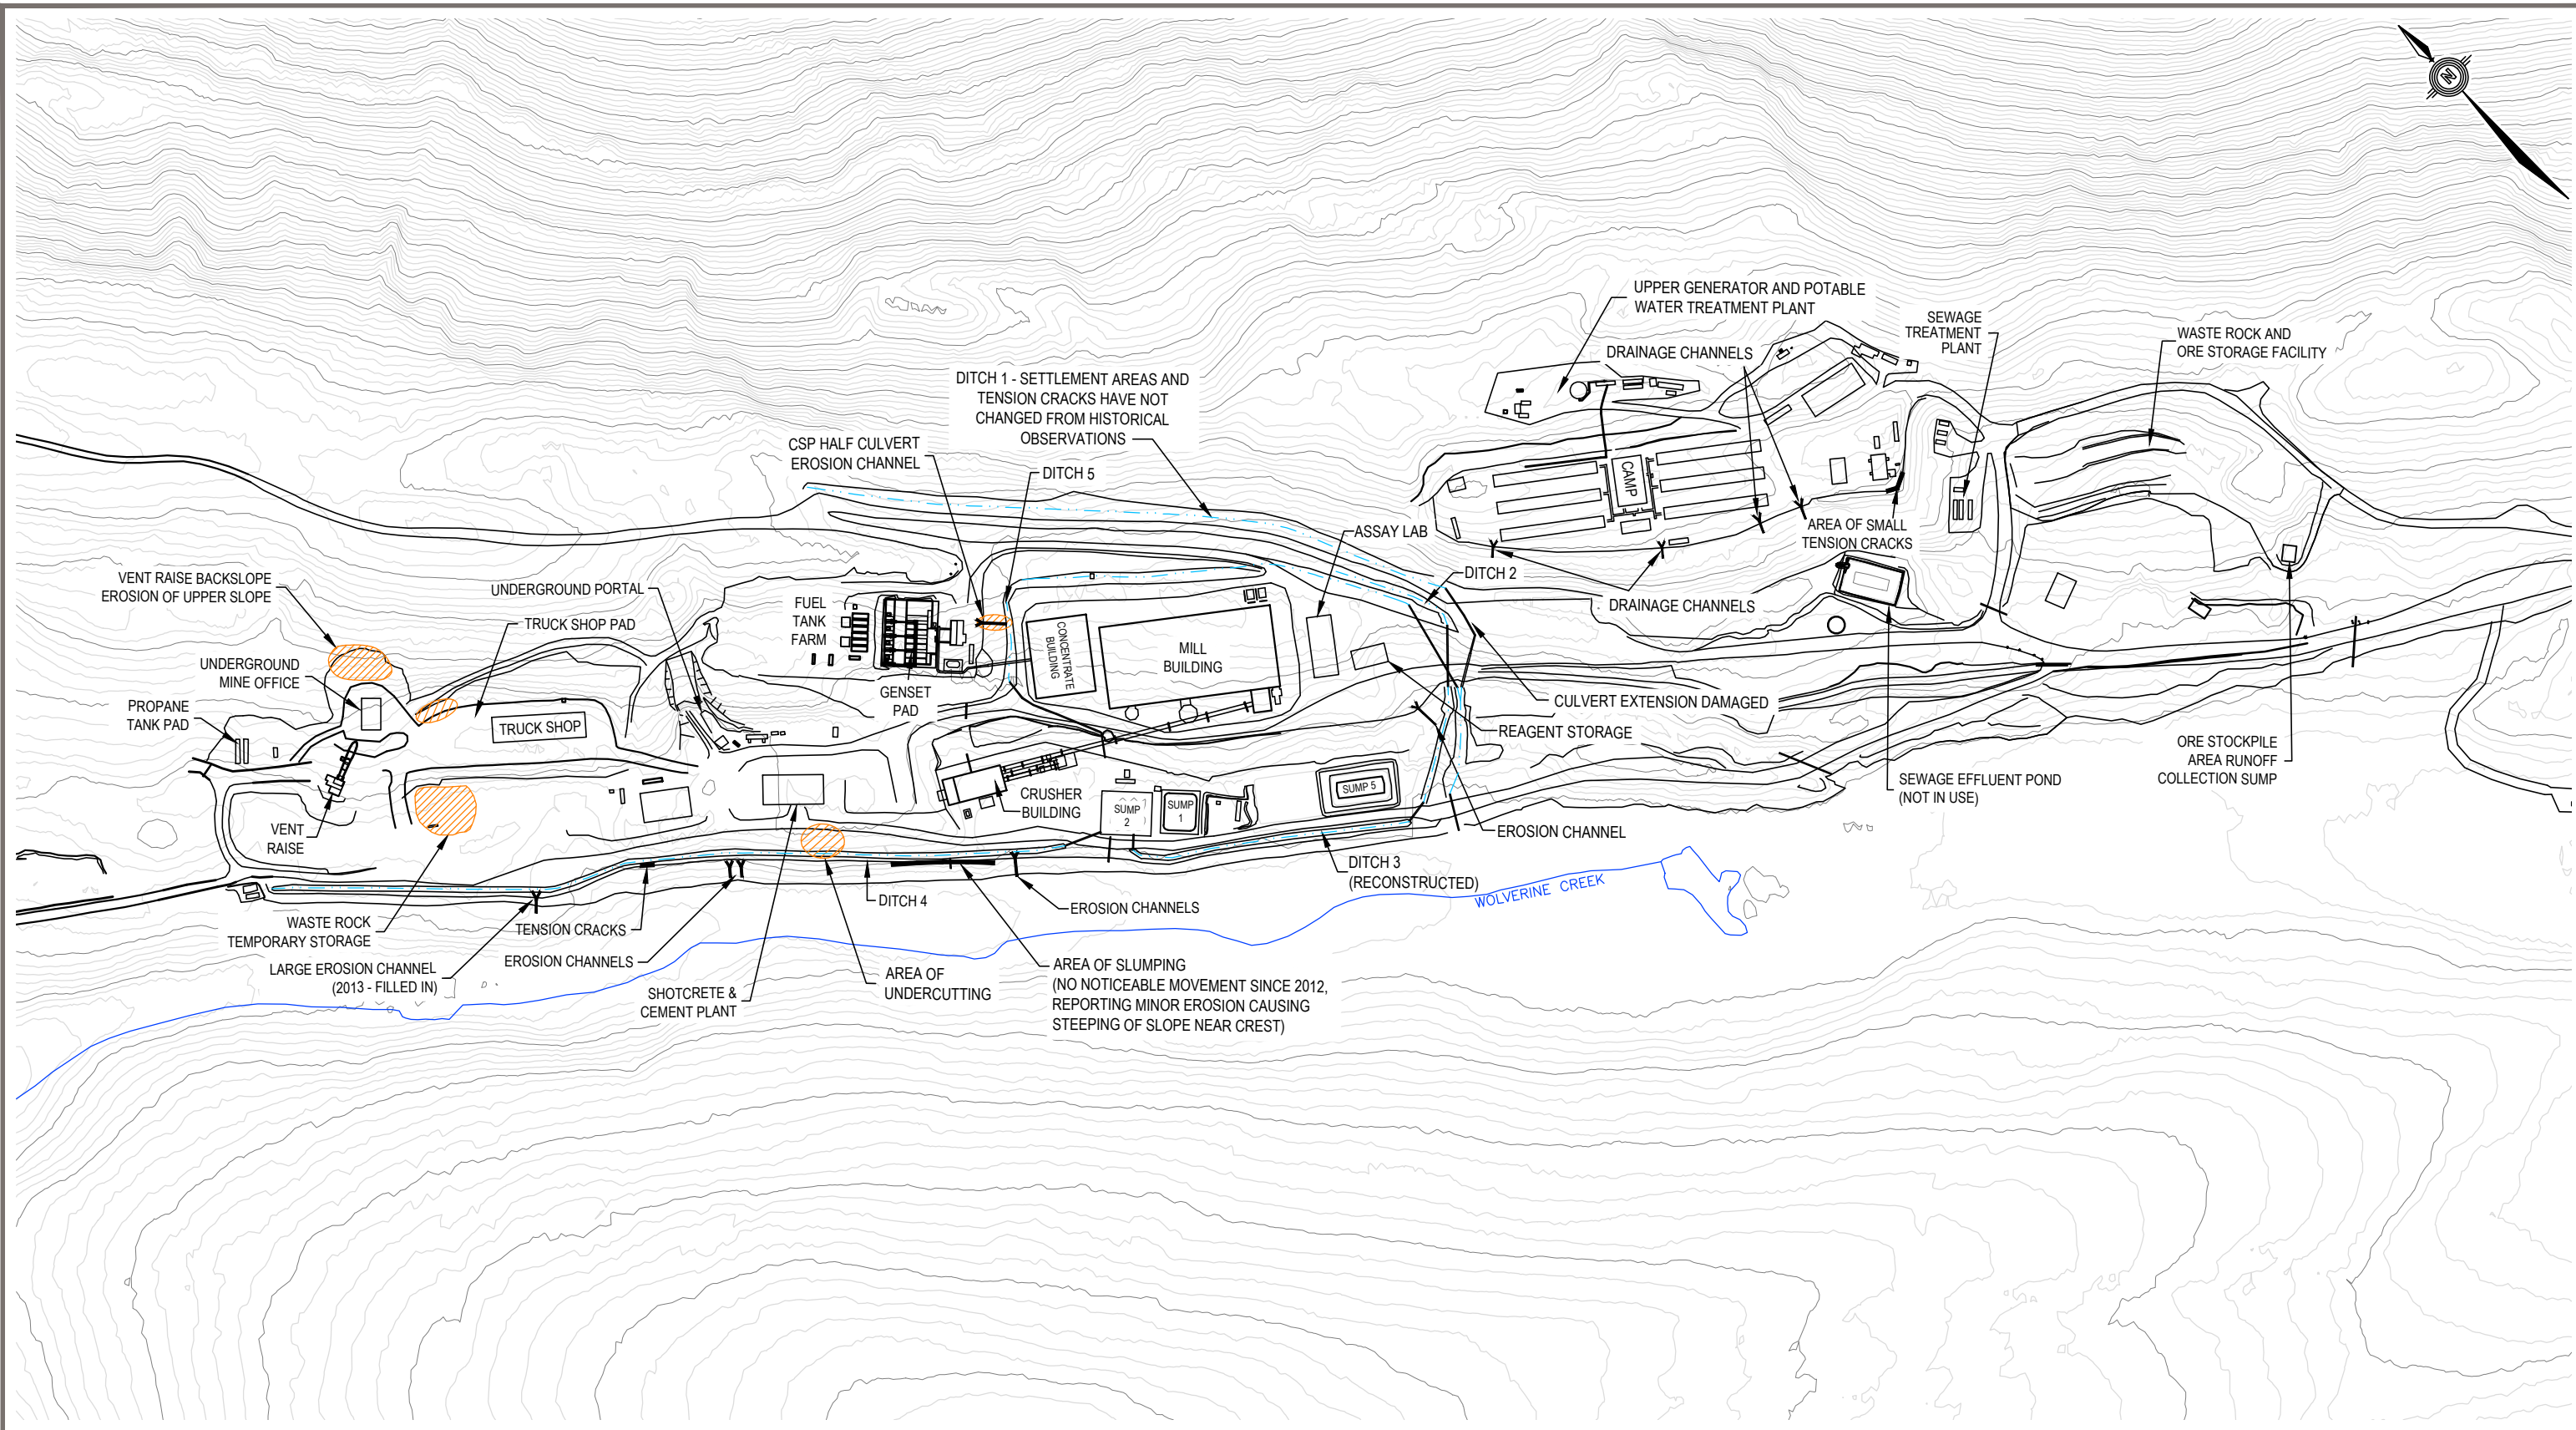
WOLVERINE MINE ANNUAL OBSERVATION REPORT WOLVERINE MINE, SOUTH EASTERN YUKON				
SITE PLAN SHOWING ON-SITE EARTH STRUCTURES				
PROJECT NO. W14103418-01	DWN CB	CKD CPC	REV 0	<b>Figure 1</b>
OFFICE EBA-WHSE	DATE June 26, 2014

The fill slope along the western sides of the mill (Photo 2) associated with the fill placement are considered stable and are constructed as per the 2:1 (H:V) design. As noted in previous annual inspection reports, there are still some noticeable erosion channels (shown on Figure 1) along the southwestern side of the mill fill that were created as a result of historical seasonal rainfall run-off events. In 2012, proper perimeter berms and site grading was completed and has been maintained throughout the last couple of years by YZC to divert surface runoff towards designated drainage ditches (Ditches 2 and 5). As a result of this grading, drainage was directed towards the southwestern corner of the mill pad where a large erosion channel has formed (Photo 3).

Item Description	Recommended Maintenance	Status
Mill Area	Fill erosion channels with coarse grained material. Still large erosion channel that requires filling at southwestern corner of the mill pad	Majority of channels completed spring 2014.
Mill Area	The MSE wall has small rocks working their way through the mesh that are considered falling hazards and should be monitored and removed as required.	
Fuel Tank Farm and Genset Pads	Small erosion channel between the two pads along the southwestern slope that requires monitoring – repair as necessary.	
Genset Pad	The main drainage channel's splash trough has broken loose and should be repaired to reduce the amount of additional extensive erosion.	
Water Treatment Sump 1	Settlement in geomembrane anchor/key trench.	No work required. Planning decommissioning for summer 2014.
Ditch 1	Fill tension cracks and areas of settlement along berm.	Still only monitoring.

Ditch 3	Minor tension cracks in new fill placement.	Monitoring.
Ditch 4	Repair liner, fill tension cracks, areas of settlement and erosion channels.	Repair work planned for summer 2014.
Ditch 5	Clean out discharge towards Sump 2.	Completed spring 2014.
Ditch 5	Clean out construction debris from upper mill pad portion of ditch.	
Camp Area	Monitor tension cracks and erosion channels – repair as necessary.	Major southwestern erosion channel has been filled in with rock.
Truck Shop Area	Small area of slumping – repair as necessary
