August 11, 2015

Yukon Zinc Corp.
#701 – 475 Howe Street
Vancouver, British Columbia
V6C 2B3

Wolverine Mine
2015 Annual Physical Inspection of TSF and On-site Earth Structures

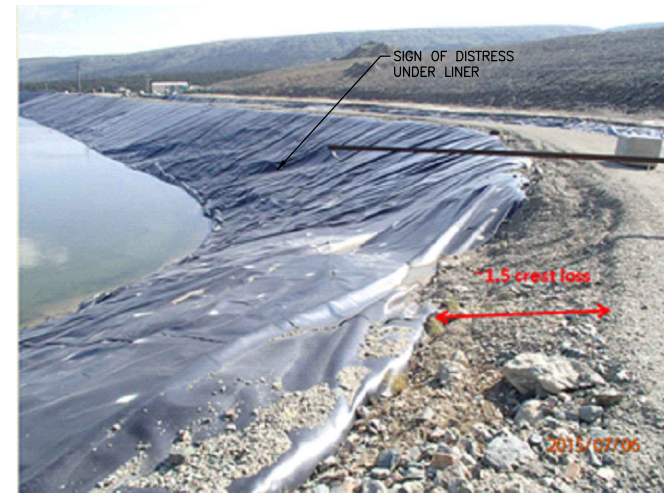
2015: SLUMP IN THE NORTH END OF IMPOUNDMENT

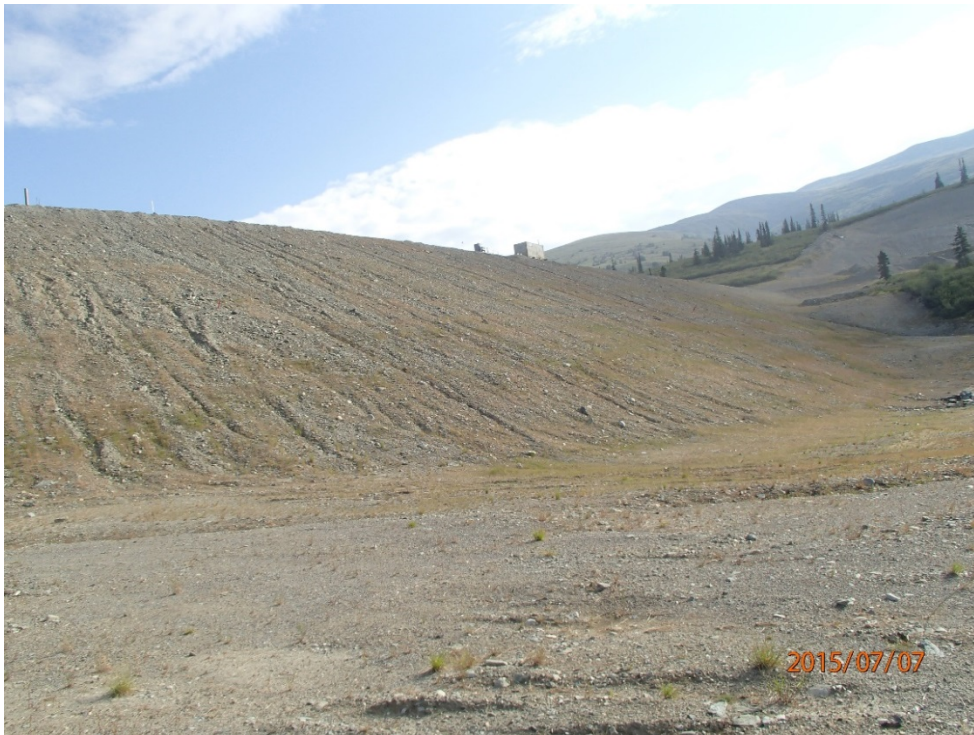
Photo 2 South dam –erosion gully on downstream edge

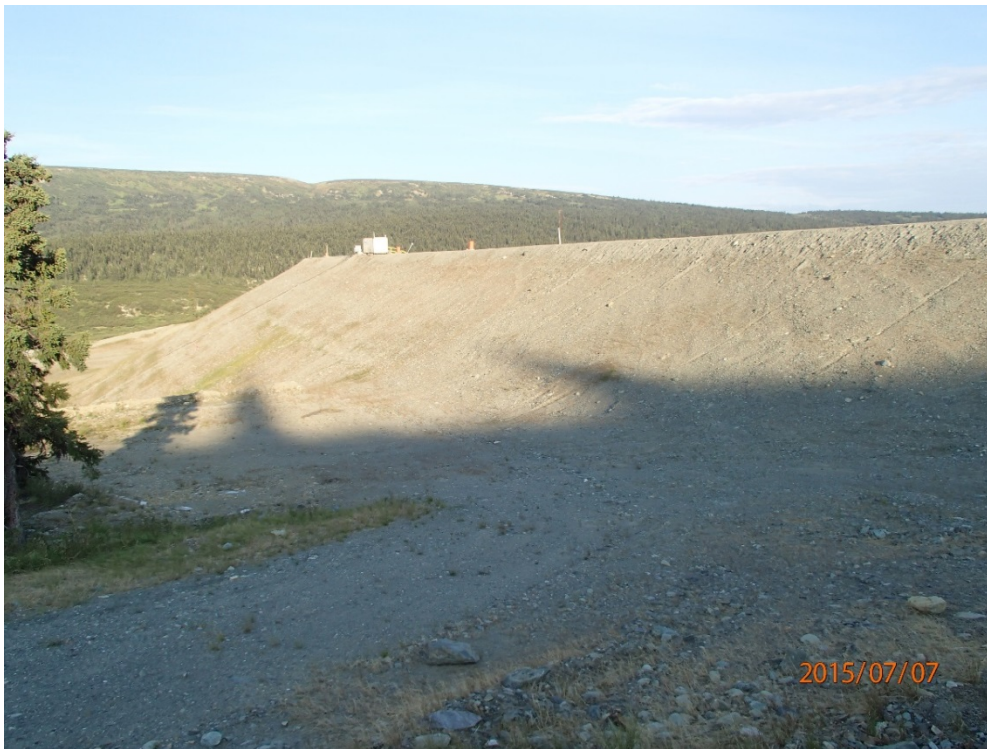
Photo 3 South dam –downstream slope looking east, erosion gully, minor grass grown naturally

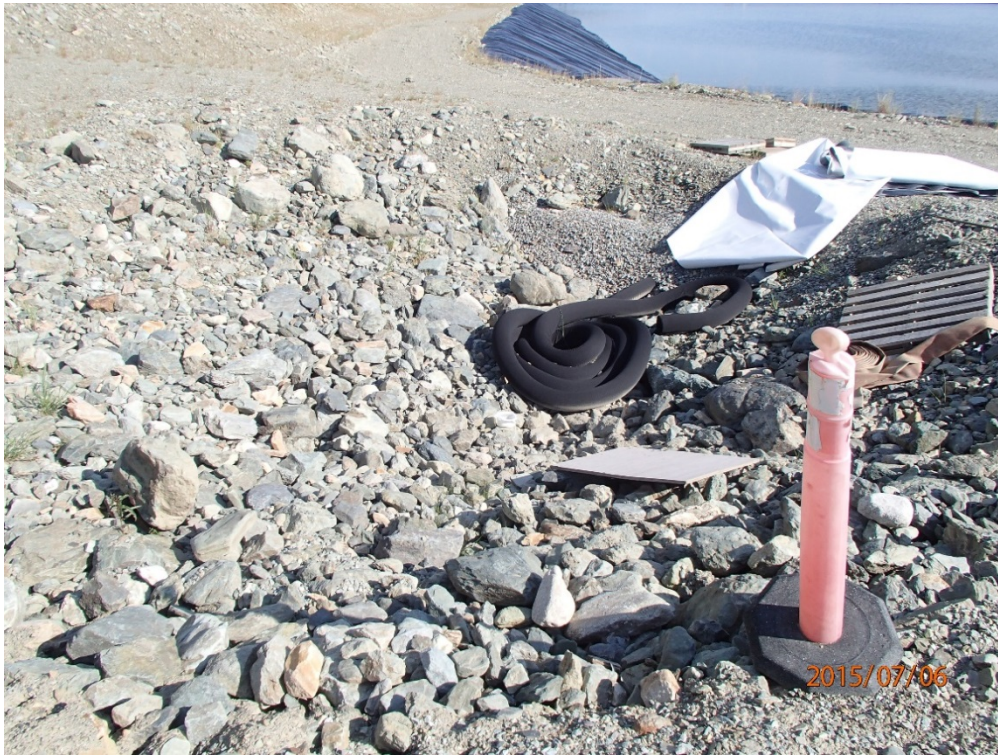
Photo 17 Spillway –looking downstream- rip rap ends upstream of the haul road and 12 inch redundant tailings line blocking the spillway

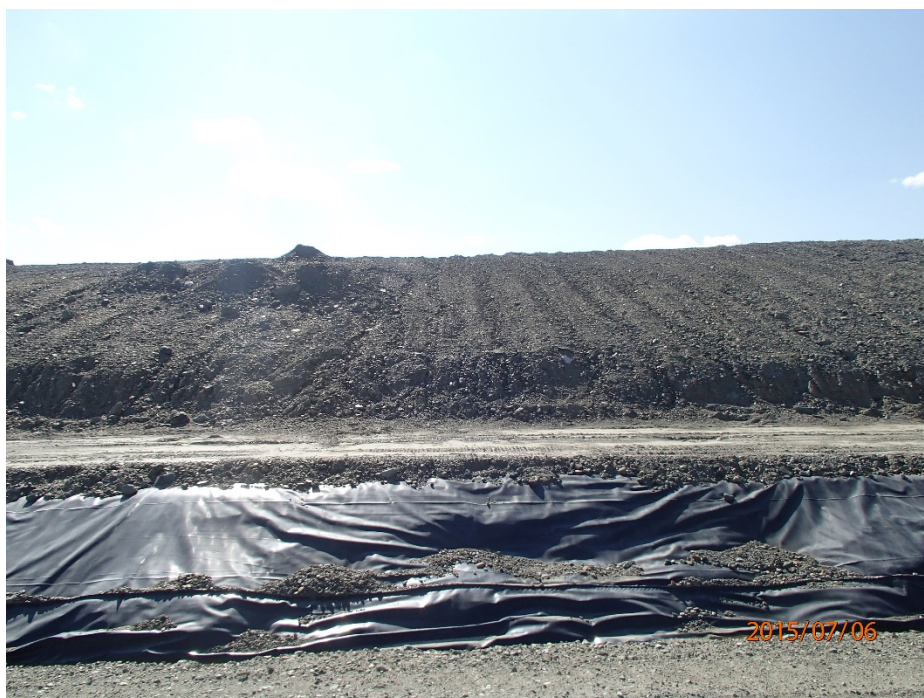
Photo 28 Ditch A – lined part – no anchoring of geotextile

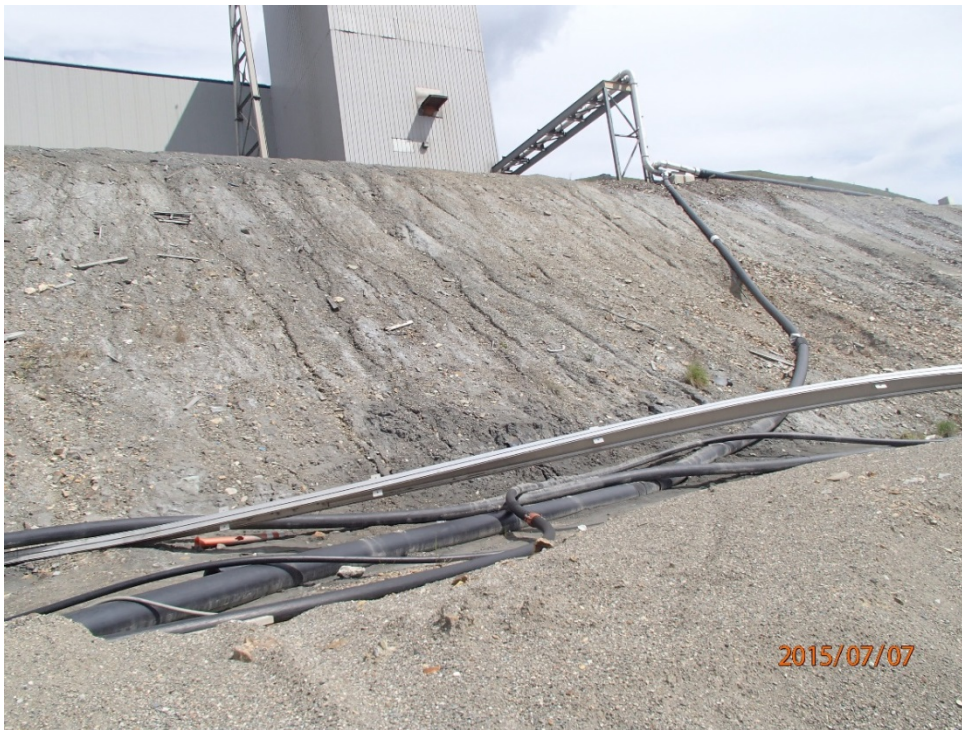
Photo 2 Mill building – downslope, minor erosion

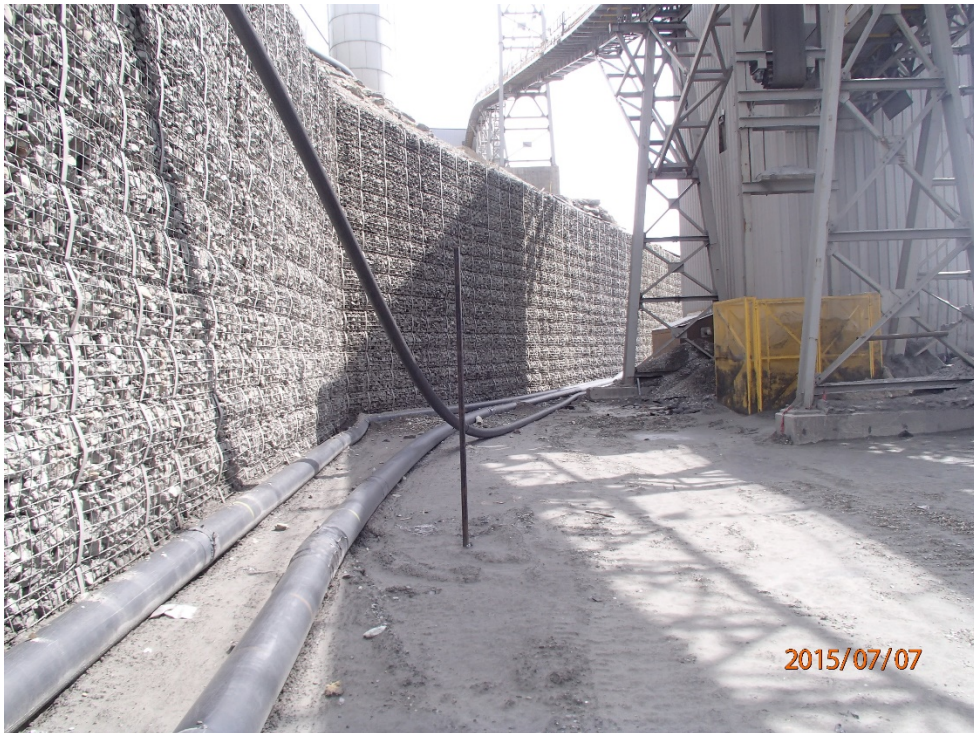
Photo 4 MSE wall – by the crusher building

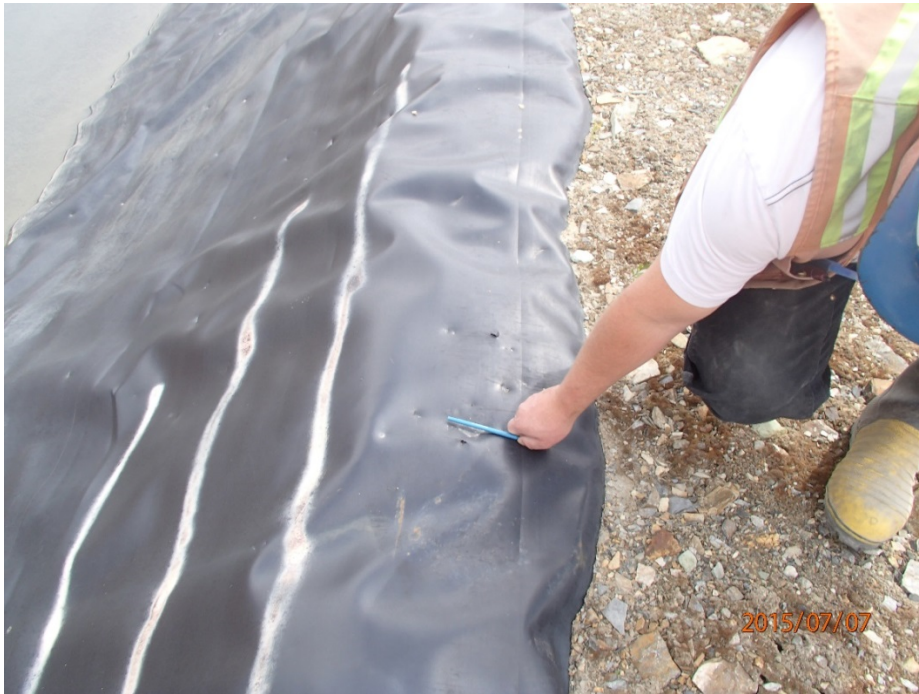
Photo 13 Sump 5

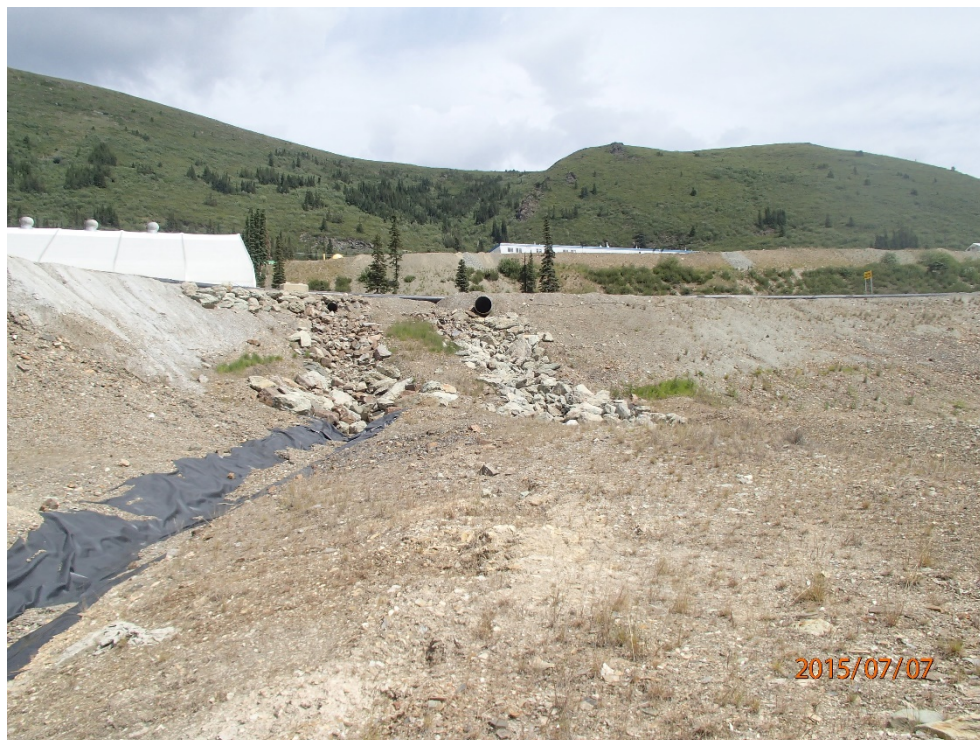
Photo 19 Ditch 2 – inlet for upper culvert, completely plugged, non-functional

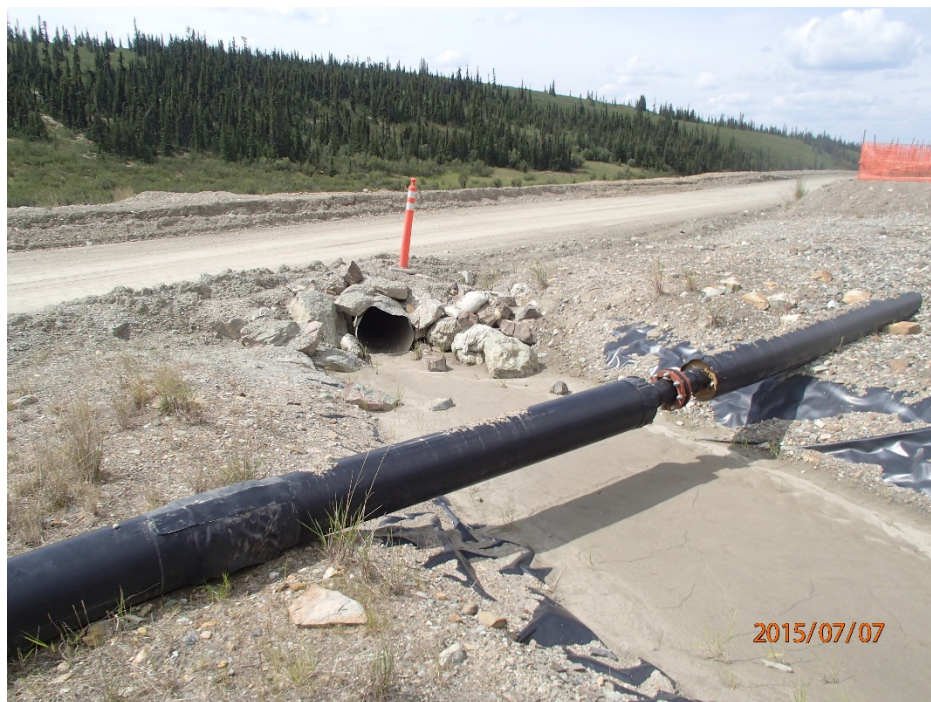
Photo 20 Ditch 2 – rip-rapped outlet for upper culvert on the left; gravel swale for groundwater culvert and Ditch 1 outlets on the right

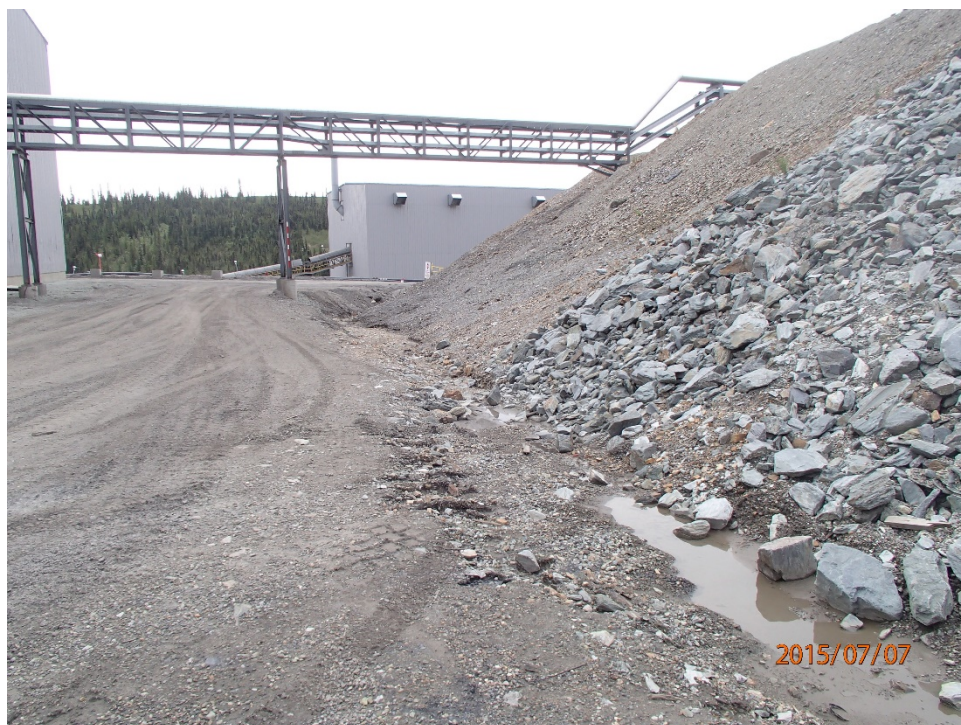
Photo 29 Ditch 4 – inlet for culvert, channel bottom and culver invert filled with sand, silt and gravel

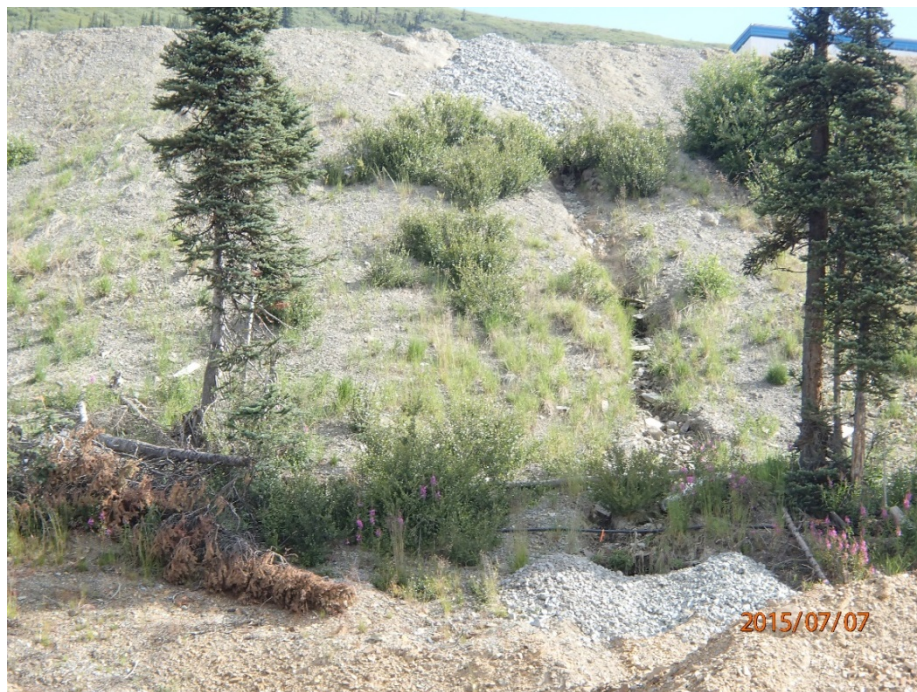
Photo 32 Camp Pad – large erosion channel in cut slope east wall, partially filled with rock, surface runoff from camp pad area accumulates at low point and drain through this area

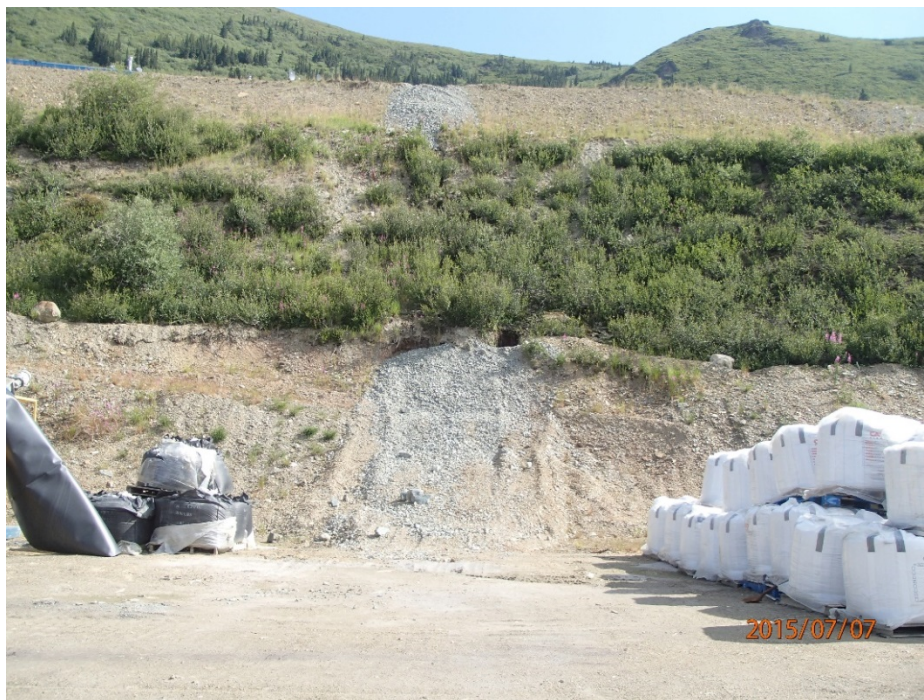
Photo 33 Camp pad – erosion channel in cut slope in south wall, partially backfilled with rock (west end)

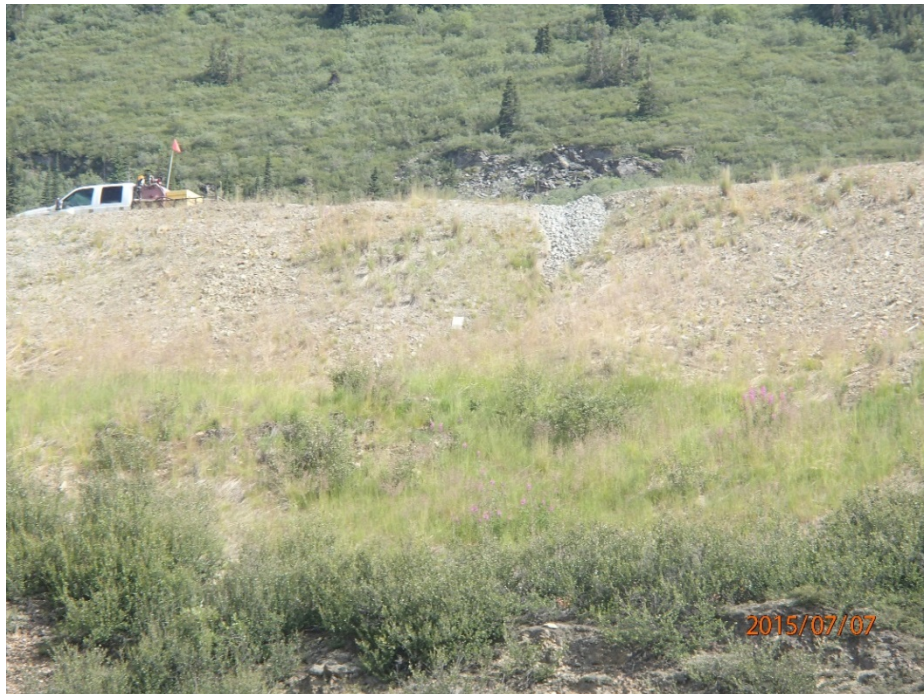
Photo 34 Camp pad – erosion channel in cut slope in south wall, partially backfilled with rock (centre part)

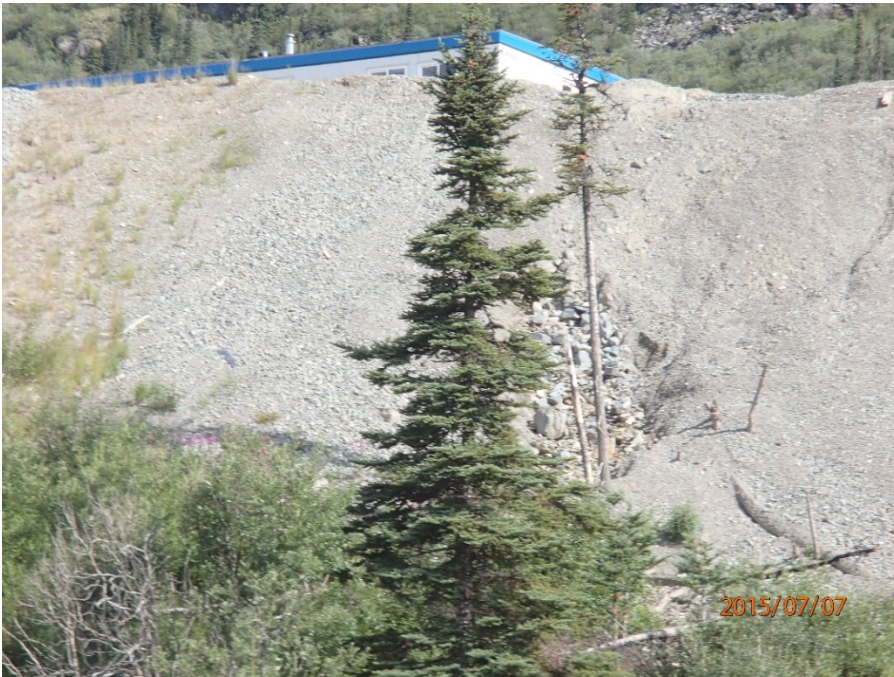
Photo 35 Camp pad – erosion channel in cut slope in south wall, partially backfilled with rock (centre part)

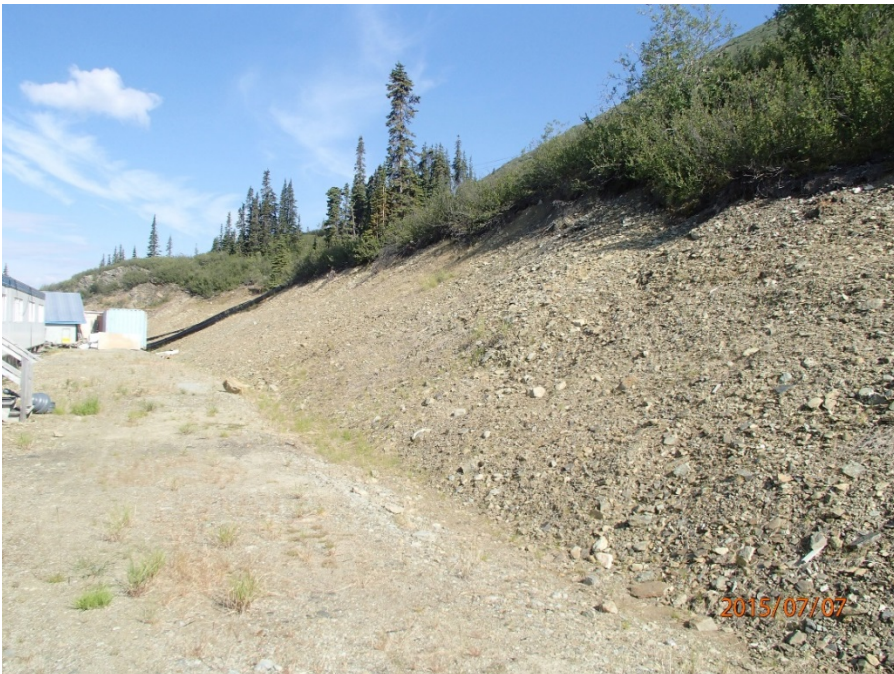
Photo 36 Camp pad – erosion channel in cut slope in south wall, partially backfilled with rock (east end), this channel was backfilled with rock to work as a French drain for surface runoff after large storm event

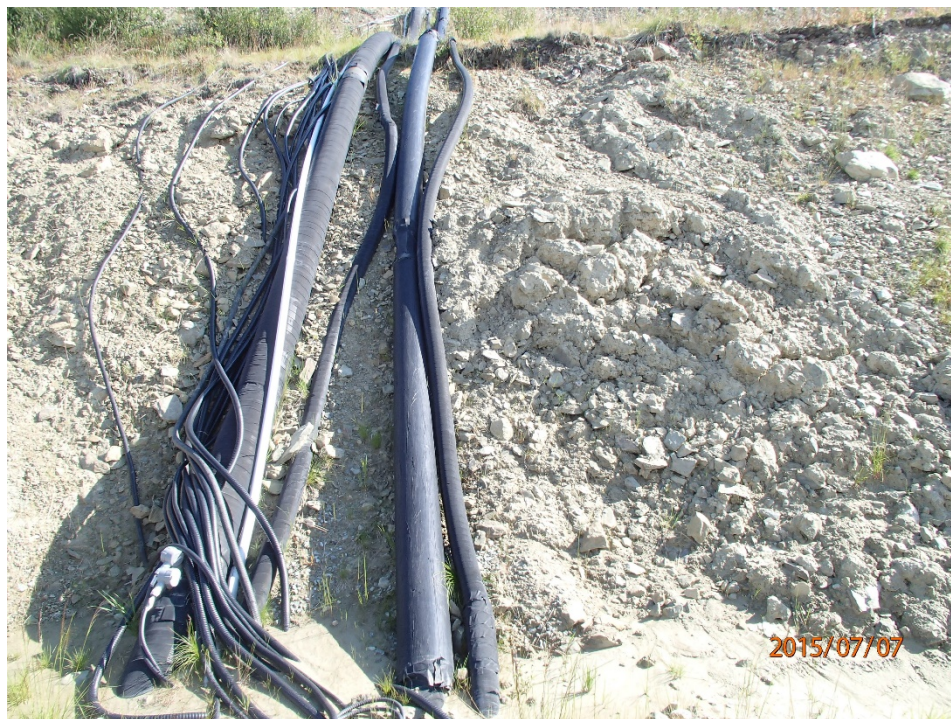
Photo 37 Upper generator and potable water treatment pad – cut slope looking west, minor erosion gullies

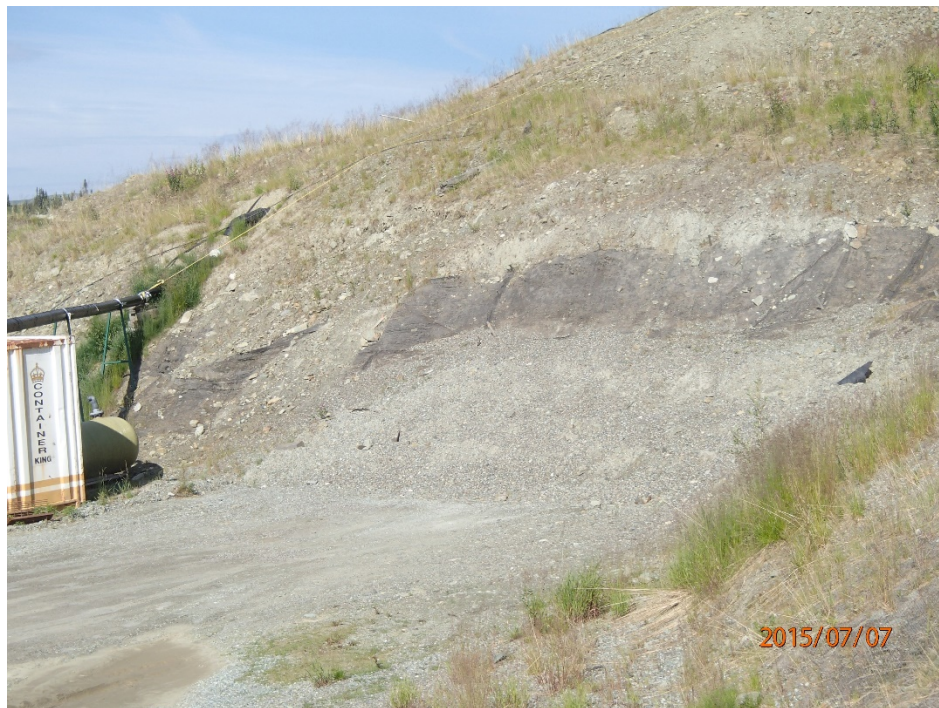
Photo 38 Upper generator and potable water treatment pad – cut slope, slumping along the water line corridor

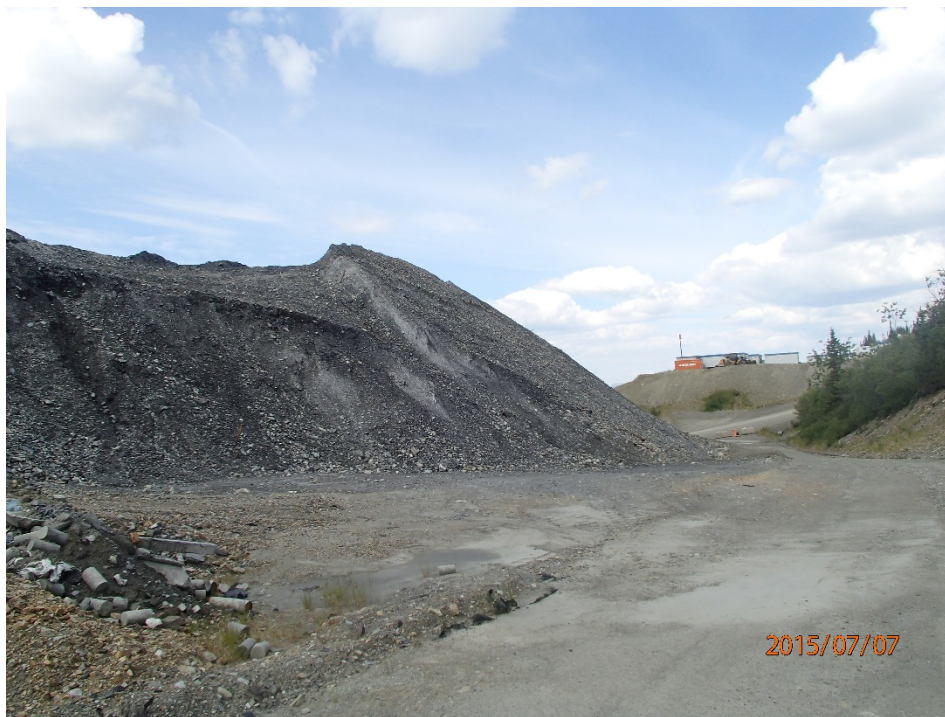
Photo 42 Waste Rock and Ore Storage Facility – outside slope

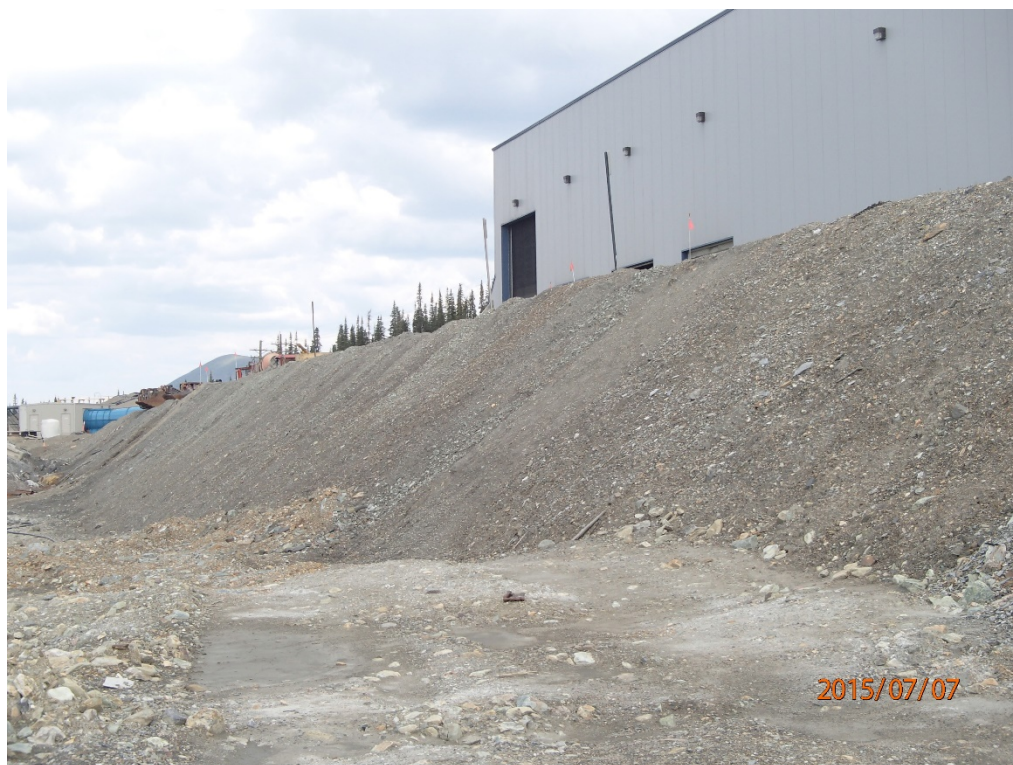
Photo 49 Truck shop pad – back slope, signs of sloughing

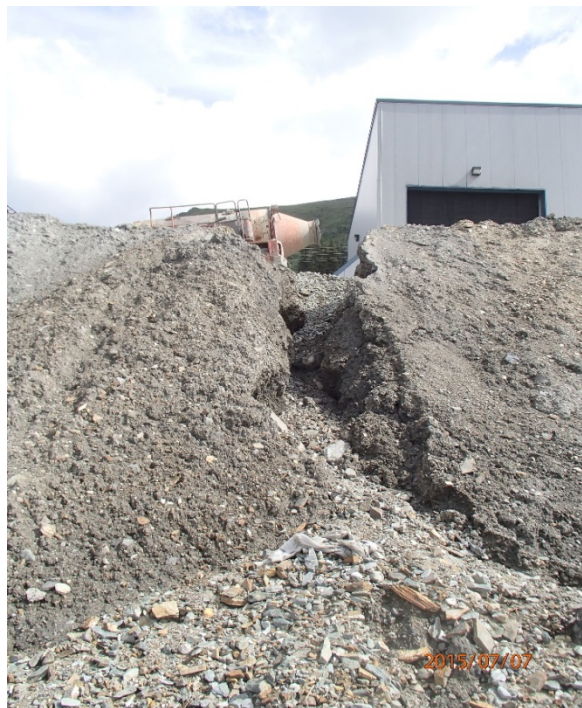
Photo 50 Truck shop pad – downslope, looking west

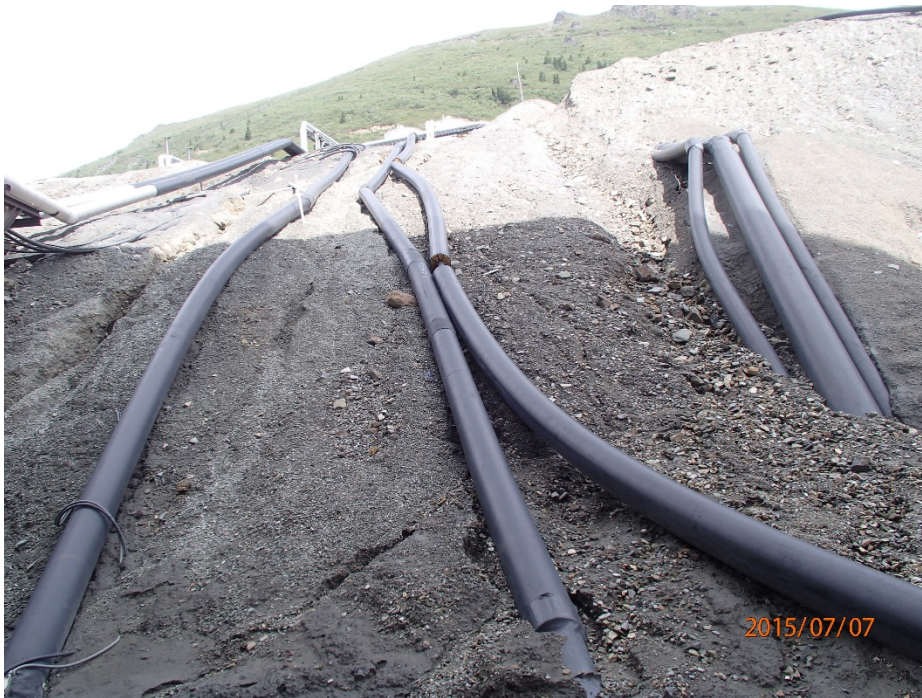
Photo 51 Truck shop pad – downslope, erosion channel near the west corner of truck shop building
