# **Yukon Zinc Corp.**

**Wolverine Mine**

***Dam Safety Review***

***Tailing Storage Facility and Earth Structures***

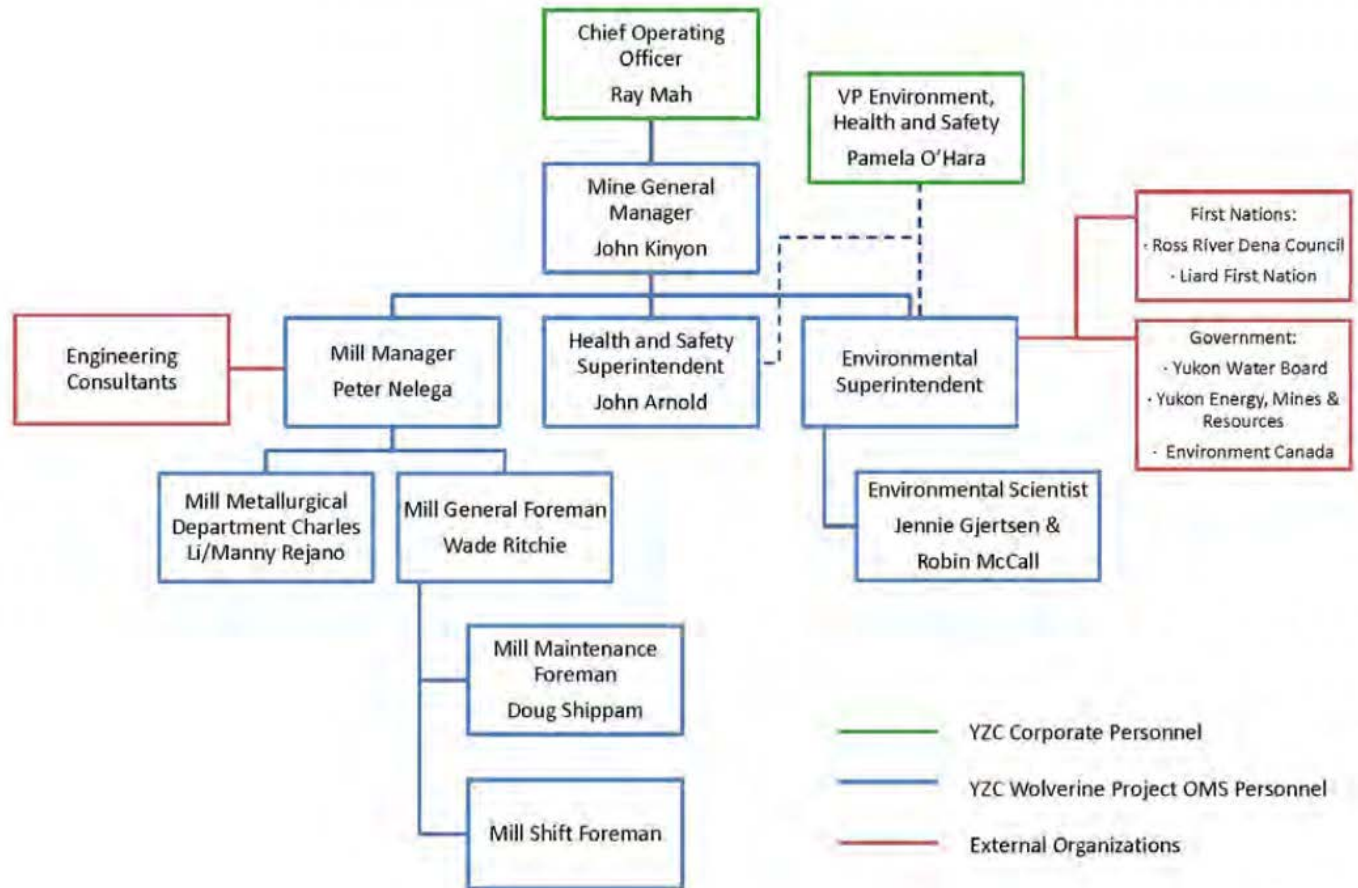
**Figure 2.1 Wolverine Mine – Operations Organization Chart (outdated) – Main Reporting Links**

The overall set up and content of the OMS manual is relevant and meets the general requirements of the CDA recommendations. However, the OMS manual is out of date as most of the people referenced in the document no longer work for Yukon Zinc. The mine is currently in care and maintenance and the OMS manual represents how the facility was managed while in operation. The OMS manual needs to be updated to the current status of the facility under care and maintenance. If the mine transitions to either restart of operations or full closure then the OMS manual should again be revised to represent these new conditions.

Currently, the TSF is managed by the care and maintenance crews and they report to Peter Mah who is responsible for the site operations. Given the small teams on site and in Vancouver the reporting structure is very lean and should be indicated in the OMS manual.

The organization structure for management of the tailings facilities is presented on Figure 2.1, but is out of date. This should be updated to reflect the current status of the operation. The OMS manual needs to be revised to reflect the current status of the mine in care and maintenance. It should also be updated again once decisions are made on whether the mine transitions back to operation or to closure.

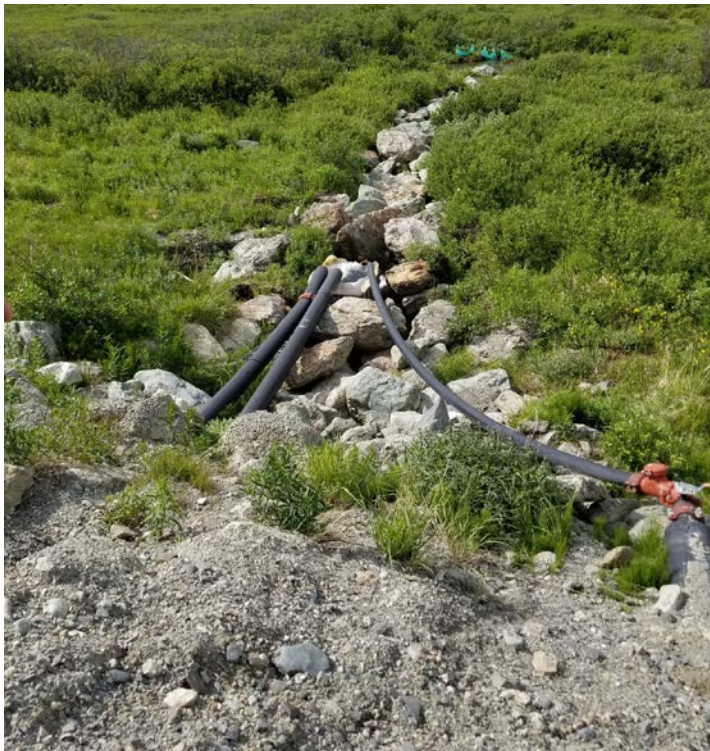
**Photo 10** Discharge from under drain pipes downstream of seepage pond

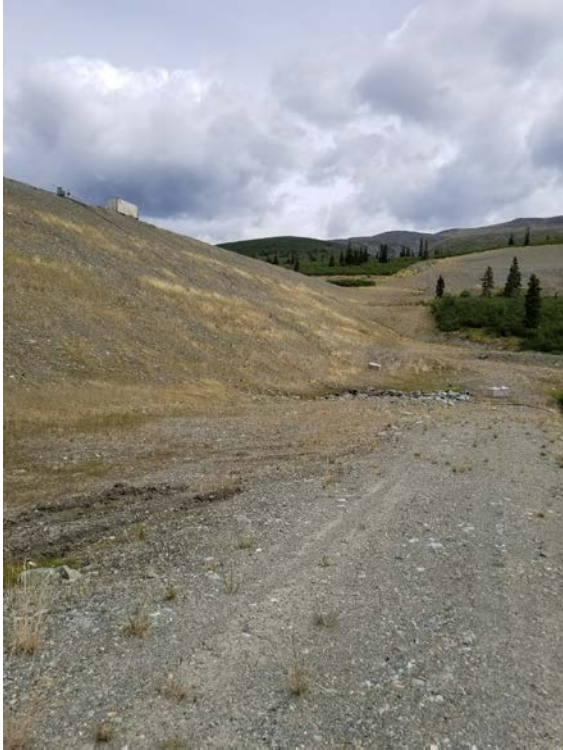
**Photo 15** Downstream toe near seepage pond

Visual observations of seepage during the 2017 DSR along the South leg of the toe were observed were limited to damp soil but not actual flowing water.

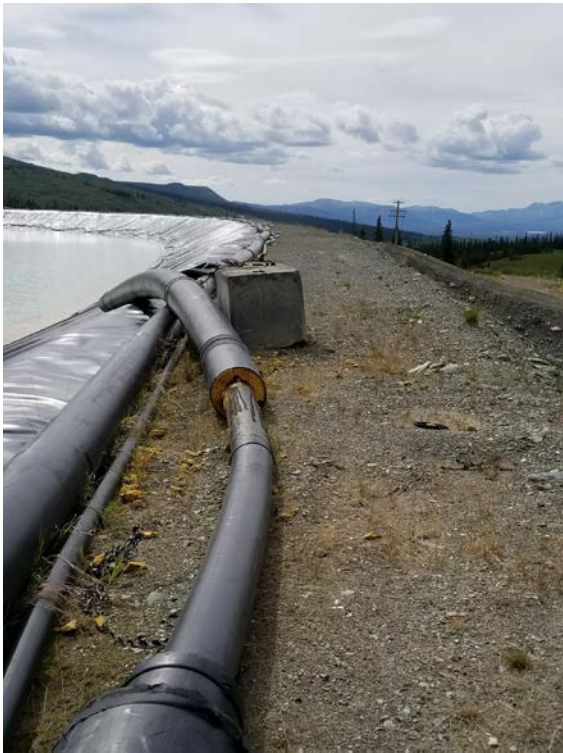
**Photo 23** Pipe discharging water from other on site facilities
