THE WHITEHORSE ESCARPMENT

(Prepared for the Advisory Committee on Northern
Development, Department of Northern Affairs and
National Resources)

R.F. Legget and G.H. Johnston

Report No. 136
of the
Division of Building Research

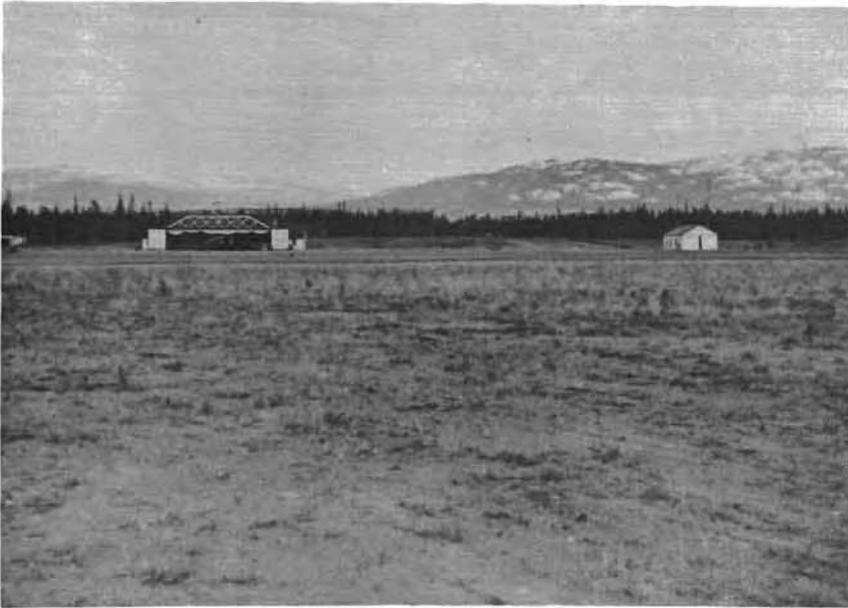
It was not until 1927, however, when the Yukon Airways and Exploration Co. Ltd. was incorporated, that commercial aviation got its start. Klondike Airways Ltd. began operations in 1928 initiating air mail service to Mayo. In 1929, it was announced by the Hon. Charles Stewart, Minister of the Interior, that ample land had been set aside (at Whitehorse) for aviation purposes. Some of the land required for the airfield was donated by the White Pass and Yukon Route. The sum of \$1,000 collected by subscription from local residents at this time was used to clear some brush and level off parts of the airstrip. Additional clearing, though not extensive, was carried out adjacent to the airstrip during 1930 to 1936. Some gravel (decomposed granite) obtained nearby was used to level off bumps and hollows on the grassy meadow (Figs. 2 and 3).

Figure 2. Whitehorse Airfield, 1939, looking east. (Geol. Survey of Canada photo No. 86836)

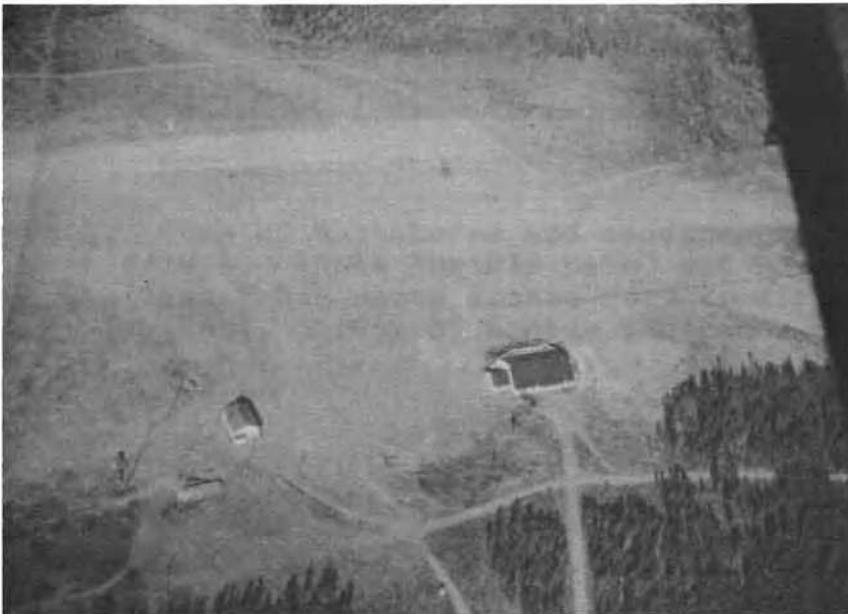
Figure 3. Vertical air view of Whitehorse Airfield, 1939, (north on right side of photo). (Geol. Survey of Canada photo No. 86838)

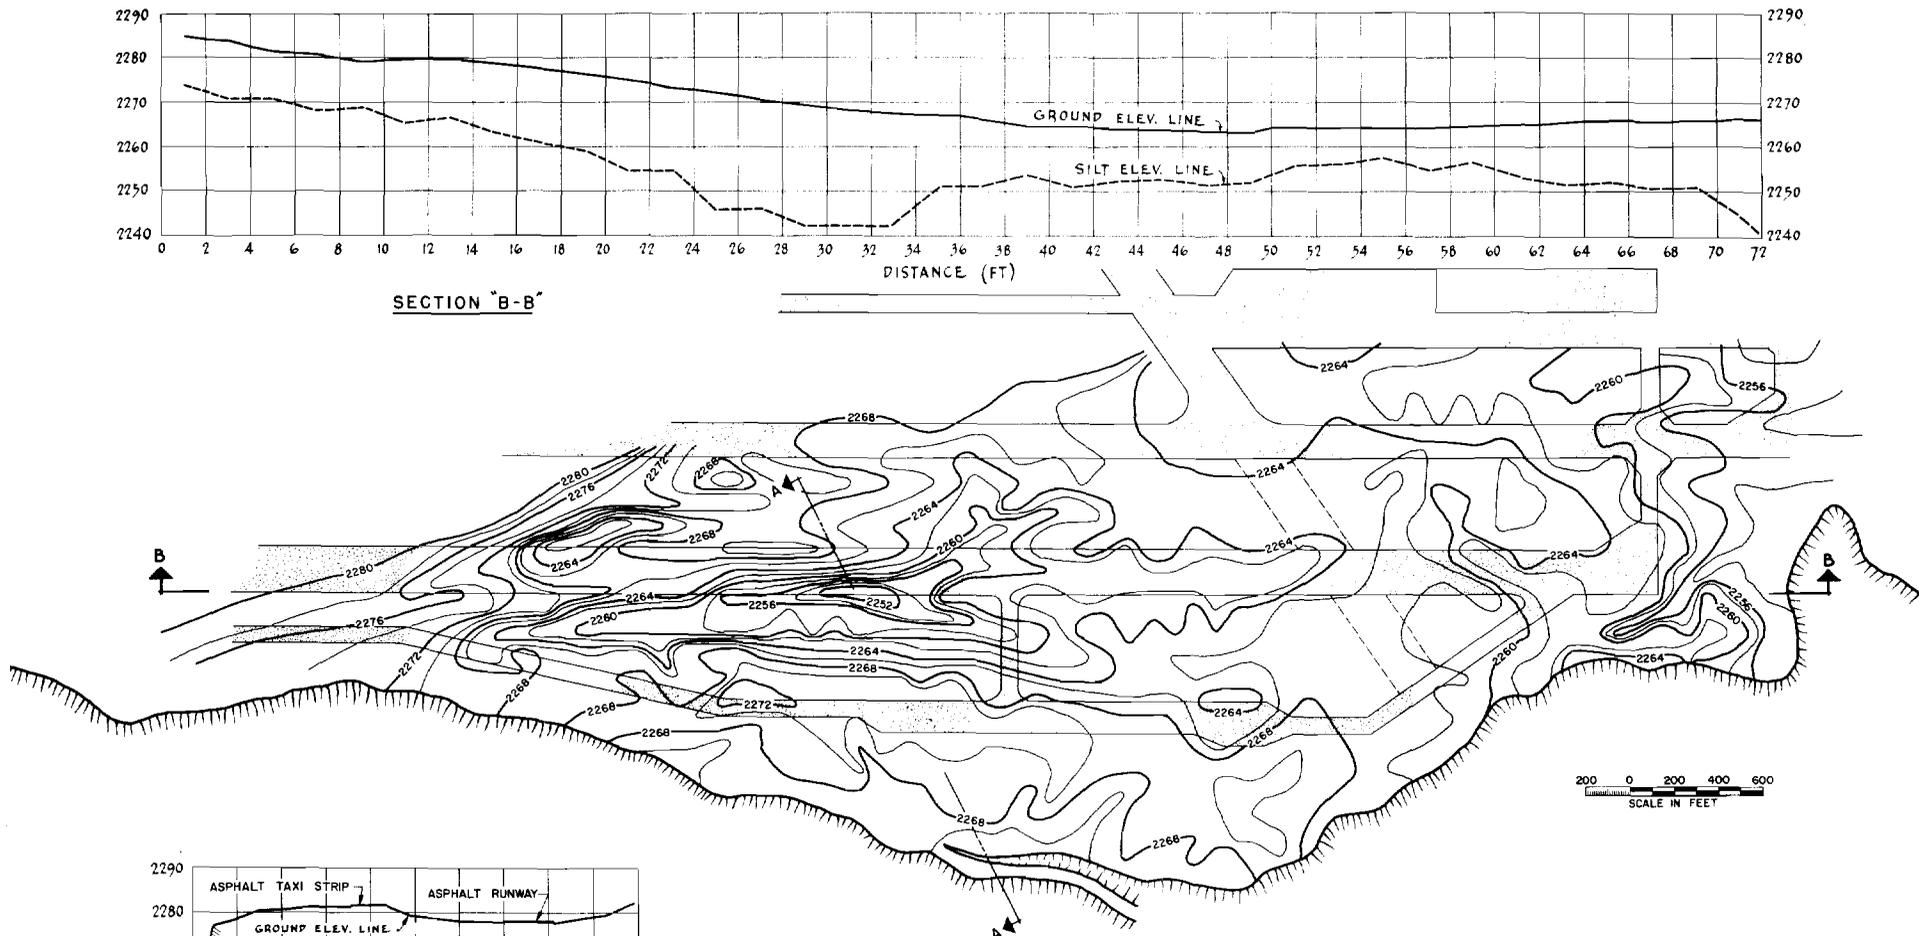
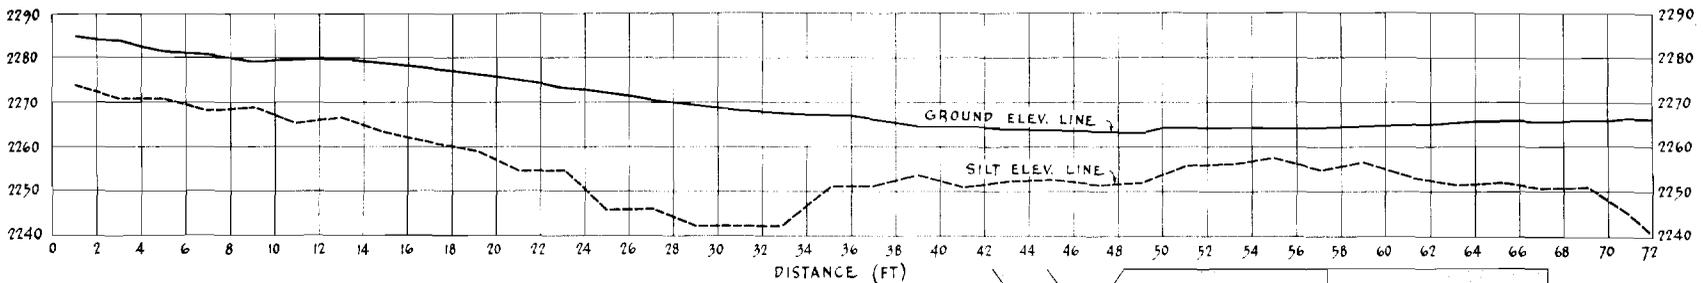
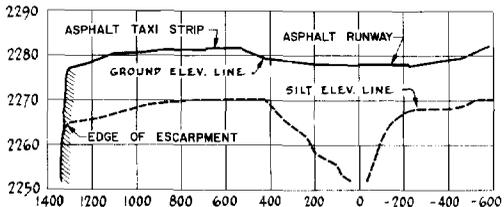
FIGURE 18

This report presented exactly the information on the silt contours required by the authors. These records have been carefully plotted and on the basis they provide, much more detailed contours of the silt surface have been prepared and are now shown on Figure 18 accompanying this report. The conclusions now included in this report were confirmed by this additional information. Excerpts from the consultants' report appear as Appendix D. The report itself went much further than giving the soil records requested but it was this information which was necessary for the completion of this report and the abstract therefore relates only to the levels of the silt. Complete information on the survey and borings program is available from the Development Engineering Branch, Department of Public Works.
