MPERG Report 2009-3

A Review of Several Yukon Revegetation Projects and Techniques

EDI Environmental Dynamics Inc.

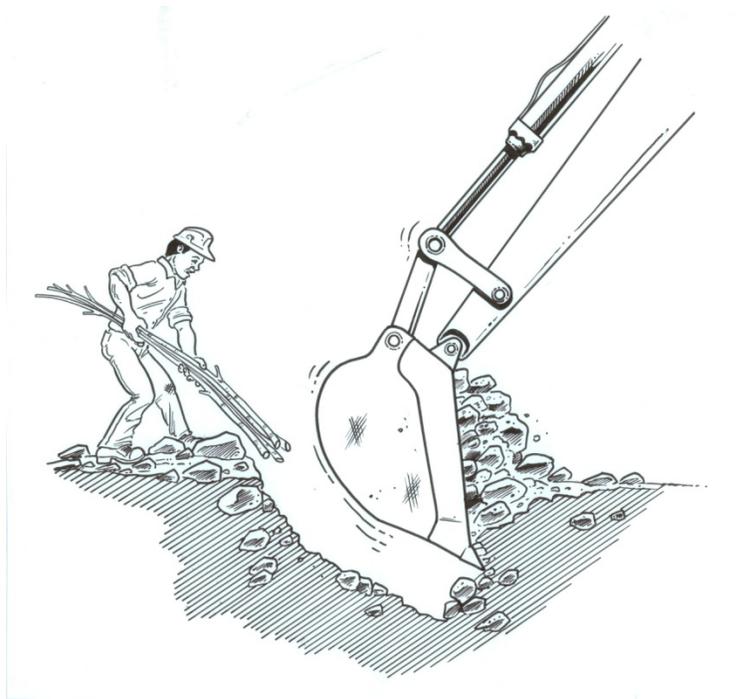
Gravel bar or river bank staking is a variation of the live staking method used specifically for river or stream bars. Stakes are inserted diagonally into the substrate with the top facing the stream flow. An excavator is often used for the installation (Photo 4). The stakes slow the water flow when the river bar or bank floods. This results in deposition of fine sediments and debris, which in turn provides suitable substrate for native plant establishment.

Gravel bar staking was completed on a side channel of the Klondike River at Germaine Creek (M. Miles and Associates Ltd. and Polster Environmental Services Ltd. 2007) and near the Beaver Creek Bridge (P. Tobler. pers. comm.). Both projects show successful growth of the stakes. The Germaine Creek site showed 110 cm long willow plants (on average) on the left bank gravel bar four years after reclamation.

Photo 4: Diagram of live gravel bar staking. Live cuttings are inserted diagonally into gravel bars (Diagram courtesy Polster Environmental Services, 2009).

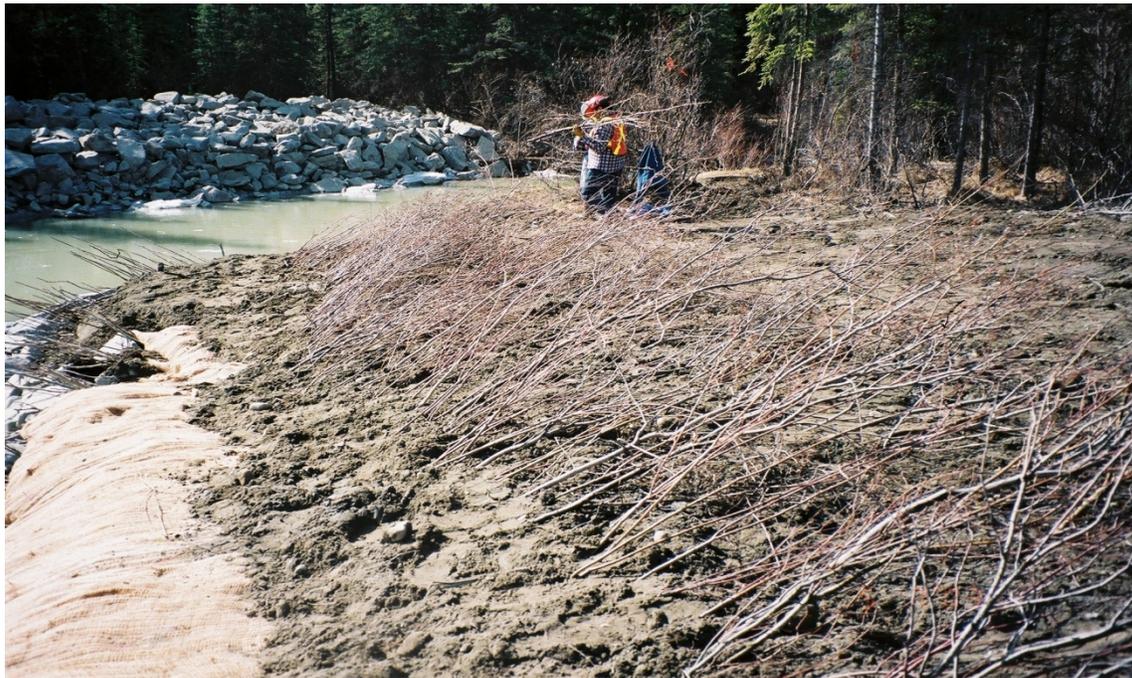
Brush mattresses are layers of interlaced live cuttings installed on gentle slopes or nearly level areas to reduce erosion (Photo 7). Live fascines are bundles of live cuttings buried in excavated trenches, perpendicular to a slope (Photo 8). Both of these structures were tried at the Mendenhall River crossing. Limited or no success was documented for these methods at this site.

Photo 7: A live brush mattress installation at the Mendenhall River crossing, near KM 1557 of the Alaska Highway in the summer of 2003. The brush mattress was buried by an excavator after taking this photo.

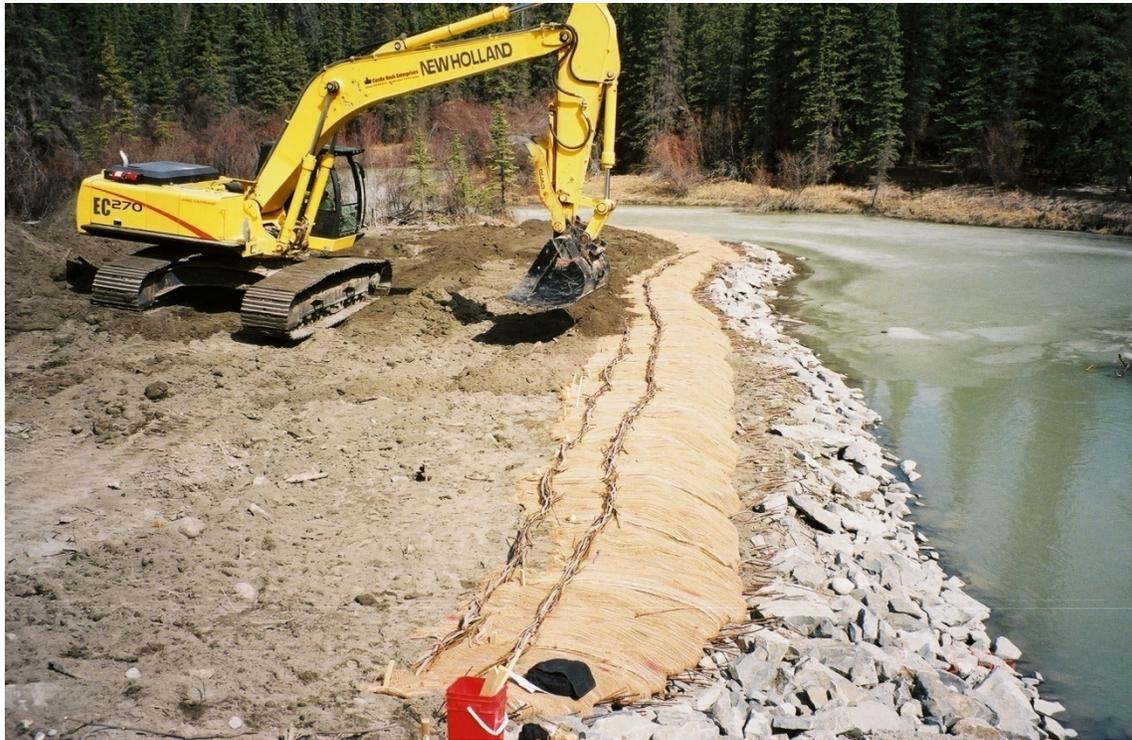
Photo 8: Live fascines assembled and ready for burial in trenches at the Mendenhall River crossing (summer 2003).

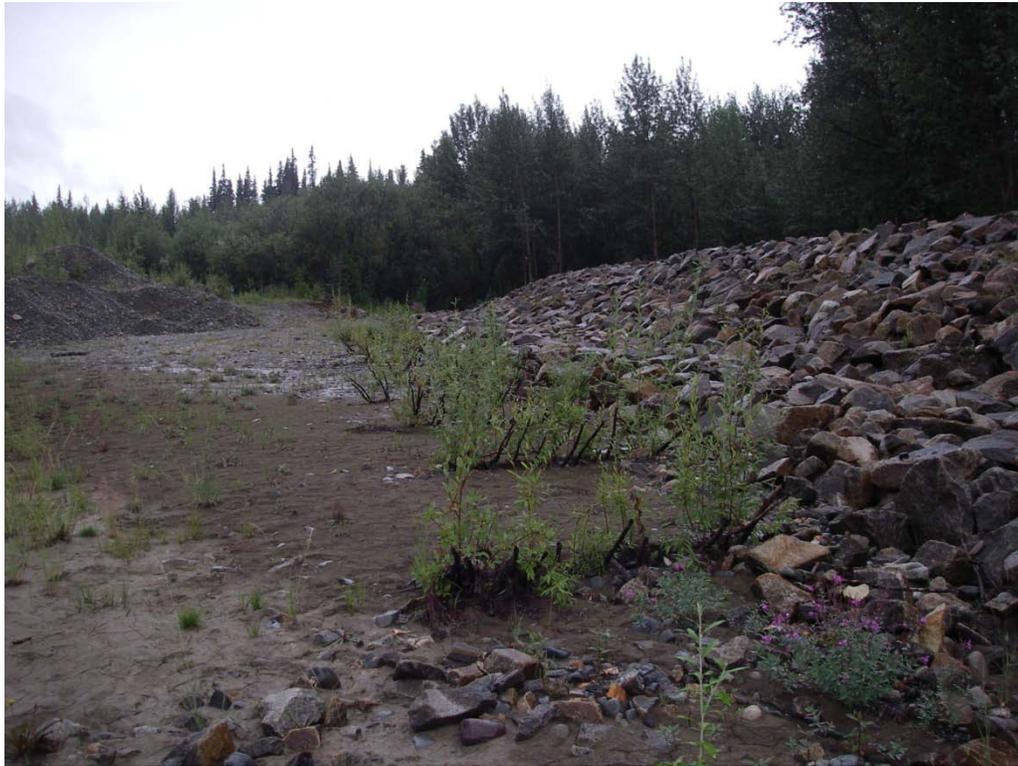
Photo 1. View of gravel bar staking upstream of Beaver Creek bridge. Photo taken in July 2007.

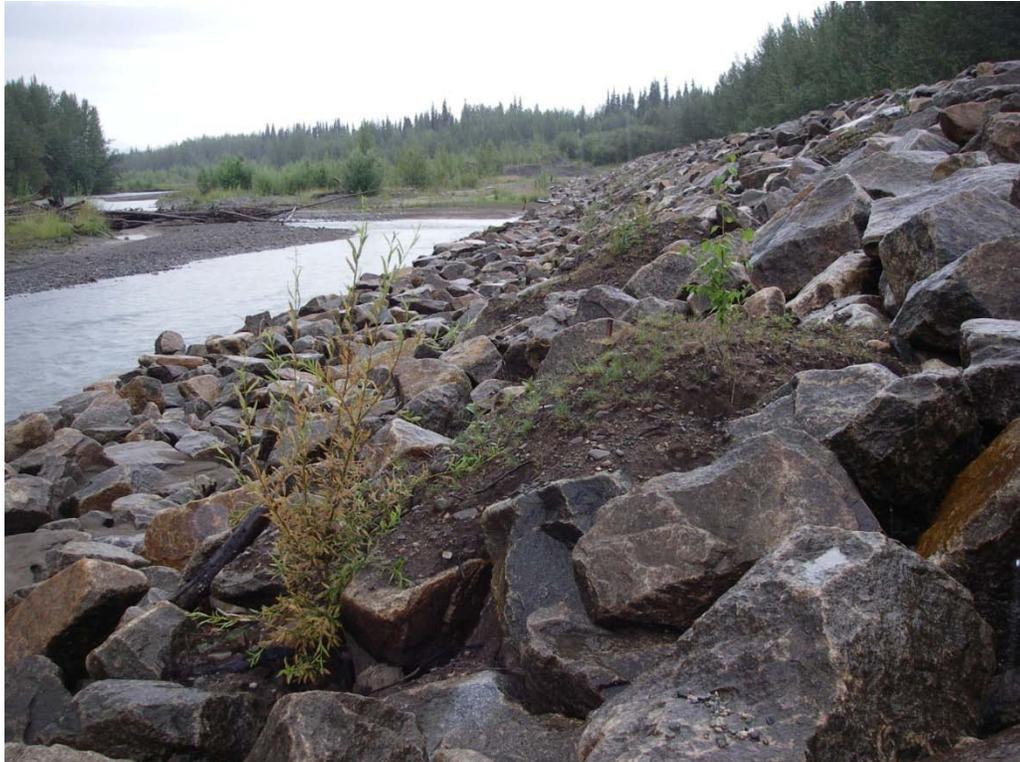
Live Staking in Soil in Void of Riprap (Pocket Planting; including grass seeding): In the first growing season, extensive grass growth was observed (Photo 3); however, this grass cover appeared to die out in subsequent seasons. Many live stakes were showed growth, during all site visits (Photo 4). Many of the stakes were > 1 m high in 2007. No evaluation on the success rate was completed.

Photo 4. Photo of live stake (left) and transplant (right) on soil placed in voids of riprap, upstream of the Beaver Creek bridge. Photo taken in July 2007.

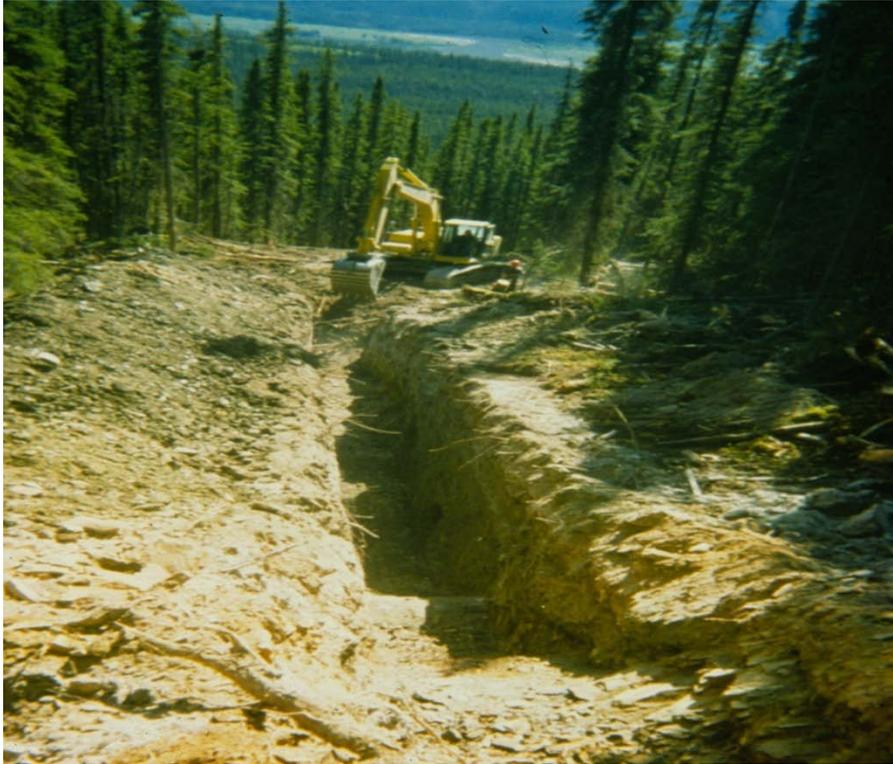
Photo 1. View of an excavated trench at the Breakaway property near Ross River in 1995. Photo courtesy of the Yukon Geological Survey.

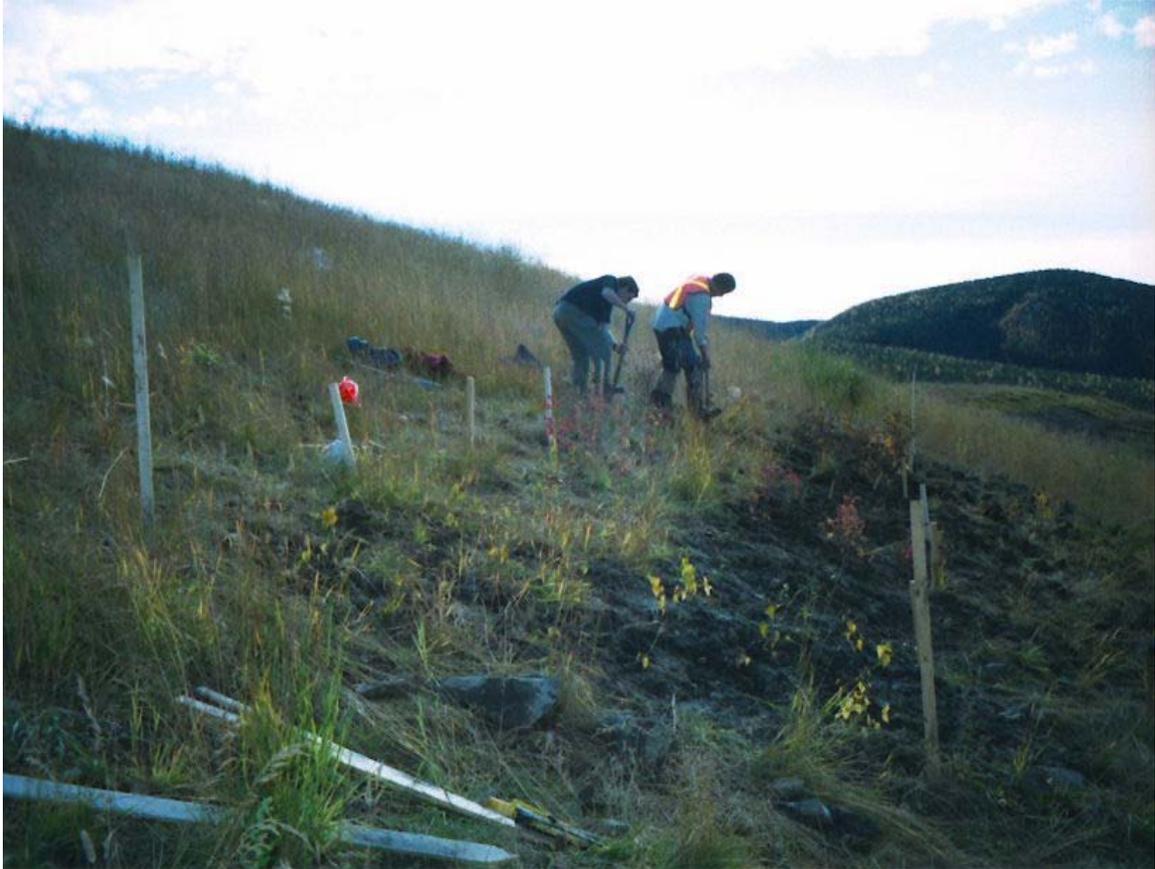
Photo 1. View of the plots at the Brewery Creek C-1 site during construction in September 2000 (looking west). The Alaska birch plot is in the foreground. Photo courtesy of Laberge Environmental Services Ltd.

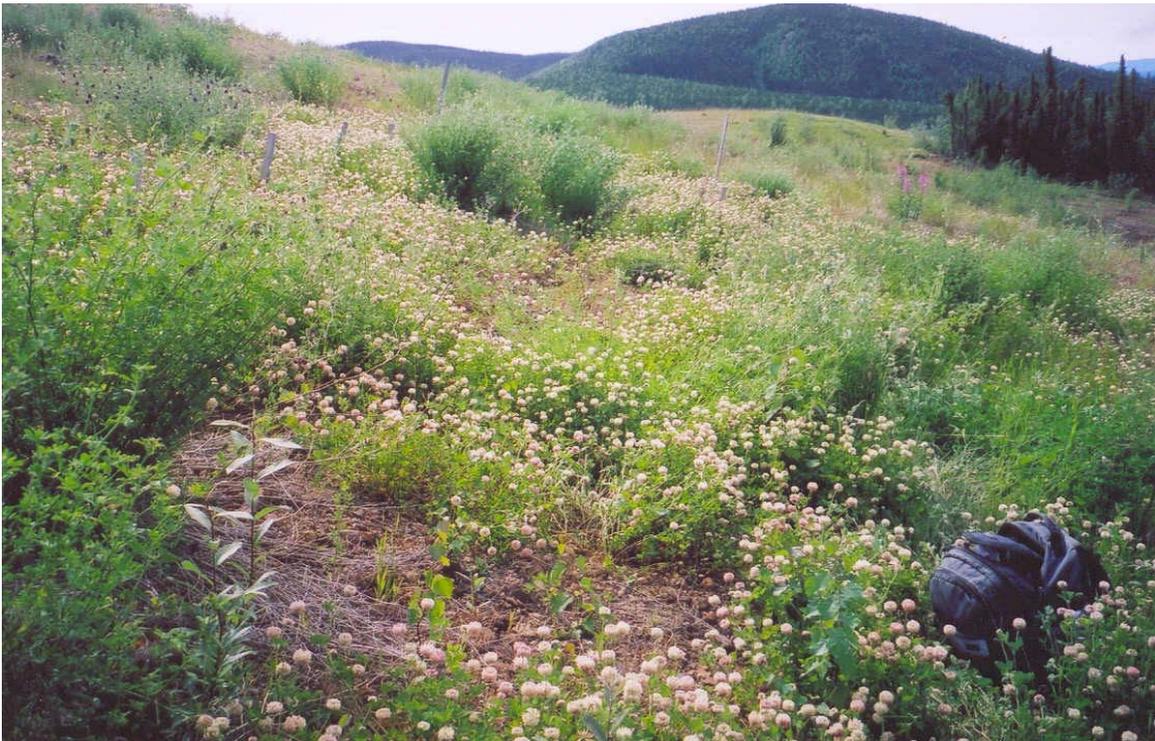
Photo 2. View of the plots at the Brewery Creek C-1 site during the latest monitoring event in 2006 (looking west). The Alaska birch plot is in the foreground. Photo courtesy of Laberge Environmental Services Ltd.

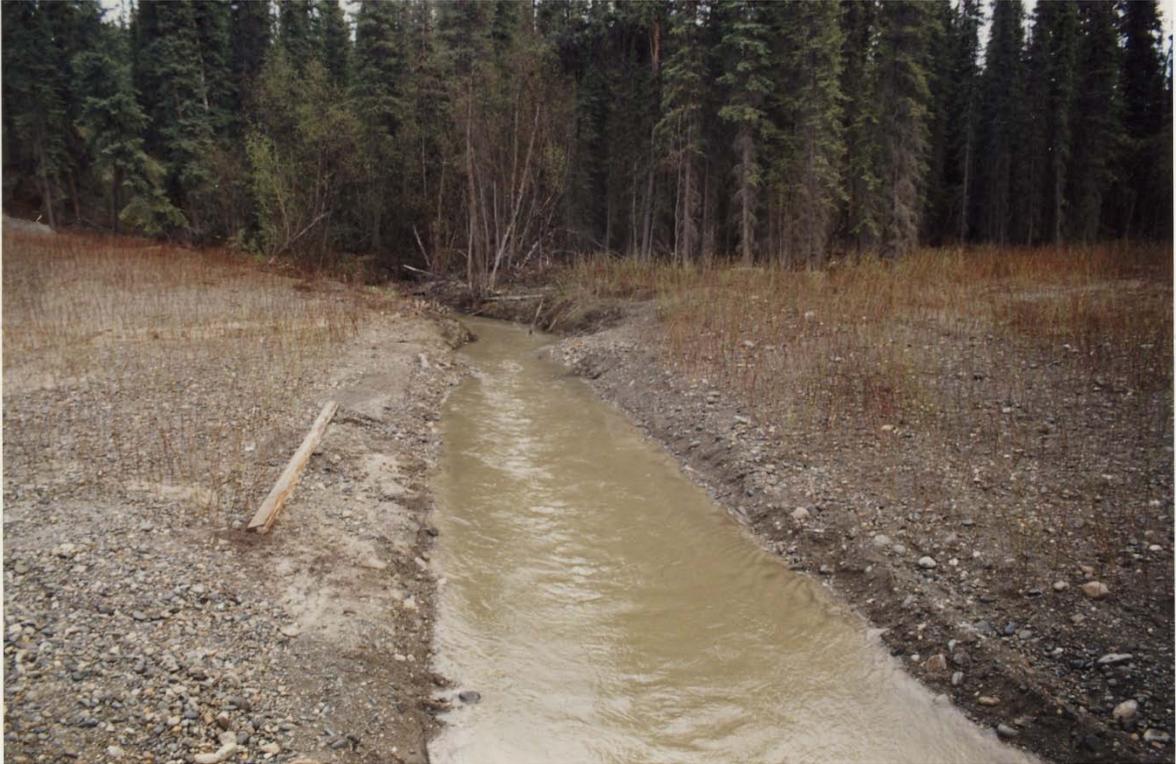
Based on the photo documentation, it appears that the stakes were of too small a diameter to ensure treatment success.

Photo 1. View of the live staking carried out along Croucher Creek near downtown Whitehorse, upstream of the bridge. Photo taken on May 31st, 1996. (Photo courtesy of Department of Fisheries and Oceans).

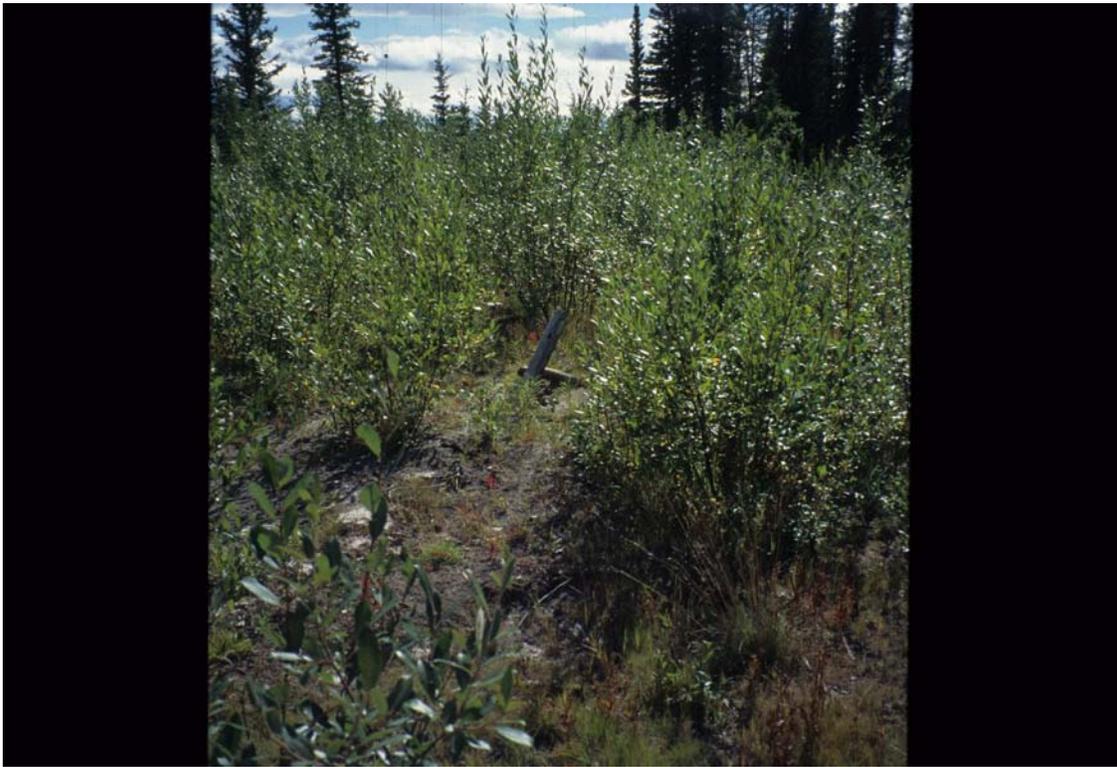
Photo 2. View of a drill pad reclaimed in 1994 at the Division Mountain coal exploration property, west of Braeburn. Photo taken in 1997, note the large amount of shrub stage species that have colonized this site. Photo courtesy of the Yukon Geological Survey.

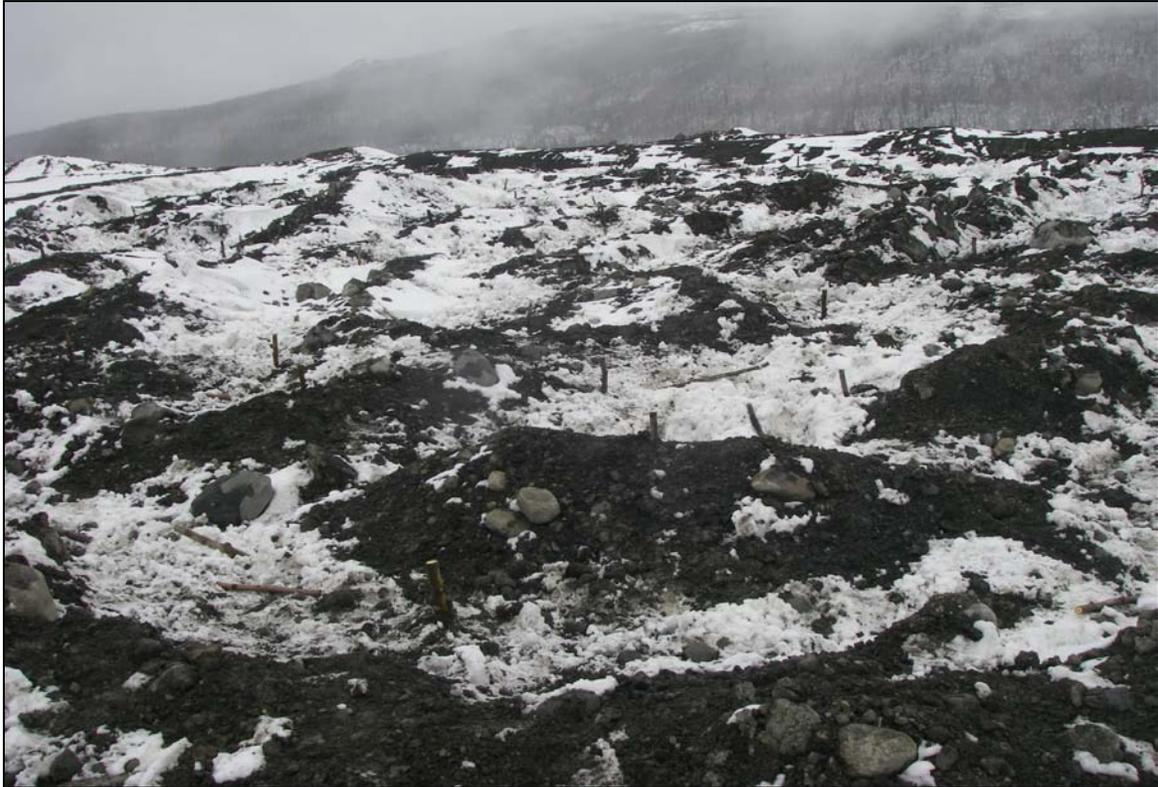
Photo 1. View of the lysimeter plot at the Anvil Range mine site, near Faro, in September 2007. These plots were constructed in August 2007 on the Vangorda waste rock dumps.

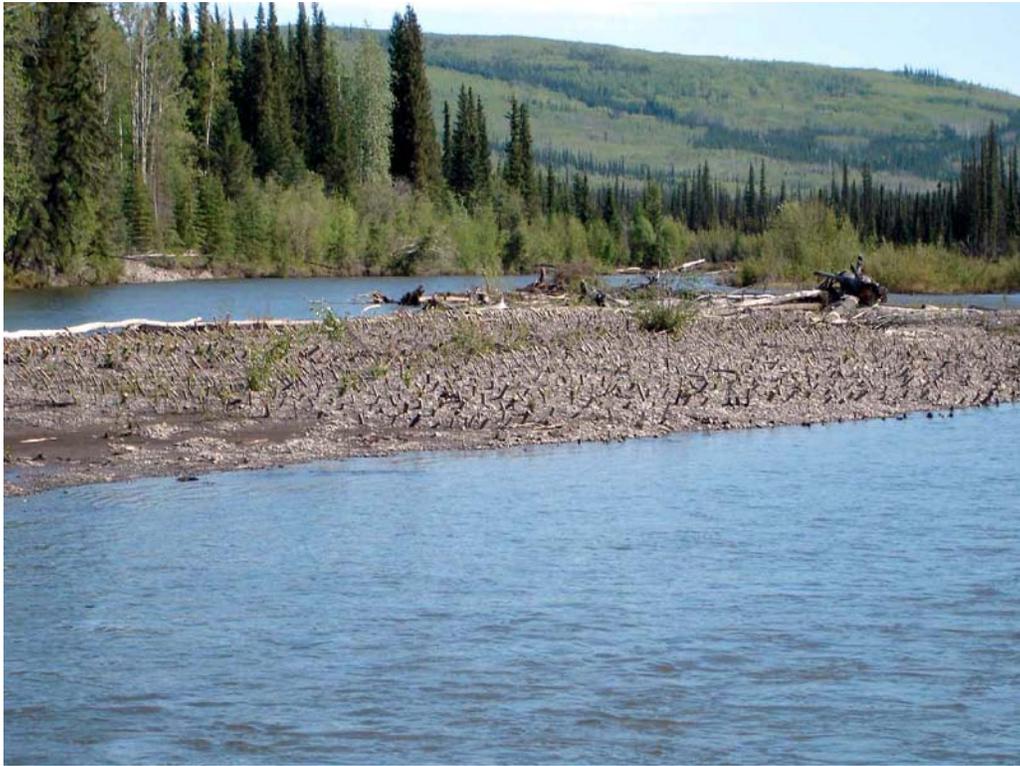
Photo 1. View of gravel bar staking on the mid-channel island of Germaine Creek, a tributary of the Klondike River near Dawson. Photo taken in May of 2005, growth is visible of several stakes in the foreground. Photo courtesy of M. Miles and Associates Ltd. and Polster Environmental Services Ltd.

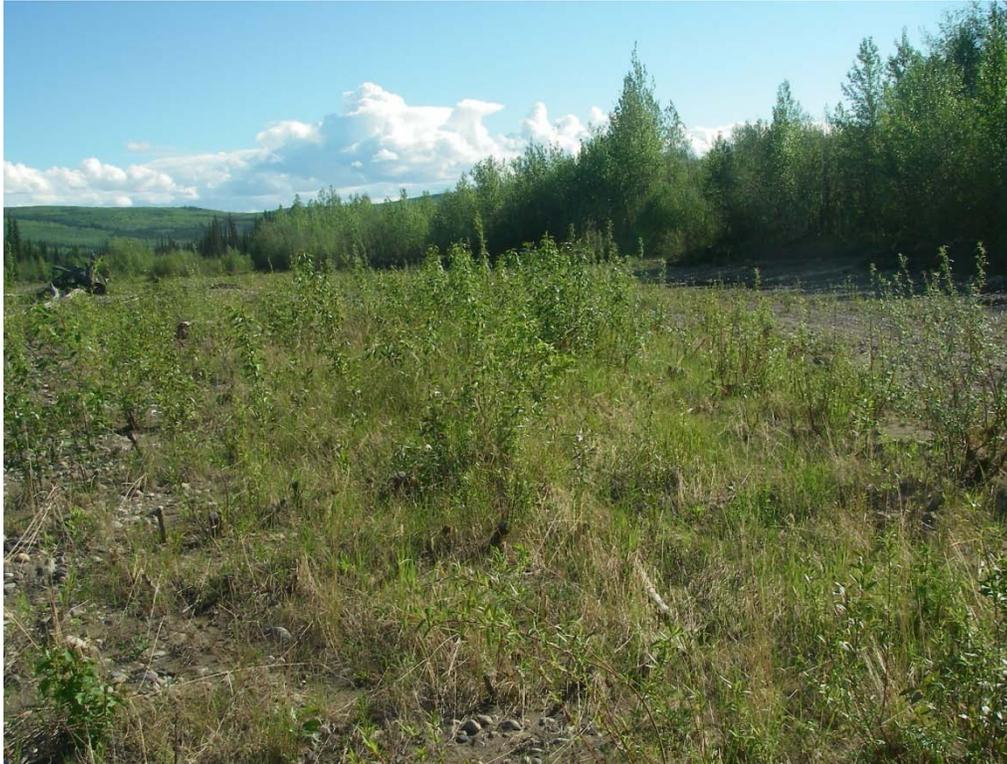
Photo 3. Gravel bar staking area with extensive growth of grass and herbs, on the mid-channel island of Germaine Creek, a tributary of the Klondike River near Dawson. Photo taken in 2008.

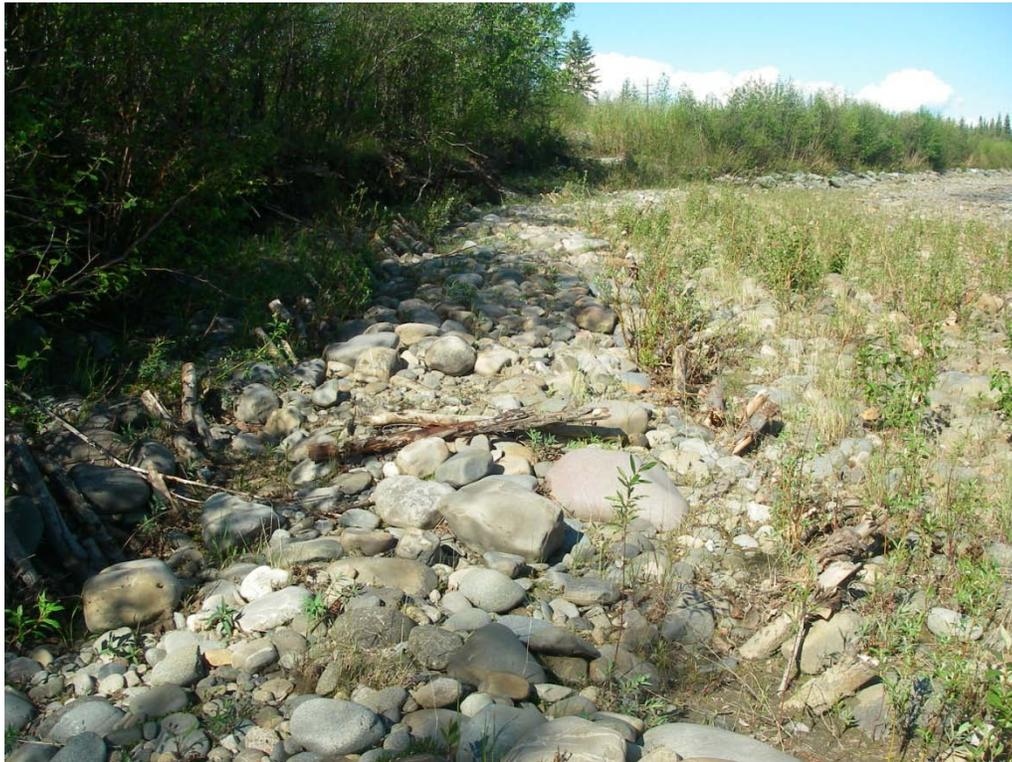
Photo 4. Photo of live palisade along the channel bank of Germaine Creek, a tributary of the Klondike River near Dawson. Photo taken in 2008.

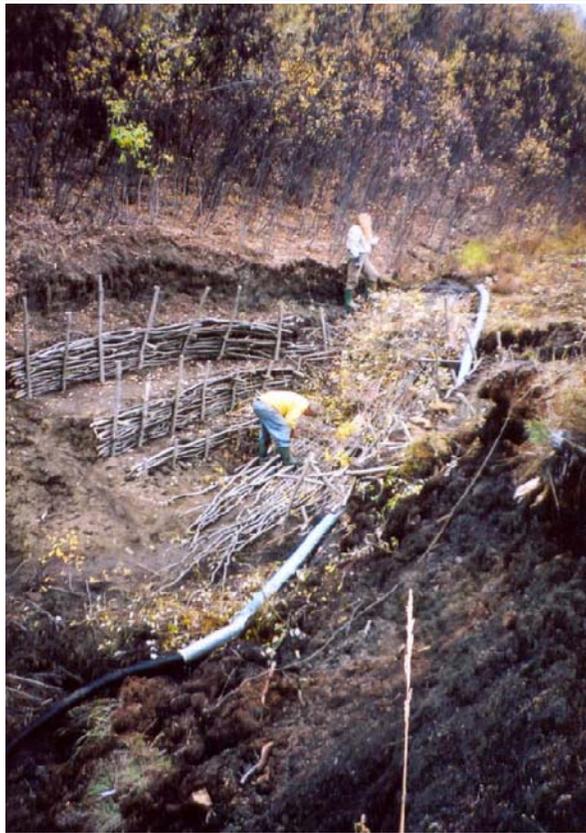
Toppled willows are sending up shoots from their prone position and this could aid in helping to stabilize the slope; however, it appears that slumping is occurring too rapidly for these willows to establish themselves before they are buried under new material. Unless the extensive melting of the underlying permafrost is slowed or halted, this situation will likely remain unchanged.

Photo 1. View of the completed live retaining walls (wattle fences) and live willow flume on the Gold Run Creek erosion cut, approximately 50 km south east of Dawson City. Photo taken on September 9th, 2005, courtesy of Laberge Environmental Services Ltd.

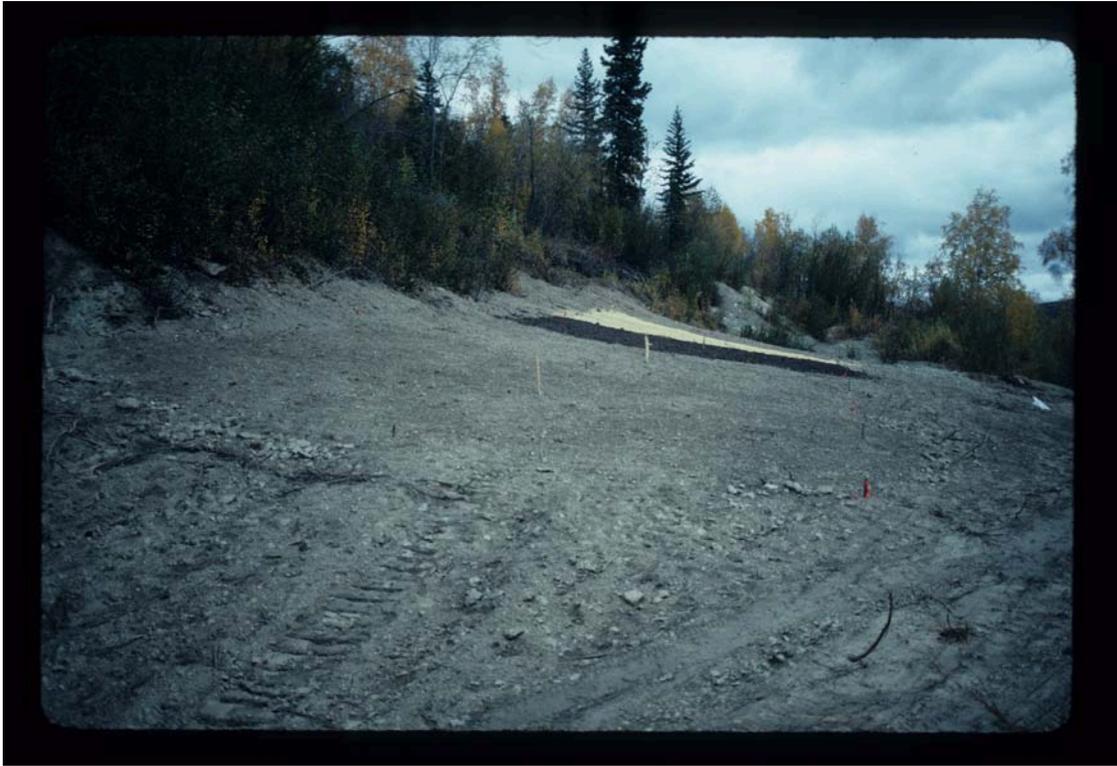
Photo 1. View of the Hawk Trench test plots, near Eldorado Creek, in 1995. The control plot is in the foreground and topsoil plot is in the background. Photo courtesy of the Yukon Geological Survey.

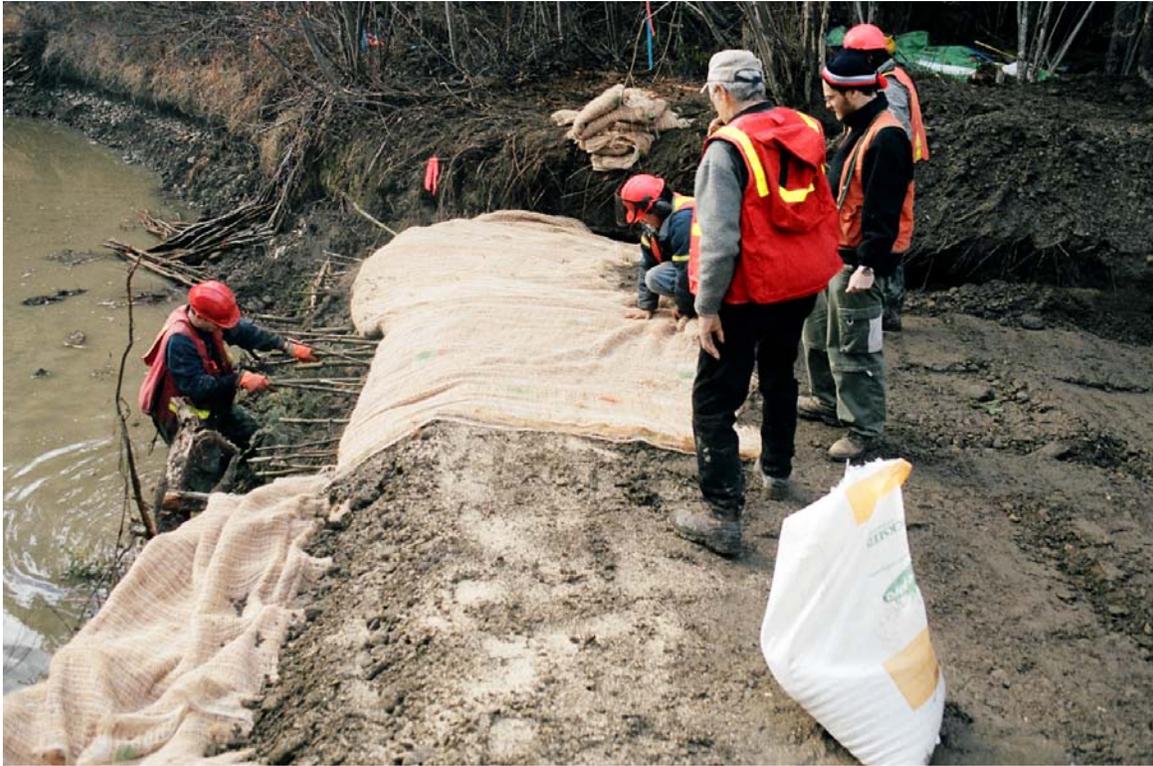
Photo 1. Restoration of the site access road on a restored side channel near the mouth of the Mayo River, in the summer of 2004. Willow stakes were planted in the bank, soil lifts were placed on top, grass seeded and wrapped with erosion control matting.

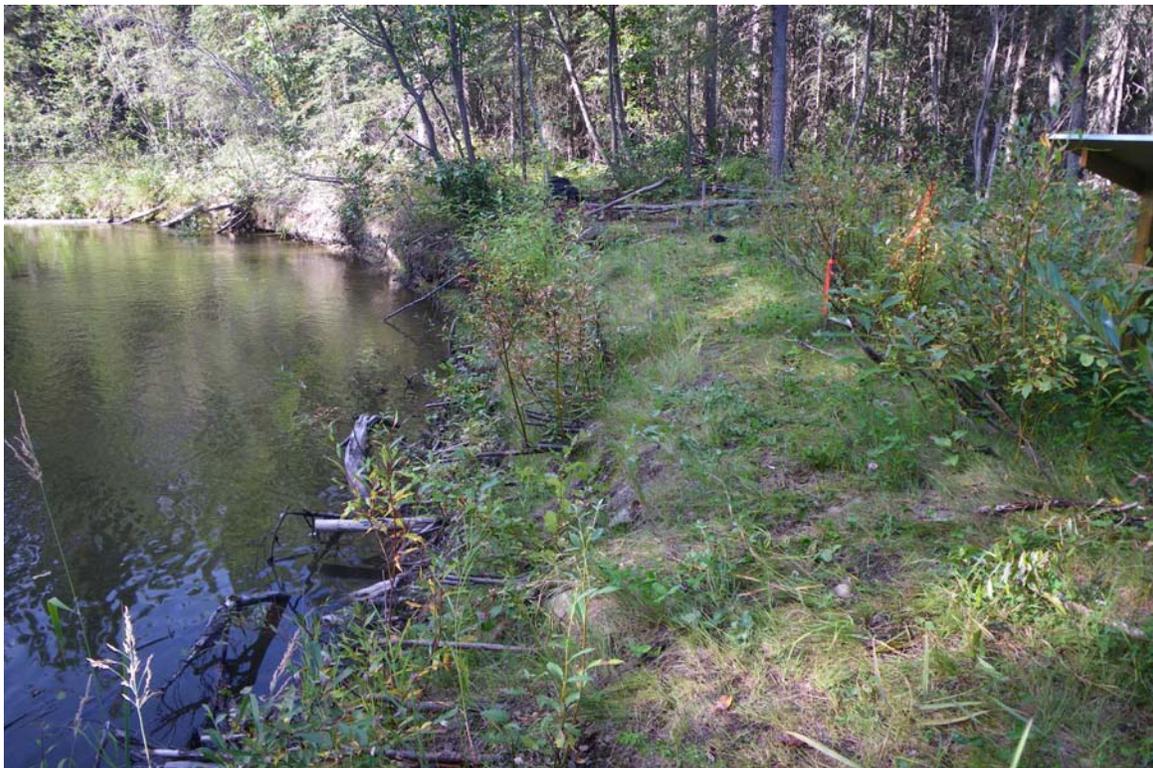
Red osier dogwood stakes were not a successful species in this re-vegetation treatment. No live dogwood stakes were seen in 2008. Aggressive grass seeding may be slowing natural colonization of native shrub species.

Photo 2. View of the restored access road, near the mouth of the Mayo River, during the most recent monitoring in August of 2008.

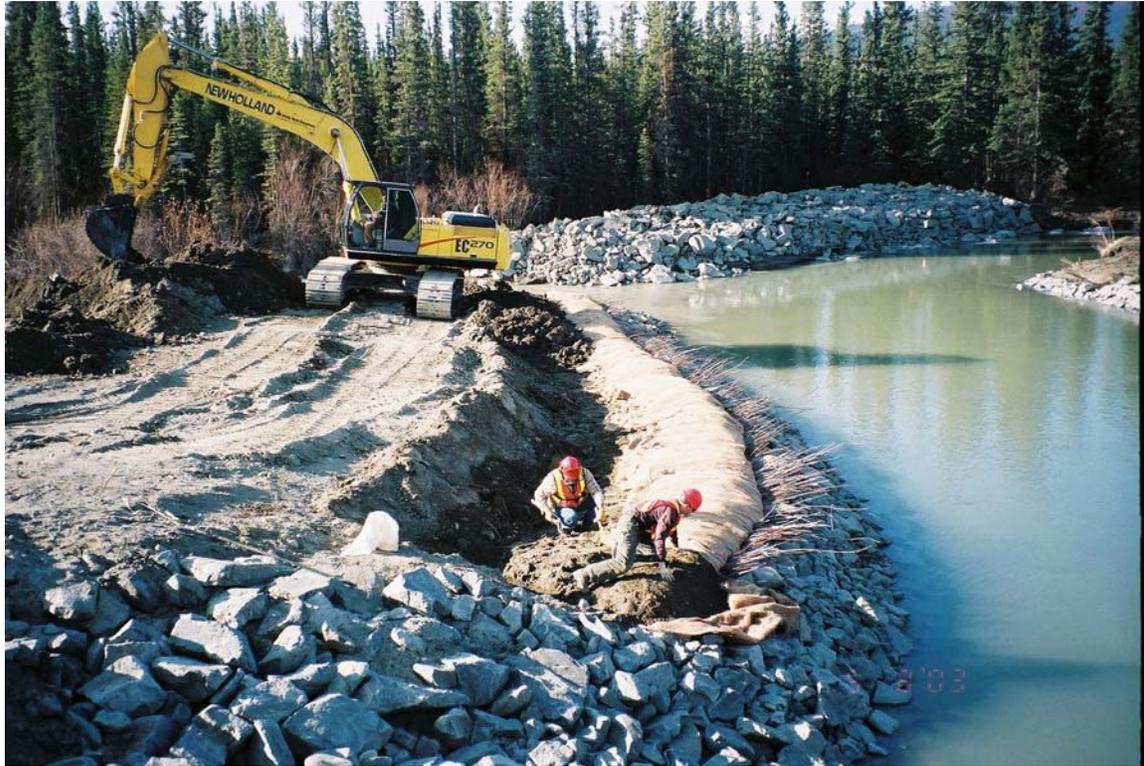
This is a very dry site and treatments with shallow depths such as live fascines and brush mattresses were less successful than the brush layers, where installation with an excavator allowed for notable planting depths. The transplants were through to be successful given that there was already an extensive root base.

Photo 1. View of the brush layers being installed at the new Mendenhall River crossing near KM 1557 of the Alaska Highway, in May 2003. Downstream (of the crossing) view, facing downstream

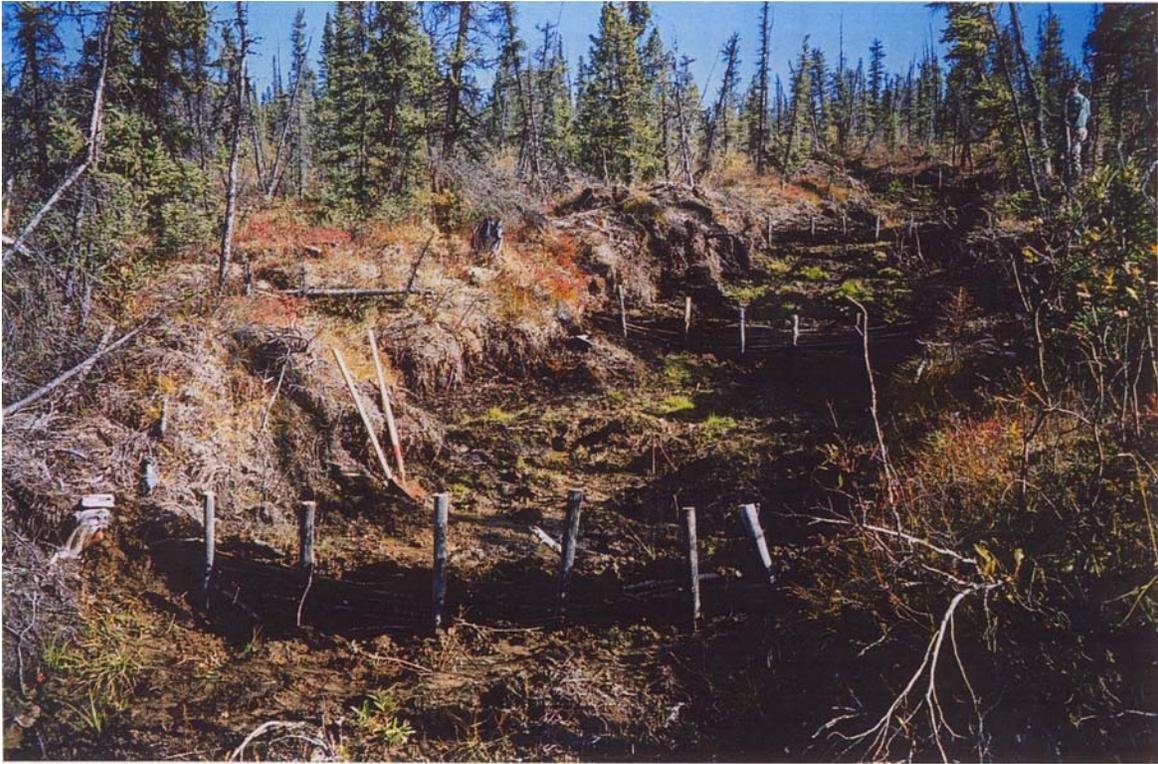
Photo 1. Upslope view of the live gully breaks on Noname Creek, 90KM west of Carmacks. Photo taken following construction, in September 2001. The most downslope gully break is visible in the foreground. Photo courtesy of Laberge Environmental Services.

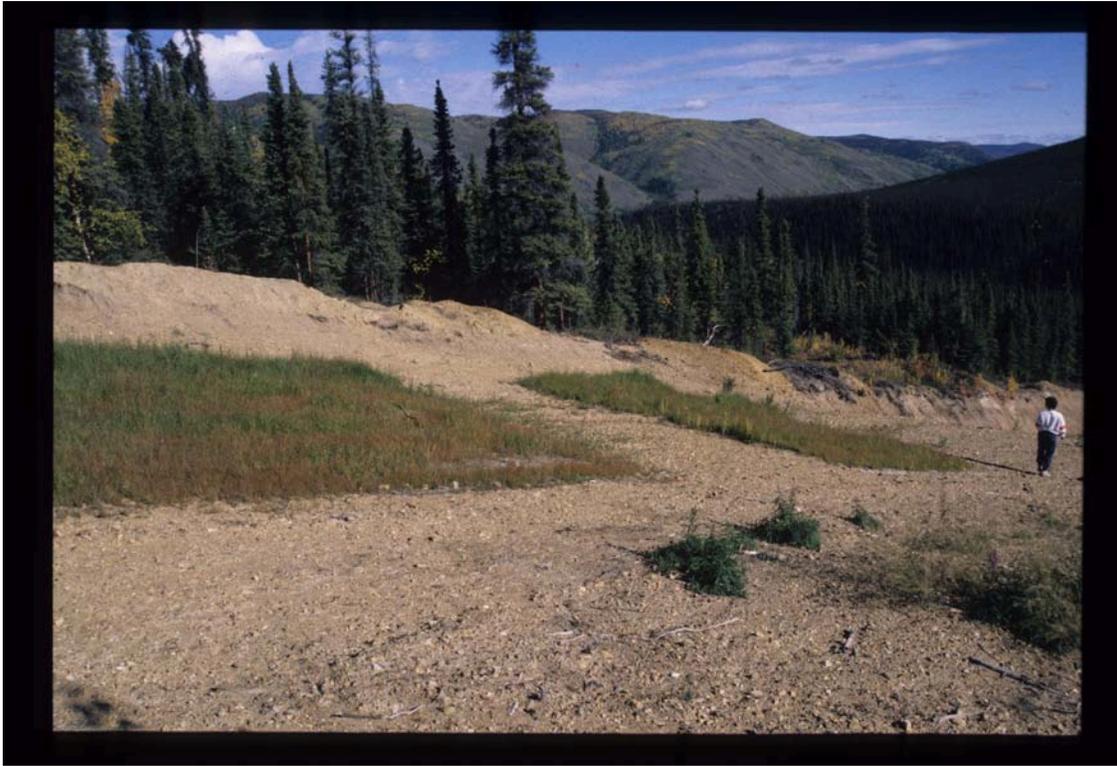
Photo 1. View of the Nucleus test plots, approximately 90 km west of Carmacks. Photo taken in 1996, one year after seeding. Note the lush growth of plants grass species. Photo courtesy of Yukon Geological Survey.

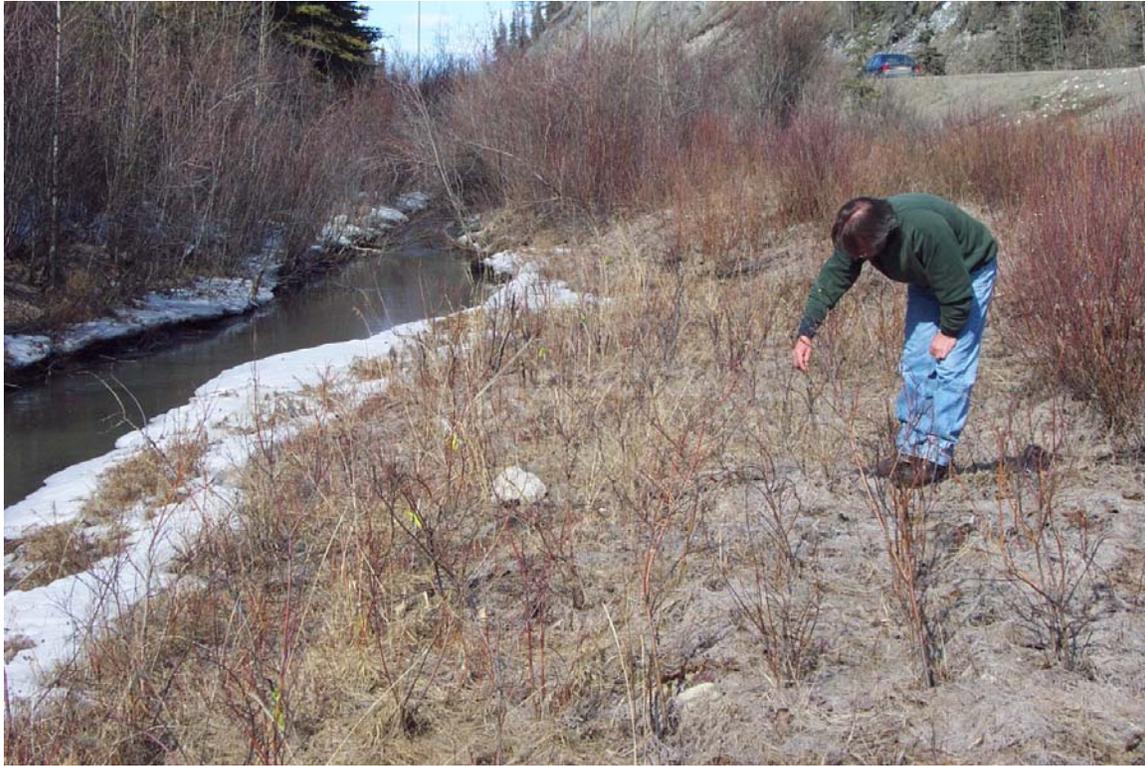
Moist, fine soils at the site provide an excellent growth medium for establishing planted willow cuttings due to increase water content in the soils, which promotes willow growth.

Photo 1. Downstream view of the live staking works along the right bank of Porter Creek, near Whitehorse. Photo taken in April 2004, two years after stakes were planted. Photo courtesy of Department of Fisheries and Oceans.

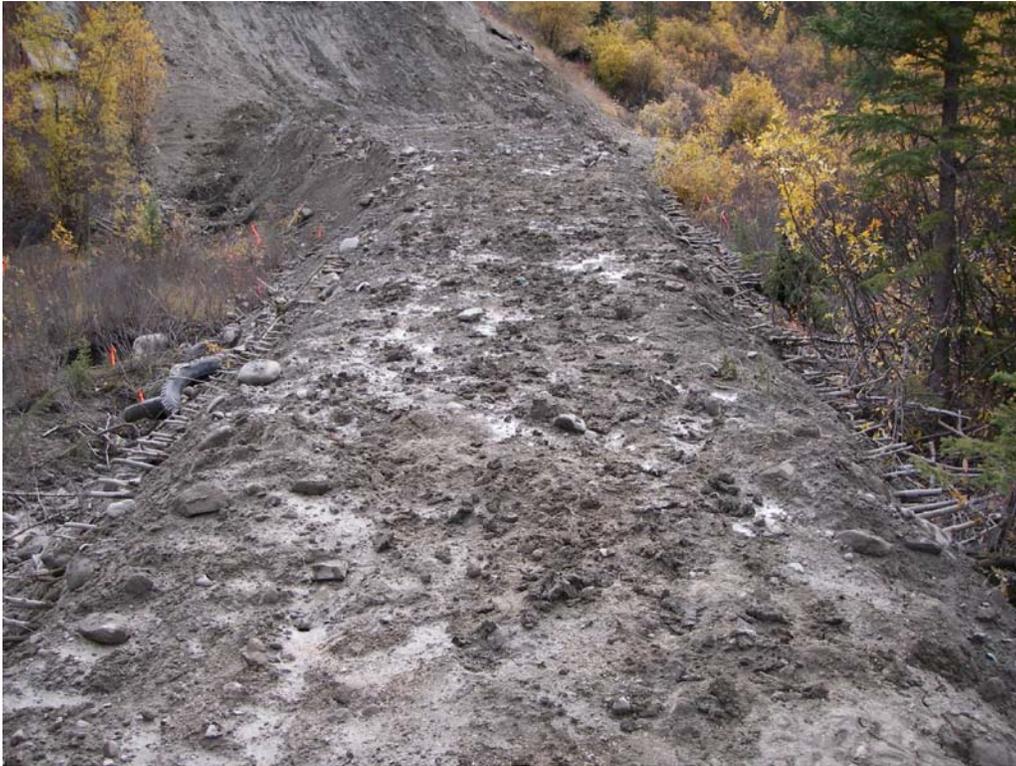
Photo 1. View of the completed berm, near the bank of McIntyre Creek, in Whitehorse. Photo taken in the summer of 2006, following construction and initial watering.

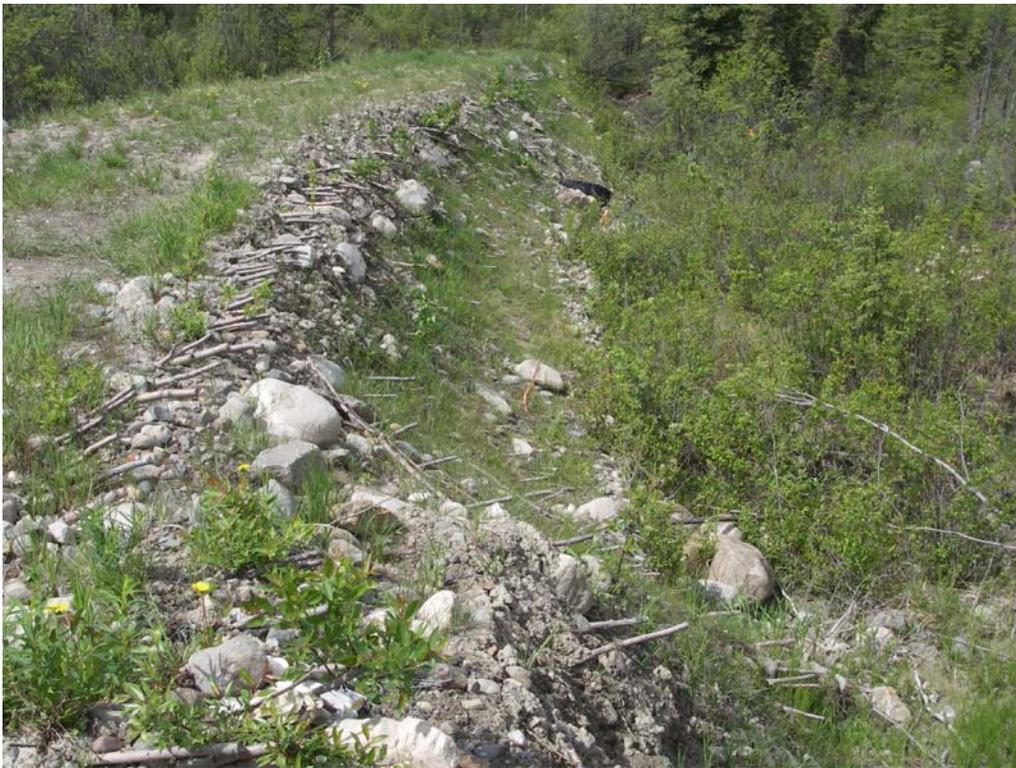
Photo 2. View of the re-vegetated berm, near the bank of McIntyre Creek, in Whitehorse during June of 2008.

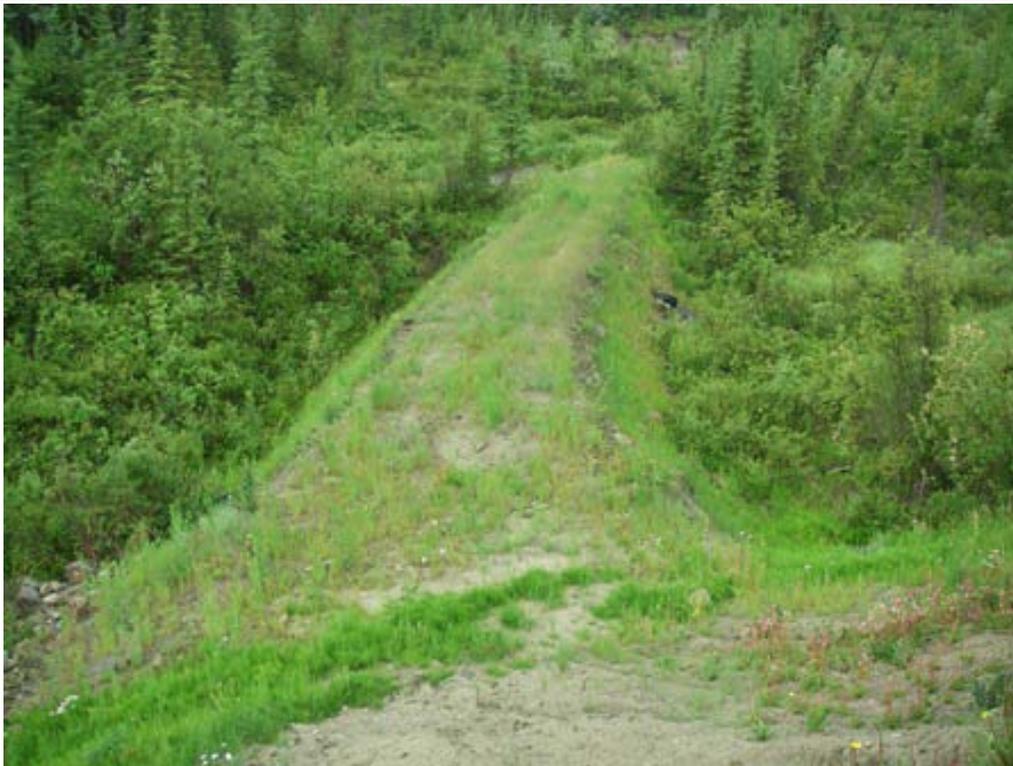
In 2008, the height of the new berm was 0.58 meters above the old berm. Approximately 23.3% of the stakes on the southwest side and 32.9% of the stakes on the northeast side of the berm were living. Overall, approximately 28.1% of stakes were living. Grass cover was estimated at 75 - 80% of the berm area (Photo 3).

Photo 3. View of entire berm near the bank of McIntyre Creek, in Whitehorse taken in July of 2008. Note extensive grass growth since June.
