MPERG Report 2009-3

A Review of Several Yukon Revegetation Projects and Techniques

EDI Environmental Dynamics Inc.

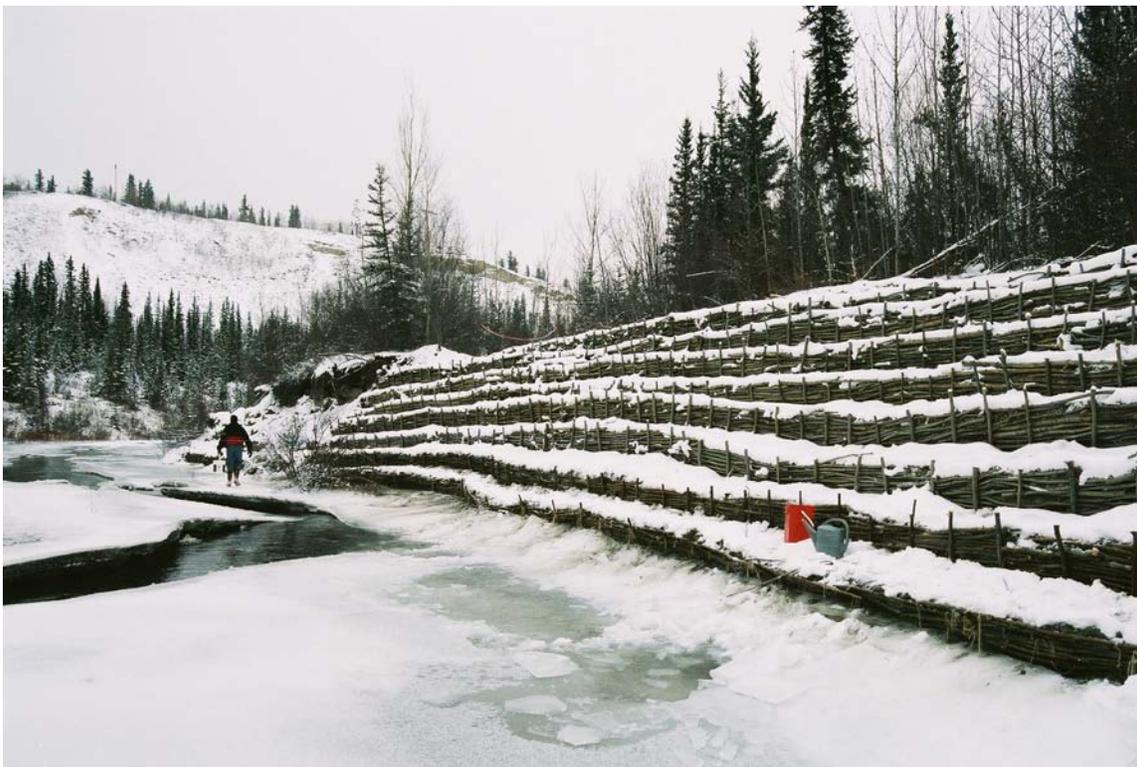
Photo 5. Completed wattle fences along the bank of McIntyre Creek, in Whitehorse in Oct 2005.

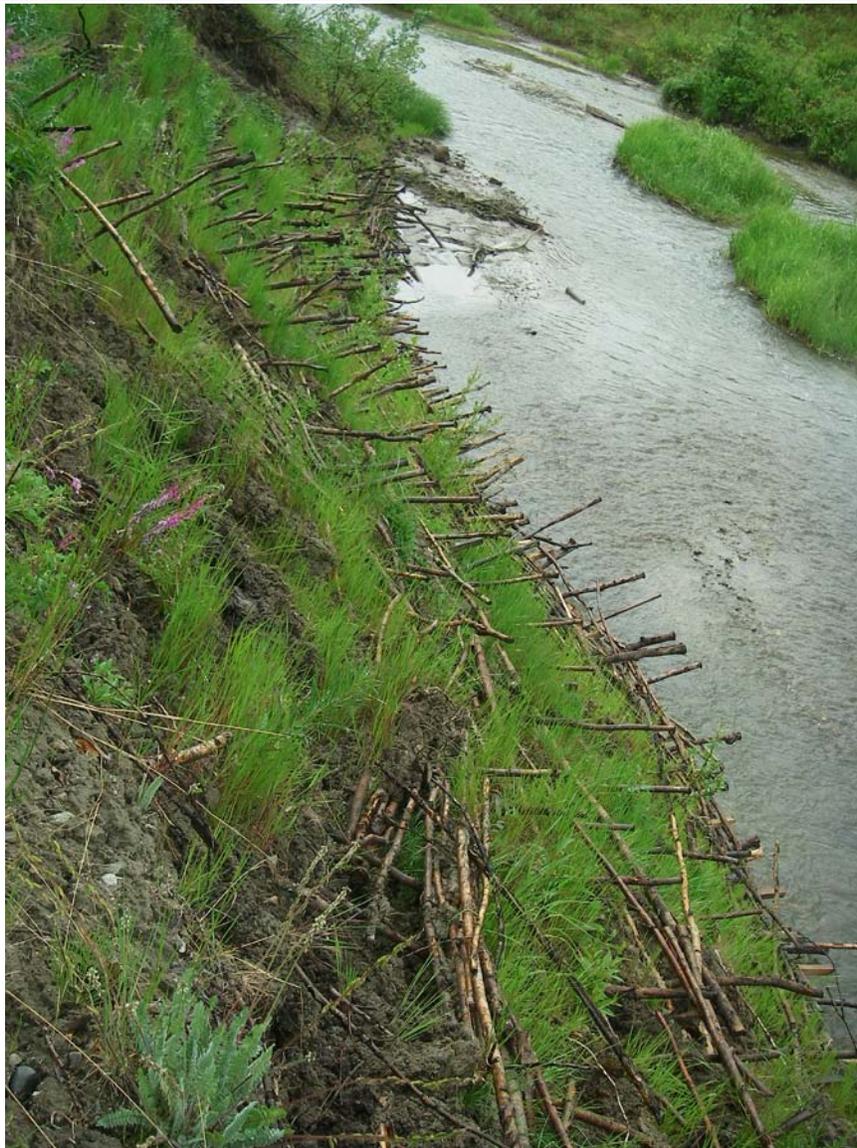
Observations of the wattle fences have been made throughout the past 3 years. The fences collapsed within the first couple years after construction. Few cuttings were observed to growing in 2008; however, substantial grass cover was noted as well as the establishment of some native species (Photo 5).

Photo 5. View of wattle fences near the bank of McIntyre Creek, in Whitehorse. Photo taken in July of 2008.

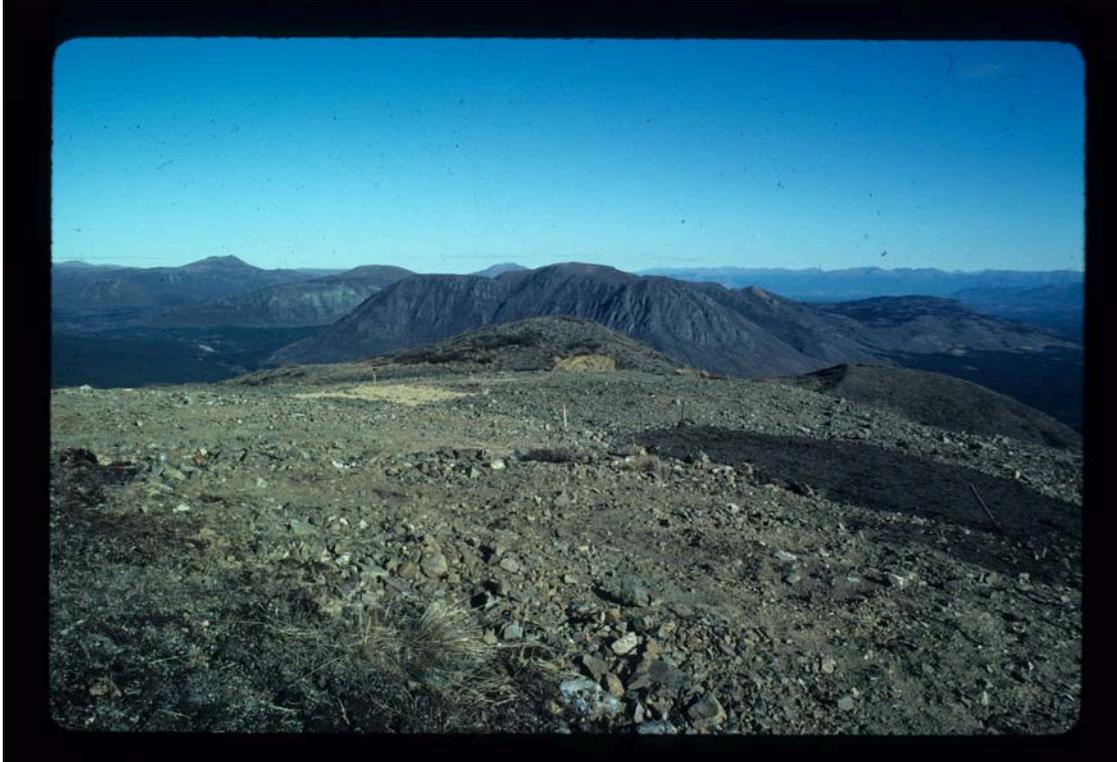
Photo 1. View of the Red Ridge plots, approximately 65 km southwest of Whitehorse. Photo taken when test plots were established, in 1995. The topsoil plot is in the foreground. Photo courtesy of Yukon Geological Survey

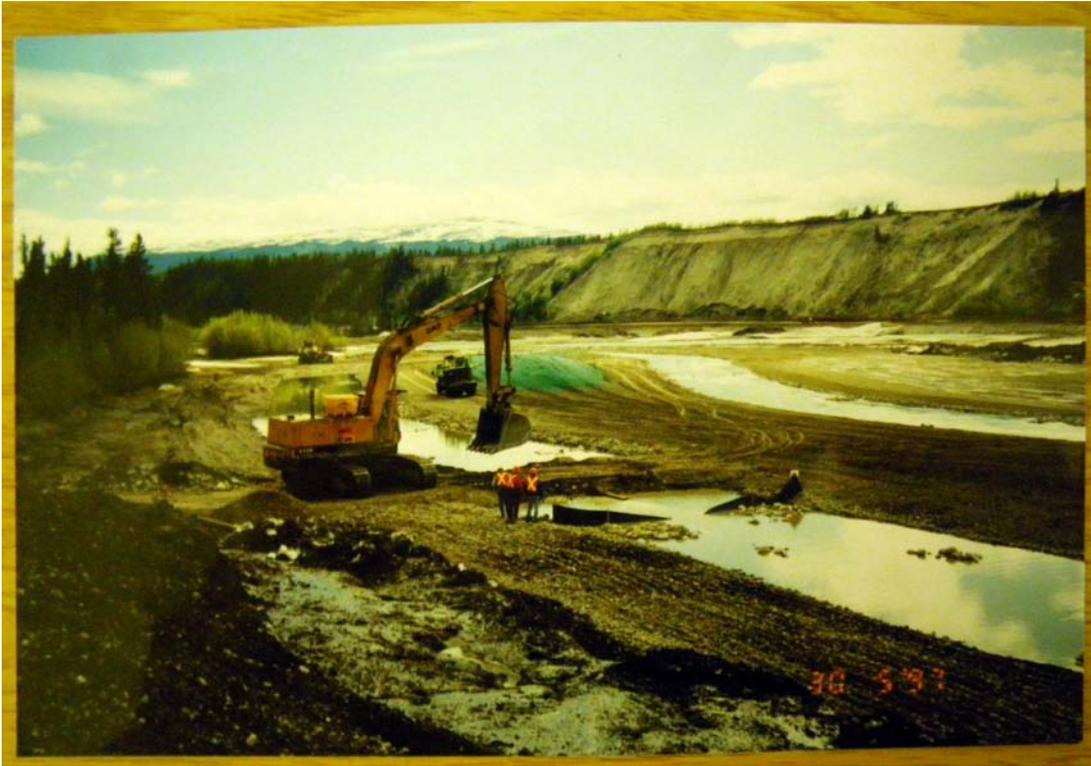
Photo 1. View of the Robert Service Way fisheries compensation channels, in downtown Whitehorse during construction in 1997. Seeding treatment has been applied in the green area in the center of the photo. Photo courtesy of the City of Whitehorse.

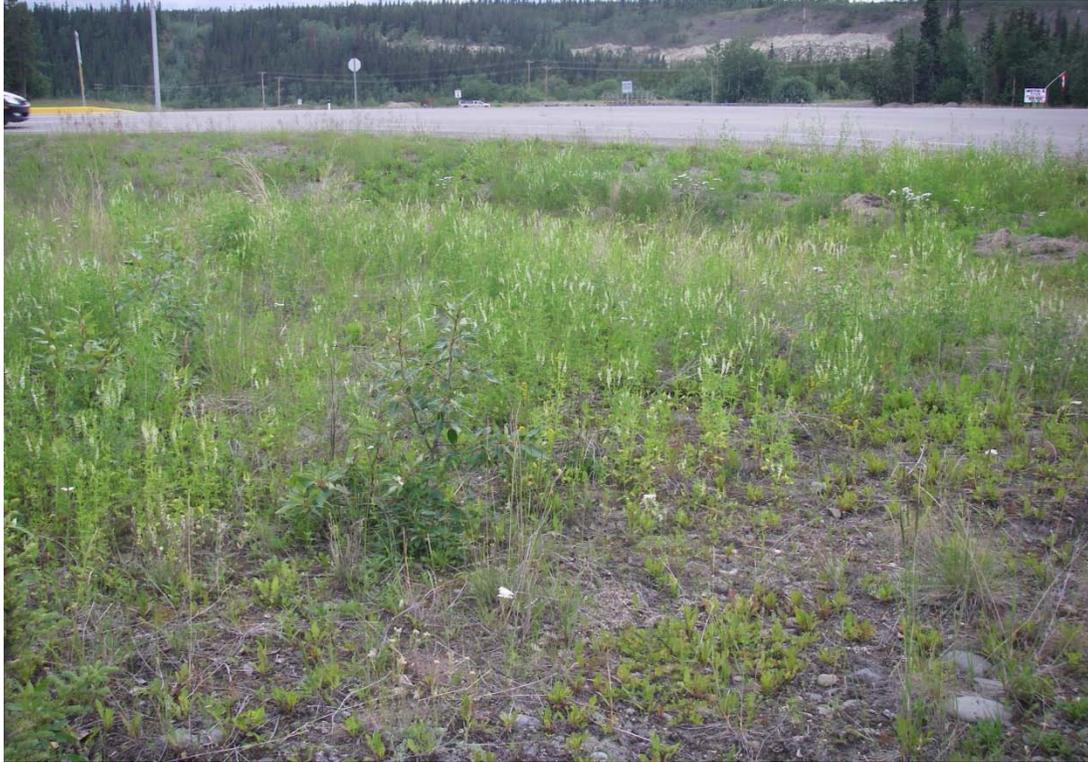
Sites were not ideal for monitoring given, the high activity in this area.

Photo 1. View of Robert Service Way, near downtown Whitehorse during the most recent monitoring in July of 2008. Go-Kart course is in the background of the photo.

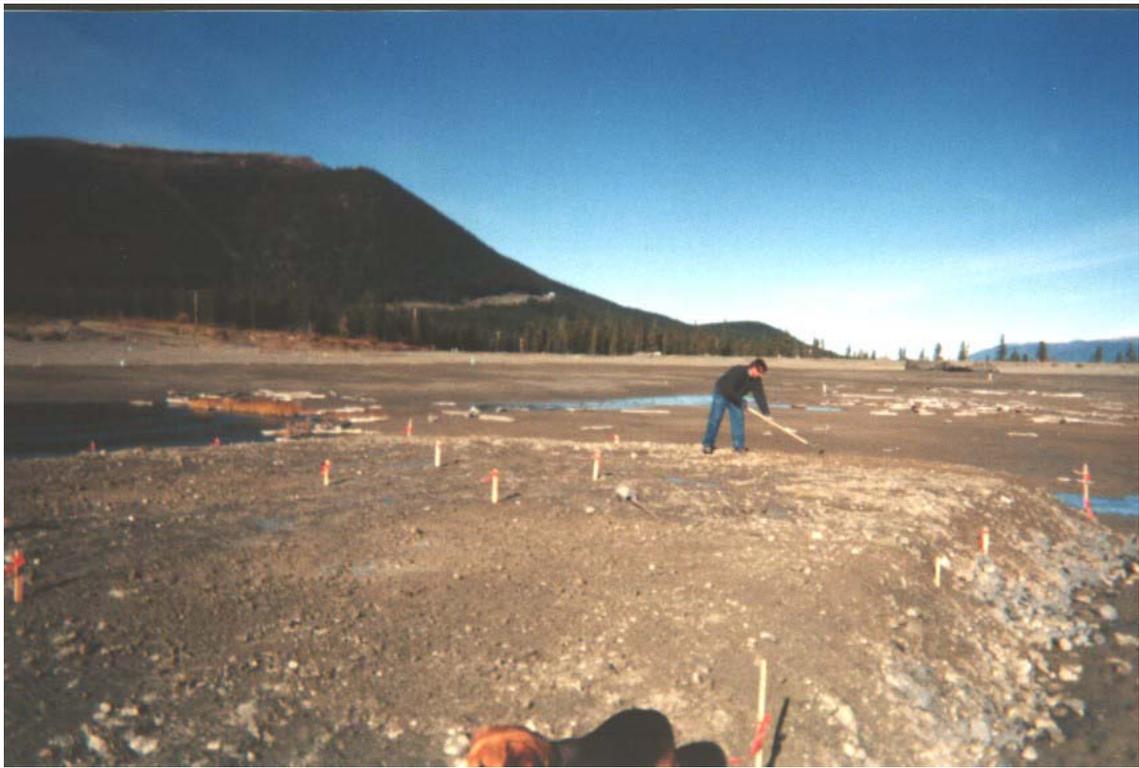
Photo 1. View of a plot on the TMF with rock and topsoil, at the Sa Dena Hes mine near Watson Lake. Photo taken during the 2001 seeding program. Photo courtesy of Access Mining Consultants Ltd.

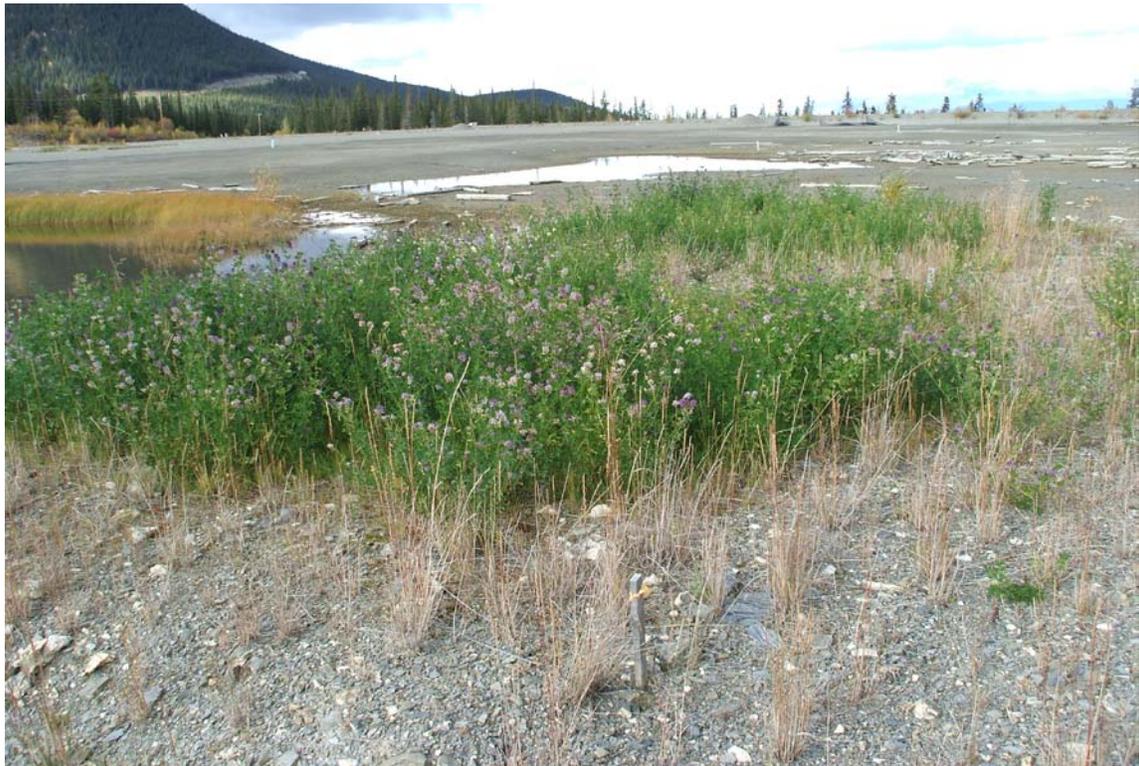
Yes. In 2007, AMCL found that violet wheatgrass, which had been the most successful of all seeded species, had declined significantly in the 2001/2003 test plots. Tufted hairgrass is now the grass species with the most consistent coverage across all sites. Alpine bluegrass, violet wheatgrass and sheep's fescue are well distributed on a few sites. Alfalfa was the only legume to show good coverage, and this was limited to just a few sites. Rocky mountain fescue has a moderate distribution on a few sites. Ticklegrass, Kentucky bluegrass and the legumes showy locoweed and bear root showed poor growth. Glaucous Bluegrass was not seen on any of the sites.

Photo 2. View of the plot on the TMF at the Sa Dena Hes mine, near Watson Lake during the most recent monitoring conducted in 2007. Photo courtesy of Access Mining Consultants Ltd.
