Mineral Resources Directorate, Yukon

RECLAMATION PRACTICES AND RESEARCH

ON MINERAL EXPLORATION PROPERTIES IN THE YUKON TERRITORY

Reclamation Practices and Research on Mineral Exploration Properties in the Yukon Territory

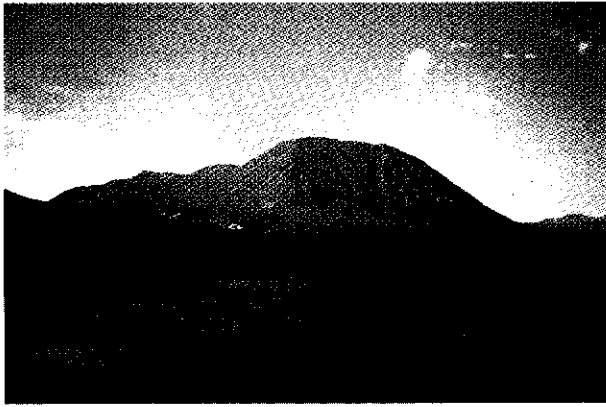
The trench selected for reclamation is located on the east end of Red Ridge, at the crest (Figure 5 and 6), trends north-northwest (335 degrees) and slopes gently ($2 - 4$ degrees) in that direction. The terrain drops off sharply to the east, the slope being $25 - 30$ degrees. Thus, although the trench is on nearly level ground some of the excavated material is spilled over the edge and lies at the angle of repose of 35 degrees. Rock types consist of hornblende diorite (Wheeler, 1961, Unit 8d) and fine grained grey volcanic rock, probably basalt dyke material. Rocks are moderately weathered and oxidized, at least part of the trench being in a gossan zone, hence the name Red Ridge. Excavated material consists of approximately 50 percent minus 2.5 cm yellowish brown decomposed bedrock, including considerable sand and silt-sized material. Coarse material includes fairly fresh, broken rock up to 20 centimetres in longest dimension. Some parts of the site, particularly Plots 1 and 5 at the north-west end, have less fines, approximately 20 to 25 percent, and a preponderance of broken rock. No permafrost features are recognized.

5. Scenic view of Red Ridge, test site is on top of ridge, right side

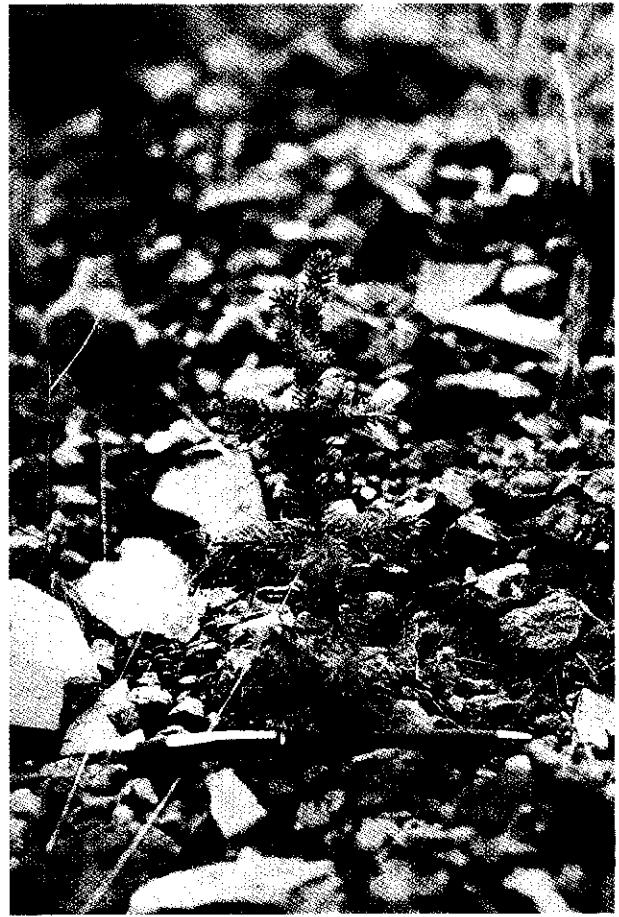
14. Nucleus trench, spruce seedling

The naturally occurring flora of the adjacent undisturbed area, regarded as the climax stage of plant succession, are listed in Appendix C, a total of 26 species recognized. The trench was cut in 1989. Revegetation in this trench cut by a backhoe is restricted to balsam poplar, black spruce and alder seedlings. Figure 14 shows a spruce seedling 15 cm tall at the Nucleus trench site. Alder grows more rapidly than does spruce in this environment (Figure 15), to greater than one metre in height, presumably in part because of nitrogen fixing bacteria hosted on their root systems.

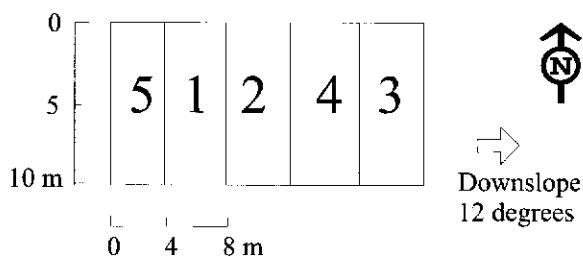
16. Test Plots, Nucleus, plots are numbered as indicated in the "Field Observations" below.

Growth was robust on the four seeded plots, with Plots 1 and 5 being almost identical except for minor alsike clover on Plot 1 and a few fireweed plants starting to re-colonize Plot 5. Plots 2 and 3, at 90 percent coverage, had slightly greater growth than Plots 1 and 5. Plot 2 (mulch) was characterized by alsike clover and Plot 3 (topsoil), surprisingly, was characterized by barley foxtail.

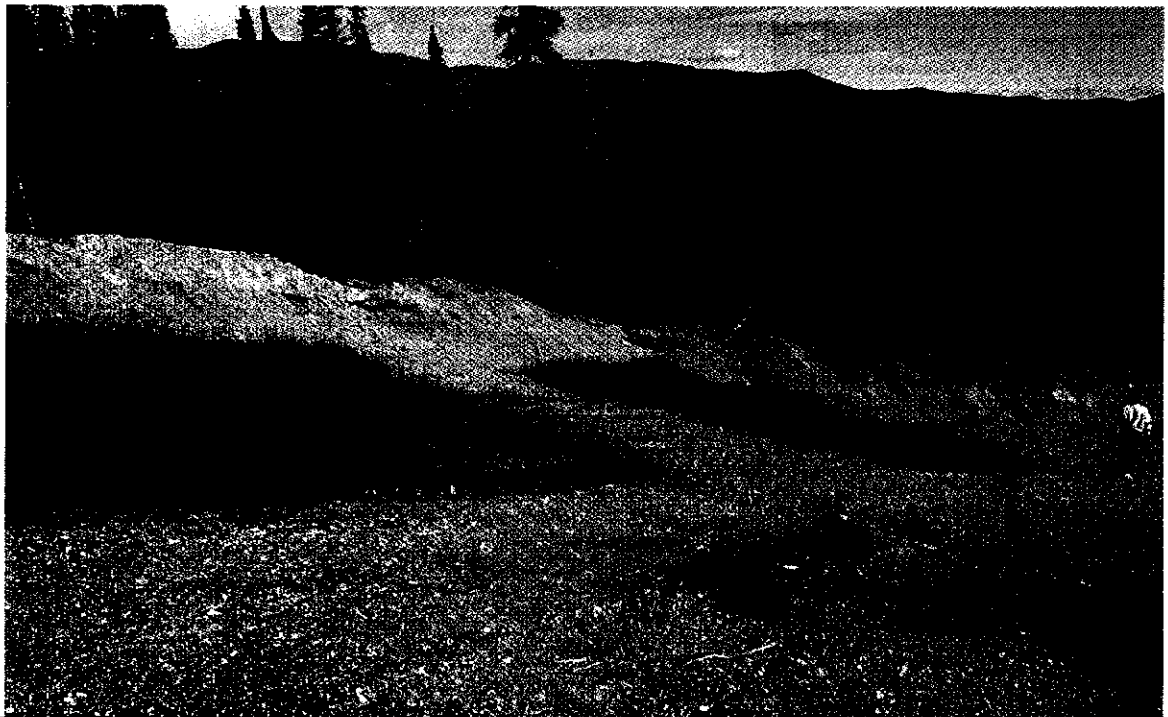
17. Nucleus trench, overview of reclaimed plots

18. Nucleus, Plot 2, straw mulch, alsike clover. Joan Craig, vegetation specialist

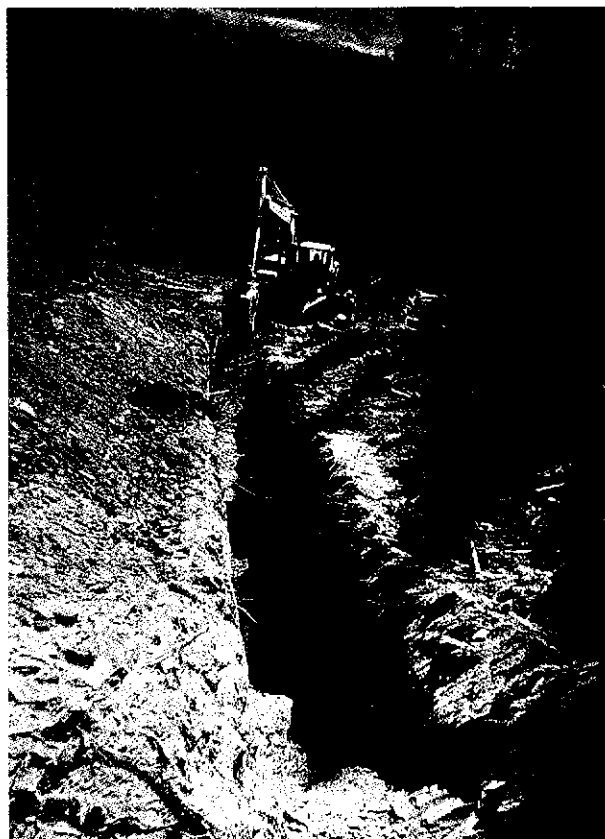
32. Excavation trenching at the Breakaway property in 1995

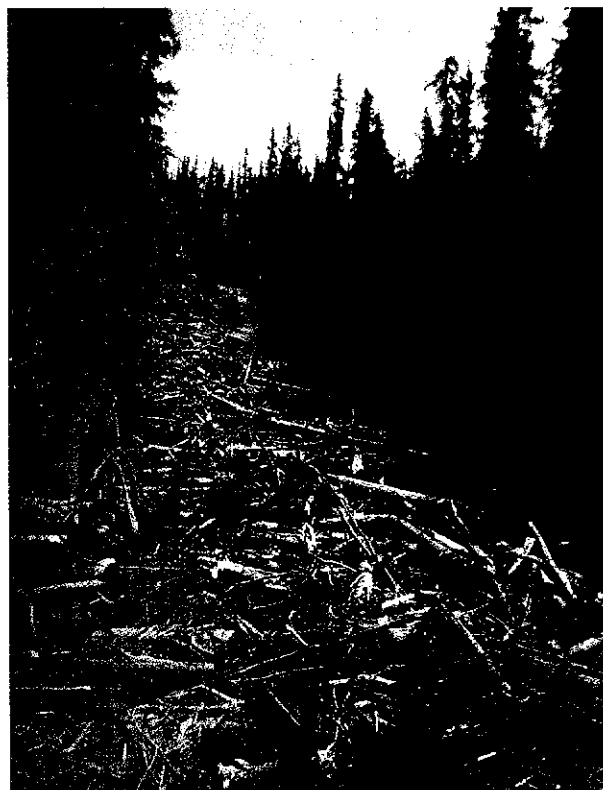
33. Refilled trench covered by slashed vegetation from the original clearing, Breakaway property.

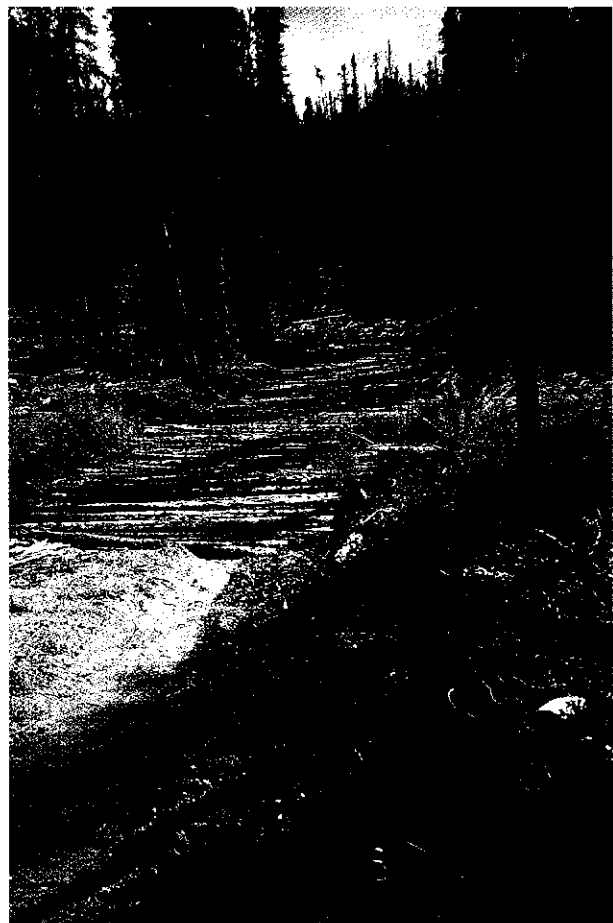
38. Corduroy style road construction at Division Coal property

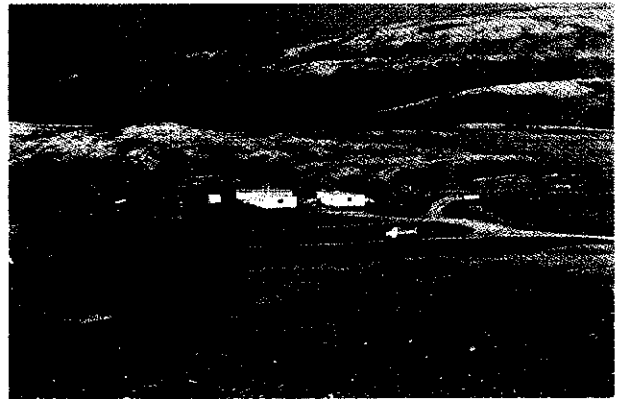
39. Howard's Pass camp in 1986 before the removal of trailers

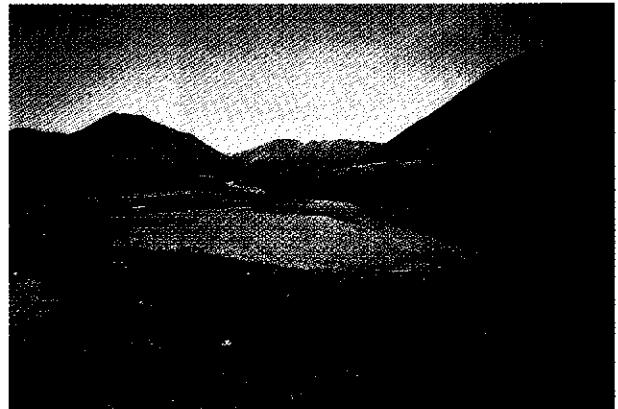
40. Location of the previous camp at Howard's Pass was in the centre of the photograph

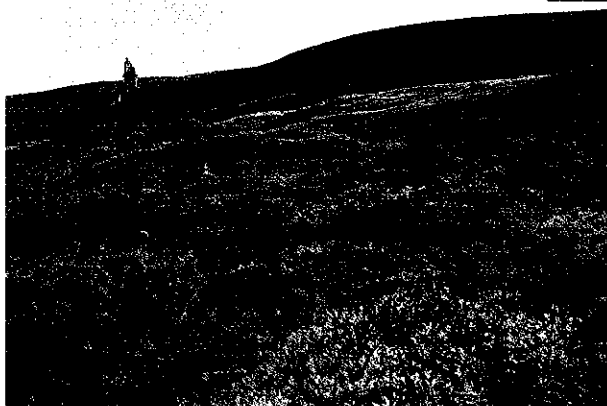
43. The backhoe trail to the Killer Gold property in 1997

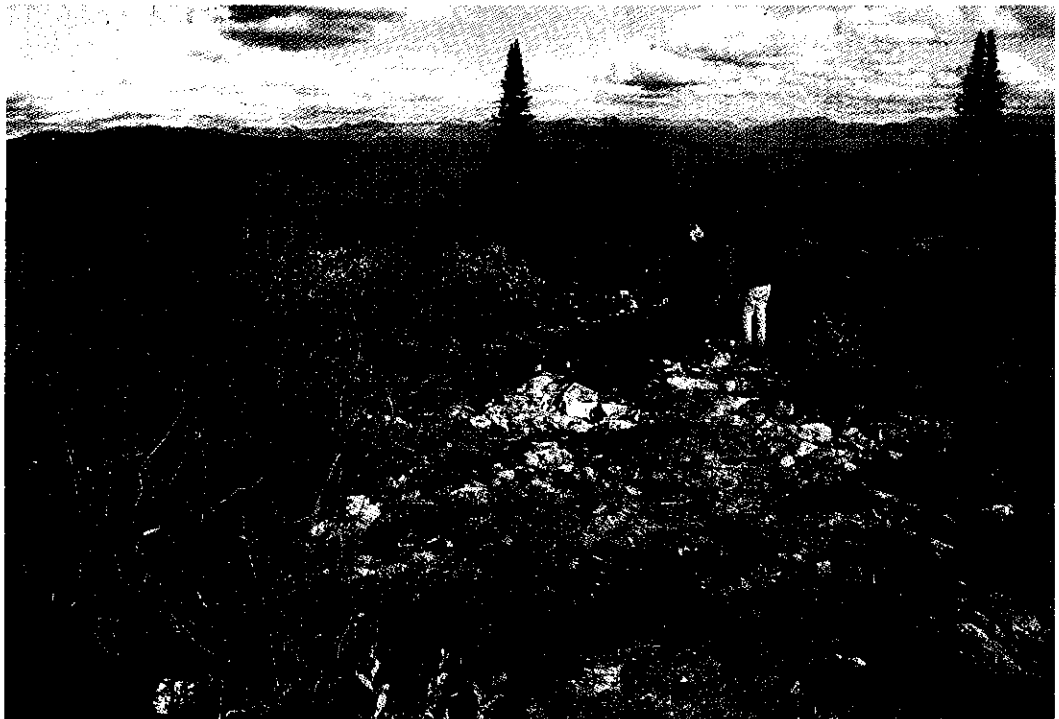
Dublin Gulch is located approximately 50 km north of Mayo and is currently owned by New Millennium Mining. Exploration on the property has been ongoing by various owners since its discovery in 1901. The bulk mineable gold deposit is currently undergoing the environmental assessment process in order to begin development and mining. Reclamation work at the property consists of the refilling of exploration trenches and pits dug in 1996 and 1997. Topsoil was retained and then restored to the surface layer. Figure 45 shows a reclaimed trench which was refilled and seeded in 1996, and photographed in the fall of 1997.

45. Reclaimed 1996 trench at Dublin Gulch property (September, 1997)

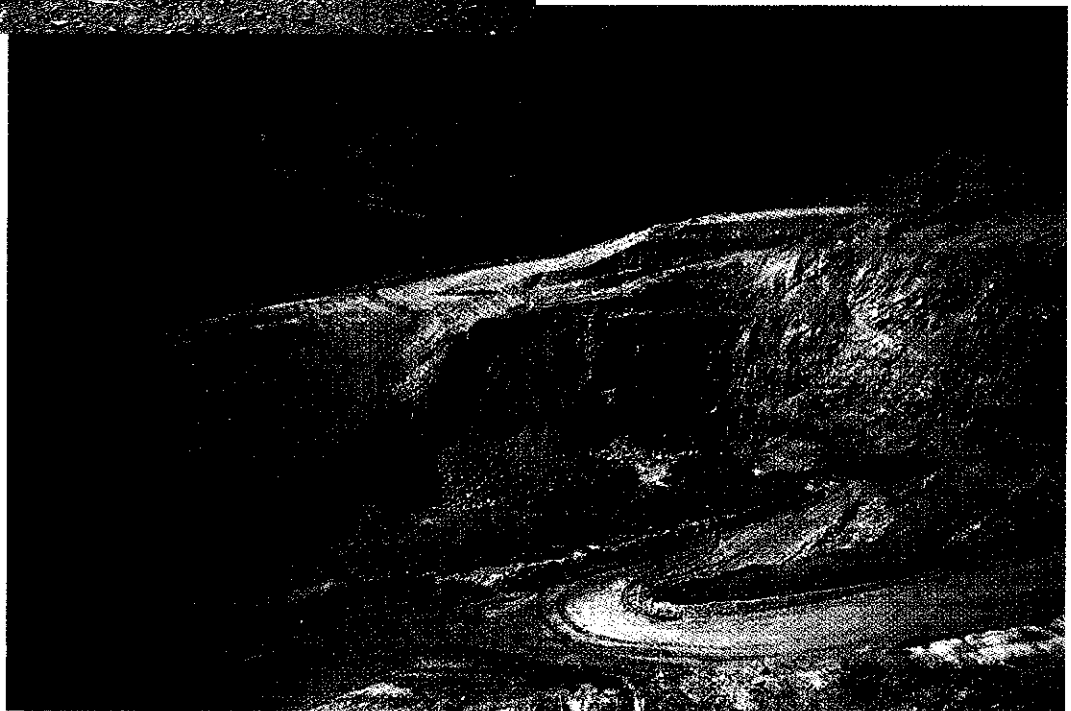
Mining had been ongoing for only one full season and was in the midst of its second season at the time it was toured in July of 1997. Consequently, reclamation work was in its early stages. Preliminary studies at the site include seed plots on waste dumps which were initiated in the fall of 1996. Various seed mixes obtained from a local supplier are being tested and have met with varied success as shown in Figure 51. Reclamation activity in 1997 also included the backfilling of open pits. Mining at the site is being done along a series of small, shallow open pits. The Canadian Pit, mined in 1996, was being backfilled with waste material from the Kokanee Pit where mining was taking place 1997 (Figure 52).

52. Mined out Canadian open pit at Brewery Creek (July, 1997)
