OPEN FILE 2004–18

A regional characterization of landslides in the Alaska Highway corridor, Yukon

C.A. Huscroft, P.S. Lipovsky and J.D. Bond

Huscroft, C.A., Lipovsky, P.S. and Bond, J.D., 2004. A regional characterization of landslides in the Alaska Highway corridor, Yukon. Yukon Geological Survey, Open File 2004-18, 65 p., report and CD-ROM.

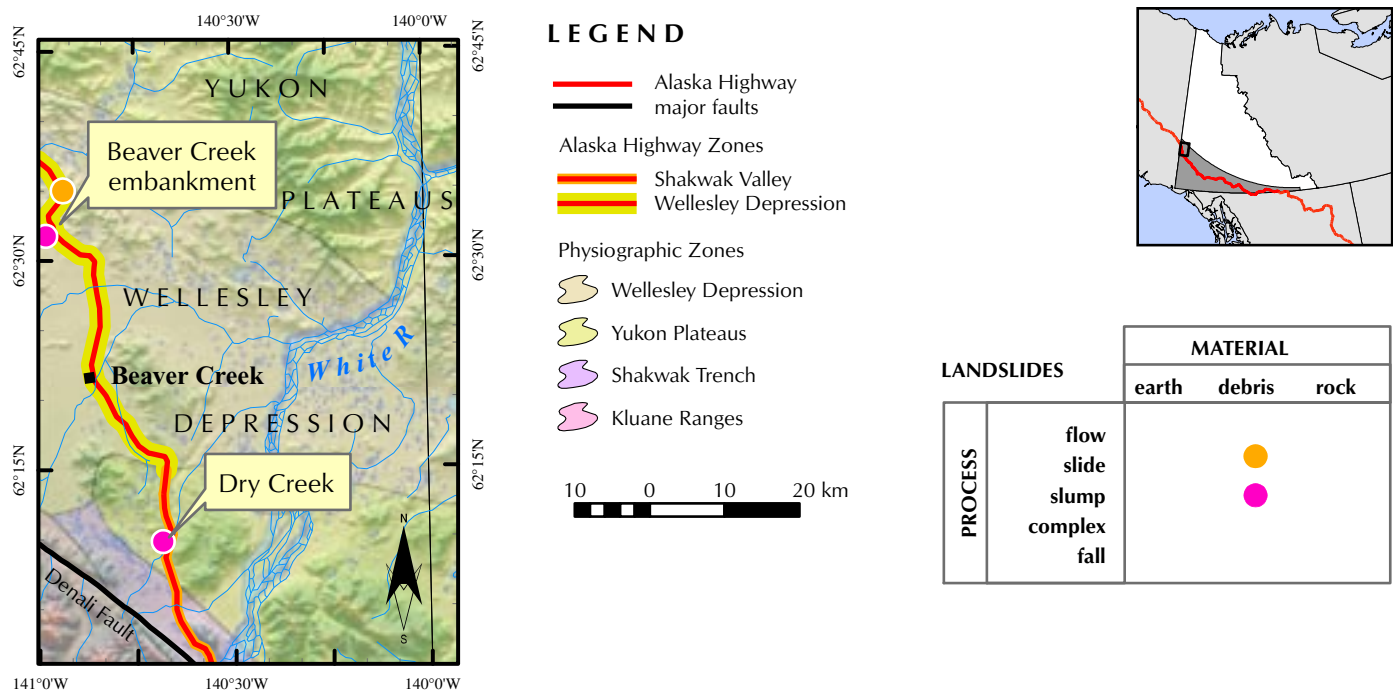
Landslides are rare in the Wellesley Depression due to the area's subdued relief and the limited extent of stream incision (Fig 8). Slope failures are primarily related to thermokarst subsidence and streambank erosion of icy organic or fine-grained sediments. Shallow debris slides and rock slumps are less common.

Figure 8. Overview of noted landslide locations within the Wellesley Depression landslide zone. Physiographic zones modified from Matthews (1986).

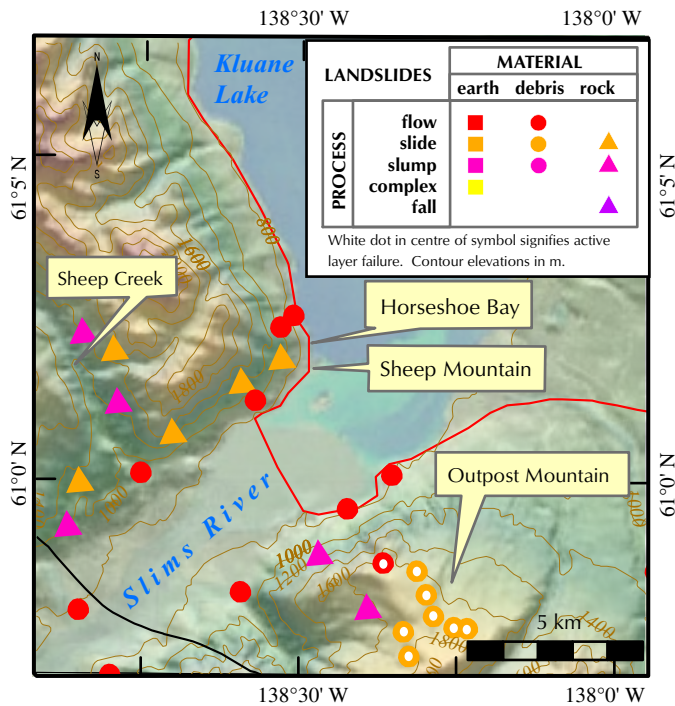
Figure 13. Map of southern Kluane Lake depicting location of various landslide types.

Clague (1981; Fig. 13 and 14). Two super-imposed phases of failure were identified, one between 1950 to 1200 years B.P., and the other 1200 to 490 years B.P. In total, approximately 5 to 10 million cubic metres descended the mountain side in two separate events. These failures involved rapidly moving masses of rock which extended up to 1.5 km from their

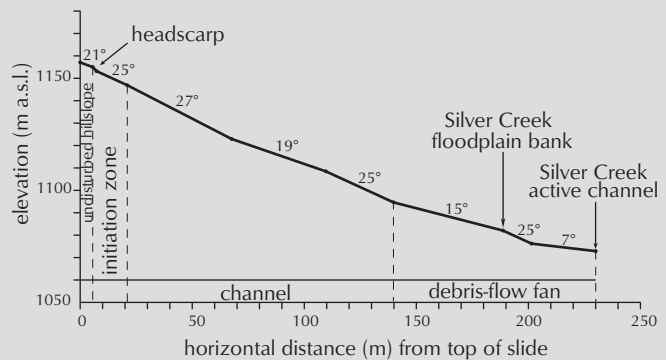
Figure VI. Diagrammatic profile of Silver Creek debris flow.

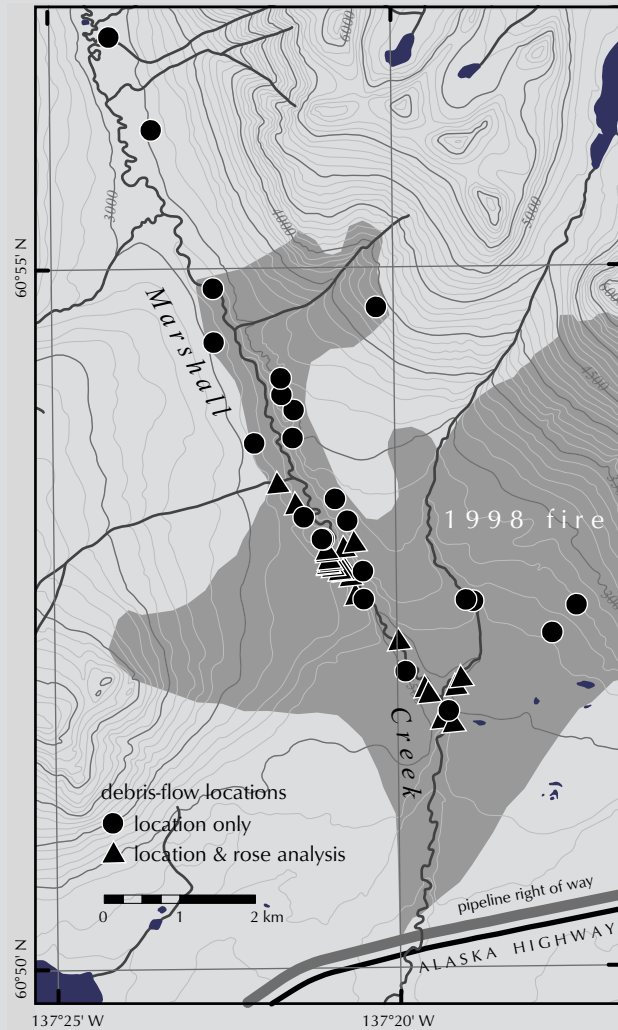
Forty-one recent debris flows exist within terraces and valley sides of Marshall Creek, 14 km northeast of Haines Junction. The vast majority of the instabilities were initiated within an area burned by forest fires during the summer of 1998 (Fig. VII). The fires affected an area of approximately 37 km² and bordered Marshall Creek for 9 km.

Figure VII. Topographic map of debris flow locations and aerial extent of burn along Marshall Creek. Dark grey is 1998 fire-burned area.

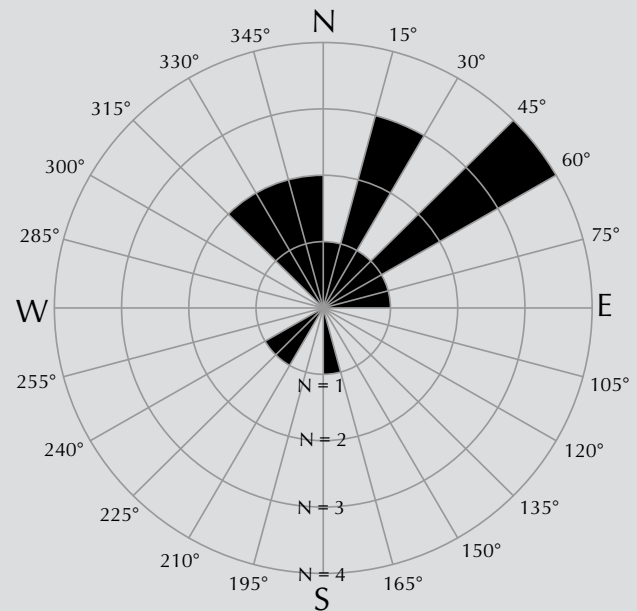
The debris flows in the Marshall Creek basin can be divided into two groups based on the landform within which they originate. The majority of the landslides (36) developed on the scarp of high-level terraces composed of glacial and glacial-fluvial material (Fig. VIII). In comparison, a lesser number (5) of the landslides occurred on gentle till-blanketed valley sides. Much of the valley fill was deposited as ice advanced and retreated from the Marshall Creek valley during the late Wisconsinan McConnell Glaciation. During this advance and subsequent retreat, silt-rich till blankets were deposited on valley sides and a thick fill of silt-rich till, glaciolacustrine and glaciofluvial strata were deposited in the valley bottom. Figure IX describes the aspect of the debris flows that were surveyed by helicopter or by foot. The average aspect of the debris flow headscarps in the high-level terraces was north-facing.

Figure IX. Rose diagram representing the aspect of visited landslide headscarps in Marshall Creek valley.

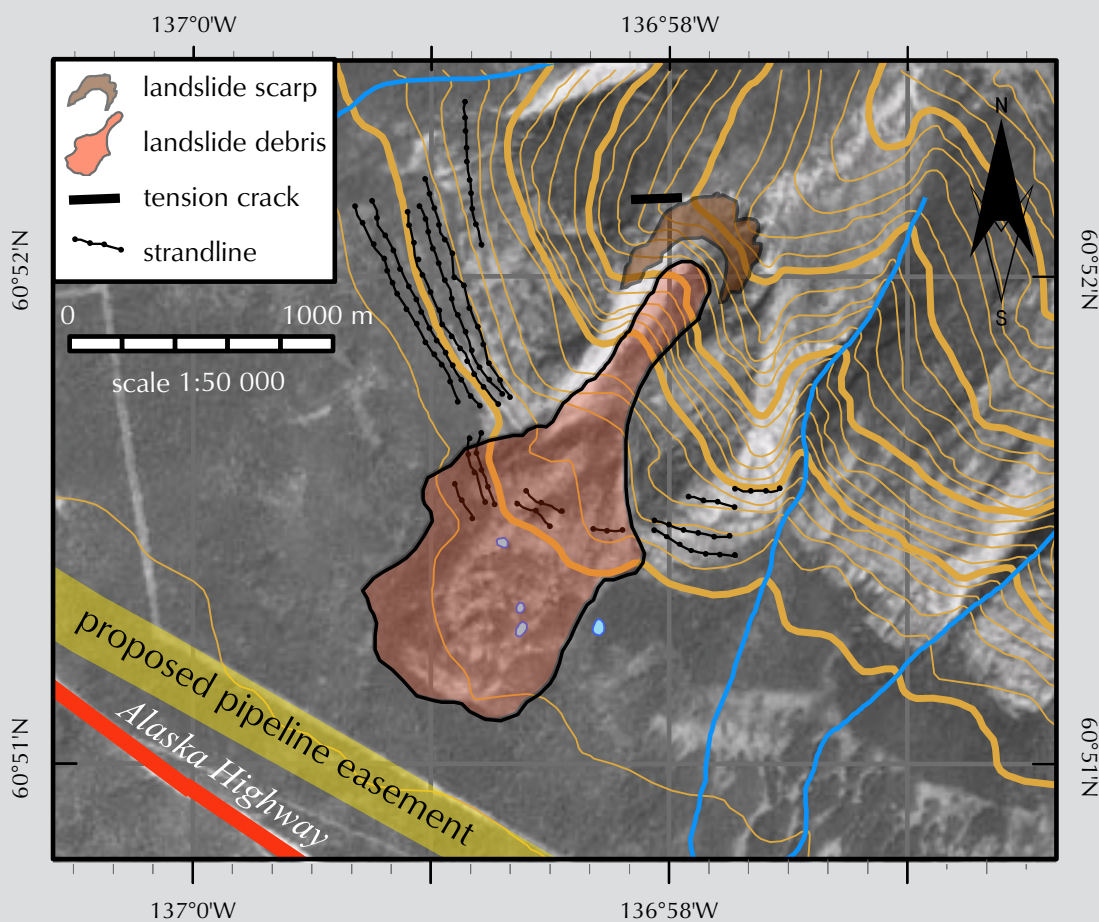
suggests that the slide entered Glacial Lake Champagne. Moist lacustrine deposits in the flat valley bottom have little frictional resistance and are suspected to have supported the mobility of the flow. Seismic shaking may have also contributed to triggering the failure.

The presence of disturbed vegetation along tension cracks indicates recent movement. Such signs of modern instability have implications for hazard assessment within this region of the Alaska Highway corridor. Prior to further development below the slopes of this upland, a more detailed assessment of the area is recommended.

Figure XI. Topographic map underlain by an ortho-corrected aerial photograph (A25275-14) depicting location of Aishihik rock slide.

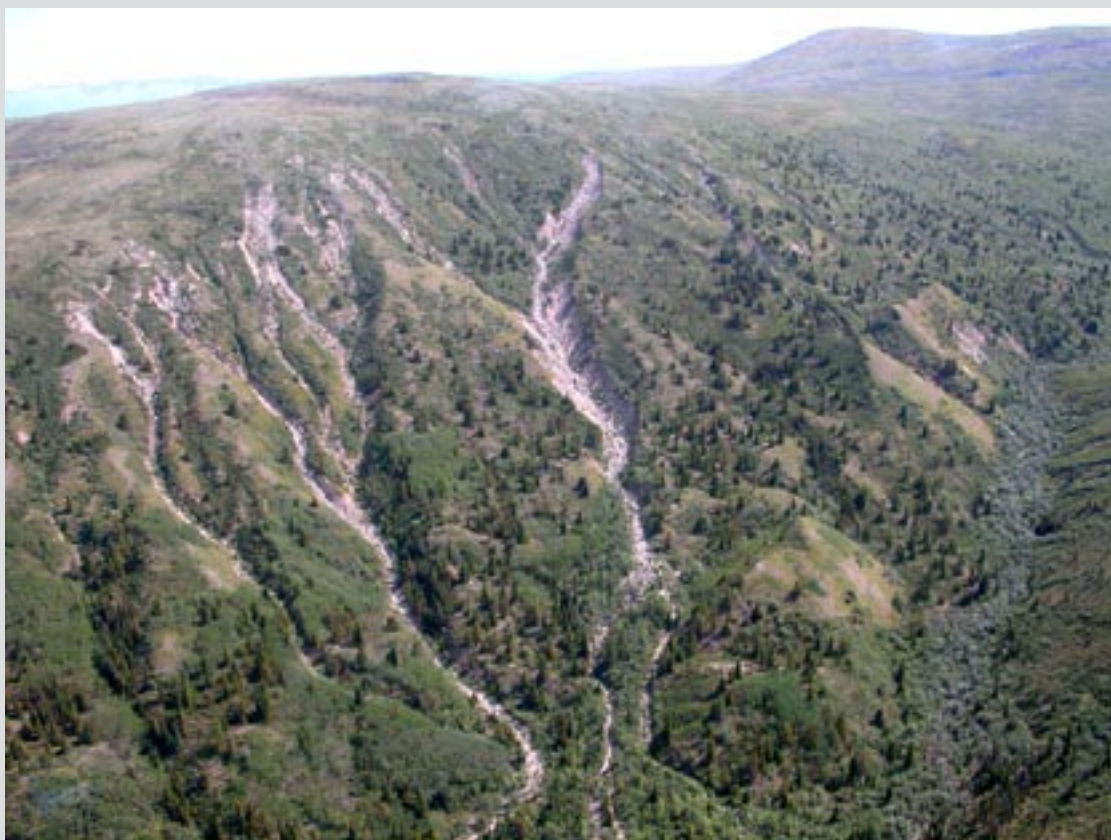
A series of ten debris-flow channels in a basin draining Mount Sumanik demonstrate a potential effect of ground-ice thawing on undisturbed alpine slopes (Fig. XVII). Mount Sumanik is located 15 km west of Whitehorse. The basin containing the landslides drains westward. Instabilities are confined to the southwest-facing slopes of the drainage basin, and occur on the apex of convex alpine slopes in silty till deposits and colluvium. The failures were initiated on fairly steep slopes (24°-29°) and travelled down the more moderate mountain slope (15°-25°), scouring gullies up to 47 m wide and 13 m deep, commonly to bedrock (Fig. XVIII). In several locations, gullies follow bedrock structures. Continued retrogression is evident in the headwalls

Figure XVII. Oblique aerial view of Mount Sumanik debris-flow channels, looking east.

Shallow slumping and evidence of poor drainage is widespread on the slope above each debris-flow headscarp. A 60-cm-thick saturated soft plastic layer was discovered on top of permafrost within this zone. This stratigraphy suggests that the presence of permafrost promotes poor drainage and may lead to the elevated pore pressures that trigger slumping on the hillside, thereby supplying debris to the gully system. Once failures initiate in the upper alpine slopes, shallow bedrock beneath the lower gullies concentrates water and facilitates long runout distances into the valley bottom.

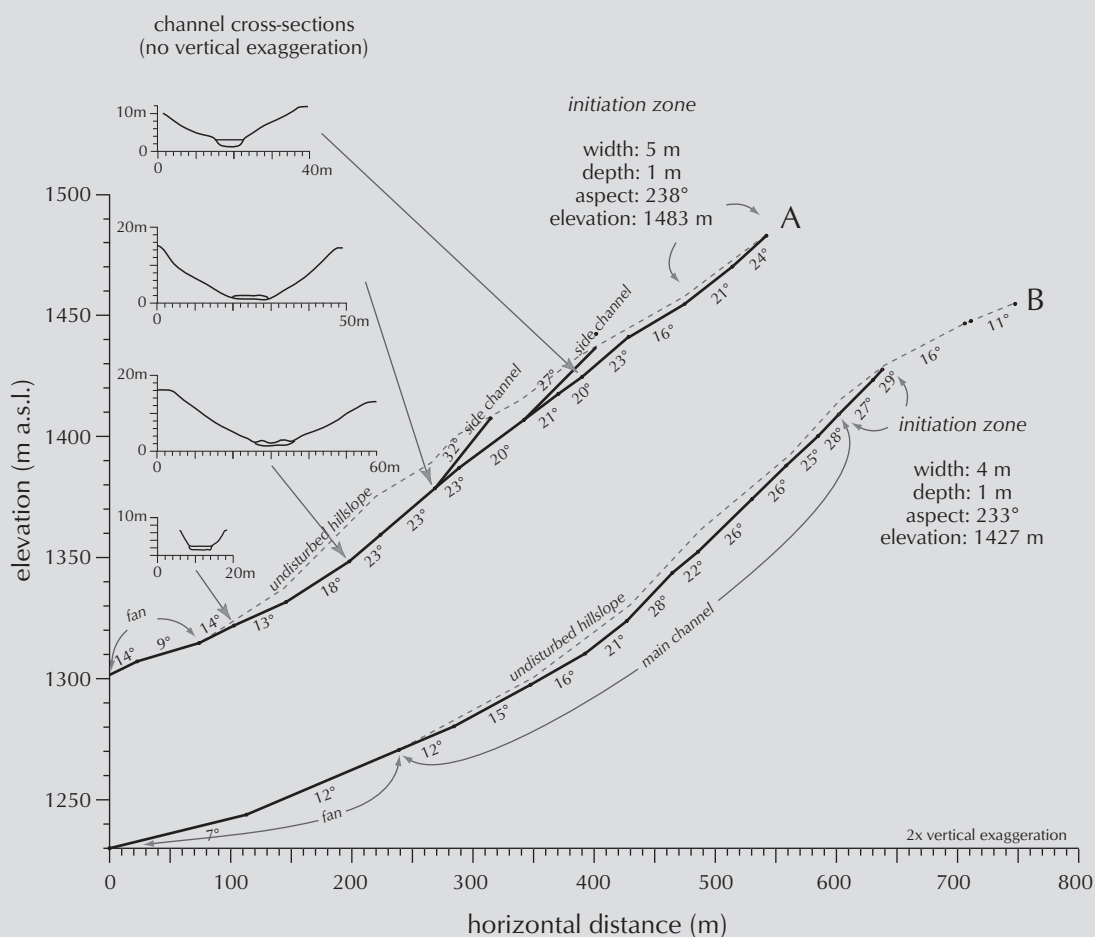
Figure XVIII. Longitudinal profile and transverse cross-sections of a debris-flow track on Mount Sumanik

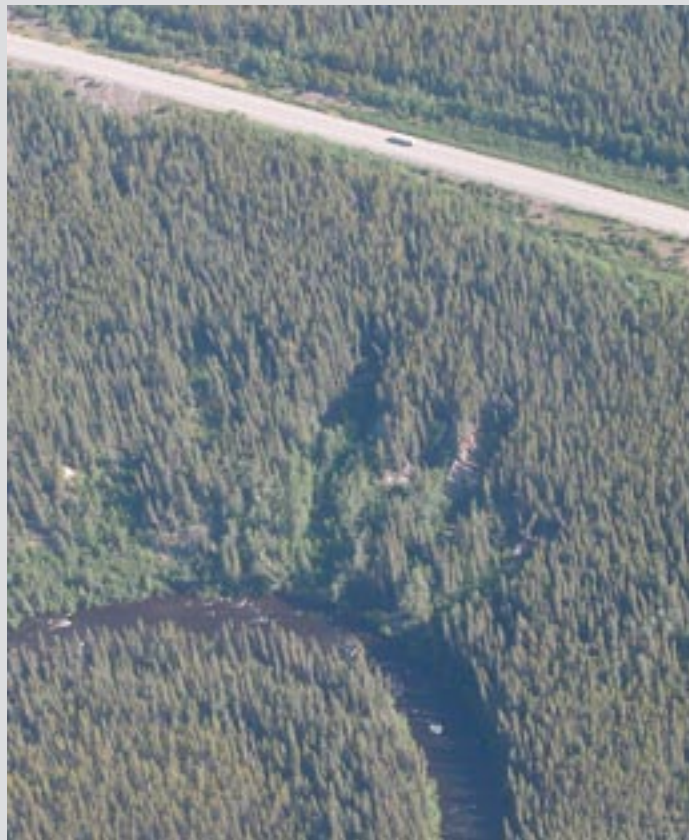
A series of five debris flow gullies are situated within the Alaska Highway corridor, 35 km southeast of Teslin (Fig. XXI). The gullies are incised into a 45-m terrace along the Morley River underlain by till. The most recent debris flow occurred down a 120-m-long gully with a steep 10-m-high headwall. The headwall exposed grey, stiff, and prismatically jointed till with a silty loam matrix and rare lenses of gravelly sand. The debris flow initiated within saturated colluvium at the base of the headwall. During field visits in the summer of 2003, a spring emanating from the debris was observed. Excavations in the initiation zone revealed a 20-40 cm sandy gravel lense as the source of water feeding the spring. From the initiation zone,

The occurrence of debris flows along the bank of the Morley River is attributed to stream incision of poorly drained source material. The debris flows are situated along the cut-bank of a meander of the Morley River, where undercutting by the river at this location leads to over-steepening of the glacial valley fill, colluviation, and accumulation of debris at the base of steep scarps. The presence of springs at the base of gully headwalls suggests that groundwater may saturate, increase pore pressure, and then cause failures within the saturated debris. In turn, these failures undermine the headwall and prevent its stabilization. This cyclical behaviour leads to retrogression of the gully headwall and widening of the gully.

Figure XXI. Oblique aerial photograph of Morley River debris flows. The Alaska Highway crosses at the top of the photograph.

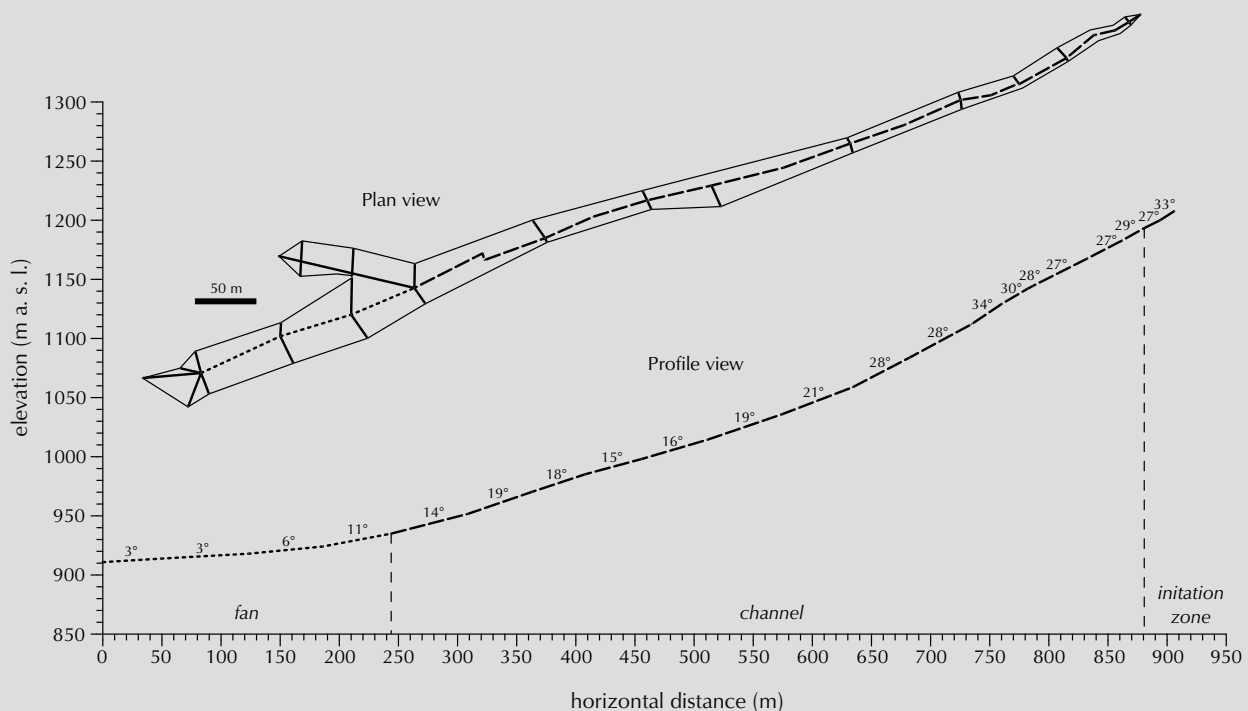
failure. Individual trunks are a maximum of 30 cm in diameter. On a gentle apron below the gullied slope section, the debris spread into two arms that cleared two 20-m-wide paths through mature subalpine fir forest. The main arm of the flow extended into a marsh on a terrace adjacent to the Alaska Highway. The debris on the fan attains a maximum observed thickness of 1.5 m. The total length of the slide is 905 m and the width of the scar ranges from 10 m at its headscarp, to 50 m across its fan (Fig. XXIII).

Figure XXIII. Long profile and plan view of Rancheria Message Post debris-flow track.

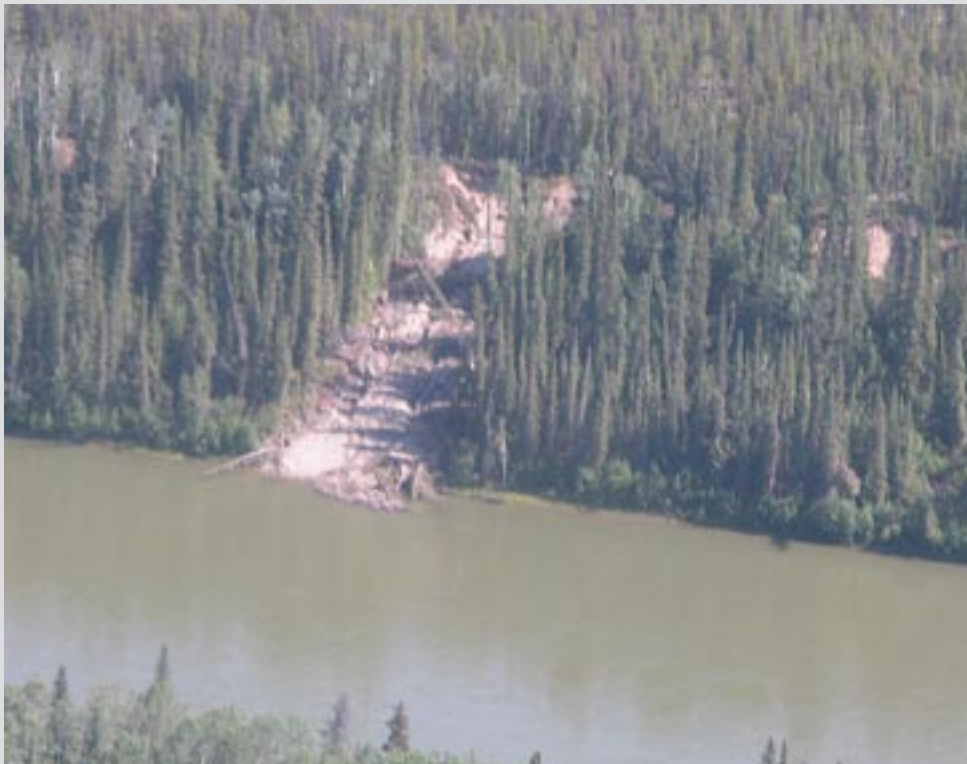
Along the forested banks of the Liard River, bedded sediments with contrasting permeability have led to translational sliding (Fig. XXIV). Approximately 10 km southeast of Watson Lake, the Liard River incises a glaciofluvial terrace underlain by stiff laminated lacustrine clay and silt, with common beds of diamicton and gravel approximately 20–35 cm thick. The shallow (1–1.5 m) failure scar extends from the top of the 35-m-high terrace bank to river level (Fig. XXV). The average width of the scar is 23 m. Undisturbed slopes adjacent to the failure are veneered with 50 cm of colluvium and a thick forest mat. Debris, composed of equal amounts of soil and organic debris, slid directly into the Liard River. A spring issuing from the interstratified base of glaciofluvial gravels was noted.

Creation of the Liard River slide is attributed to high groundwater storage combined with restricted drainage resulting from colluviation of bedded fine sediment. Colluvial processes and vegetation growth disturb the stratification of bedded sediment and result in a less permeable veneer of colluvium capping underlying undisturbed sediment. The impermeable cap restricted drainage at the base of the outwash gravel and increased groundwater storage. The resulting rise in pore pressure during a suspected snow melt or rainstorm event decreased effective stress and initiated translational sliding within the colluvial layer.

Figure XXIV. Oblique aerial photograph of debris slide along Liard River.
