# Geophysical and borehole investigations of permafrost conditions associated with compromised infrastructure in Dawson and Ross River, Yukon

Laxton, S. and Coates, J., 2011. Geophysical and borehole investigations of permafrost conditions associated with compromised infrastructure in Dawson and Ross River, Yukon. *In: Yukon Exploration and Geology 2010*, K.E. MacFarlane, L.H. Weston and C. Relf (eds.), Yukon Geological Survey, p. 135-148.

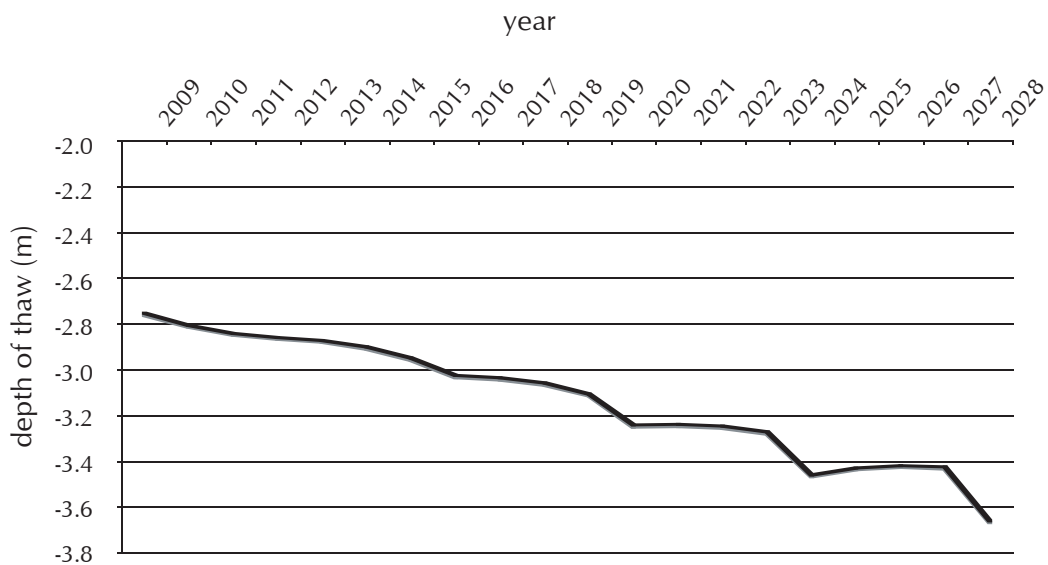
Permafrost conditions in Dawson City were modeled as part of a YG Transportation Engineering Study (Coates, 2009) using the MUT 1D, a finite element analysis geothermal modeling program designed by the Alaska Department of Transportation. Results from Coates (2009) indicate that active layer depths are expected to increase by up to 1 m, from 2.6 to 3.6 m, by 2020 in ice-rich permafrost in the Dawson town site due to anticipated climatic warming rates of 0.1°C per year (Fig. 11).

**Figure 11.** Projected increase in maximum depth of seasonal permafrost thaw by 2020 for Dawson (Coates, 2009).
