# Anvil Range Mine Complex

## 2004 to 2008 Water Licence Renewal Application Report

Anvil Range Mining Corporation  
(Interim Receivership)

May 2003

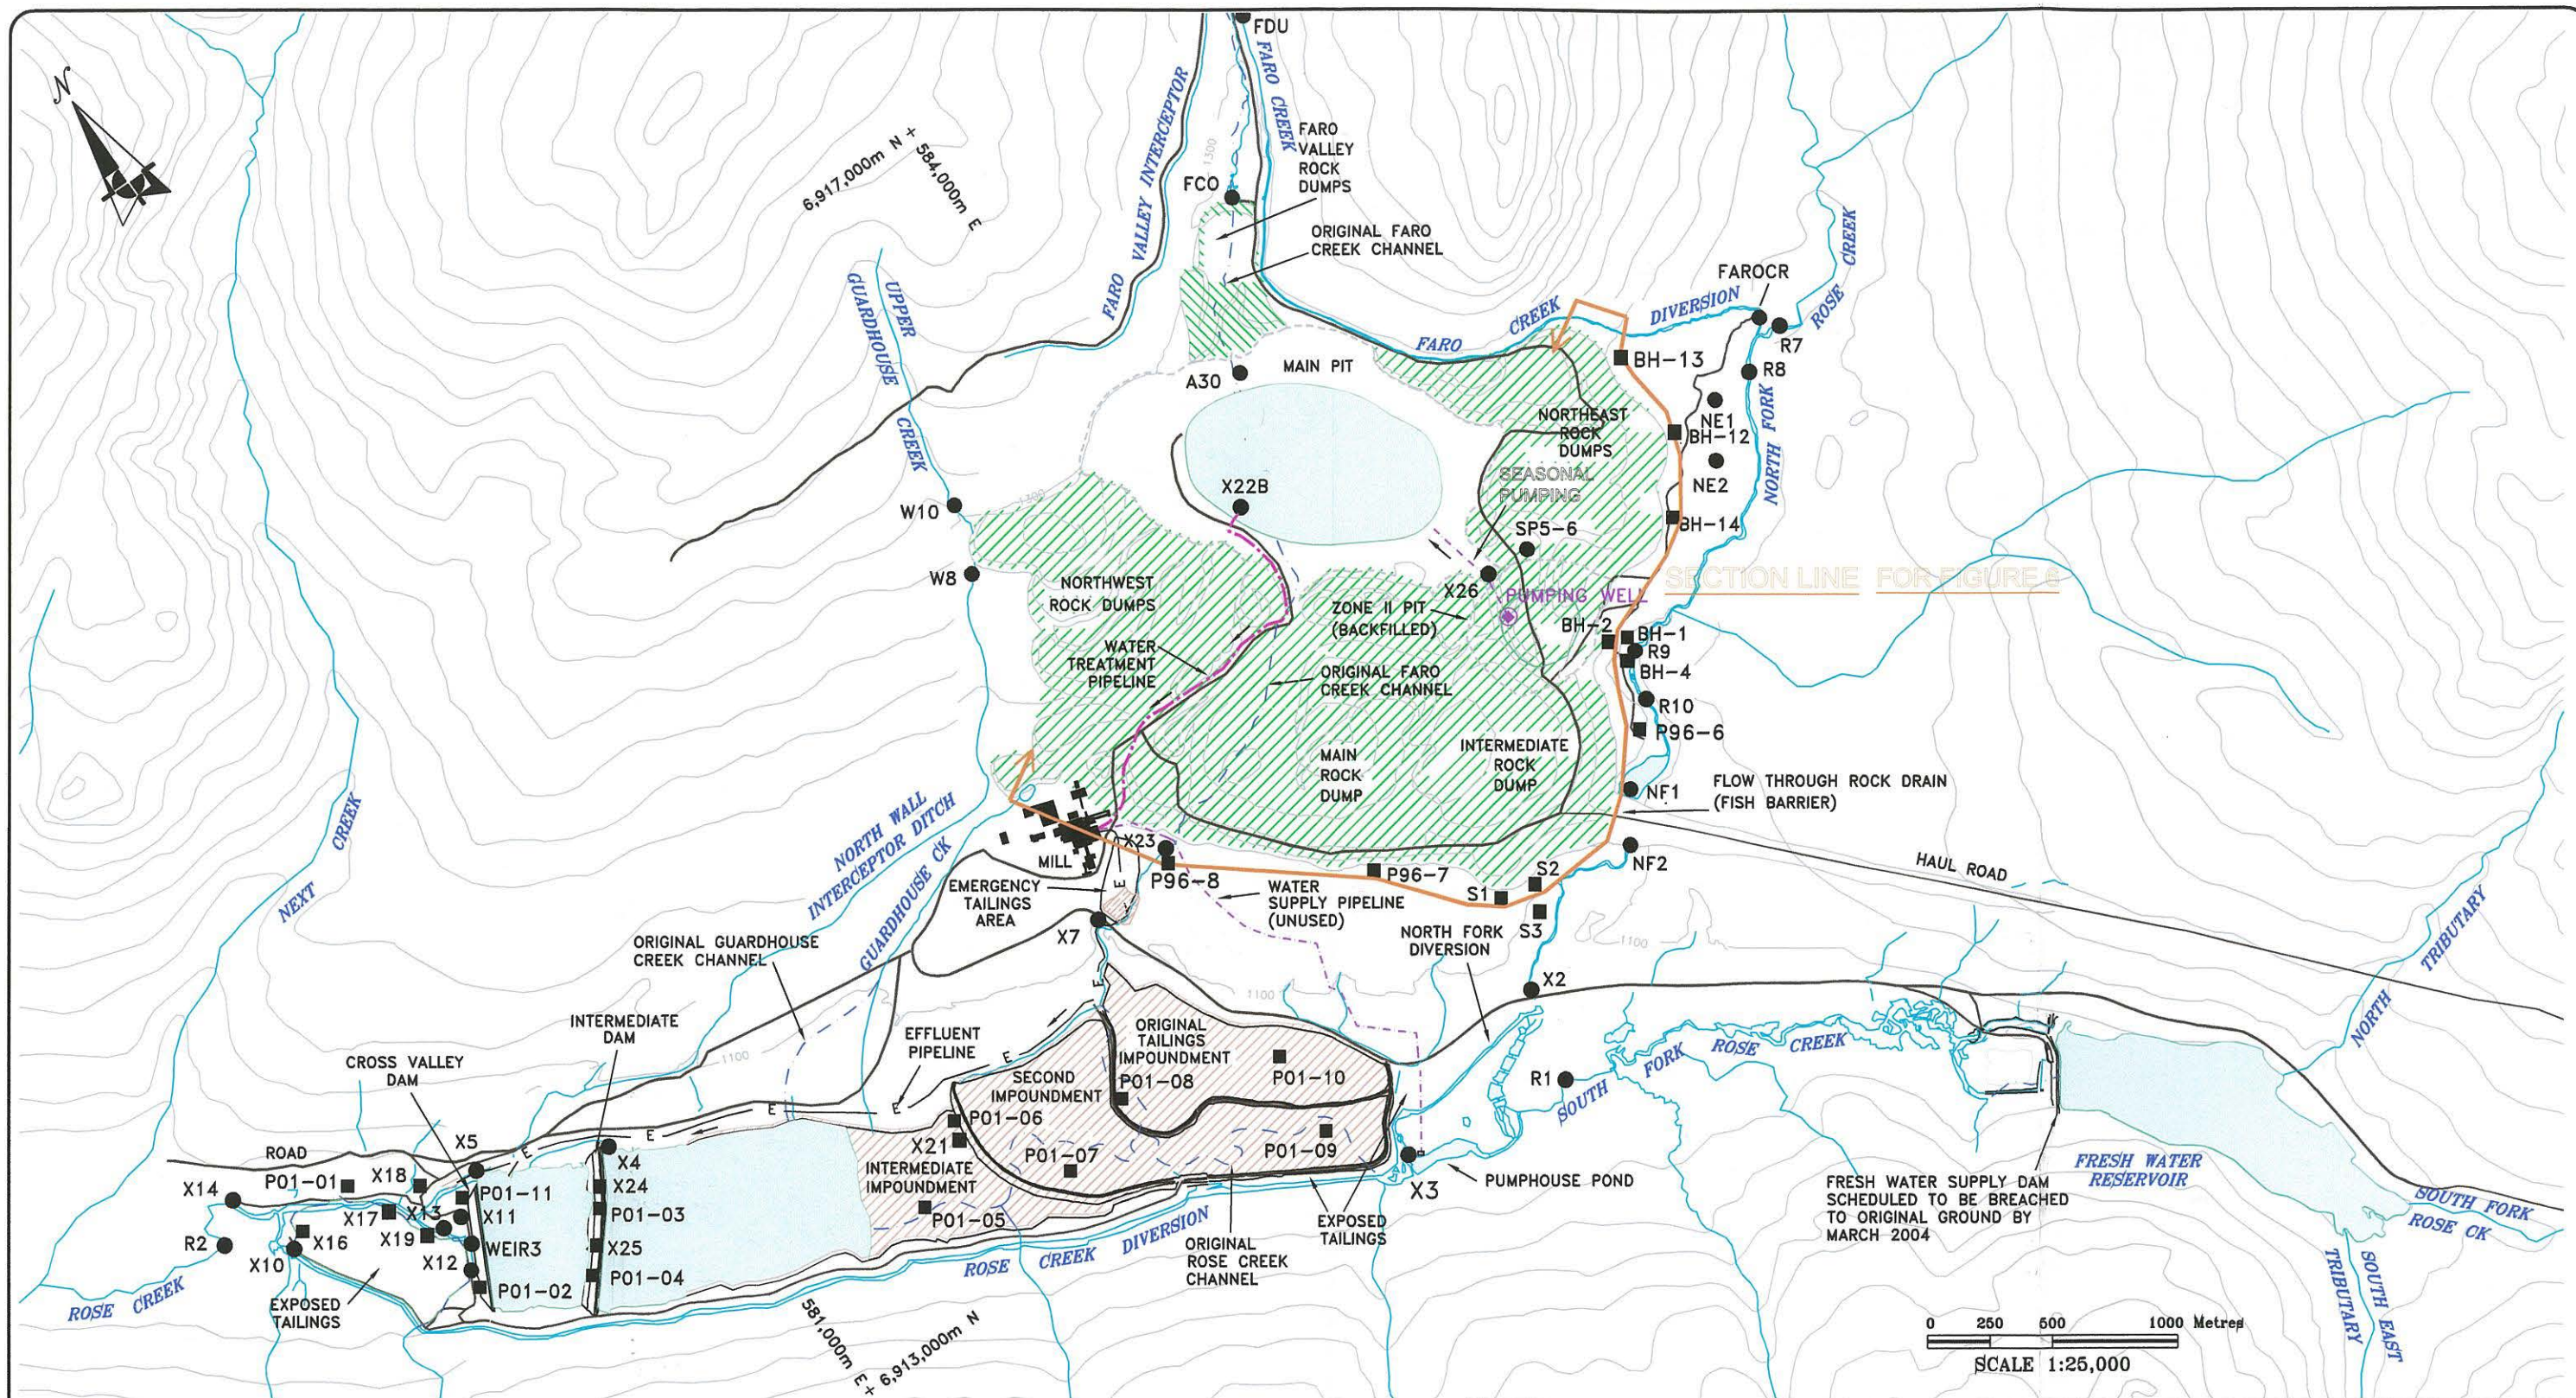
SECTION LINE  
FOR FIGURE 6

Tables 6 and 7, repeated from RGC 1996, provide a listing of the individual rock dumps, the years of construction, their dimensions and tonnages. The individual dumps are illustrated on Figures 4 and 5 and a section that illustrates the surface topography around the perimeter of the dumps is provided on Figure 6. RGC 1996 provides a detailed listing of the estimated composition of the individual rock dumps according to rock type, which is not repeated here.

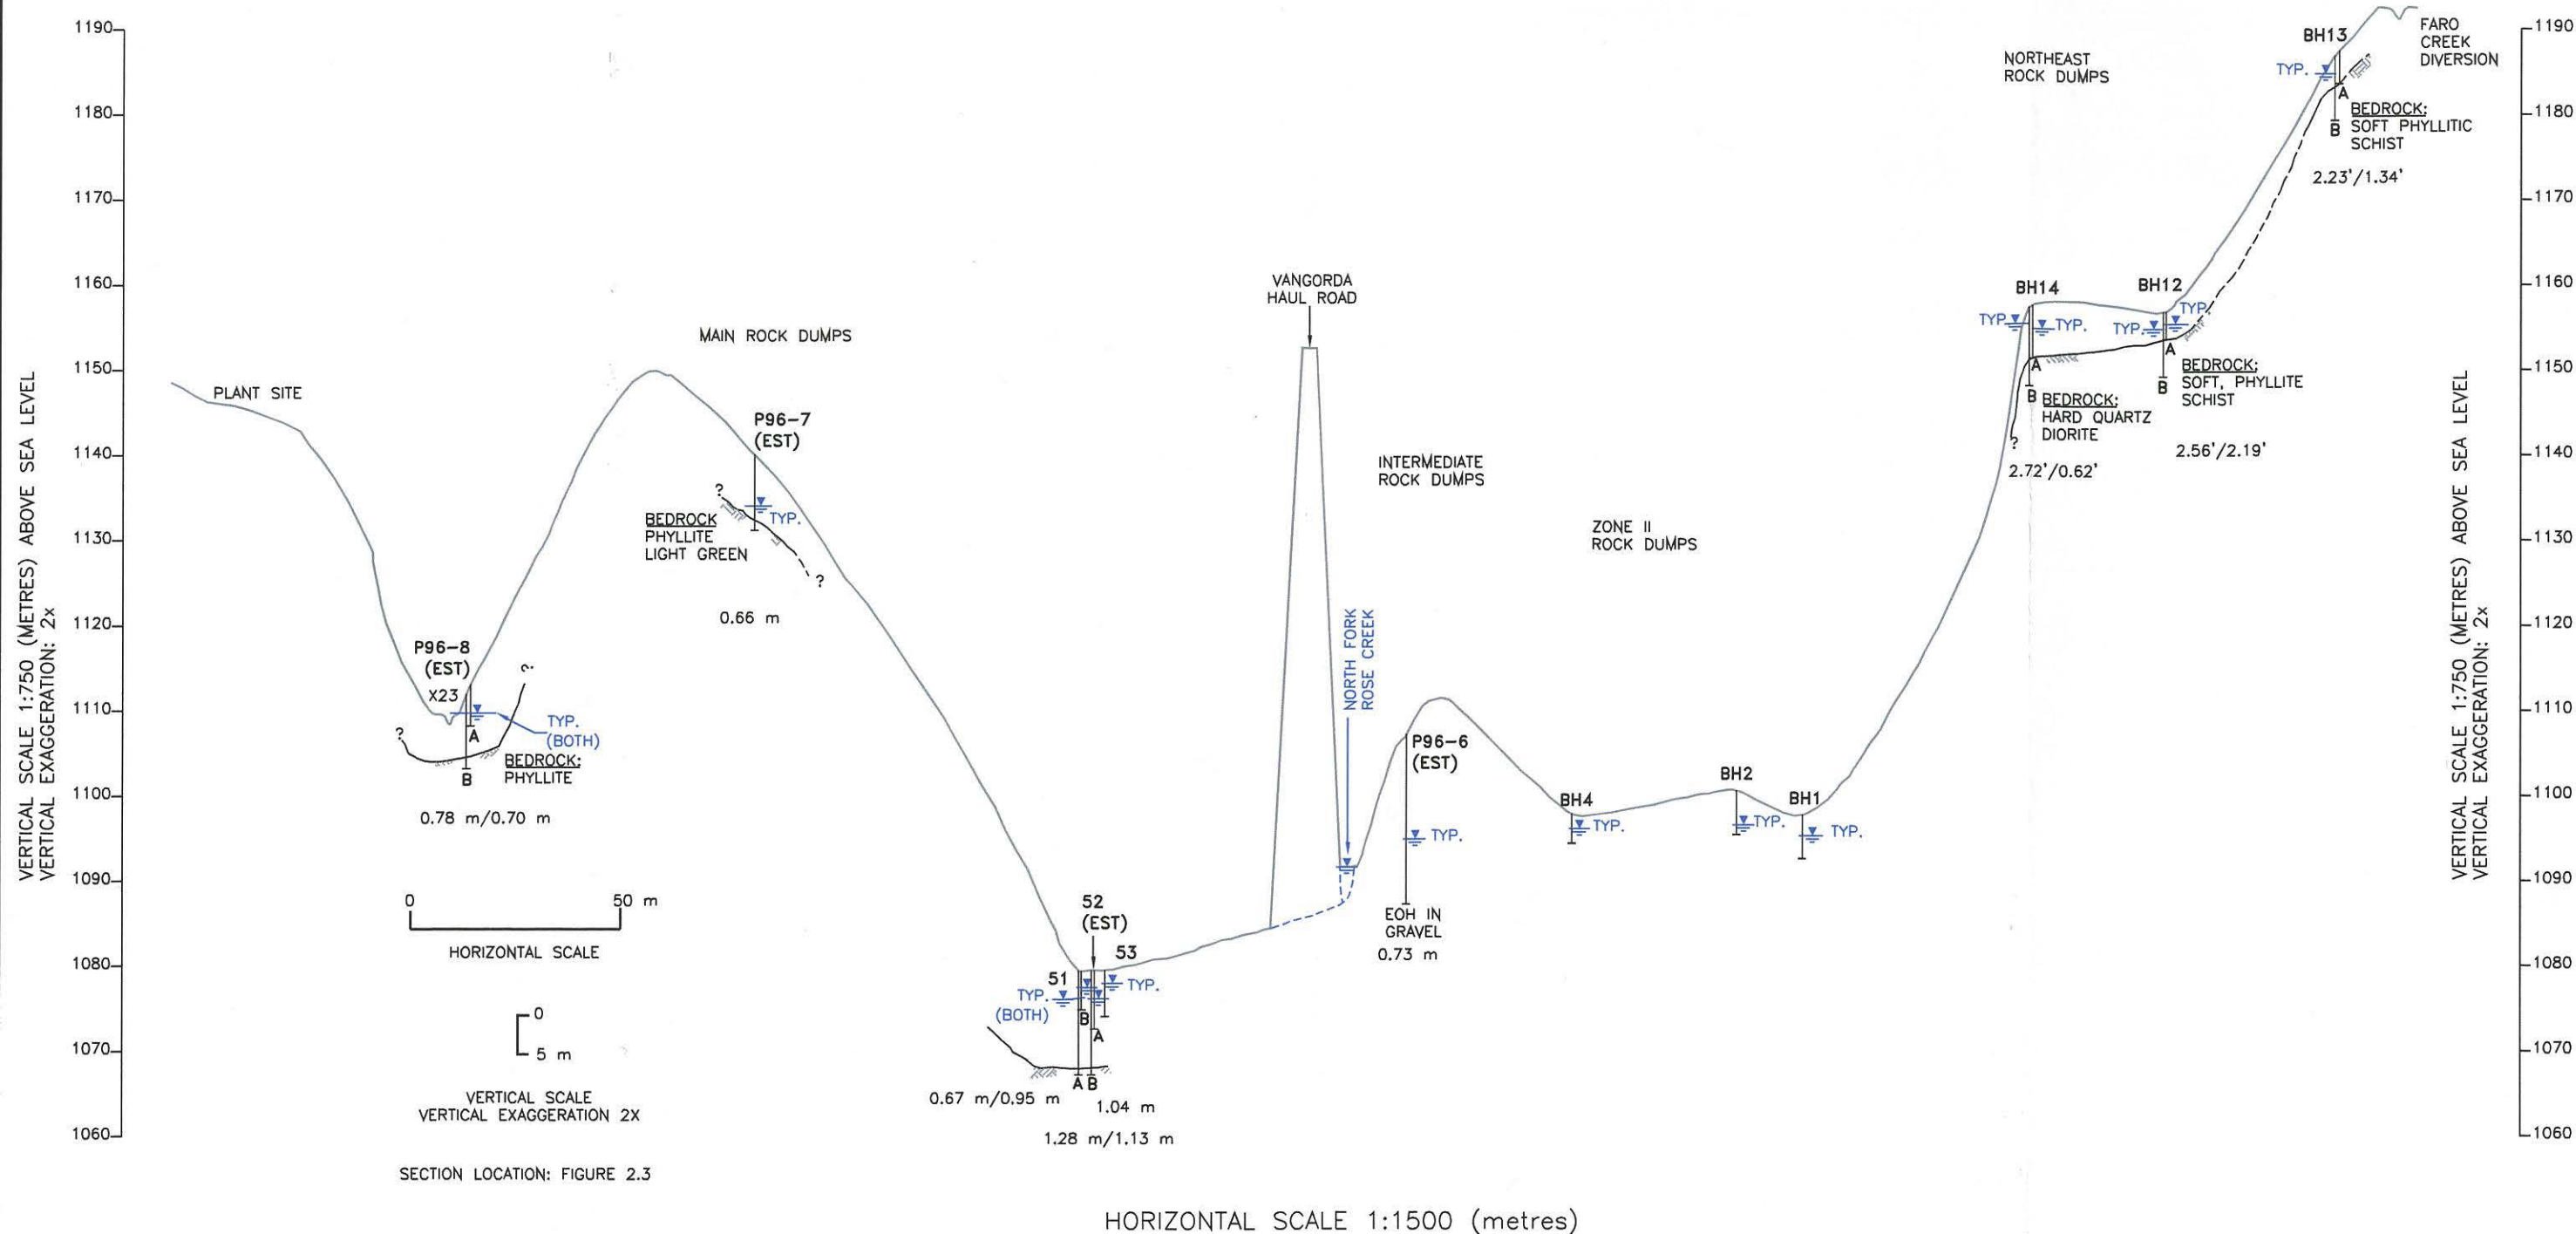
6

SOURCE OF FIGURE:  
SKETCH BY ERIC DENHOLM, GARTNER LEE LIMITED

MEASURED GROUNDWATER (m)

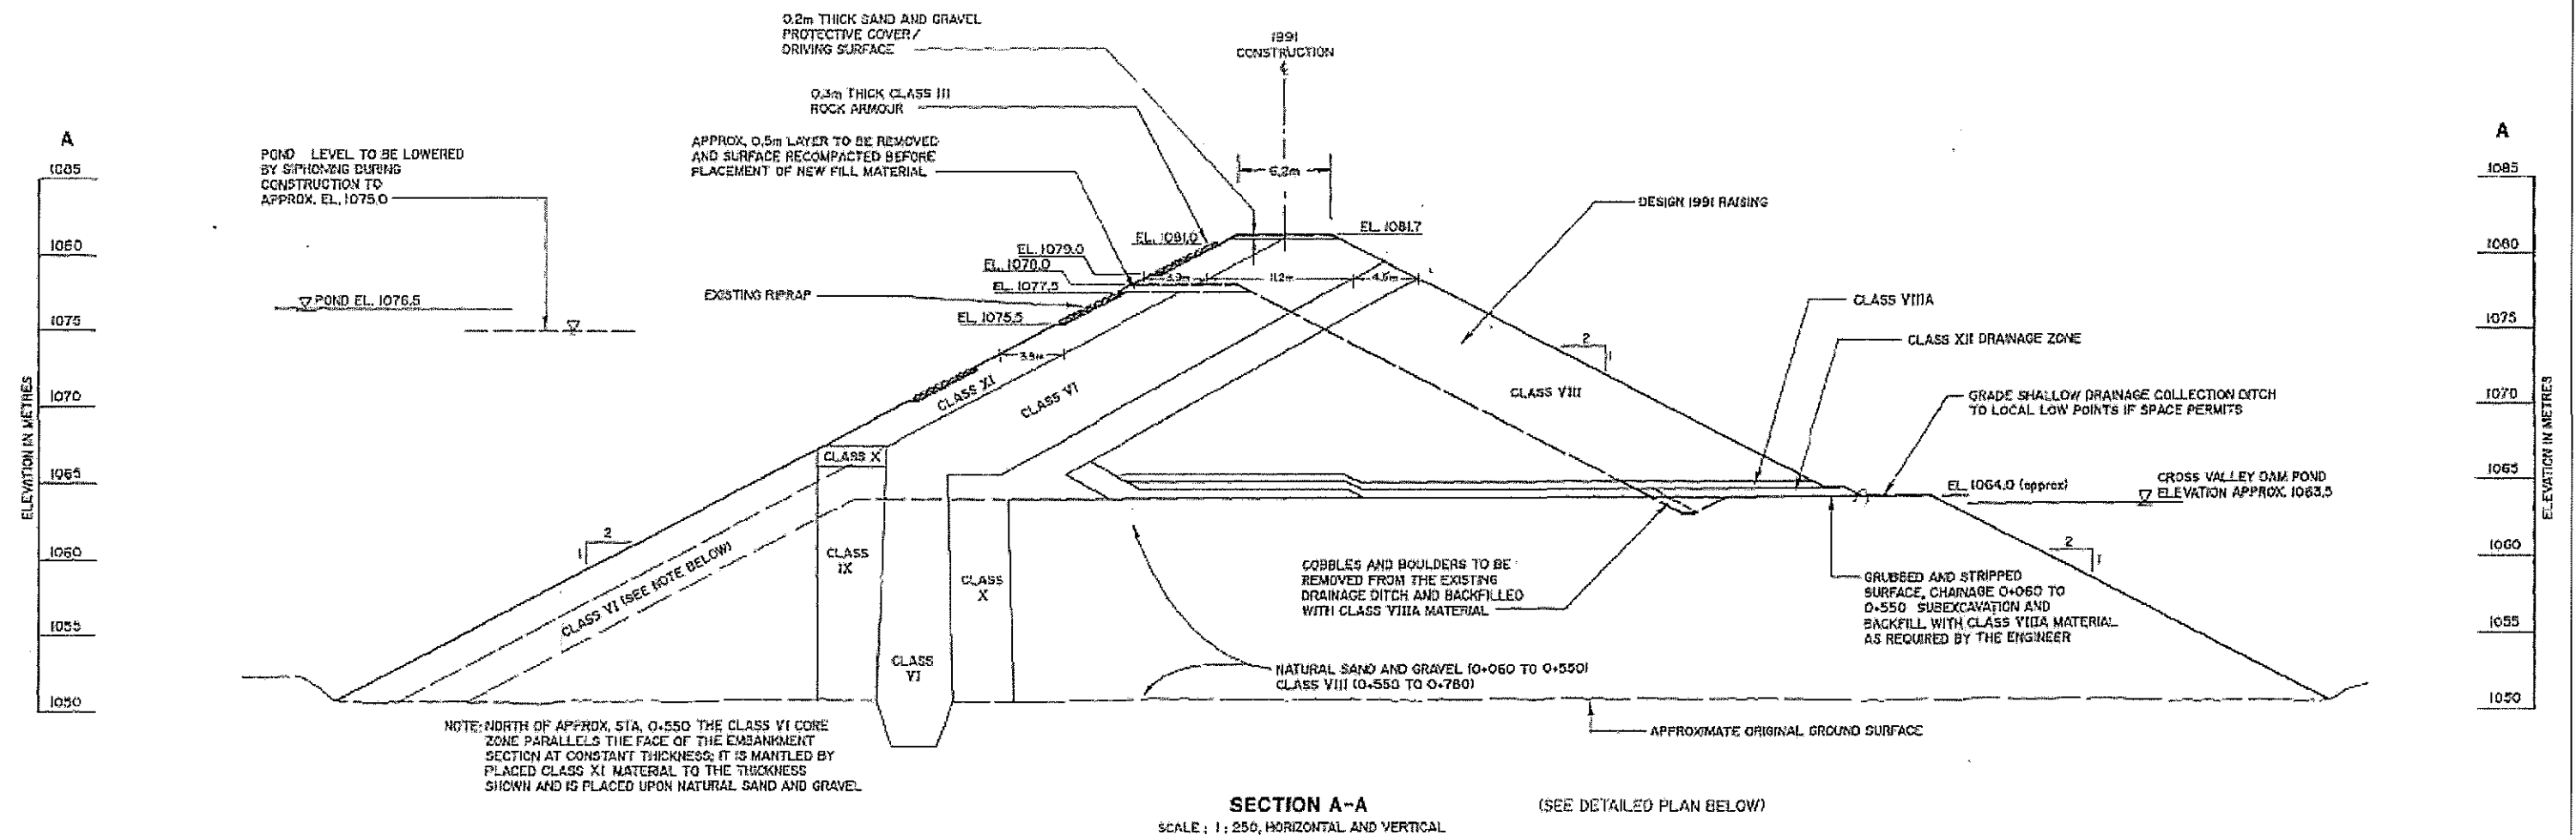
7

SOURCE OF FIGURE:  
DRAWING SHOWN BELOW DRAWN FROM REPORT BY GOLDER ASSOCIATES LTD.  
REPORT NO. 912-2402  
DATED: JULY 1991  
"INT. DAM RAISING & CV DAM TOE DRAIN"

Scale: 1:250 Job No. 2003-01 Drawing No. 2003-01-01	CORRAIG-RESOURCES INC. Ferd Yukon Territory	CROSS SECTION AND DETAILED PLAN	Golder Associates Ltd.
Drawn by: [Signature] Date: 2003-01-01	Reviewed by: [Signature] Date: 2003-01-01	INT. DAM RAISING & CV DAM TOE DRAIN	Sheet 3 of 3

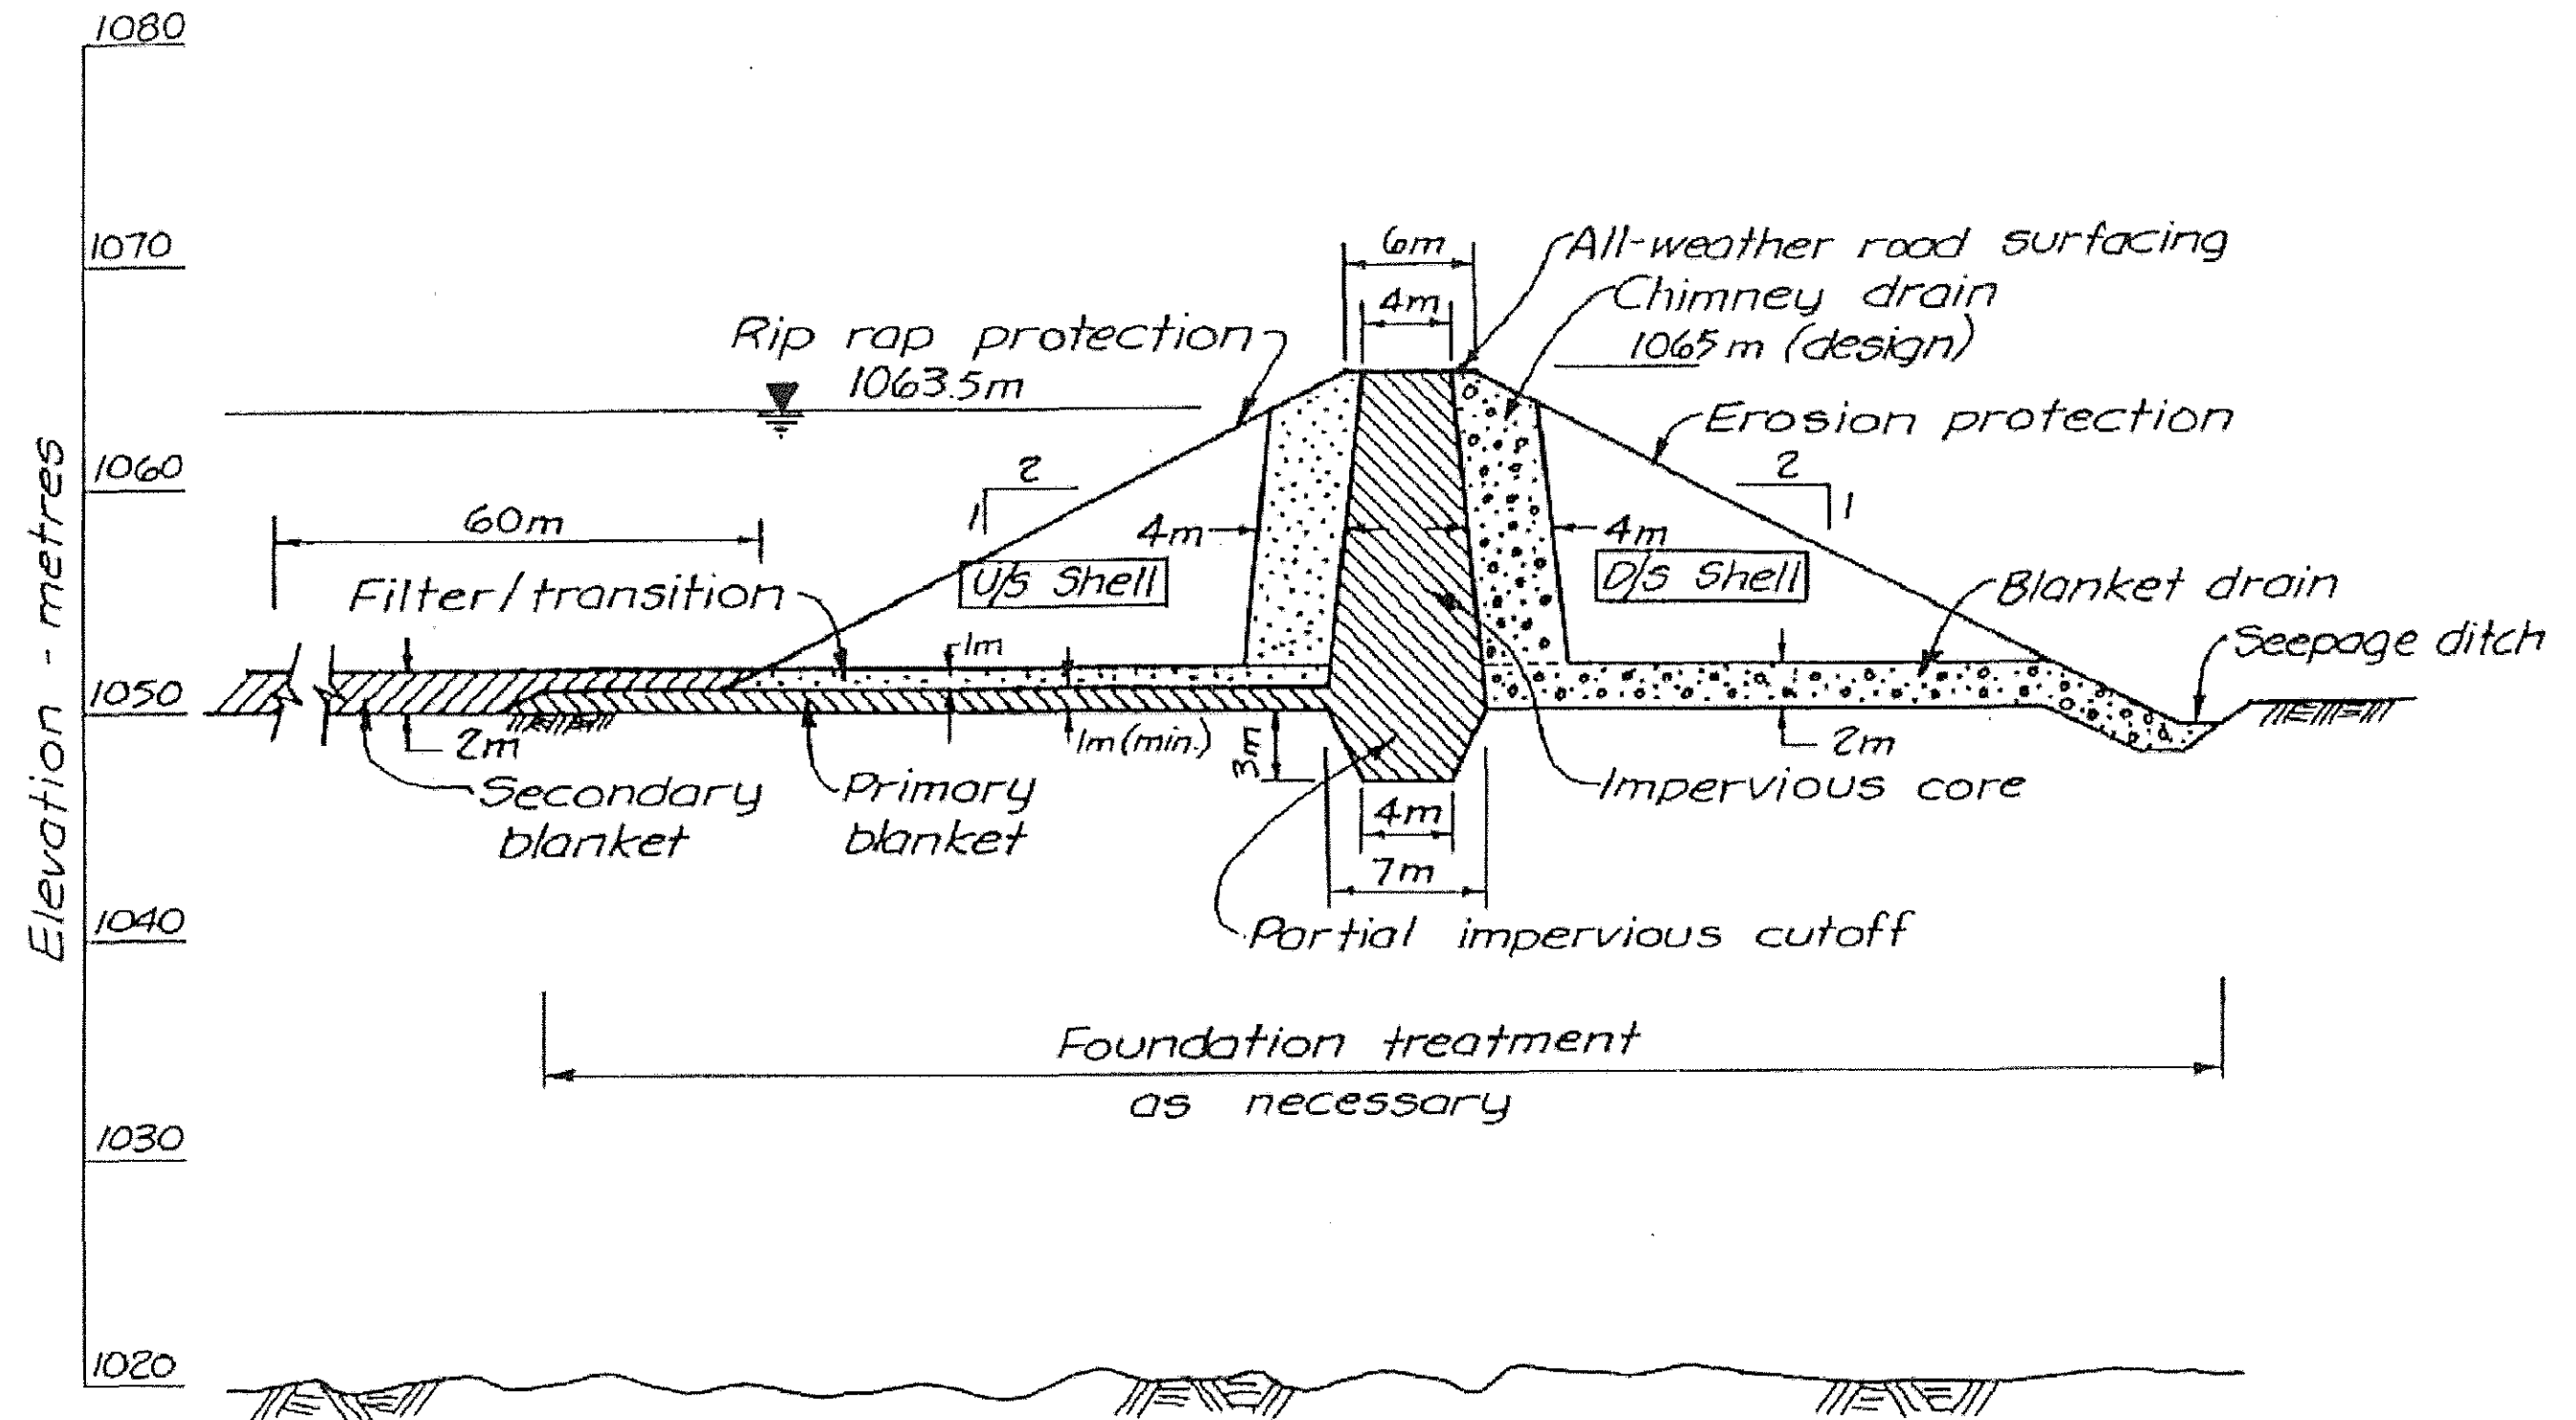
FIGURE NO.  
8

SOURCE OF FIGURE:  
GOLDER GEOTECHNICAL CONSULTANTS LTD., 1980  
REPORT TITLED "DOWN-VALLEY TAILINGS CONTAINMENT FACILITY  
REPORT TO CYPRUS ANVIL MINING LTD." JUNE 6, 1980 3 VOLS.

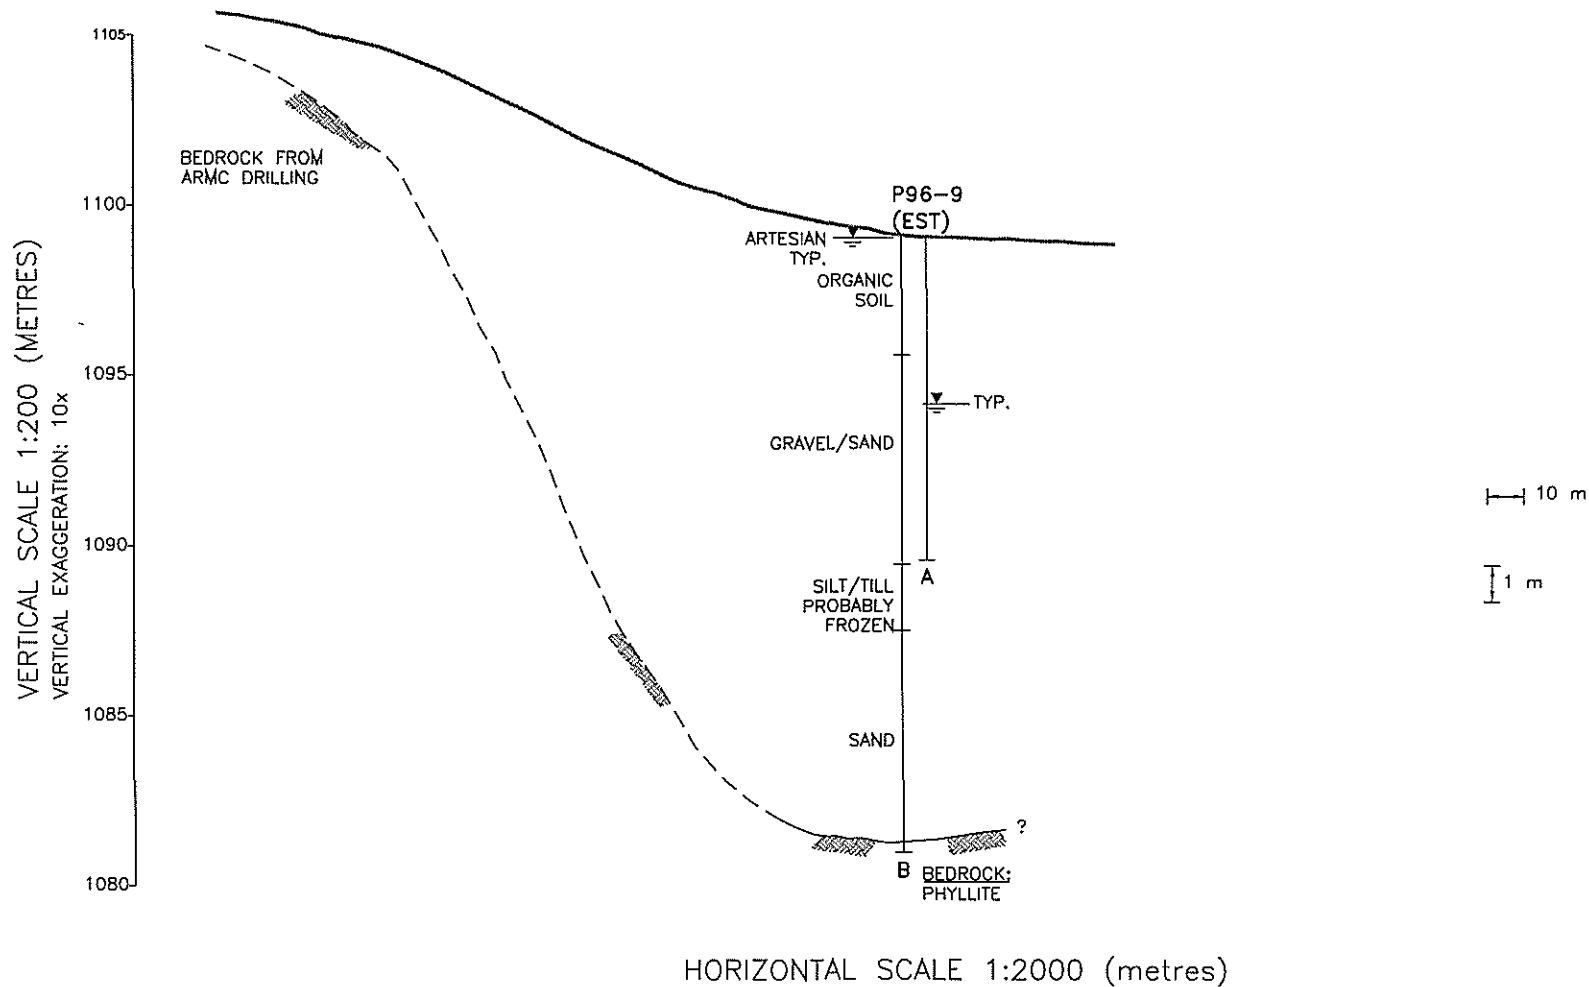
12

SOURCE OF FIGURE:  
SKETCH BY ERIC DENHOLM, GARTNER LEE LIMITED

MEASURED GROUNDWATER ELEVATION (m)

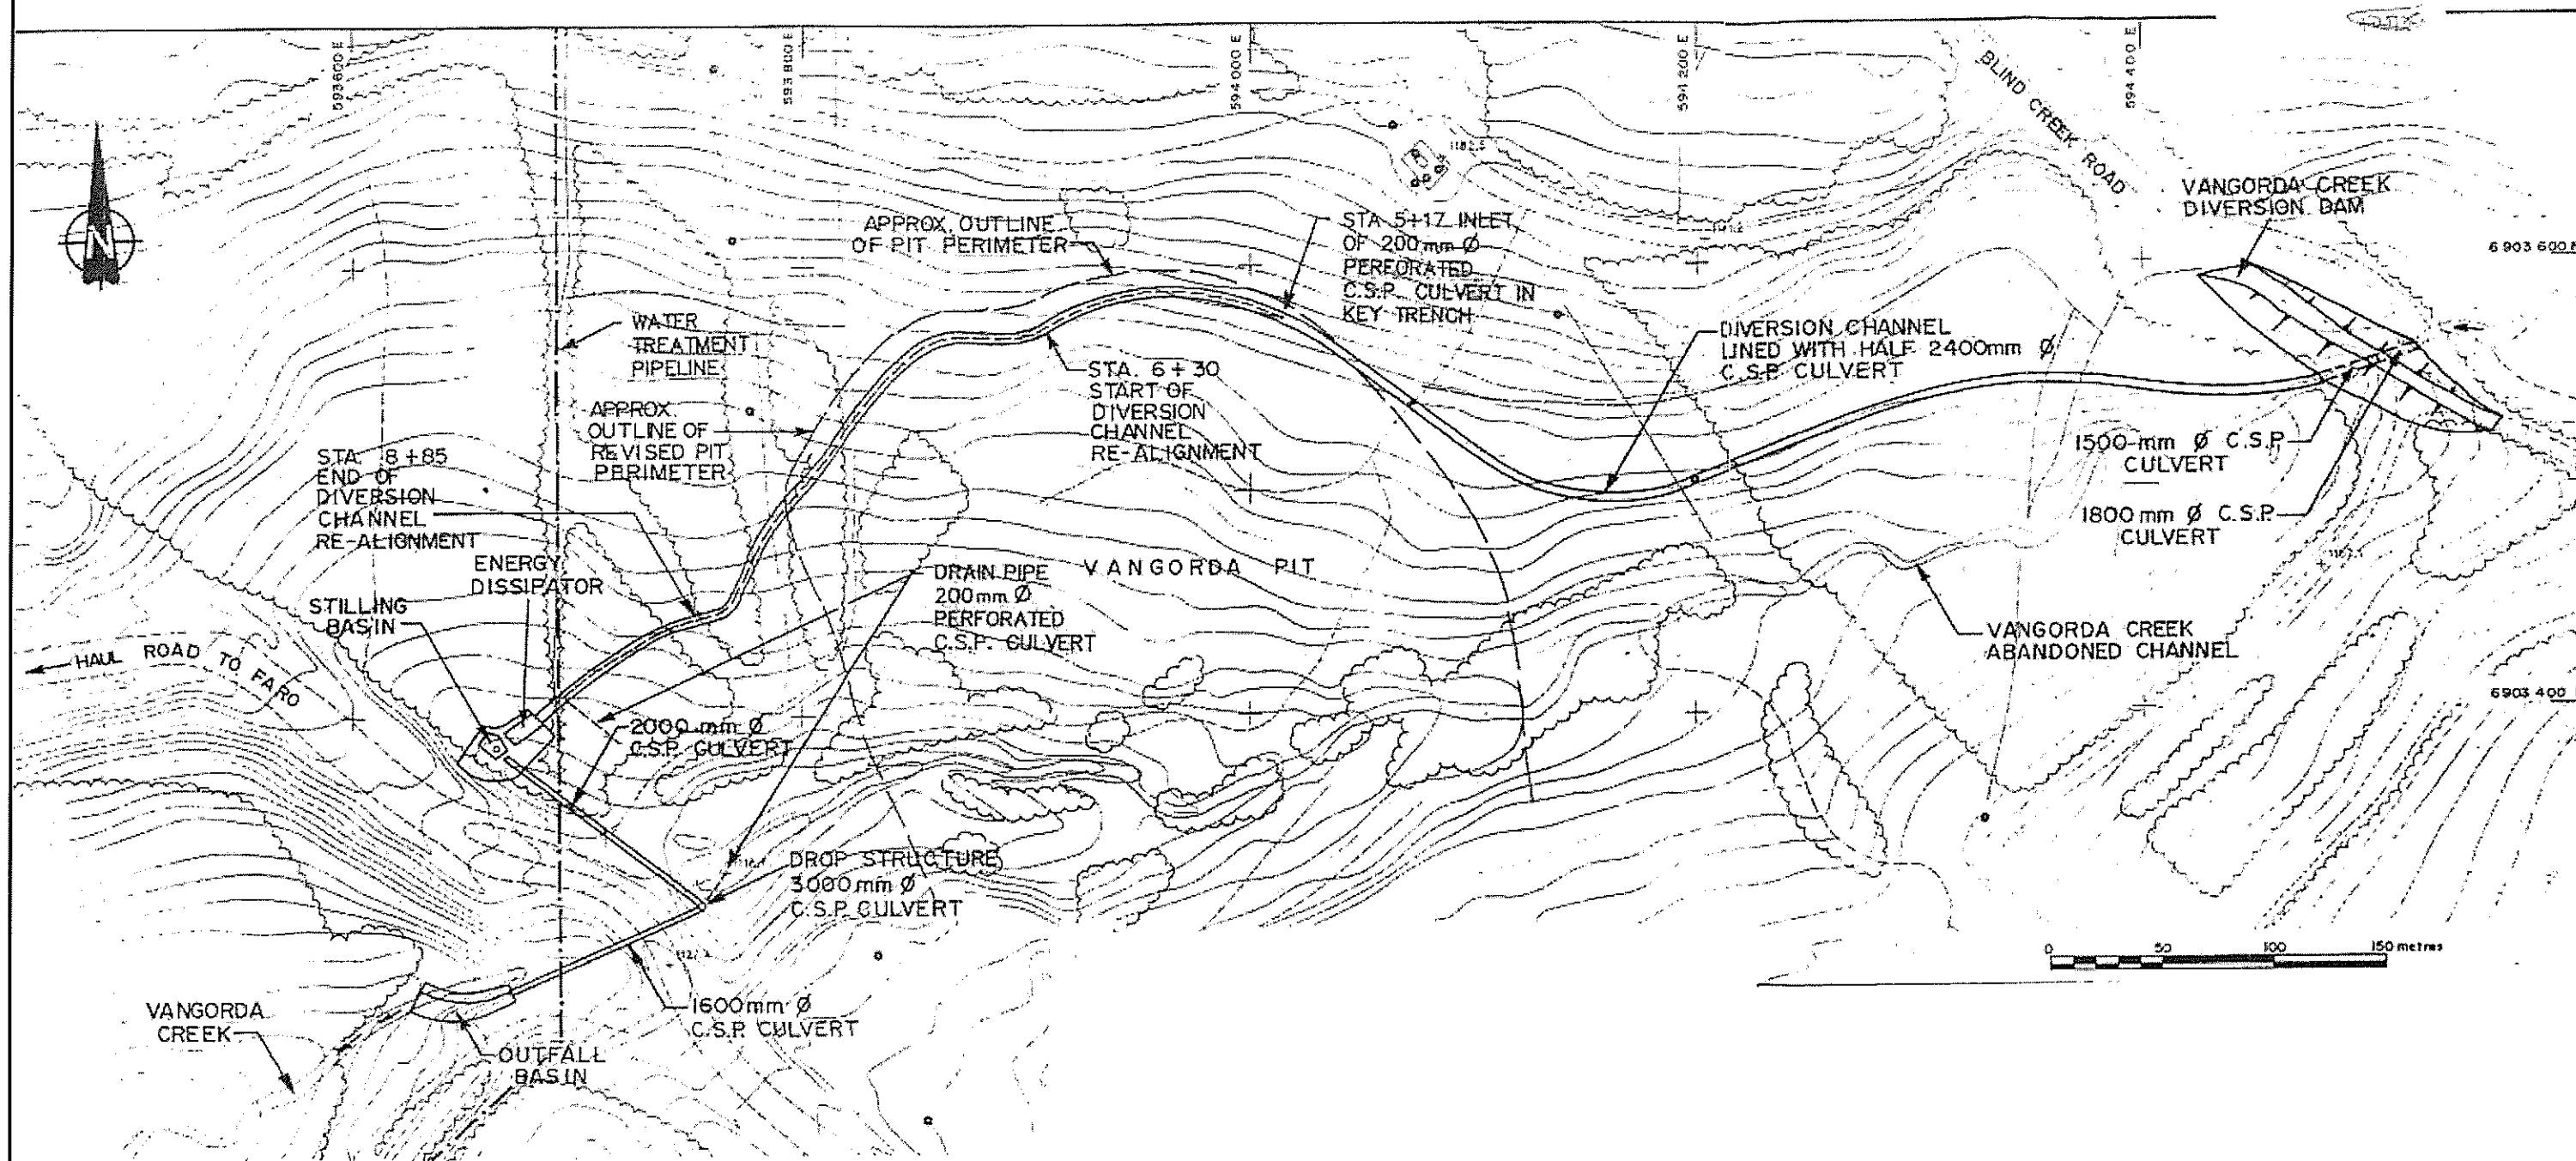
15

SOURCE OF FIGURE:  
DRAWING SHOWN BELOW DRAWN FROM REPORT BY STEFFEN, ROBERTSON KIRSTEN (CANADA) INC.  
REPORT NO. 60647 DATED MAY 1992  
"CONSTRUCTION REPORT VANGORDA CREEK DIVERSION REALIGNMENT VANGORDA PLATEAU DEVELOPMENT"

CURRAGH RESOURCES INC.	VANGORDA CREEK DIVERSION	APRIL 1992
GENERAL ARRANGEMENT		60647
STEFFEN ROBERTSON & KIRSTEN, Consulting Engineers		2

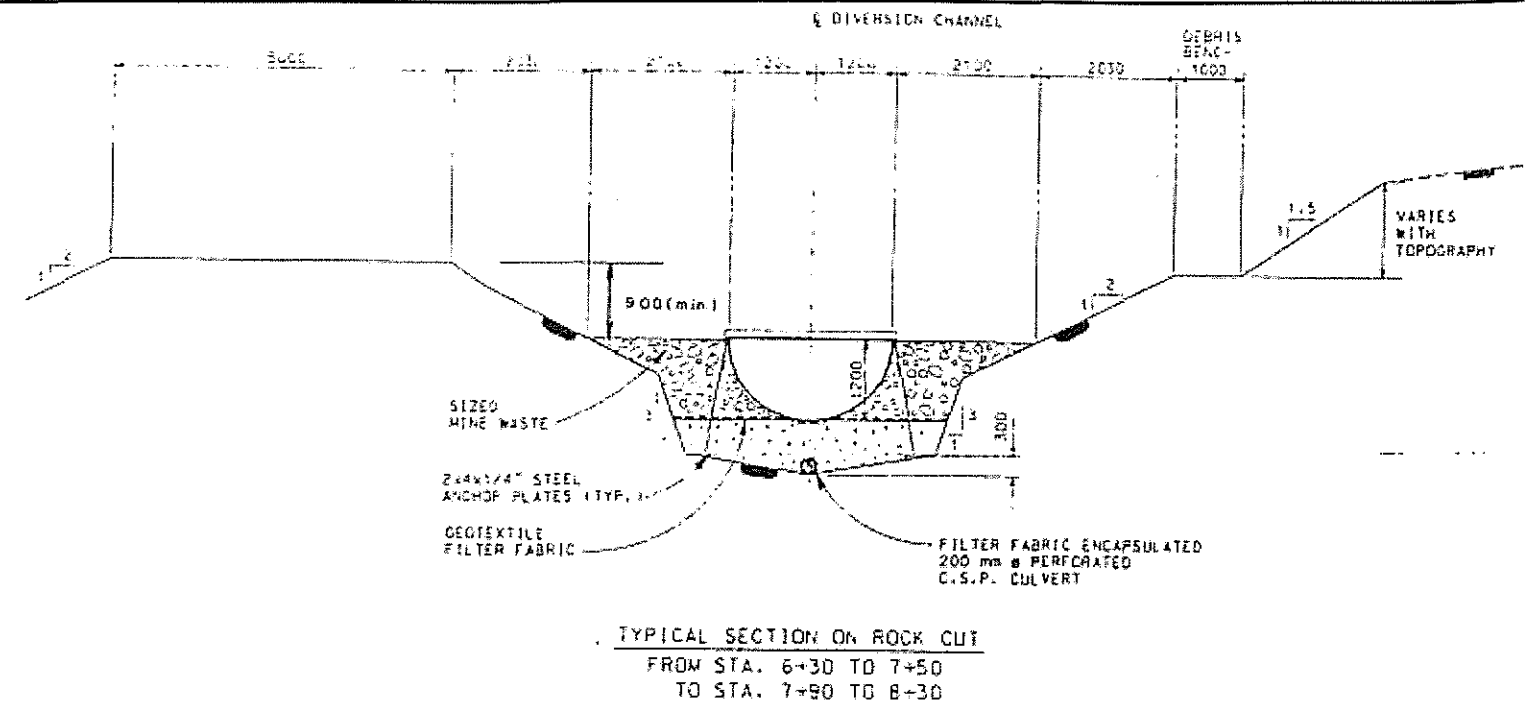
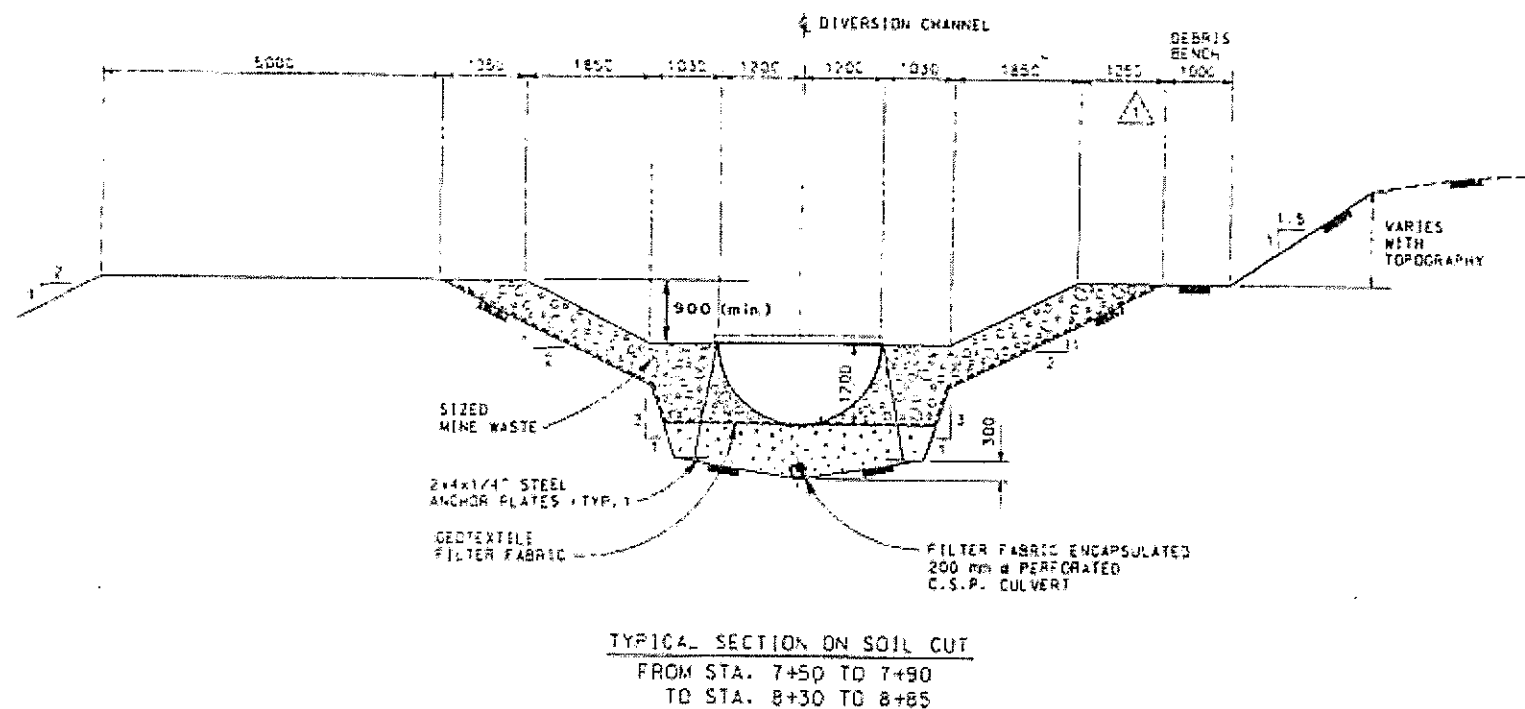
FIGURE NO.  
16

SECTION A  
SCALE: 1:50

SOURCE OF FIGURE:  
DRAWING SHOWN BELOW DRAWN FROM REPORT BY STEFFEN, ROBERTSON KIRSTEN (CANADA) INC.  
REPORT NO. 60647 DATED MAY 1992  
"CONSTRUCTION REPORT VANGORDA CREEK DIVERSION REALIGNMENT VANGORDA PLATEAU DEVELOPMENT"

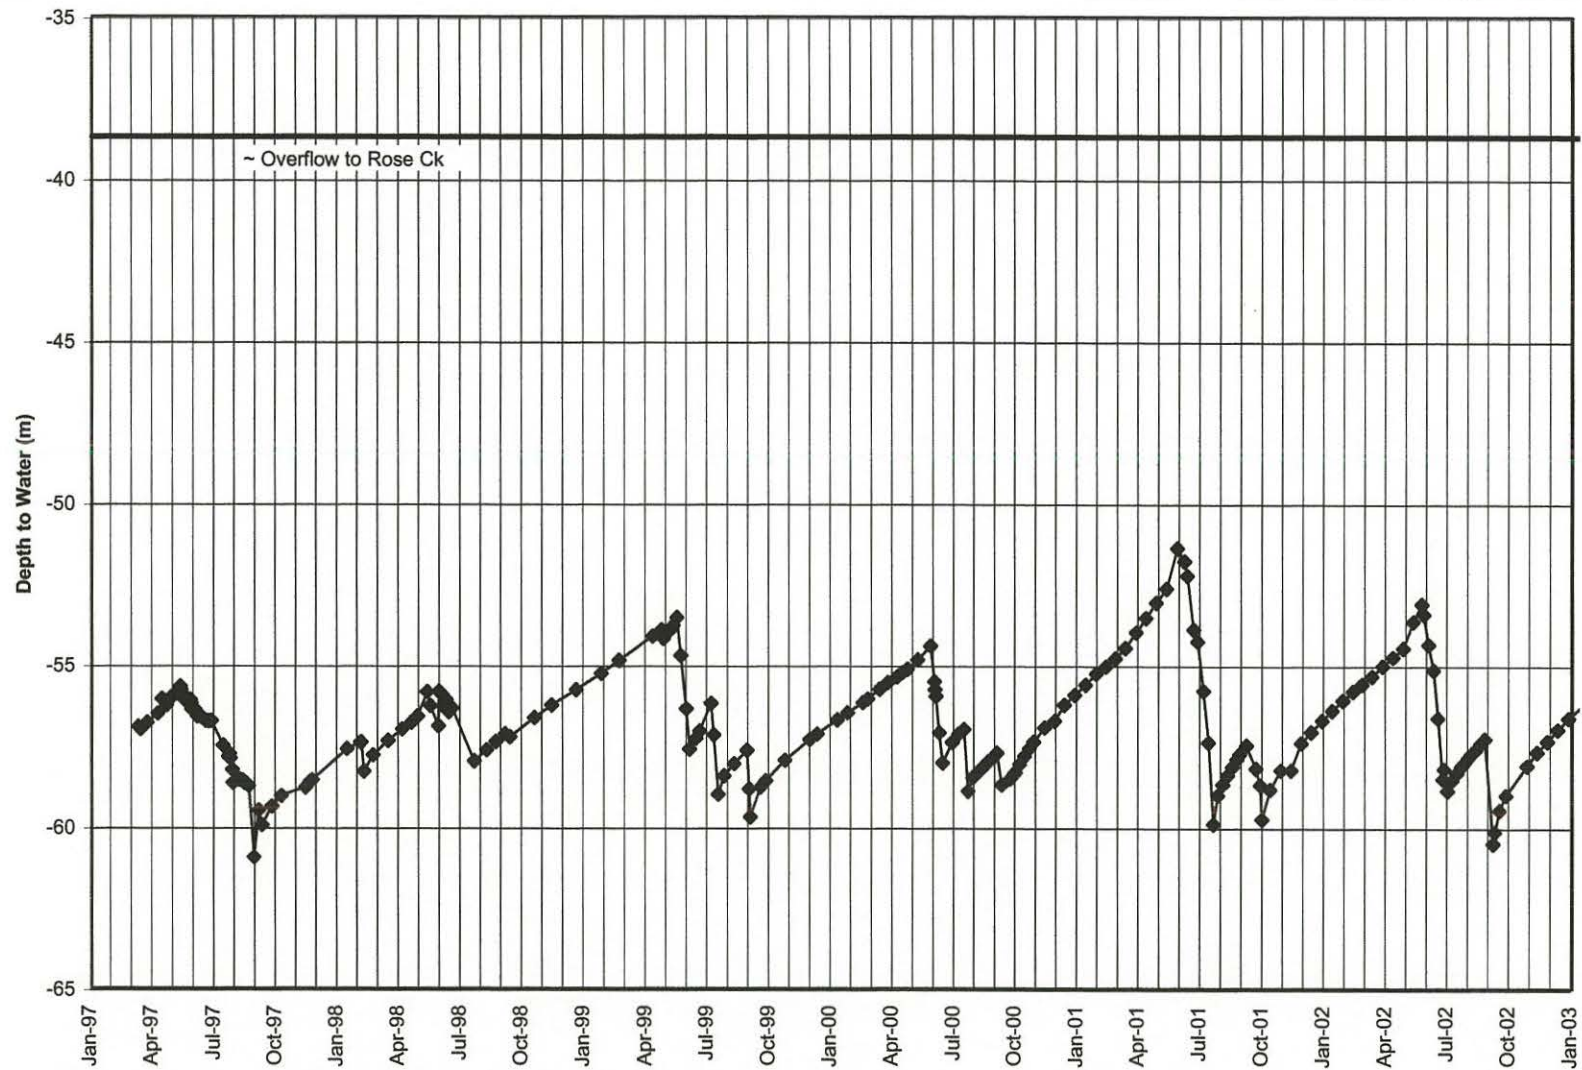
Figure 18. Zone II Pit Water Elevations, 1997 to 2002

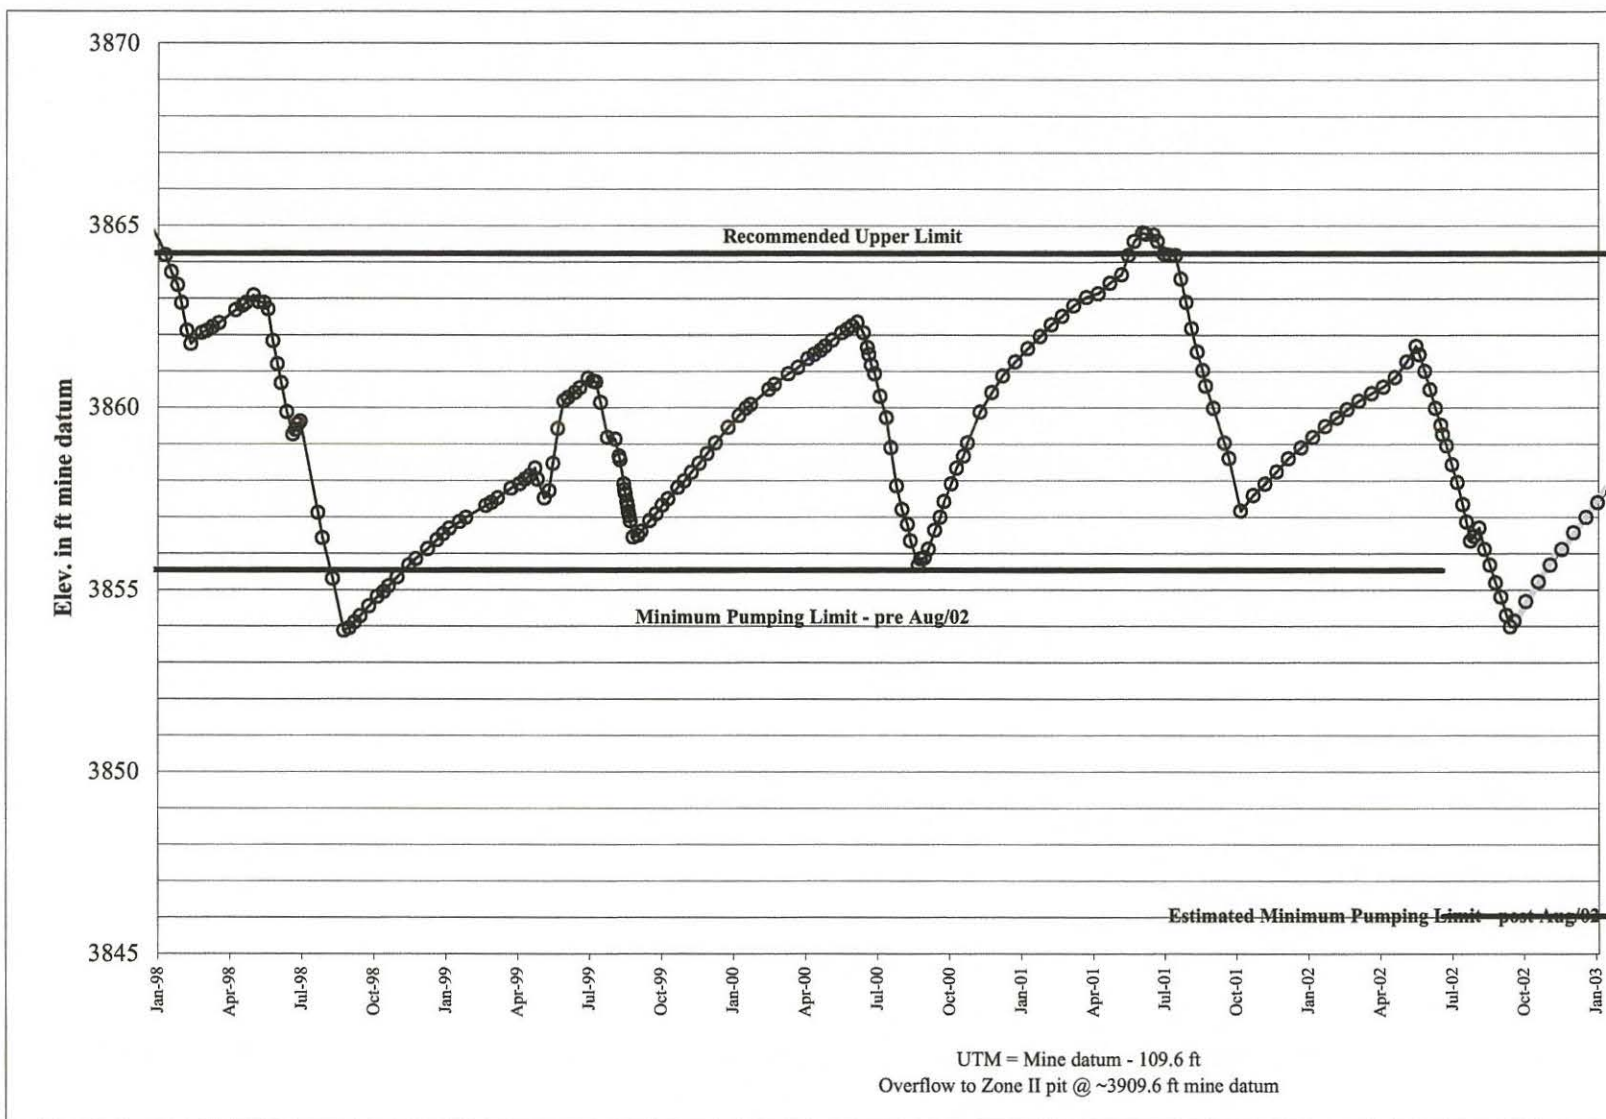
Figure 19. Main Pit Water Elevations, 1998 to 2002
